**CRAIG COTTAGE,
BANKS,
BRAMPTON,
CUMBRIA**

WATCHING BRIEF REPORT

CP. No: 10213/12

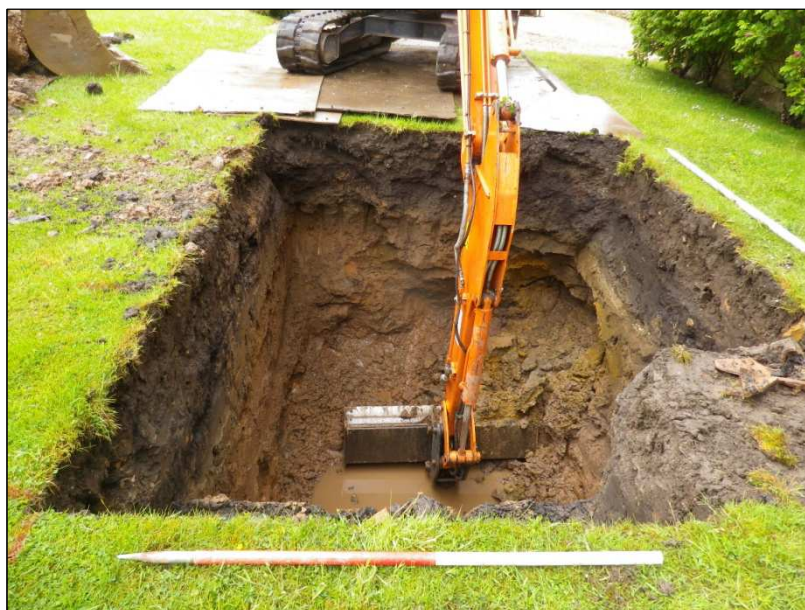
Plate 1: excavation of new septic tank pit (facing west)

4.2.1 At a distance of 2.20m south of the south east corner of the garage a rectangular pit measuring 3.20m in length and 2.44m in width was excavated to a maximum depth of 2.55m (Figure 2; Plate 1). This was to contain the new septic tank. The orange/brown, sandy/clay natural substrate **(100)** was excavated into for a depth of 1.70m. Over this lay 0.70m of dark brown made ground **(102)** containing late 19th, early 20th century pottery and bottle glass sherds along with some clay tobacco pipe fragments. This was covered by 0.15m of dark brown, silty topsoil **(100)**.

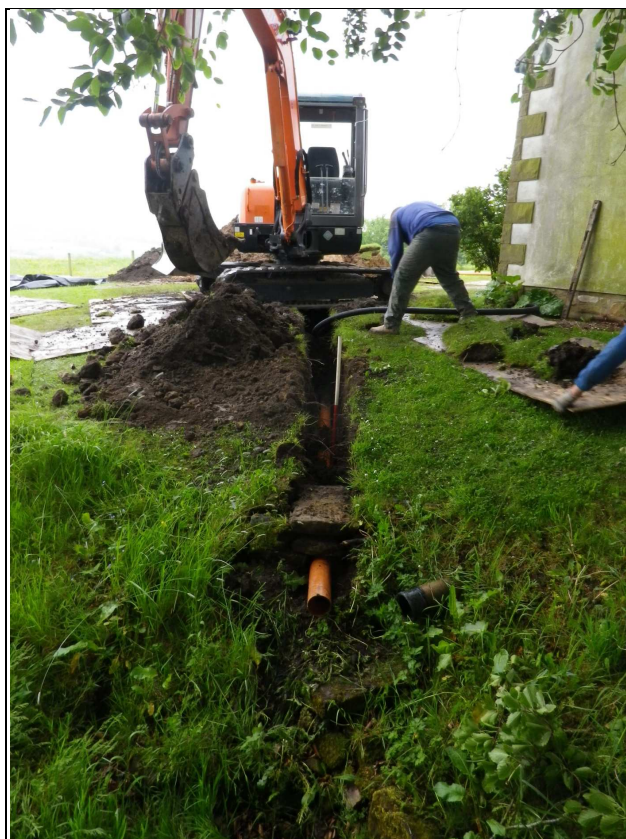
Plate 2: excavation of outflow trench (facing south-west)

4.2.2 From the north-east corner of the new septic tank pit a trench was excavated in a north-easterly direction toward the stream (Figure 2; Plate 2). This was done in order to contain a water sampling chamber and the outflow pipe. The trench measured 6.60m in length, had a maximum depth of 1.00m and

measured 0.35m in width. Made ground (102) was covered by 0.15m of topsoil (100).

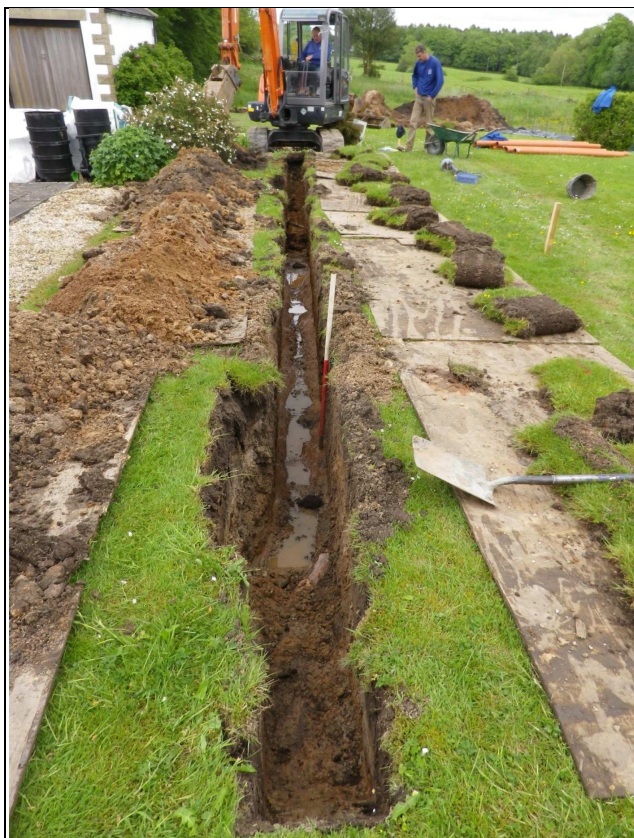
Plate 3: excavation of foul pipe connection trench (facing east)

- 4.2.3 In order to connect into the existing foul water pipe a trench was excavated from the front of Craig Cottage, across the lawn in an easterly direction, to the south-west corner of the new septic tank pit (Figure 2; Plate3). The trench measured 22.60m in length. 0.35m in width and had an average depth of 0.75m. At the western end of the trench 0.60m of excavated natural substrate (100) was covered by 0.15m of topsoil (100). At a distance of c.4.00m west of the new septic tank pit the deposit of made ground (102) was encountered. This gradually increased in depth, toward the pit and stream, in an easterly direction until at the eastern end of the trench it measured 0.60m in depth with 0.15m of topsoil (100) over it.

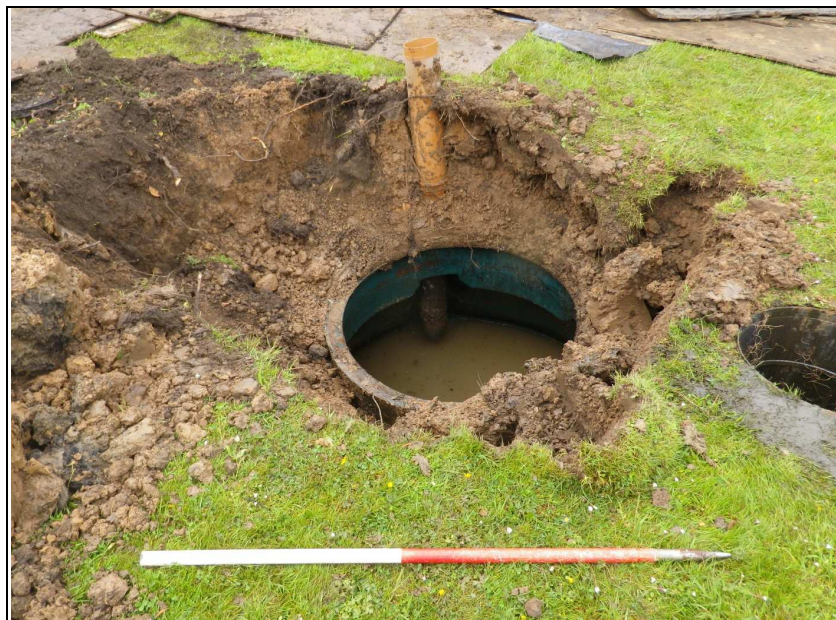
Plate 4: Excavation for removal of redundant septic tank (facing north)

- 4.2.4 On the lawn at a distance of c.13.00m south of the garage was the site of the redundant septic tank (Figure 2; Plate 4). In order to extract this a rectangular pit measuring 2.40m in length and 1.80m in width was excavated to a depth of 1.00m around it. Excavated natural substrate (101) measuring 0.85m in depth was covered by 0.15m of topsoil (100).
