**MIREHOUSE TO LONG
CLOSE FARM,
BASSENTHWAITE,
KESWICK**

**RAPID DESK-BASED ASSESSMENT,
GEOPHYSICAL SURVEY AND TRIAL
TRENCH EVALUATION**

CP10316

DOCUMENT TYPE: Rapid Desk-Based Assessment, Geophysical Survey and Archaeological Evaluation Report

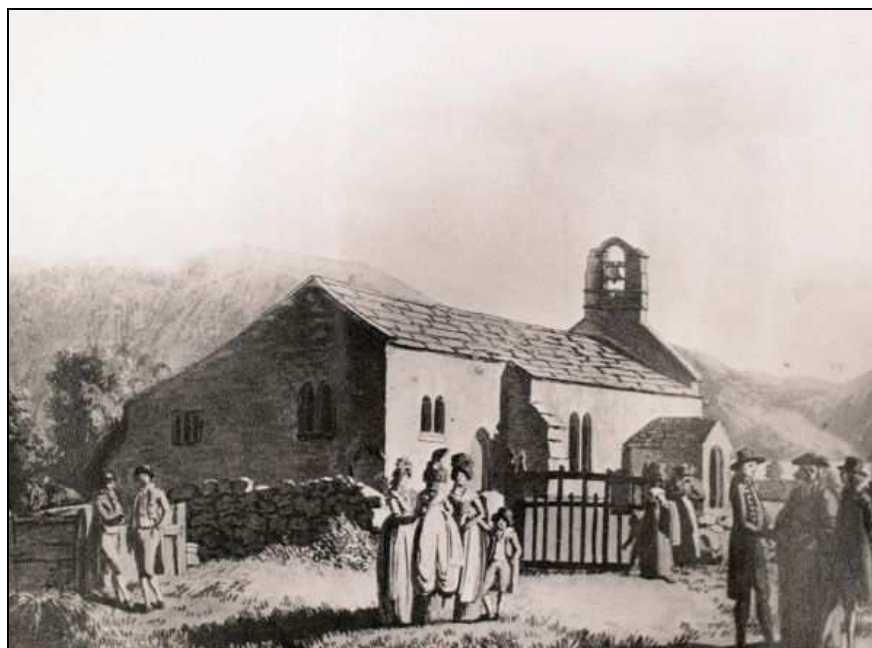
Plate 2: St Bega's Church at Bassenthwaite, c.1830 (Courtesy of Carlisle Library)

- 4.2.21 St Bega's Church at Bassenthwaite was restored and *'almost entirely rebuilt'* in 1874 at the expense of the Spedding family of Mirehouse (Bulmer 1901, 334). Plate 2 below provides an illustration of the church prior to this date, showing the simple nature of the structure as it appeared in an artist's impression in c.1830.

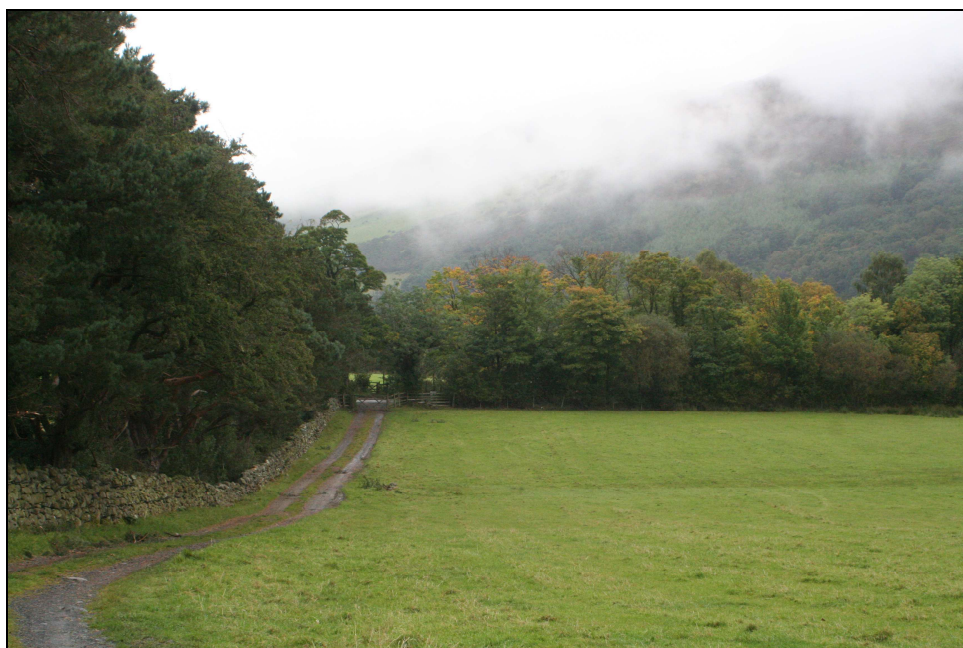
Plate 3: View of Field 2 looking northwest; the infilled stream can be seen by the presence of a dark band running towards the track. The row of Scots Pines is visible on the left

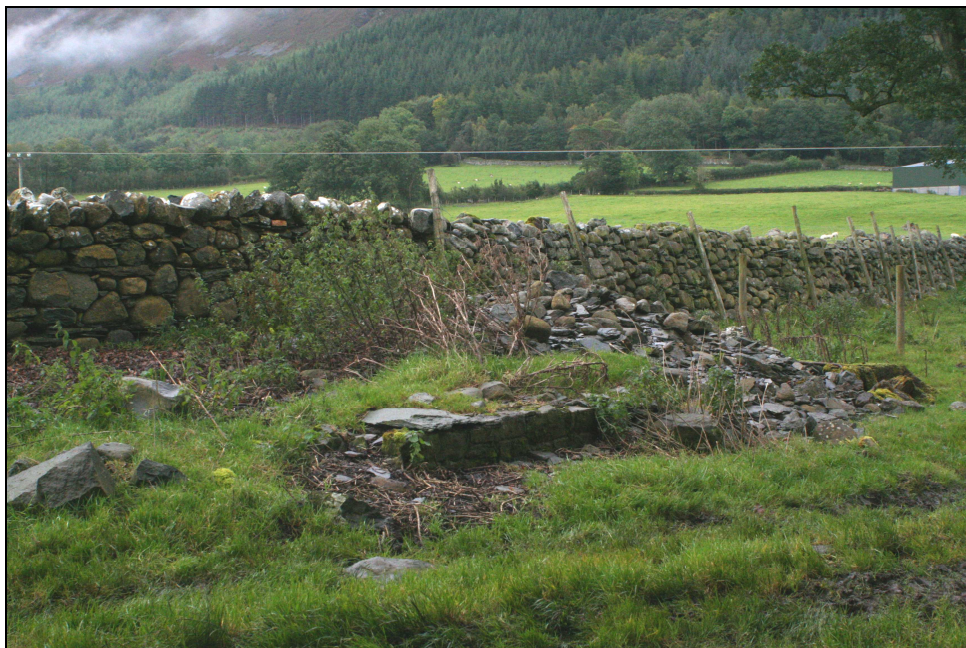
- 5.2.3 *Field 3:* This area contains a number of interesting landscape features which may relate to the activities of Thomas Storey, Esq, discussed above in paragraph 4.2.15. At the northern end of this field is a ruined building. The walls are present, but only to c.0.3m (Plate 4). Occasional bricks present in the rubble suggest that the construction of this building may be quite late (i.e. post-medieval). The building material is reminiscent of other vernacular architecture in the area, with its rough stone construction and stone flag roofing.

Plate 4: The ruins of a small building at the northern end of Field 3, facing northeast; the remains of the foundation can be seen, as well as the remains of a stone flagged roof

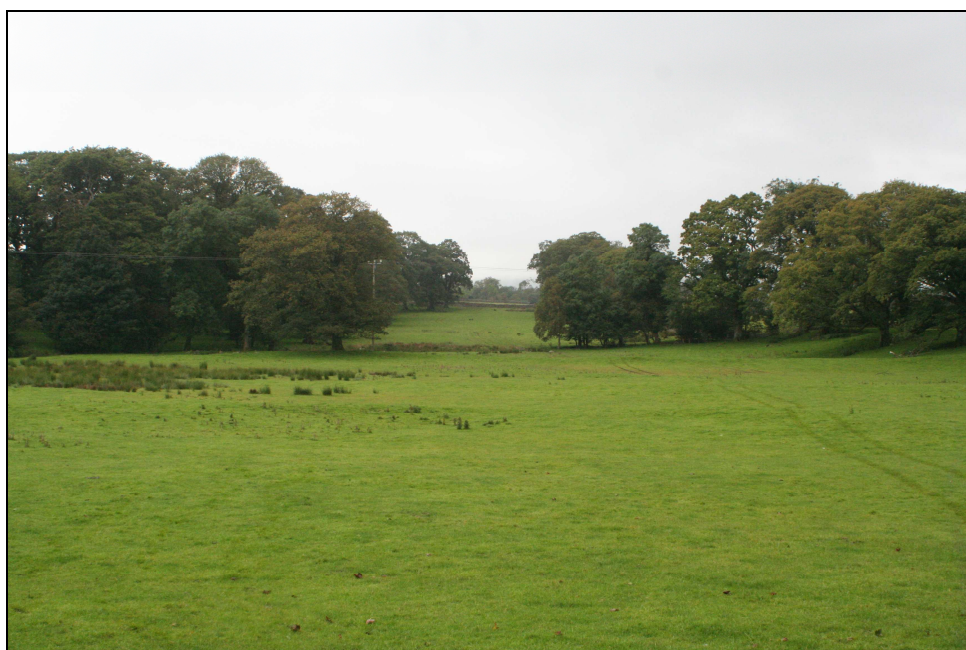
- 5.2.4 South of this building a long tree lined avenue seems to have been laid out. This consists of evenly spaced oak trees occupying this whole length of this area. The view is very clear from Field 2 to the north and Field 4 to the south (Plate 5). This view may have been planted to be appreciated by those walking from Mire House to the lake. When taken as a whole the landscape between Mire House and the lake strongly suggests the informal landscaping arrangements made popular in the 18th century by landscape architects such as Lancelot Brown and William Kent, and again, is supported in the historical record by the works of Thomas Storey referred to above, though the formality of a tree-lined avenue is somewhat at odds with a strict adherence to the works of popular 18th century landscaping fashions. The suggestion that this is a deliberate tree-lined avenue is somewhat confirmed by its appearance on the First Edition Ordnance Survey map (1867).

Plate 5: View of the possible tree-lined avenue taken from Field 5 looking north into Field 3

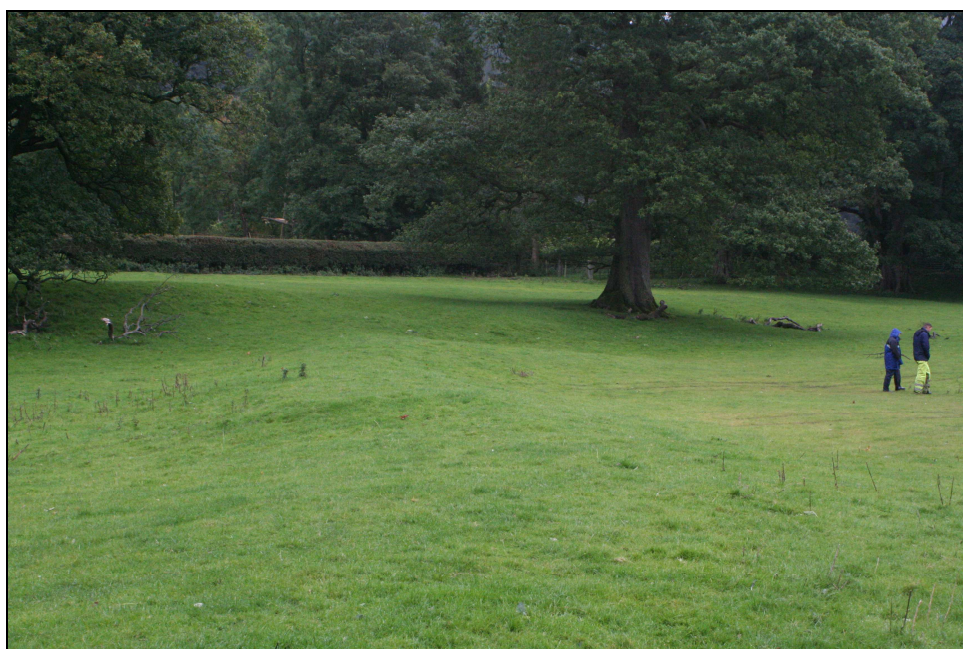
(c.0.3-0.4m) mound of earth is supplemented to the east by the growth of ash, silver birch and hawthorn trees. As the presence of a high field boundary would have spoiled the view up the avenue in Field 3 it is likely that if this boundary was once a more substantial upstanding structure then it was knocked after the layout of this avenue. Two earthworks were noted within Field 4. To the north a low earthen feature crossed the field from east to west, before turning south near the confluence of two steams. As can be seen in Plate 6 this is a broad (c.5-6m) and low (c.0.3-0.4m) mound of earth. Approximately 20m south of this earthwork a line of stones can be seen just at the turf-line (Plate 7). This may be the remains of an old field-boundary. The second, southern, earthwork appears to be shorter than the first, but is of similar dimensions.

Plate 6: Most northerly of the two earthen ridges in Field 4, the photo is taken looking north

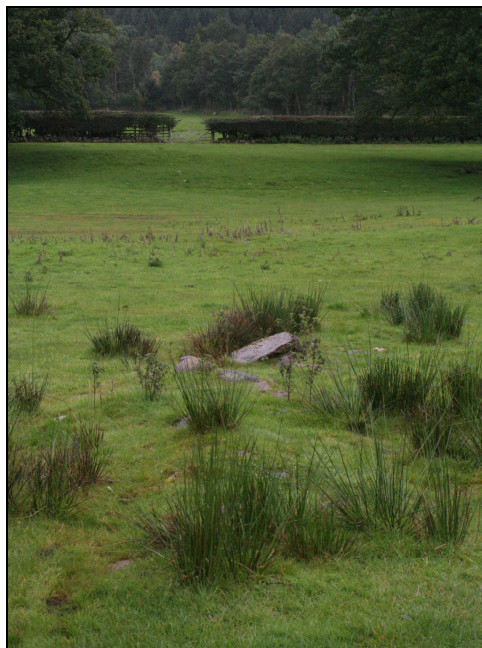
Plate 7: View looking east; section of stone alignment between the two earthen mounds within Field 4

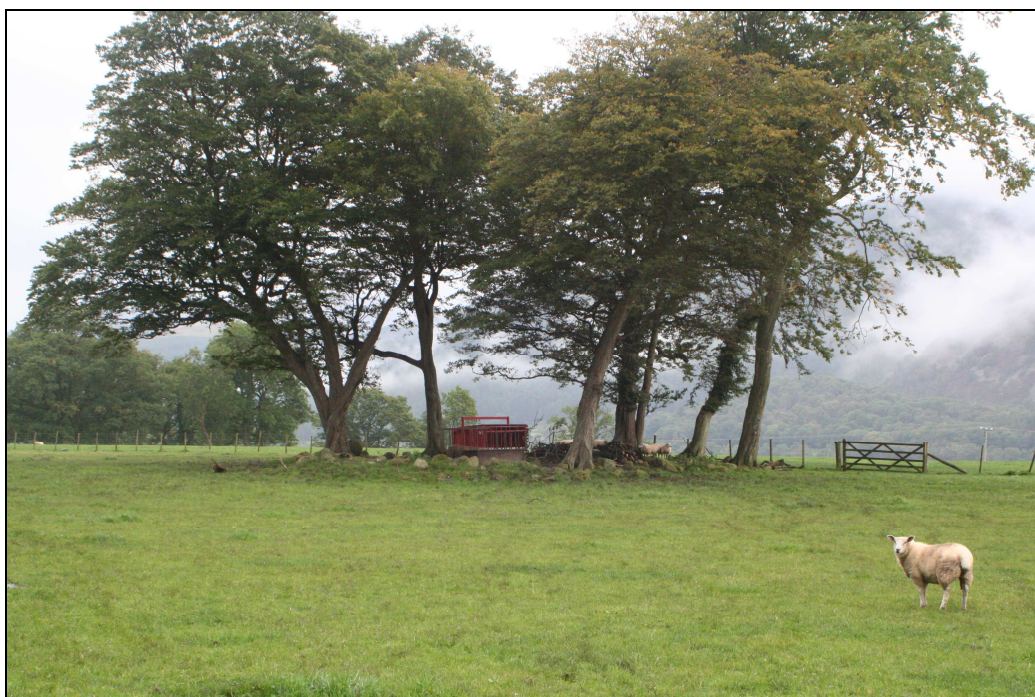
Plate 8: View looking southwest in Field 6; the feature consisting of a rough mound of large sub-rounded stones intermittently planted with oak trees

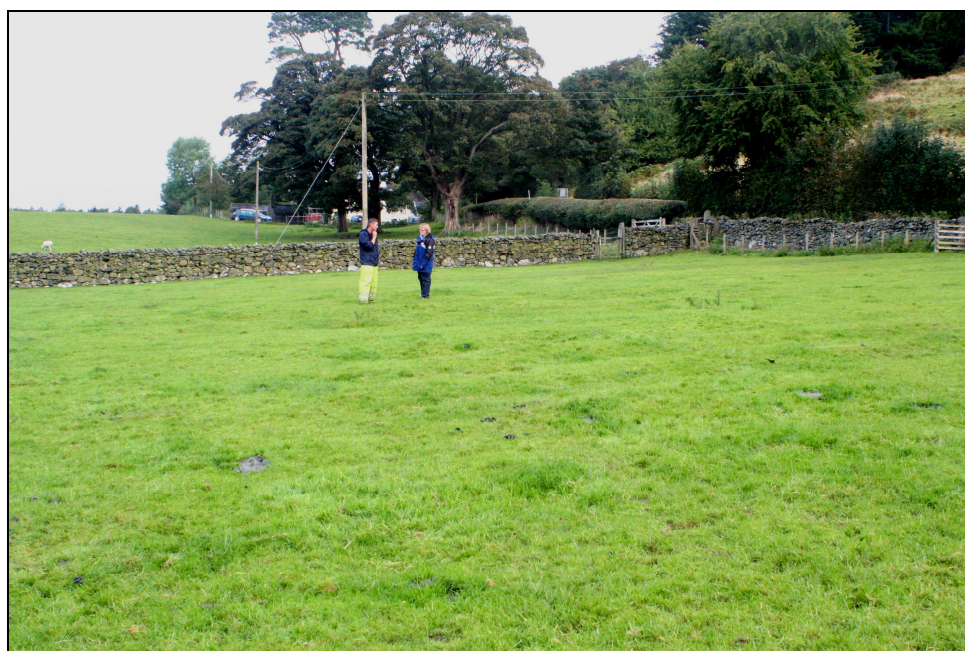
Plate 9: View looking north in northern corner of Field 10; a small area of cultivation evidence enclosed by a possible low mound can be seen in a small area of this field

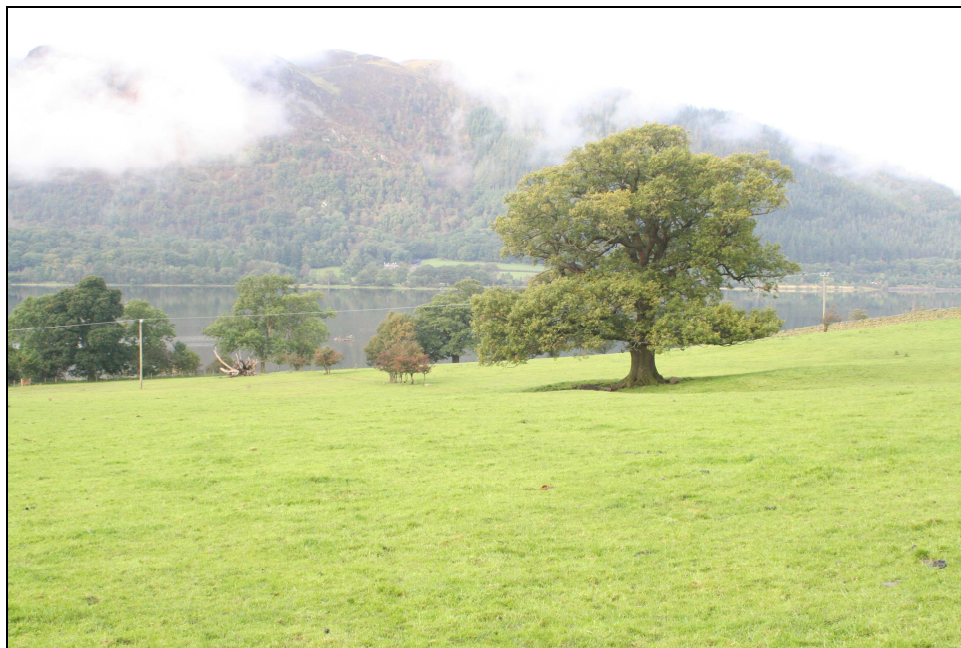
Plate 10: View of Field 10 looking northwest; a field boundary is clearly marked on modern mapping, but on the ground it is marked only by a mature oak tree, a number of hawthorn trees growing along a low ridge of earth, and a now fallen oak tree visible to the left of the photograph

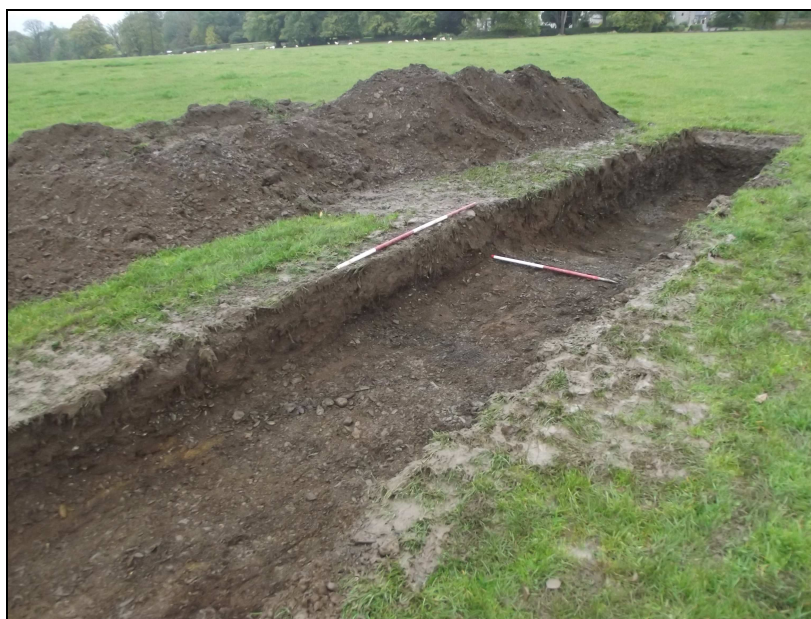
Plate 11: Trench 1, looking north east

7.2.1 *Trench 1:* Trench 1 was located within Area 3 toward the northern extent of the study area and was aligned broadly north east – south west (Figure 38). The trench was excavated to a maximum height of 89.32m A.O.D and a minimum of 89.01m A.O.D. revealing mixed brown and grey, loose limestone fragments (**102**) below c.0.20m of moderately soft mid brown clayey silt subsoil (**101**), and c.0.20m of moderately compact dark brown clayey silt topsoil (**100**) (Plate 11).

7.2.2 Modern ruts possibly caused by vehicles traversing Area 3 were observed within the topsoil and subsoil and were heading roughly southwards towards the entrance of the field. These were identified within the geophysical survey (see Section 6.4.4), No archaeological remains were observed within Trench 1.

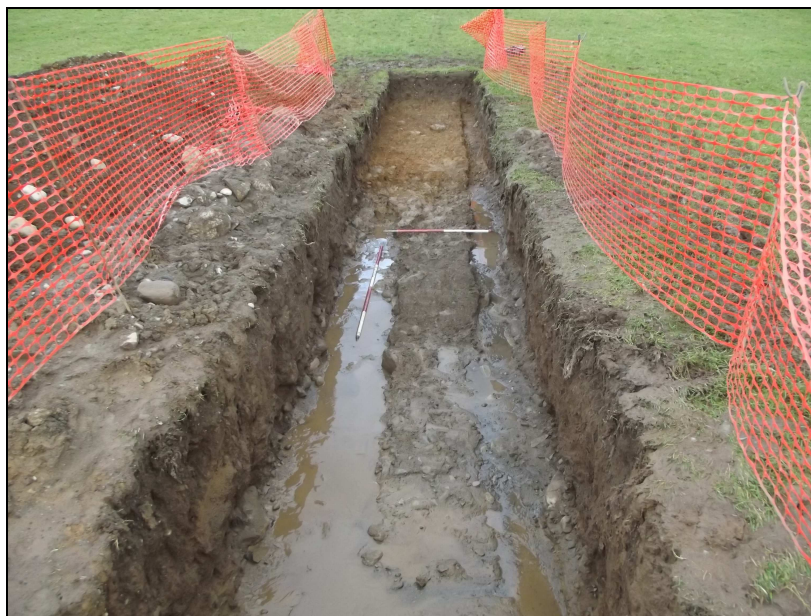
Plate 12: Trench 2, looking north east

7.2.3 **Trench 2:** Trench 2 was located within Area 5 of the study area, south of Area 3 in a north east – south west orientation (Figure 38). The trench was excavated to a maximum height of 95.00m A.O.D and minimum of 93.88m A.O.D. This revealed soft orange sandy silt (**202**) below c.0.20m of soft mid grey - brown silty clay subsoil (**201**), and c.0.35m of soft mid brown clayey silt topsoil (**200**) (Plate 12).

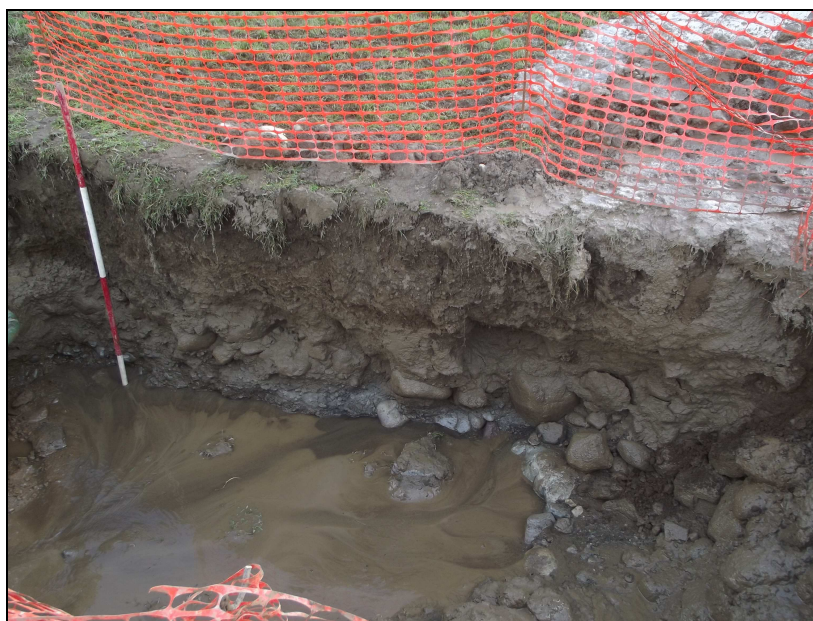
7.2.5 The paleochannel [**203**] had poorly defined edges, with fairly steep edges and a sharp break of slope leading to a flat base. The possible waterway had incised through a naturally deposited orange sandy silt (**202**) glacial till which itself was observed to overlie loose mid to light grey gravels (**206**) (Figure 39).

Plate 13: A machined section part of the way through the possible paleochannel, looking south east

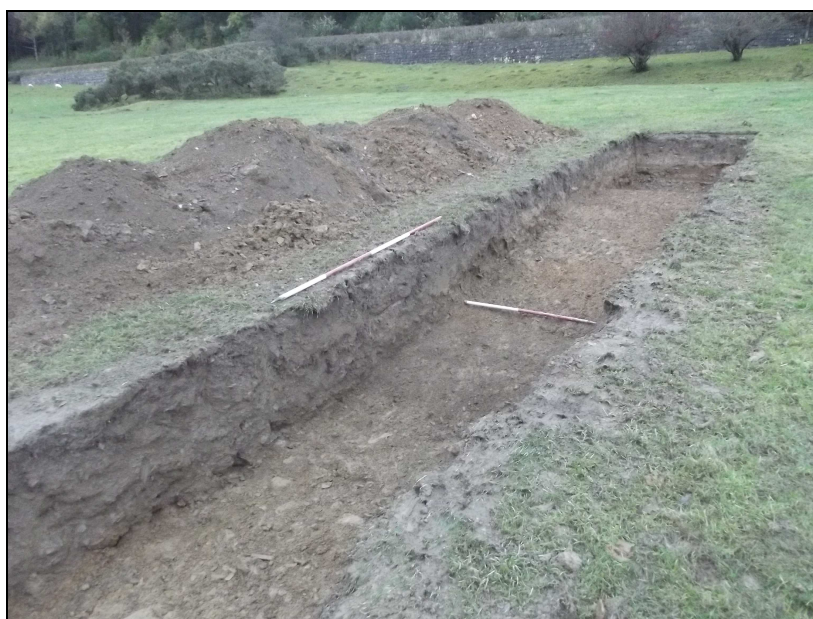
Plate 14: Trench 3, looking north

7.2.6 **Trench 3:** Trench 3 was located in Area 9 at the southern extent of the study area and was aligned broadly north east – south west (Figure 38). The trench was excavated to a maximum height of 77.15m A.O.D and minimum of 76.32m A.O.D. This revealed moderately compact orangey – grey gravelly clay (302) below c.0.22m of soft mid yellow – brown silty clay subsoil (301), and c.0.24m of soft greyish – brown silty clay topsoil (300) (Plate 14).

7.2.7 Evidence of possible land slippage was observed towards the south – western end of the trench with a deposit **(303)** of moderately compact greyish brown silty clay with moderate pebble inclusions recorded in the south east facing section. The deposit extended from the south west extent of the trench towards the north east up to 5.64m to a maximum thickness of 0.35m whereupon it was truncated by a small gully **[304]** (Figure 40) which was identified in the geophysical survey (see Section 6.10.3). The gully spanned the width of the trench, measured up to 0.70m wide and had a maximum depth of 0.45m (Plate 15). With a rounded base and steep edges, the gully **[304]** was filled entirely with brown silty clay **(305)** which contained no observable archaeological artefacts.

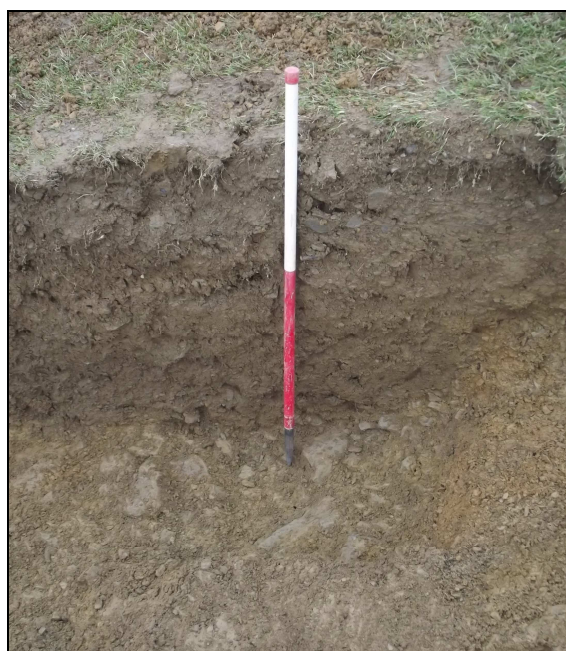
The only archaeological feature identified within the 4 trenches was a gully [304] in trench 3. No artefactual remains were present within the exposed length of gully, and therefore the purpose and date of the feature is unclear. Of the other features identified as part of the geophysical investigation, a large possible paleochannel was recorded within Trench 2, and depressions caused by vehicular access and egress from Areas 3 and 9 were observed within Trenches 1 and 4

Plate 15: Section of gully [304] within Trench 3, looking north west

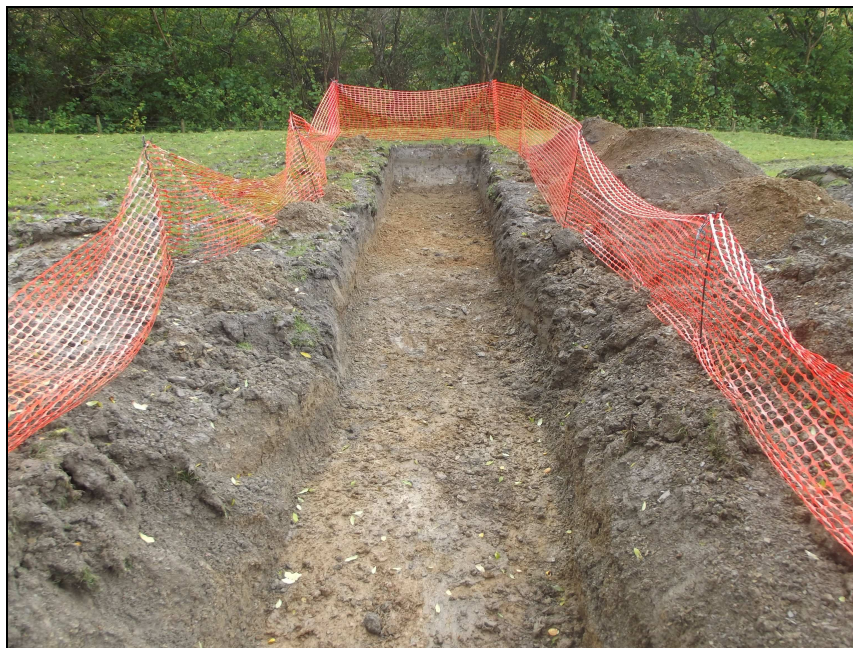
Plate 16: Trench 4, looking south west

7.2.9 **Trench 4:** Trench 4 was located south of Trench 3, at the southern extent of Area 9. and was aligned north east – south west (Figure 38). The trench was excavated to a maximum height of 76.27m A.O.D and minimum of 74.95m A.O.D. This revealed soft mid orange – grey clay **(402)** below c.0.25m of soft mid brown silty clay subsoil **(401)**, and c.0.15m of moderately compact mid grey – brown silty clay **(400)** topsoil (Plate 16).

7.2.10 Similar to Trench 1, gravelly depressions were observed towards the south eastern end of the trench, which were identified within the geophysical survey (see section 6.10.3). These depressions led towards the southern entrance of Area 9, and are therefore probably a result of modern vehicle use. No archaeological remains were observed.
