**NORTHFIELDS DAY  
CENTRE,  
STONE ROAD,  
STAFFORD**

**ARCHAEOLOGICAL BUILDING  
RECORDING**

**CP. No: 10423**

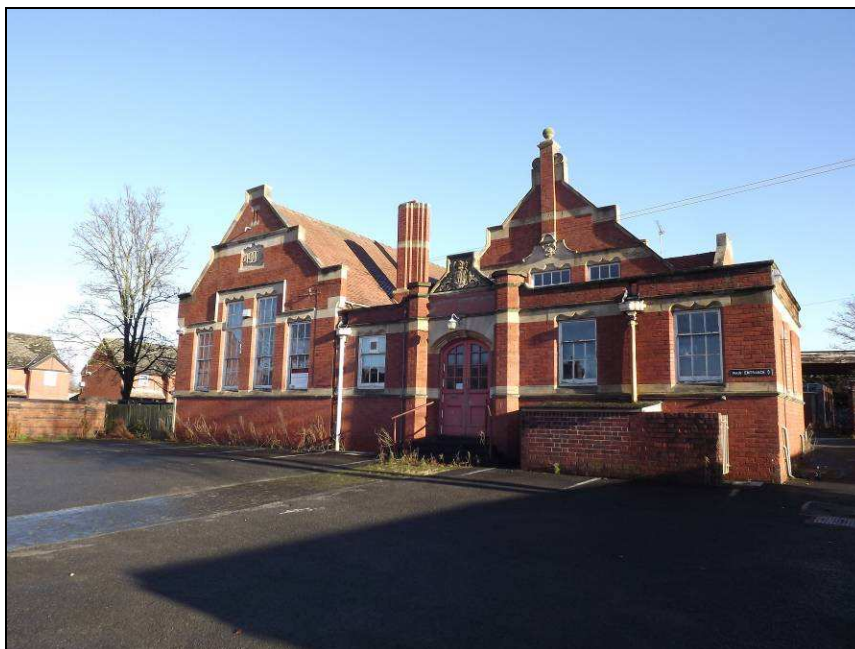
*Plate 14: West elevation of the earliest phase of the Northfields Day Centre*

- 5.2.2 The west elevation of the former school building faces towards Stone Road (Plate 14). This elevation illustrates that the school is constructed of red brick laid in Flemish Bond (alternate headers and stretchers used in each course) with yellow masonry dressings, and that the architectural style of Neo-Gothic was utilised, typical of such buildings of the late 19<sup>th</sup> and early 20<sup>th</sup> century. This elevation, which is not symmetrical, contains an off-centre main entrance accessed up four concrete steps which presumably replaced earlier stone versions. The double doorway itself is flanked to either side by projecting hexagonal columns with flat masonry capping stones, and decorative horizontal string courses which extend along the whole of the elevation (Plate 15). Above the doorway is a coat of arms which contains a castle within a shield, and above the 'Stafford Knot' is depicted (Plate 16). To either side of the doorway there are windows which all have decorative stone lintels and plain sills that form part of the horizontal string course which runs around the building (Plates 14 and 17). The roof over this section of the building, which contains this main entrance and flanking windows, appears to be flat, although it could not be accessed at the

- 5.2.5 Set behind the flat-roofed section of the west elevation there is a further highly decorative shaped gable, which was not clearly observed due to it being set back from the elevation (see Plate 14 for example). This gable has slightly different detailing to that shown on Plate 22, with the use of a vertical projecting brick column down the centre of the gable surmounted with a masonry ball finial. At the base of this brick column there is a further depiction of the Stafford Knot (Plate 24).

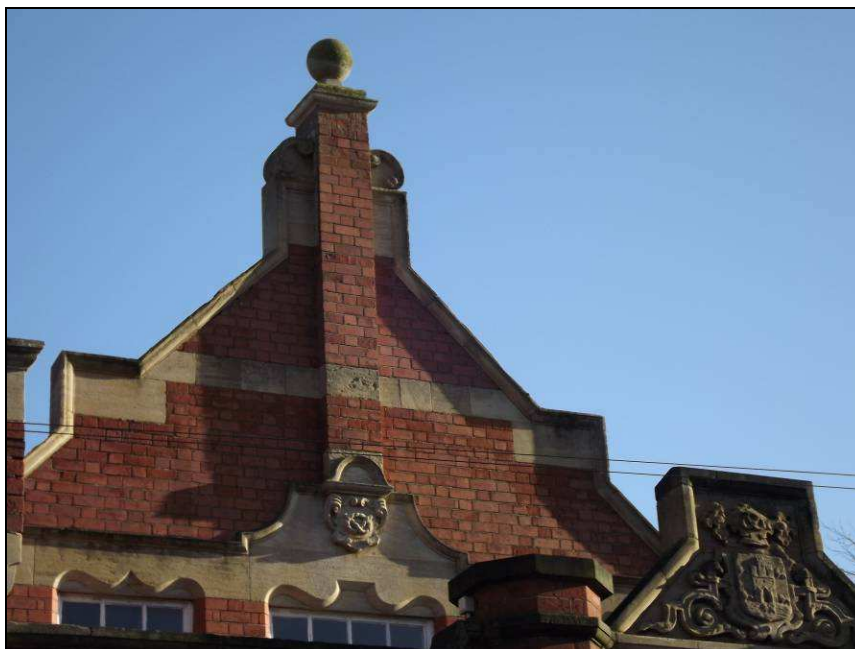
*Plate 24: Detail of 'set back' gable, west elevation*

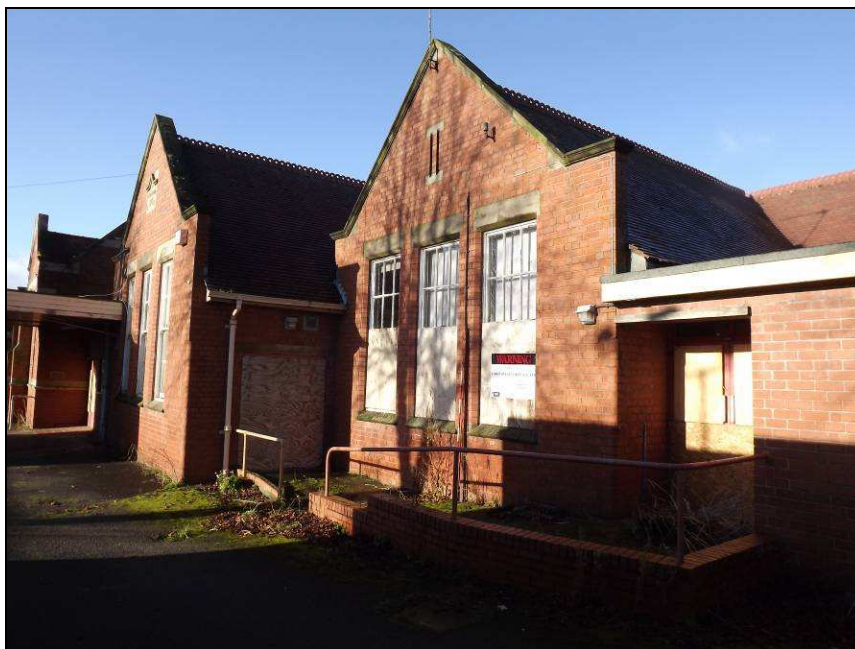
*Plate 32: View looking west showing the east end of the south elevation*

- 5.2.9 To the east of the projecting canopy, the south elevation is formed by two further shaped gables, one set back from the other, and a flat-roofed extension (Plate 32). The gabled section immediately to the east of the canopy has three large windows, all of the same size, with plain masonry lintels and plain sills, none of which form part of string courses which are present on the earlier building to the west. The gable is defined by decorative moulded coping stones, however the apex is not square-headed as has been observed in the gables already described, and the brickwork of this part of the former school building is laid in English Bond (alternate courses of headers and stretchers) (Plate 33). Set close to the apex of the gable is a commemorative plaque which reads 'Enlarged 1909' with the initials 'S C C' which presumably stood for Staffordshire County Council (Plate 34). The roof ridges of this section

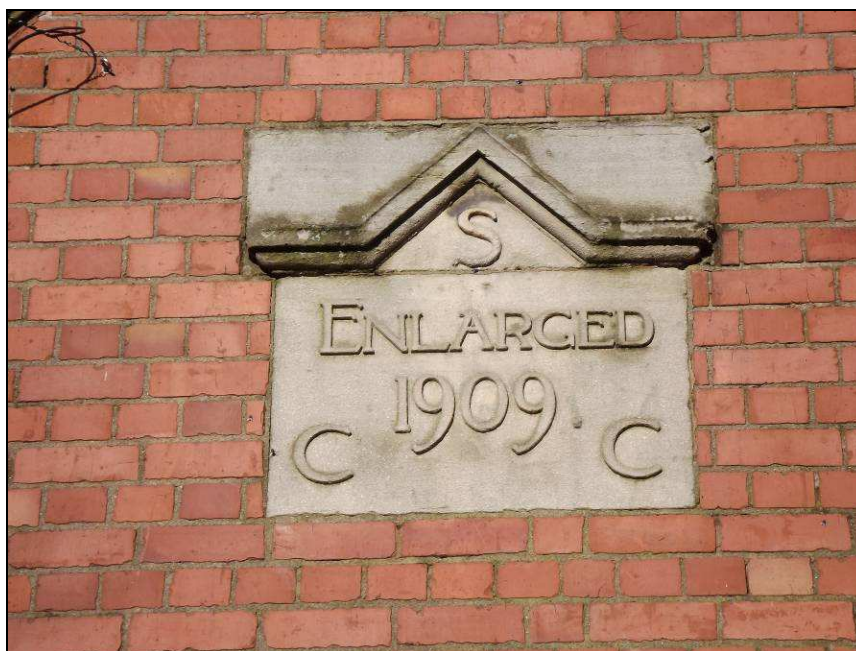
*Plate 34: Detail of plaque, south elevation*

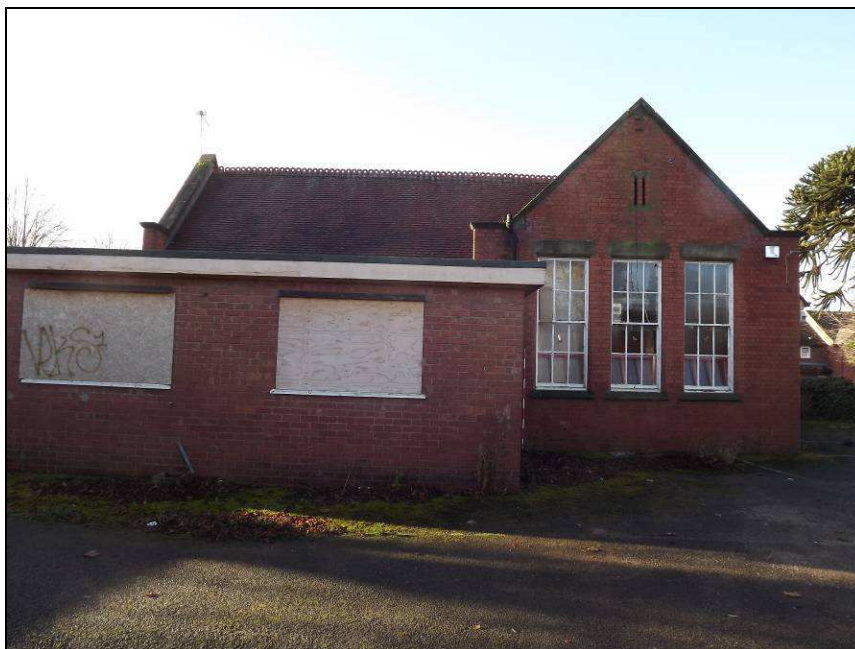
*Plate 36: East elevation of singles-storey extension and gable of 1909 addition*

- 5.2.11 The remainder of the east elevation of the 1909 addition remains unobstructed, and consists of a gabled section with three large windows all of the same size, of the same form as those noted in the south elevation. The two vertical 'ventilation slit' detailing which exists in the original 1900 school building has been replicated in this section of the 1909 addition (Plate 36).

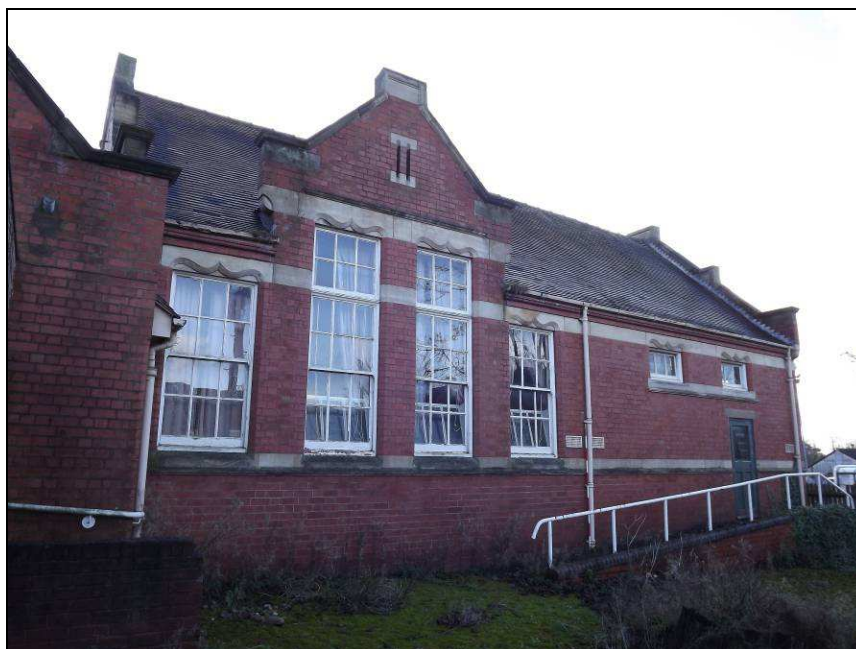
*Plate 43: North elevation of the original 1900 school building*

- 5.2.15 The remainder of the north elevation consists of the original 1900 school building (Plate 43). Within this section there are four windows, two smaller versions to either side of the two taller windows (although interestingly no buttresses on this elevation), each with the decorative lintels and sills forming part of horizontal string courses, as already observed in the west and south elevations. As with the south elevation, there is a gabled dormer projecting from the pitched roof, complete with the same architectural detailing of masonry coping stones, square-headed apex, kneelers and two vertical 'ventilation slits'. At the west end of this elevation there are two small windows, set below eaves level, with the same decorative lintels as noted elsewhere in the 1900 building, indicating that these are original openings. It is unclear externally why these windows are set so high up, and it is presumed it may have related to the use of the internal space. The door and ramp at the west end of this elevation appear to be later creations as the doorway does not have the same decorative lintel, and the string course appears to have been truncated (Plate 44); the door is not shown to exist on the 1948 ground plan (Plate 4) but is present by 1972 leading out from Classroom 1 (Plate 8).

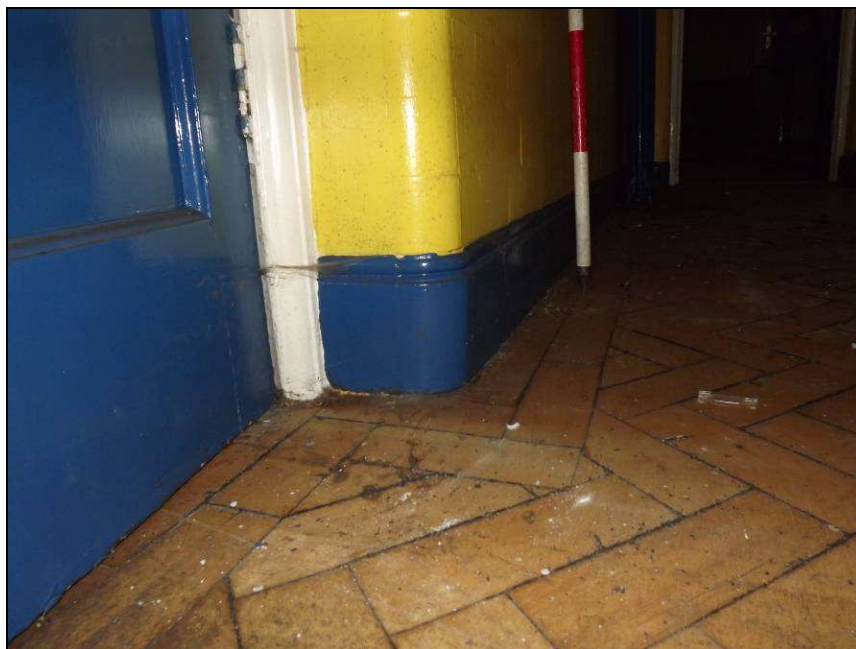
*Plate 53: Detail of skirting board, Room 1*

- 5.3.6 The floor of this room is laid in parquet (Plate 5), although it is unclear if this is original as the 1948 plan annotates 'new wood block floor' in Classroom 2 (Room 2) which suggests this type of flooring was still being installed in the mid-20<sup>th</sup> century. It was noted that the lower half of the walls of this room were tiled, with a ceramic 'dado rail' separating this tiling from the plastered walls above. The skirting board running along the bases of all the walls in this room is moulded, and appears to be ceramic (Plates 51 and 52). Where some of the paintwork has fallen away it was possible to observe the original tile colour scheme (Plate 53).

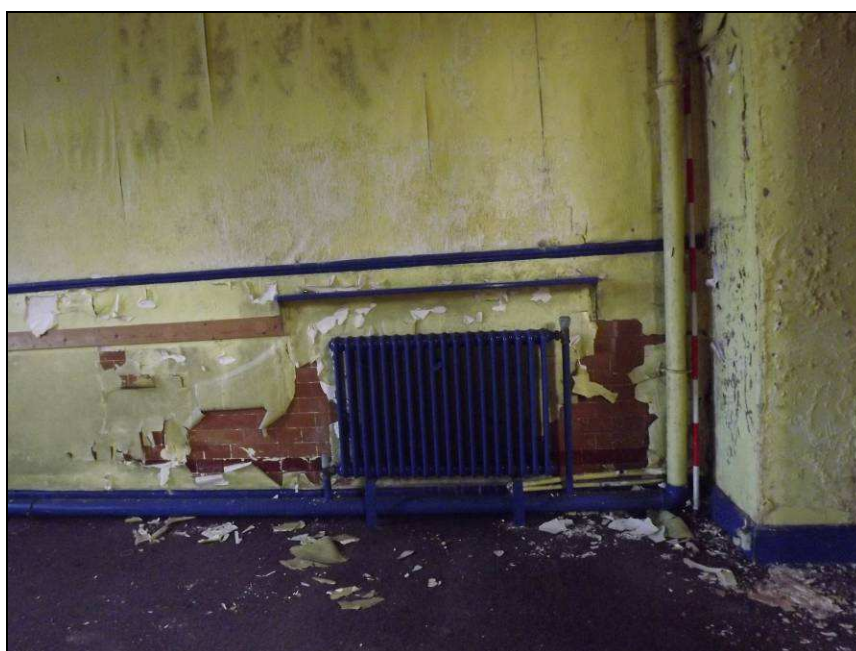
*Plate 60: Detail of radiator and exposed tiling, east wall of Room 2*

- 5.3.10 *Room 2:* Room 2 could seemingly only have been accessed originally from Room 1, through the large openings in its south wall (Figure 8). This room would have been well-lit by the four large windows in the north wall, complete with hoppers similar to those already observed in Room 1 (Plate 59). As with Room 1, this classroom also retains evidence for its partly tiled walls, separated from the upper section of wall by a dado rail. The tiling is of the same brown colour scheme, where it could be observed (Plate 60).

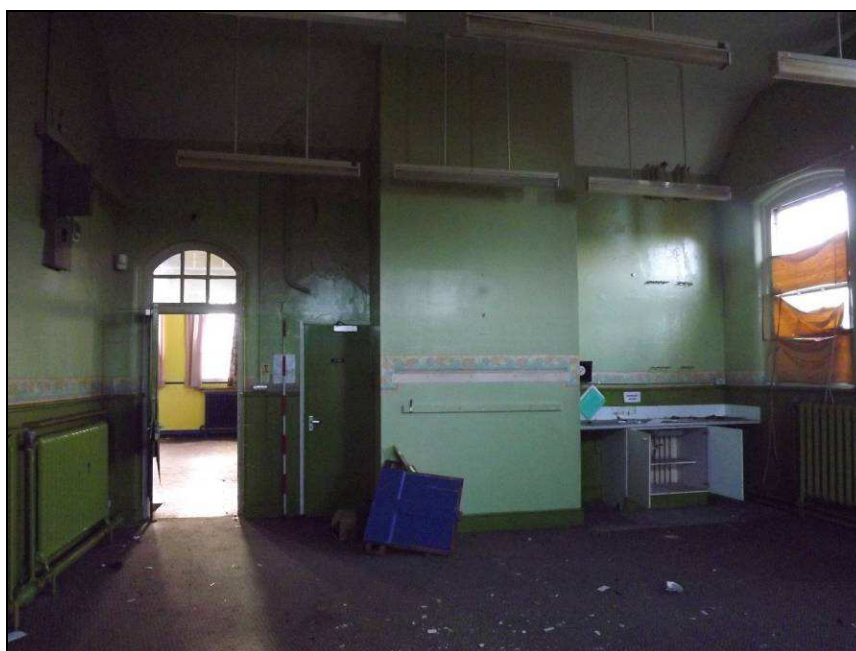
*Plate 69: South wall of Room 3 showing possible boxed-in fireplace*

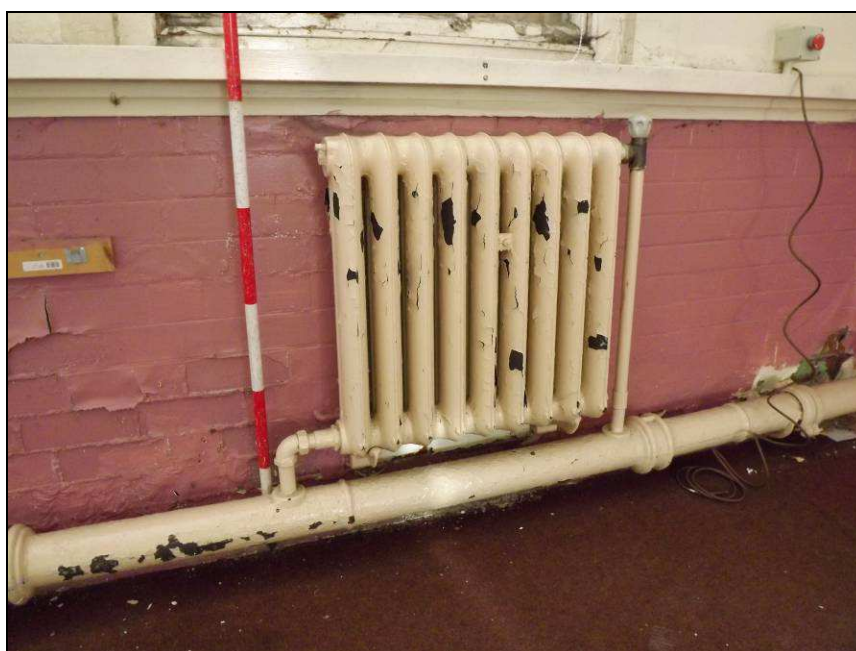
*Plate 92: Detail of one of the radiators in Room 9*

- 5.2.32 This room, as with all the others described, was heated more latterly by central heating, and several radiators survive within this space (Plate 92). The roof structure, where visible, was also of the same form as the former class room to the west (Room 7) (Plate 93).

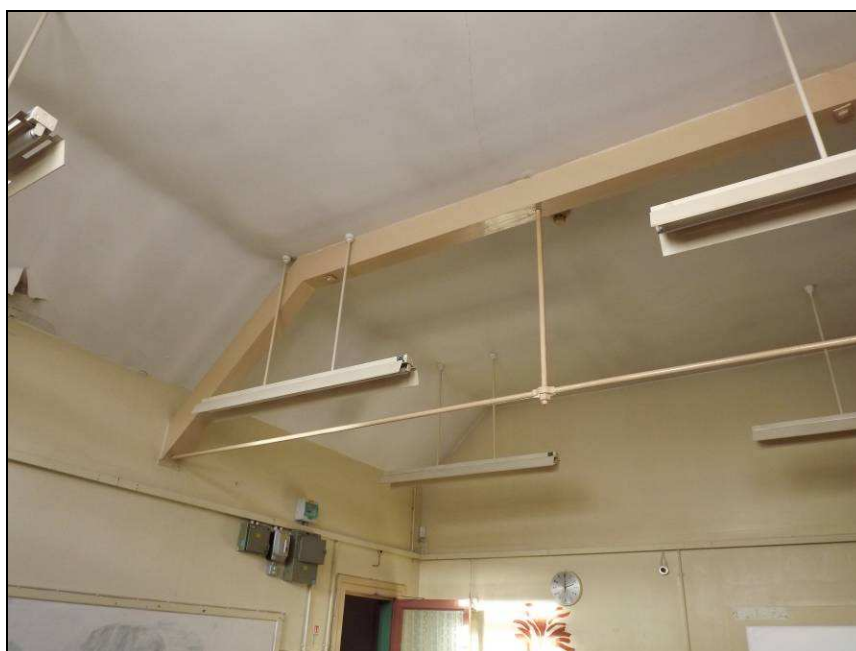
*Plate 93: Detail of roof structure in Room 9*
