# COCKERMOUTH FLOOD ALLEVIATION SCHEME, COCKERMOUTH, CUMBRIA

**WATCHING BRIEF REPORT**  
**CP. No: 10220/10463**  
**24/04/2013**

**DOCUMENT TYPE:** Watching Brief Report

**CLIENT:** The Environment  
Agency

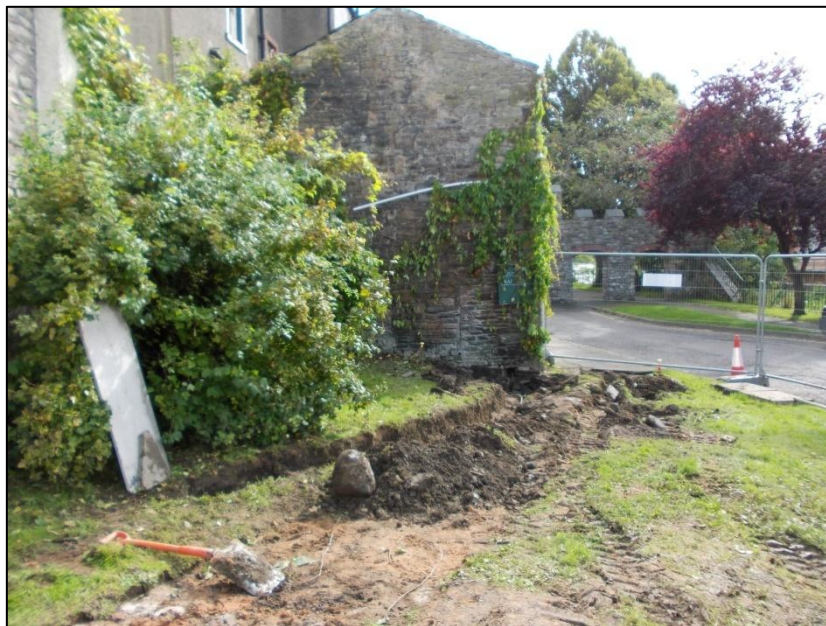
*Plate 1: Location of Trench 1 looking south*

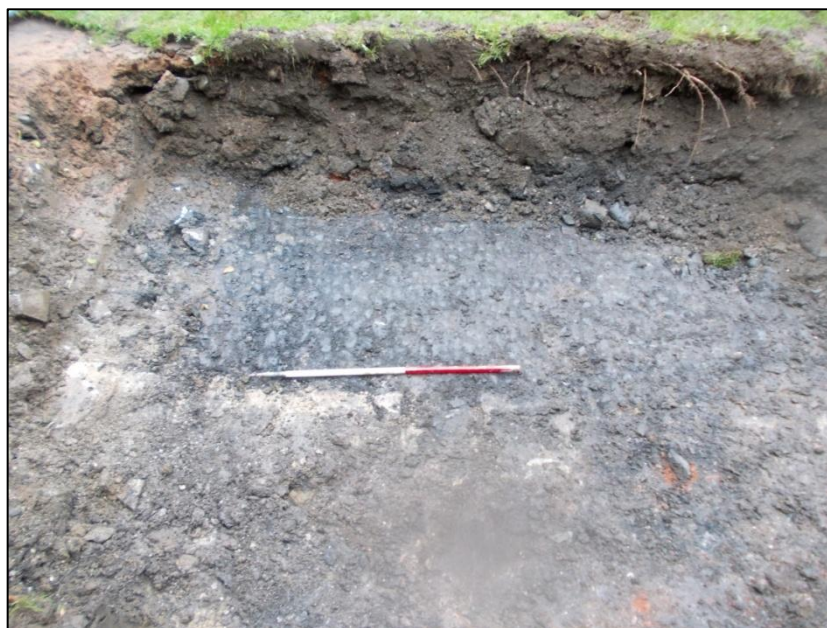
- 4.2.5 At a depth of roughly 0.80m below the current ground surface a cobbled surface **(103)** was observed in the western half of the trench. This appeared to be formed of rounded river pebbles and was present throughout the length of the trench (Plate 2). This surface was sat upon bedding layers of small river pebbles **(112)**, a thin black silt deposit **(113)** and a layer of crushed red brick rubble hardcore **(114)**.

- 4.2.6 Surface **(103)** was laid against substantial sandstone walls **{104}** and **{105}** which continue the north-south line of the front of the standing building. These walls were 0.40m thick and faced to both edges and had a rubble core. The foundation of these walls was very shallow and only a single course remained approximately 0.20m deep below the cobbles (Figure 3).

*Plate 2: Cobbles (103) and Wall {104} looking south*

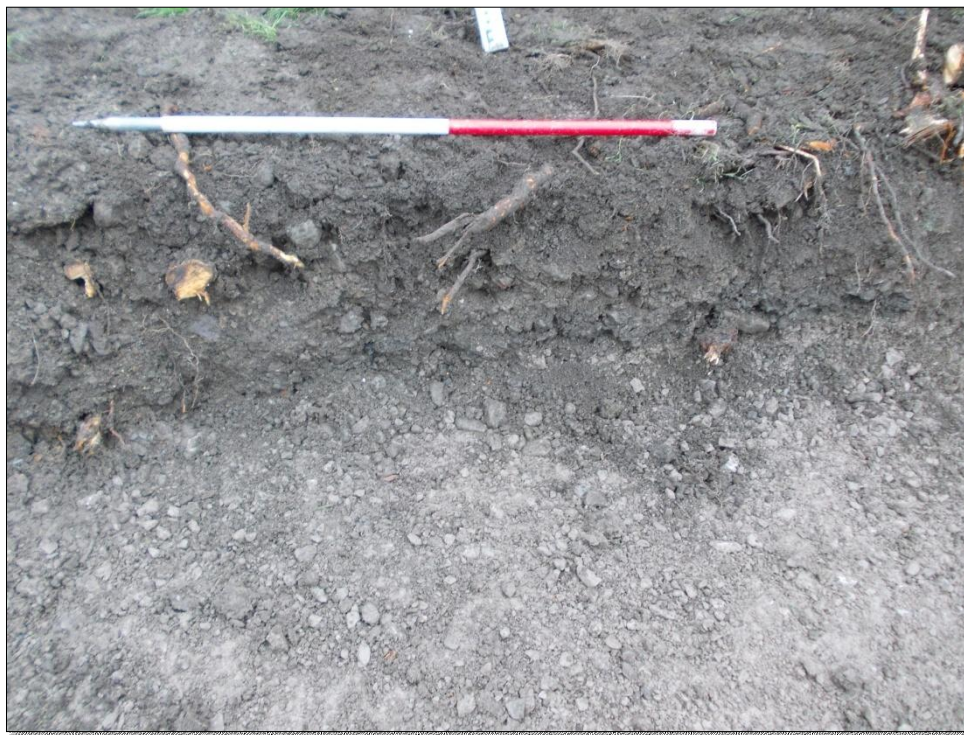
measured upto 0.25m in depth. In the base of the trench, a compacted layer of pale grey hardcore (202) was uncovered (Plate 3). No archaeological remains were found in Trench 2.

*Plate 3: Trench 2 north facing section*

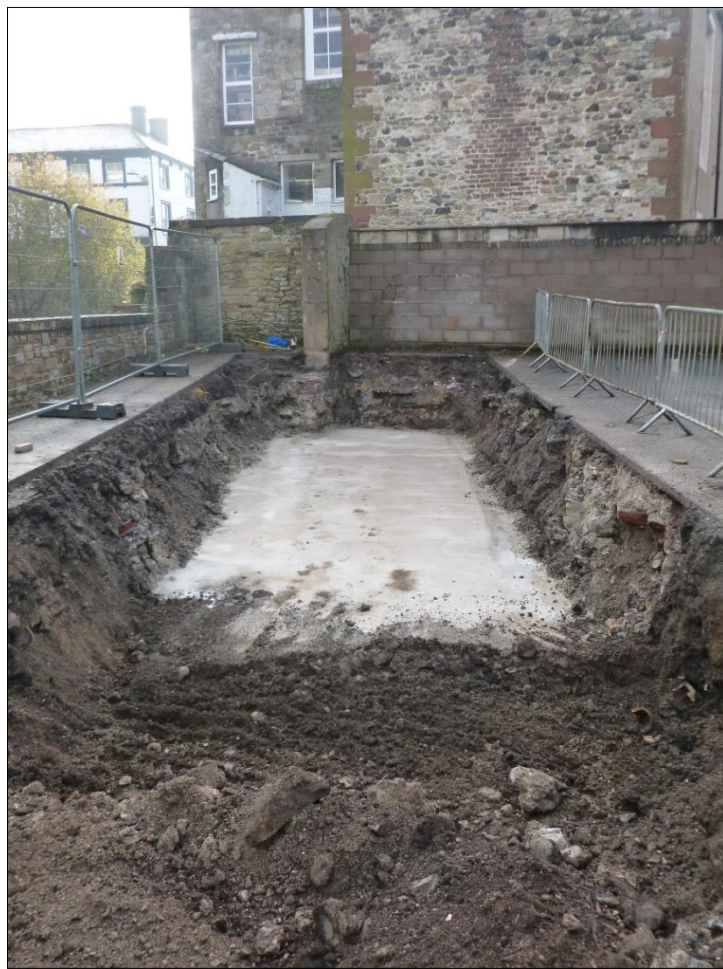
- 4.3.4 At the southern end, a stone foundation wall {305} was seen which clearly followed the line of an existing buttress running northeastwards from the end of the trench. It measured over 4 metres in length by 0.60 metres wide by 0.90 metres in height remaining. This wall then linked with another wall {307} which ran northwest-southeast across the trench and measured 4 metres by 0.30 metres wide by 0.60 metres in height. This area was capped by a layer of concrete (302) and by a backfill of large boulders, rubble and demolition layers (303).

- 4.3.5 A second wall {308} was found on the same alignment as {307}, approximately 4.5 metres to the north. It measured 0.5 metres wide and over 4 metres long. Wall {306} could be seen to join this at the northeast facing section and appeared to follow the same alignment as {305}. This area was again filled with modern rubble backfill (309) which also contained several ceramic drainage pipes.

*Plate 4: Southern end of trench showing remnants of walls {305} and {308} in section*

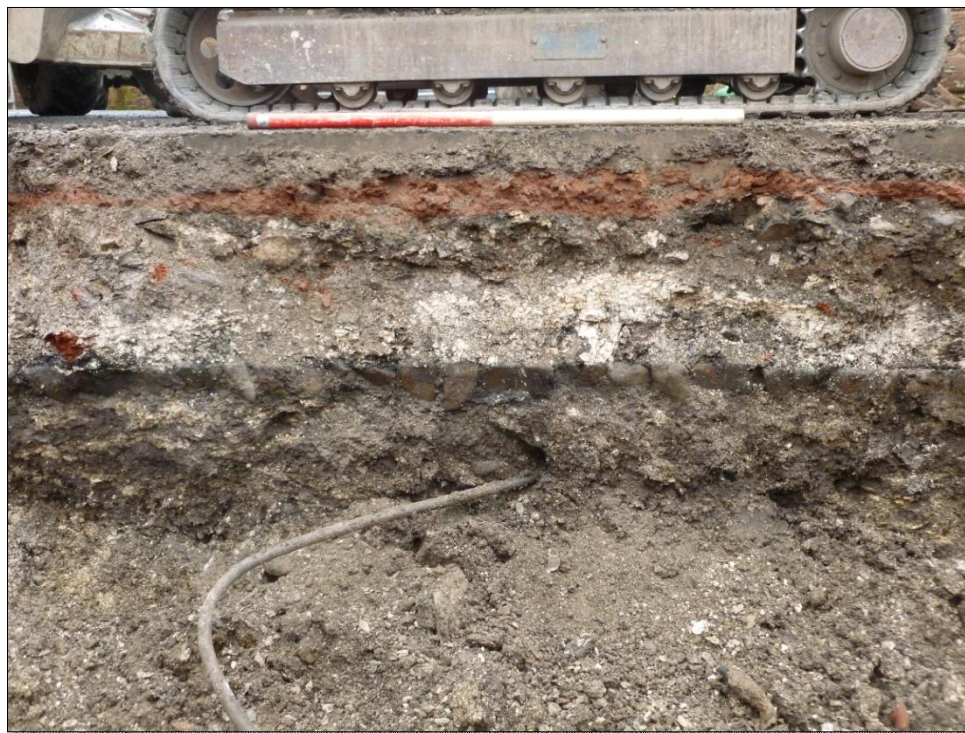
- 4.3.9 Very close to {316} a cobbled surface (317) could be seen. This was comprised of one course of very regular smooth cobbles approximately 0.15m thick and 4m length in section. These two features probably formed a courtyard, possibly with {318} as the northern boundary wall. This could be related to the police stables still standing close by to the northeast of the trench.

*Plate 5: Northeast facing section showing cobbled surface (317)*

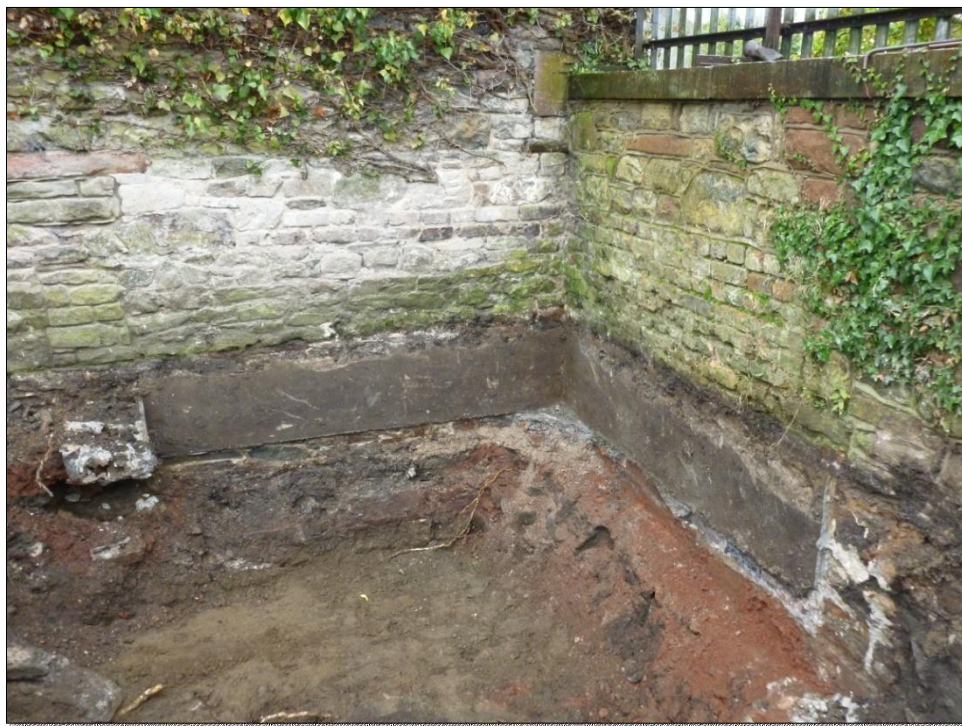
- 4.3.10 At the northern end of the trench, two further walls were discovered. Wall {319} projected northeastwards from the back stable wall and wall {320} projected southeastwards from the far north garden boundary wall. These two structures formed a northeast corner that had a thick concrete raft {321} as a floor surface. The lines of the walls were evident within the remaining standing structures. It is likely that this area was used as a separate storage area for the stables.

*Plate 6: The Police Stable building showing the projection of walls {319} and {320} with concrete raft {321}*

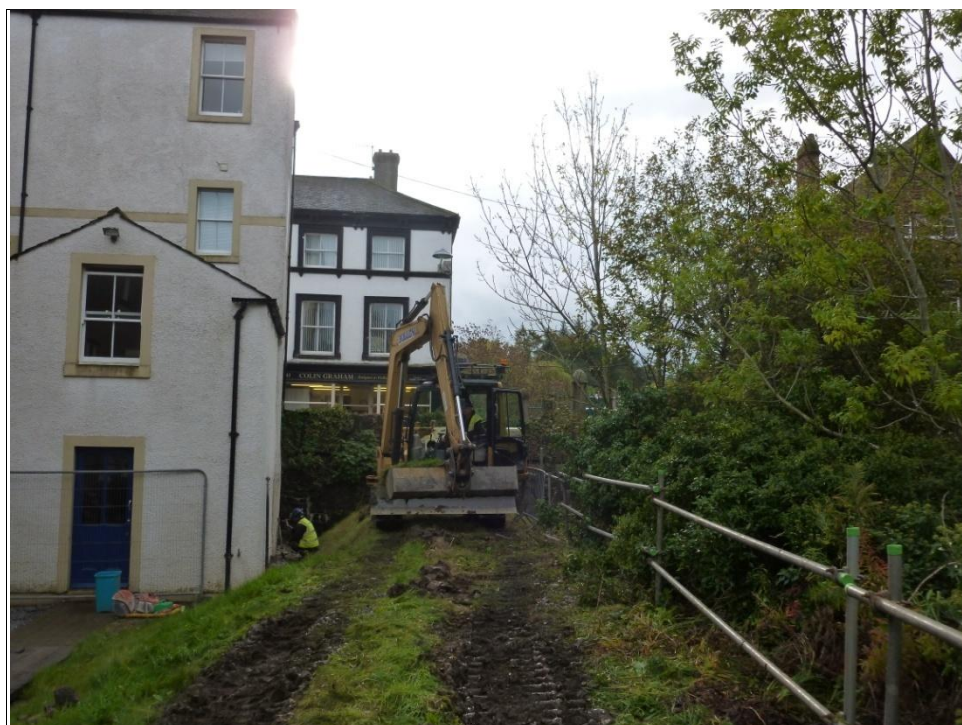
- 4.4.3 Digging began at the southern end of the site, in the small area adjacent to the Cocker Bridge and the Bridge House (Plate 7). A bank of modern made ground was stripped to the ground level of the house. This bank was comprised of a thin deposit of turf and dark silty topsoil (400) above dense grey/brown clays (402) up to 1.10 metres in depth (Plate 8). It was discovered that this bank had only been instated by Volker Stevin after the last floods in 2009, to protect the Bridge House before the flood defence walls could be built.

*Plate 7: Looking southeast across area of Phase 3*

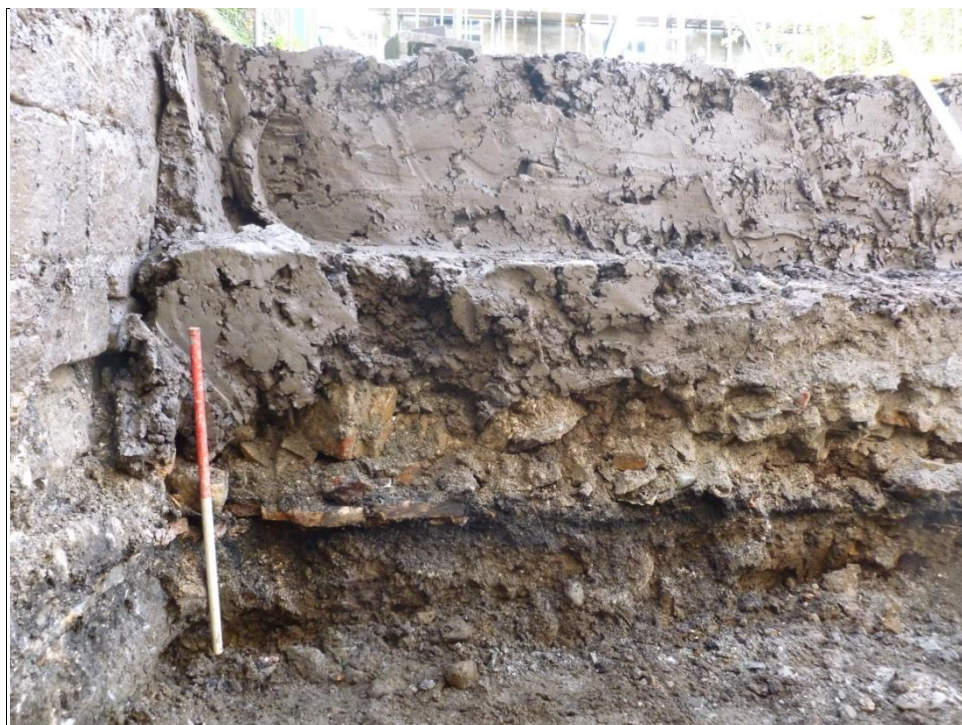
- 4.4.4 Below this modern bank, mixed deposits of ashy soils with thin stone inclusions and late twentieth century rubbish and debris (403) were found. This measured between 0.42 metres and 1.5 metres thick (Plate 8).

*Plate 8: Northeast facing section through deposits at southeastern end of site*

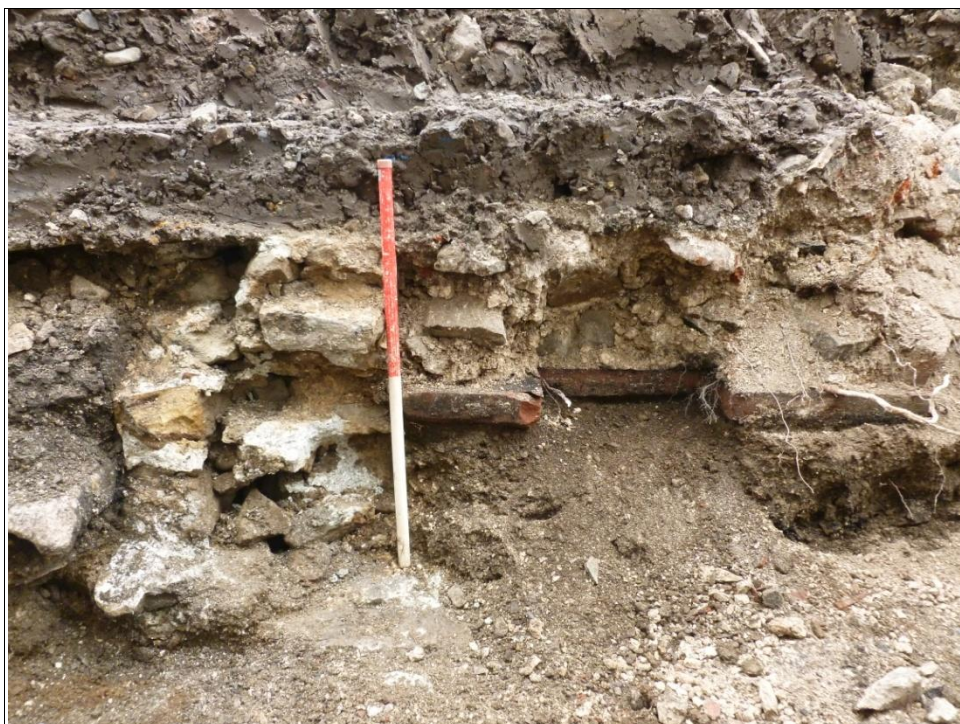
- 4.4.7 In relation to this, a second sandstone paving layer {410} was uncovered. This was found abutting {409}, slightly higher than the base of this and adjacent wall {411}. It measured approximately 0.75m long by 0.07 metres

thick. This could be the cellar floor of an old house that once stood there (Plate 9).

*Plate 9: Masonry remains {409} and floor surface {410}*

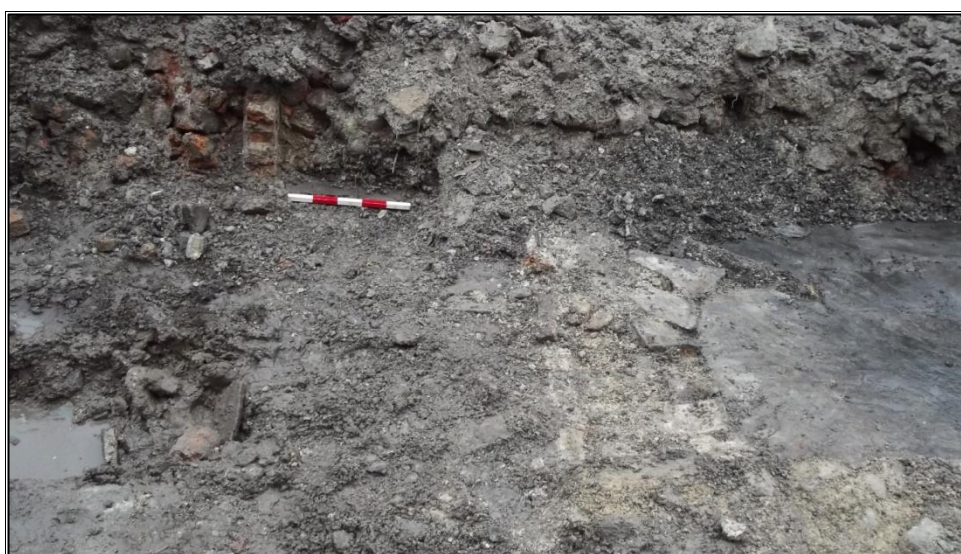
- 4.4.15 The remnant of a red brick wall was seen towards the centre of the trench. This wall {421} was double thickness with a central cavity, it measured 0.3 metres wide with only 0.3 metres height remaining. A 0.05 metre thick stone slab floor {422} was found adjacent to this, of which only 0.3 metres length and 0.3 metres width remained.
- 4.4.16 A second narrow line of brick {423} was uncovered adjacent to the base of another rough stone wall {424}. This measured 0.60 metres wide and ran northeast-southwest across the trench. The partial remains of another stone flagged floor surface were seen to the north of this wall. The floor {425} measured 2.5 metres long by 2.20 metres wide.

*Plate 10: Picture looking southwest across trench showing contexts (418), {421-25}*

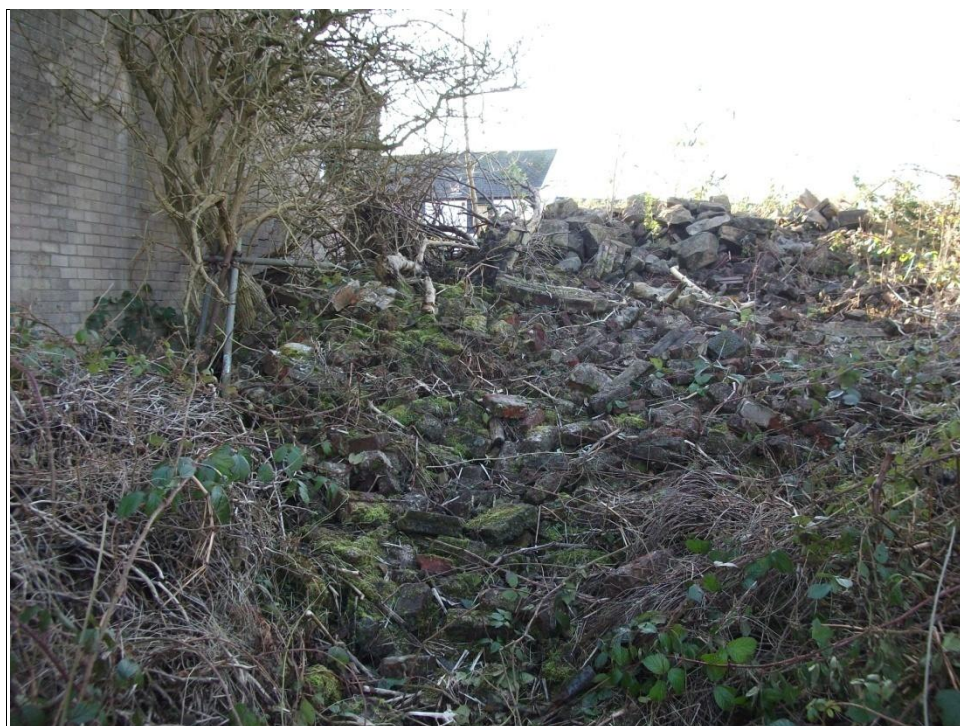
*Plate 11: View of windmill site pre-excavation looking southwest*

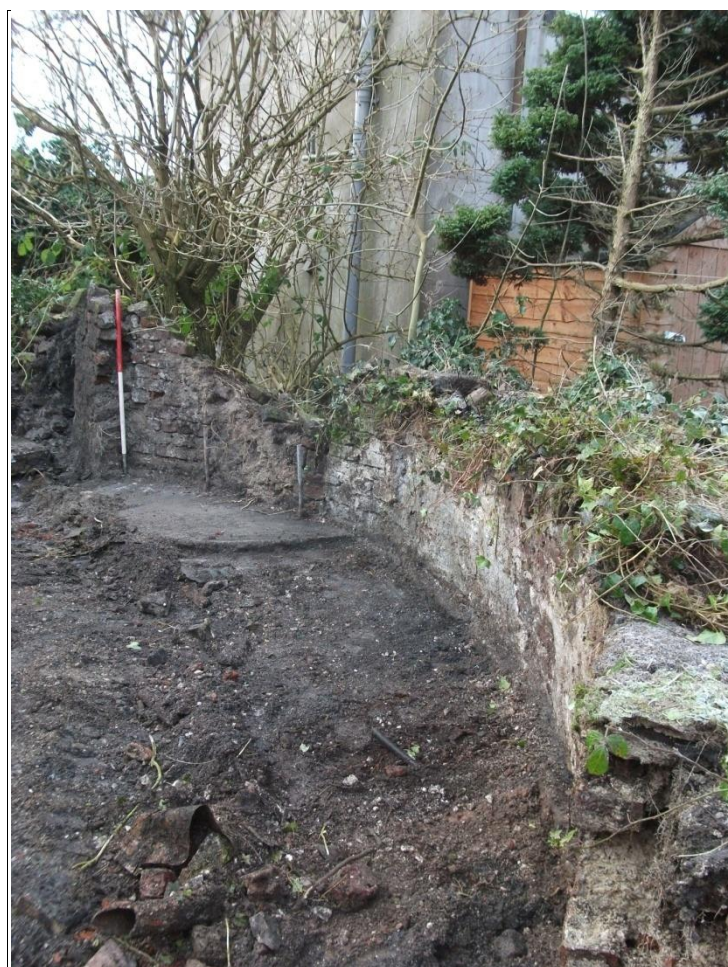
4.5.3 During removal of the rubble it became apparent that a portion of the northwestern side of the windmill structure was still standing but elsewhere was extensively damaged. A total of 5.56 metres of wall remained standing, approximately one quarter of the total 20.12 metre circumference of the windmill. This was recorded as structure {501}. The width of the wall was 0.35 metres. Up to ten courses of brickwork survived to a height of circa 0.90 metres. The bricks were red/orange handmade bricks bonded with rough white mortar with some more modern brick repairs visible. This was built upon rough, rounded stone foundations (Plates 12-15).

*Plate 12: View looking southwest of extent of surviving windmill structure {501}*

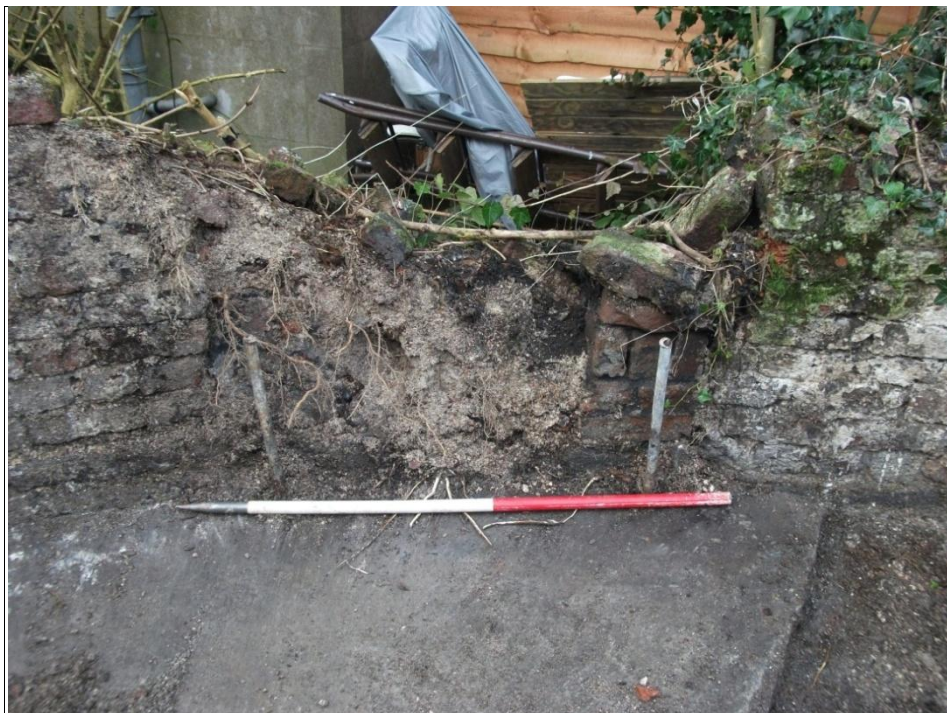
4.5.4 A bricked up doorway measuring 1 metre wide was noted although it had been heavily damaged. Plaster to the internal wall was observed (Plates 12-15).

*Plate 13: View of blocked doorway within windmill structure {501}, looking southwest*

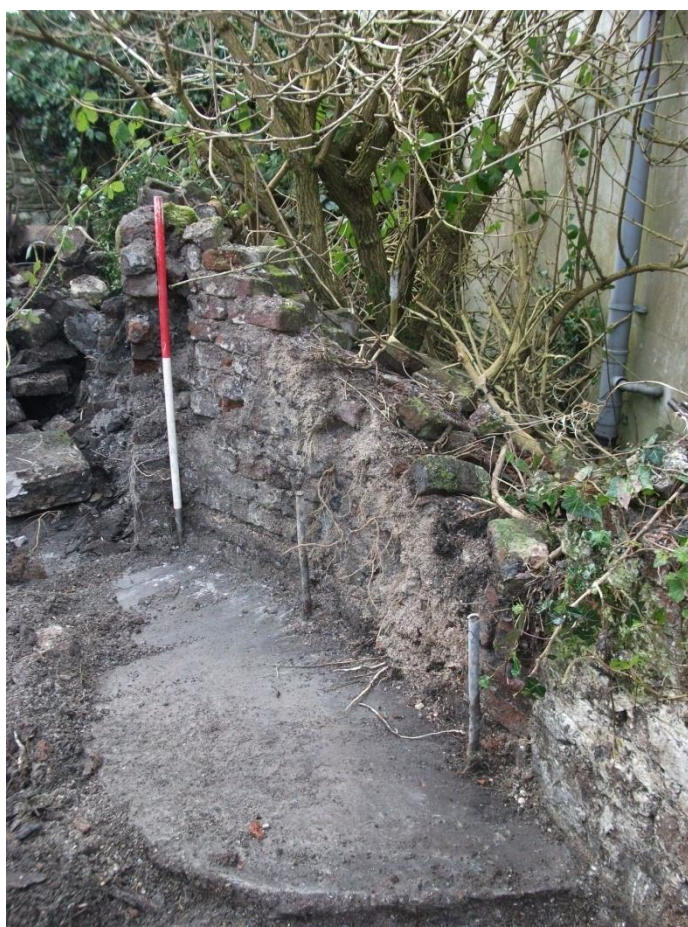
*Plate 14: View of windmill {501} looking southwest, showing height of structure and blocked doorway*

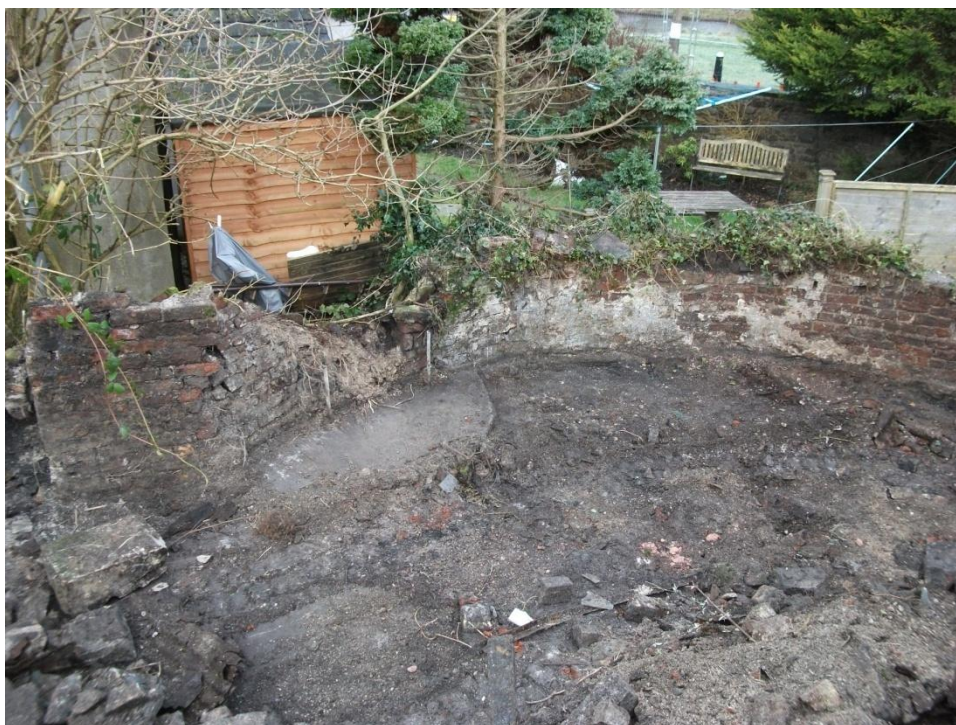
*Plate 15: Aerial shot of windmill {501}, looking northeast*

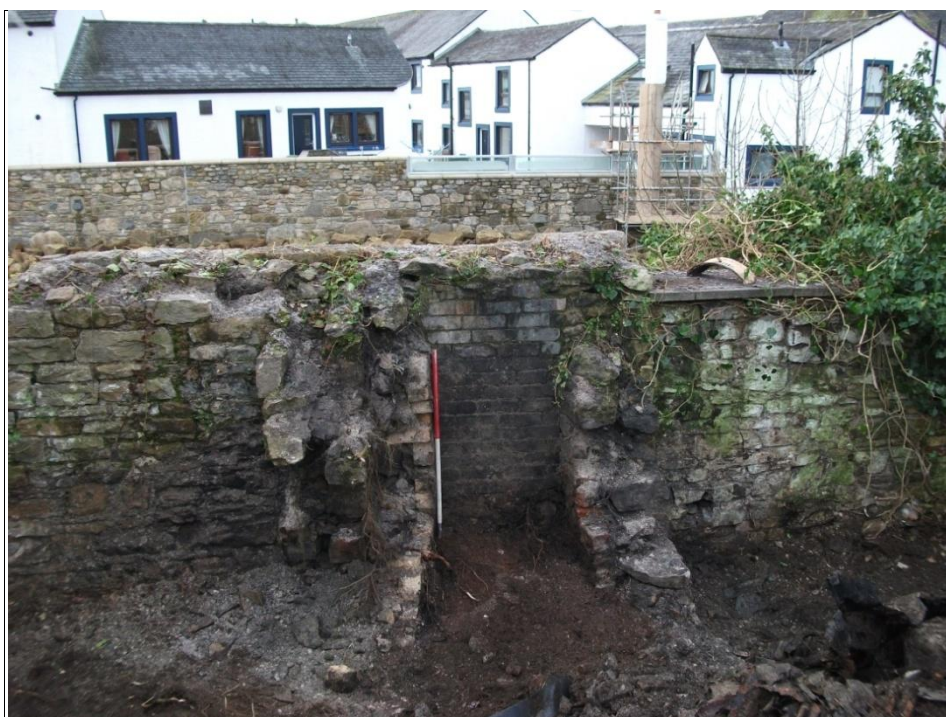
*Plate 16: View southwest from site of structure {505} showing brick-lined chimney*

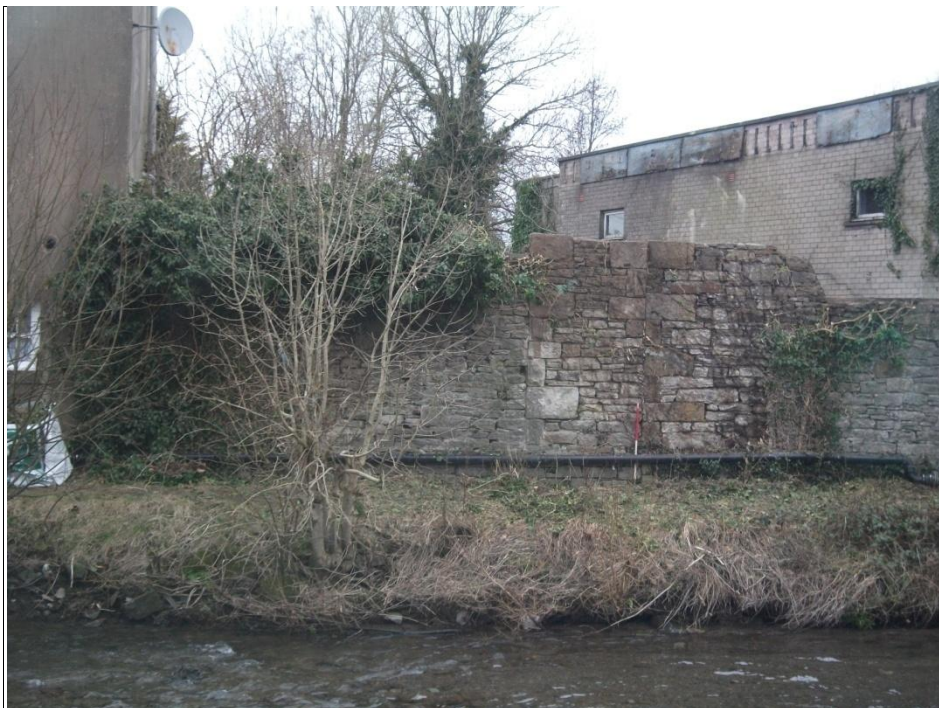
*Plate 17: View of wall {503}, {505} and {506} from west bank of river*

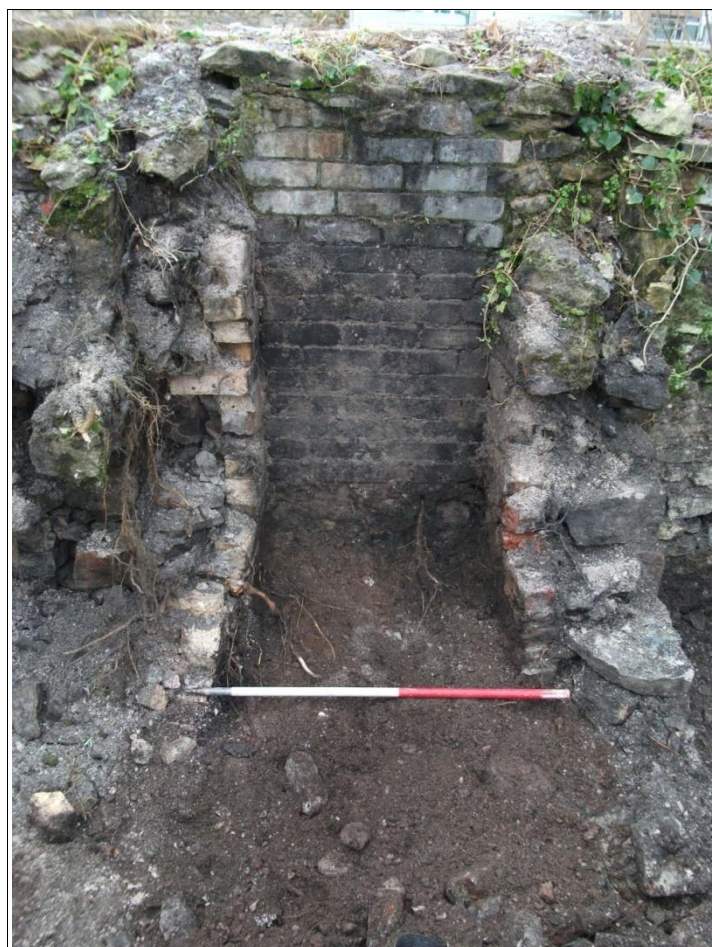
*Plate 18: Close-up of chimney in {505}*

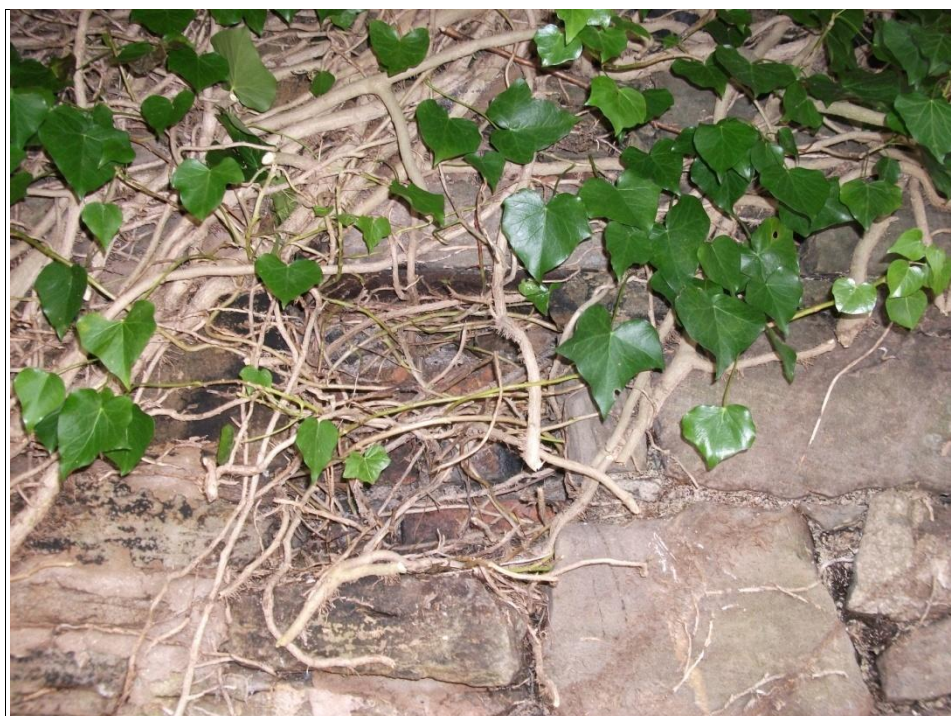
- 4.5.11 A smaller, square window was noted 2.5 metres southeast along the wall {506} from Foundry House. This measured 0.30 metres by 0.33 metres and started at a height of 1.80 metres from the ground level. A thin steel lintel plate was still visible, although the window had since been blocked up with bricks (Plates 19-21).

*Plate 19: Close-up of blocked up window from riverbank in {506}*

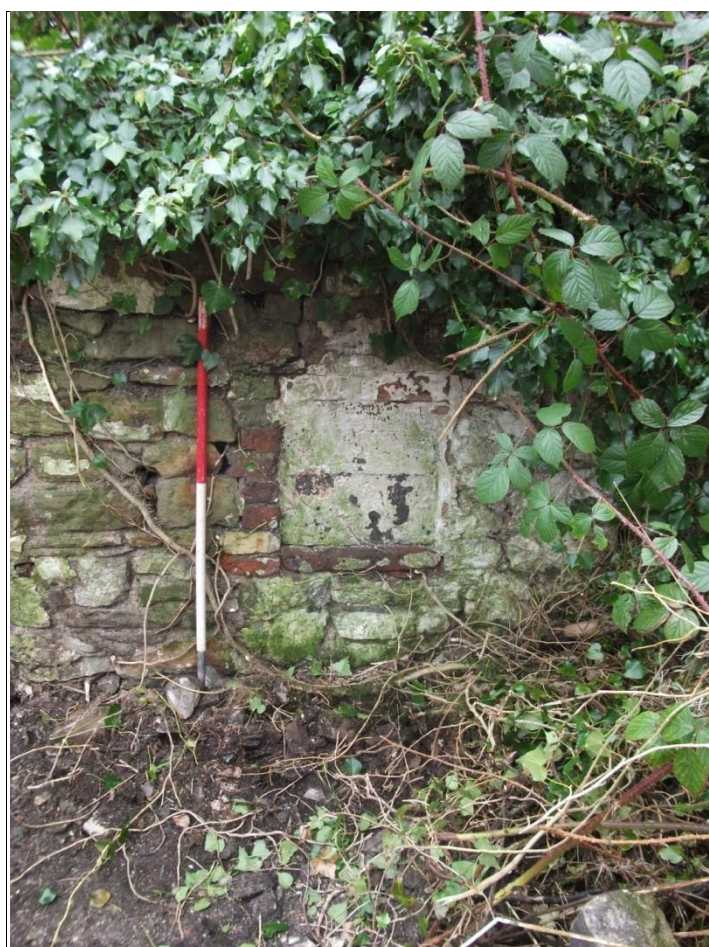
*Plate 20: Close up of blocked window from site in {506}*

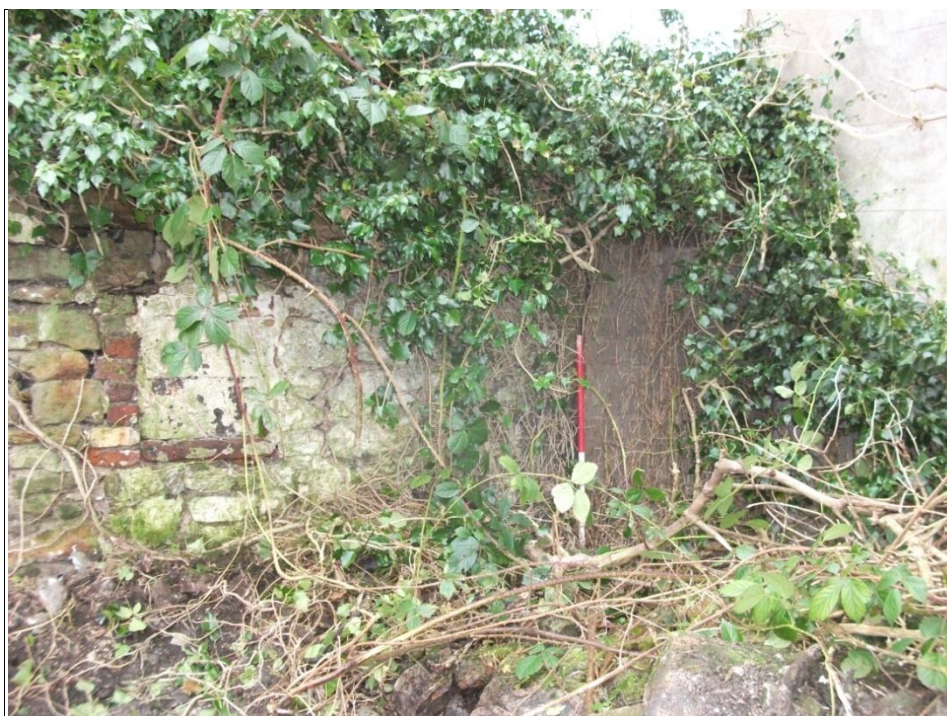
- 4.5.10 A potential blocked window or door was observed in the wall {506} directly next to Foundry House. This was observed as a blocked alcove 0.80 metres above the base of the wall and measured 1 metre wide by 1.80 metres tall by 0.17 metres deep (Plate 21).

*Plate 21: View from site of structure {506} with blocked door and window visible*

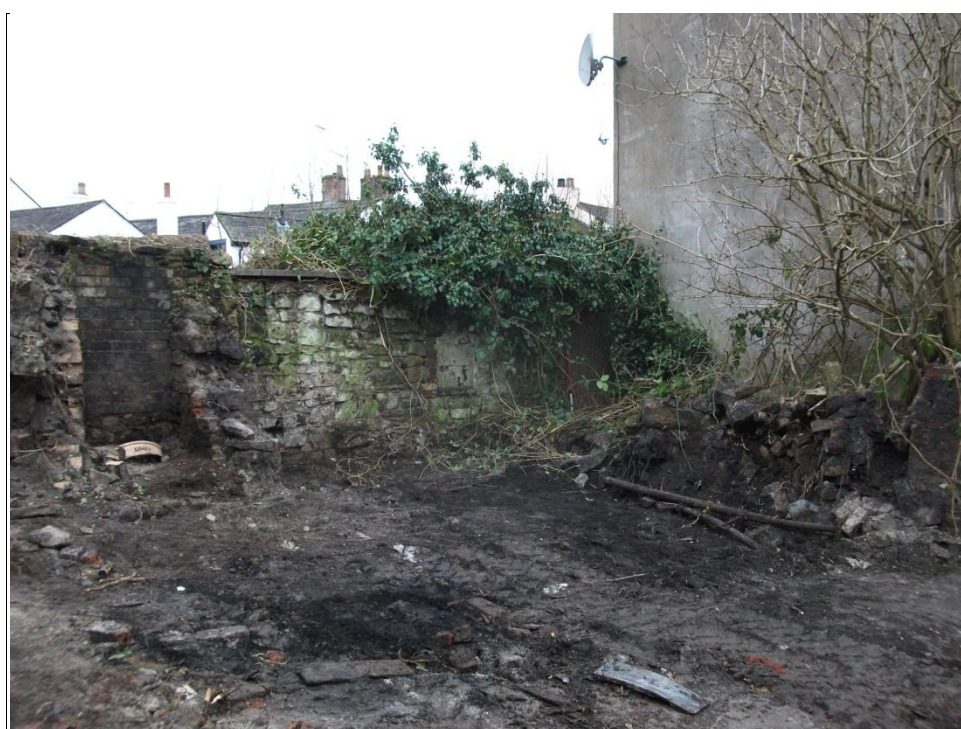
*Plate 22: Overview of {505} and {506} looking southwest towards Foundry House*

4.5.12 Inbetween the windmill and the tannery wall, partial remains of a wall {502} ran parallel to wall {506}. This was 0.40 metres wide and existed 0.90 metres high and circa 3 metres long. It was made up roughly hewn limestone blocks, bonded with mortar with a rubble core and was faced to the north side (Plate 22).

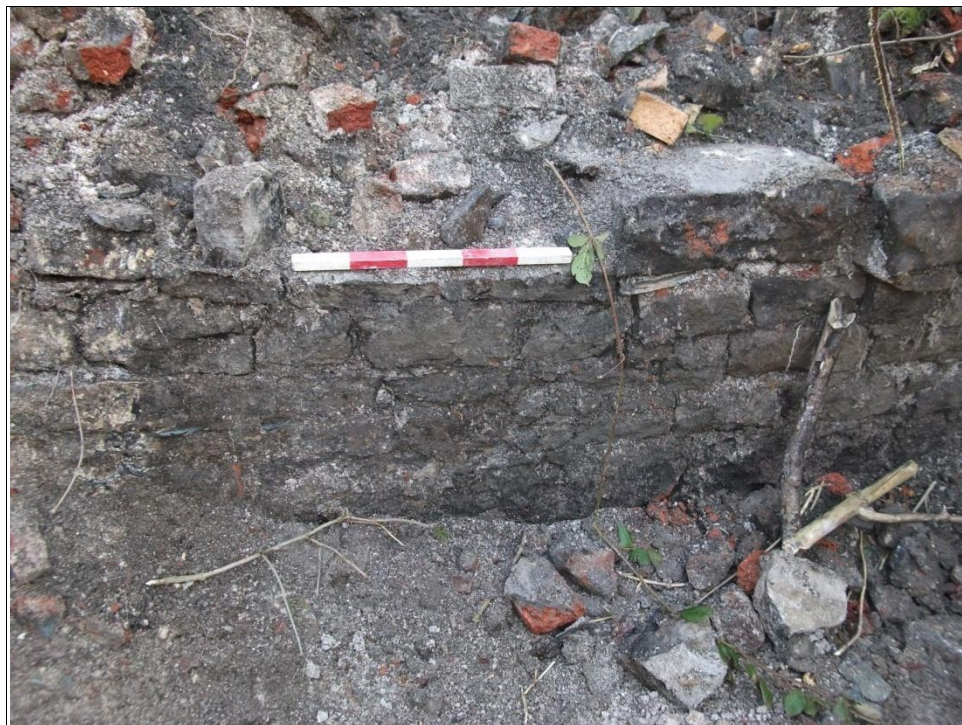
*Plate 23: Wall {502} facing south*

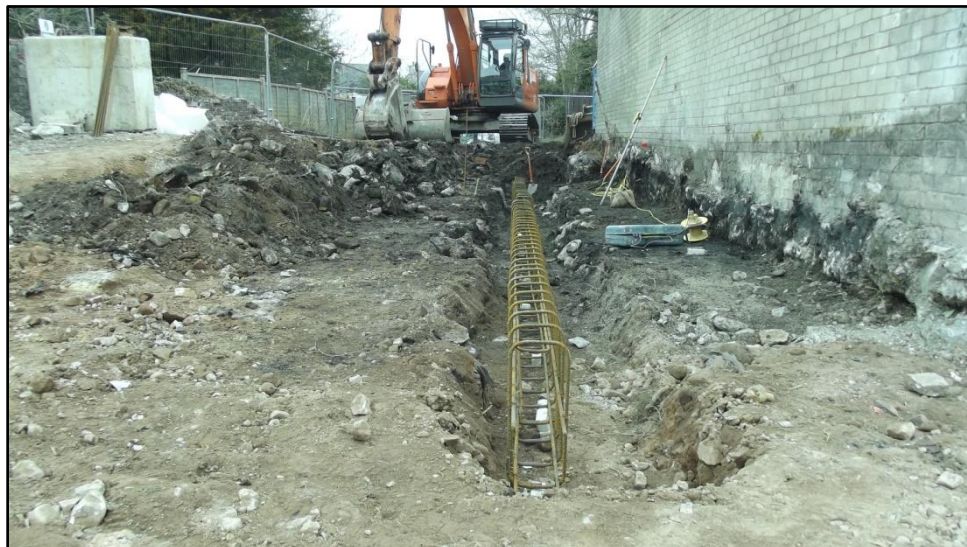
- 4.5.14 Following the clearing of the rubble associated with the windmill and the recording of the riverside wall consisting of {503}, {505} and {506}, the reduction of the wall to allow access to the riverbank was undertaken.
- 4.5.15 An area of approximately 3 metres wide immediately adjacent to the back of the brewery building was excavated to a maximum of 1 metre deep, exposing modern building rubble and concrete (504).
- 4.5.16 Within the reduced area, a narrow trench was dug measuring 0.80 metres in width and was an average of 0.30 metres deep. The same modern rubble deposits (504) were observed throughout the trench which ran along the length of the brewery building (Plate 23).
- 4.5.17 No remains of the tannery buildings were observed within the trench and no other archaeological features were observed in Phase 4.

*Plate 24: Trench for Phase 4 showing rubble deposit (504) facing north*

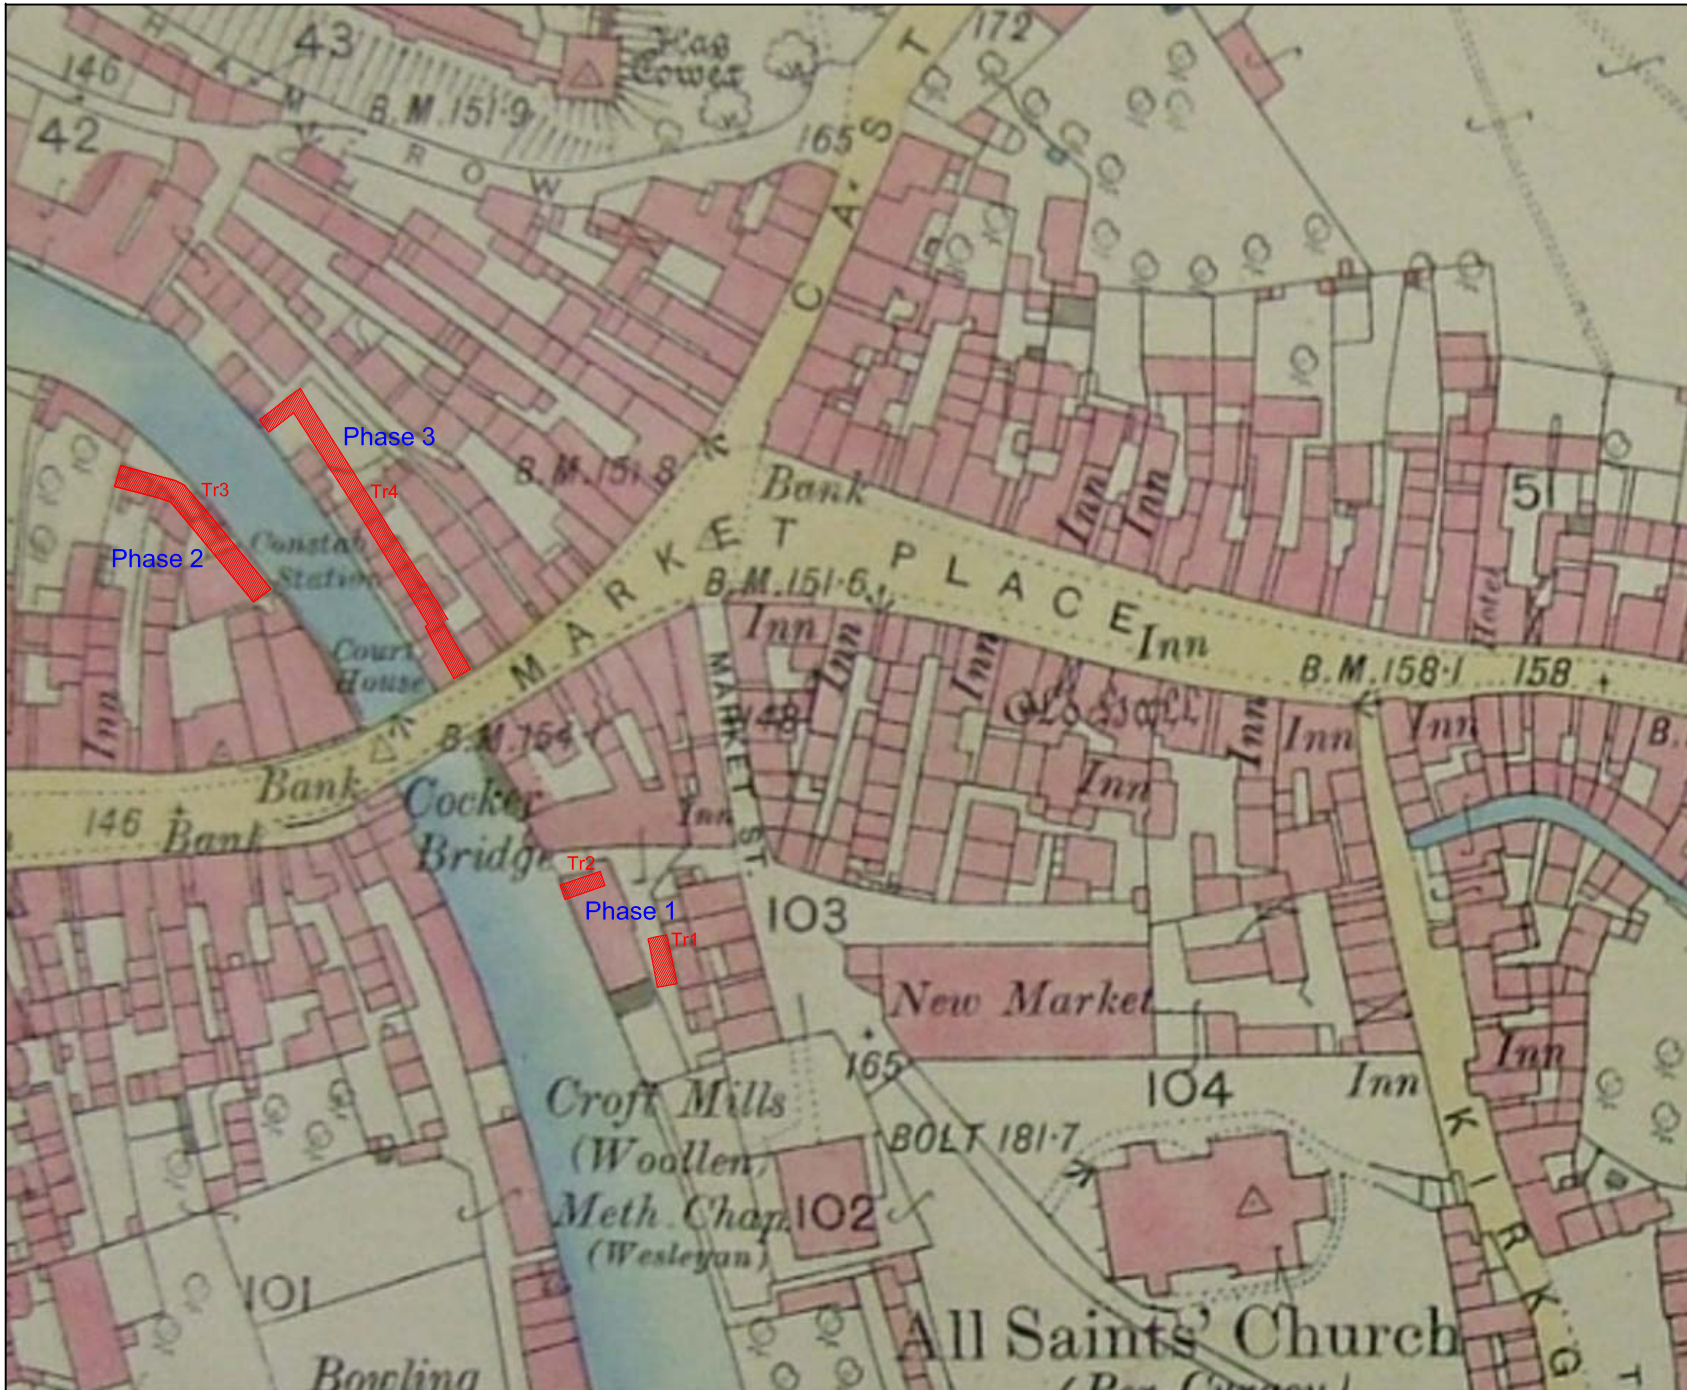
Figure 7: Watching Brief, Phase 4 elevation.

- 4.5.8 The chimney formed the second phase of the wall with two sets of corner stones butting up against {503} and {506} (Plates 16-18, Figure 7).
