**DR BROWN'S ROAD,  
MINCHINHAMPTON  
COMMON,  
MINCHINHAMPTON,  
GLOUCESTERSHIRE**

**WATCHING BRIEF REPORT**

**CP. No10334**

**DOCUMENT TITLE:** Dr Brown's Road, Minchinhampton, Gloucestershire  
**DOCUMENT TYPE:** Watching Brief Report  
**CLIENT:** Wardell Armstrong LLP  
**CP NUMBER:** 10334  
**SITE CODE:** BMG-A/12  
**OASIS REFERENCE:** wardella2-139794  
**PRINT DATE:** 20/12/2012  
**GRID REFERENCE:** SO 867 011

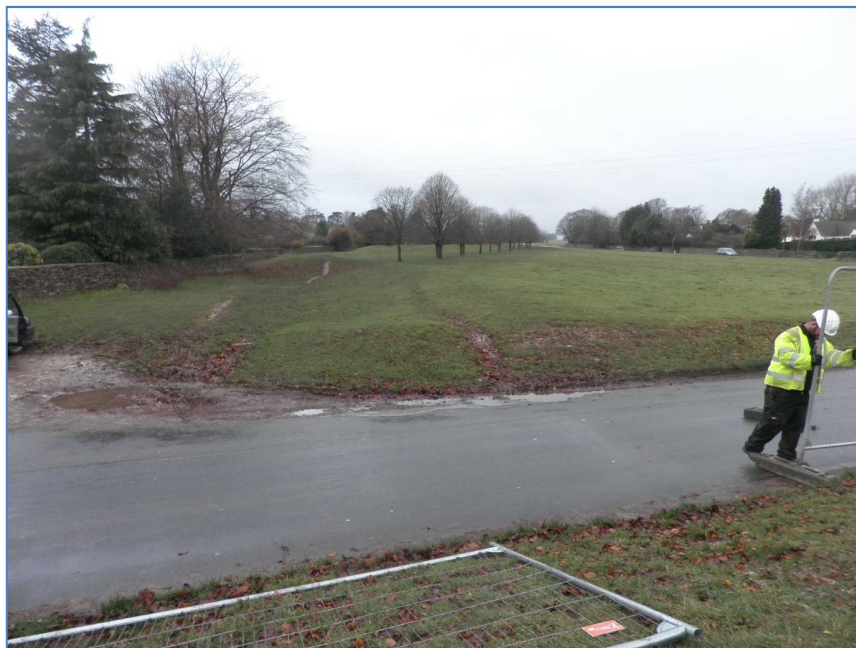
*Plate 1: Looking west across Dr Browns Road, down the length of The Bulwarks (bank and ditch)*

- 3.2.3 The Bulwarks have been variously interpreted as a land boundary, a defensive feature, a prestigious public monument, and even as a huge animal enclosure. A difficulty with interpretation is that the monument is 'inside-out', with the stone revetted face of the bank and the ditch being on the inside of the apparently incomplete circuit. This circuit extends to the west, north and east of Minchinhampton, with a series of near straight sections and distinct changes of alignment, one which is just to the west of Dr Brown's Road (Figure 2, Plate 1).

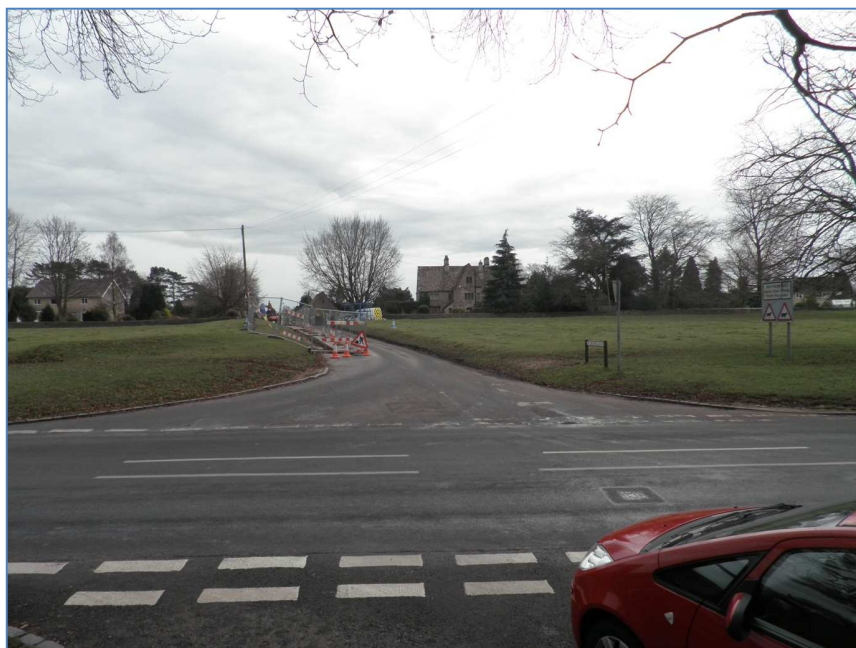
*Plate 2: Looking south down Dr Browns Road, showing north end of monitored replacement trench*

- 4.1.2 Dr Brown's Road is already lower than the surrounding common land, and has clearly been truncated and levelled in the past (Plate 2). The verges consist of stony earth mounds on each side, presumably upcast from levelling the roadway. Whether this originated as an earlier (e.g. medieval) hollow way is unclear. It is quite likely that all or most of the deposits now present originate from more recent phases of road construction.

- 4.1.4 At the point of intersection with Dr Brown's Road, The Bulwarks seem to follow a slight topographic high (Plate 2), with the land sloping gently away to the north and south. Possibly this has significance in relation to the change in alignment of the monument in this area, if it was intended to followed this slight ridge.

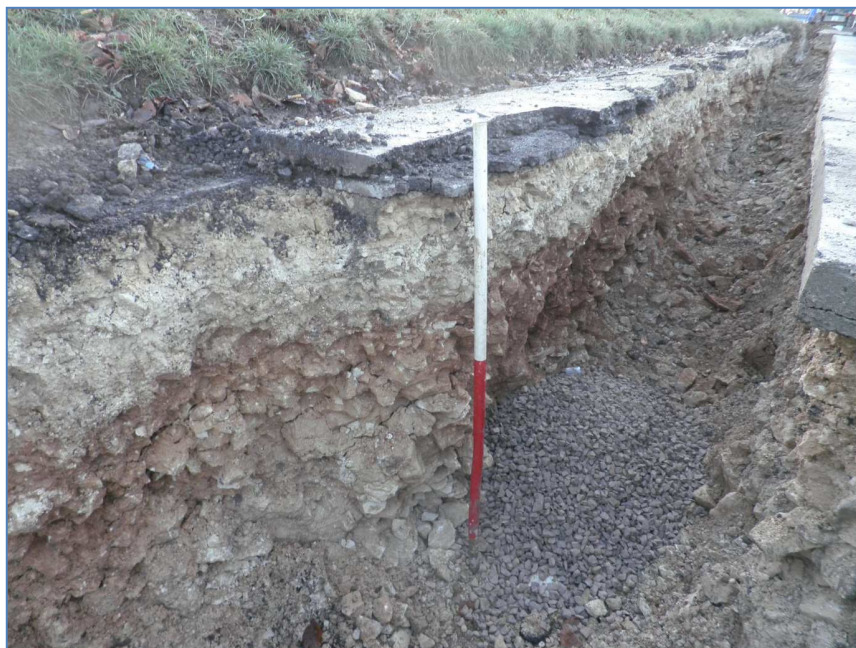
*Plate 3: Looking south down open cut replacement trench, showing tarmac (101), made ground (102), and truncated limestone bedrock (103)*

- 4.2.4 Context **(102)** immediately overlay context **(103)**, solid limestone bedrock. It is clear that Dr Brown's Road has been stripped to bedrock and levelled, prior to any phases of road makeup. The banked verges probably consist of up-cast from this activity. However, only the tip of the banks toe slope was visible during the trenching, and only in the southern half of the monitored area, where deviations in the course of pre-existing services caused the replacement trench to veer closer to the verge banks.

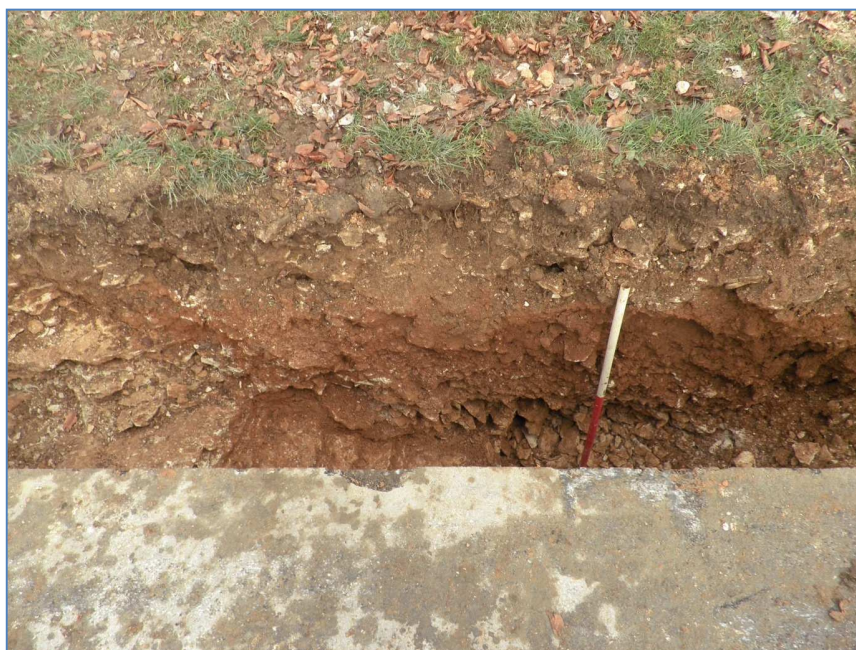
*Plate 4: Looking east at the hand cleaned northern side of The Bulwarks ditch [109] (Section 2)*

- 4.2.7 Ditch **[109]** was cut in solid, flat-bedded limestone. It had a very steep southern side, and more stepped northern side. Although the loose stony fill and narrow trench made examination of the deposits difficult, five archaeological contexts were identified in the ditch sequence (Figure 4). The uppermost (truncated) deposit **(110)** was a mid orangey brown silty clay

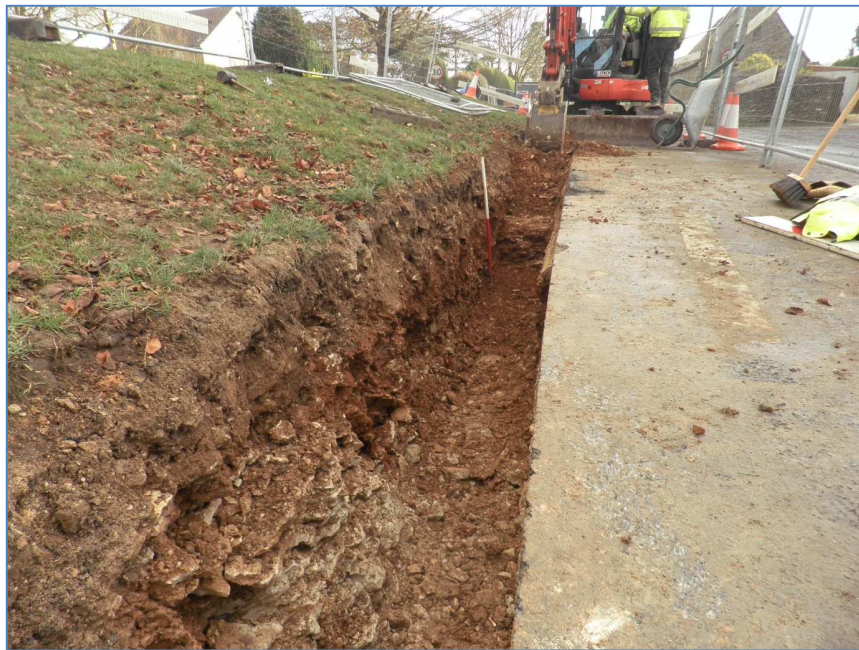
*Plate 5: Looking south from truncated northern side of ditch [109], to the hand cleaned southern side of [109], Section 2*

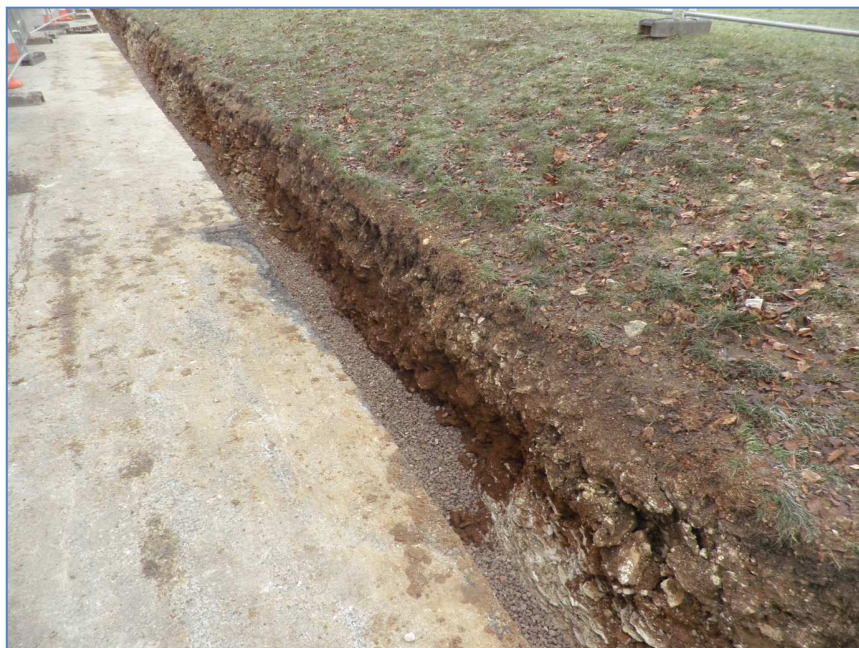
*Plate 6: Looking northeast at the fully truncated profile of ditch [9], with fresh aggregate in base of replacement trench*

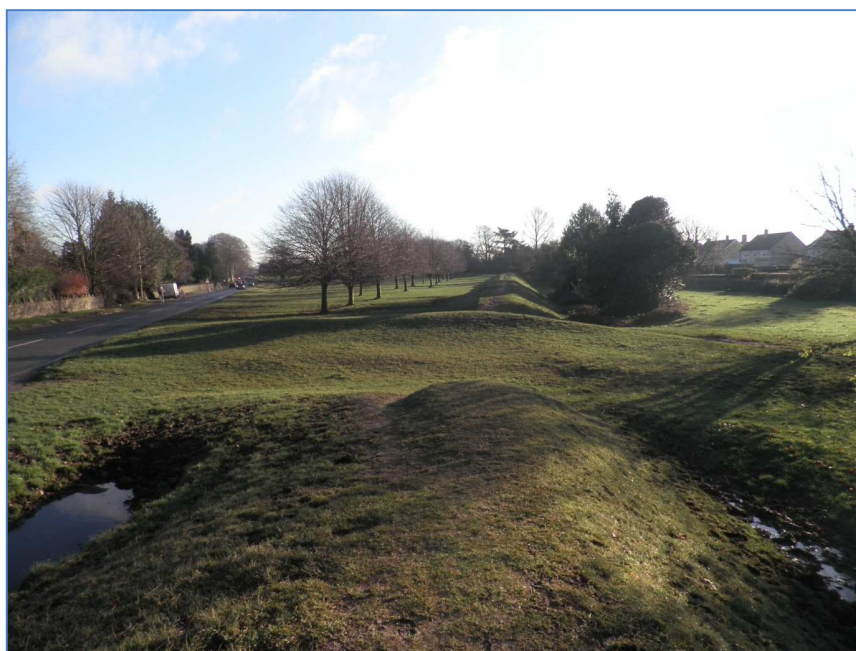
*Plate 7: Looking east towards Dr Browns Road (obscured by trees) from the northern bank of The Bulwarks, with the deep ditch clearly visible on the southern side (right). Cirencester Road on (left)*

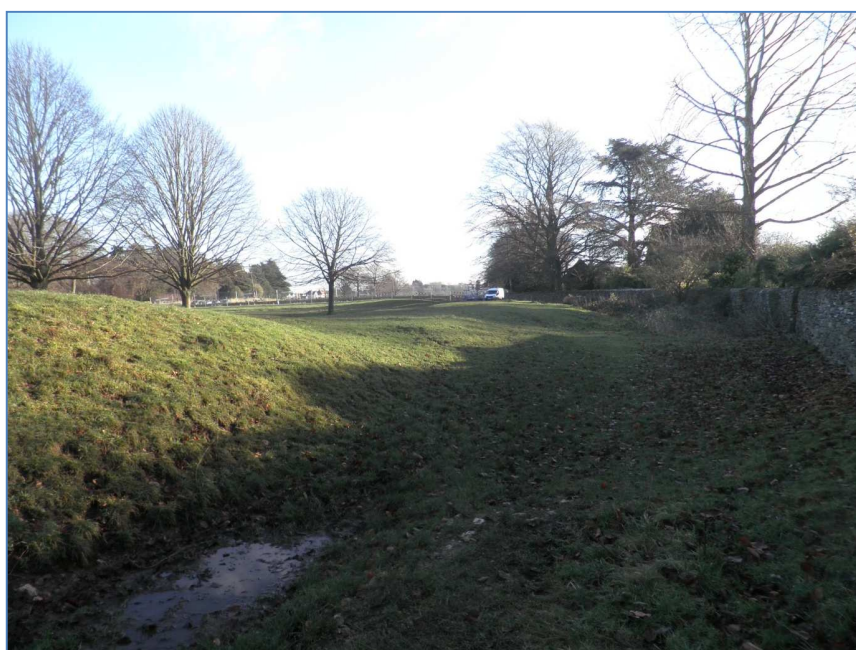
*Plate 8: Looking east towards Dr Browns Rd (white van), from within The Bulwarks ditch to the west of the monitored trench. This is the point from which the earthworks appear to have been deliberately levelled, becoming progressively harder to trace on the ground further east beyond Dr Browns Rd.*

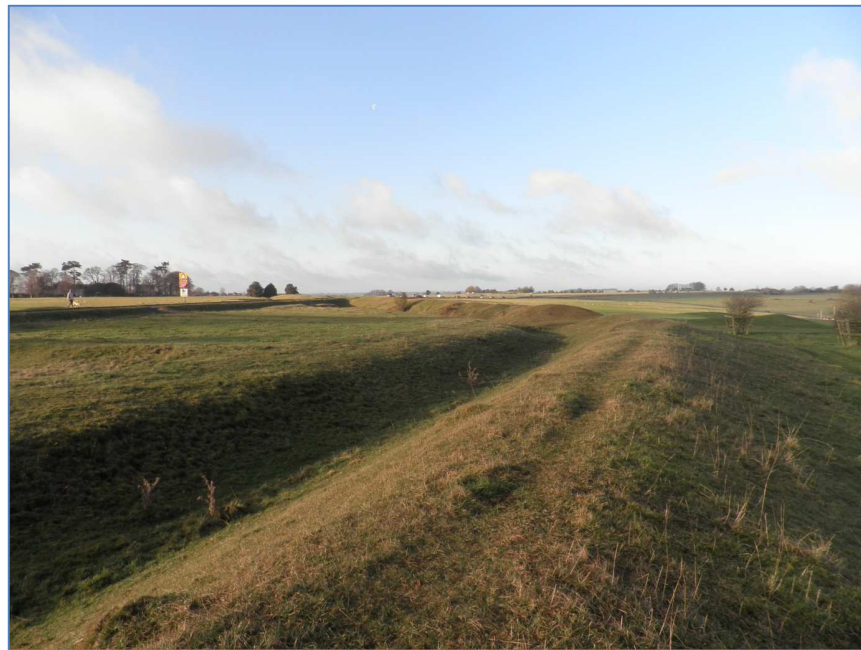
*Plate 9: Looking west over the well preserved section of The Bulwarks on Minchinhampton Common, cut by the Cirencester Road*

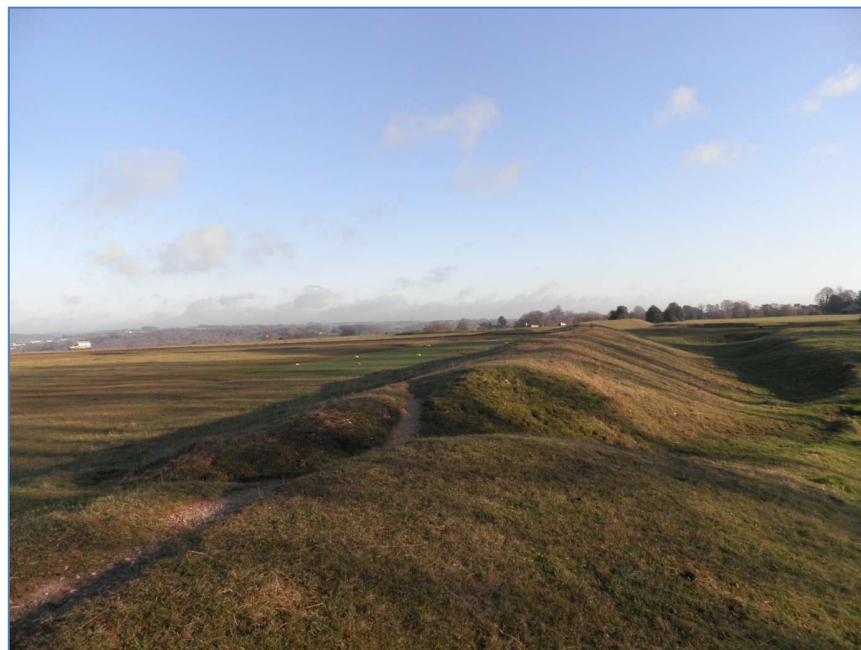
*Plate 10: Looking north-east at the northern circuit of The Bulwarks, with 'internal' ditch to right, and narrow area in front of the northern scarp to the left*

west, and is backed-up quite close against the valley edge in the northern section i.e. with low ground behind it (Plate 10). The elusive function of the monument is one reason for its continuing archaeological and local significance.
