MOLAND STREET, BIRMINGHAM, WEST MIDLANDS

WATCHING BRIEF REPORT CP. NO: 10096 JUNE 2012

DOCUMENT TITLE	Moland Street, Birmingham, West Midlands
DOCUMENT TYPE:	Watching Brief Report
CLIENT:	Watkin Jones
Ref Number:	CP10096
SITE CODE:	MSB-A
OASIS REFERENCE:	wardella2-143161
PRINT DATE:	June 2012
GRID REFERENCE:	SP 0747 8786

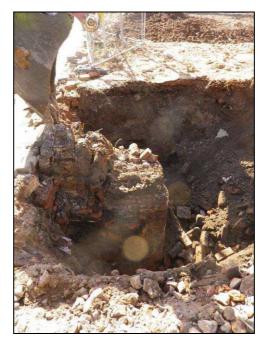
Plate 1: South facing photo of Stanchion 2 {1001} being excavated

- 4.2.4 The stanchions {**1001**} were made up of concrete with a brick covering and each measured *c*.1.7m by *c*.1.1m and were *c*.1.1m in height. They were assumed to be from the large building labelled as 'Stable and Vehicle Building Works' on the 1952 OS map (Figure 8).

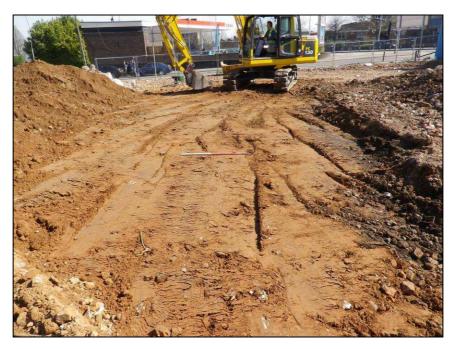
Plate 2: East facing photo of site being stripped of (1000) to reveal (1002)

- 4.2.3 Beneath the hardcore, was layer (**1002**). This was excavated into by *c*.0.2m but its lower interface was not reached (Plate 2). Layer (**1002**) constituted of a yellow loose sand with occasional small stone/gravel inclusions. Finds from (**1002**) consisted of modern pottery including one sherd of moulded white china, 14 sherds of post medieval pottery consisting of creamware, mocha, glazed earthenware, transfer printed china and white china; three pieces of post medieval china wall tile; 13 pieces of shell button waste; part of a glass crucible; a piece of drainage pipe and a plastic circular spacer/drill blank. These finds all have 20th century dates.

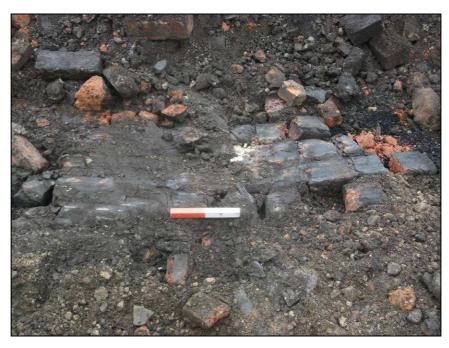
Plate 3: Detail of brick floor {1010} in the centre of the site from the east

- 4.3.2 The second phase of monitoring commenced with *c*.80m² of ground being reduced in the south-west corner and the centre of the site with a 360 degree tracked excavator using a toothed bucket. This ground reduction exposed *c*.0.5m of the demolition layer (**1000**) seen during the Phase 1 monitoring works. A red brick wall {**1009**}, one course high, was found in the centre of the site *c*.3.0m long, 0.33m wide and aligned east to west (Figure 9). There was also a brick floor {**1010**} *c*.1.0m south of this *c*.2.0m long north to south by *c*.0.4m wide (Plate 3 and Figure 9).

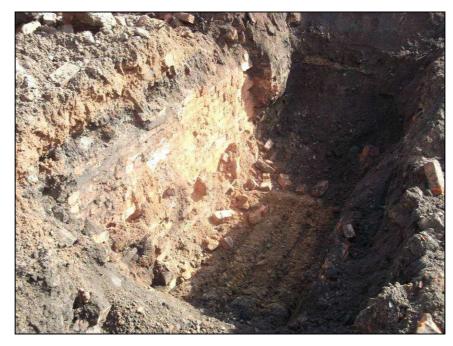
Plate 4: Post-excavation shot of Trial Pit 5 with wall {**1012**} visible in the south facing section

Trial Pit 5 (TP5) was excavated in the west centre of the site, aligned east to west through *c*.2.0m of (1000) onto (1005) (Plate 4). A graphite crucible was found with a fragment of coarse woollen textile inside and retained (Plate 5). There was a red brick wall {1012} in the south facing section aligned east to west *c*.1.7m high. (Figure 9).

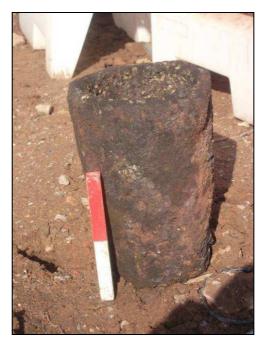
Plate 5: Detail of graphite crucible found in Trial Pit 5 in the centre west of the site

5.8.1 A total of seven fragments weighing 9.2 kg, were recovered from four contexts. Of note was an almost complete graphite crucible, from (1000) so called because it has been made from a graphitic clay. It consists of a tall conical crucible with one pointed triangular pouring spout. It is 300mm tall and has a diameter of 200mm at the top. It weighs 7.4 kg. The graphitic clay helped maintained reducing conditions as it is a refractory fabric (Bayley 1990, 3). Crucibles like this were used in foundry, normally for the smelting of iron. From within the crucible, fragments of a graphite rich smelting slag were found and a small scrap of a woollen twill weave fabric.

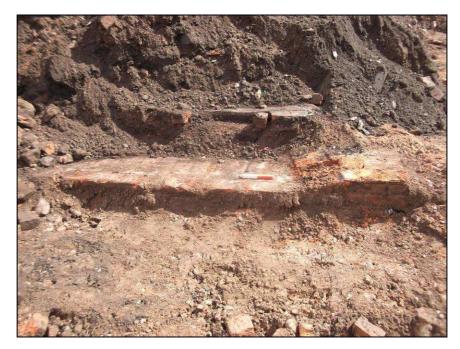
Plate 6: Detail of brick floor {1022} in west centre of site

4.3.5 Further reduction in the west centre of the site revealed a concrete base with a metal pin {1014} with a brick wall and associated brick floor to the east {1015}. The concrete base {1014}] could have been the upper surface of another concrete stanchion probably associated with the 'Stables and Vehicle Buildings Works' shown on Figure 8. Wall {1015} was aligned north to south and a *c*.4.0m length was visible. It could have been the same wall as {1013} found in Trial Pit 3 since they seemed to be on the same alignment. Unfortunately these structures were removed without supervision and so nothing more can be observed regarding them. Around 4m east of these structures, a brick floor was recorded measuring c.4.0m in length north to south and *c*.0.5m in width {1022} (Plate 6). Slightly further east and probably associated was a square brick structure {1007} 3.1m north to south and 3.3m east to west (measured from outside edge to outside edge). The walls were 0.33m thick and the south wall continued further east by c.0.4m before the remains ended. There were small areas of brick floors attached to the northeast and north-west walls on the outside of the building (Figure 9). The room was filled with deposit (1006) a moderately compact black carbonised material with some inclusions of post medieval pottery and slag (not retained) *c*.0.2m thick.

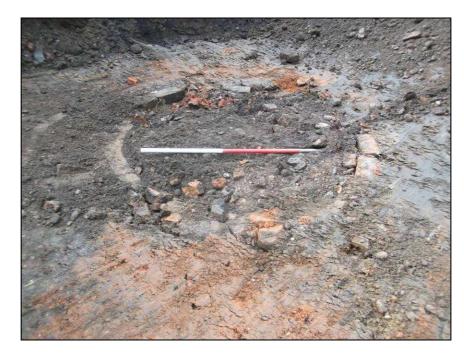
Plate 7: Detail of circular brick built structure, possibly a well, {**1016**} in the centre west of the site

- 4.3.8 The 360 degree excavator with toothed bucket reduced the ground level by another 0.5m revealing more of (1008) before continuing north and northeast at this level. More of (1005) was revealed towards the centre of the site. In the west centre of the site there was a circular brick structure {1016} 1.2m in diameter constructed from a single line of bricks placed end to end in context (1005) (Plate 7). This structure did not appear to relate to anything visible on the 1889 OS map (Figure 9) and it is thought that it could be a well positioned inside one of the buildings that stood against the centre of the west wall {1021}.

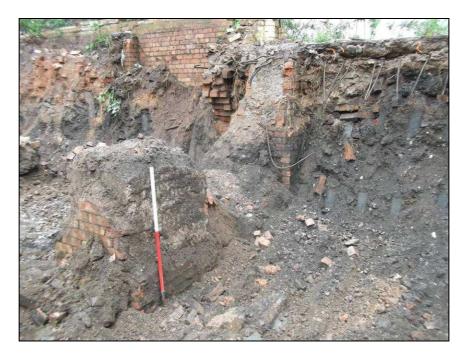
Plate 8: Shot of concrete stanchions {1017} in north-west corner from north-east

- 4.3.9 The ground was then reduced in the north-west corner to the depth of the (1008) previously uncovered. This revealed a series of three reinforced concrete stanchions with brick linings running east to west {1017} (Plate 8). The western most stanchion was below an existing concrete floor that had been flush with the original level of the site and remained attached to the west and north walls in the north-west corner (Figure 9). The centre stanchion had a very large concrete base *c*.3.0m by *c*.2.0m by *c*.1.0m thick. Adjacent to the north of this centre stanchion was another, set beneath concrete floor remains on the north wall. These two stanchions were also in line with an iron girder reinforcing the north wall. Another iron girder reinforced the north wall *c*.3.5m to the east (Plate 9). These structures were thought to relate to the '*Stables and Vehicle Building Works*' building noted on the 1952 OS map (Figure 8) and the stanchions removed previously in the first phase.

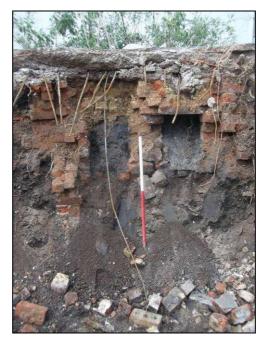
Plate 10: Shot of furnace {**1018**} and burnt material (**1023**) next to west wall in north-west corner

- 4.3.10 On either side of the reinforced concrete stanchions and beneath the concrete floor in the northwest corner was a deposit of burnt material (1023) surrounding a brick structure {1018}. Deposit (1023) contained 8 sherds of post medieval pottery including; English stoneware; mocha ware; and white china, a clay tobacco pipe with an unmarked stem and 1 piece of iron slag. They had a 19th -20th Century date. {1018} was too damaged to define but had two furnaces facing east (Plate 10). The northern one had an iron hollow square in the roof and was filled with paper ash and carbonised material. These were thought to be the remains of buildings labeled Brass Foundry on the 1889 OS map (Figure 9).

- 4.5.5 It is probably quite likely that {**1018**} and {**1019**} are the remains of brass foundry furnaces. {**1025**} is less convincing due to its state of preservation.

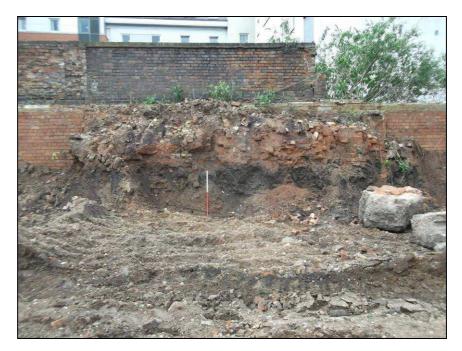
Plate 11: Shot of brick built structure {1025} on west wall {1021}

- 4.3.11 There were two more similar brick built structures. One structure {**1025**} next to the centre of the west wall {**1021**} which appeared to have had multiple furnaces along its *c*.5.5m length (Plate 11), and the other next to the centre of the north wall which had a brick built furnace {**1019**} with a square iron lid across its upper surface (Plate 12) filled with a deposit of (**1024**) ash that contained a copper pot (not retained) and four crucible fragments; 14 pieces of copper alloy consisting of a caster fitting; escutcheon; furniture fitting; handle; machine parts; mount; and rivet /loop; strip an iron: fitting and one piece of non-diagnostic iron slag. These finds have a 19th to 20th century date. Structures {**1018**} and {**1025**} may have been the remains of buildings labelled 'Brass Foundry' at the north of the site, and 'Iron Foundry' to the south on the 1889 OS map (Figures 6 and 9).

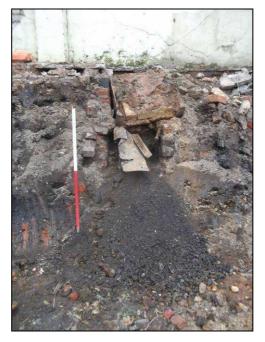
Plate 12: Shot of furnace {1019} next to N wall

- 4.5.1 Brick structures {**1018**} and {**1019**} both contain what may be ovens or furnaces related to the Brass Foundry that was indicated to be undertaken here on the 1889 OS map (Figure 9). Brick structure {**1025**} may also have had a bank of similar features.

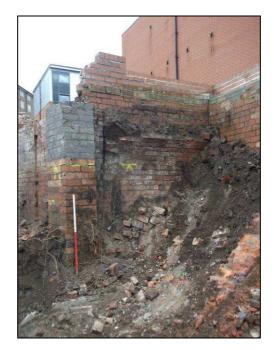
Plate 14: Shot of kink in west wall {1021} with arching brickwork

- 4.3.13 Where the west wall {**1021**} kinks westwards at its south central part the north facing section of the wall has the remains of bricks arching out as if the ceiling had been vaulted. There was also white paint remaining on these bricks. This could be the remains of a small building seen on the 1889 OS map in this corner (Figure 9) (Plate 14).
- 4.3.14 The 360 degree tracked excavator used a toothed bucket to reduce the ground to the north and east to the level reached in the south west corner. The natural subsoil (**1026**) was reached and was composed of yellow sand with occasional sub-round boulders. It was found that this interface rose upwards as we moved east probably indicating that the site was originally a hill sloping down from east to west.

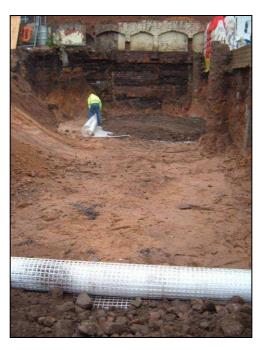
Plate 15: General working shot in north-east corner facing north

4.4.1 After a brief hiatus the final phase commenced on the 7th and 8th June 2012. An area roughly 10m by 23m was excavated in the north-east corner. The 360 degree excavator removed around 1.5m of hardcore surface layer (1000) and subsoil layer (1008) revealing more of the north wall (Plate 15).

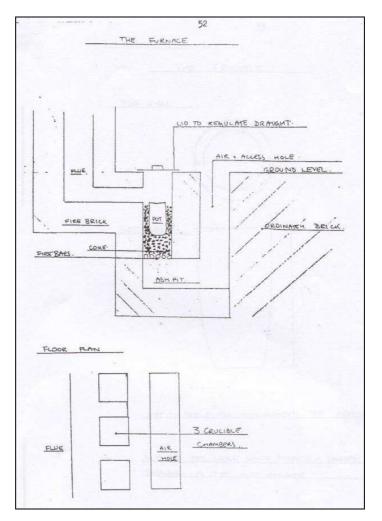
Plate 16: Section through a single foundry furnace, and the complete installation of three such furnaces at Bewdley foundry (Day 1992, 52)

- 4.5.4 The availability of cheaper zinc ingot brought the general adoption of the melting process of brass making. It could be carried out almost anywhere in a simple installation with a single-holed foundry furnace (Plate 16) below working floor-level, holding a single foundry crucible where the brass would have been heated to about 900°C. The resulting brass could then be further crafted in a small workshop (*ibid*).

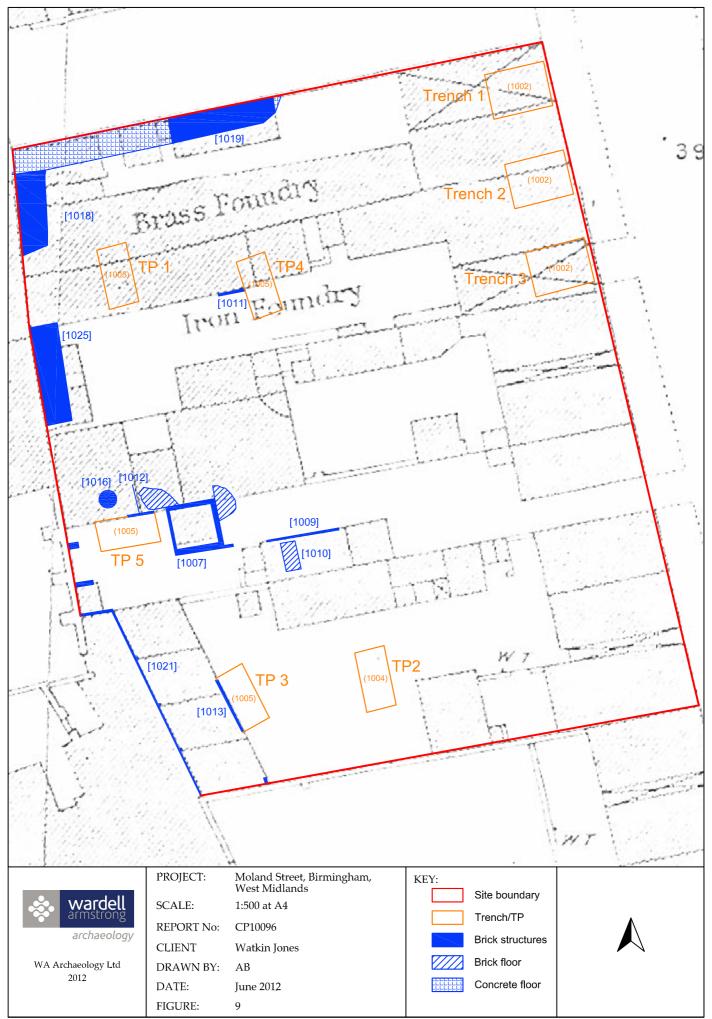
Figure 9: Approximate location of brick structures based on First Edition Ordnance Survey 1889

- 4.5.6 All the remains of brick walls and structures found beneath the overlying demolition layer (**1000**) seemed consistent with the structures on the 1889 Ordnance Survey map (Figure 9) that still existed when the 1937 Ordnance Survey map was drawn (Figure 7). This interpretation is supported by the 19th to 20th century dates of all the finds from (**1000**) which is probably the demolition rubble of these buildings. Finds of shell button manufacturing waste, crucibles and industrial residues tend to support an interpretation of mixed, small scale industrial activity.
