FORMER MAGISTRATES COURT, RUPERT STREET/NELSON STREET BRISTOL

> HISTORIC BUILDING SURVEY CP. NO: 10561 DATE: 28/05/2013

DOCUMENT TITLE:	Former Magistrates Court, Rupert Street/Nelson Street, Bristol, BS1 2PY					
DOCUMENT TYPE:	Historic Building Survey					
CLIENT:	Watkin Jones Group					
PROJECT CODE:	CP10561					
PLANNING APPLICATION:	13/00452/F					
OASIS REF:	wardella2-150077					
PRINT DATE:	28/05/2013					
GRID REFERENCE:	ST 58734 73207

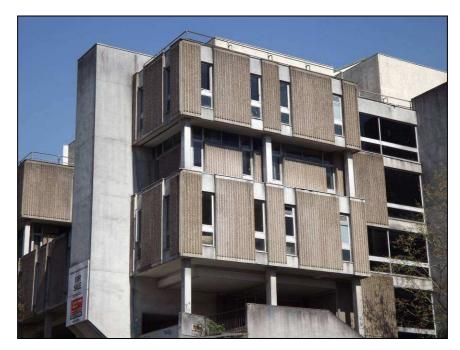
Plate 7: Detail of the tall windows, with larger examples to the right which light the landings of the public staircases, south-west elevation

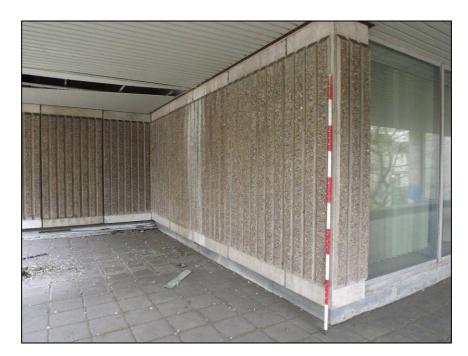
Plate 8: Detail of 'cladding' effect created by grooves cut into the concrete panels, and pebble-dashing, as seen at second floor level, south-west elevation

- 5.3 Externally, the building is typical of its period, with concrete 'cladding' being the main architectural feature, with overhanging elements, external stairways and apsidal stair towers. It was interesting to note the lack of a dominant main entrance, as is often present in civic buildings such as this; the main doorways were noted to be present in the north-east elevation, at first floor level, although they could not be observed externally at the time of survey due to the external staircases being boarded up.

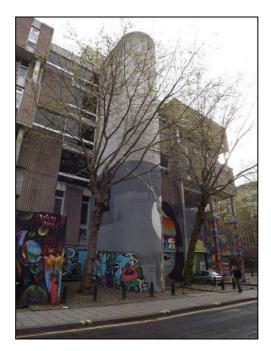
Plate 9: Detail of the south-western apsidal stair tower, Christmas Street

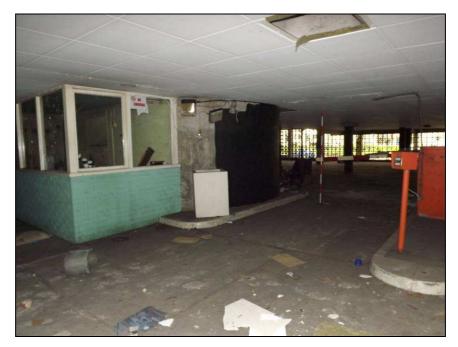
- 4.2.3 It was noticeable that the ground floor elevations contained no windows; this is due to the fact that this level was constructed as a car parking area at the base of the building, with vehicular access noted to have been from Nelson Street (see Figure 3). Along the north-west elevation, at ground floor level, there are decorative air bricks which would have allowed natural light to penetrate into the car park, as well as provide ventilation (Plates 1 and 10). Further access points to the ground floor parking area were provided in the south-west elevation, and a large doorway in the south-east elevation (providing access into a separate 'police yard' see Figure 3). It is interesting to note that the main public pedestrian access into the building was not provided at ground floor level.

Plate 21: Ground floor of former Magistrates Court, showing security office and barrier in car parking area (Scale = 2m)

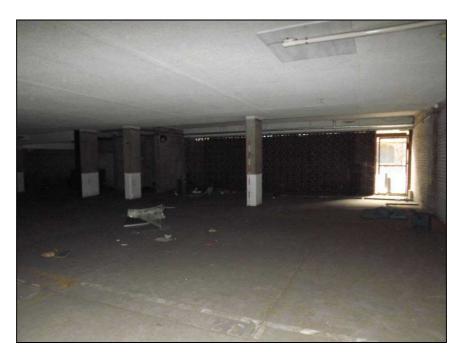
Plate 22: Ground floor car parking area

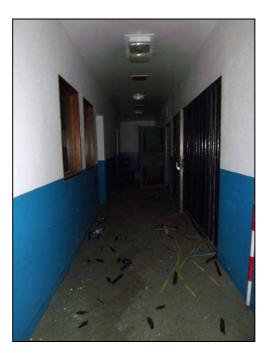
- 4.3.5 As noted, the basement was largely utilised as cells, seemingly arranged off short corridors towards the north-western side of the building (Plates 24 to 26).

Plate 24: Detail of one of the short corridors in the basement, with cells leading off to the right

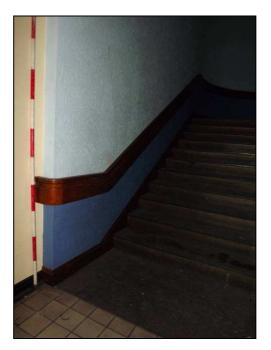
(Plates 32 to 34) compared to the plain square balusters, metal handrails and linoleum floors of the staff staircases (Plate 35).

Plate 32: Example of part of one of the public staircases

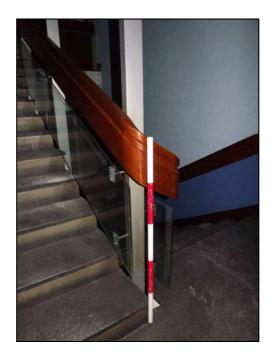
Plate 33: Example of the finish to one of the public staircases (Scale = 1m)

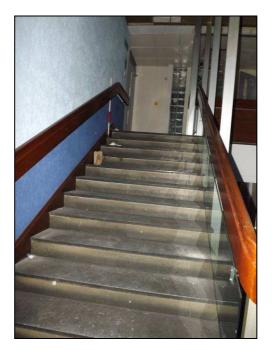
Plate 34: Detail of public staircase (Scale = 1m)

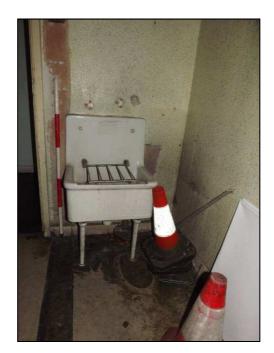
- 4.3.13 An original basin with metal stand for buckets was noted on this floor in a cleaners store (Plate 39).
- 4.3.14 *Third Floor (Figure 6):* this was the first floor encountered during the survey where court rooms were located, with associated spaces such as magistrates rooms, waiting rooms, toilets and defined areas for prisoners (Plate 40). There are four court rooms on this floor, two (Courts 1 and 2) being slightly larger than the others (Courts 3 and 4). These court rooms are central to the building, with the surrounding space being utilised as corridors and offices arranged around the outside edges (Figure 6).

Plate 39: Example of a cleaners basin, second floor (Scale = 1m)

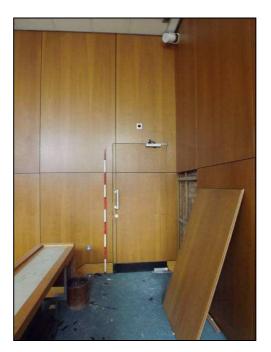
level than the rest of the court room, with access for the magistrate through a doorway which is flush with the wall, and with no architrave (Plate 44). The panelling of the court rooms on Floors 3 and 5 was of the same form throughout the building, and it was noted that this panelling was fixed to studwork which in turn was attached to internal brick and concrete walls, although it appears that this brickwork was not laid particularly well. As these internal walls were not load bearing, it would appear that they were inserted simply to define specific spaces and allow the panelling to be affixed (Plate 45). It was interesting to note that the panelling was constructed from chipboard that has been applied with a veneer to give it a higher quality finish (Plate 46).

Plate 44: Detail of magistrates doorway, north-west wall of Court 2 (Scale = 2m)

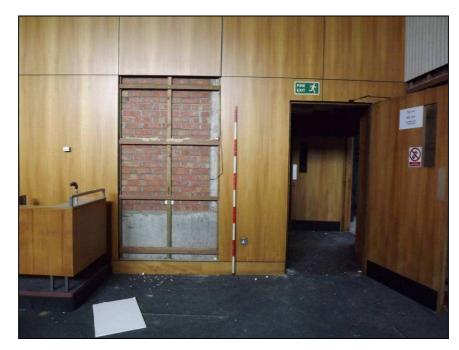
Plate 45: Example of removed panelling, Court 7 on the Fifth Floor (Scale = 2m)

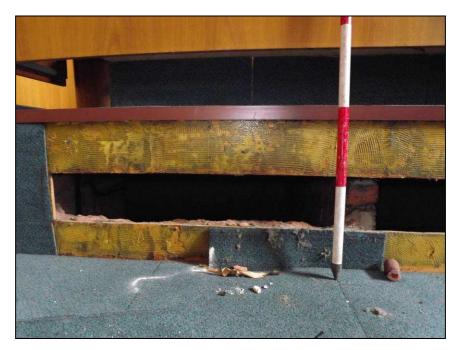
- 4.3.17 The magistrate's benches, which as already noted are set on a raised platform, were noted to be constructed of timber with a void below where it would appear a heating system was located (Plate 47). The outline of a Royal Coat-of-Arms was present in all of the court rooms, with the Coat-of-Arms themselves having been removed; at least one (in Court 1) has been removed since the desk-based assessment of 2013 (Townsend 2013, Plate 15). All of courts on the Third Floor are well-lit by large windows in the north-west and south-east walls; this has been made possible by the inclusion of a mezzanine on the Fourth Floor above, with Courts 1 to 4 extending in height into part of that floor (see Figure 7) (Plates 48 and 49).

Plate 47: Detail of raised platform of magistrate's bench, showing void below, Court 2 on Third Floor

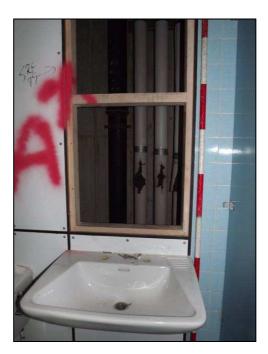
- 4.3.18 It has already been noted that some service pipes, such as electricity and heating, were concealed above the suspended ceilings. Additional services and drainage were housed in boxed-in areas within spaces such as the toilets (Plate 50). Also of interest is the original provision of firefighting equipment such as hose reels and recesses for fire extinguishers, as well as hydrants such as that noted on the Fourth Floor (Plates 51 to 54).

Plate 50: Detail of pipework hidden within ladies toilets, Third Floor

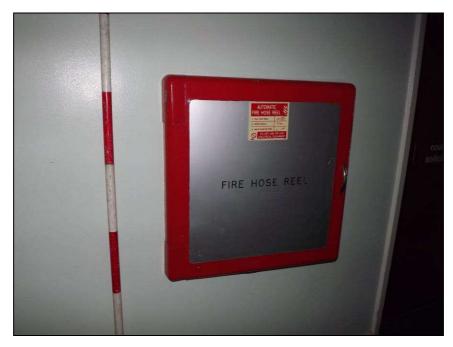
Plate 51: Detail of fire hose reel storage, Third Floor

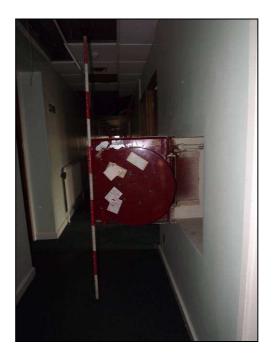
Plate 52: Detail of fire hose reel, Third Floor

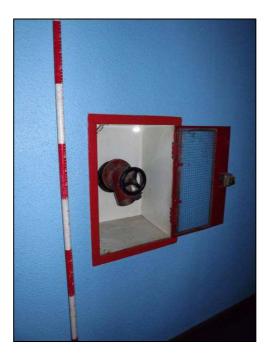
Plate 54: Fire hydrant, Fourth Floor

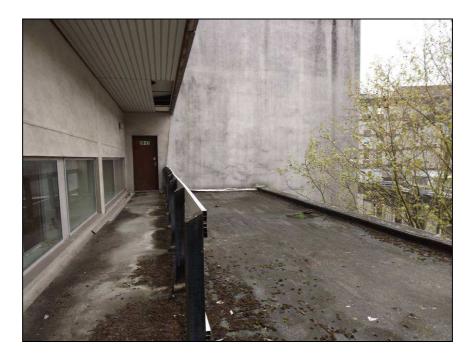
- 4.3.20 This floor was used mainly as offices around the outer corners, and within the central area where the lift shafts and magistrate's and prisoners stairways are located. Located to the north-west and south-east sides of this floor are mezzanines, the provision of which has allowed plenty of natural light to enter the court rooms on the Third Floor as noted above (Plate 55).

Plate 55: Mezzanine level, Fourth Floor

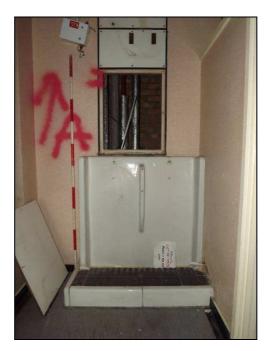
- 4.3.21 Original features of interest noted on the Fourth Floor included urinals in the gentlemen's toilets, the aluminum window frames of the building and the electrical heating (Plates 56 to 58).

Plate 56: Original urinals, Fourth Floor

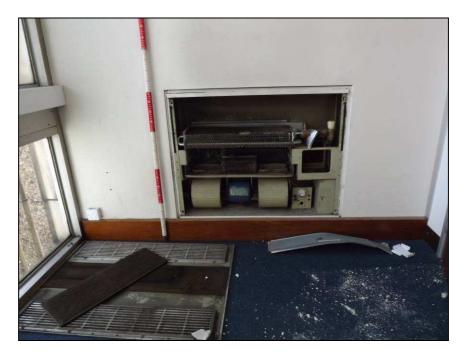
Plate 58: Detail of electric heater, Fourth Floor

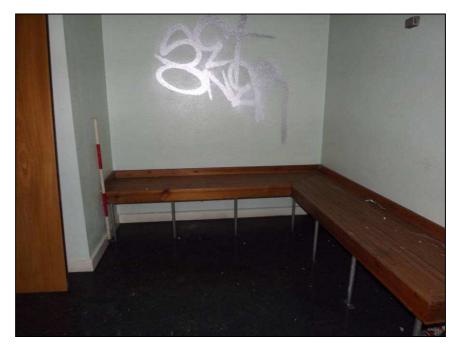
- 4.3.26 Features of note observed at Fifth Floor level included the benches in the prisoners lobby of Court 7, and an original sink and drainage area in the male toilets (Plates 64 and 65).

Plate 64: Prisoners bench, lobby of Court 7, Fifth Floor (Scale = 1m)

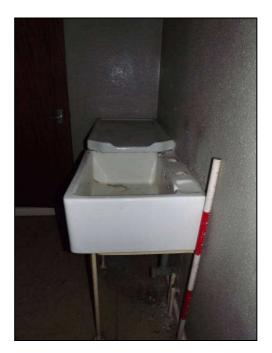
Plate 65: Original sink and drainage area, Fifth Floor

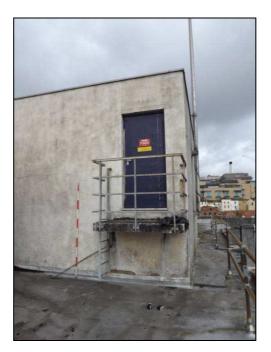
Plate 66: Roof level showing plant room for lift machinery

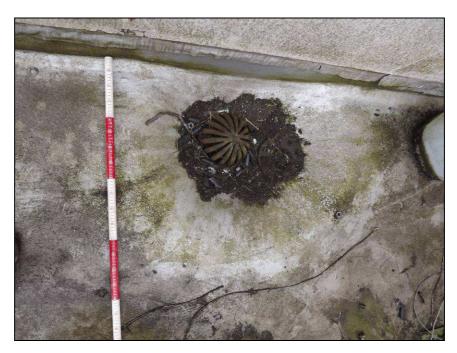
Plate 67: Detail of drainage hole, floor of roof level
