**LAND AT FISHPONDS ROAD,
KIRKLEATHAM,
TEESSIDE**

**WATCHING BRIEF REPORT
CP. No10353
12/08/2013**

DOCUMENT TITLE: Land at Fishponds Road,
Kirkleatham, Teesside

DOCUMENT TYPE: Watching Brief Report

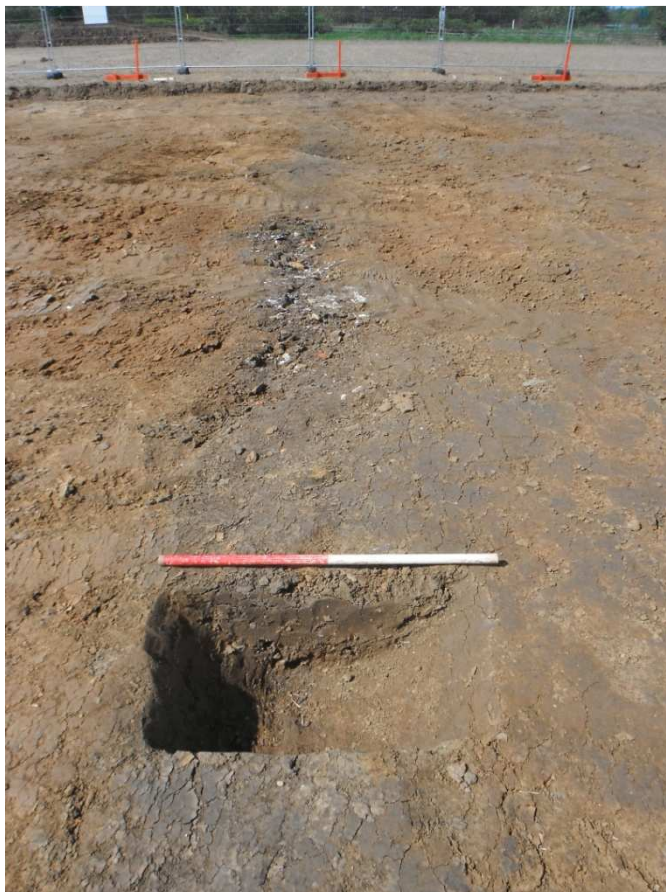
4.2.4 A narrow linear feature on the same alignment was detected north of the furrows extending beyond the limits of excavation. This feature comprised a steep sided U-shaped gully **[102]** filled by a moderately compacted dark brown sandy clay **(103)**, and is believed to be the remnants of a former field boundary, believed to be post-medieval or modern in date. Within this gully, for a length of 4.6m, a modern waste deposit **(104)**, consisting of red brick fragments, mortar, broken roof tiles, glass shards, pottery sherds and metal objects was observed. This deposit is believed to have been deliberately placed into the ditch perhaps in order to make a crossing or access point from one field to another.

Plate 1: North-east facing section, field boundary [102] (1m scale).

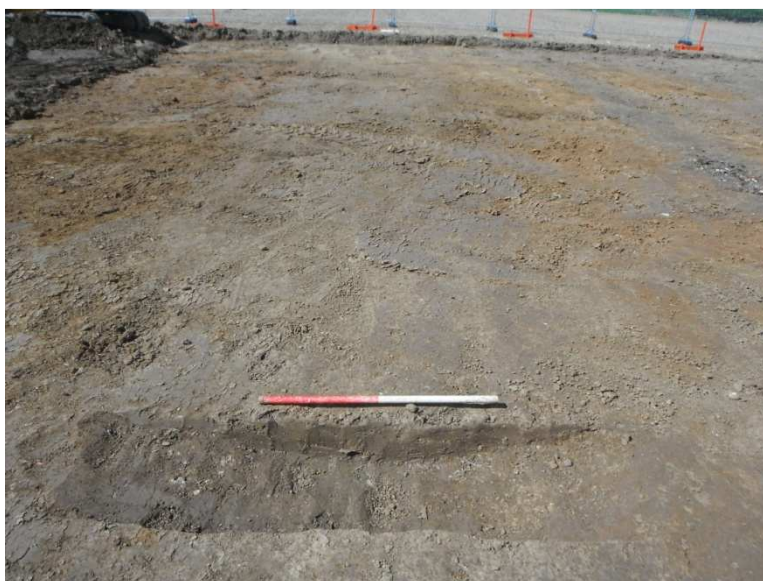
4.2.5 Three parallel shallow linear features approximately 3m apart were observed aligned southwest-northeast towards the southern aspect of the area. These features [105], [107] and [109] are believed to be the remains of post-medieval plough furrows (Figures 3 and 4). The general characteristics of these features consisted of a shallow ditch with gently sloping sides leading to a flat base and measured an average width of 2.5m with a depth of 0.25m. All three furrows were filled with a moderately compacted light to mid grey sandy silt. No dating evidence was recovered from any of the features but due to their size and spacing they have been categorized as post-medieval in origin.

*Plate 2: North-east facing representative section of furrows, showing [105]
(1m scale).*

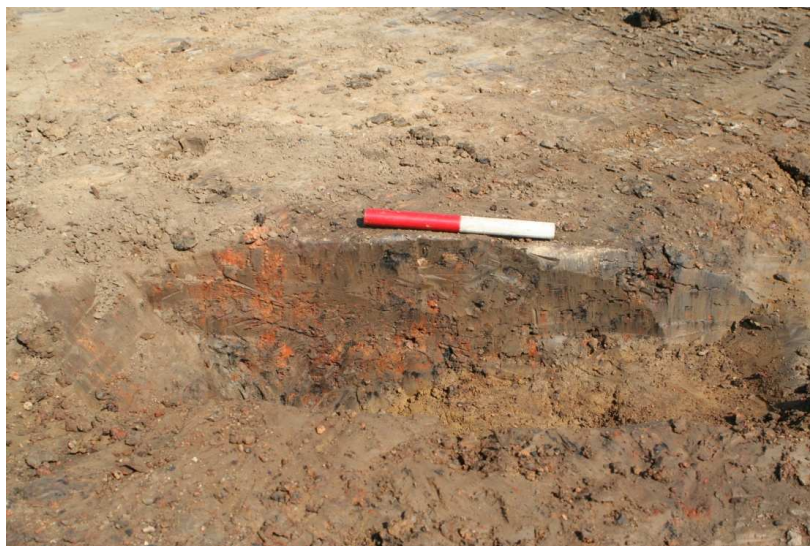
4.3.5 The only other feature of note in this area was in the form of a small pit situated c.10m south of the former field boundary. This sub-circular feature, [115], measured 0.6m x 0.7m with a depth of 0.23m and contained a single fill, (114), of dark orangey brown/mid greyish brown sandy clay with frequent inclusions of burnt sandstone fragments. A soil sample was retained to assist in the dating of this feature as no dating evidence was recovered from it, though this was inconclusive.

Plate 3: South facing section, pit [115] (0.2m scale).

- 4.4.1 No finds of archaeological interest were recovered during any phase of the watching brief. One environmental sample was collected, this being from the pit [115] found within the car park area (Phase 2a). This sample was unable to provide any further information regarding its date or function.
