Land off Crookston Road, Leverndale, Glasgow

Archaeological Excavation Report

Wardell Armstrong Archaeology Limited

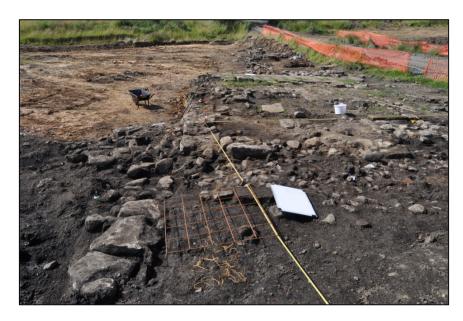
Plate 1. Structures 1 & 2 during excavation, looking south-west.

- 4.2.8 Two complexes of buildings, located either side of a roughly metalled north to south aligned track way (250) were exposed during the excavation of Area C: Three structures (Structure 1 & 2 on the east, and structure 3 to the west of track way (250). All three of these structures would appear to be of a contemporary, mid 19th century date. Track way (250) was laid directly onto agricultural horizon (195) and did not demonstrate any phases of use beyond its original construction.

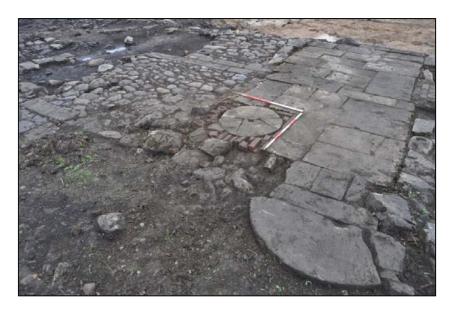
Plate **2**. Re-used millstones within floor (221), Structure 1,looking east (2 *x* 1*m scales*).

- 4.2.10 Three re-used architectural gate/ door 'spud' stones were incorporated into this floor (not retained). The northernmost extent of (207) was truncated and it would appear likely that a shallow linear depression [205] barely truncating into underlying (195) was the remnants of a truncated or robbed out kerb (206). No surface was present on top of agricultural deposit (195) in the northern extent of Structure 1, and the presence of a stone-built, clay lined drain (211)/(192) leading downhill from the north-eastern corner of the structure suggests it was utilised as a drainage area into the underlying subsoil for the rest of the structure.

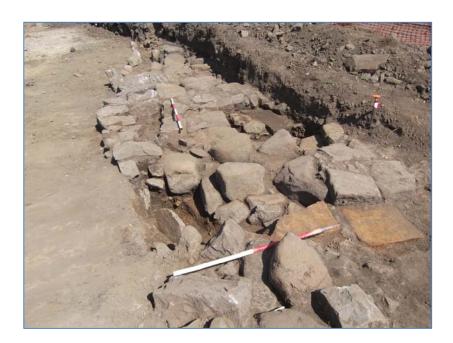
Plate 3. Northern end Structure 3, looking north (1x1m & 1x2m Scales)

- 4.2.16 Like Structures 1 and 2, two distinct phases of activity were present within Structure 3. The primary construction comprised of walls (217) and (214) forming the western side. Whilst contemporary two distinct masonry types were present, with the southern end of the wall (217) comprised of large sub rounded boulders (maximum 0.6m) and (214) constructed of smaller stones with occasional rough facing. A stone built, clay lined drain (198) ran alongside wall (214) and was incorporated into wall (217).

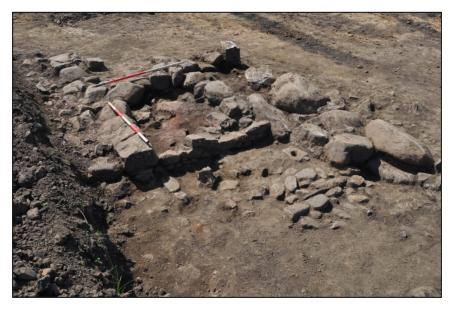
Plate 5. Structure 3, hearth (196), looking south-west.

4.2.17 The southern end of Structure 3 was formed by a series of walls (196) forming an internal arc of a large hearth/ oven/ fireplace 1.45m in depth by 2m in width. Within the hearth was a deposit of mixed compacted charcoal, ash and red heat affected clay (190). A flagged floor (229), laid directly onto natural was associated with this hearth. Internal walls (200), (251) form small bays and a distinctly separate room within the northern part of Structure 3, with a floor of compacted rubble (201).

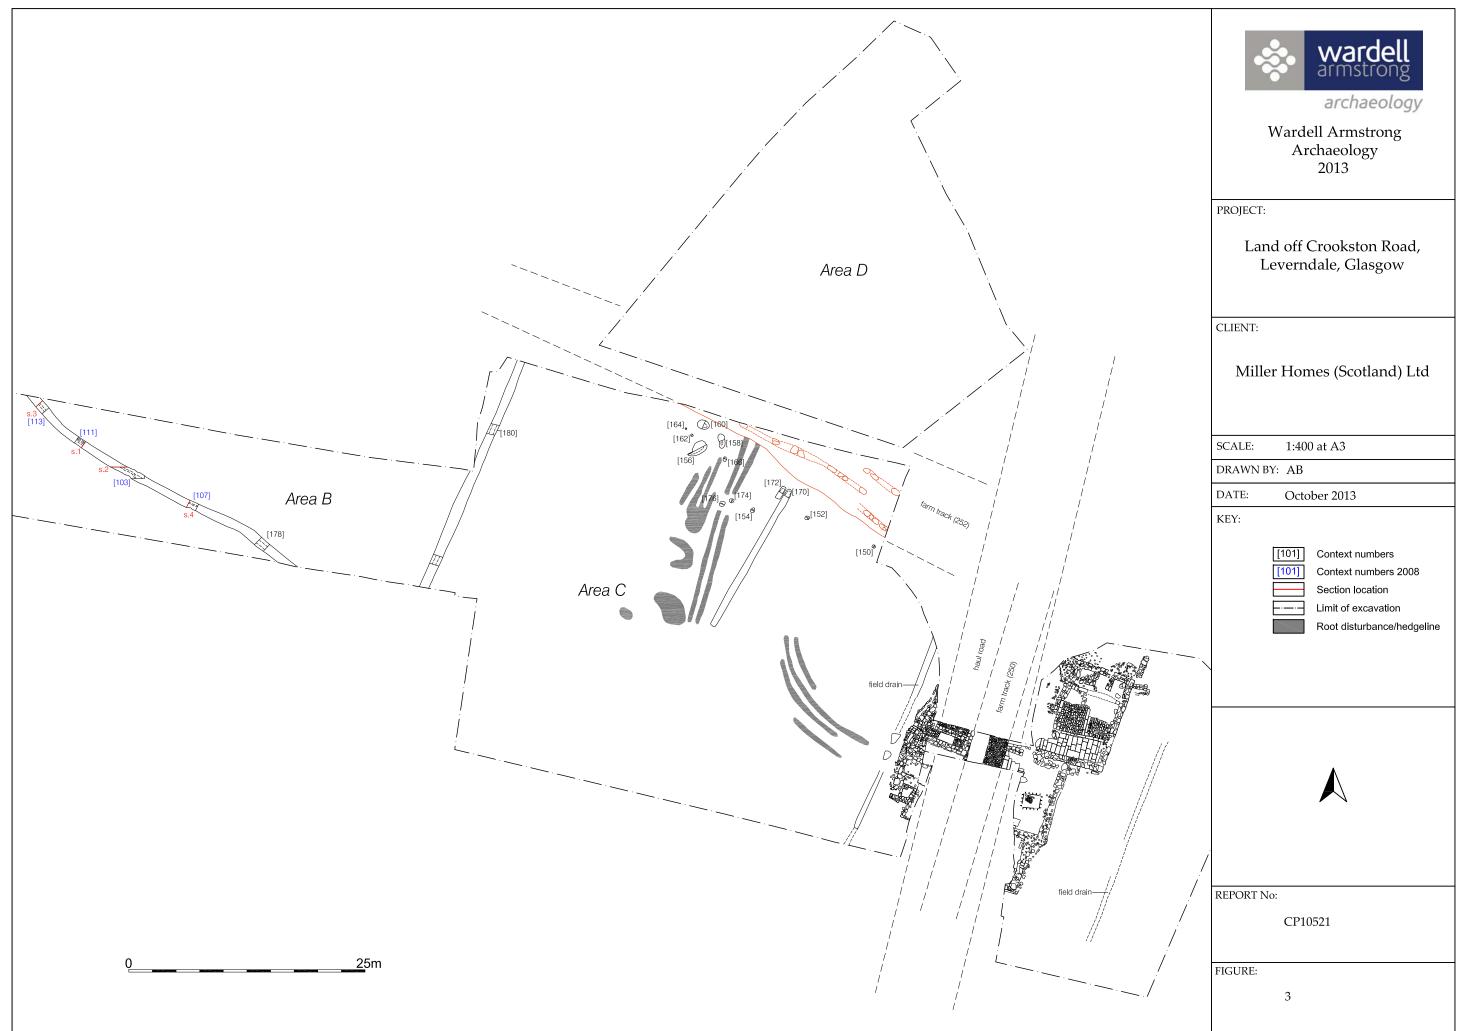
Figure 3: Plan of open area excavation.

- **4.2.1 Areas B & C (Figures 2, 3, 4)**; Areas B and C comprised 6120 m². The 2013 excavation attempted to re-strip those areas that had been opened in 2008, but the level of turbation and plant growth in the already stripped areas made the exposure of these areas impossible; Area B was fully restriped to locate the line of a ditch identified in 2008, with the remaining areas of archaeology recorded in 2008 being left mostly unstripped. The excavated features from the 2008 and 2013 phases of excavation are compiled in this report.

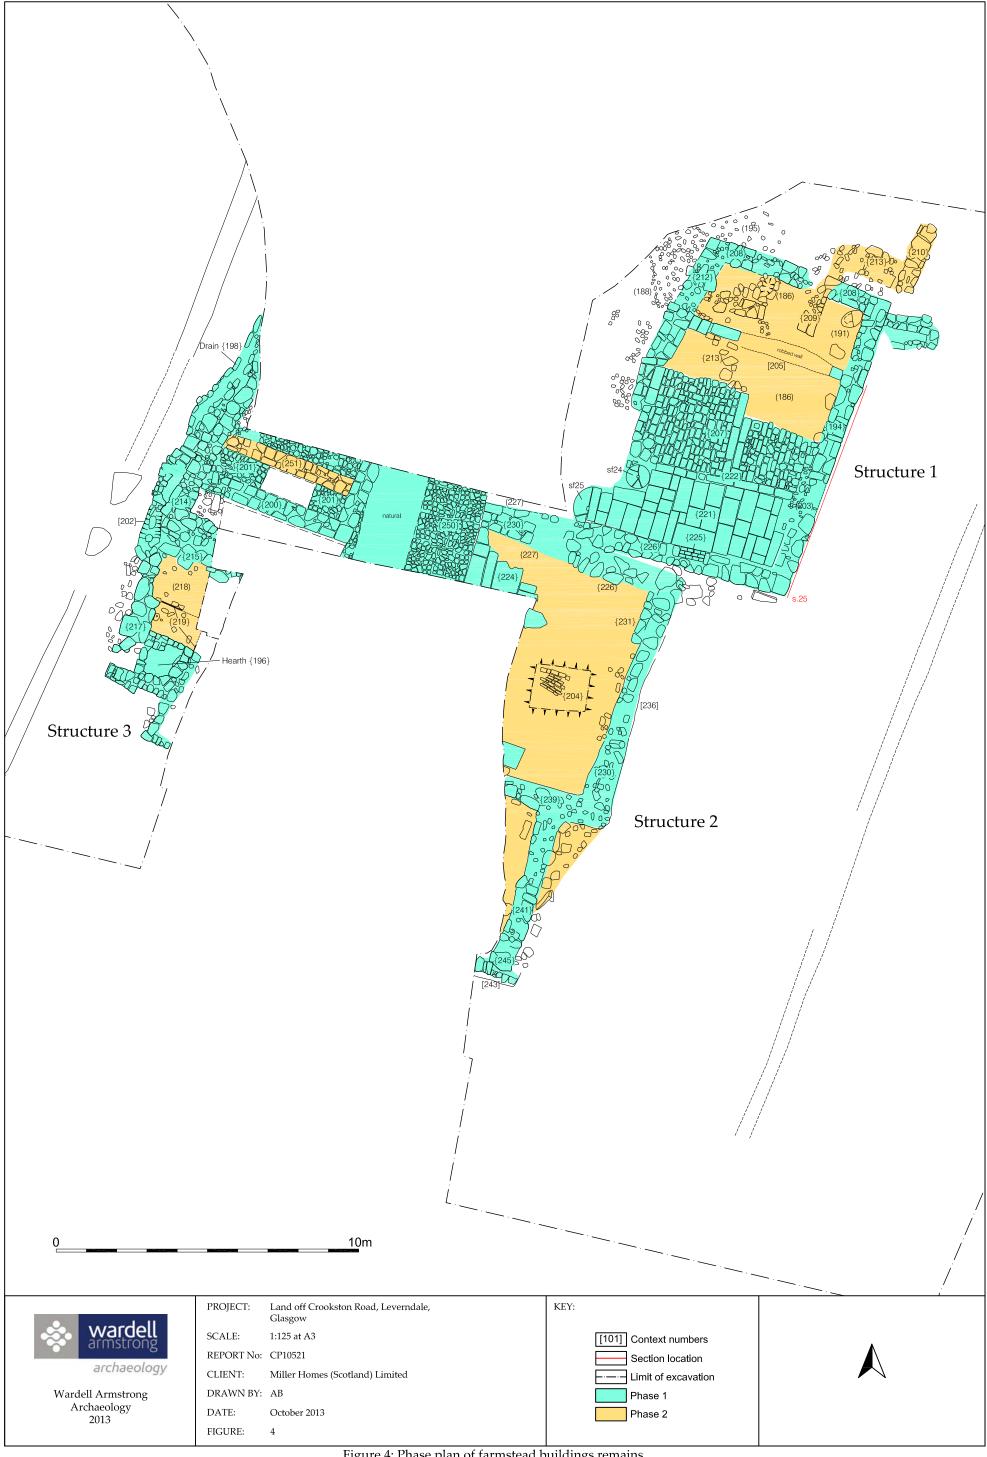
Figure 4: Phase plan of farmstead buildings remains.

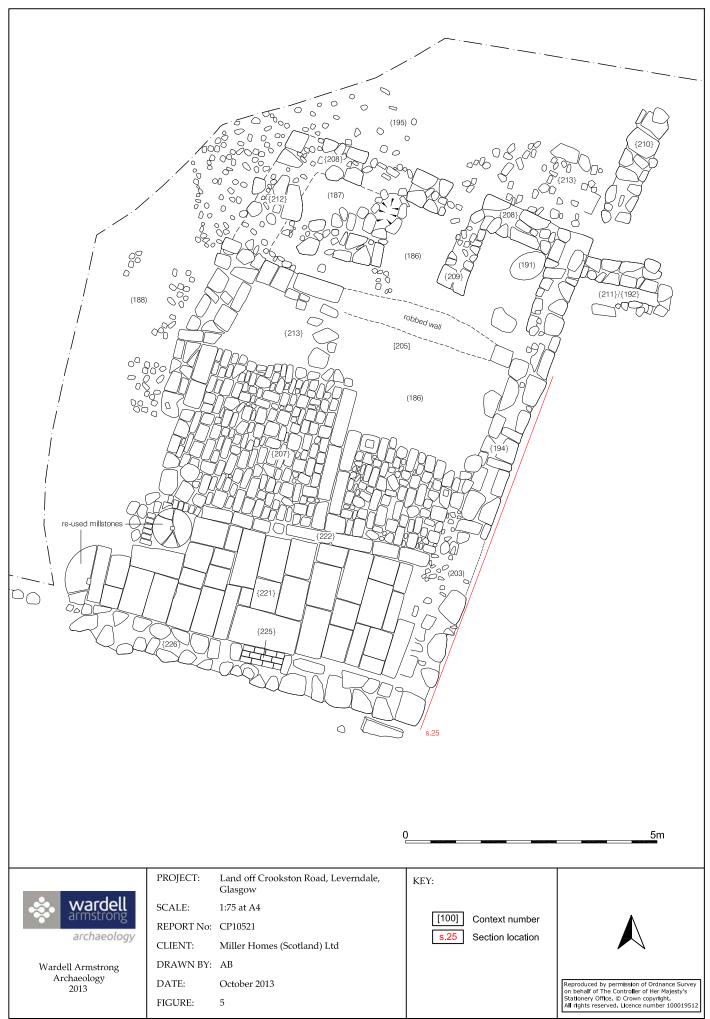
Figure 5: Farmstead buildings; Structure 1, detail.

- 4.2.9 Structure 1 (see figure 5); was 10.5m long by 8m wide; A primary phase of construction/ activity comprised of walls (226) and (194) forming the southern and eastern sides. Walls (208) and (212) formed the northern and western sides, leaving the western side partially open with a gap of 6m. Internally, the building was floored at the southern end by a flagged surface (221); laid directly on top of agricultural horizon (195) two broken millstones (SF24 & 25, not retained) were included in this floor. A brick lined doorway/ entrance (225) through wall (226) was associated with this floor. Adjacent to and separated from floor (221) by a line of irregular, sub-rectangular kerb stones (222) was a surface comprised of irregular rounded and sub-rounded cobbles (207).

- 4.2.11 A second phase of construction/ activity within Structure 1, contemporary with the truncated yard surface (207) was illustrated by the insertion of three short rubble built walls (209); (210); (213) within the northern end and immediately outside of the northern end of the structure creating narrow bays or stalls. Associated with this, an entrance was created through wall (208). An accumulation of charcoal, clinker and sandy gravels with a small quantity of slag (186) within these bays, as well as filling the void within truncated yard (207) suggest an industrial purpose. A possible hearth or kiln base (191) cutting into (186) in the north-eastern corner contained a denser concentration of slag as well as mid 19th century pottery.

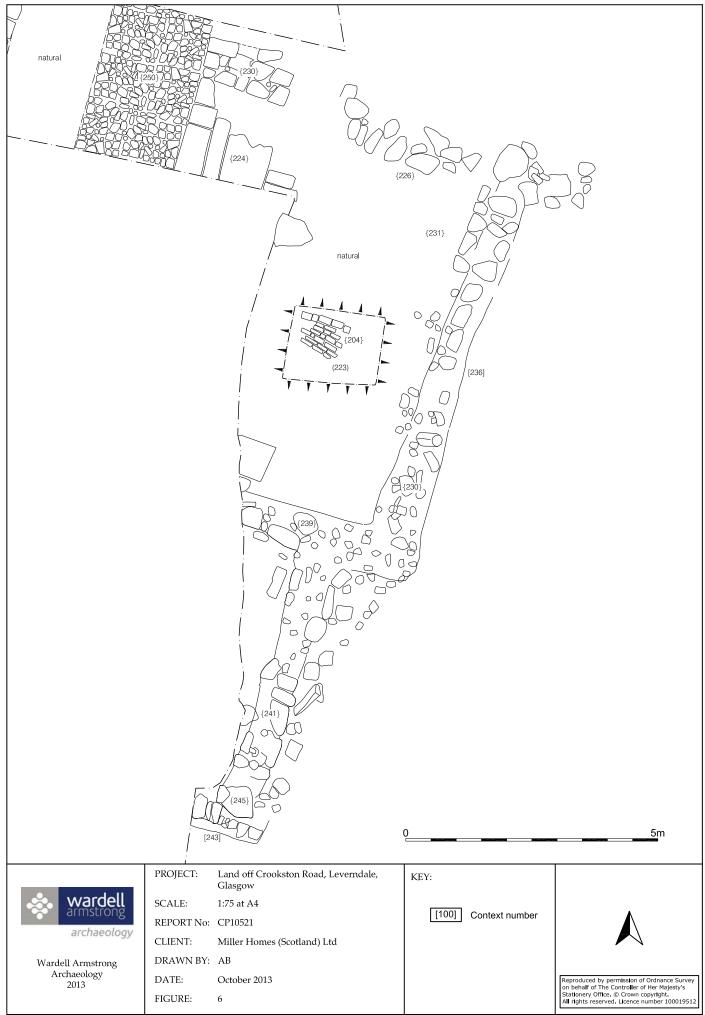
Figure 6: Farmstead buildings; Structure 2, detail.

- 4.2.12 Structure 2 (see figure 6); was located immediately south of Structure 1 on the eastern side of track (250). It comprised of two rectangular rooms, neither of which were fully exposed due to the in-use haul-road. The larger of the two was a maximum of 7m wide from track (250) by 8.5m in length. The northern wall (230) was adjacent to and on a slightly different alignment to wall (226) of Structure 1. Wall (231) with a visible foundation cut [236] into natural formed the eastern side and wall (245) formed both the eastern side and the northern side of the smaller room. All the walls of Structure 2 were comprised of uncoursed, unbonded, random rubble, contrasting with the larger occasionally worked stone of Structure 1, suggesting it to be contemporary outhouses or workshops.

- 4.2.14 A second, industrial phase of activity of Structure 2 corresponding with that identified in Structure 1 was present with the truncation and removal of a large

- part of flag floor (224) and an accumulation of a deposit of very mixed of clinker, charcoal and ash (223)/ (227) within both rooms. A deposit of burned bricks, likely representing a collapsed chimney (204) was associated with the industrial activity.

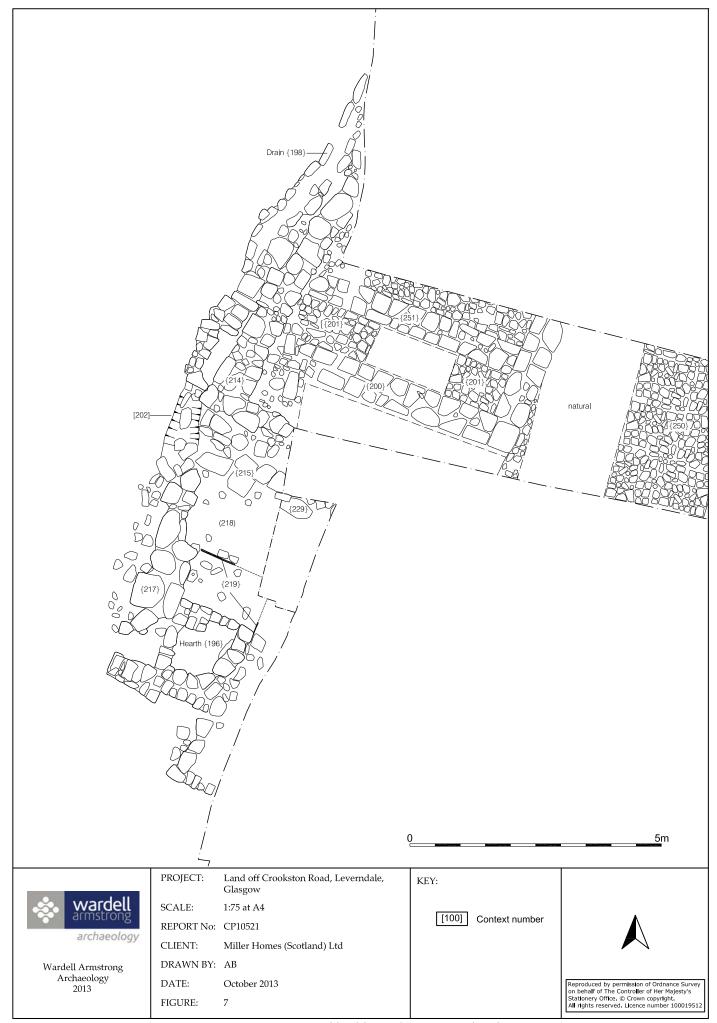
Figure 7: Farmstead buildings; Structure 3, detail.

- 4.2.15 *Structure 3 (see figure 7)* was located on the western side of track way (250) and comprised of two rooms within a single structure; 14.5m in exposed length and a maximum of 6.5m in length. No remnants of agricultural horizon (195) were associated with it, and it appears that an attempt to level the structure on either side of the track way was made.

- 4.2.18 A second phase of activity, suggesting like that within structures 1 and 2, a change to a more industrial use of Structure 3 is evidenced by an accumulation of charcoal, ash and slag clinker (220) overlying flag floor (229); it is likely that the drain at alongside the western wall was, by this phase silted up and redundant, resulting in a large amount of waterlogging of this deposit; requiring the construction of a compacted angular rubble platform (218) with a thin retaining kerb of upright thick states (219) at the opening of the hearth. A second flag floor (215) appeared to be inserted in an attempt to consolidate the industrial deposits.

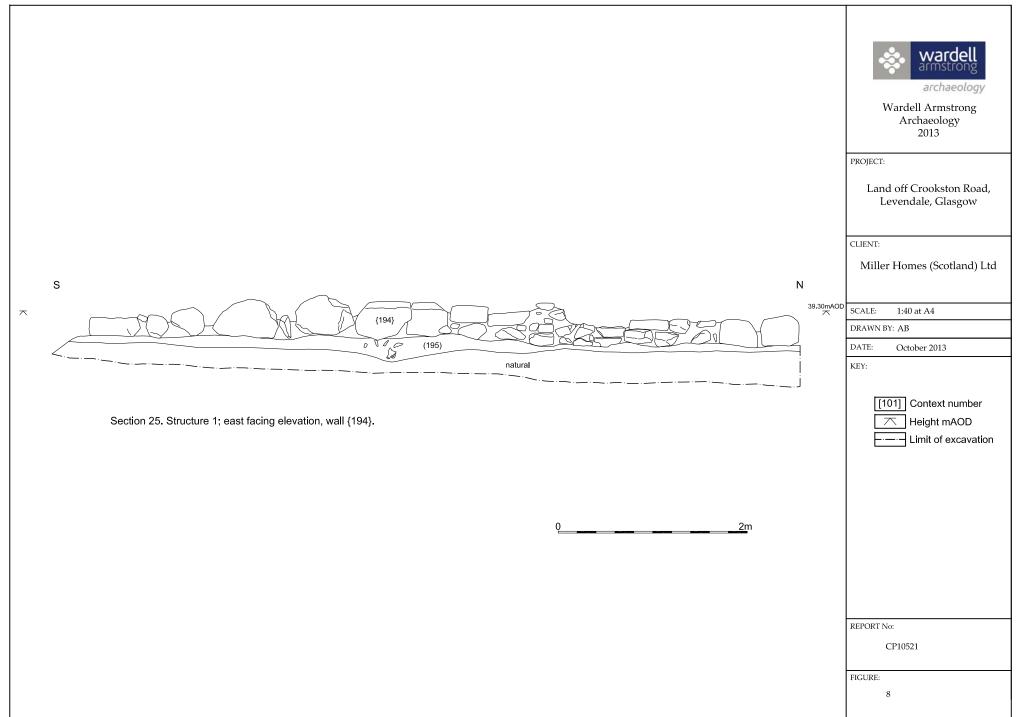
Figure 8: Structure 1, elevation.

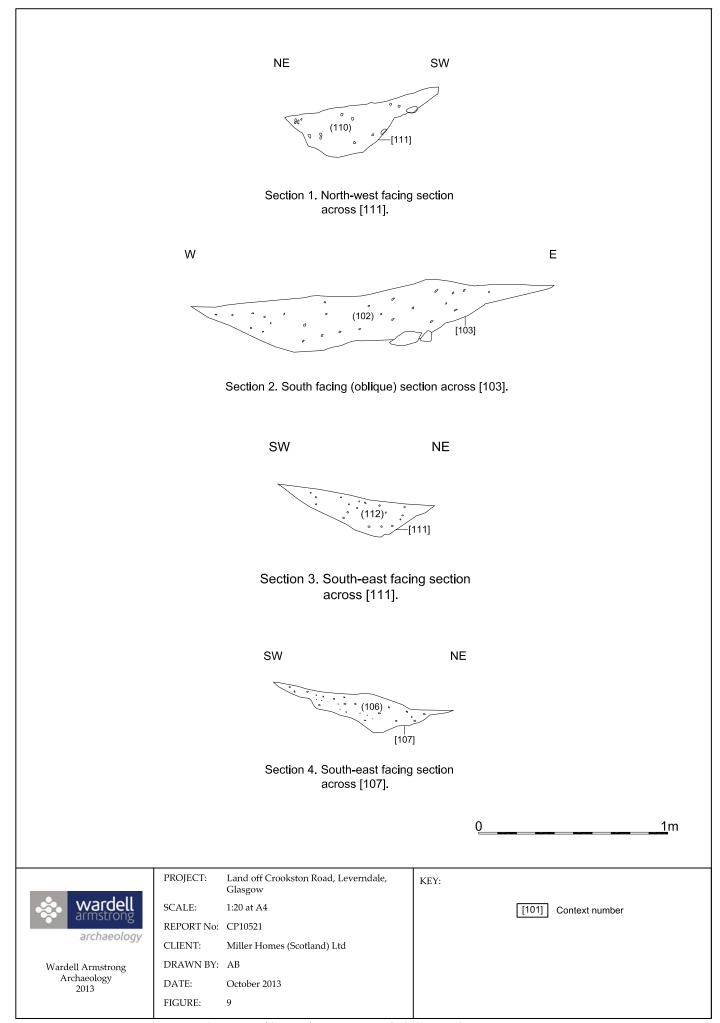
Figure 9: Sections of linear features recorded during the 2008 excavations.
