MIDDLE SKELGILL ALSTON, CUMBRIA

WATCHING BRIEF REPORT CP. No 10446 14/10/2013

DOCUMENT TYPE: Watching Brief Report

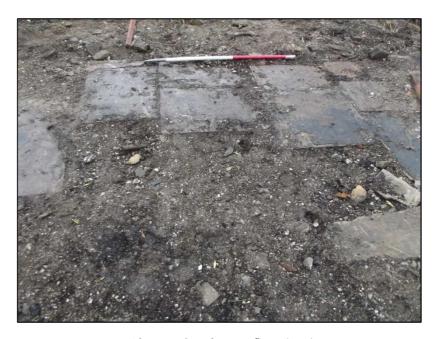
- 4.2.1 The watching brief aimed to monitor all groundworks associated with the excavation of the foundation trenches (Figure 2).
- 4.2.2 A small portion of flagged stone floor (**104**) relating to the 1694 house was revealed during the demolition phase. These flags consisted of varying sizes of sandstone slabs, which were chamfered on the underside edges to allow for close fitting (*Plate 1*). The remnants of the flagged floor were removed prior to the excavation of the foundation trenches to allow them to be stored for reuse in the new building.

Plate 1: Sandstone floor in situ

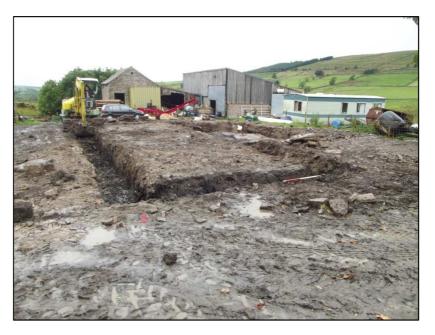
4.2.3 The stratigraphic matrix observed within the excavated area remained constant throughout. The uppermost layer removed consisted of demolition/collapse rubble (100), which contained sandstone blocks, broken stone roof tile, modern pottery and glass and large amounts of plastic sheeting. The depth varied but was a maximum of 0.50m in depth. This overlay the natural drift geology (101), which consisted of a firm blue grey clay.

Plate 2: Foundation trenches

- 4.2.4 Only occasional foundation stones for the former buildings were observed within the foundation trenches, consisting of large rounded sandstone boulders. These were also removed and stored on site.

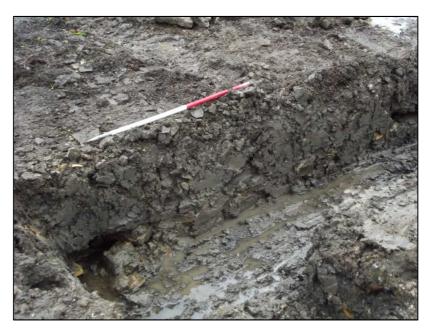
- 4.2.6 A stone lined culvert (103) was observed running north south in the easternmost foundation trench. This was observed at a depth of 0.40m below current ground surface. The culvert was constructed using sandstone blocks and measured 0.30m in depth and was approximately 0.40m wide. The line of the culvert ran parallel to the former farmhouse and must therefore be contemporary or later than the latest phase of building.

Plate 3: West facing section, showing stone lined culvert

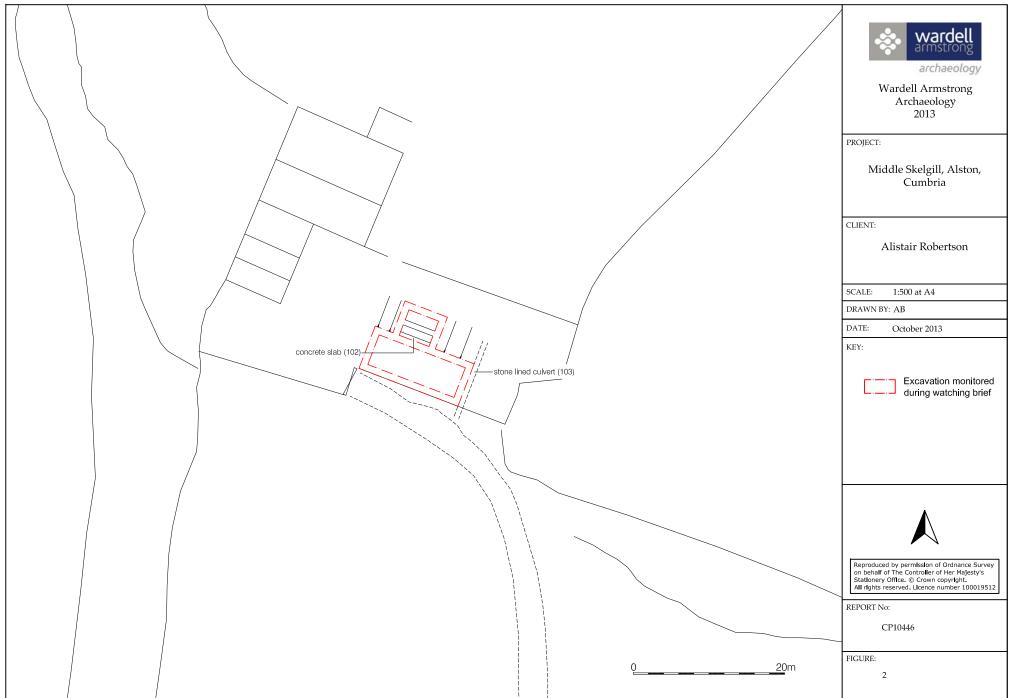
Figure 2: Location of watching brief.
