**ABBAY RETAIL PARK,
ABBAY ROAD,
BARKING,
LONDON**

**ARCHAEOLOGICAL
EVALUATION REPORT
CP. No: 10721/14
24/07/2014**

DOCUMENT TITLE: Barking Retail Park, Barking, London
DOCUMENT TYPE: Archaeological Evaluation Report
CLIENT: Estates and Agency Properties Ltd.
CP NUMBER: 10721
SITE CODE: ABR-14
OASIS REFERENCE: wardella2-177651
PRINT DATE: 24/07/2014
GRID REFERENCE: TQ 4390 8390

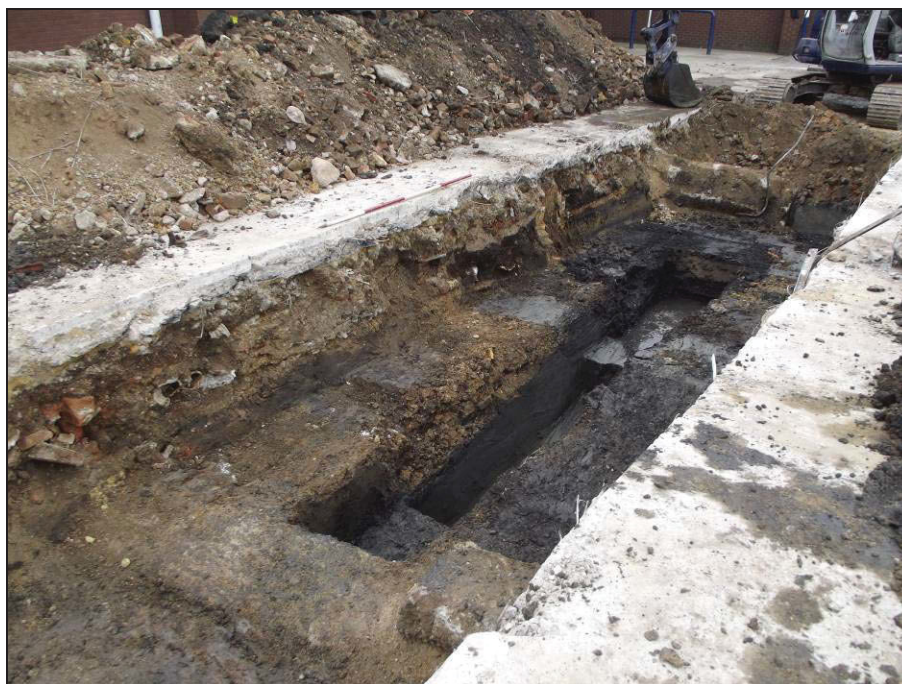
Plate 1: Overview of Trench 1, looking north-east

4.2.1 *Trench 1:* Trench 1 was located toward the north-western extent of site and was aligned east – west (Figure 2). The trench was excavated to a maximum depth of 2.69m aOD revealing plastic dark bluish-grey clay alluvium (105) at a height of 4.15m aOD (Plate 1). The length of the trench was shortened to the east for health and safety and environmental reasons as water strongly polluted with hydrocarbons was encountered at one meter below modern ground level (Figure 3).

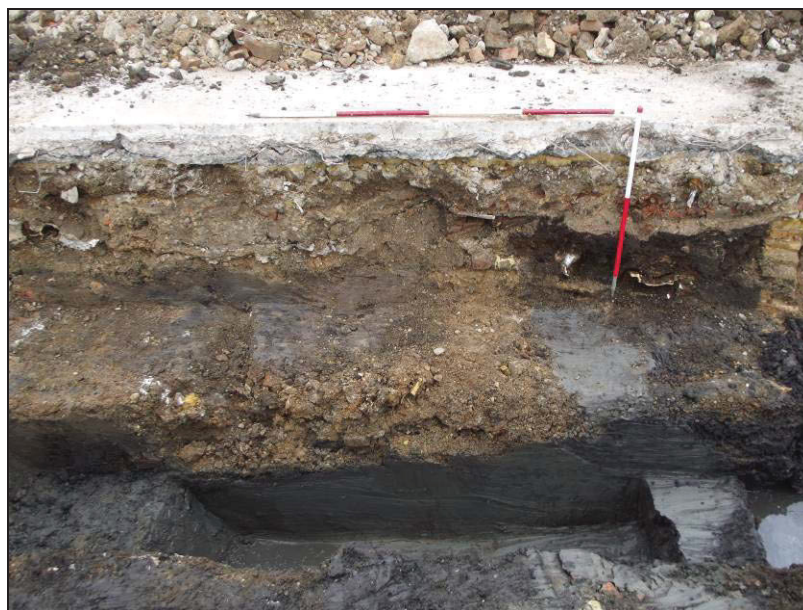
Plate 2: Detail of modern material within Trench 1, looking north

4.2.2 The alluvial deposit (105) was heavily truncated to the east and west by modern activity (Plate 2), associated with the demolition of possible pre-existing structures to allow for the construction of concrete wall footings {115} and {118}. To the west, a north – south orientated concrete footing {115} spanned the width of the trench. To the east of wall {115} a demolition cut [103] was observed. The earliest fill, (104), was burnt black ashy industrial

waste on top of which re-deposited clay (106) was situated. The last fill, loose orange – brown sandy degraded mortar and brick fragments (102) was overlain by demolition deposit (112), a stiff orange – brown clay with modern brick and mortar flecks. The demolition deposit (112) was located to either side of the concrete footing {115}. This sequence of deposits was situated beneath further modern demolition deposits the largest of which comprised of a 0.50m thick dump of red brick, degraded mortar and concrete (110) (Figure 3).

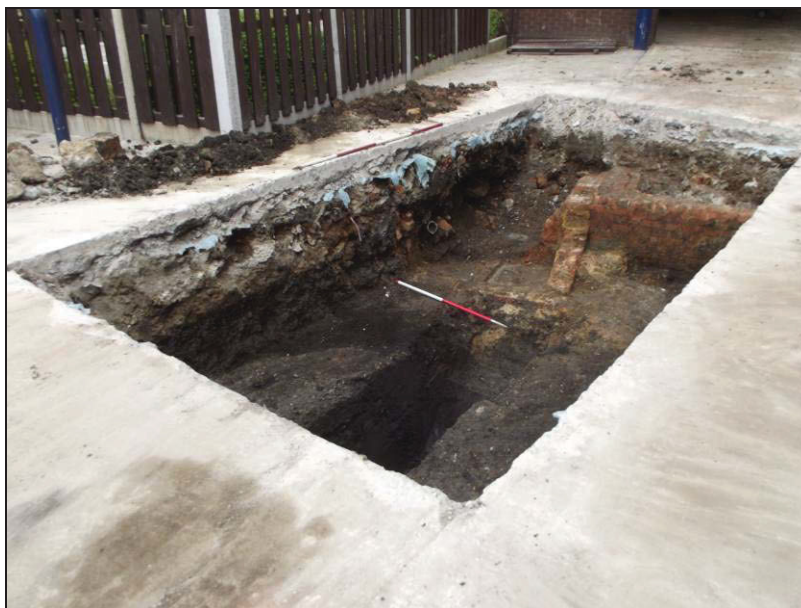
Plate 3: Overview of Trench 2a, looking north

- 4.2.4 *Trench 2a:* Trench 2a was located toward the western side of site and was aligned north-east – south-west (Figure 2). The trench was excavated to a maximum depth of 2.03m aOD revealing alluvium deposits comprised of soft light blue-grey clay alluvium (207) below c.0.57m of firm dark grey clay (208) which was encountered at 3.01m aOD(Plate 3).

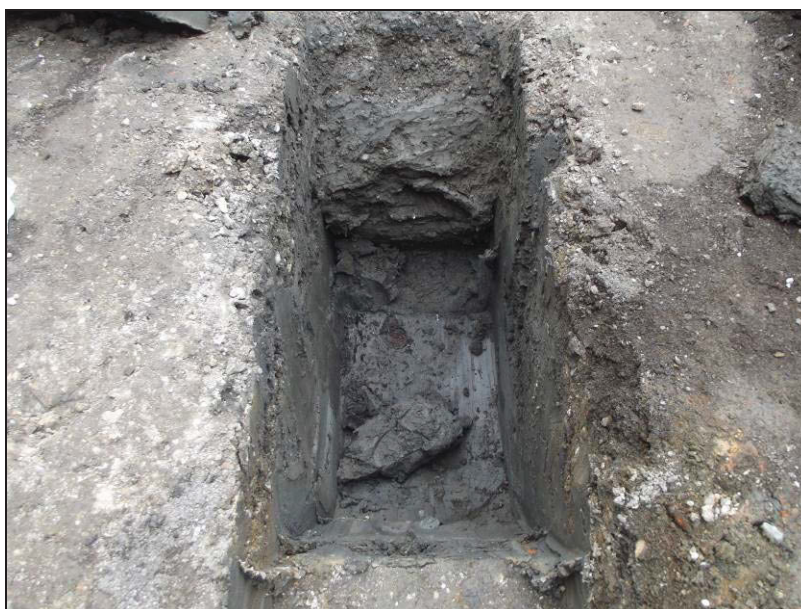
Plate 4: Location of wooden post within alluvial clay (207), looking south-west

4.2.5 Within the alluvium (207), an upright wood, 0.10m in diameter was encountered towards the southern extent of the central sondage within trench 2a (Plate 4, Figure 4). The top of the wood was located at a height of c.6.04m aOD, and although truncated during the machining process, the uppermost 0.29m of the wood was recovered for further analysis. The remaining length of wood was left in-situ and un-excavated.

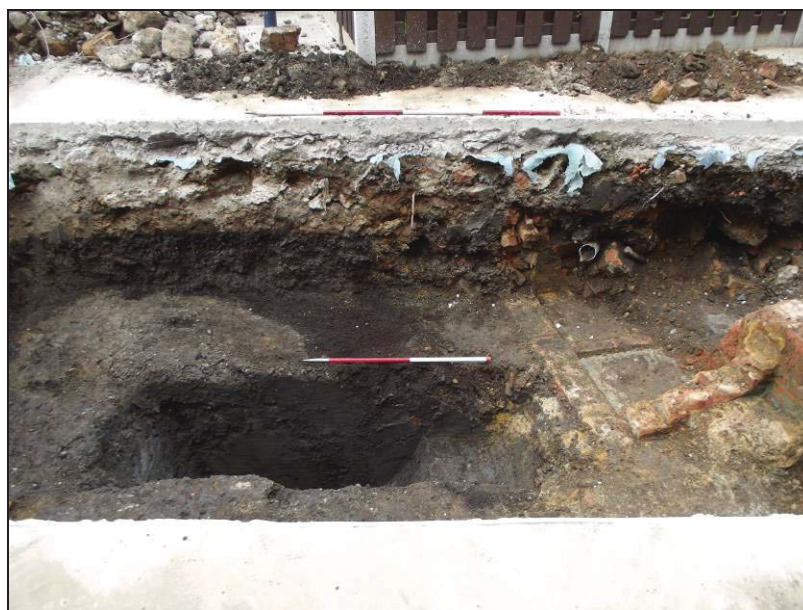
Plate 5: Section 31 detailing the modern deposits of trench 2a, looking north-west

- 4.2.7 This sequence of deposits was truncated by a construction cut [209], for a brick and concrete structure {205} located in the north-east of the trench (Plate 5). The structure spanned the width of the trench and extended three meters from the south-west facing baulk (Figure 4). The construction cut [209] was backfilled with mid grayish brown silty clay with brick and tile inclusions (210) and a deposit of concrete (206).

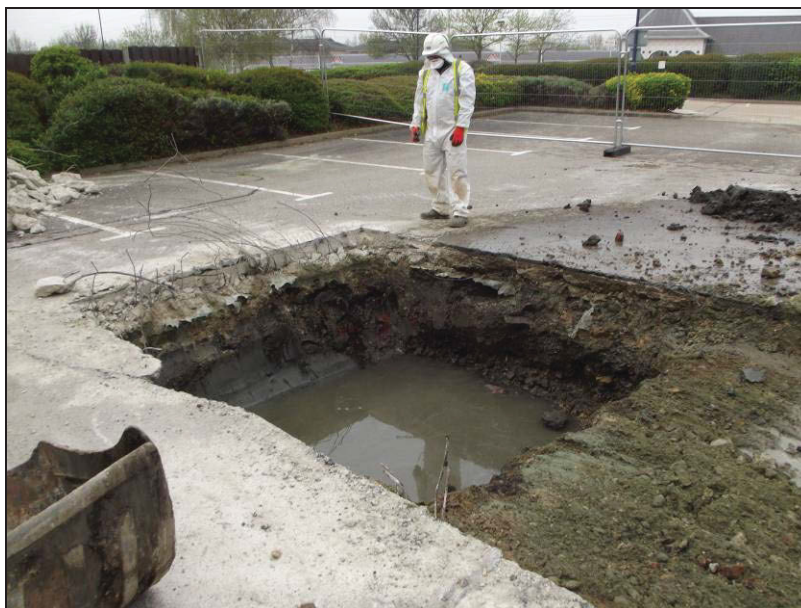
Plate 6: Water polluted with Hydrocarbons at the southern extent of Trench 2b, looking south-west

- 4.2.8 The brick, tile and concrete rubble (212) situated within the footprint of Structure {205} were likely to be the remains of the building and used as backfill once it had been demolished (Figure 4). The trench was capped by a 0.20m thick deposit of reinforced concrete (200) forming part of a modern loading bay surface.
- 4.2.9 **Trench 2b:** Trench 2b was located toward the west of site and was aligned north – south (Figure 2). The trench was excavated at both the northern and southern end, to a maximum depth of 3.61m aOD. Modern demolition rubble was encountered to this depth. Water strongly polluted with hydrocarbons was encountered at 1 m below modern ground level, and so excavation of the trench was halted and the middle of the trench remained unexcavated (Plates 6 & 7).

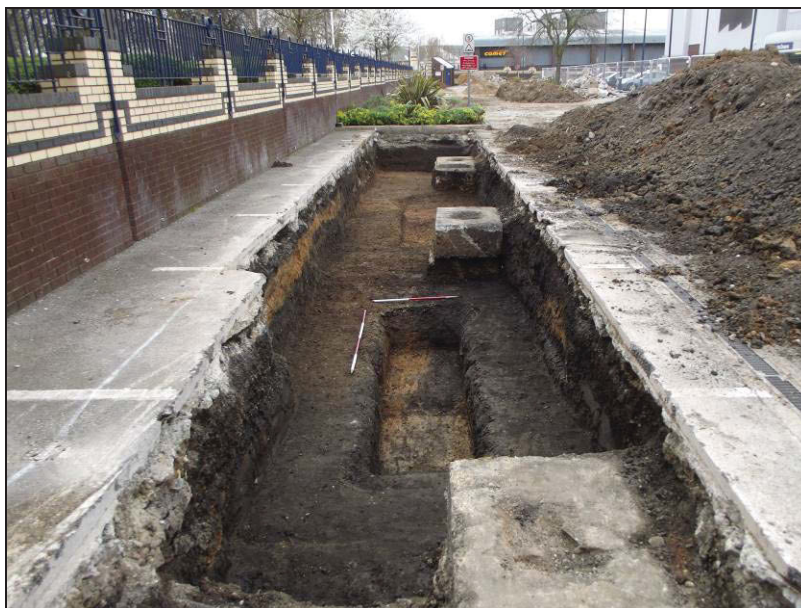
Plate 8: Overview of Trench 3, looking south

4.2.10 **Trench 3:** Trench 3 was located toward the eastern edge of the site and was aligned north – south (Figure 2). The trench was excavated to a maximum depth of 2.49m aOD revealing firm orange-brown sandy alluvial clay (**311**) below c.0.20 m of mottled firm mid orange sandy clay with light grey flecking (**303/309**); a possible weathered natural deposit (Plate 8).

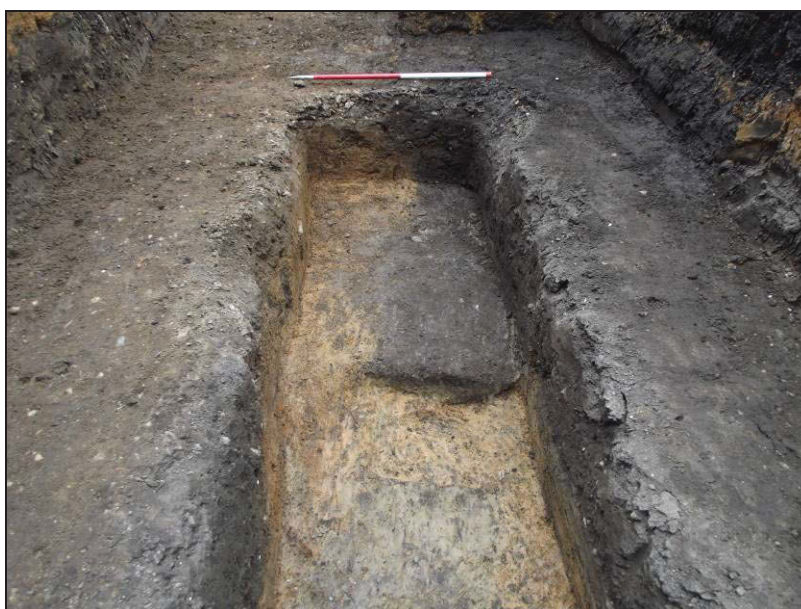
Plate 9: Ditch (305), post excavation looking south

4.2.11 Two linear ditches were observed in Trench 3, both cut into deposit (303/309) (Figure 5). Ditch [305] was aligned north-east – south-west and situated at the northern extent of the trench. Heavily truncated by modern activity, the ditch measured up to 0.18m deep, 0.65m wide and it was filled with firm grey sandy clay (306) (Plate 9). No artefactual evidence was recovered from fill (306).

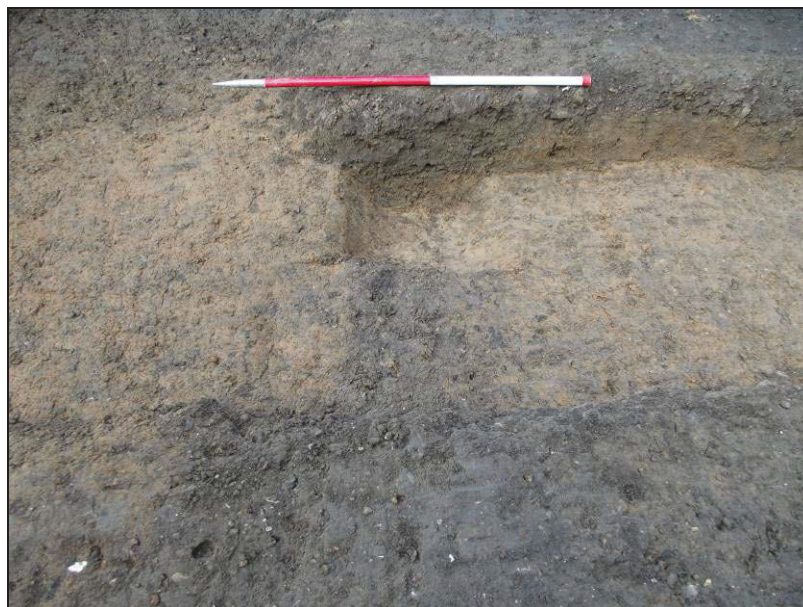
Plate 10: Ditch [304], post excavation, looking west

4.2.12 Orientated east – west, the second ditch [304] was located approximately 6.95m north of the southern limit of Trench 3 and measured up to 0.70m wide and 0.34m deep. (Figure 5, Plate 10). The ditch contained two fills, the

earlier of which was compact slightly orangey-grey sandy clay containing a small quantity of gravel material (302). Overlying this was moderately firm greyish – brown silty sand (301), up to 0.18m thick. Neither fill contained dating evidence.

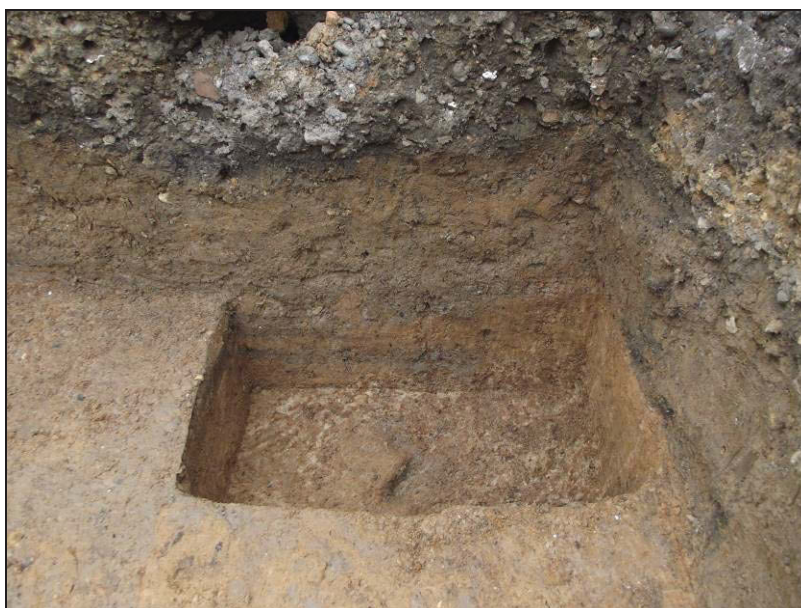
Plate 11: Natural deposits at the southern extent of Trench 4a

geology (405) overlain by up to 1.24m soft orange-brown silty sandy clay alluvium (404) at the southern extent of the trench (Plate 11).

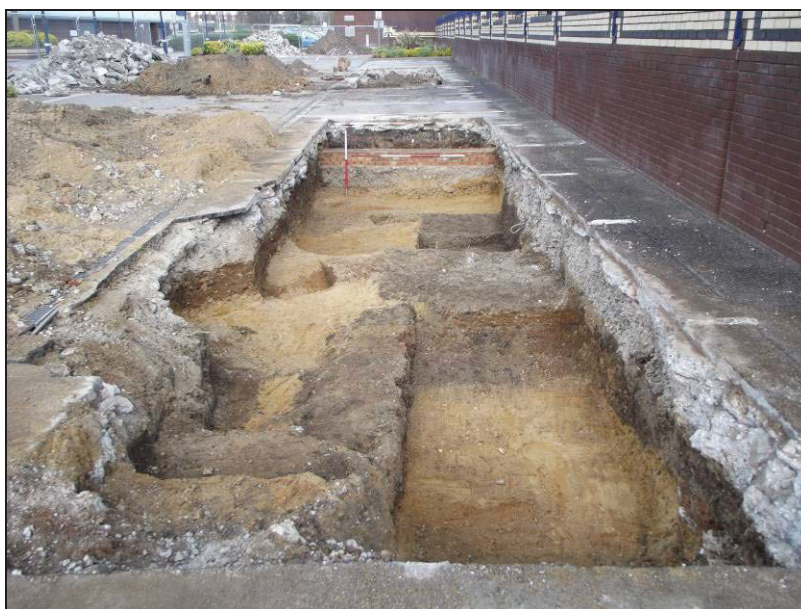
Plate 13: Overview of Trench 4b, looking north

4.2.17 **Trench 4b:** Trench 4b was located toward the eastern edge of site and was aligned north – south (Figure 2). The trench was excavated to a maximum depth of 2.19m aOD revealing friable orangey yellow gravelly sand (468) at a height of 3.40.m aOD (Plate 13).

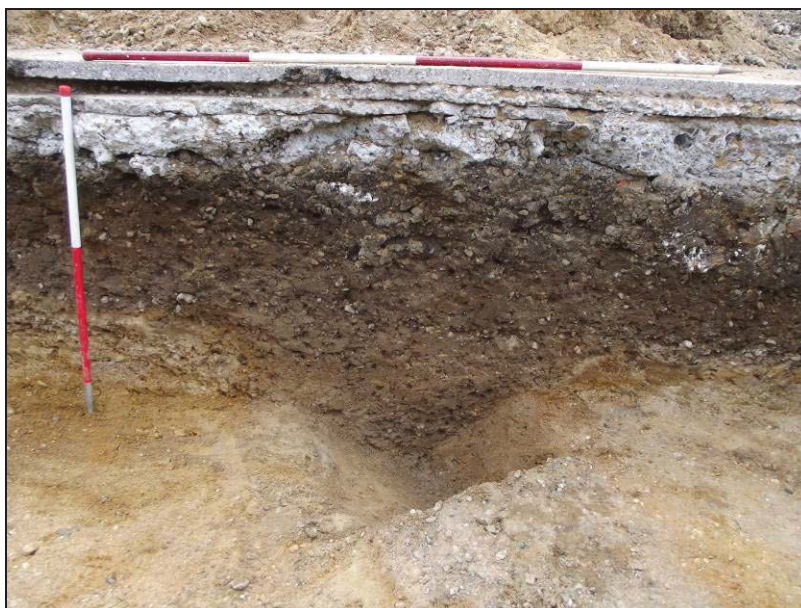
Plate 14: Oblique section across Ditch [454], looking west

4.2.17 Two linear ditches, both orientated broadly north-east – south-west, were located in the northern half of Trench 4b (Figure 7). The northernmost ditch [454] had a “V” shaped profile, with a sharp break of slope leading to a concave base, measured up to 0.72m wide, 2.12m in length and was filled

with a 0.61m thick deposit of clean brownish-grey silty gravel (455) (Plate 14).

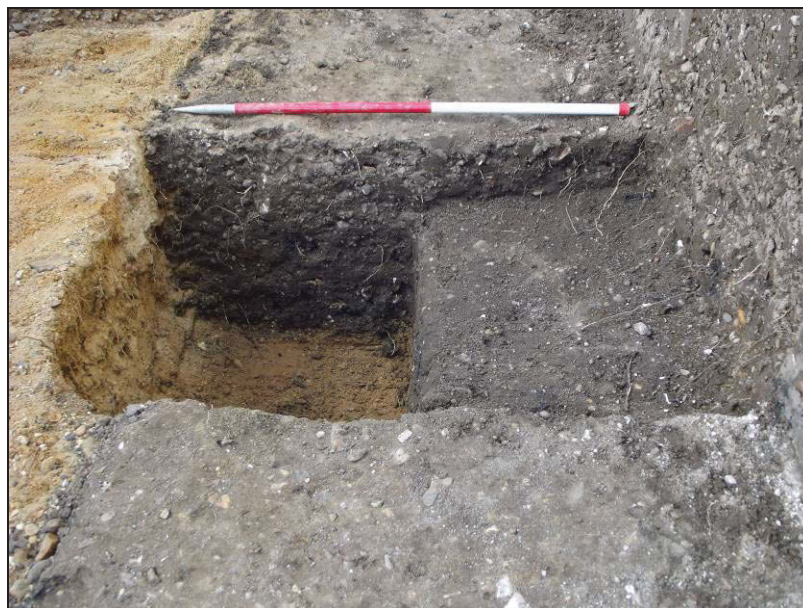
Plate 15: South facing section through Pit [452], looking north

4.2.18 Both ditches were truncated by pit [452]. The pit was roughly square in shape, up to 1.14m deep with vertical edges and a sharp break of slope leading to a flat base (Figure 7). The fill consisted of dark blackish grey gravelly silt (453) and contained Post-medieval material, the latest of which was a 19th century brick (Plate 15). Medieval material was also recovered from the pit which consisted of four sherds of pottery dated to the 13 – 14th centuries, along with ceramic building material (CBM) dating to the 14th – 15th Centuries AD.

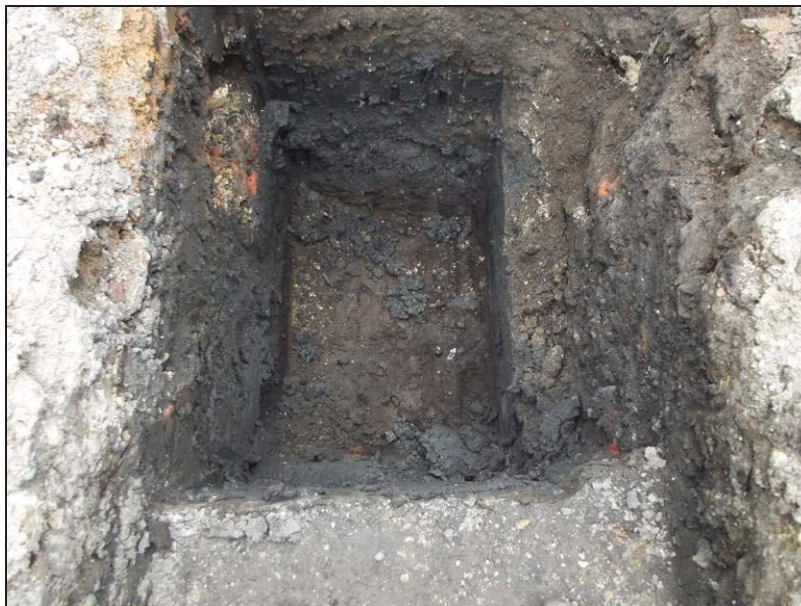
Plate 16: Organic deposit (511) located within a sondage at the eastern limit of Trench 5a, looking east

4.2.23 The clay alluvium (512) was overlain by a 0.24m thick deposit of mid to dark brown organic clay (511) (Plate 16, Figure 8). The clay (511) was uncovered within a sondage at the eastern limit of the trench. A similar deposit (556) was observed within a sondage in Trench 5b. A 20 litre sample was recovered from the organic clay material (511).

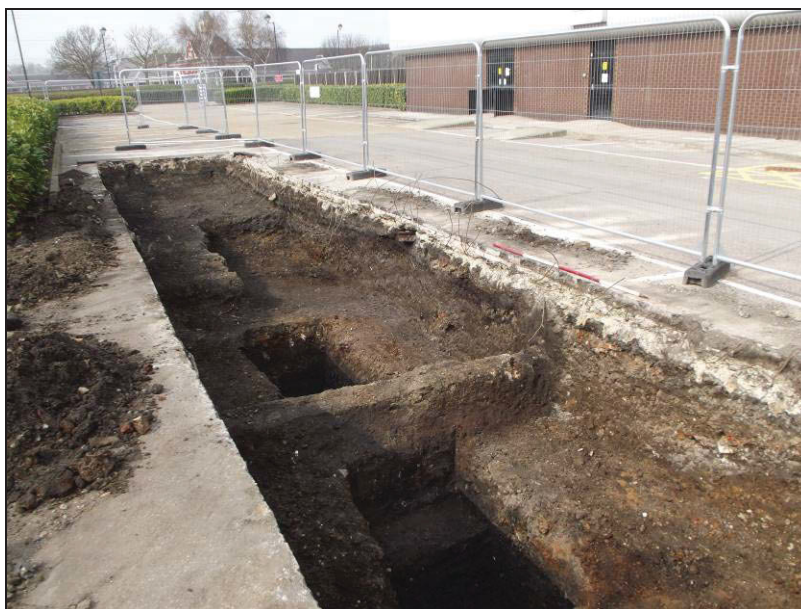
Plate 17: Overview of Trench 5a, looking north-west

4.2.24 Deposit (511) was overlain by a 0.62m thick un-dated dark grey clayey silt (510). Above this material, a deposit of modern demolition debris (509) was observed (Figure 8). The demolition debris consisted of red brick fragments

with degraded mortar inclusions. This was the earliest in a sequence of modern demolition deposits and made ground each with tip lines from the east to the west (Plate 17). The most substantial deposit measured up to 0.9m thick and comprised of greyish brown sandy silt with degraded concrete inclusions (504)

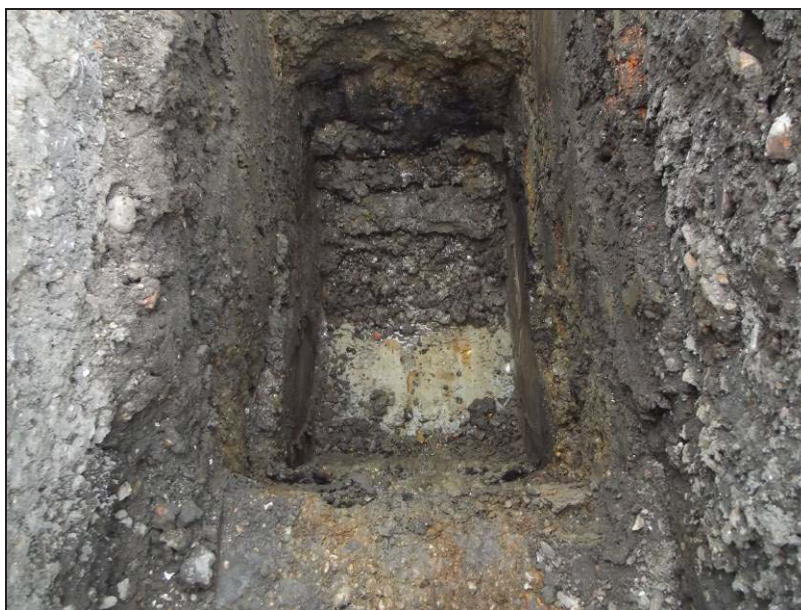
Plate 18: Sandy gravel (559) located beneath alluvium (557) within a sondage at the eastern limit of Trench 5b, looking east

4.2.26 *Trench 5b*: Trench 5b was located toward the south of site and was aligned east – west (Figure 2). The trench was excavated to a maximum depth of 0.82m aOD, revealing loose grayish yellow sandy gravel (559) which was encountered at a height of 1.04m aOD below c.0.40m of stiff light brown silty clay alluvium (557) (Plate 18).

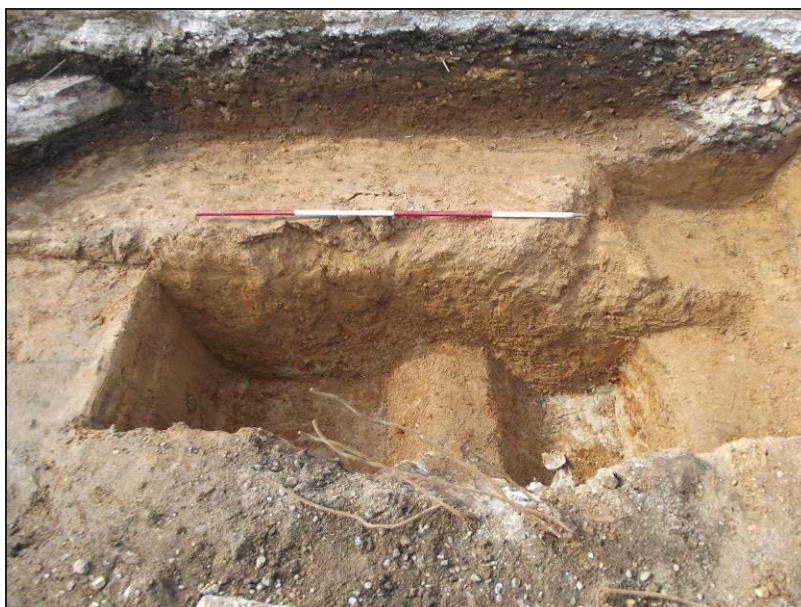
Plate 20: Alluvial deposit (606) overlying clayey sand geology (610), looking north-west

4.2.29 *Trench 6a:* Trench 6a was located toward the south-eastern corner of site and was aligned north-east – south-west (Figure 2). The trench was excavated to a maximum depth of 1.84m aOD revealing firm mottled orange and grey clayey sand geology (610) overlain by up to 1.24m soft orange-brown silty sandy clay alluvium (606) (Plate 20).

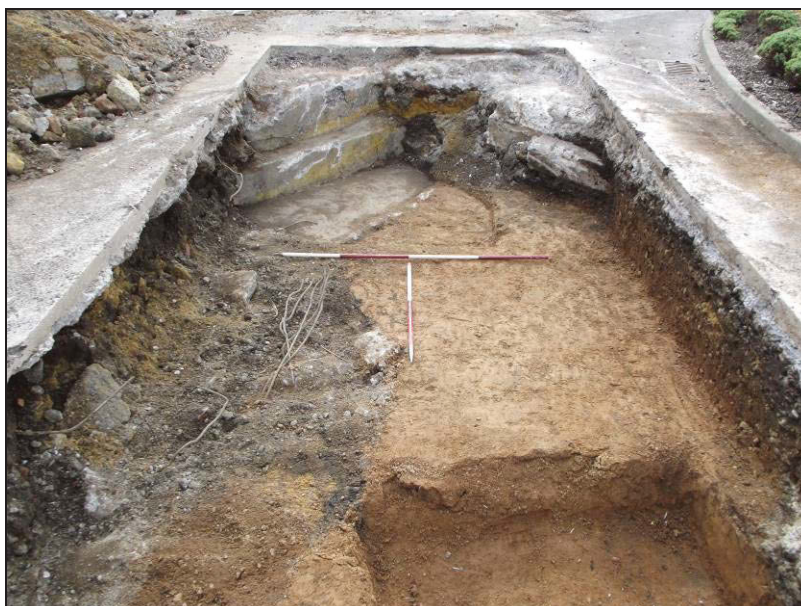
Plate 21: Trench 6a overview, looking south-west

- 4.2.32 The concrete footings {607} were truncated to the east by a large modern pit [611] (Figure 10) containing moderately compact brown clayey rubble with yellow sand and frequent large concrete inclusions. The remains of a concrete pile with reinforcing bar was also observed (Plate 21).

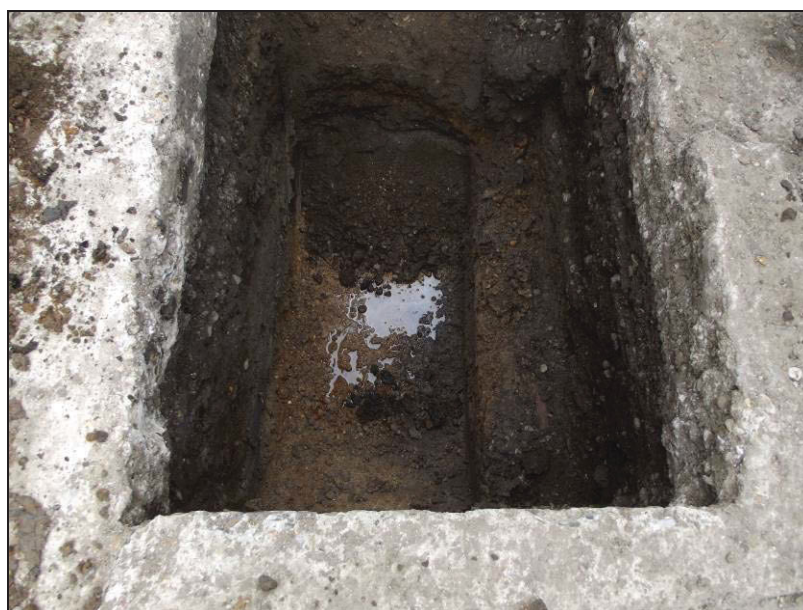
Plate 22: Natural gravel geology within a test pit at the western limit of Trench 6b, looking east

- 4.2.34 **Trench 6b:** Trench 6b was located toward the south-eastern corner of site and was aligned east – west (Figure 2). The trench was excavated to a maximum depth of 1.91m aOD revealing loose yellow – brown gravel geology (677) which was encountered at a height of 2.09m aOD (Plate 22).

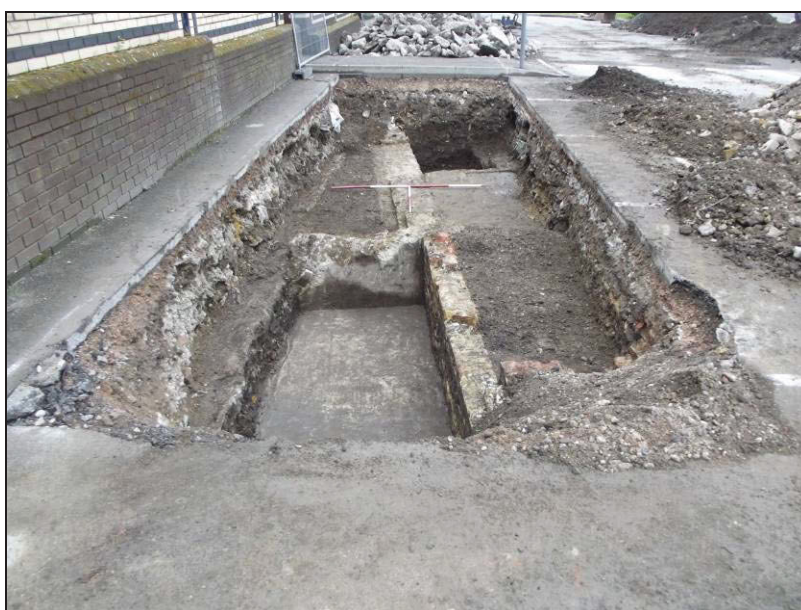
Plate 23: Overview of the modern concrete and brick remains in trench 6b

4.2.37 A set of concrete wall foundations, {653} and {663} along with associated concrete flooring {657} and {660} was constructed into these silts, (656) and (659), along with a further concrete wall {662} and a later brick extension formed of two walls {658} and {666} (Plate 23, Figure 11). The sequence of concrete walls and flooring formed the northern side of modern 20th Century factory buildings. These were demolished in order to construct the current car park, with the demolition material (652) and (654) levelled and sealed by a concrete base (651) for a hardcore gravel sub-base (676) for modern tarmac (650).

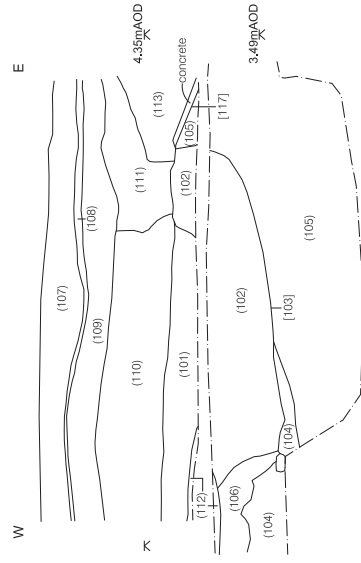
Figure 3: Trench 1, plan and sections.

Sections 33 (lower) & 34 (upper). South facing section, Trench 1.

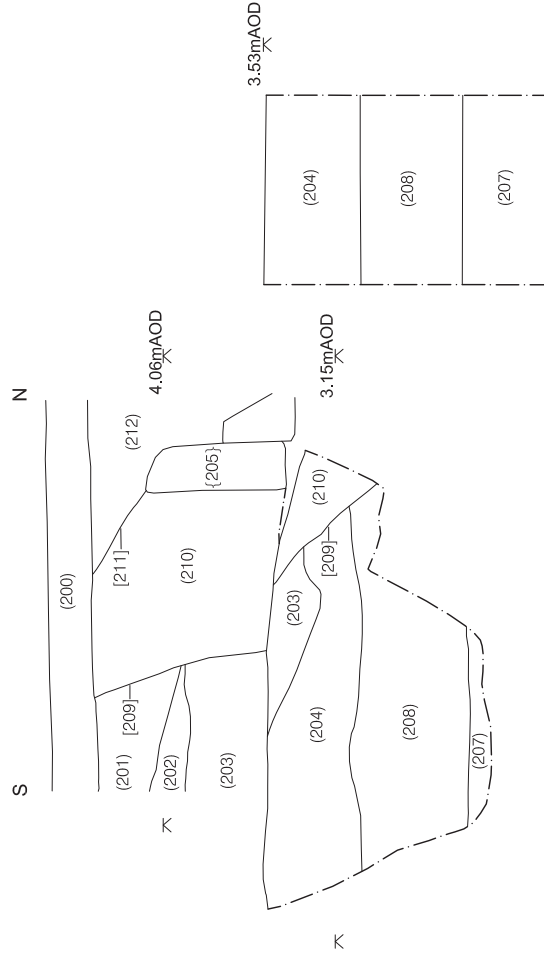
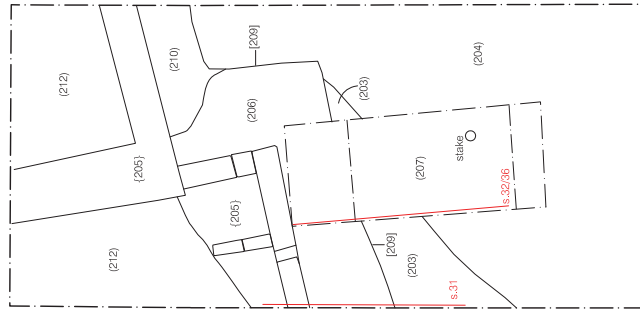
Figure 4: Trench 2a, plan and sections.

Section 31 (upper) & 32 (lower). East facing section, Trench 2a.

Section 36. East facing section.

4.2.6 The alluvial deposits were overlain to the south-west, by a series of levelling deposits, the earliest of which, mixed silty clay (204), was up to 0.5m thick. A loose very dark grey deposit of friable industrial refuse (203) and light

brown silty clay (202) was sealed by a layer of loose ashy mortar and brick rubble (201) (Figure 4).
