**MULCASTER HOUSE,
CHURCH LANE,
STANWIX,
CARLISLE,
CUMBRIA**

DESK-BASED ASSESSMENT AND BUILDING SURVEY

CP. No: 10898

DATE: MAY 2014

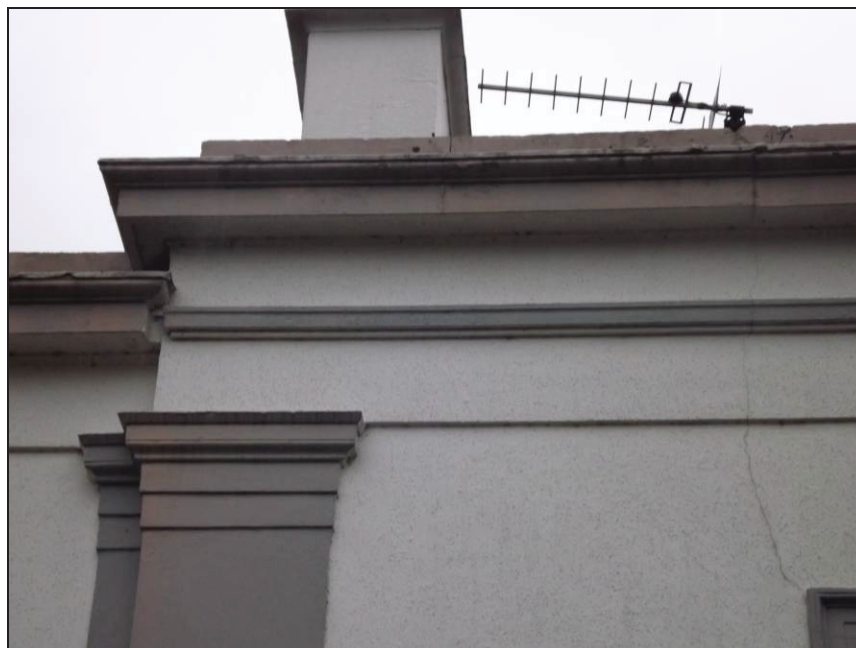
Plate 6: Detail of eaves cornice, south elevation

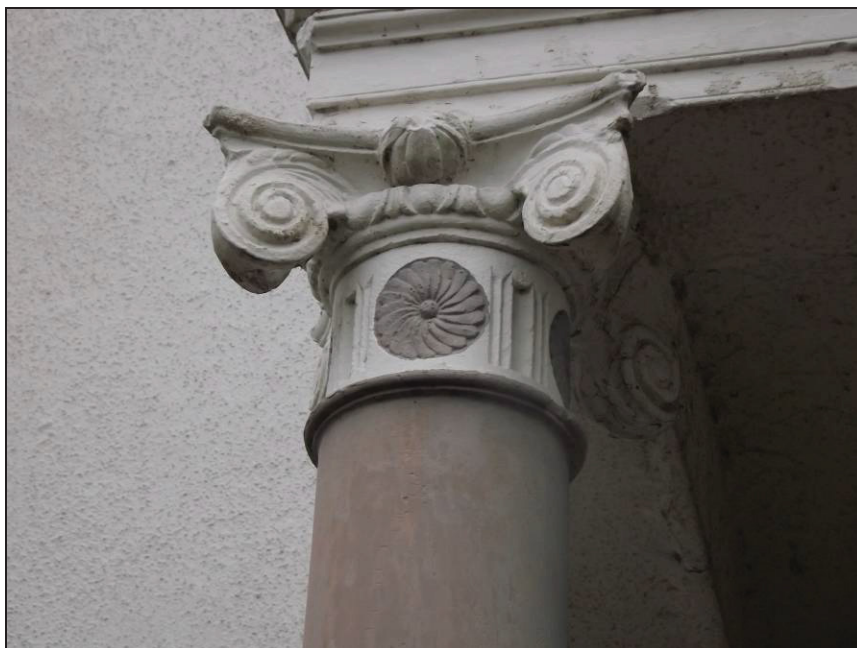
Plate 8: Detail of capital, main entrance portico, south elevation

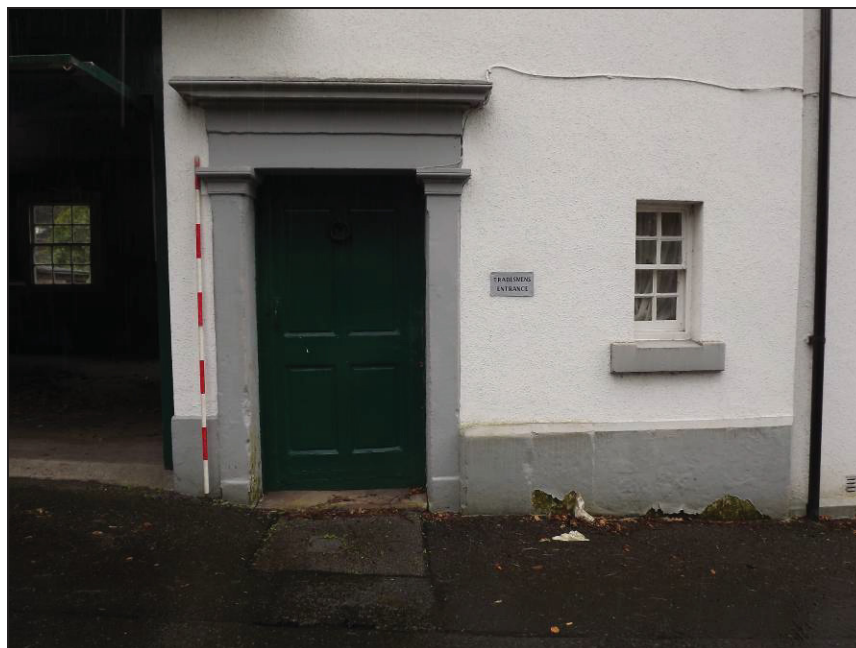
Plate 12: Northern doorway, west elevation, with 'Tradesmens Entrance' sign

- 4.2.15 To the north side of this section, there is a further two-storey part to the western range, although it is not as wide, and is clearly set back from the rest of the range (Plate 23); this is the section that was noted from Church Lane to possibly not have been contemporary with the main phase of the house (see 4.4.7 above, Plate 12). At

ground floor level there is an arched passageway which leads to the door shown on Plate 12 (with the 'Tradesmens Entrance sign'). The window immediately to the south of this passageway may be a later insertion as the head is not of the same form as the rest of the original windows, although if it lit a more utilitarian space, it is possible it may not have been prescribed the same detailing. The first floor window above, although of the same size and containing the same type of sash frames as those already noted, also does not have the flat-arched head, and instead is a plain stone lintel, which may be further indication that this two-storey section is a later addition.

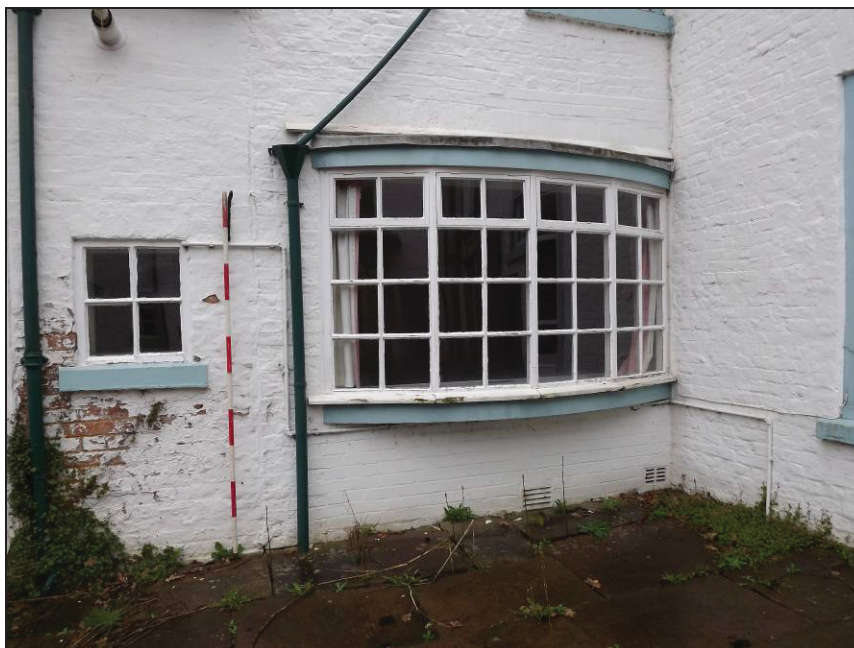
Plate 22: Detail of inserted bay window, west elevation of east wing

- 4.2.13 The two-storey section of this wing has a large bay window at ground floor level; this has clearly been inserted into earlier fabric as shown by the presence of more modern brickwork above and below the opening (Plate 22). At first floor level there is a further window which appears to be original as it is of the same form and size as those in the north elevation of the central section (Plate 21); there is, however, no keystone detail above this aperture, although this was also noted in an apparently contemporary window in the opposing western wing, which may indicate that architectural detailing was reserved for the central core of the dwelling (see Plate 23).

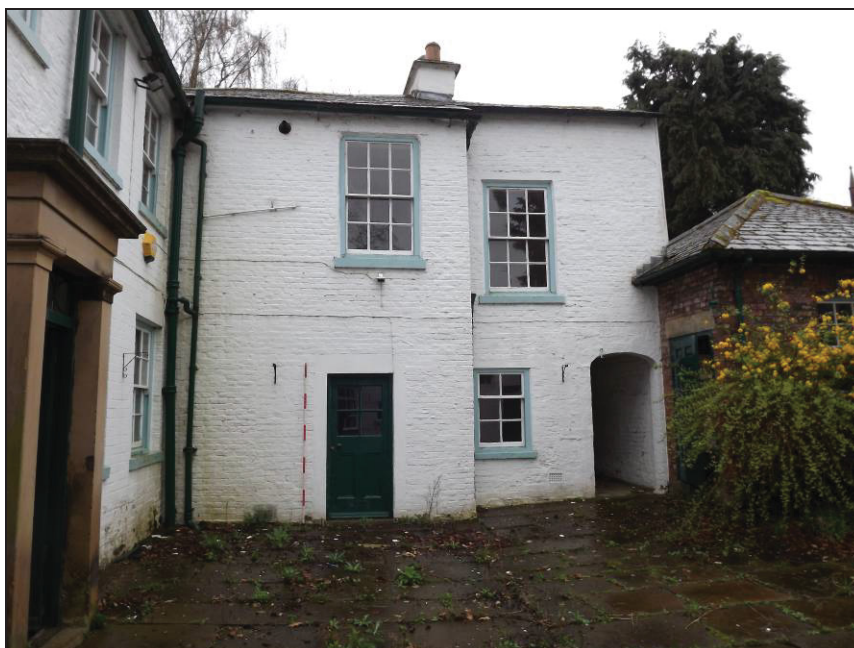
Plate 23: East elevation of the western wing (Scale = 2m)

- 4.2.14 The western wing of the property consists of two apparent separate phases, with the modern garage building adjoining its north end (Figure 12 and Plate 23). The section nearest the central core of the house has a doorway at ground floor level set in a plain stone surround, although there is a vertical break visible in the brickwork to the south (left hand) side of this entrance which may indicate the presence of an earlier opening (Plate 24). At first floor level there is a six-over-six pane sash window, of the same form as those already noted in the north elevation of the central core, and in the eastern range; as with the example in the eastern range, this window also does not have the keystone detailing (Plate 23).

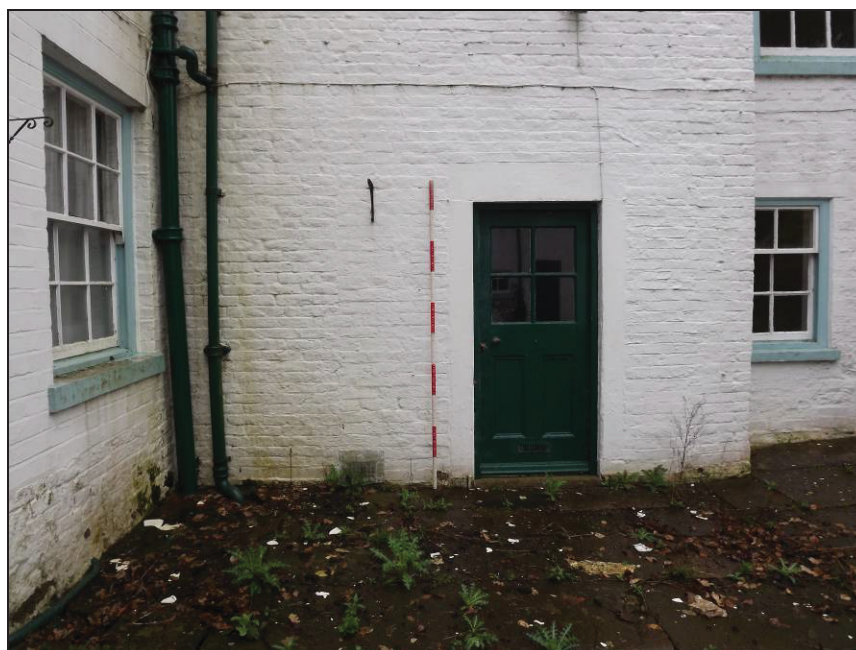
Plate 24: Detail of vertical construction break to left of doorway, western wing (east elevation)

- the east elevation may be a later insertion, as suggested from evidence noted on the external wall (see 4.2.14 above and Plate 24). In the north wall of this room there is a doorway which provides access into Room 9, and a blocked doorway (Plate 52). This room is lit by the large window in the west elevation, and by the glazed section of the door in the east elevation. The only other detailing in this room is the plain coving.

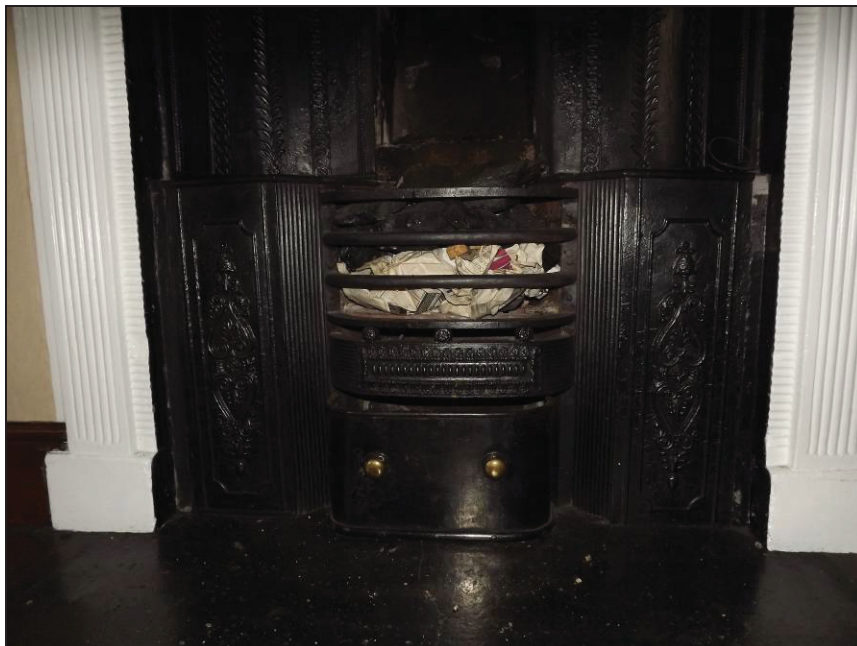
Plate 28: Detail of hob grate, Room 1

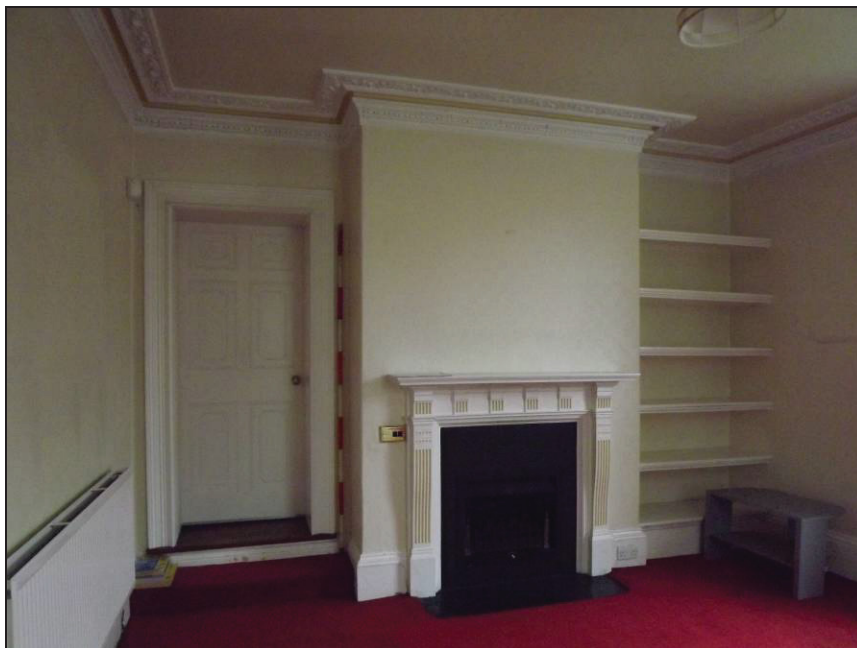
Plate 40: East wall of Room 3

- 4.2.8 The fireplace in this room is situated in the east wall, and although the present example is modern, it is located in the original position (Plate 40). The coving is decorative, but appears to be more Victorian in character than Georgian, and this was one of only two locations in the property where such elaborate coving was noted (Plate 41). The door surrounds in this room were noted to be different from those already observed in Rooms 1 and 2, being unlike the fluted design with square floral motifs. The surrounds in this room consist of moulded architrave with no inserted motifs or 'chamfer blocks' at the base, and it has been considered that these may be the original (or certainly historic) form of the surrounds (Plates 40 and 42).

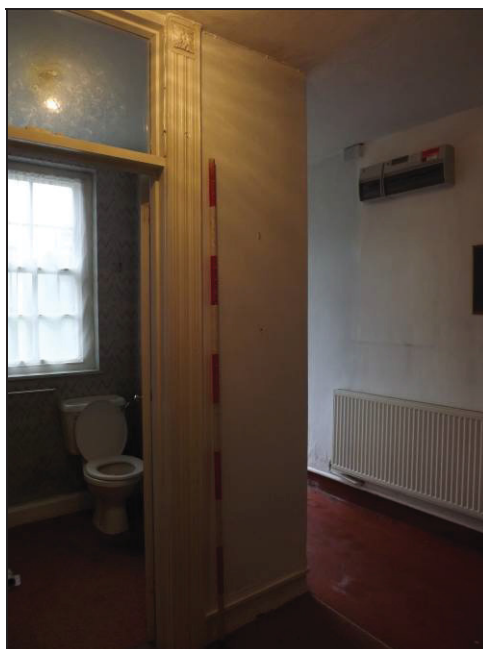
Plate 47: Detail of modern partition for WC, Room 6, showing architectural detailing found elsewhere in the property

- 4.2.13 *Room 6, Ground Floor:* this room, which is located to the west side of the main staircase and rear corridor (Figure 12) has been subdivided at some point, possibly when the property was split into individual dwellings. All that survives of its original form is the location of a fireplace in the west wall (Figure 12). The two windows which light the two spaces in this room are later insertions as already noted from the exterior (see Plate 17). Of interest in this space, however, is the use of a stud wall to create a separate area for a WC and washbasin; this partition includes the same detailing of fluted panel and foliage motif as noted around the doors in the rooms already described, and therefore it is considered that where these are architectural elements are found, they appear to be modern reproductions (Plate 47).

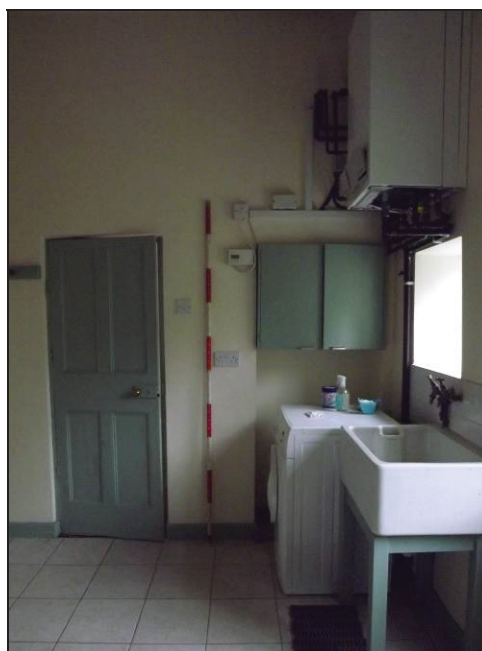
Plate 62: South wall of Room 12 showing present door to Room 11, and possible blocked door to right of photograph

- 4.2.19 *Room 12, Ground Floor:* this room has more latterly been a utility room, with an area for coal storage in the north-east corner. The only feature of note in this space is a possible former doorway in the south wall (not visible on the opposing side), which may have been the original external doorway in the north elevation (Plates 61 and 62).

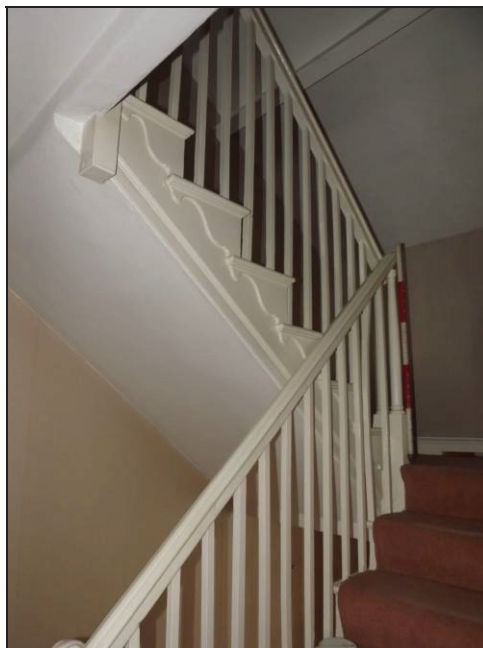
Plate 63: Detail of staircase as it ascends to the attic from Room 14

- 4.2.33 *The Attic:* the attic space is accessed by the main staircase housed in Room 4 at ground floor level, and Room 14 at first floor level (Plate 63 shows the staircase continuing to the attic). At the time of survey, the attic was divided into two spaces, with three dormer windows in the south elevation, and a single window in the east and west elevations (Figure 14 and Plates 87 and 88). The roof structure has been designed as such to create the maximum amount of head space, and the amount of windows clearly indicates that this area was utilised as accommodation. There was no evidence that either of the staircases to the east or west of the property continued up to this space (although that in the east range may have originally), with indicates that the primary access point was from the main stairs which was associated with the main family, rather than as a separate access point for servants as has been observed in properties such as Hutton Hall in Penrith, or The Nunnery near Kirkoswald.

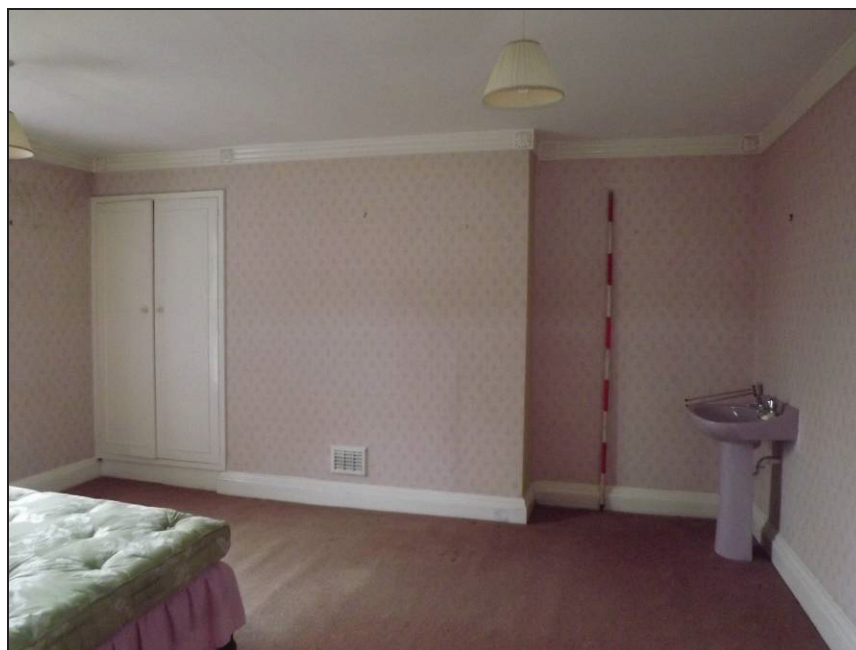
Plate 70: West wall of Room 18 showing projecting chimney breast of former fireplace

- 4.2.24 *Room 18, First Floor:* Room 18 has more recently been used as a bedroom, with a former fireplace being situated in the west wall as shown by the projecting chimney breast (Plate 70). The east wall of this room has a curved section at its north end, close to the doorway, which is unlikely to be an original feature (Plate 71). It must be noted that the architectural detailing of the fluted woodwork and floral motifs respect this curved wall, indicating that this is not an original design element, as has already been suggested from evidence on the ground floor. It is therefore necessary to consider where the original dividing wall between Rooms 18 and 23 would have been located, given the position of the windows in the south elevation (Figure 13). It is possible that the partition may not have been symmetrical, creating two different sized rooms as is the case on the ground floor immediately below (Rooms 1 and 2). There may have been a corridor which ran along the north side of Rooms 18 and 23, and possibly even provided access to Rooms 19 and 24, although if this was the case, no evidence for a corridor in this location survives.

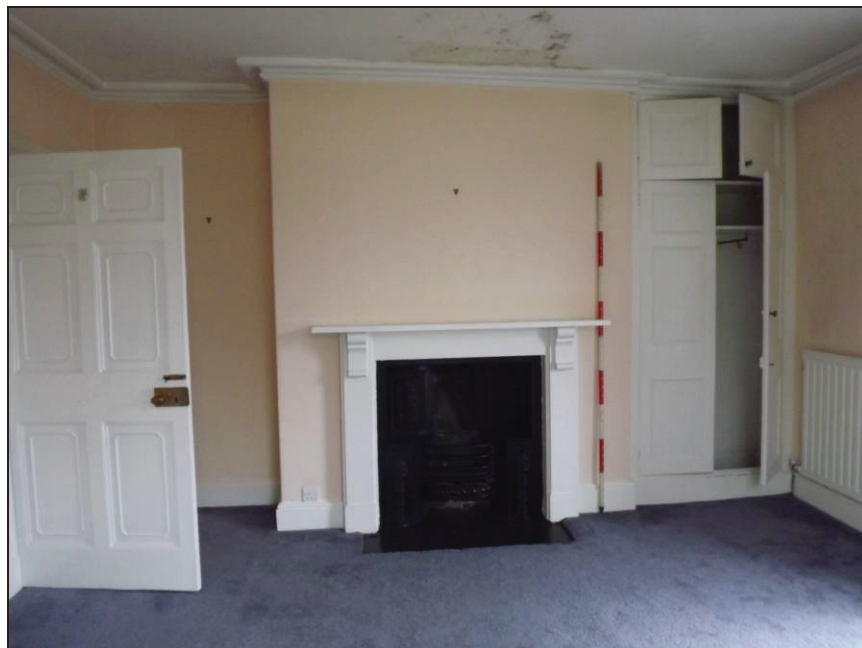
Plate 72: East wall of Room 19 showing hob grate fireplace

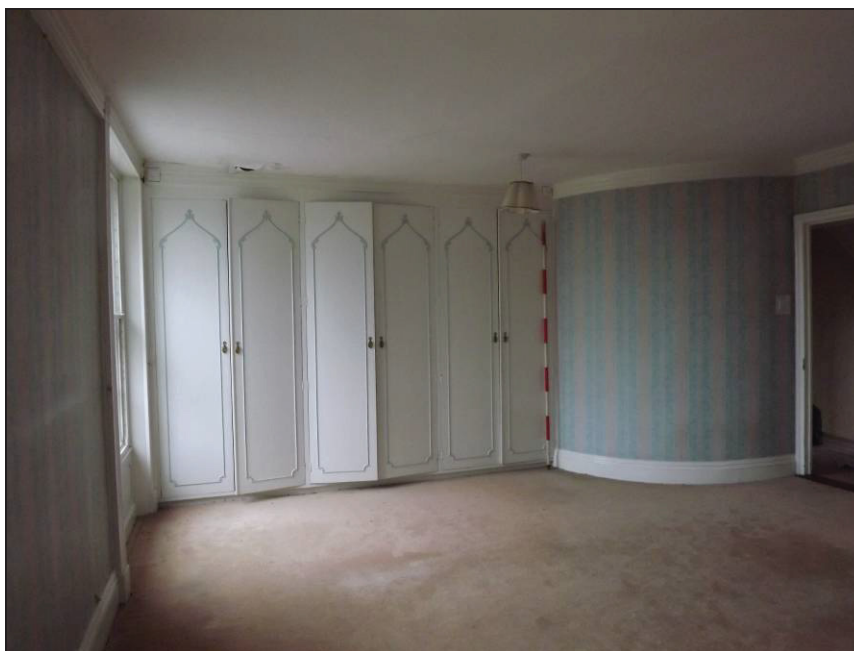
Plate 80: *West wall of Room 23*

- 4.2.29 *Room 23, First Floor:* this is the largest bedroom on the first floor, but as the west wall appears to be a later creation (Plate 80), it is possible it may originally have been smaller. The fireplace for this room was in the east wall, although the aperture has been infilled and covered over (Plate 81). The window surrounds and coving are of the same fluted design with floral motifs noted elsewhere (Plate 82), however further evidence for this being a modern addition is given by the fact that on the east wall, the coving has been fixed out from the wall to accommodate strip lights (Plate 83).

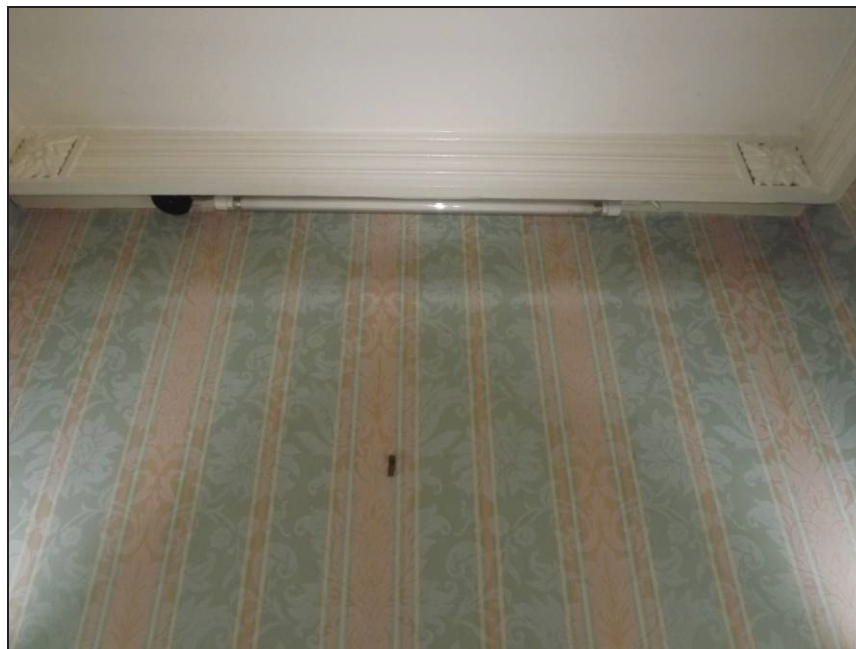
Plate 83: Detail of coving fixed away from the south wall to accommodate strip lights, Room 23

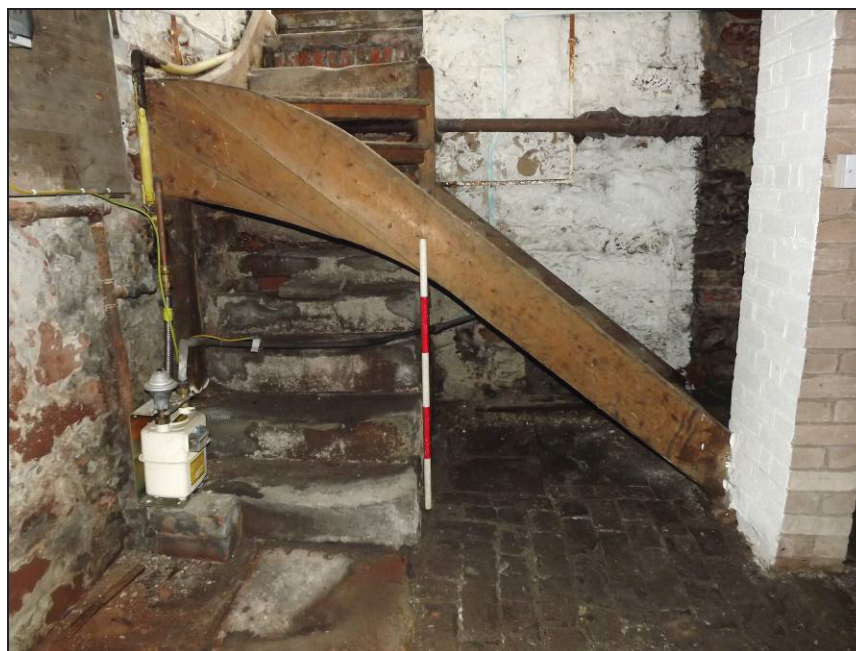
Plate 89: View looking north showing the original stone steps to the cellar and the present wooden stairs (Scale = 1m)

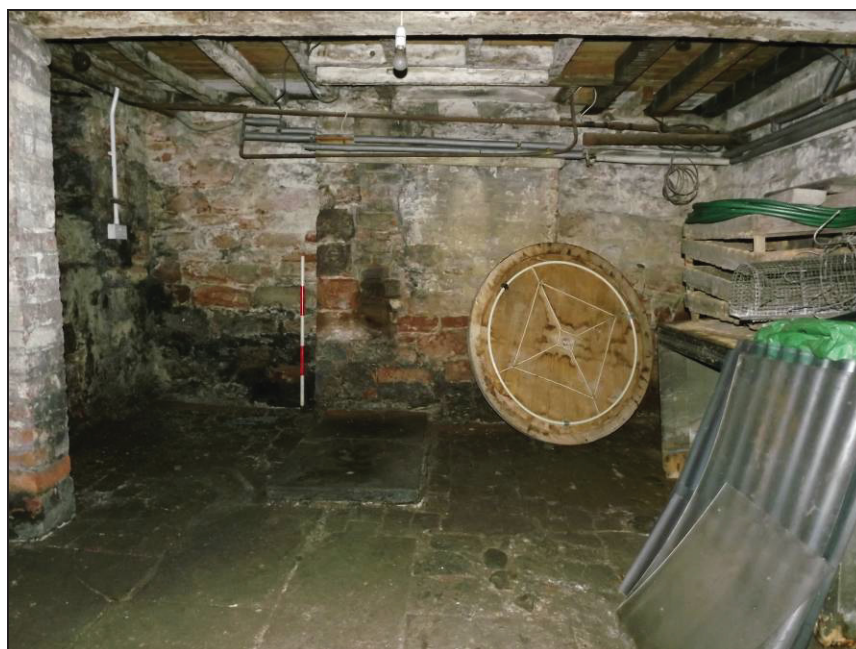
Plate 90: East wall of the cellar showing masonry walls and projecting support for fireplace in kitchen (Room 5) above (Scale = 1m)

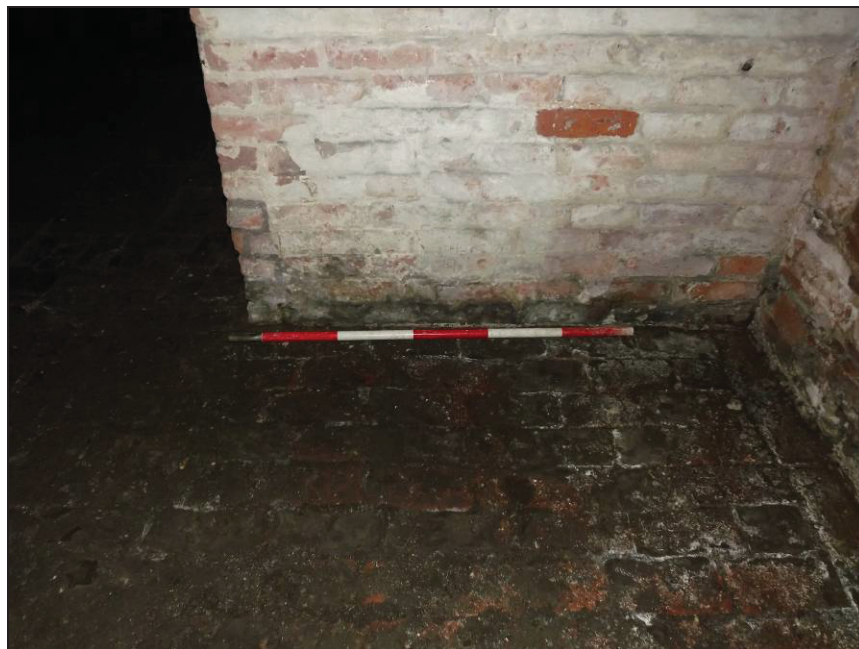
Plate 91: Detail of brick floor, cellar (Scale = 1m)

- 4.2.34 *The Cellar:* unusually, the cellar at Mulcaster House is accessed from the exterior of the property rather than from the interior, although it is possible there was access at some point from the staircase located in the east wing as noted above. The door to the cellar is immediately to the east of the main rear entrance (see Plate 18). At present, the steps down to the cellar are wooden, and take a turn to the east upon descending; however, originally access was by stone steps which descended directly ahead from the entrance (Plate 89). All the cellar walls are constructed of sandstone, although there is one brick cross wall, and a modern brick support. In the east wall there is a projection which relates to the fireplace in the kitchen (Room 5) above, and presumably acted as a load bearing support for the chimney breasts above (Plate 90). There was no evidence in this room for any other access point apart from via the external door already noted. The floor of the cellar is a mixture of handmade brick and sandstone flagstones (Plate 91).

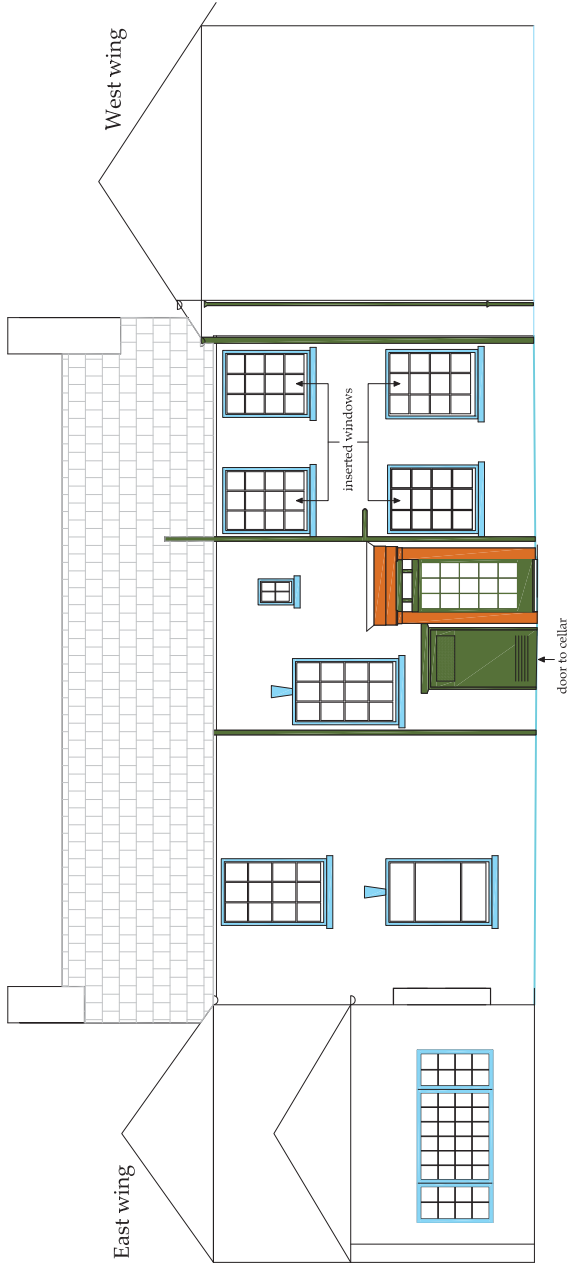
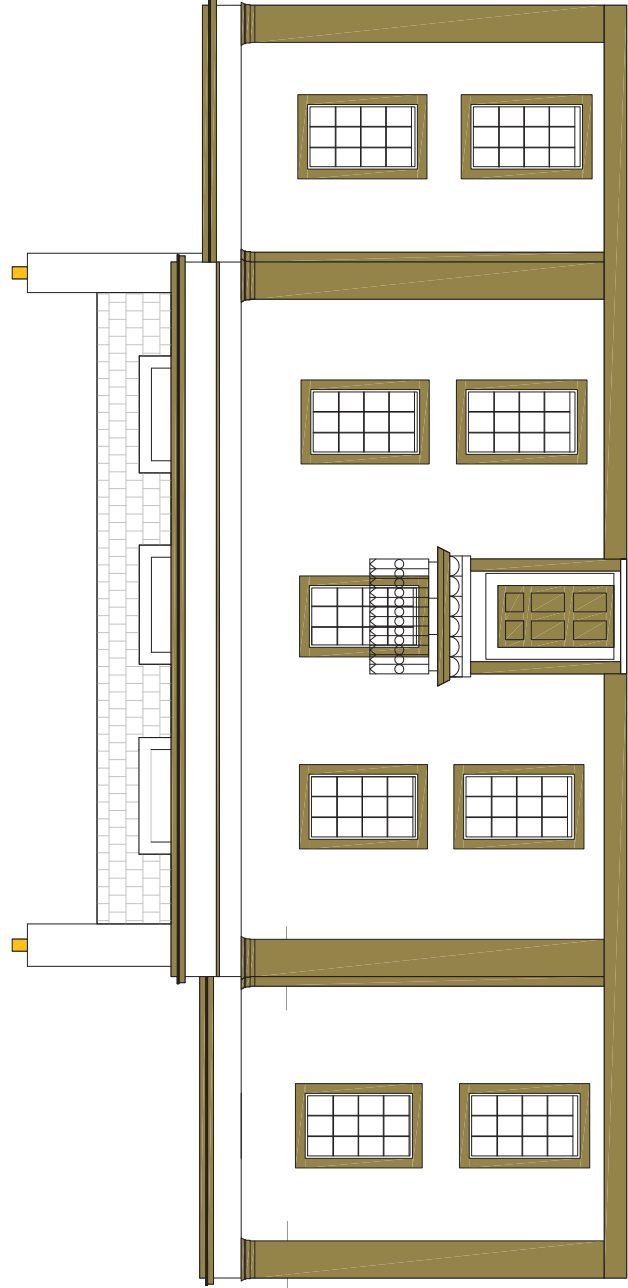
Figure 10: North and south elevations of Mulcaster House.

North elevation

South elevation

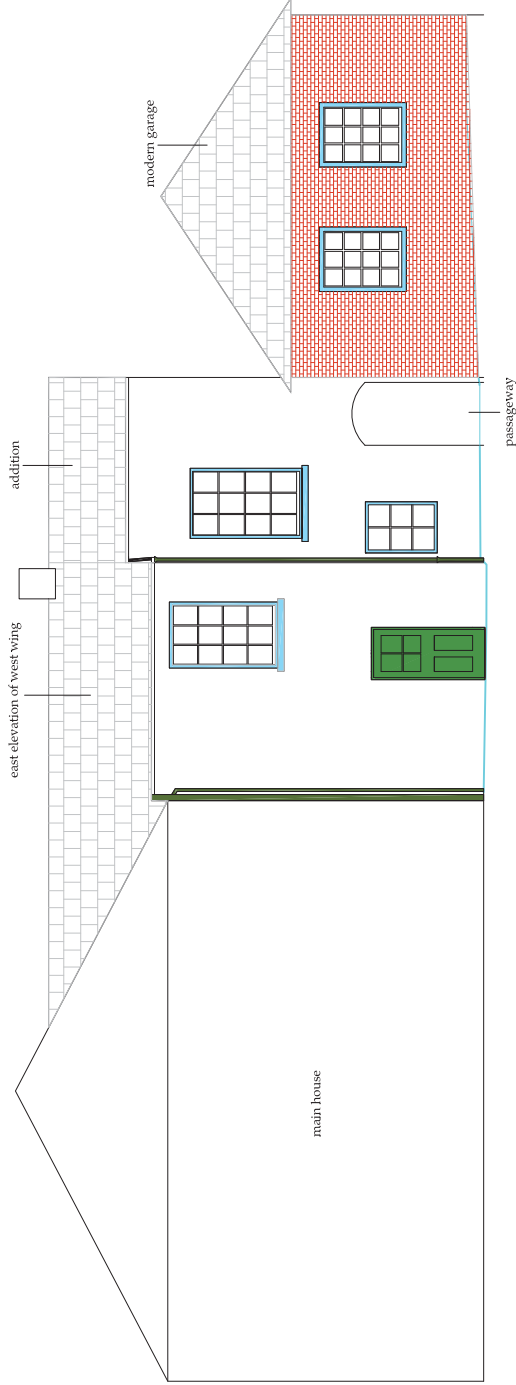
Figure 11: East and west elevations of Mulcaster House.

East elevation

West elevation
