WESTMINSTER PARK,

ARCHAEOLOGICAL RECORDING REPORT

CP. No: 10581/14

DOCUMENT TITLE: Westminster Park, Crewe, Cheshire
DOCUMENT TYPE: Archaeological Recording Report
CLIENT: United Utilities
CP NUMBER: 10581/14
SITE CODE: WSC-A
PLANNING APP. NO: -
OASIS REFERENCE: wardella2-180510
PRINT DATE: 11/06/2014
GRID REFERENCE: SJ 7034 5470

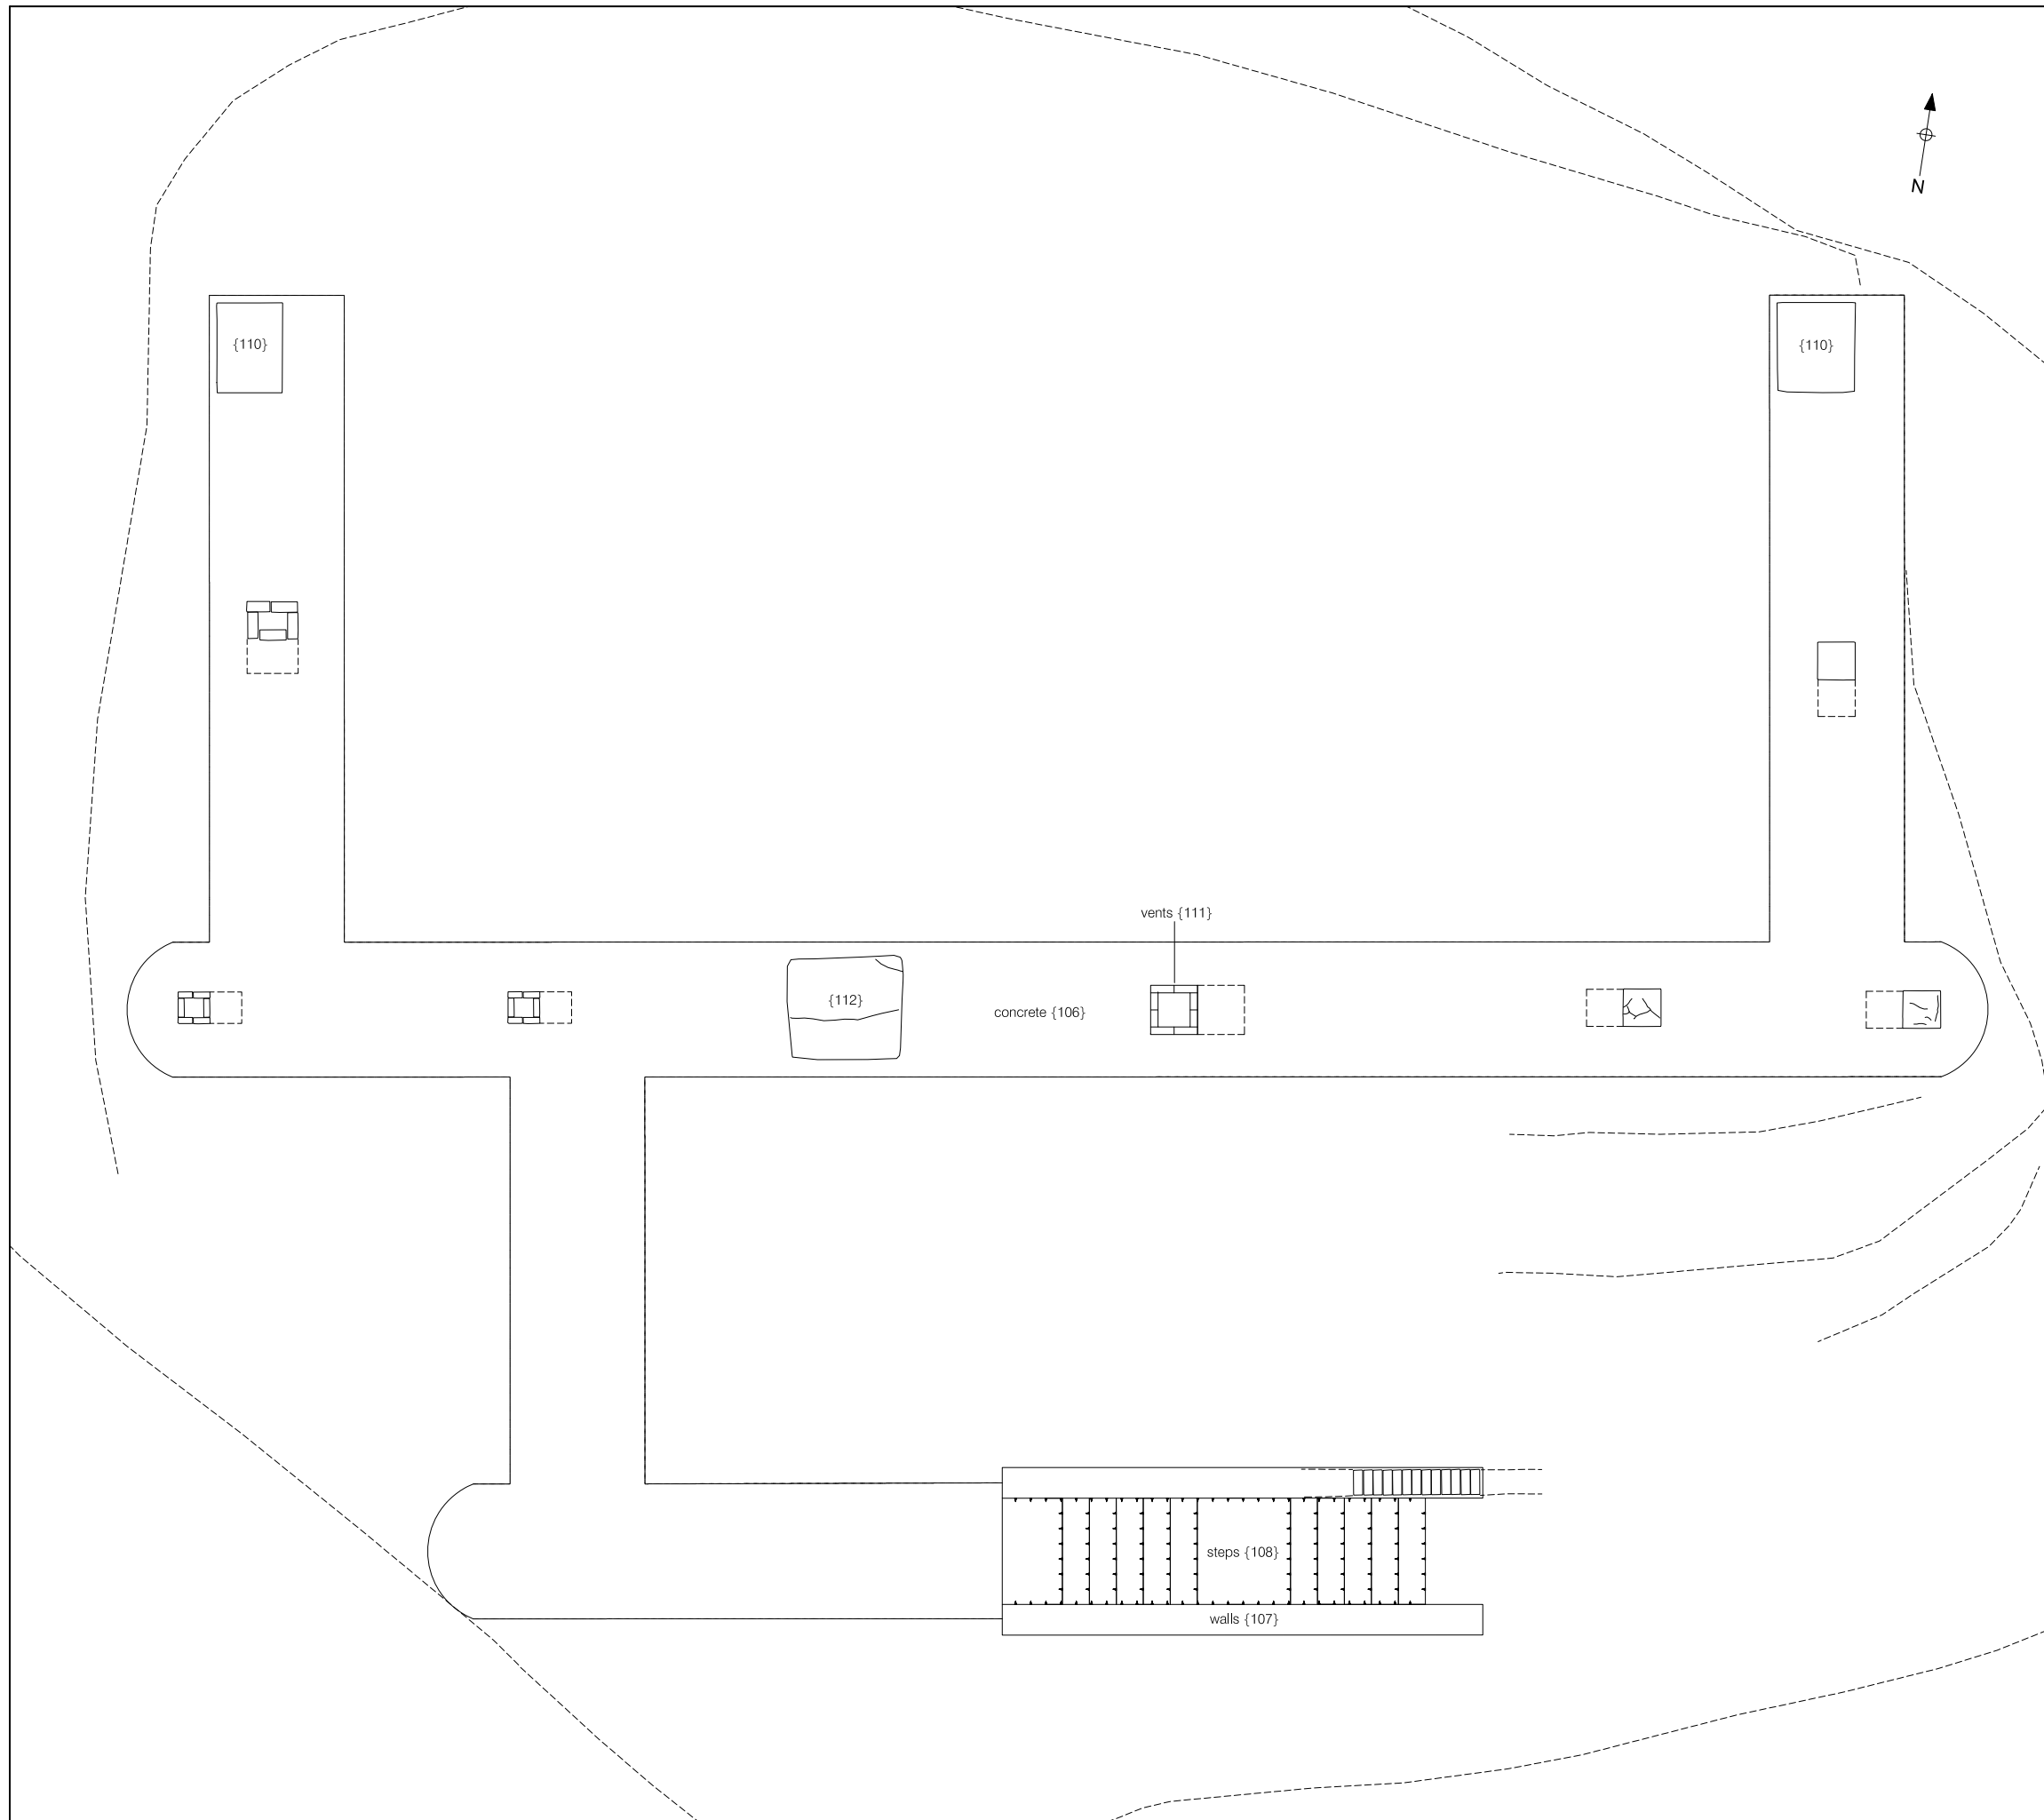
FIGURE 3: PLAN OF AIR RAID SHELTER PRIOR TO EXCAVATION

- 4.2.2 The shelter consisted of five linking corridors of which two, corridors A and C were aligned east-west and three, corridors B, D and F were aligned north-south (Figures 3 & 4). All corridors varied in length but all were 1.39m wide by 2.04m high. The trench cut [102] was rectilinear shaped with vertical sides and a flat base that measured 50.45m in overall length by 1.55m wide by approximately 1.95m deep. The shelter was covered over by a layer of topsoil (100) that consisted of a dark brown silty clay and was roughly 0.3m thick. The shelter was not flooded and only had shallow, muddy puddles of water in places. It was mostly dry with some damp patches and there was debris scattered throughout the corridors along with a couple of broken tools, bunk beds and rubbish (Plates 10 – 11).

- 4.2.7 There was a total of seven vents {111} that were visible in the shelter roof. There was one apiece in corridors B, D and E and five in corridor C (Figure 3) (Plates 1 &

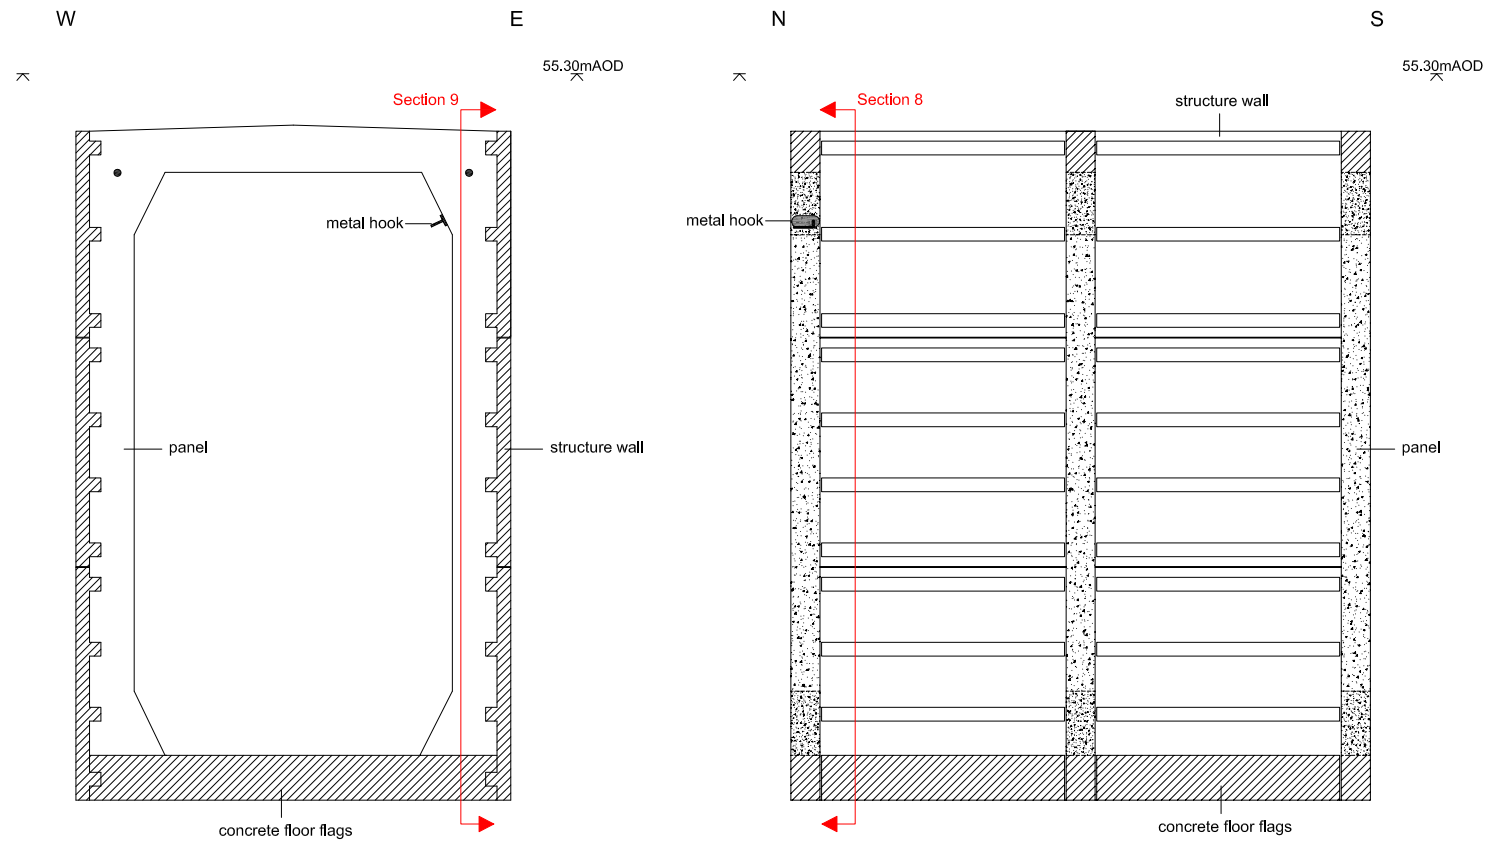
5

Section 8. South facing representative profile.

Section 9. West facing representative elevation.

projected out 0.03m along the inner sides that measured 0.83m long by 0.04m thick and were in evenly spaced rows of three or four. The sections of the wall {103} were made up of three rows of panels that were laid on end against the sides of the cut. The lower and middle panels measured 0.89m wide by 0.76m high by 0.05m - 0.08m thick with the top panel 0.66m high for most of the shelter except at the ends and sections where the corridors join. The panels at the ends of the corridors were largest and measured 1.55m wide by 0.16m thick and the panels on either side of the adjoining corridors were 0.68m wide. The panels were kept in place by concrete and rebar braces {109} that were rectangular shaped and measured 2.18m high by 1.45m wide by 0.08m thick on the sides and 0.14m thick on the base and top. They were spaced at intervals of between 0.84m – 0.86m. The braces were closer together at both ends of corridor C and the west end of corridor A and at the junctions with the other corridors. In these locations they were 0.52m and 0.6m apart. They had holes near their top corners that suggested that they were lowered into trench and placed where the ends of the panels met, in a vertical gap created by the reinforced bars on the inner sides of the panels as they stopped 0.04m short of either end (Figure 5) (Plates 4 – 7 & 11).

- 4.2.5 The floor panels {104} were placed in the gaps between the braces and measured 0.14m thick that were also the same thickness as the base of the braces. The flat side of the panels faced upwards with the reinforcing strips underneath. The panels measured 1.35m long by 0.81m wide throughout the shelter except at either end of corridor C at its junctions with D and E and also at the junction between corridors A and B. Additional braces that were closer together at the junctions meant smaller panels in the recesses and third of the proceeding panels at either end of C and in A. The panels measured 0.52m and 0.61m respectively. A panel in corridor A had holes in its northern half near to the opening into corridor B that appeared to have been a drain. It consisted of three narrow parallel slits in a cross shape with a round hole in the centre. The drain could not be measured as there was no safe access to it (Figure 5) (Plate 15).

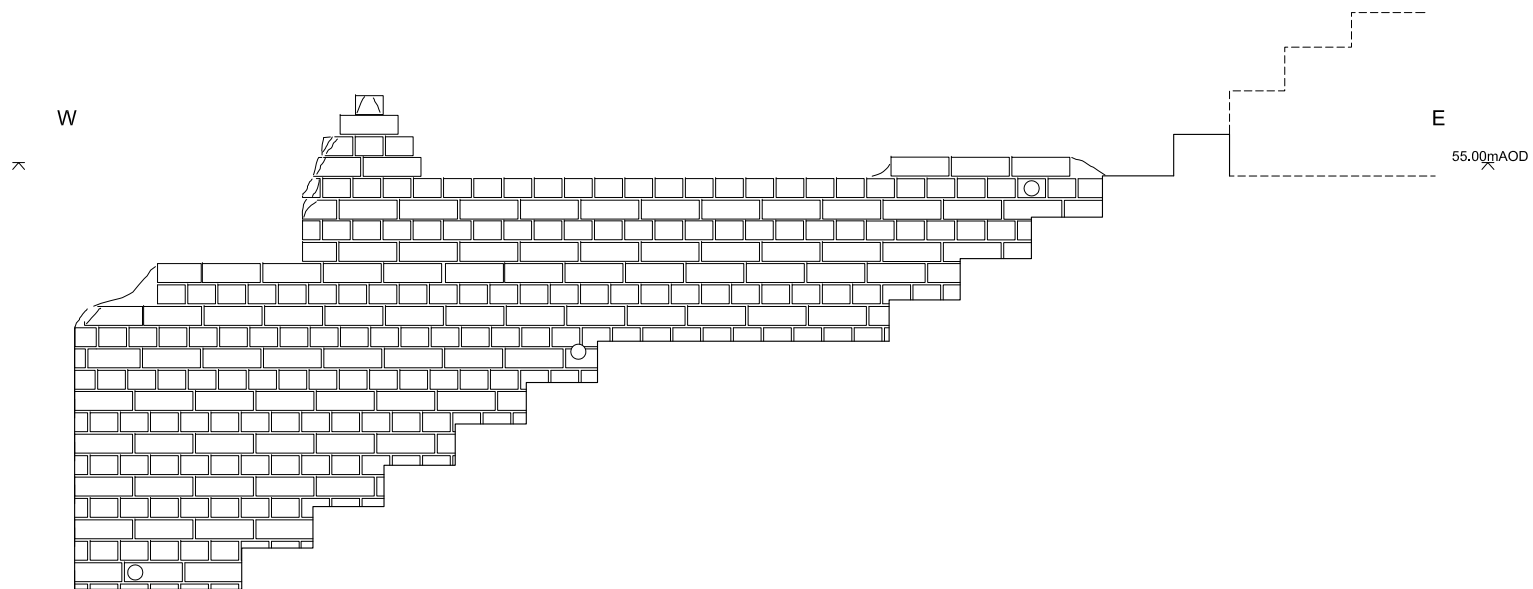
Figure 6: Elevation of wall at the entrance to the shelter.

Section 7. South elevation. Wall at the entrance to the shelter.

- 4.2.8 The entrance to the shelter was located at the east end of corridor A. It had been blocked by brick infilling {114} consisting of 23 courses of red bricks in stretcher bond using cement mortar (Plate 9). The blocking measured 2.04m high by 1.39m wide. The bricks measured 0.23m long by 0.11m wide by 0.07m thick. The stairs that lead down to the entrance had been backfilled with a mixture of topsoil, light brown clay and modern rubbish (113). The stairs measured 5.4m in length by 1.865m and had a fall of 2.045m high. It also appeared that two or three of the upper steps had been removed prior to this recording project. The stairs consisted of twelve concrete steps {108} between brick walls {107} on the north and south sides. Ten of the concrete steps had risers of 0.29m thick by 0.16m high on average, with a wider step at the bottom of the stairs at the entrance that measured 0.66m wide and the seventh step measured 1.6m wide. The walls on both sides consisted of at least 23 courses of red brick that was laid down in English bond using cement mortar (Plates 12 – 14). The bricks measured 0.23m long by 0.11m wide by 0.075m thick and both walls measured 5.4m long by 0.24m wide (Figure 6). There were circular ceramic pipes visible in the 2nd, 12th and 19th courses of the wall that mirrored each other and measured 0.08m in diameter. It was unclear what their function was but it may have been for drainage or holding the base of railings.
