**BRAMHALL HOUSE,
HAZEL GROVE,
STOCKPORT,
GREATER MANCHESTER**

ARCHAEOLOGICAL BUILDING SURVEY

CP. No: 11034

DATE: 23/07/2014

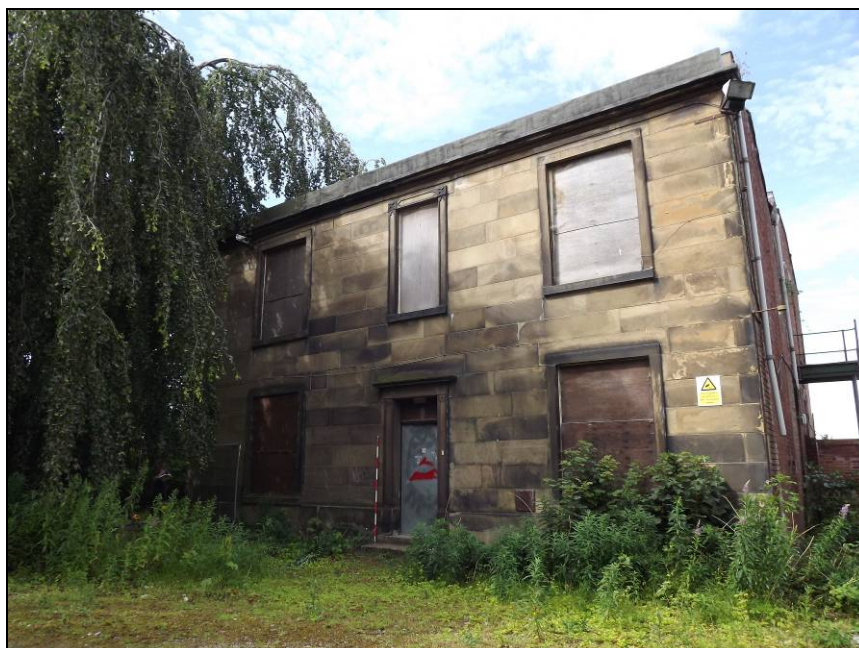
Plate 4: East elevation of Bramhall House

- 5.2.2 The main elevation of the property faces to the east; this was clearly the elevation that was meant to be seen by passers-by, as it has already been noted above that the access track and a footpath ran alongside this part of the building. This elevation is constructed in ashlar blocks (16 courses) which typically measure 0.37m in height set above a plinth which measures 0.70m in height (Plates 4 and 5).

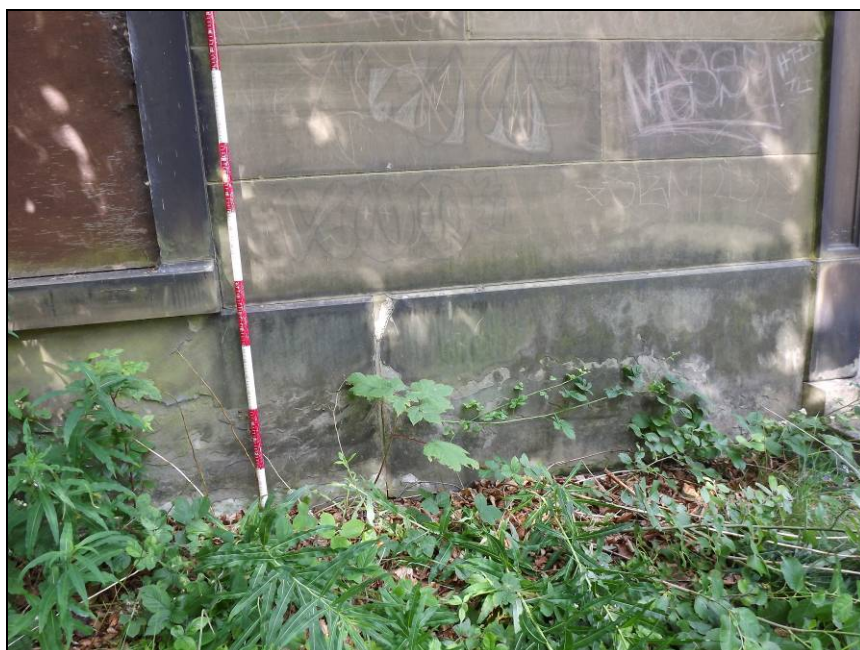
Plate 5: Detail of plinth along the east elevation

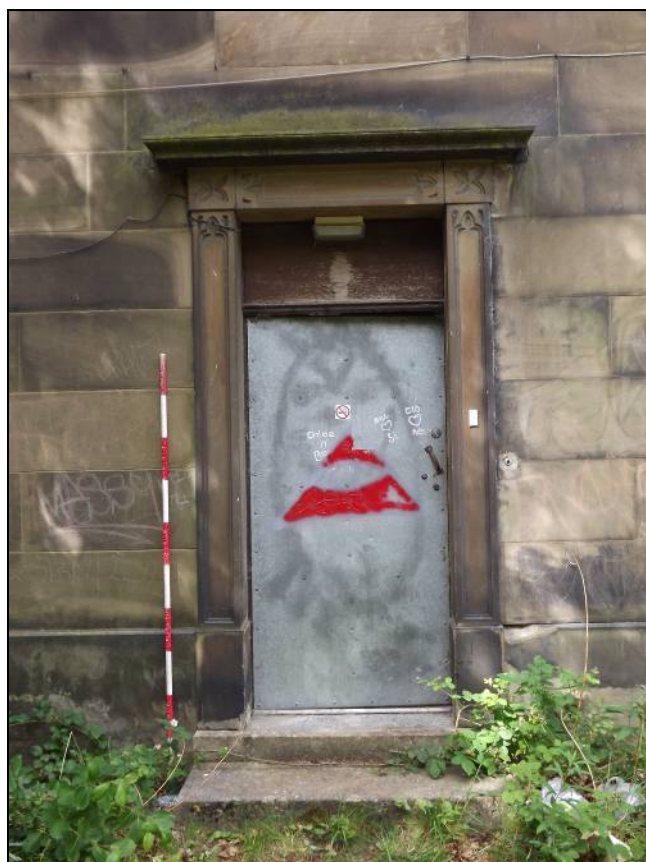
Plate 6: Detail of main entrance door surround, east elevation (Scale = 2m)

- 5.2.3 This elevation is symmetrical with a central main entrance flanked to each side at ground floor level by a large window. The doorway itself has decorative detailing with pilasters to each side terminating in plinths which align with the plinth which runs along the base of the elevation. Above the doorway is a simple projecting door hood. The door itself is presently covered over by metal sheeting (Plates 6 and 7). The windows to each side have plain stone projecting surrounds (Plate 8).

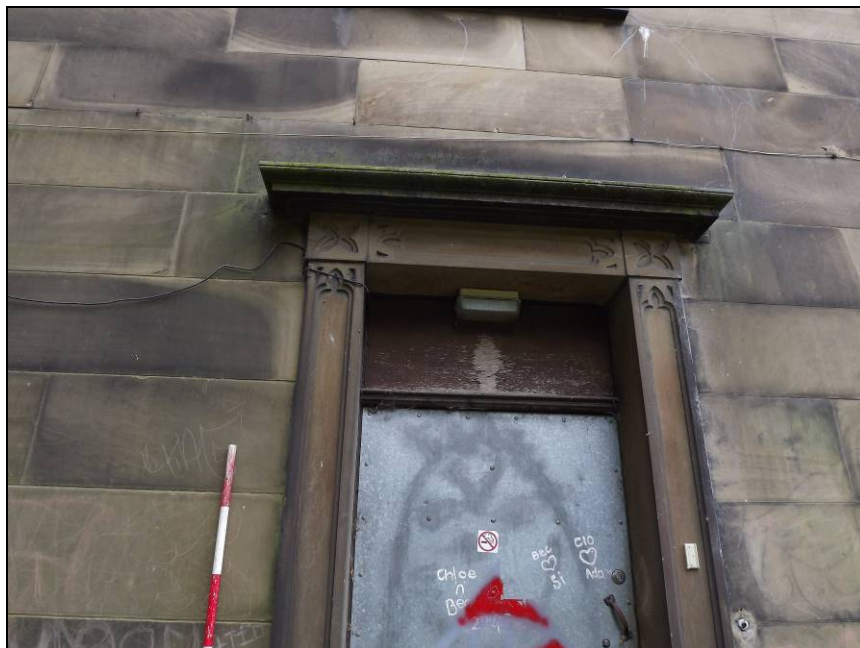
Plate 7: Detail of decorative door surround with simple projecting door hood, east elevation

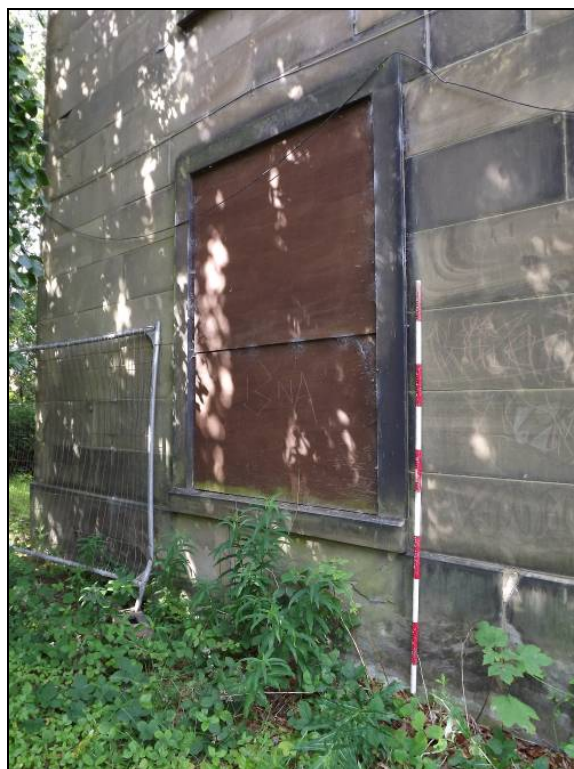
Plate 8: Detail of ground floor window surround, east elevation

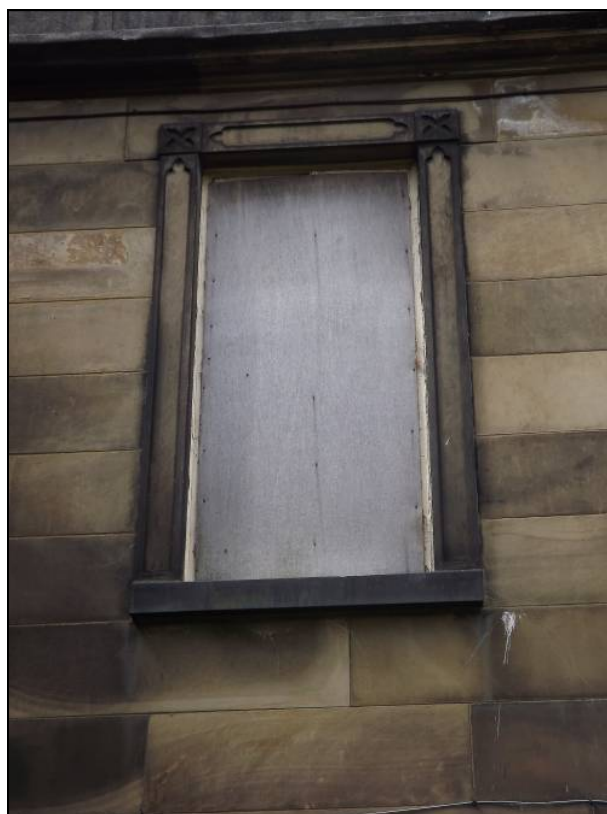
Plate 9: Detail of first floor central window, east elevation

- 5.2.4 At first floor level in the east elevation there are three windows; the two outermost are of the same plain surrounds as those directly below, however the central surround has the same quatrefoil detailing and

- decorative jambs as already observed around the main entrance (Plate 9). At eaves level on this elevation there is a moulded cornice with a course of, what appears to be, stone blocks, which are now hidden by a modern asphalt covering (Plate 10).

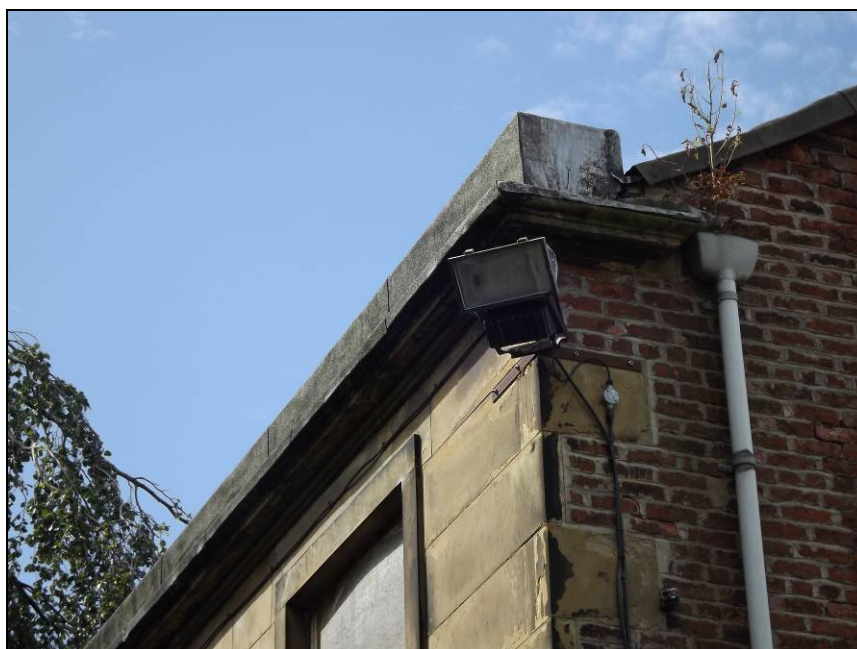
Plate 10: Detail of cornice and line of stone blocks along the top of the east elevation

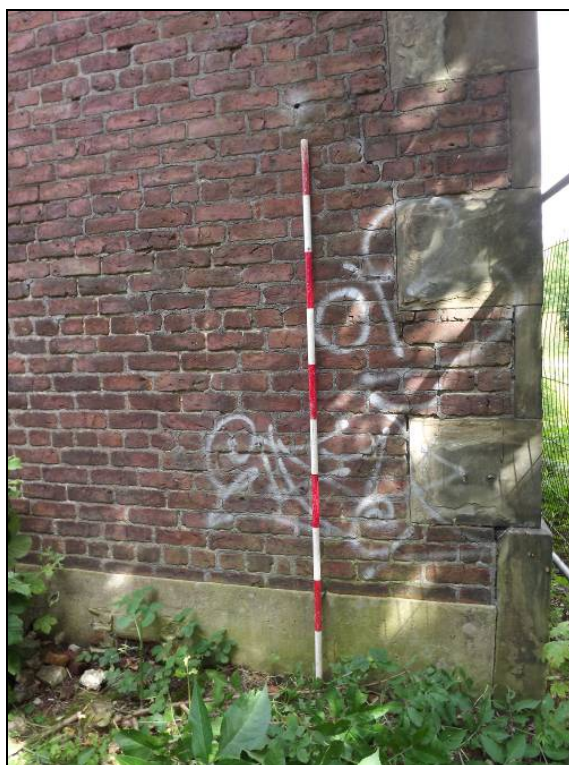
Plate 12: South-east corner of Bramhall House showing the ashlar quoins and brickwork of the south elevation (Scale = 2m)

- 5.2.5 The south elevation, which would have originally faced into the garden which was associated with the property, is constructed of handmade brick laid in English Garden Wall bond. This elevation clearly shows the doubled-gabled roof with its central gutter valley although no rainwater goods are now present (Plate 11). The two gables of this elevation were seemingly defined by flat coping stones which terminate in plain kneelers, although it appears some of the coping has been removed. There is the remains of one chimney stack at the apex of the eastern gable, which provides an indication of the location of the internal fireplaces. The ashlar quoins of the east elevation are visible in the south-east corner of this wall, highlighting the difference in construction and appearance between the two (Plate 12).

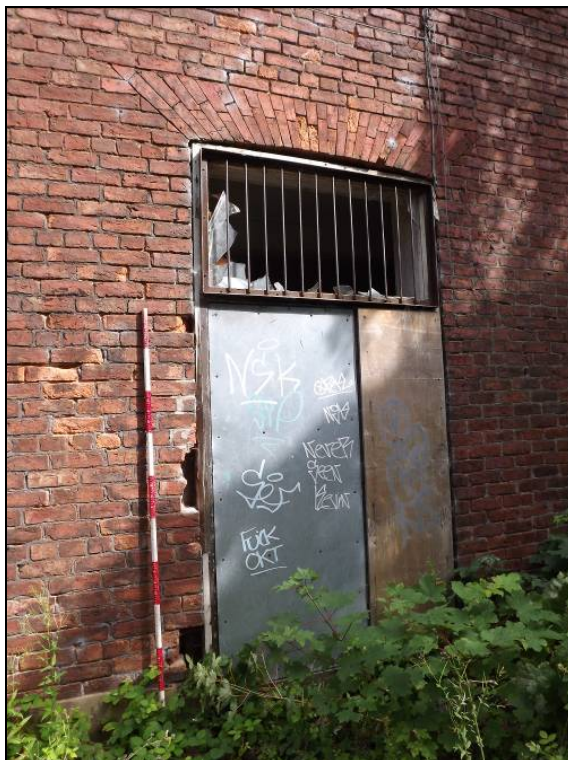
Plate 13: Detail of former French doors, south elevation

- 5.2.6 At ground floor level there is a doorway, which may have historically accommodated French doors to provide access from one of the front rooms into the garden. The head of this opening, as with all those in this elevation, has gauged brickwork forming a shallow arch (Plate 13). It has been considered that this opening may have originally been a window, however the vertical jambs appear to be relatively undisturbed which suggests that this doorway is an original feature. To the west of this doorway there is a window with two over two pane sash frame and stone sill (Plate 14). The first floor of this elevation has two similar windows, however these have been boarded over and it was not possible to note the form of window frames (if they still survived).

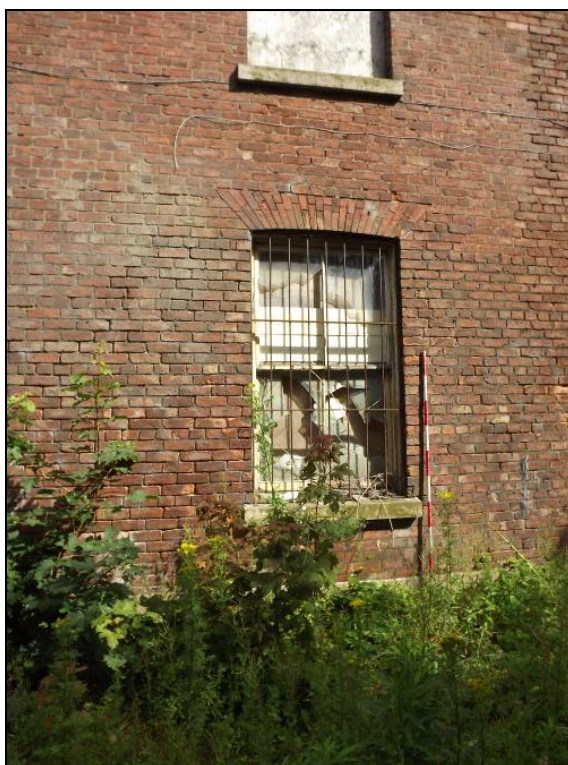
Plate 14: Detail of ground floor window, south elevation

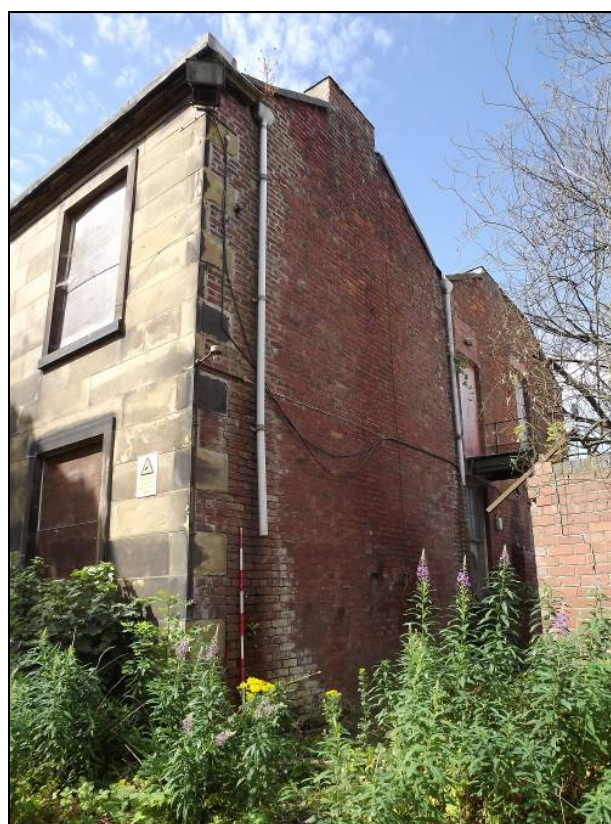
Plate 16: Detail of ashlar quoins of the east elevation and the brickwork of the north elevation

- 5.2.7 The north elevation was difficult to photograph due to the presence of a modern brick boundary wall just to its north side. This elevation is not symmetrical like the opposing south elevation due to the existence of a two-storey addition (Plate 15). As with the south elevation, the quoins of the east elevation extend into the brickwork of this wall showing the difference in construction and appearance (Plate 16).

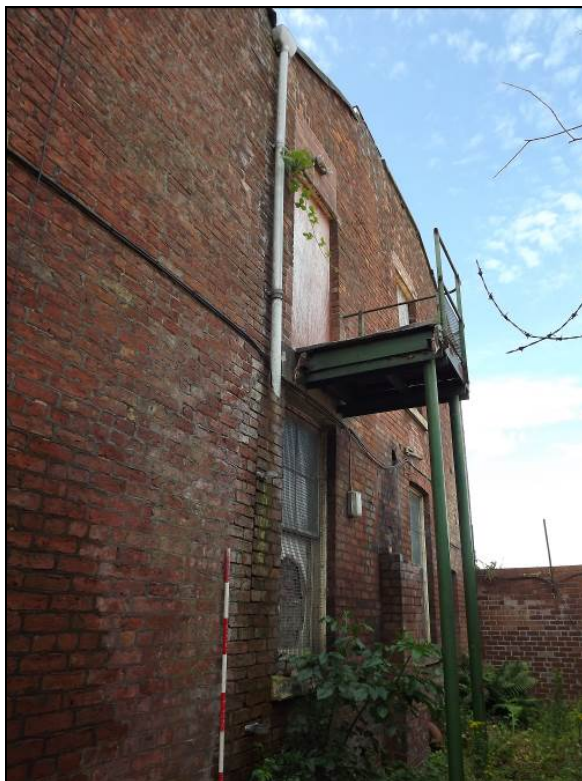
Plate 17: North elevation showing vertical construction break (in line with the white downpipe)

- 5.2.8 Of all the elevations of Bramhall House, the north elevation displays the most evidence for adaption and addition. Most obvious of these is a vertical construction break located at the point where the gully between the two gables is located (Plate 17). This vertical break indicates that the western part of this elevation forms an addition to the earlier eastern section; this addition is evidenced not only by the construction break but by the way the brick coursing of each section is not exactly aligned. Of note is the fact that a vertical construction break is not present in the south elevation, indicating that the earliest phase of the house was not a linear, one-room deep range, but an 'L-shape'.

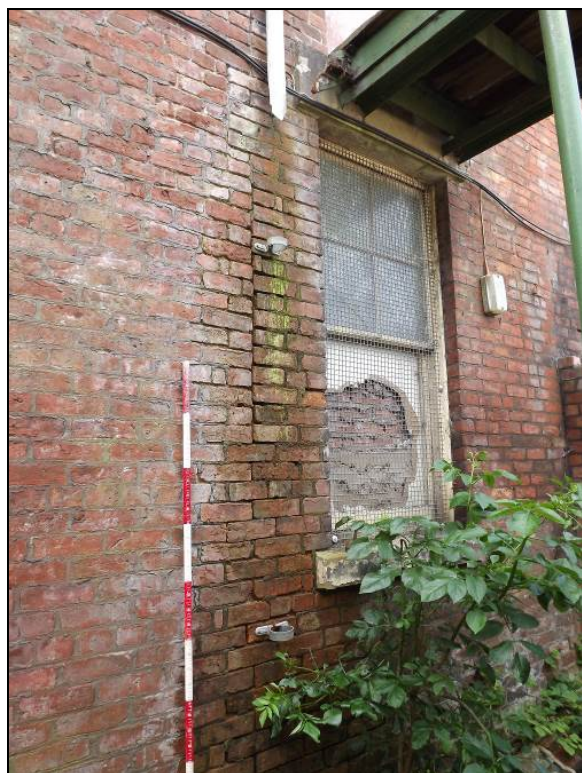
Plate 18: Ground floor window, north elevation. The lintel has been replaced to allow a fire escape to be fixed to the wall

level, must have been lit well enough by the windows in the east elevation, or there were windows present in the west facing side prior to the addition of the extension. There are two windows at ground floor level in the western section of this side of the house (the addition), with brick heads and stone sills although the lintel of one has been replaced with concrete to allow a fire escape to be fixed to the wall (Plate 18). Both of these windows have four over four pane sashes (Plate 19). To the west of these windows there is a doorway, now covered by a metal sheet, with the same form of brick head (although not gauged brickwork as noted in the south elevation), and a concrete step (Plate 20).

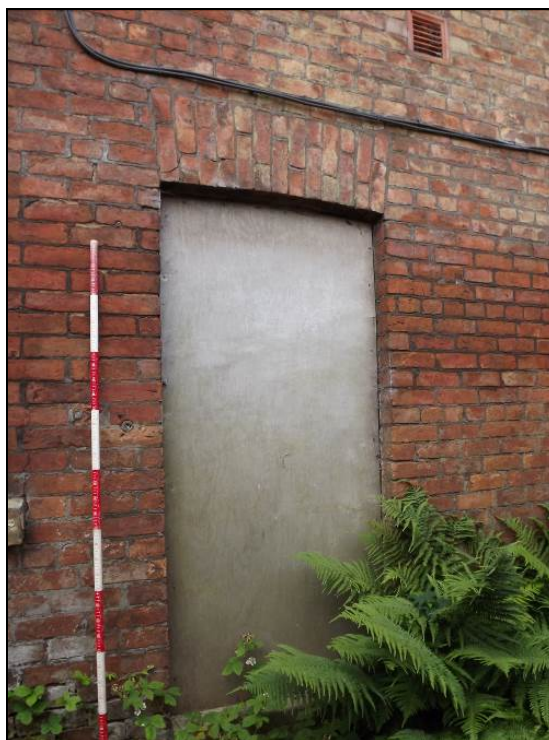
Plate 20: Doorway in north elevation (Scale = 2m)

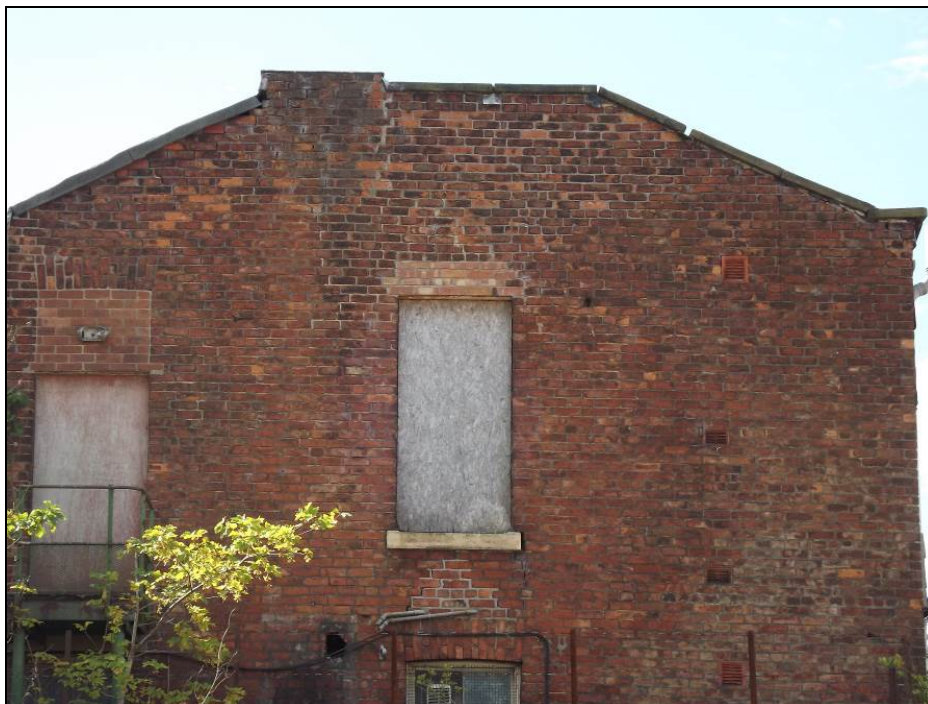
Plate 21: North elevation showing two windows, one of which has been converted to a fire escape

- 5.2.10 At first floor level of the north elevation there were originally two windows, however one has been converted to a fire escape with the remains of the metal escape stairs still present. The stump of a chimney stack is present above these openings (Plates 19 and 21).

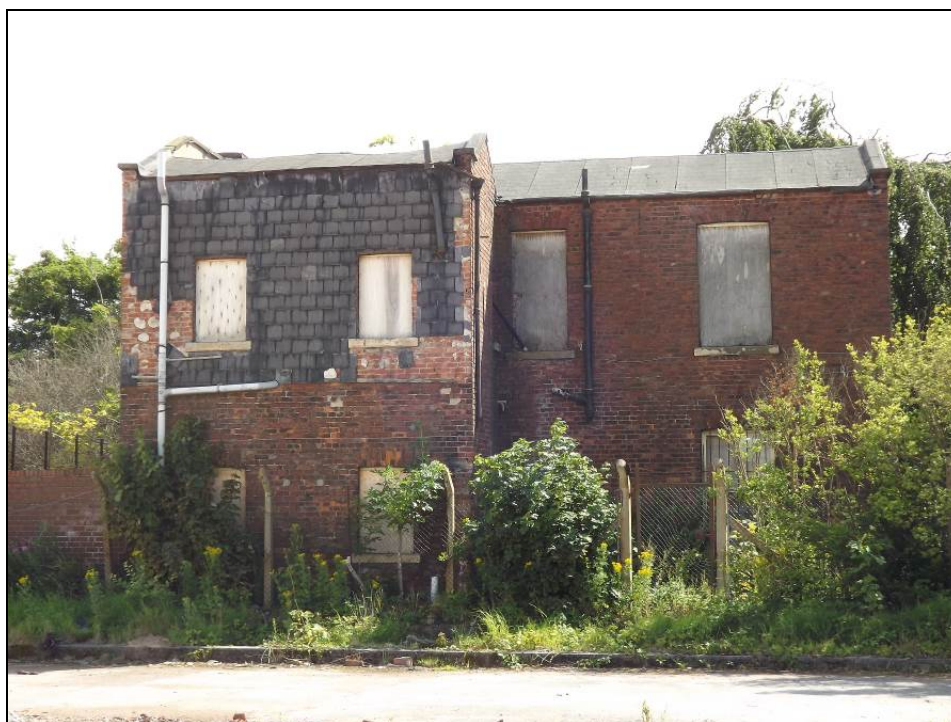
Plate 22: West elevation of Bramhall House showing the later (projecting) addition to left of the photograph

- 5.2.11 The west elevation of Bramhall House consists of part of the earliest phase (to the south), with a later two-storey extension to the north end (Plates 22 and 23). The southern part of this elevation has a window and doorway at ground level, and two windows at first floor level, all with the same form of gauged brickwork for the heads as already noted in the south elevation (Plates 22 and 24 and Figure 8). Below the ground floor window there is a further window which would have lit the basement (Plate 25).

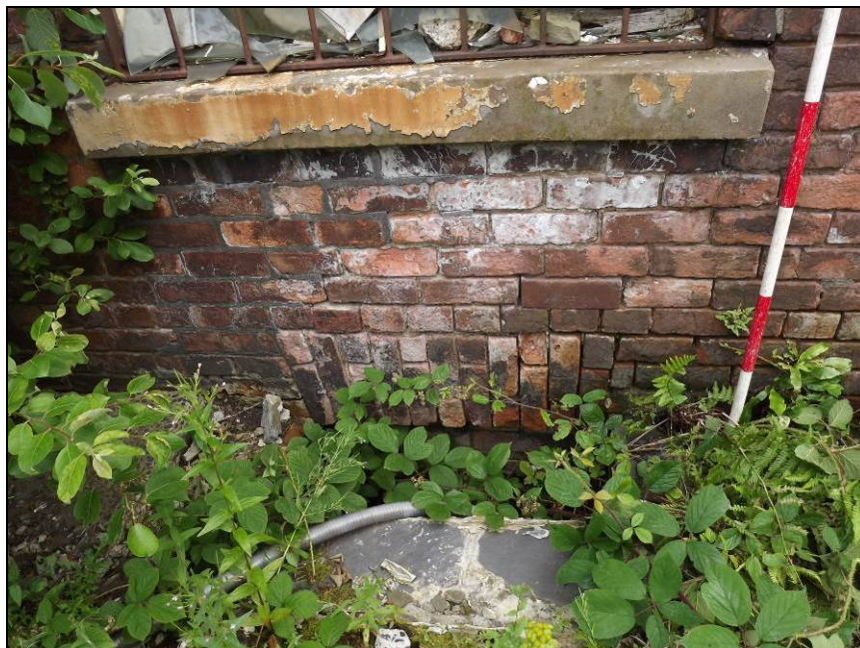
Plate 25: Basement window, west elevation

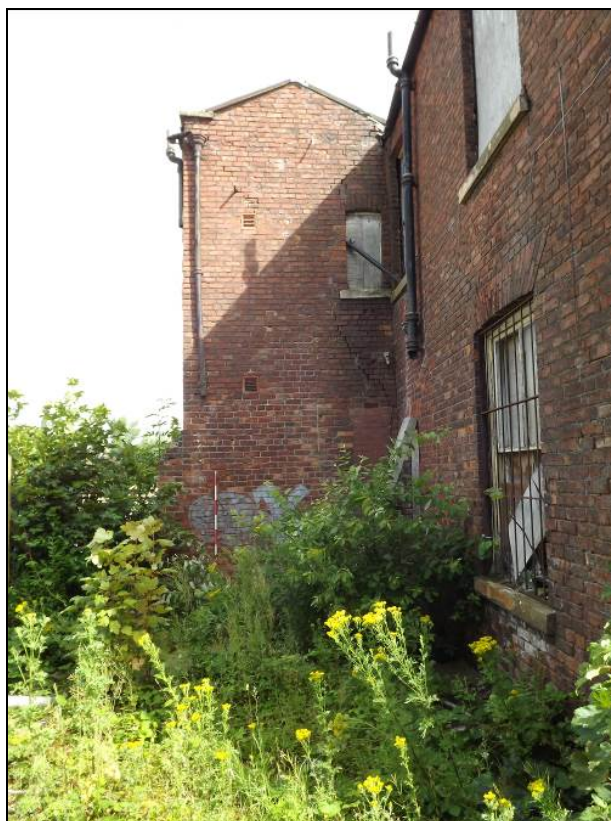
Plate 26: South facing elevation of addition showing blocked ground floor window and first floor window

- 5.2.12 Within the south facing elevation of the addition there is a blocked-up small window at ground floor level, and a small window at first floor level, the head of which is not of the same form as those of the west and south elevations (Plates 26 and 27). This addition is gabled when viewed from the south, with the gable defined by coping stones which terminate in a flat kneeler at its west side (Plate 28). The opposing north side of the gable is not visible due to the brickwork of the north elevation extending westwards at a higher level, possibly a deliberate attempt to conceal the gable of the addition when viewed from the north (see Plate 21).

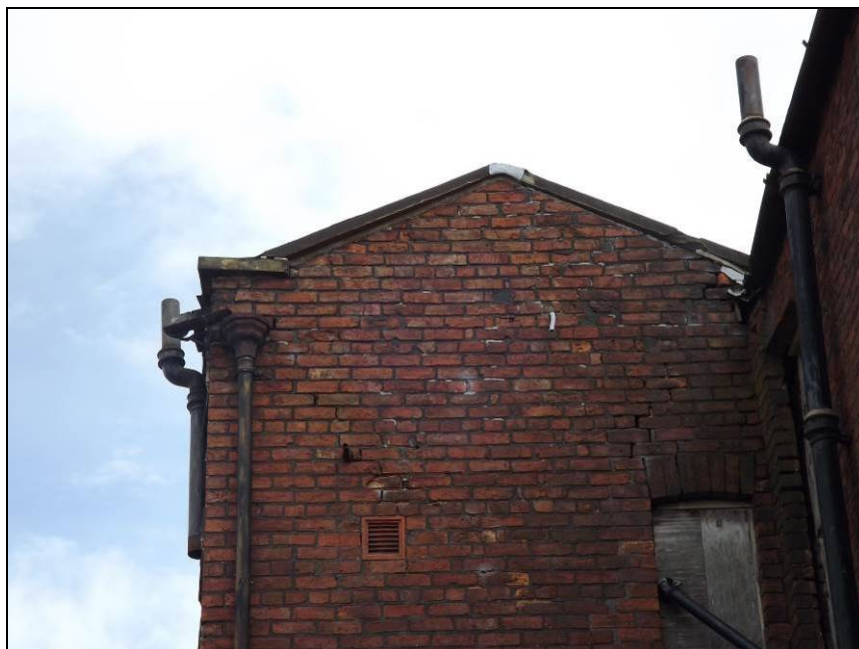
Plate 28: Detail of coping stones and kneeler, south elevation of addition

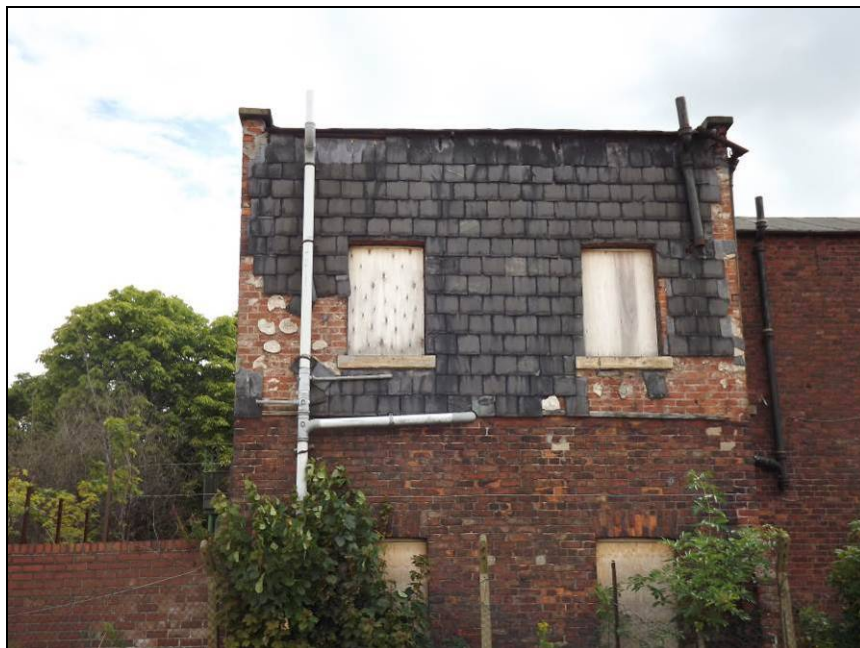
Plate 29: West elevation of two-storey addition

- 5.2.13 The west facing elevation of the addition has been partly weatherproofed by the application of courses of slate, although some of these have now fallen away (Plate 29). This elevation has two small windows at ground level with two directly above at first floor level. The only other feature of note on this part of the building was the stump of a wall which formerly projected westwards; this may have related to the wall between the house and the glass house which is shown on mapping from 1875 onwards (see Figure 4 for example).

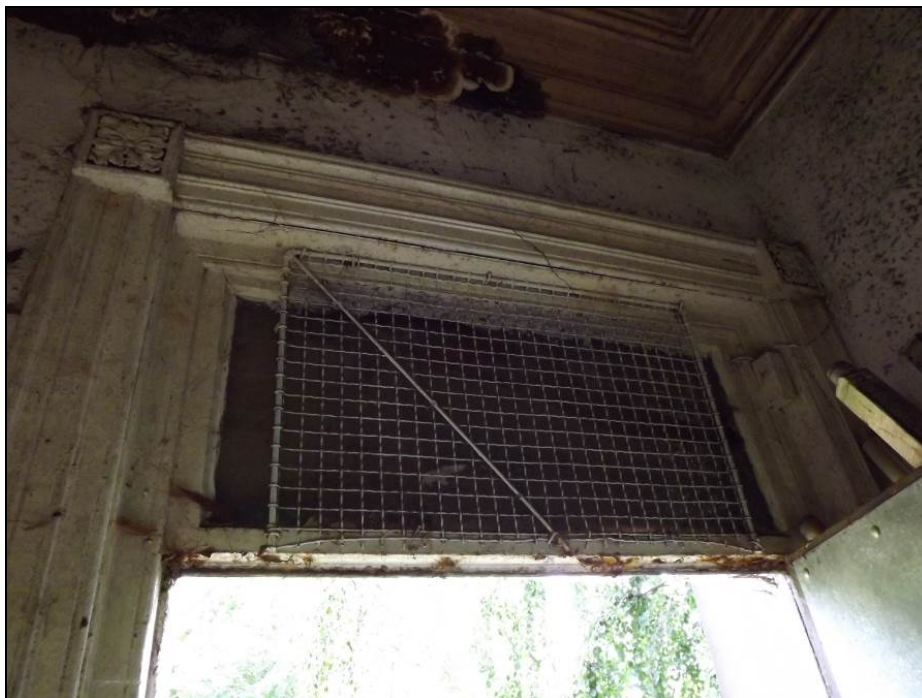
Plate 31: Detail of decorative door surround and fan light over main entrance as seen from the vestibule

- rooms could be safely accessed, and there was no access possible to the basement or the first floor.
- 5.3.2 Upon entering the property through the main entrance in the east elevation (see Plate 4), there is a small vestibule with double doors and etched glass panels, although these are not original (Plate 30). It was noted from the vestibule that the main doorway has decorative architrave and floral design in square panels to each side of the rectangular fanlight (Plate 31). The coving in the vestibule is heavily moulded (Plate 32).

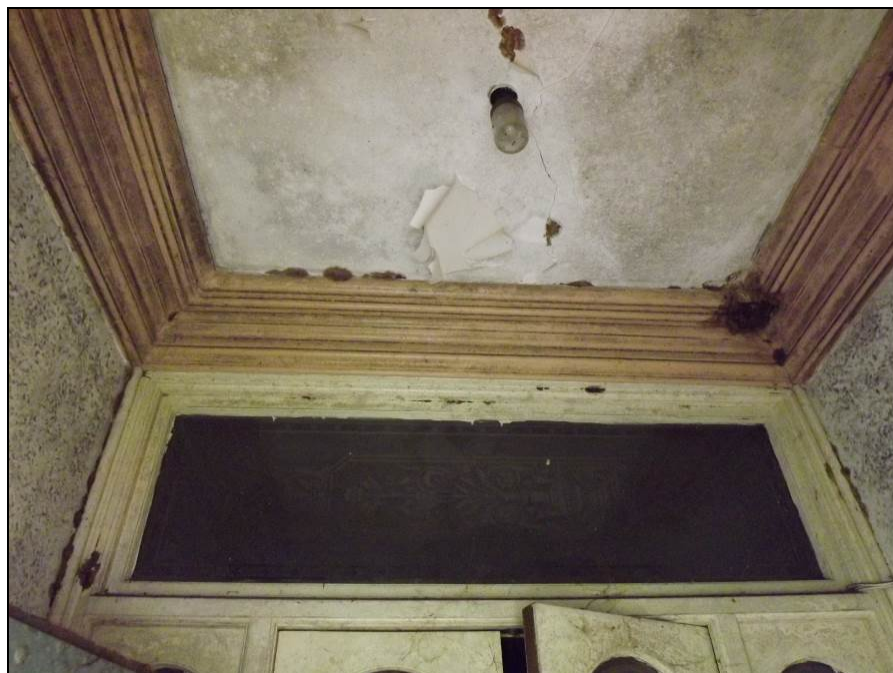
Plate 32: Detail of moulded coving in vestibule

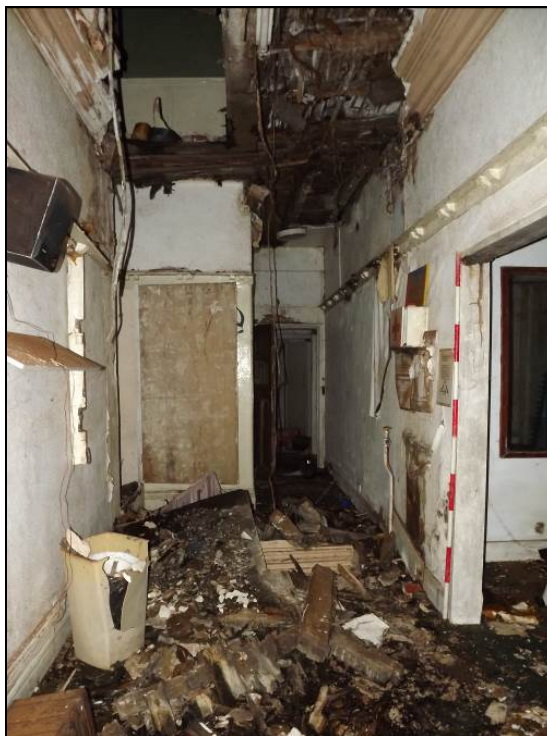
Plate 33: View looking west showing the hallway

- 5.3.3 The vestibule leads into a hallway which has suffered extensively through water ingress, and the ceiling has recently fallen away prohibiting access beyond this point to the west side of the house. Features of note in the hallway include the decorative cornice, where it survives, and it was noticeable that the original staircase appears to have been removed, and instead the first floor has more latterly been accessed by a boxed-in stairwell of possible early 20th century date (Plate 33). Where some of the ceiling of the hallway had fallen away, it was possible to observe a hexagonal roof light which would have provided natural light for the first floor landing (Plate 34).

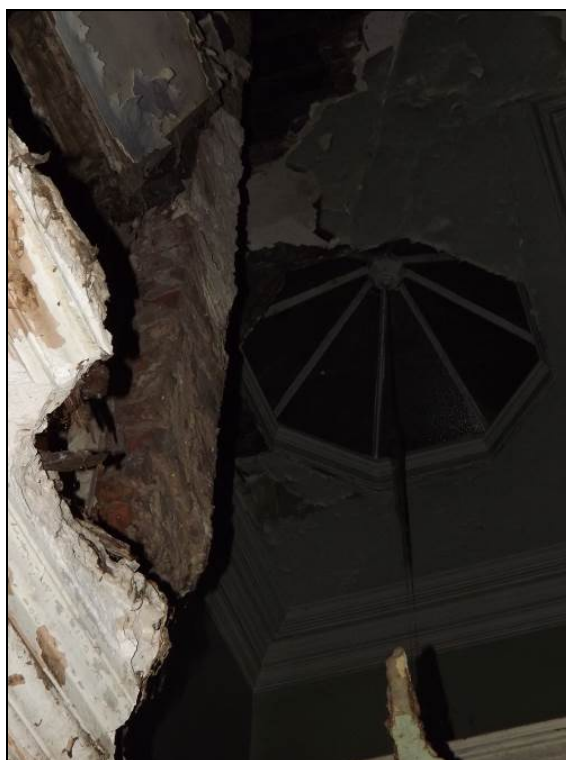
Plate 34: View of a hexagonal roof light which would have lit the first floor landing

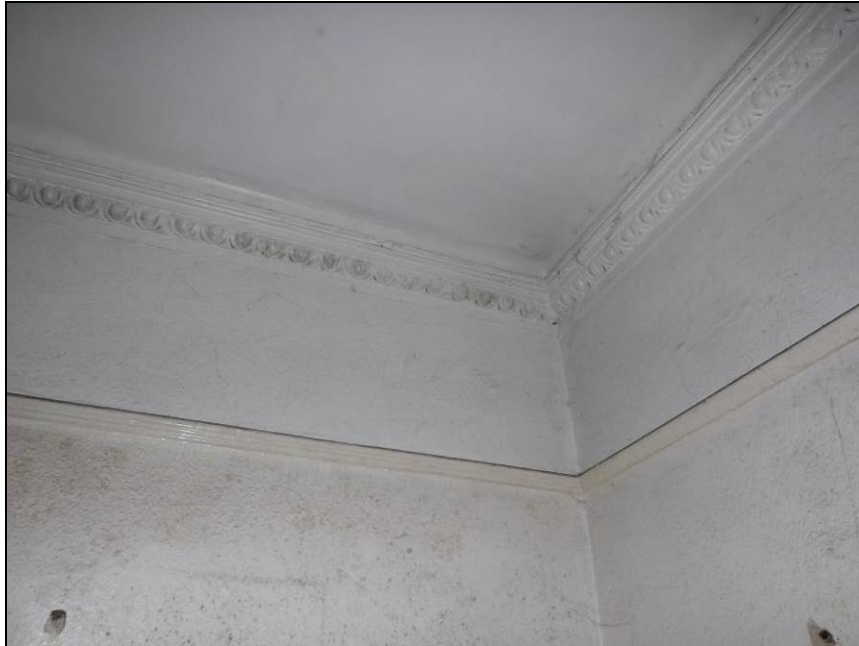
Plate 39: Detail of egg and dart coving, south-east ground floor room

- 5.3.4 From the hallway it was possible to enter a room in the south-east corner of the property. The doorway into this room from the hallway has the same decorative architrave and square panels as noted in the vestibule (Plate 35). This room would have formerly had a fireplace in its south wall as shown by the projecting chimney breast, although no evidence for the fireplace itself was visible. To the west side of the fireplace is the French doors which would have provided access into the garden (Plate 36). The surround of this opening, along with the surround of the window in the east wall and the doorway leading into the hallway, all have the same decorative architrave and floral square panels (Plates 36 to 38); this appears to be original to the early 19th century house. The coving in this room is of egg and dart design (Plate 39). Other features of note in this room include an inserted door into the rear (west) room, and steel girders inserted below the ceiling, presumably relating to the period when the property was used as a gym.

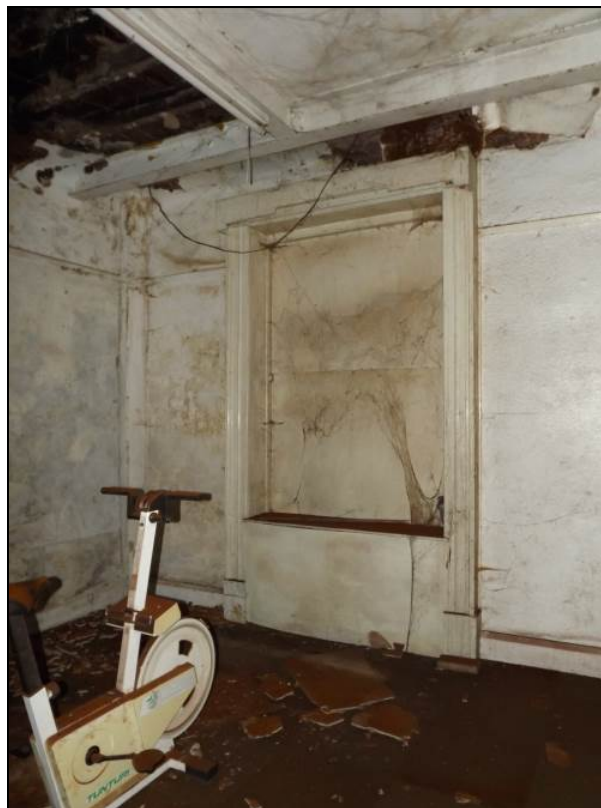
Plate 40: Original window surround, east wall of north-east room

- 5.3.5 The only other room that could be accessed was that to the north side of the hallway, located in the north-east corner of the house. No architectural detailing appears to have survived within this room apart from the architrave and surround of the window in the east wall (Plate 40).

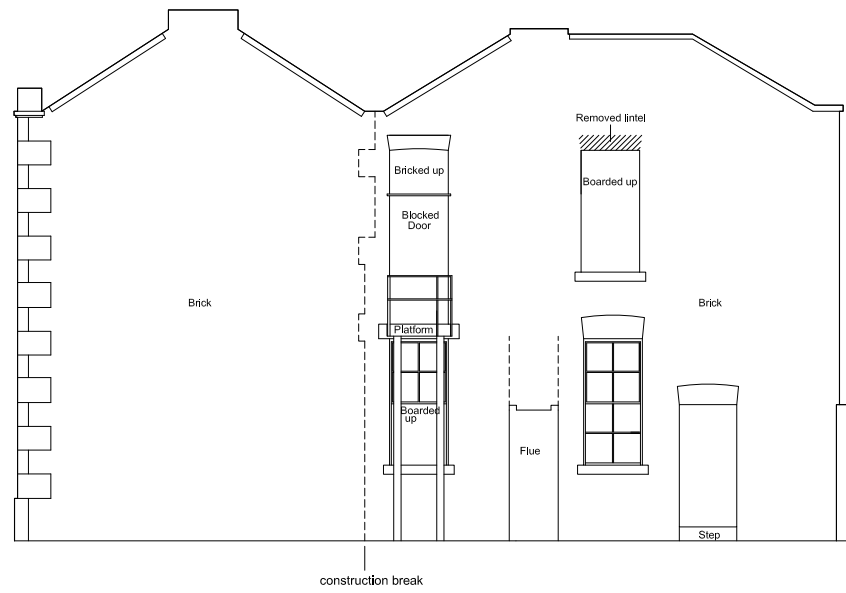
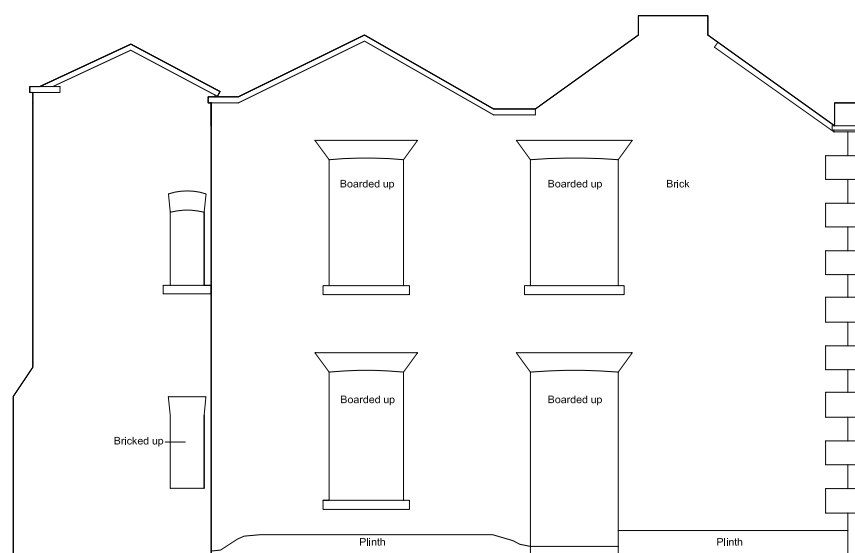
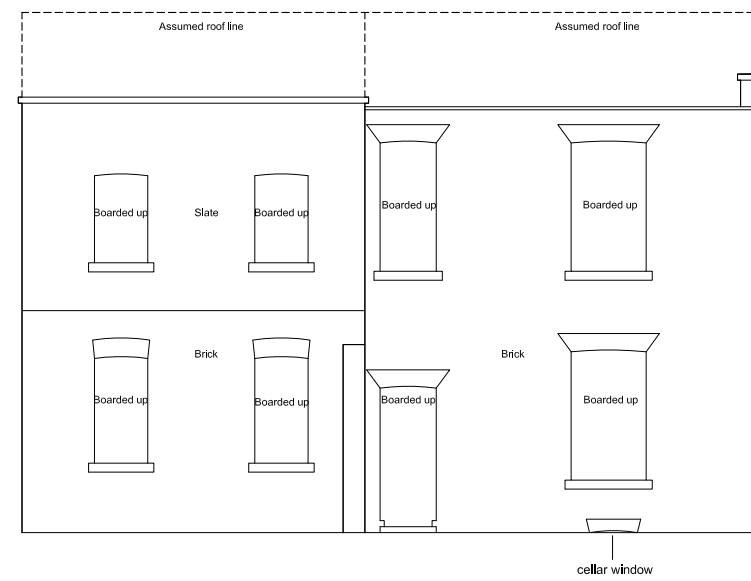
Figure 8: Existing elevations.

North elevation.

East elevation.

South elevation.

West elevation.
