Assessment Report 934c.1

Assessment Report of Archaeological Evaluation at 29 - 65 Garden Street Sheffield, South Yorkshire

May 2007

Prepared For:
Merlin Estates
194 Crookes
Sheffield
South Yorkshire
S10 1TG

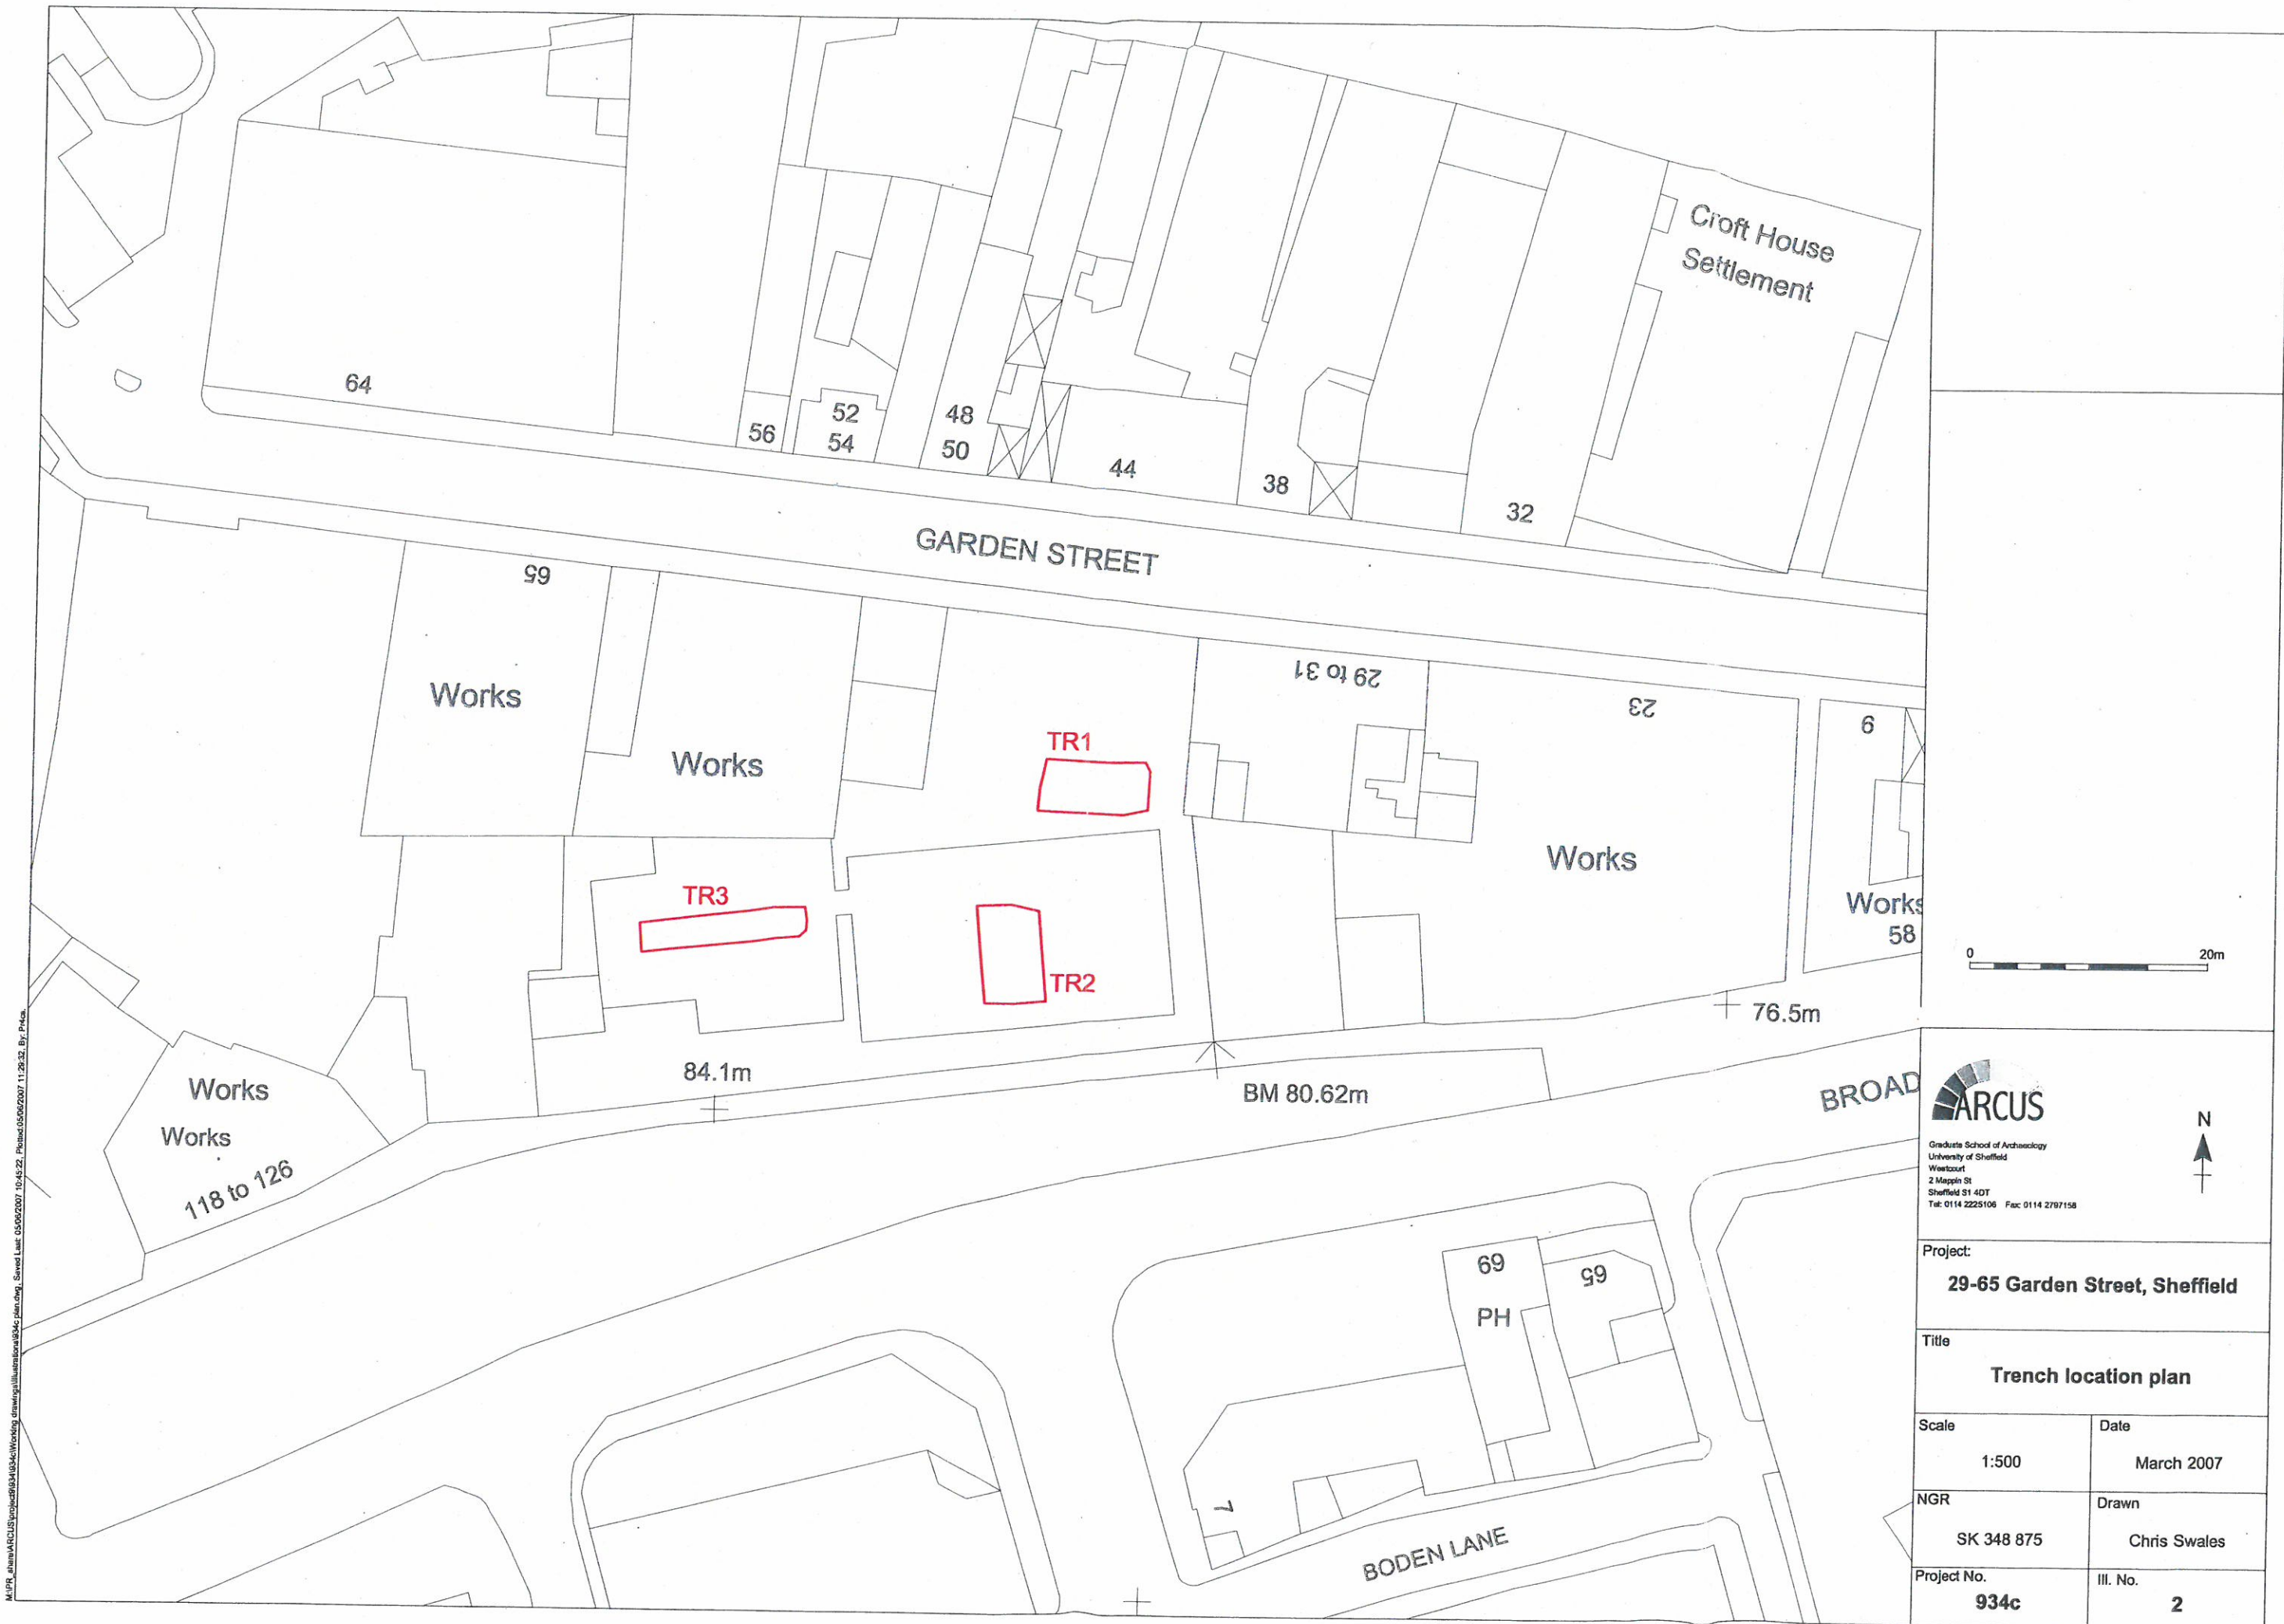
Graduate School of Archaeology University of Sheffield Westcourt 2 Mappin St Sheffield S1 4DT Tel: 0114 2225106 Fax: 0114 2707158	Project:	29-65 Garden Street, Sheffield		Scale	Date
	Title	Location of areas A-E and evaluation trenches		NGR	March 2007
				Project No.	Drawn
				934c	Chris Swales
					Illustration No.
					3

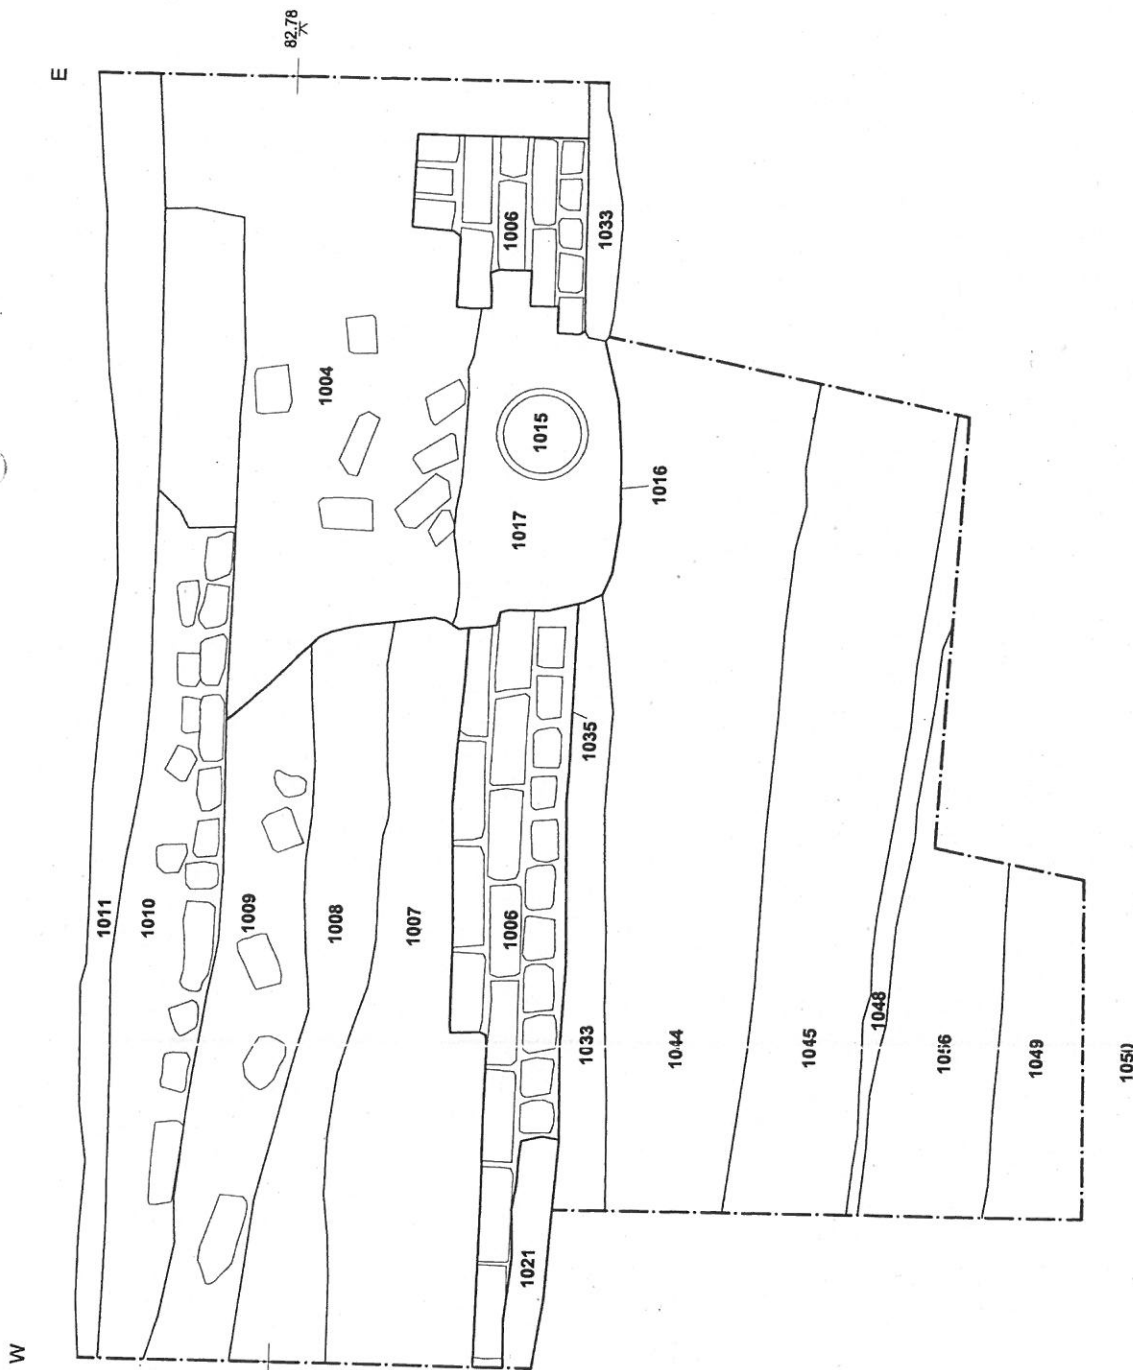
Project:		Scale	Date
29-65 Garden Street, Sheffield		1:20	March 2007
Title		NGR	Drawn
South facing section at west end of trench 1		SK 348 875	Chris Swales
		Project No.	Illustration No.
		934c	6

The earliest deposit identified, interpreted as a natural geological layer (1050), was observed in the base of a machine slot excavated towards the western end of the trench against the south facing section. Deposit (1050) was located 2.65 m below the surface of the trench (**Illustration 6**).

The earliest archaeological phase was represented by a remnant of a possible buried subsoil horizon (1049) that lay immediately above (1050) (**Illustration 6 and Plate 2**). Deposit (1049) consisted of pale reddish brown silt with inclusions of occasional charcoal flecks and sub-angular sandstones. Above (1049) was a greyish silt (1056), possibly a buried topsoil horizon. Also assigned to this phase was deposit (1055), similar to (1049), seen below a later levelling layer (1052) at the southern extent of the trench.

A second phase of activity was initially represented by deposit (1056), a possible levelling layer that overlay (1049) (**Illustration 6**). Deposit (1056) was 0.34m in depth and contained occasional handmade brick and charcoal fragments.

Perhaps contemporary with walls (1028), (1029) and (1031), was a possible surface of compacted clinker (1048) that overlay deposit (1056) within the sondage at the north-western end of the trench. Deposit (1048) was up to 0.06m in depth and a number of clay tobacco pipes were recovered from this context (**Illustration 6**).

Visible in the north-facing section was a north to south running brick wall (1005) (**Illustration 6**). Its sandstone foundation was observed sitting atop concrete surface (1021). Wall (1005) was double skinned and its ten visible courses were made from machine pressed frogged bricks (average dimensions: 0.23m x 0.11m x 0.09m) bonded with black ash mortar. The wall had been truncated to the north. In the south-facing section, wall (1006) partly overlay and abutted concrete surface (1021) at the western end of the wall. Wall (1006) was 3.24m long and up to five courses high, and was constructed of machine pressed bricks (Average dimensions: 0.24m x 0.12m x 0.09m) bonded with black ash mortar. At the eastern end of wall (1006) there may have been a return running northwards. Walls (1006) and (1005) were likely to be contemporary and may have formed part of the same structure (**Illustration 6**).

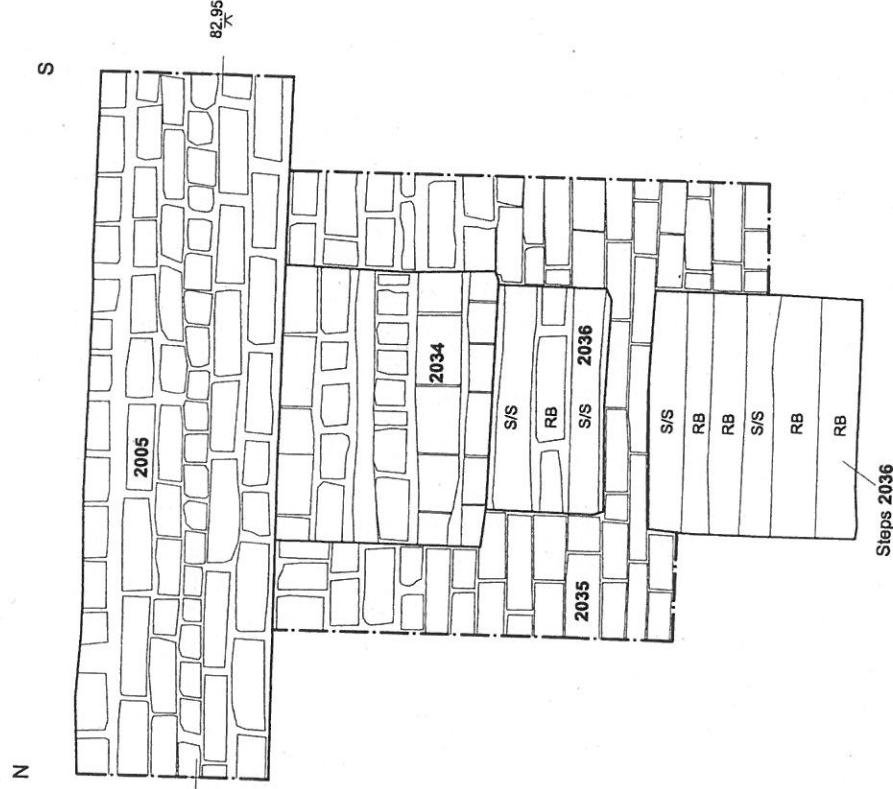
Title: West facing elevation of wall
[2005] and structures [2034],
[2035], [2036].

The opening within wall (2035) was blocked by six courses of handmade bricks (average dimensions 0.22m x 0.12m x 0.08m) bonded with black ash mortar. The upper courses of wall (2035) must have been truncated since the doorway only survived to a height of 0.56m. The remaining courses of (2035) were then used as the foundation for the construction of wall (2005) which followed the same north to south alignment as (2035) (**Illustration 9 and Plate 3**).

Wall (2005) was a double-skinned wall and measured 4.42m in length (**Illustration 9**). Six courses of handmade bricks (average dimensions: 0.23m x 0.12m x 0.08m) bonded with black ash mortar survived. Roughly built, the courses were laid in a fairly random manner using a mixture of headers, stretchers and possibly reused bricks. At the northern end of (2005), a double-skinned brick wall (2023) running east to west was keyed into the western face of (2005). Bonded with black ash mortar, wall (2023) survived to a maximum length of 0.26m, including the sandstone block foundation. No cutting for (2023) was found. The function of this wall could not be ascertained and further excavation was impeded by the stepping of the trench. However (2023) may have been an external wall fronting onto a courtyard, possibly Court No. 20 as shown on the 1890 OS map (**Illustration 4**).

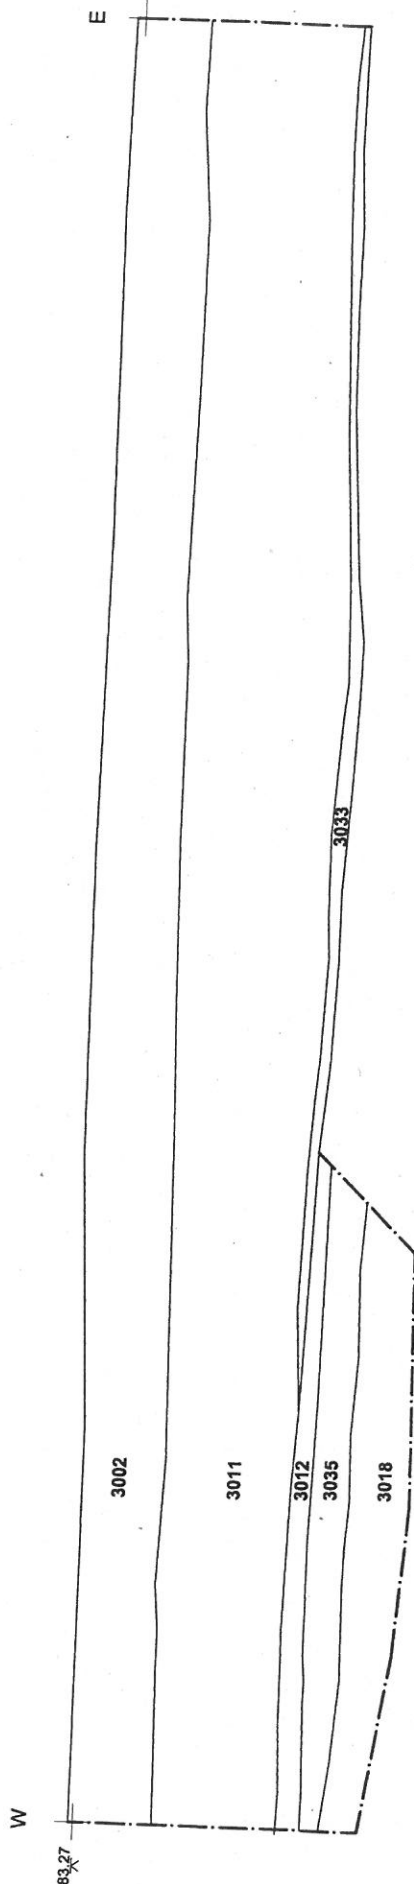
Natural geology was observed in two machine slots in the central area of the trench (3018) and at its western extent (3010). Both deposit (3018) and (3010) consisted of brownish orange sand with stratified sub-angular sandstones. Deposit (3018) was 0.7m below the surface of the trench and (3010) was at a depth of 0.8m. (**Illustrations 10 and 11**).

At the eastern end of Trench 3, the final phase of activity comprised of a levelling layer (3011), 0.52m in depth and consisting of demolition rubble, handmade and machine-made frogged bricks and redeposited natural sand. The deposit was observed to extend across the entire length and width of the eastern part of the trench covering all structures. Overlying (3011) was a reinforced concrete floor, (3002), 0.30m in depth, which extended over the entire eastern end of the trench and formed the floor in the eastern side of the current works building (**Illustration 11**).

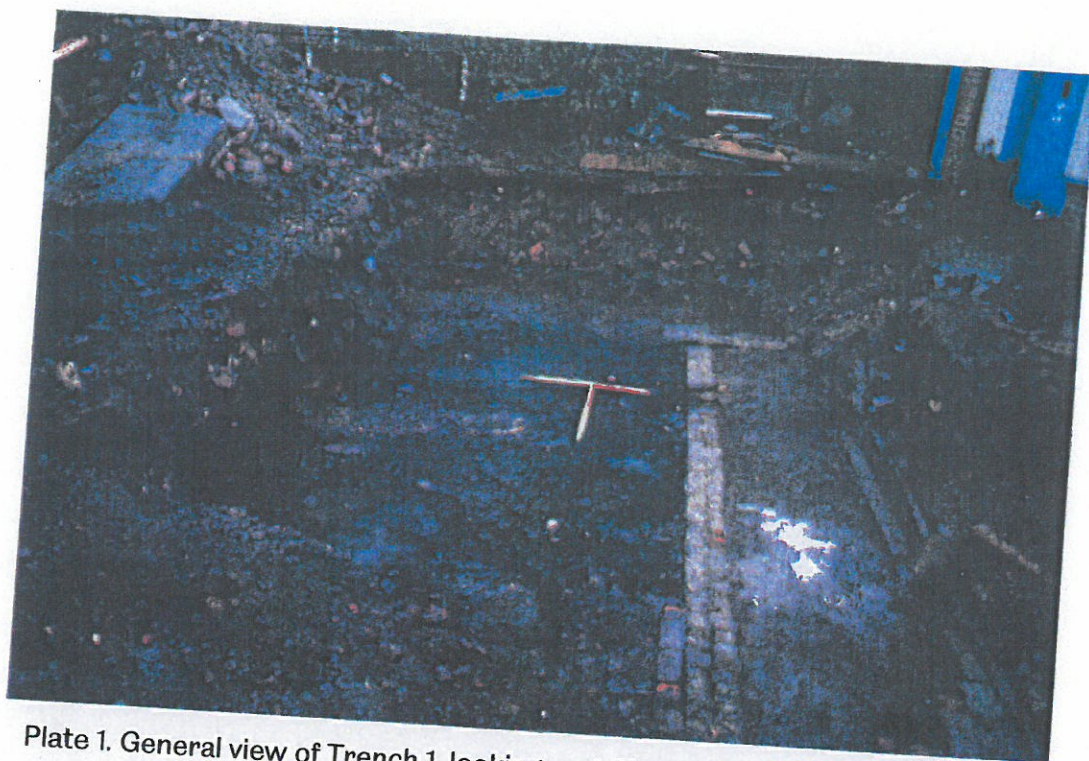
Plate 1. General view of Trench 1, looking east. Wall (1028) is in the foreground.

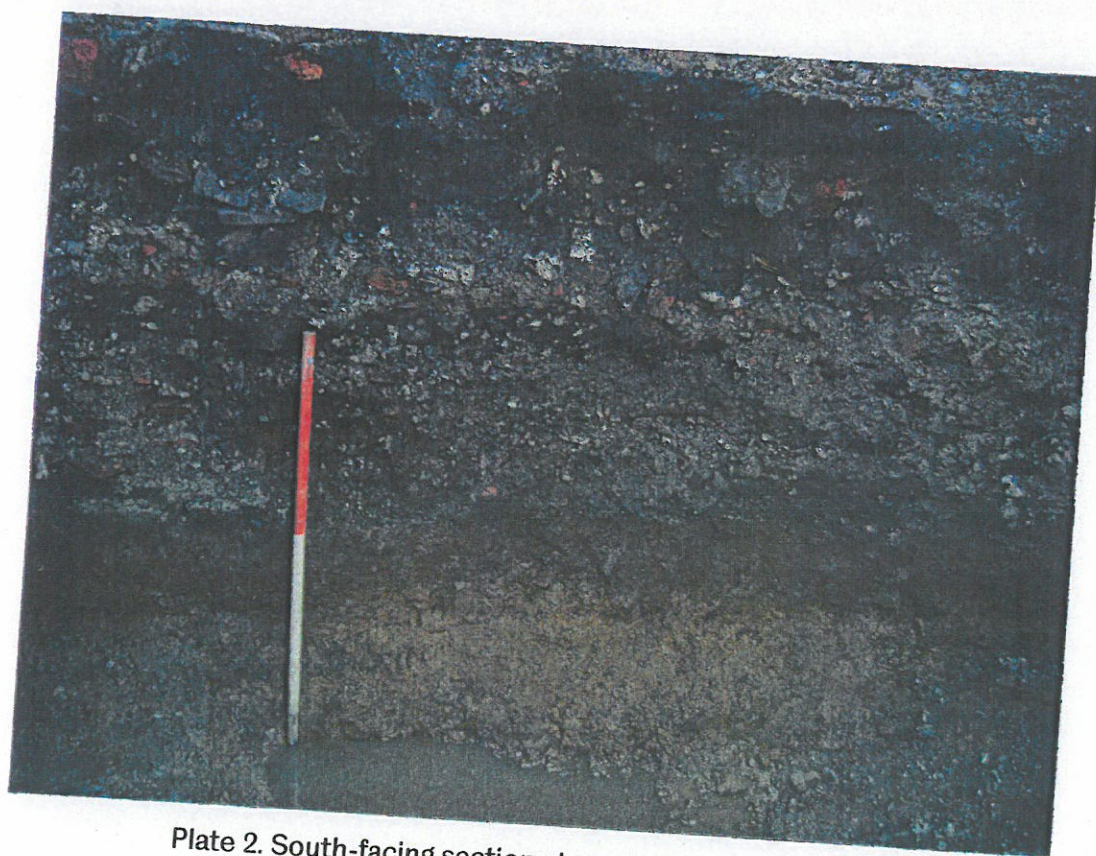
Plate 2. South-facing section at western end of Trench 1

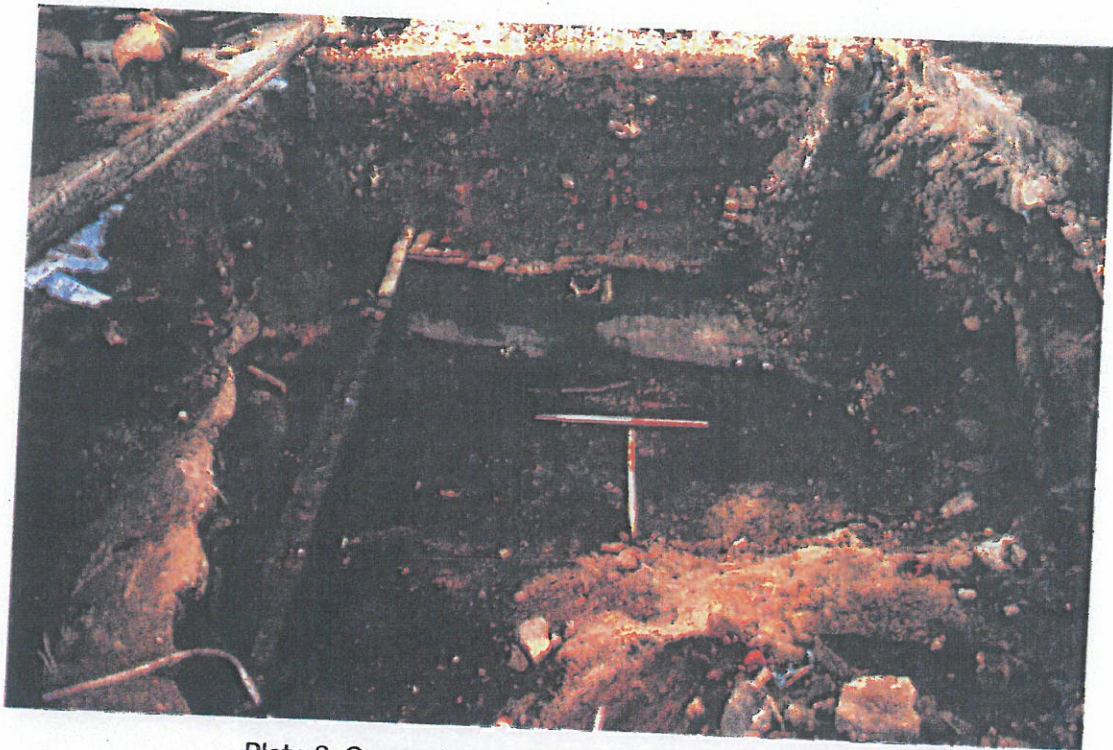
Plate 3. General view of Trench 2 looking south

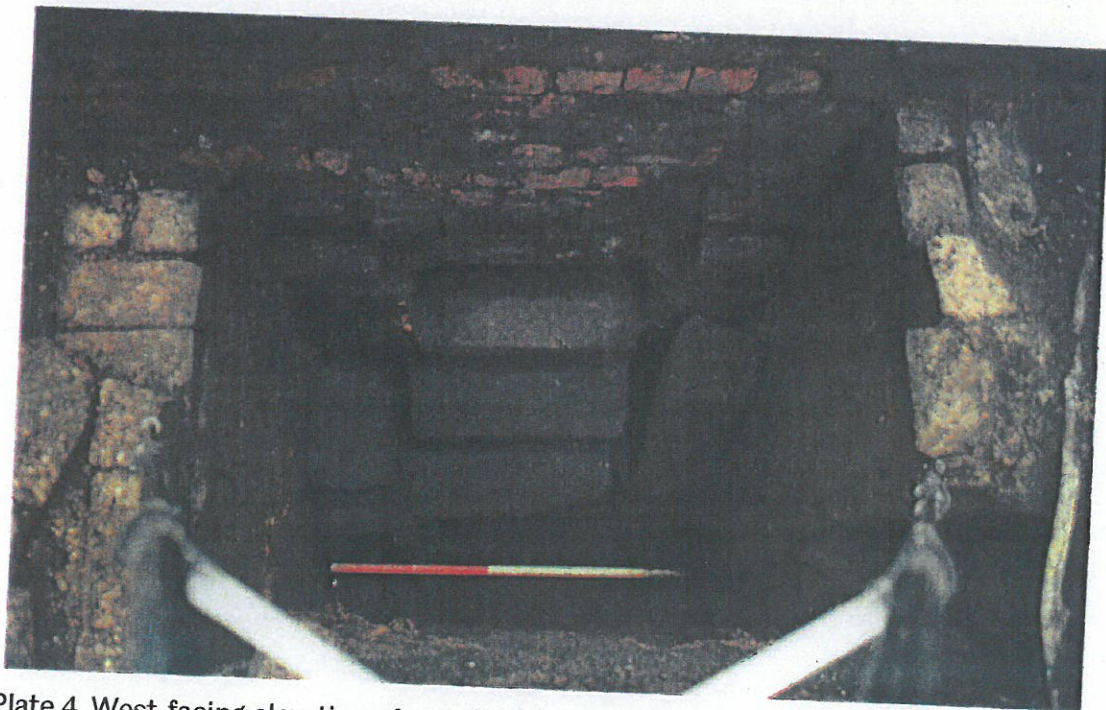
Plate 4. West-facing elevation of wall (2005) and structures (2034), (2035) & (2036)

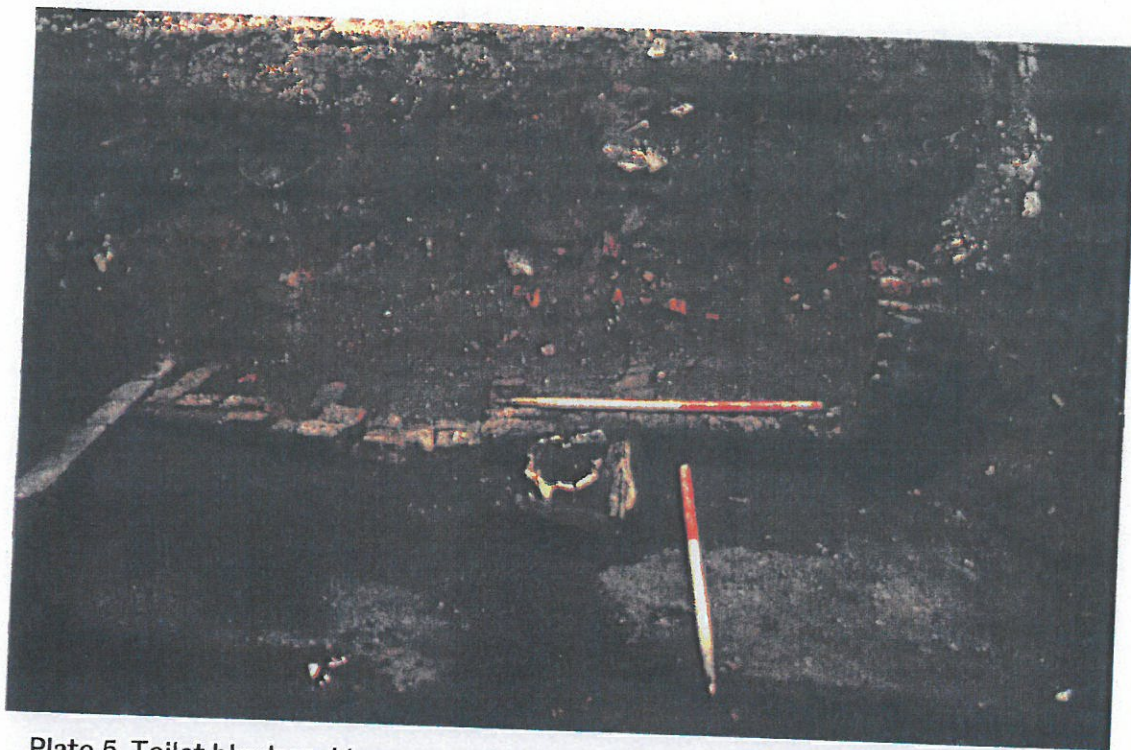
Set within the southern part of the tarmac (2009) was a ceramic drain (2010) and four sandstone slabs (2011) (**Illustration 8 and Plate 5**). The largest slab lay to the west of the drain and measured 0.58m x 0.46m. The two largest slabs may represent the remains of a sandstone yard surface later replaced by (2009). The two remaining slabs (2011) and a small piece of associated concrete were set upright to the west and south of the drain and may have formed a 0.20m high box around it.

Plate 5. Toilet block and tarmac surface at southern end of Trench 2 looking south

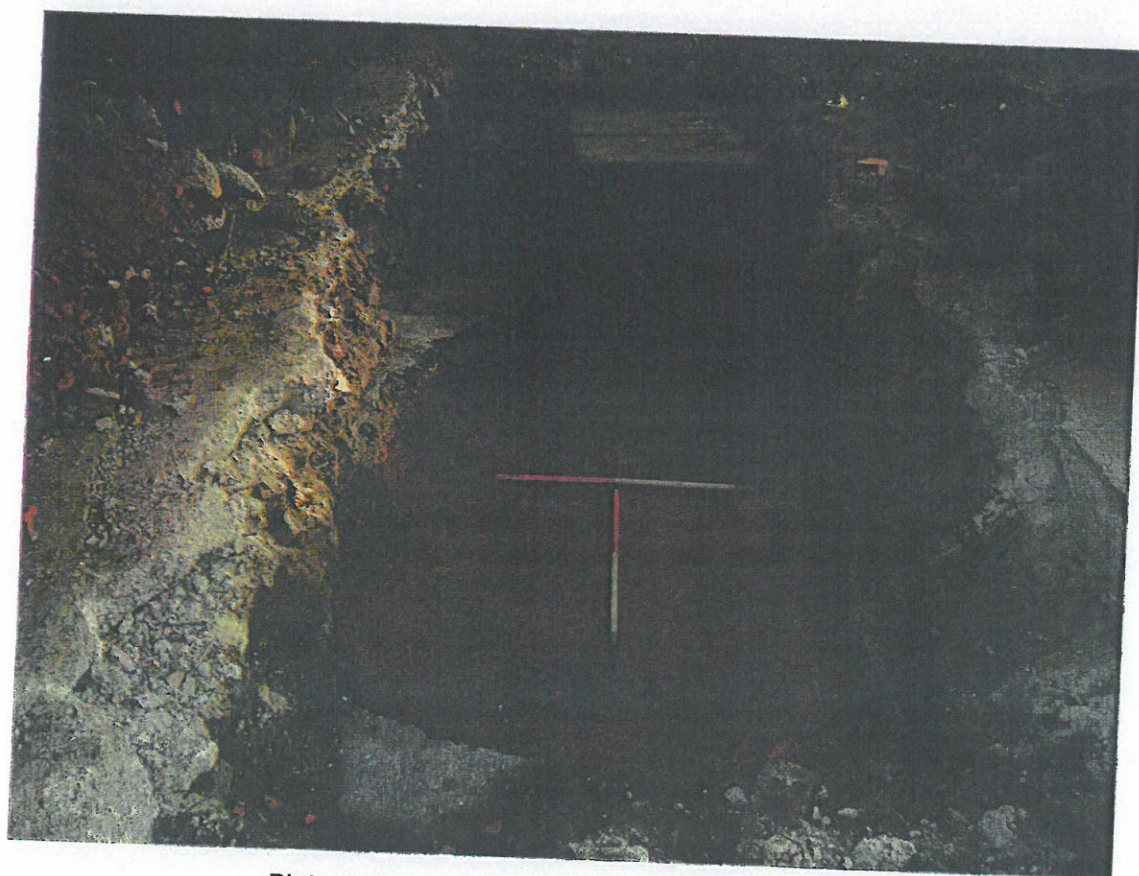
Plate 6. General view of Trench 3 looking east

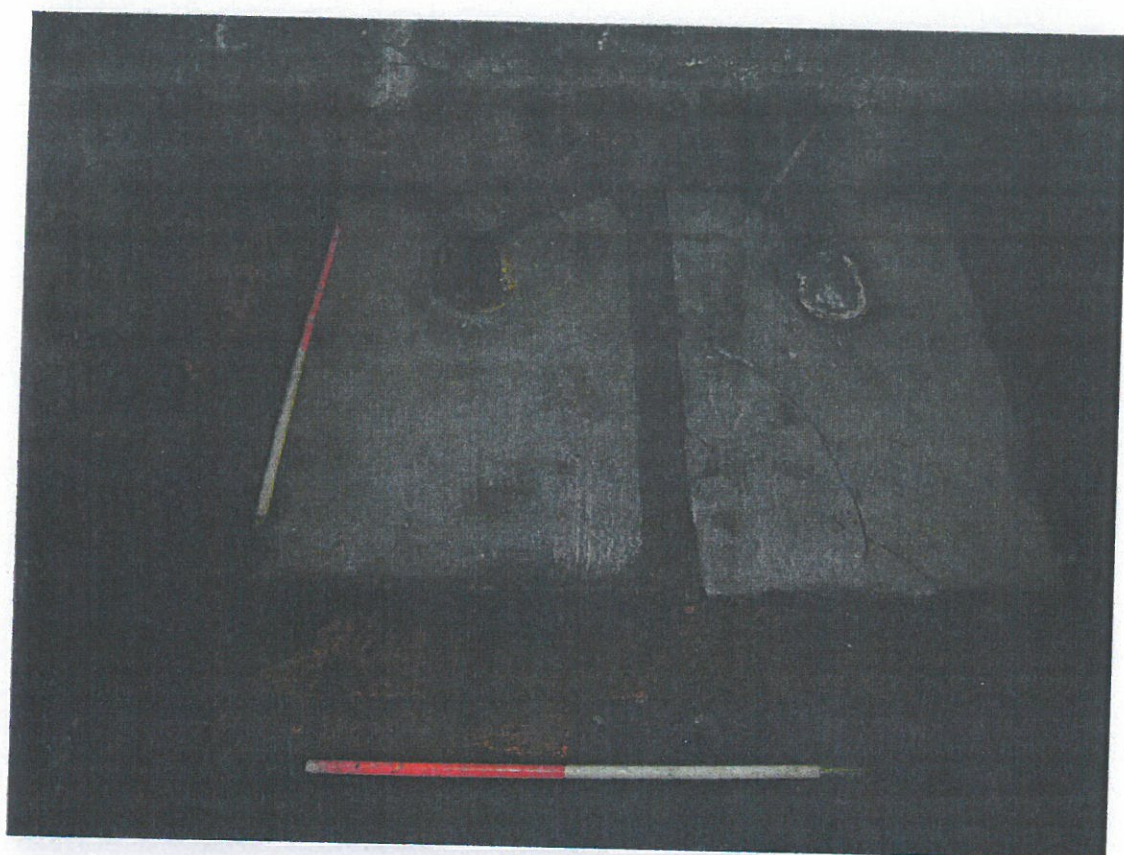
Three closely set concrete bases (3020) located at the eastern end of the trench, each measured 0.90m by 1.35m and all displayed traces of ceramic drains and toilets. They were bedded on top of a gritty sand and rubble layer (3023). To the east of (3020), a damaged brick stretcher bonded single-skin wall (3021) ran north to south and probably formed the eastern wall of the toilet block. It measured approximately 1.9m long and was made of handmade bricks measuring 0.23m x 0.11m x 0.075m. The three surviving courses were bonded with a black ash mortar. At its northern end, the presence of an industrially pressed rectangular frogged brick suggests that the wall may have been extended and later truncated. No cut for wall (3021) was visible. Between wall (3021) and the eastern-most concrete base (3020) lay brick structure (3024), a single course of half-bricks some of which were frogged. They were bonded with a concrete mortar. Structure (3024) seems to have filled the gap between the older wall (3021) and the concrete toilet base (3020). The north-western end of wall (3021) was abutted by (3022), a single coursed area of handmade bricks laid on bed and bonded with the same mortar as that used in (3024). Structure (3022) was truncated at its western end and may have functioned as a support for a later removed drain leading from the toilets (**Plate 7**).

Plate 7. Concrete base of toilet block (3020) looking south

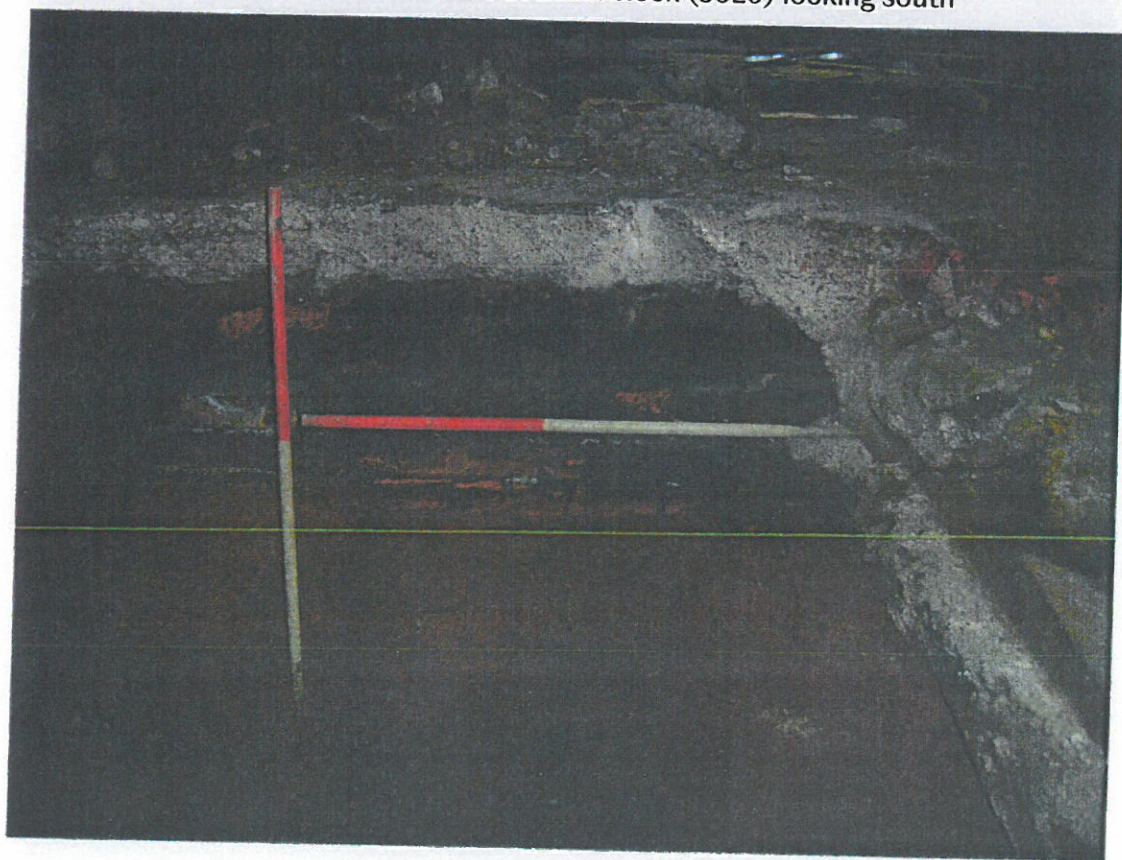
Plate 8. Wall (3008) looking north
