**LAND AT TULIP'S HAULAGE YARD,
HEDDON-ON-THE-WALL,
NORTHUMBERLAND**

ARCHAEOLOGICAL EVALUATION REPORT

CP. No: 11129/14

11/12/2014

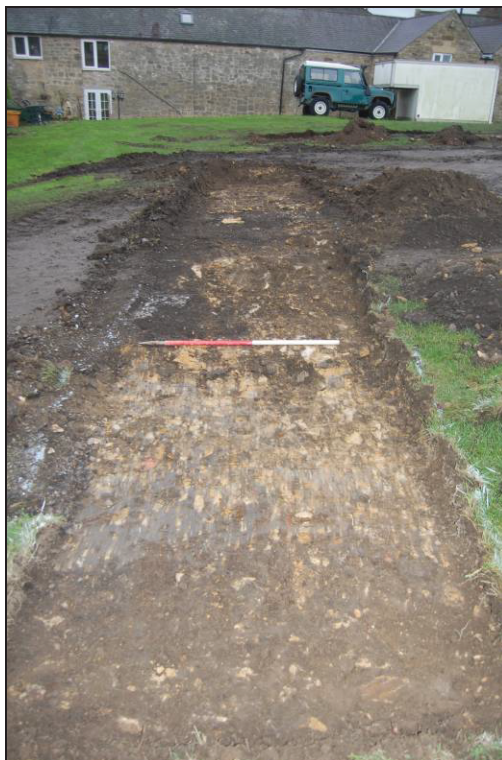
Plate 1: Trench 2, facing south-southwest

- 4.2.2 **Trench 2:** Trench 2 was located along the northern boundary of Area A, approximately 10m east of Trench 1 and on the proposed line of Hadrian's Wall. The north-northeast to south-southwest aligned trench measured 10m in length, 1.6m in width and was excavated to a maximum depth of 0.2m, revealing solid sandstone bedrock **(101)** below c.0.1m of dark brown clayey silt topsoil and hardstanding **(100)** (Plate 1).

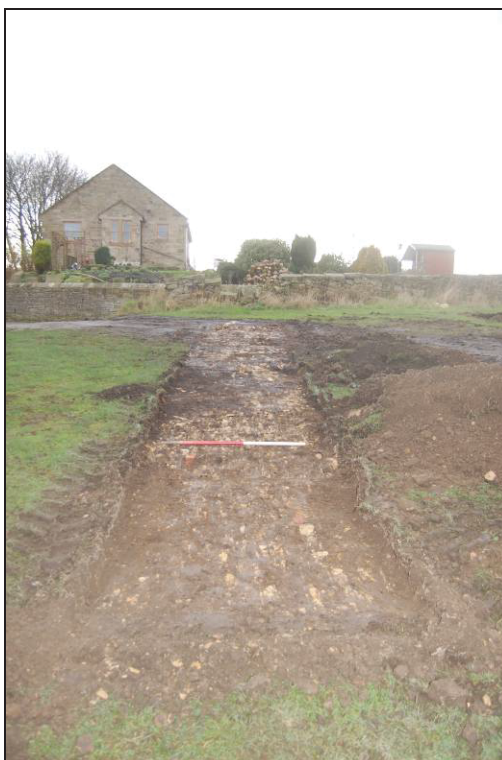
Plate 2: Trench 3, facing west-northwest

- 4.2.3 **Trench 3:** Trench 3 was located centrally within the western half of Area A, approximately 7m south of Trench 2 and situated between the proposed routes of Hadrian's Wall and the vallum. The east-southeast to west-northwest aligned trench measured 10m in length, 1.6m in width and was excavated to a maximum depth of 0.2m, revealing solid sandstone bedrock **(101)** below c.0.1m of dark brown clayey silt topsoil **(100)** (Plate 2).

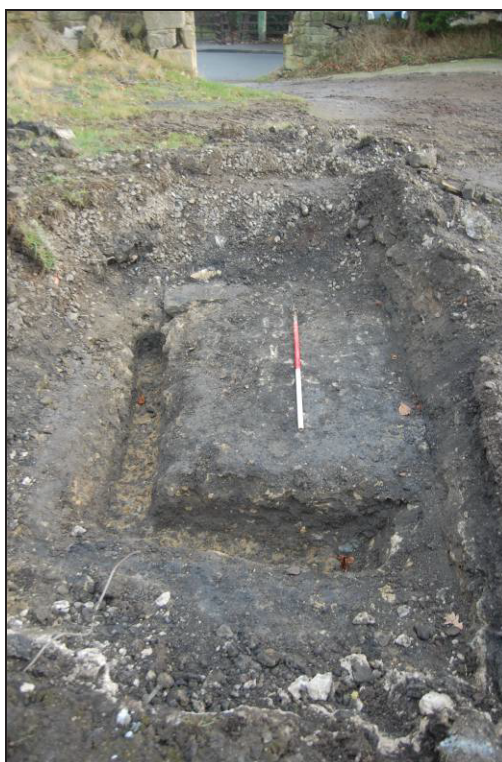
Plate 3: Trench 5, facing east-southeast

4.2.6 **Trench 5:** Trench 5 was located towards the northeast corner of Area A, approximately 12m east of Trench 4 and on the proposed line of Hadrian's Wall. The trench measured 3m² and was excavated to a maximum depth of 0.9m, revealing the natural drift geology (**201**) which was comprised of firm yellow clay. The natural clay was sealed by a 0.15m deposit of dark grey redeposited clay (**104**), which included modern waste and had probably been used to level out the area. This was further sealed by 0.2m deposit of solid fragments of yellow sandstone (**103**), many of which appeared to have been worked including a large faced block. It is likely that this deposit of fragmented stone was used to further level out the area following the demolition of a building which is present in the same location on the First, Second and Third Edition OS Maps. The fragmented sandstone deposit was below a c.0.35m deposit of ash and modern waste (**102**), and c.0.2m of hardstanding (**100**) (Plate 3).

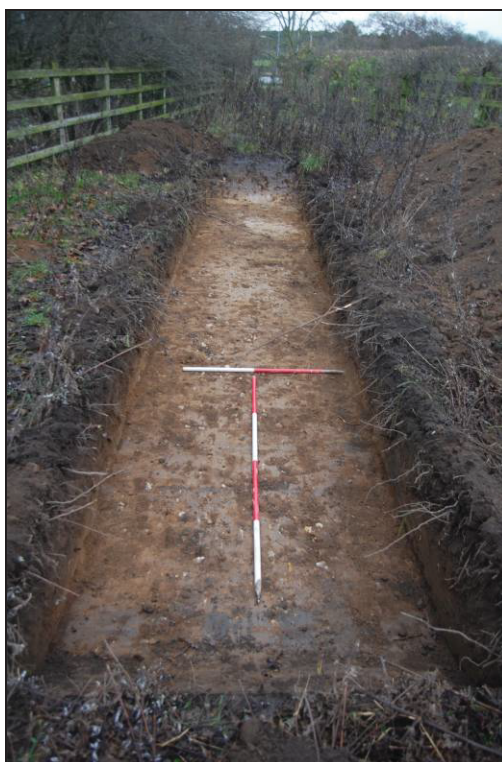
Plate 4: Trench 7, facing east-southeast

4.3.2 **Trench 7:** Trench 7 was located within the eastern half of Area B, approximately 17m east of Trench 6 and approximately 25m north of the proposed line of Hadrian's Wall. The west-northwest to east-southeast aligned trench measured 10m in length, 1.6m in width and was excavated to a maximum depth of 0.7m, revealing the natural drift geology **(201)**, which was sealed by c.0.25m of mid-brown clayey silt subsoil **(202)** and c.0.15m of dark brown clayey silt topsoil **(200)** (Plate 4).
