107-117 BOTCHERGATE, CARLISLE, CUMBRIA

Historic Building Survey

December 2014

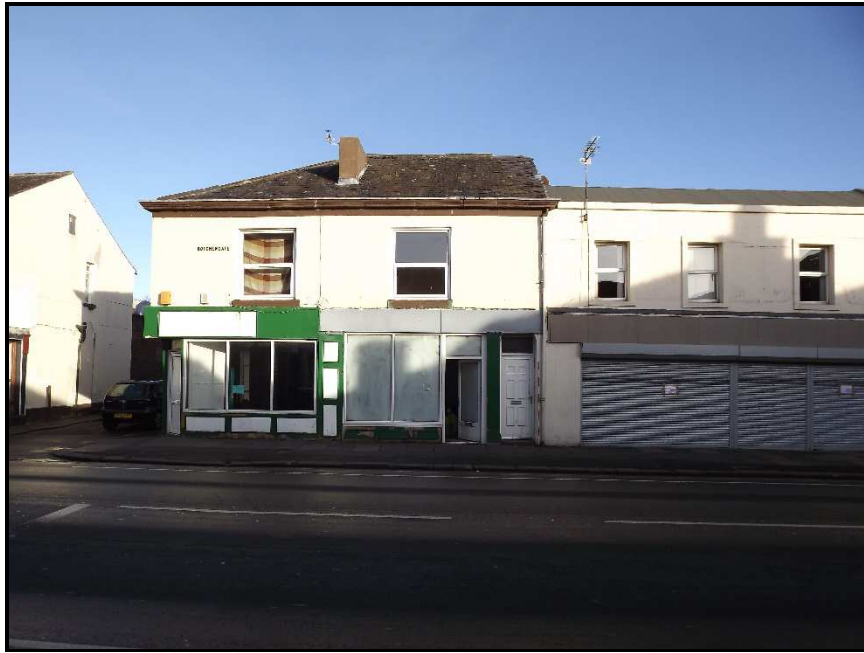
Plate 6: South-west elevation of No's 107-111 Botchergate

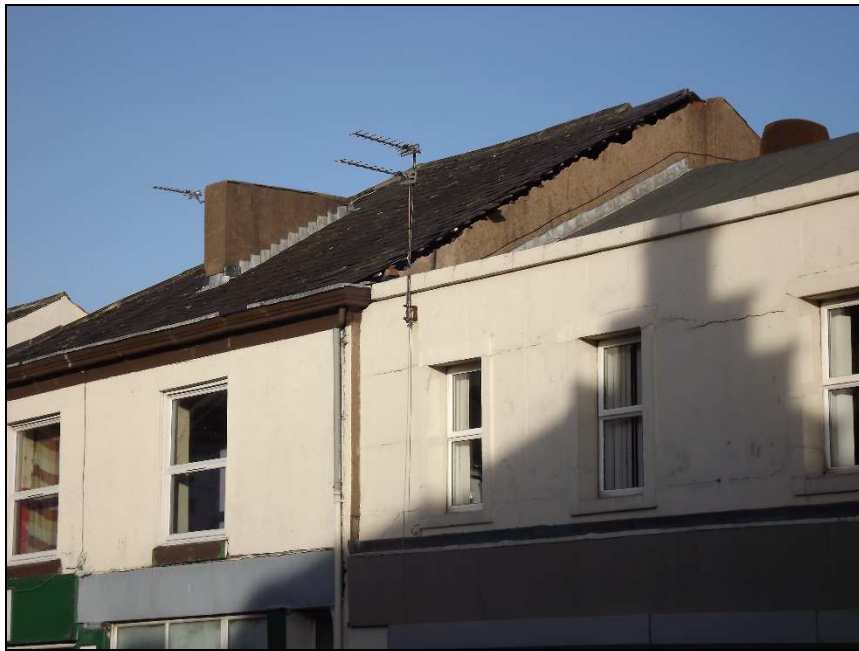
Plate 10: Detail of change in roofline between No's 107-111 (left of photograph) and No's 113-117 (right of photograph)

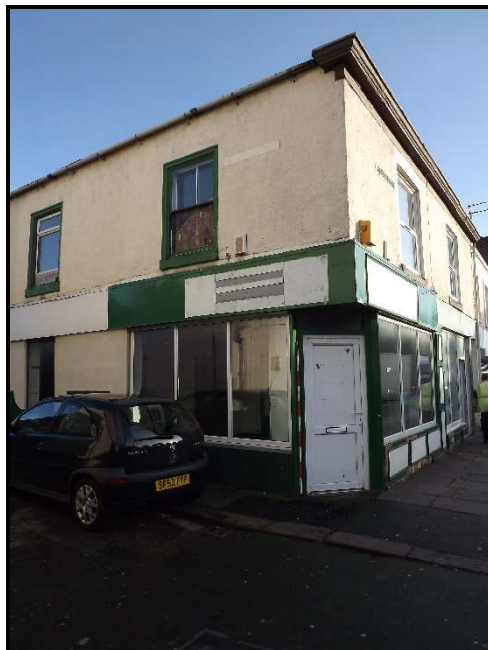
Plate 11: Door into No.107 on the corner of William Street and Botchergate

- 3.10 The interior of No.107 Botchergate was accessed from the angled doorway on the corner of William Street and Botchergate (see Plate 11). It was noted that at ground floor level there was no access into the interior of No.109/111, indicating that in their most recent form, the properties were separate businesses. It was also noted that from the interior of No.107 there was no access to the first floor of the linear range which extends north-eastwards towards William Street Car Park; access to this floor was noted to be through a staircase that had been inserted in an addition in the small yard (see Plate 21).

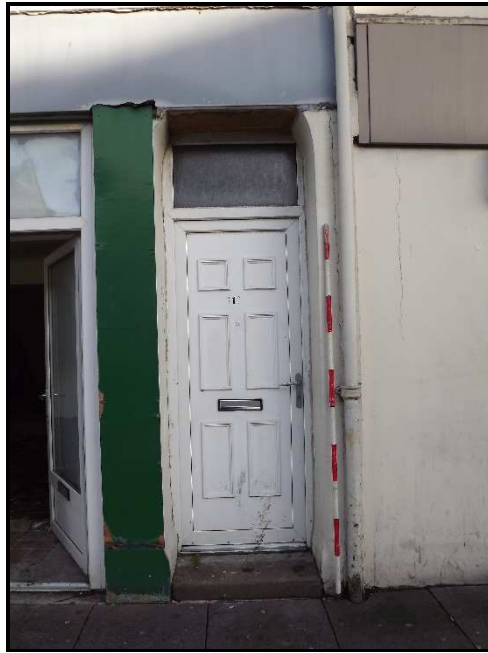
Plate 12: Doorway to the first floor above No's 107-109 (No.111), south-west elevation facing onto Botchergate

another doorway with arched head which now provides access to the first floor above No's 107 and 109/111 only, indicating that the upper floor was under separate occupancy, and was presumably residential rather than retail in character (Plate 12). This doorway was certainly in existence in the 1960s as it is shown on a photograph of 1961 (see Plate 1); however it is unclear if it is original to the properties. It may have been inserted at a later date when the division between ground floor retail space and upper residential space was made. It does not appear to represent a former passageway from Botchergate to rear residential courts, as a passage is not shown at this location on historic maps (see Figure 7 for example).

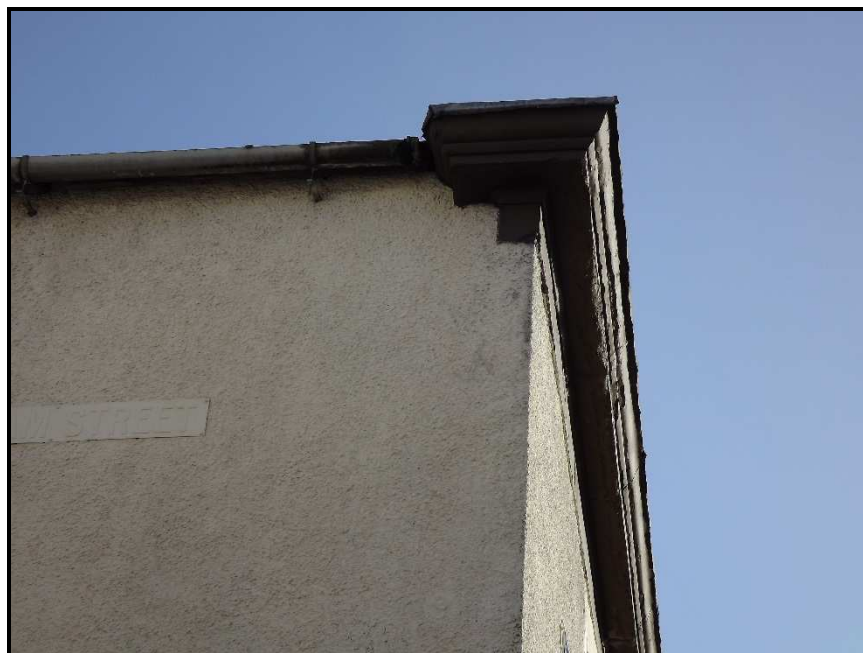
Plate 13: Detail of moulded guttering, south-west elevation of No's 107-111 Botchergate

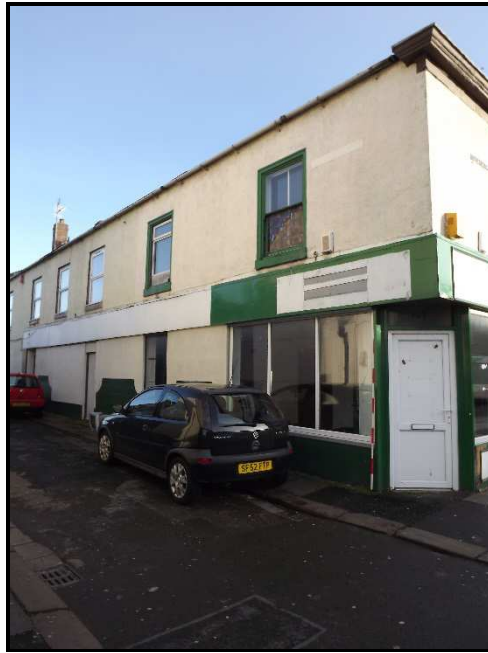
Plate 14: North-west elevation (facing onto William Street) of No.107 Botchergate

- 3.7 The William Street elevation of No.107 Botchergate is also rendered and has modern shopfronts with areas of modern shaped tiling at the base (Plates 14-16). Apart from the shopfront on the southern end of this elevation (on the corner of William Street and Botchergate) there are two windows and two doorways at ground floor level; it is difficult to assess if these are historic, although certainly the windows are both in line with those at first floor level which may suggest that they are original features. There are six windows with square heads and stone sills at first floor level. The two nearest to Botchergate still retain decorative architrave, although frames have been replaced (Plates 14 and 17). The remaining four first floor windows have lost any decorative surrounds, if they existed historically (Plate 18). It has been considered that originally, the properties along William Street (which now form the linear range of No.107), may have consisted of several separate dwellings which had one room at ground level and one at first floor level. There was no archaeological evidence noted externally for the two passageways which are shown on historical mapping to have existed from William Street to the rear yards (see Figure 4 for example).

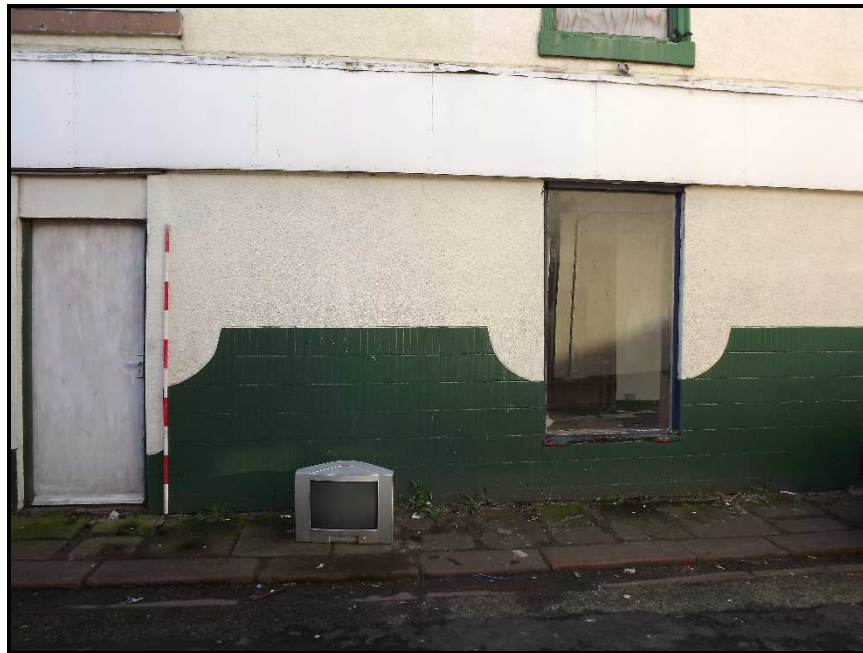
Plate 16: Detail of modern tiling on part of the north-west elevation of No.107 Botchergate (as seen from William Street) (Scale = 2m)

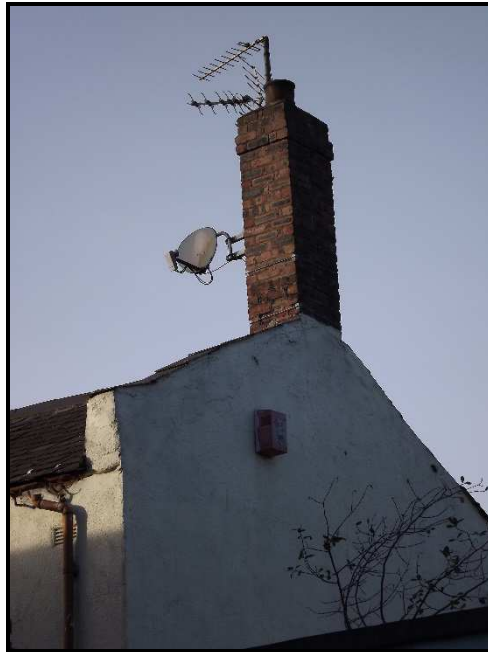
Plate 20: North-east elevation of linear range of No.107 showing parapet of gable and tall chimney stack

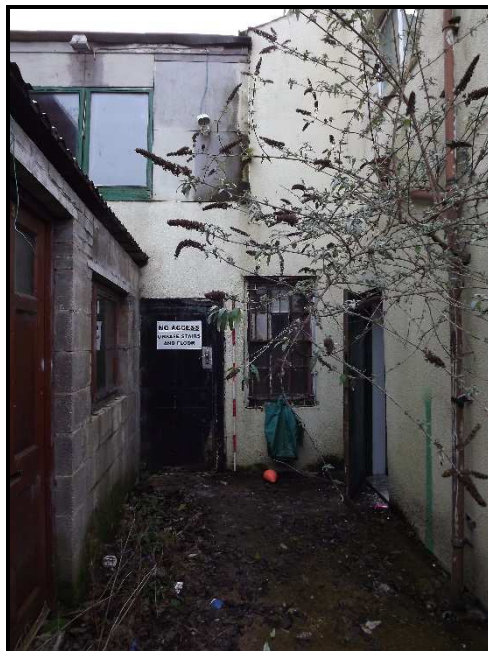
Plate 21: Small yard to the rear of No.107 Botchergate showing modern additions. Access to the first floor of No.107 was through the black doorway with the sign 'No Access'

- 3.9 The south-east elevation of the linear range that now comprises No.107 Botchergate is largely obscured by modern additions which have been constructed in the location of the earlier courts (Plate 21). From the first floor of No.109/111 it was possible to note that the south-east elevation was seemingly constructed of brick although modern windows have been inserted at first floor level, and the brickwork may represent reconstruction following these insertions (Plate 22). The only feature of note that could be observed in the south-east elevation of the linear range of No.107 is a possible original passageway doorway, which is shown on the Board of Health Map of 1853 (see Figure 4), but which has now been blocked up (Plate 23).

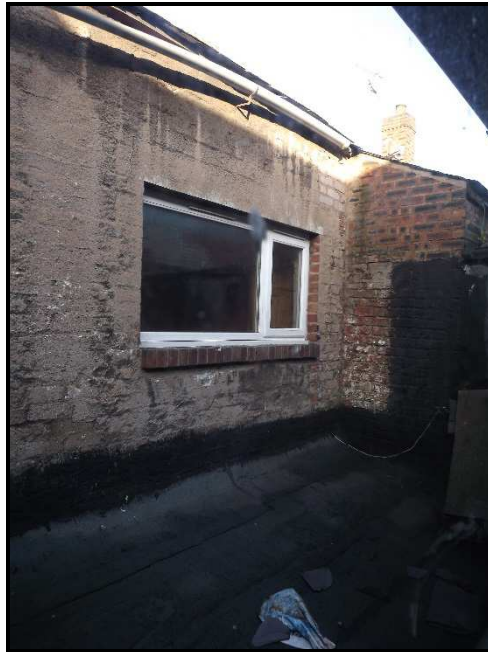
Plate 22: South-east elevation of the linear range of No.107, as seen from the first floor of No.109/111, showing modern window and brick construction

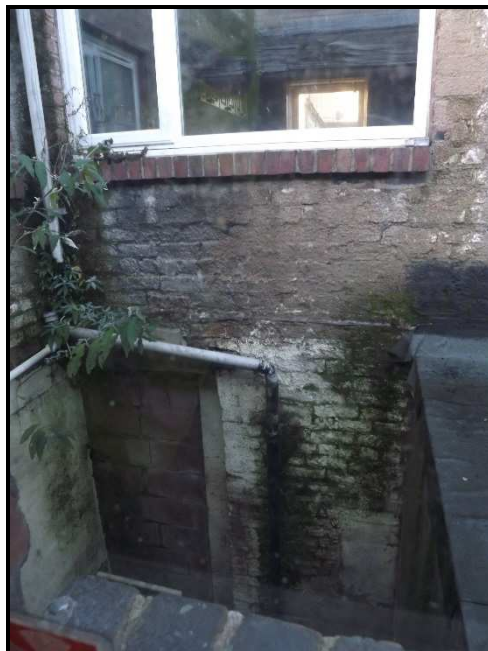
Plate 23: South-east elevation of the linear range of No.107, as seen from the first floor of No.109/111, showing blocked ground floor doorway

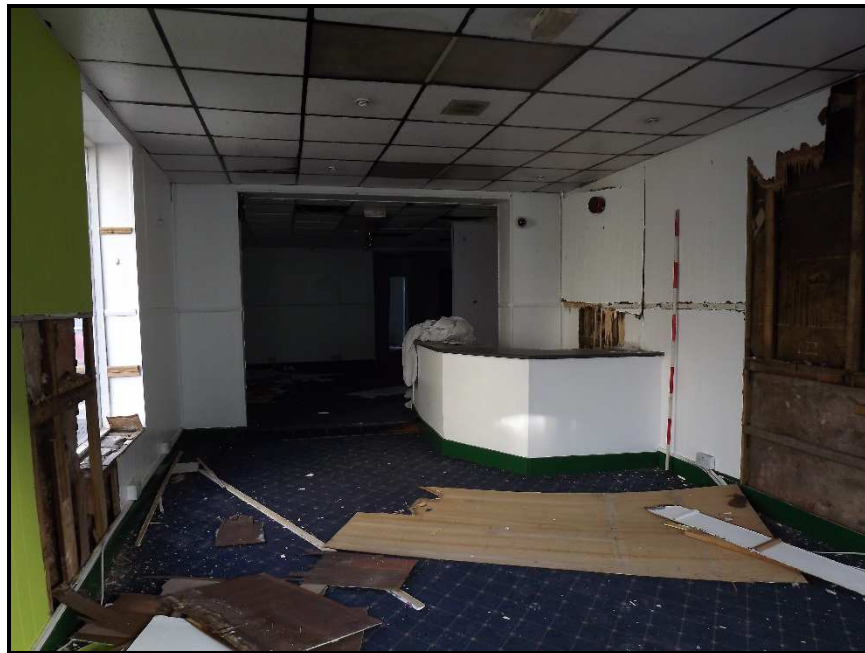
Plate 24: View looking north-east showing the interior of No.107 (Room 1)

- 3.12 Room 1, located on the corner of Botchergate and William Street, had more latterly been the public area of a shop as shown by the surviving counter (Plate 24). Features

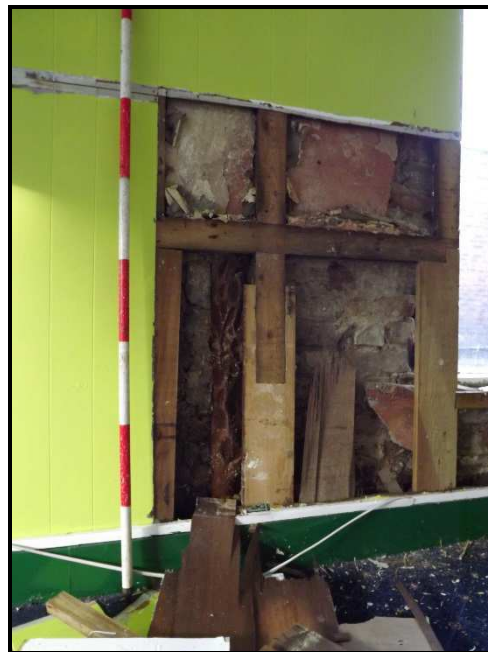
Plate 25: North-west wall of Room 1 showing sandstone door jamb behind modern studwork

of note that could be observed within Room 1 include a piece of vertical sandstone noted behind modern coverings in the north-west wall (Plate 25); this appeared to represent a former doorway, possibly for the passageway shown in this location on historical mapping to provide access from William Street to a court behind (see Figure 4 for example). It was noted that brickwork that formed the south-east wall of this room, where it could be observed, was only one skin thick which may suggest that the dividing walls between the properties were relatively thin. It must be noted, however, that later modifications may have resulted in this wall only being of this width.

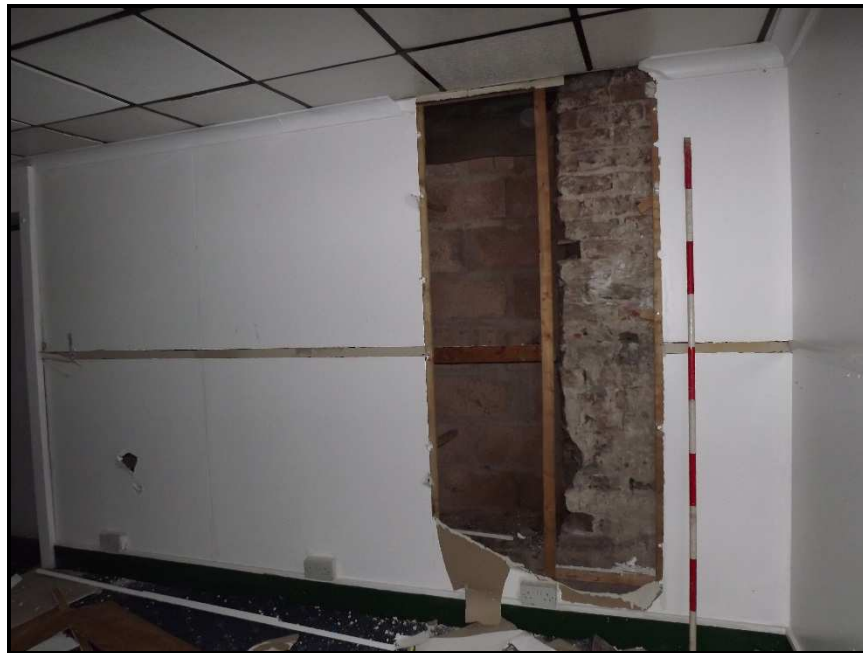
Plate 26: North-west wall of Room 2 showing truncated brickwork and blocked modern shop window (Scale = 2m)

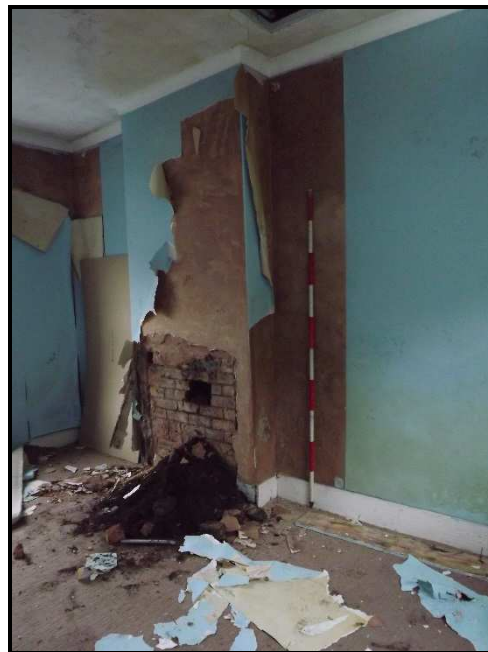
Plate 29: Former fireplace, north-east gable of first floor, No.107

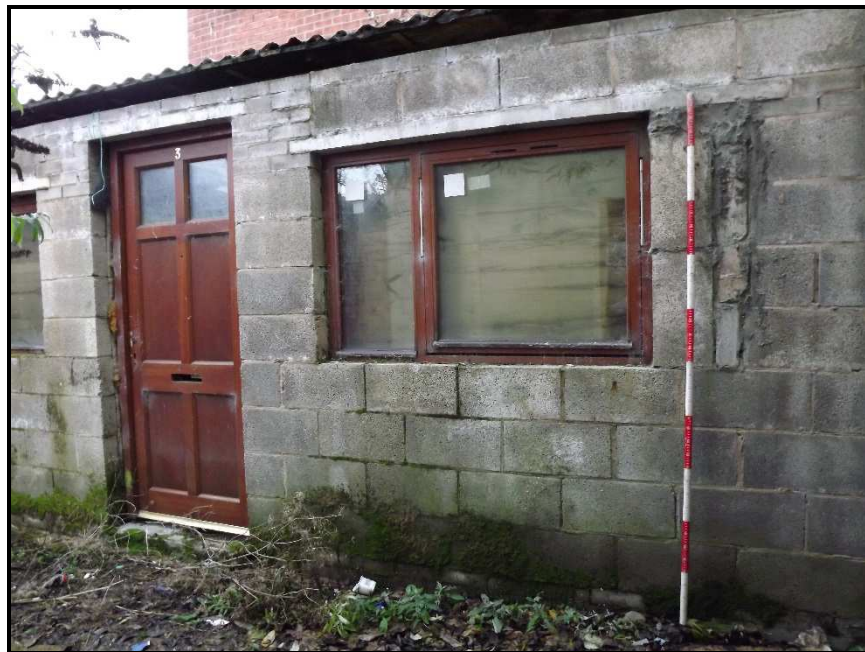
Plate 31: North-west elevation of modern concrete block extension to the rear of
No's 109/111 Botchergate

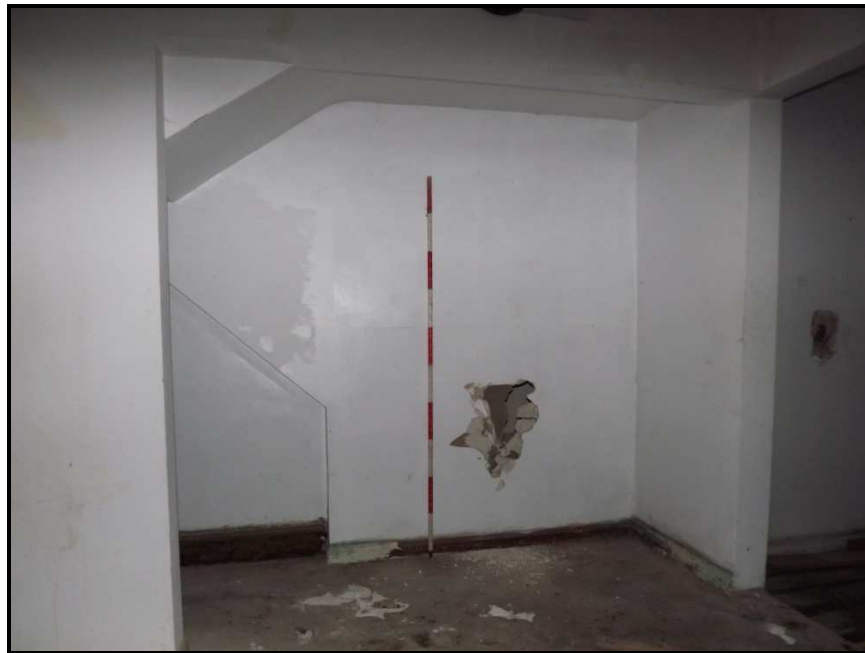
Plate 32: South-east wall of Room 6 showing outline of staircase to first floor

- 3.18 Rooms 5 and 6 would have been the main shop area in its most recent form. There was little in the way of historical features that could be observed in these rooms apart from the south-east wall which is constructed of studwork (to create the hallway for the staircase to the upper floor, accessed through the door shown on Plate 12), indicating that this is not the original or an historical dividing wall. The north side of the staircase to the first floor is visible in the south-east wall of Room 6 (Plate 32). It is possible, however, that the staircase, which will be discussed below, is in an original position. There was no evidence for a cellar below the floor of Room 5 as a test pit excavated to assess the archaeological potential did not reveal any voids.

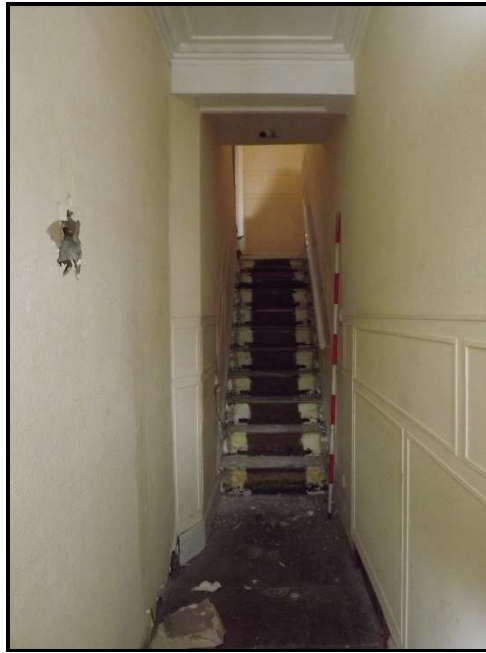
Plate 36: View looking north-east showing the hallway and staircase to the first floor of No.109/111 Botchergate

- 3.21 The first floor of No.109/111 Botchergate could only be accessed through the doorway shown on Plate 12. This doorway provides access to a narrow hallway which leads to the staircase (Plate 36). The north-west wall of the hallway is of studwork, as has already been noted from Room 5, however the hallway itself may be historic (although not necessarily original) as suggested by the decorative coving.

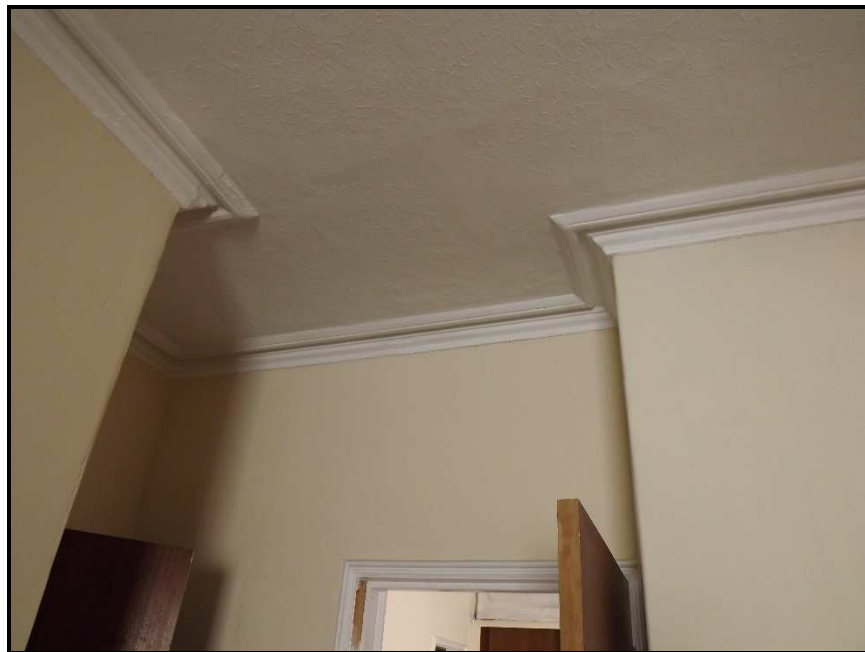
Plate 43: Detail of coving, first floor bedroom of No.109/111 Botchergate (over Room 1)

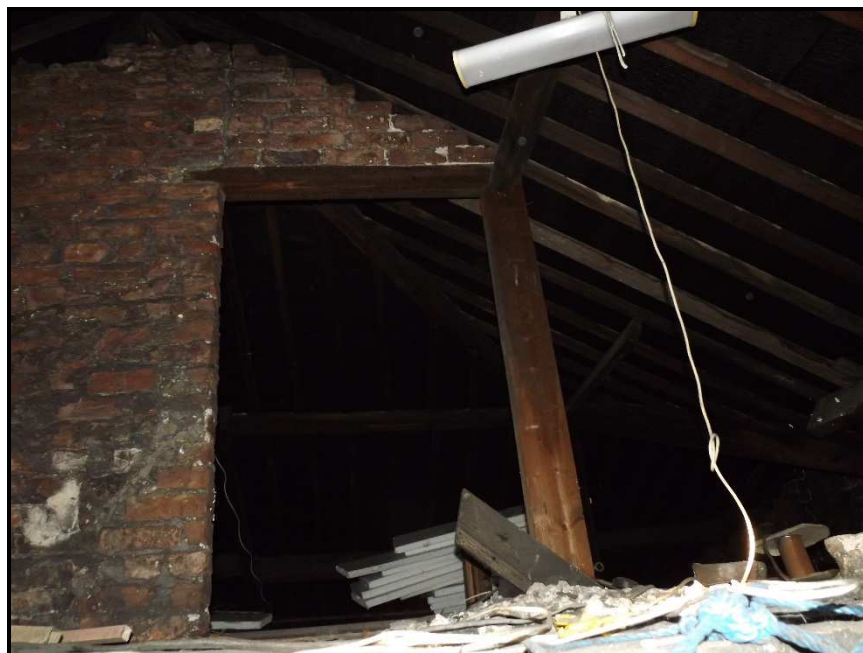
Plate 45: Detail of brick internal wall between No.107 and No.109/111 Botchergate, as seen in the attic over the two properties

features of note in this area however it was possible to look up through an access point to the attic located within the ceiling of this corridor. Although this was restrictive, it was possible to observe that the internal dividing wall between No.107 and No.109/111 Botchergate is constructed of brick, as is the south-east gable of No.109/111 (Plate 45). It was noted that the underside of the roof had modern timbers and felting which may indicate it has been reroofed at some point.

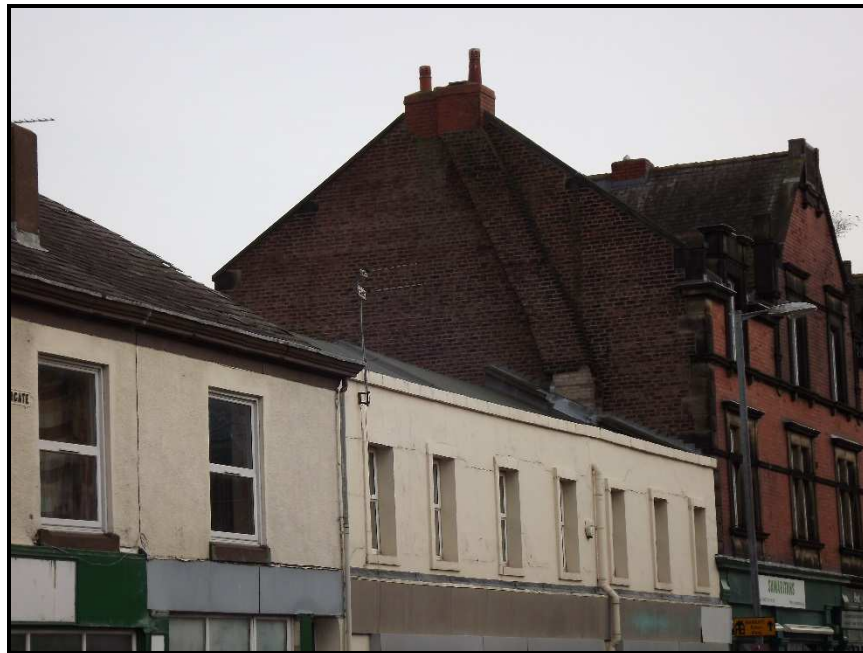
Plate 48: North-west elevation of the property adjacent to No.113-117 Botchergate showing scarring of former roofline

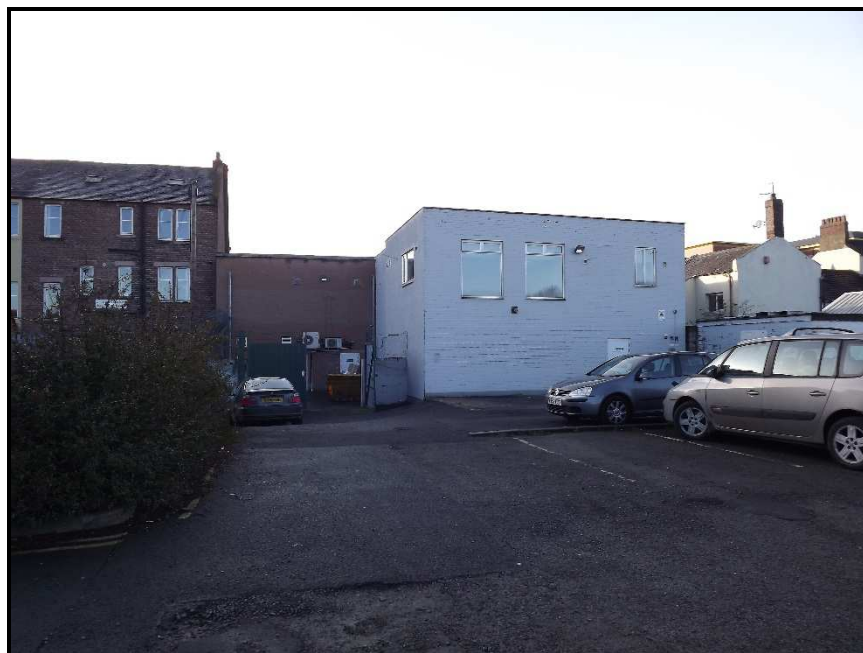
Plate 49: Rear (north-east) elevation of No's 113-117 Botchergate

- 3.28 It would appear that No's 113-117 have not only been remodelled on the Botchergate frontage, but also to the rear as shown by the modern flat-roofed, two-storey extensions which are now present (Plates 49-52). Buildings are shown at this location on the Ordnance Survey map of 1965 (see Figure 10), however it is unclear if these are the buildings which now stand. Despite these structures being relatively modern, there is still some phasing visible within the projecting extension painted white in the form of blocked windows at ground and first floor level (Plate 52).

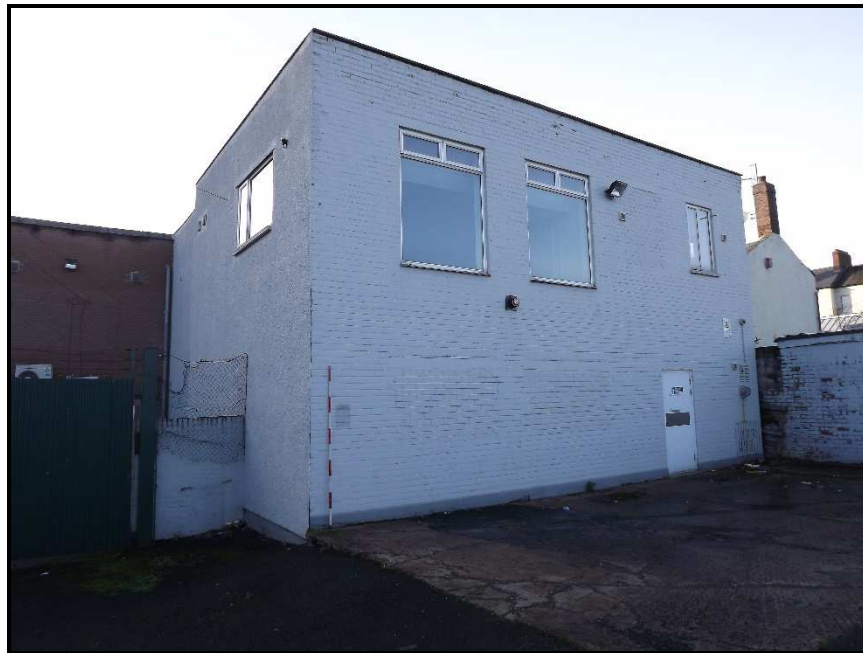
Plate 52: Rear (north-east) elevation of No's 113-115 Botchergate

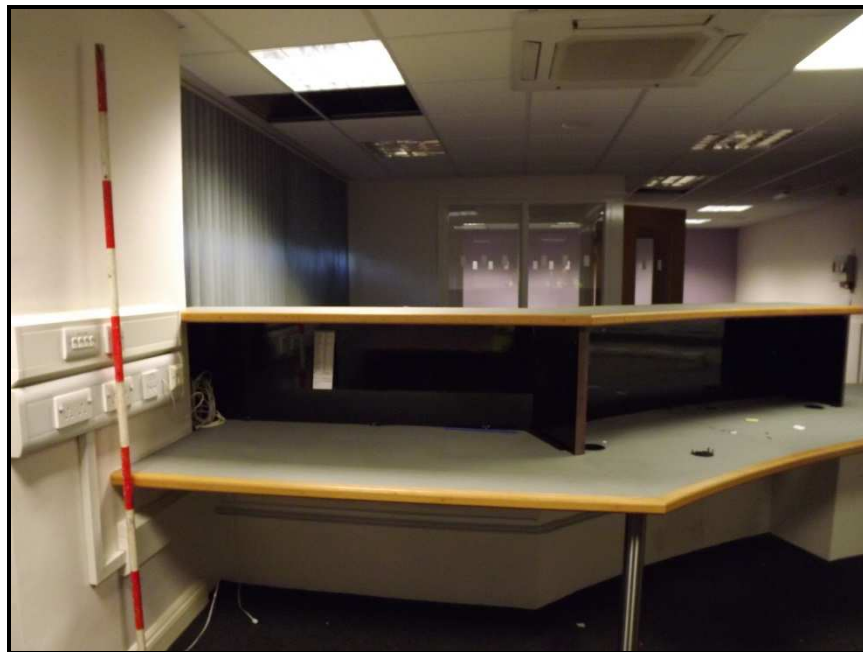
Plate 53: Ground floor of No's 113-117 Botchergate showing modern internal fittings

- 3.29 As noted in 3.1 above, access into the interior of No's 113-117 Botchergate was restricted to a cursory inspection. It was clear that the interior has recently undergone extensive modifications with modern reception area, meeting/consulting rooms at ground and first floor level. The roof space, following the consolidation of the two former properties shown on Plates 2 and 3, has been partly incorporated into the first floor frontage (Plates 53-55). The only possible historic feature noted within the restricted inspection was the possible location of a fireplace as shown by a projection incorporated into one side of a modern staircase (Plate 56). This may have related to fireplaces between No.115 and No.117 although this was difficult to establish as no existing floor plan is available for these properties.
