**DERWENT ISLE,
DERWENTWATER,
KESWICK,
CUMBRIA**

**WATCHING BRIEF REPORT
CP. No: 11098
16/03/2015**

DOCUMENT TYPE: Watching Brief Report

CLIENT: The National Trust

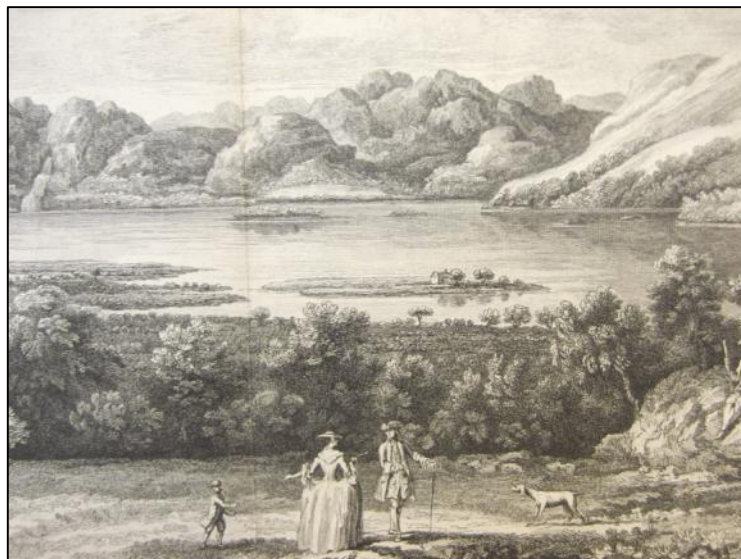
cottage, presumably Hinds Cottage (Asset 36) is shown in William Bellers' 'View of Derwentwater towards Borrodale' (CLSS 61/1; Plate 1). The building is shown towards the east of the island, with some trees around it, presumably the aforementioned sycamores.

Plate 1: Extract from William Bellers' 'View of Derwentwater towards Borrodale', 1752

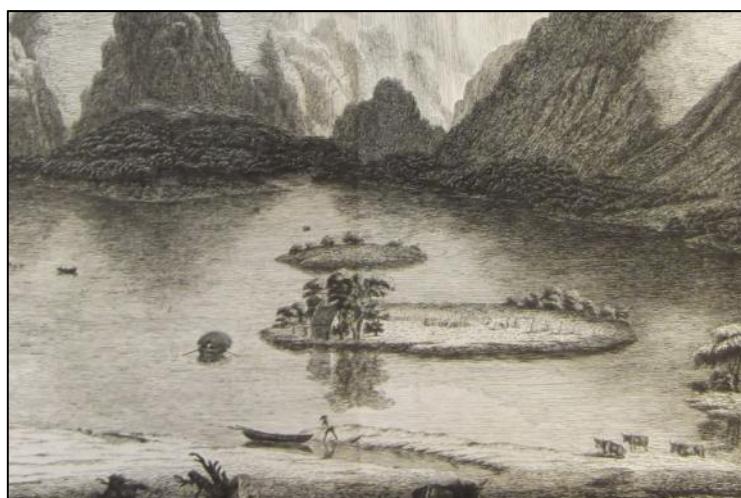
3.2.7 Similarly, Thomas Smith, in his 'View of Derwentwater &c from Crow Park' of 1761, shows a building towards the eastern side of the island amongst some trees, with crop stacked up to the west (Plate 2). In his accompanying text, Smith states "*The Vicar's Isle, about five acres of well cultivated land, had (when the view was taken) a good crop of wheat upon it. This island belongs to John Ponsonby of Hale, Esq*" (Smith 1761, 5). Ponsonby sold the island in 1778 to Joseph Pocklington, and at around that time, West had seen the island, noting it as "*a third [island] with a hut upon it, stript of its ornamental trees, by the unfeeling hand of avarice*" (West 1778, 114), presumably a criticism of the Ponsonbys' 18th century changes.

Plate 2: Extract from Thomas Smith's 'View of Derwentwater &c from Crow Park', 1761

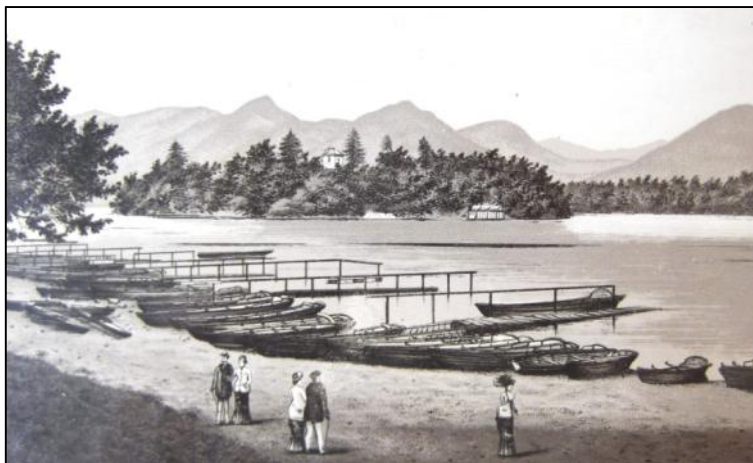
- 3.2.17 In 1850, Anthony Salvin extended the house (Asset 4) eastwards and westwards for William Marshall; to the east to include an entrance tower, large dining room and stone stair running from the cellar to the attic; and to the west, to provide a single-storey kitchen wing, flat-roofed (Hyde and Pevsner 2010, 450). A characteristic of all Marshall estates was “*the planting of fine trees, typically around a landscaped garden with terrace walks, steps and lawns that swept down towards a lake view. This was certainly achieved at Derwent Island*” (National Trust 2001, 2). An Italianate loggia and roof terrace on top opens from Pocklington’s upstairs drawing room, which may represent a later c. 1900 phase (*ibid*). A view of ‘Derwentwater & Boat Landing’, from an Album of English Lake Views (CAC(C) DX173/16) shows the island from the north-east at around this time (Plate 11). It shows the island with extensive tree cover, the redesigned house visible at the top, and a boat house on

the north-east side (Asset 7), the redesigned ‘mock church’ (Asset 5), presumably hidden in the trees.

Plate 11: Derwentwater & Boat Landing, c. 1910 (CAC(C) DX173/16)

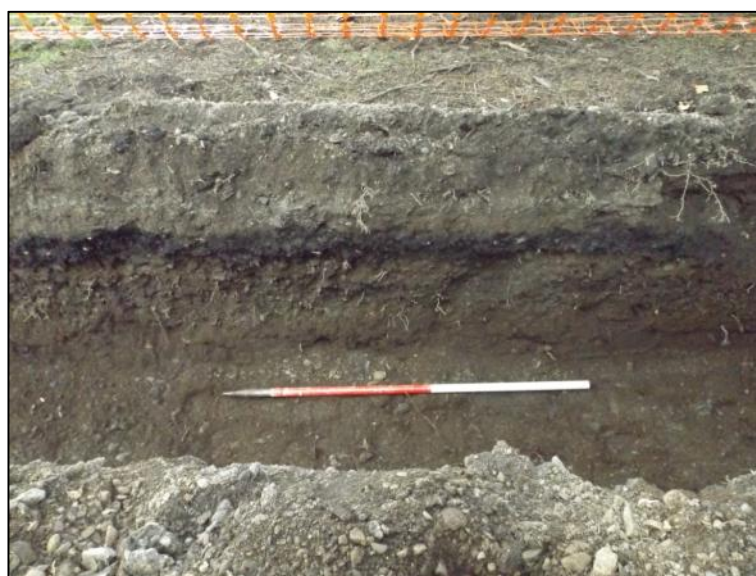
Plate 16: Possible earlier black ash pathway seen in section (facing south-west)

4.2.1 Immediately to the south of the northern watching brief area was an area of excavated trench adjacent to the eastern shore. Archaeological inspection of the groundworks before backfilling revealed a deposit of black ash measuring 0.06m thick in the north-east facing section of the service trench (Figure 16; Plate 16). This was believed to be the surface of a pre-existing pathway following the same alignment of the current path.

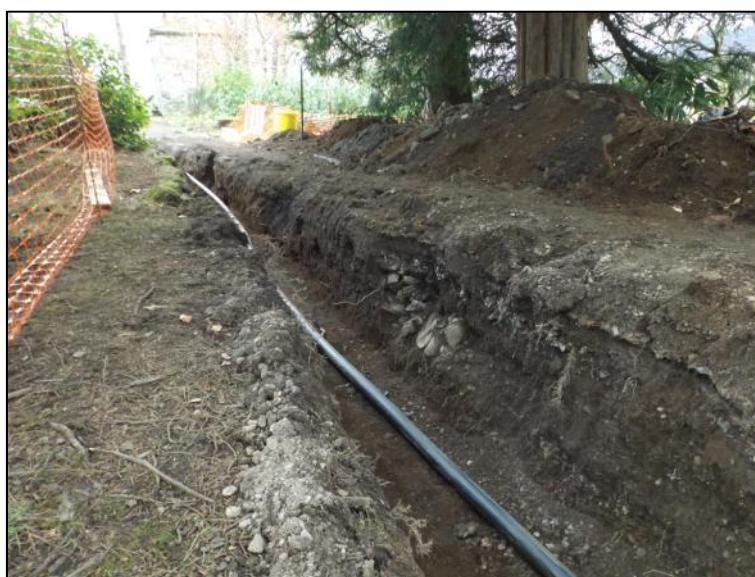
Plate 17: Possible rubble wall in trench south-west facing section (facing north-west)

- 4.2.4 Despite previous ground intervention several areas of archaeological interest were noted in the northernmost area, two of which had been encountered prior to permanent archaeological monitoring commencing on 18th February 2015. These were a rubbish dump (Figure 16), and the remains of a possible shallow and poorly built rubble wall (Figure 16; Plate 17), the latter of which was still visible in the south-west facing section only of the service trench. No remains of the rubbish dump were visible, though pottery and glass was visible on the spoil heap, a sample of which was retained for further analysis (*confer* 5.2).

- 6.1.2 Throughout the watching brief no significant evidence for subsurface remains of earlier buildings can conclusively be said to have been observed. One potential wall (Plate 17) recorded in the early stages of the watching brief cannot be positively identified as a structure and would need further investigation to provide some certainty on the matter.

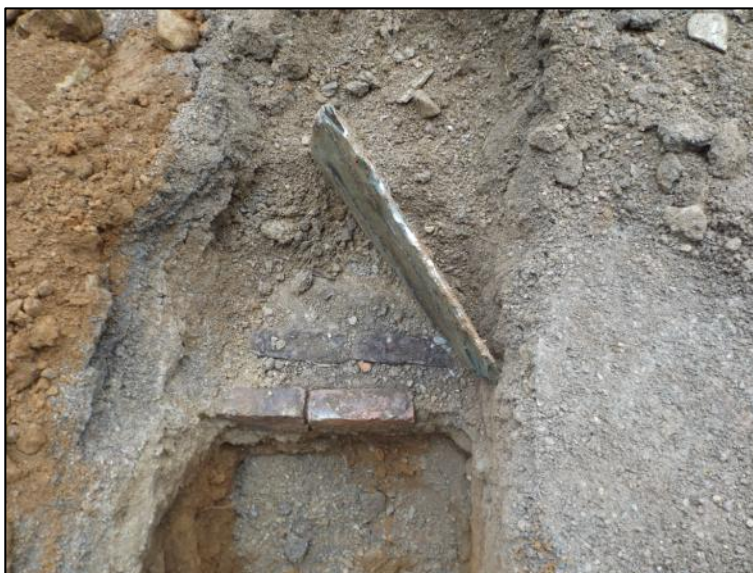
Plate 18: Brick and slate topped culvert (facing north-west)

- 4.2.6 Just to the west of the crossing point of the paths, the northernmost extent of a narrow brick-lined slate topped gully was encountered (Figure 16; Plate 18). To the west of this, brick edging was encountered at the southern extent of the trench for a distance of approximately 3m, perhaps once forming the southern edge of the path. Several bricks had 'LONSDALE' stamped on them. Lonsdale bricks were manufactured at the Lonsdale Brick and Tile Works at Cumwhinton, 3.5 miles south-east of Carlisle, Cumbria, during the 19th century (<http://www.scottishbrickhistory.co.uk/lonsdale>).

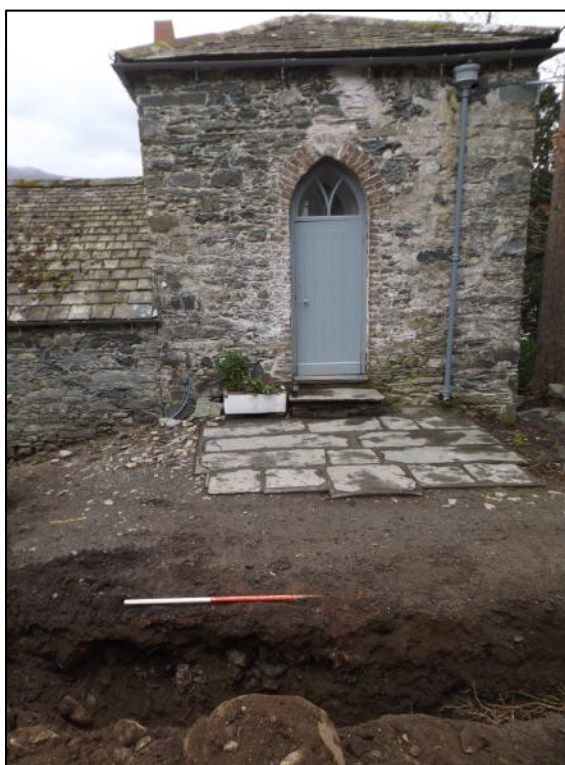
Plate 19: Made ground adjacent to church tower door (facing north-east)

4.2.7 Close to the tower of the 'church' (Asset 5), two areas of stone and mortar were observed in the south-west facing section of the service trench. This was within a wider area of made ground consisting of mixed stone and rubble. It is probable that the material was deposited in this area to raise the ground up to the height of the door in the south-west wall of the church tower. The site gardener stated that the area had been 'backfilled' to aid drainage and provide a more stable area outside the entrance to the tower.

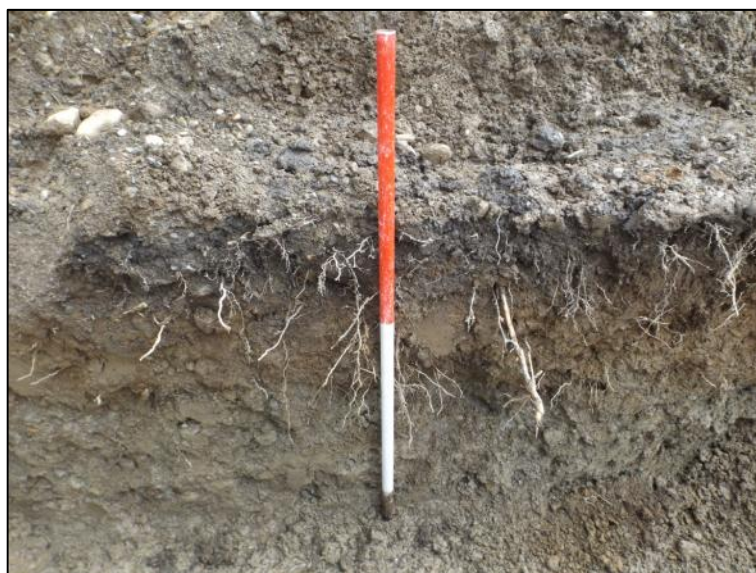
Plate 20: North-west facing section of trench west of derelict buildings (facing south-east)

- 4.2.10 The excavated service trench to the north-west of the 'church' measured 0.60m in width and 0.75m in depth and ran in a shallow curve toward the south side of the derelict buildings situated close to the north shore. The groundworks in this area revealed a stratigraphic sequence of 0.40m of excavated, very hard and compact, fine gravel, natural substrate. This was sealed by 0.18m of brown, gravelly clay, sub-soil and 0.15m of dark brown silty topsoil (Plate 20).

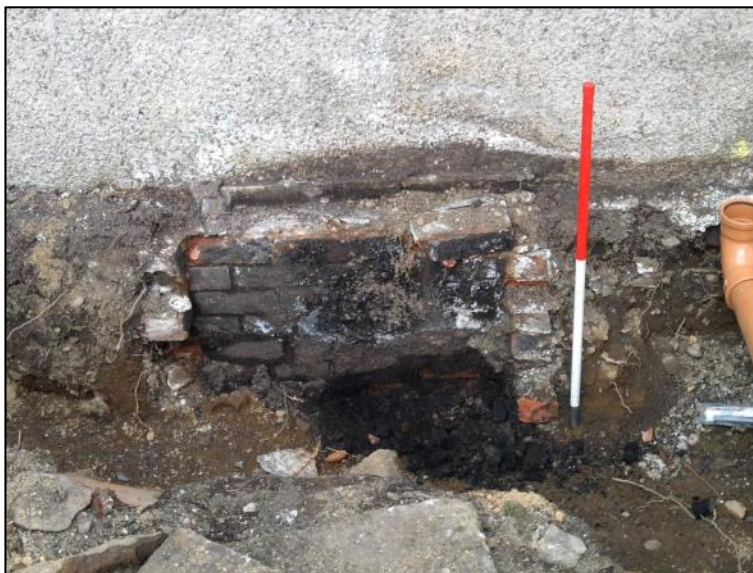
Plate 21: Removed brick structure from the north-west side of the battery house (facing south-east)

- 4.2.11 Adjacent the derelict buildings and from there on the trench ran in a south-western direction to the south side of a small rectangular, standing building known as the 'battery house' (Island gardener pers. comm.) Here it was observed that part of a sub-surface brick structure had been removed (Figure 16; Plate 21). Constructed of modern brick it had been earlier observed to have an iron pipe from the 'battery house' running vertically into it. It is likely that this was an exhaust pipe from a generator that had once been installed in the 'battery house'. The sooty deposit at the base of the brick structure might support this idea (Plate 21). Unstratified bricks found in the spoil heap adjacent the structure bore the name CAMERTON CUMBERLAND.

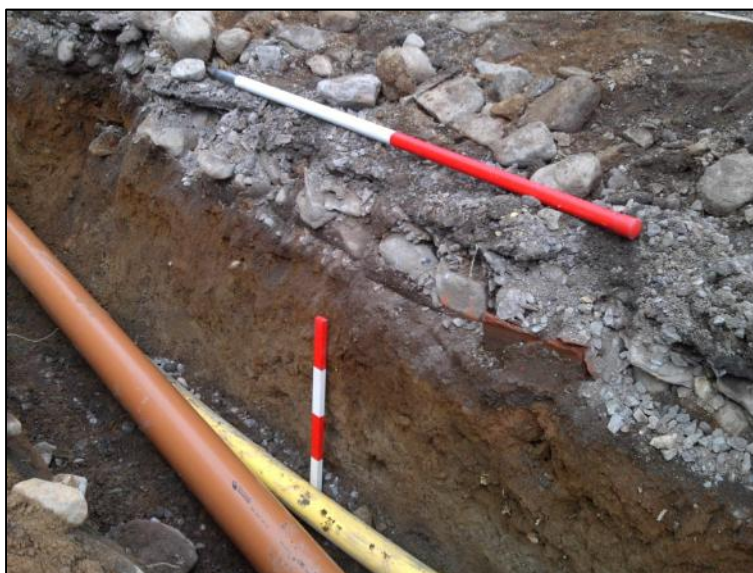
Plate 21: Earlier cobbled pathway in trench section. Note the remaining piece of orange horseshoe land tile (facing north-east)

- 4.2.12 In the area of inspected trench running north-south toward Derwent Isle House an earlier cobbled pathway was uncovered (Figure 16; Plate 22). More conspicuous in the west facing section it consisted of blue/grey, sub-rounded river/lake cobbles and

measured 0.15m in depth. These lay on top of the brown sub-soil and were sealed by the current lake gravel path which measured 0.10m in depth. Under the cobbled pathway ran a land drain of horseshoe ceramic tiles. It is believed these led to a soakaway of sub-rounded boulders observed at the northern end of the cobbled path in the western facing section of the trench only.

- 6.1.3 The majority of features revealed were associated with garden / woodland pathways and land drainage. Possible earlier slate and brick edges to the islands perimeter path were uncovered. A cobbled pathway was revealed in the western groundworks, climbing toward Derwent Isle House. A possible earlier black ash path near to where the new services were to come ashore should be viewed with some caution. This was not observed being excavated as it was outside both the designated watching brief areas and there appears to be a considerable amount of rubbish and ash randomly deposited throughout the grounds of the island.

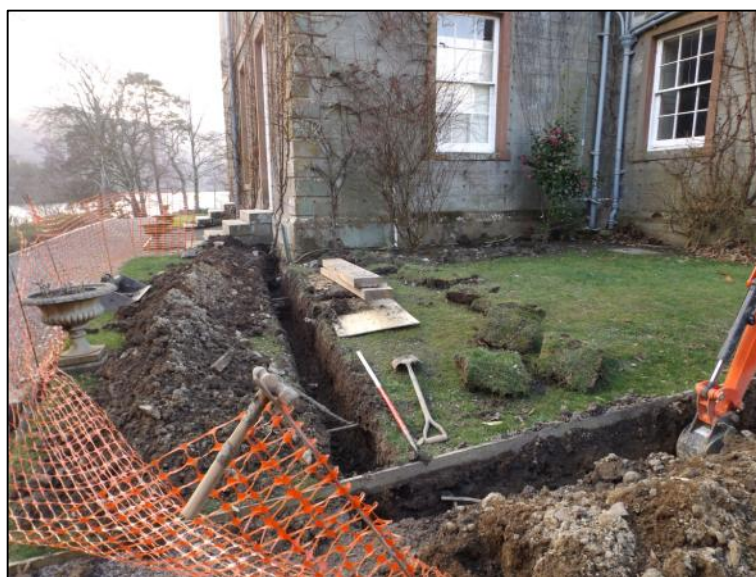
Plate 22: Trench excavation at the northern front of Derwent Isle House

- 4.3.2 The area ran approximately west-south-west to east-north-east, across the northern front of Derwent Isle House (Figure 16; Plate 22). Two offshoot trenches ran north-south up to the fabric of the building. Between the two north-south offshoots the trench was reduced to 0.30m in width and 0.50m in depth. Apart from a slate lined, V shaped culvert (Figure 16) no significant archaeological features were observed in this area. Several lead pipes and modern service pipes were observed in the trenches.

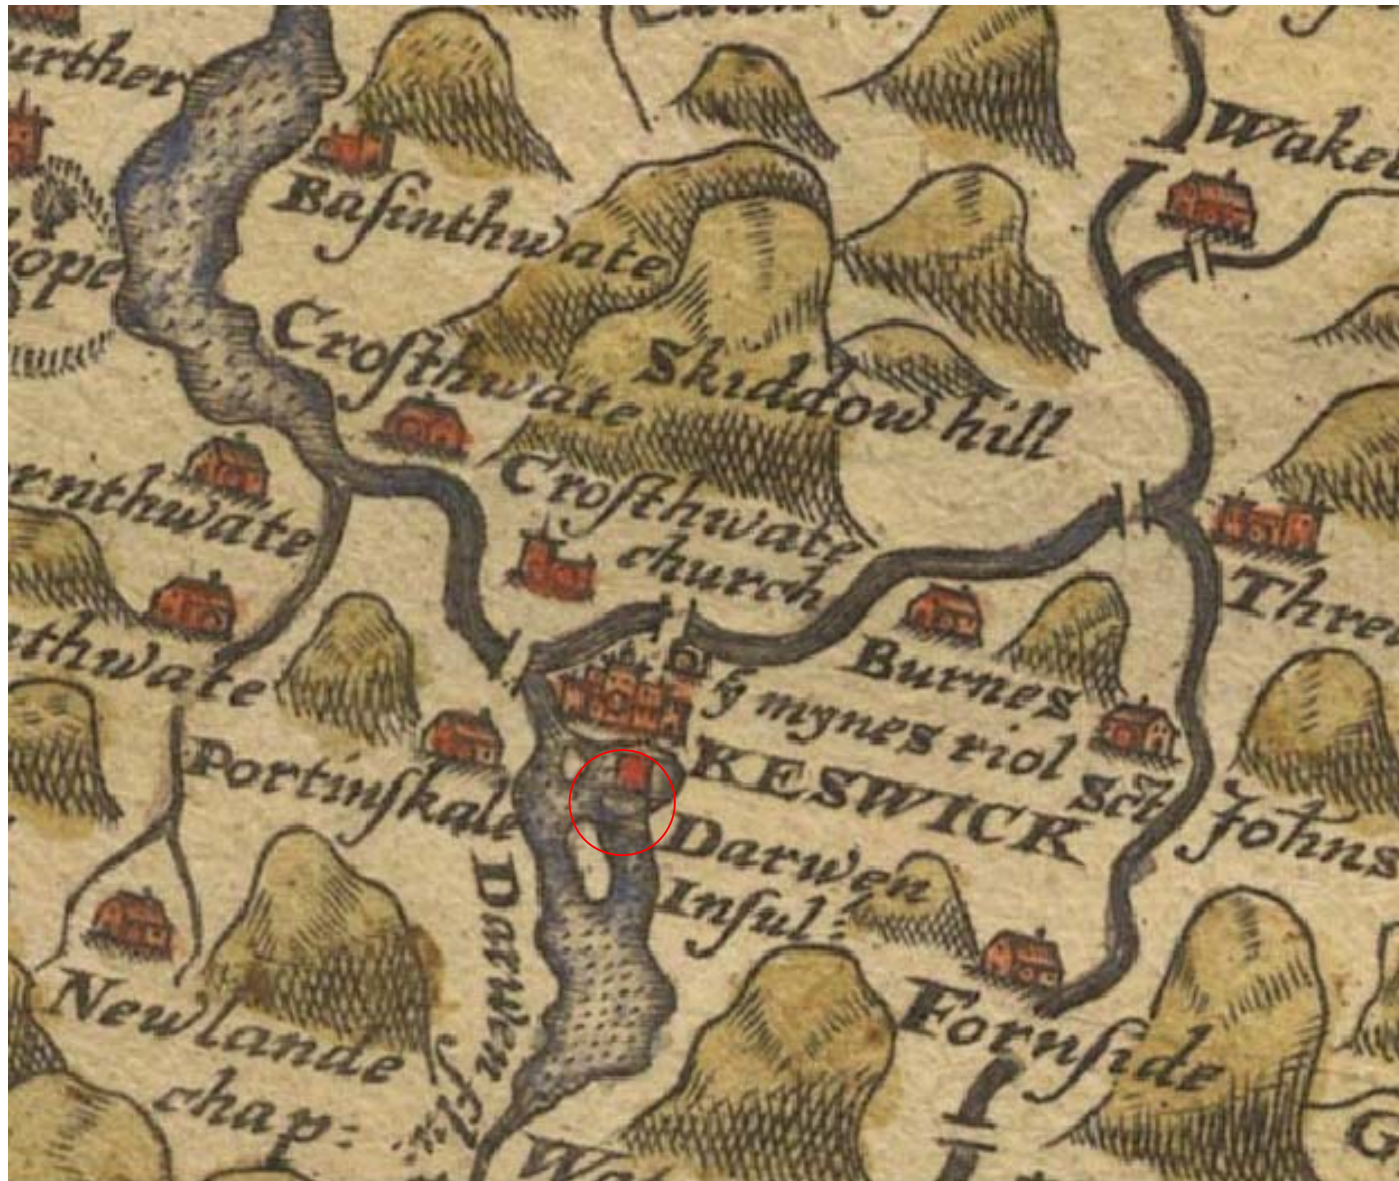
FIGURE:
 4

- 3.3.2 **Saxton’s Plan of Westmorland and Cumberland, 1579 (Figure 4):** this plan shows the settlement of Keswick, with Derwent Isle being the most north-easterly of the islands of Derwentwater, labeled ‘*Darwn Insul*’. ‘*y mynes riol*’ is written in the vicinity of the German miners’ workings at Brigham, to the north-east of Keswick.

Figure 4: Extract from Saxton's Plan of Westmorland and Cumberland, 1579.

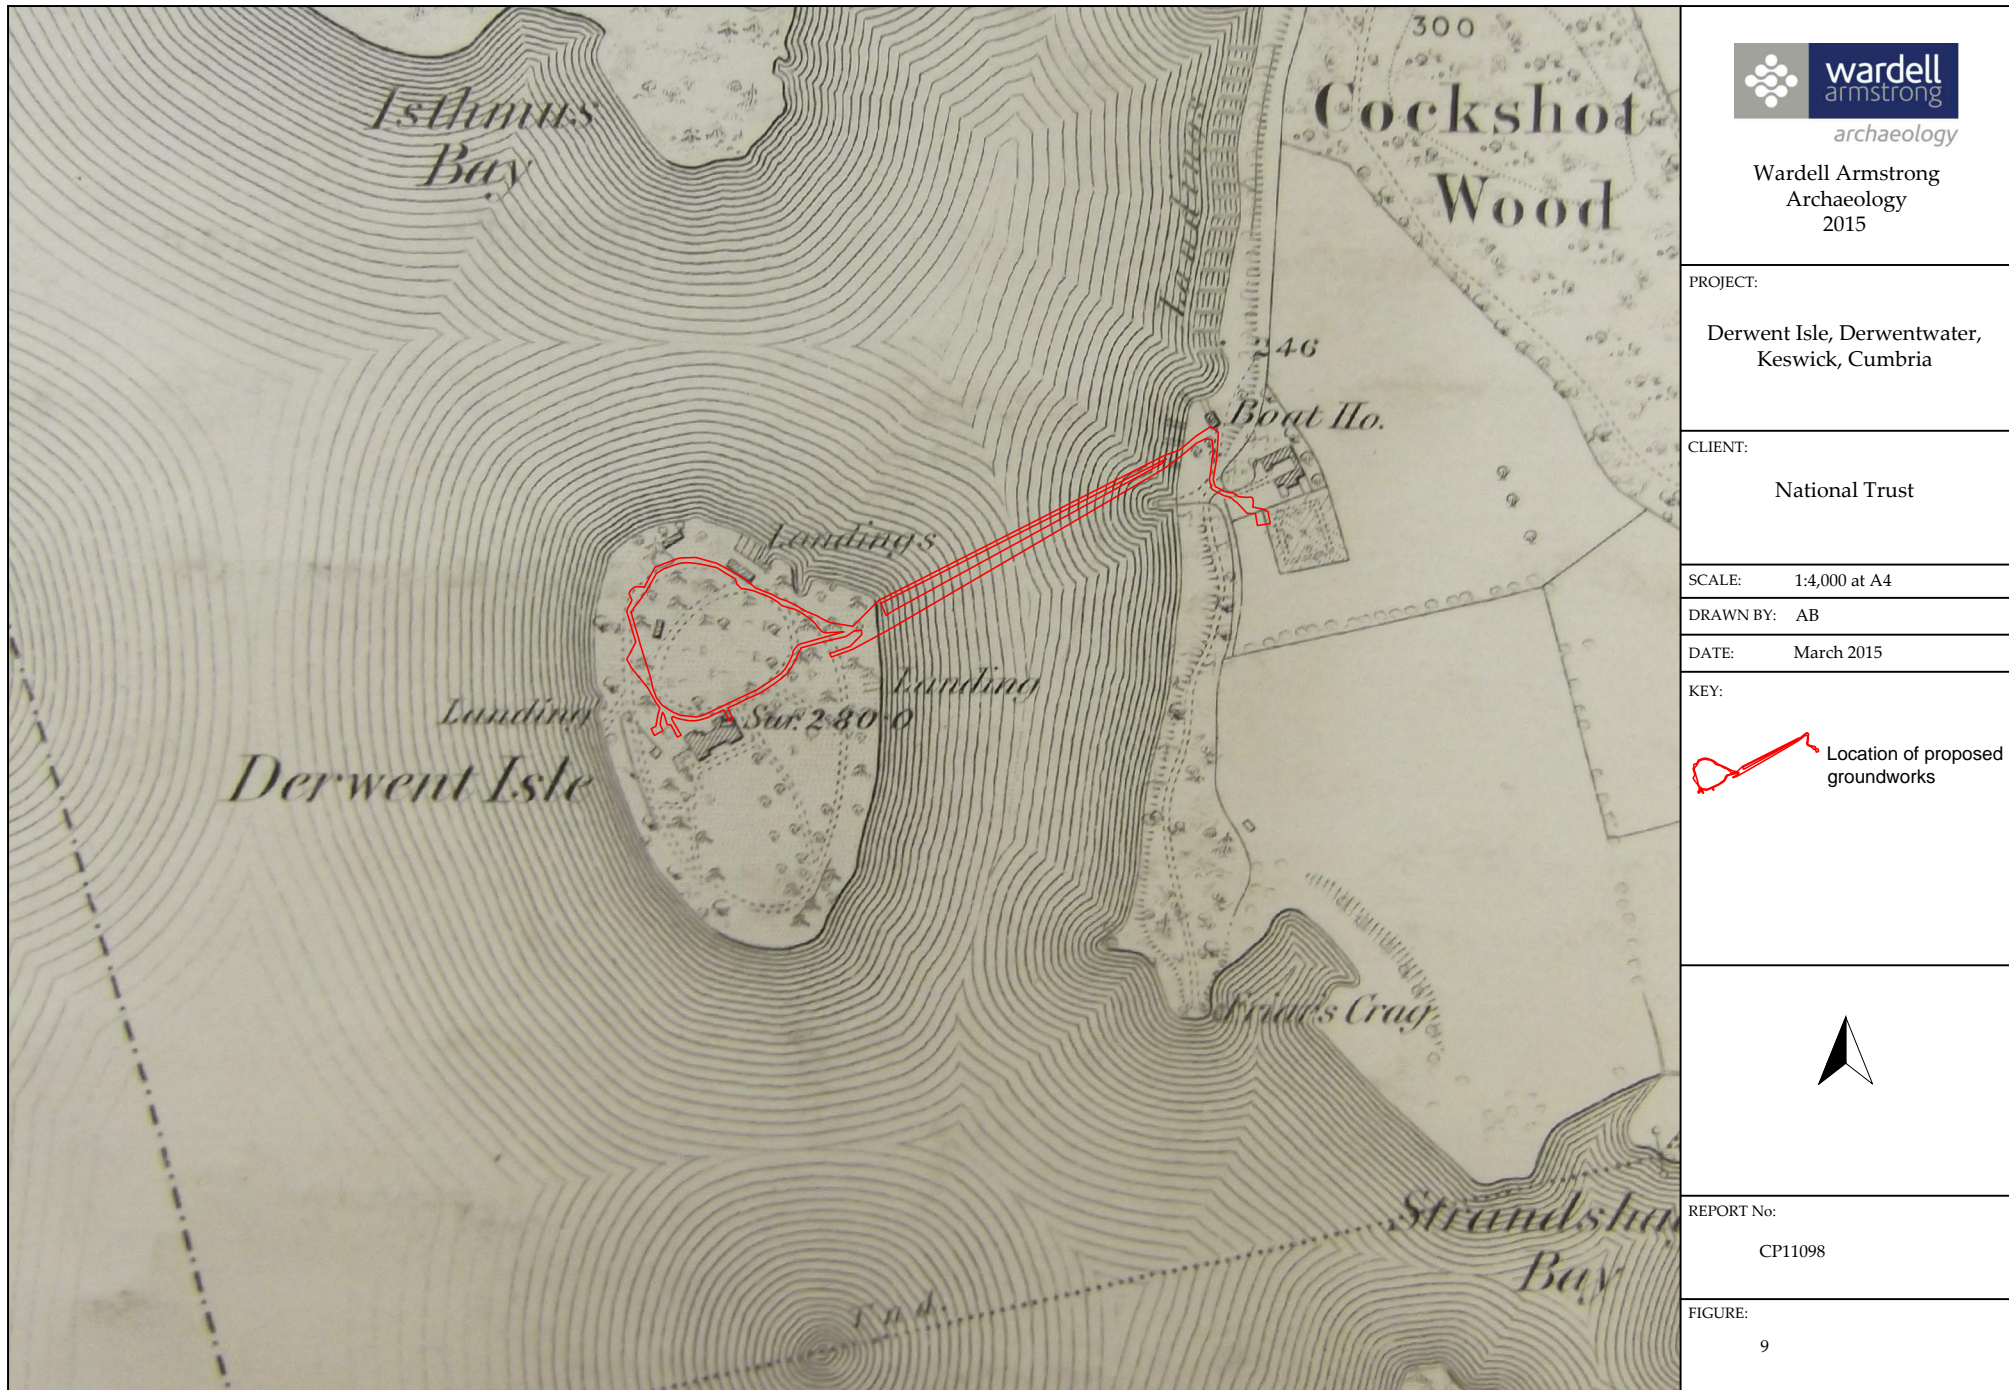
- 3.3.7 ***First Edition Ordnance Survey Mapping, 6 inch to the mile, 1862 (Figure 9)***: this map indicates Peachy's demolition of the majority of Pocklington's structures except the church (Asset 4), shown at the north of the island, set back from the shoreline. To the north-east of this is a new building, presumably a boat house,

Figure 9: First Edition Ordnance Survey Map, 1862 (6" to 1 mile scale).

41	1 st ed OS map, 1862 (Figure 9)	Boat house on mainland	Post 1797, pre 1862	326387 522548
42	2 nd ed OS map, 1899 (Figure 10)	Site of building south of Derwent Cottages (Asset 15) and washhouse (Asset 14). Gone by 1925 (Figure 12)	Post 1862, pre 1899	326413 522435
43	2 nd ed OS map, 1899 (Figure 10)	Site of north-west south-east orientated building next to Asset 38. Possibly out of use by 1938 (Figure 14)	Post 1862, pre 1899	326094 522488
44	2 nd ed OS map, 1899 (Figure 10)	Square outbuilding to south-west of Assets 38 and 43	Post 1862, pre 1899	326083 522476
45	2 nd ed OS map, 1899 (Figure 10)	Site of a boat house next to westernmost jetty (Asset 9). Gone by 1925 (Figure 12)	Post 1862, pre 1899	326057 522390
46	Taylor 2005, 84	Site of a bath house. Part of the Elizabethan miners' island settlement. See also Assets 3, 25-34	16 th century	Unknown

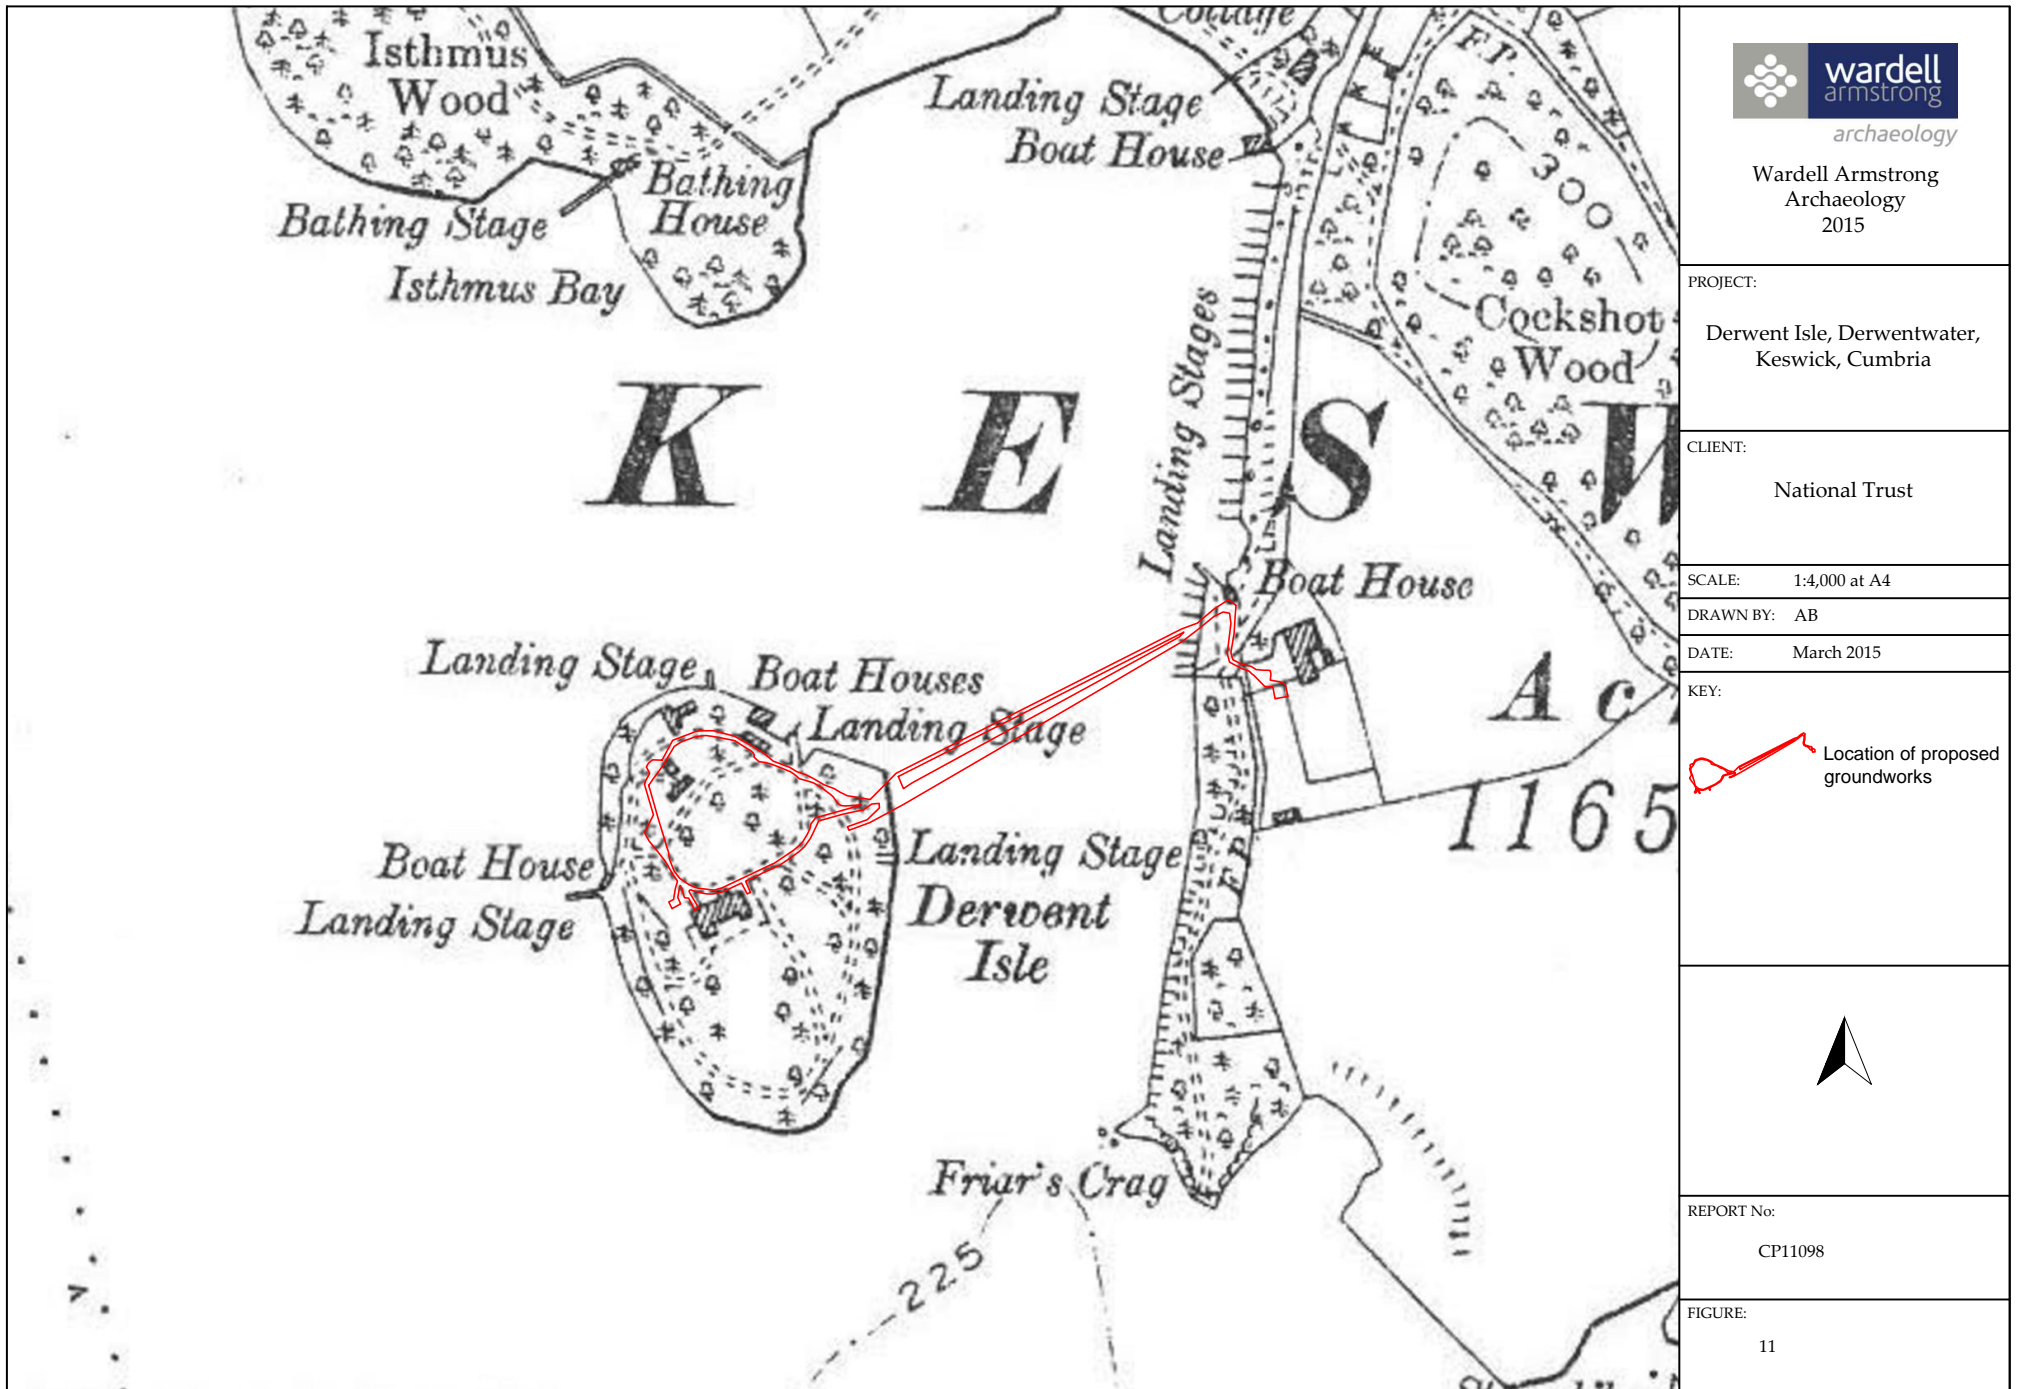
- 3.3.9 **Second Edition Ordnance Survey Mapping, 6 inch to the mile, 1900 (Figure 11):** this edition of the Ordnance Survey mapping shows the same layout on both the island, and mainland to the east, as shown on the Second Edition 25 inch scale of 1899 (Figure 10).

Figure 11: Second Edition Ordnance Survey Map, 1900 (6" to 1 mile scale).

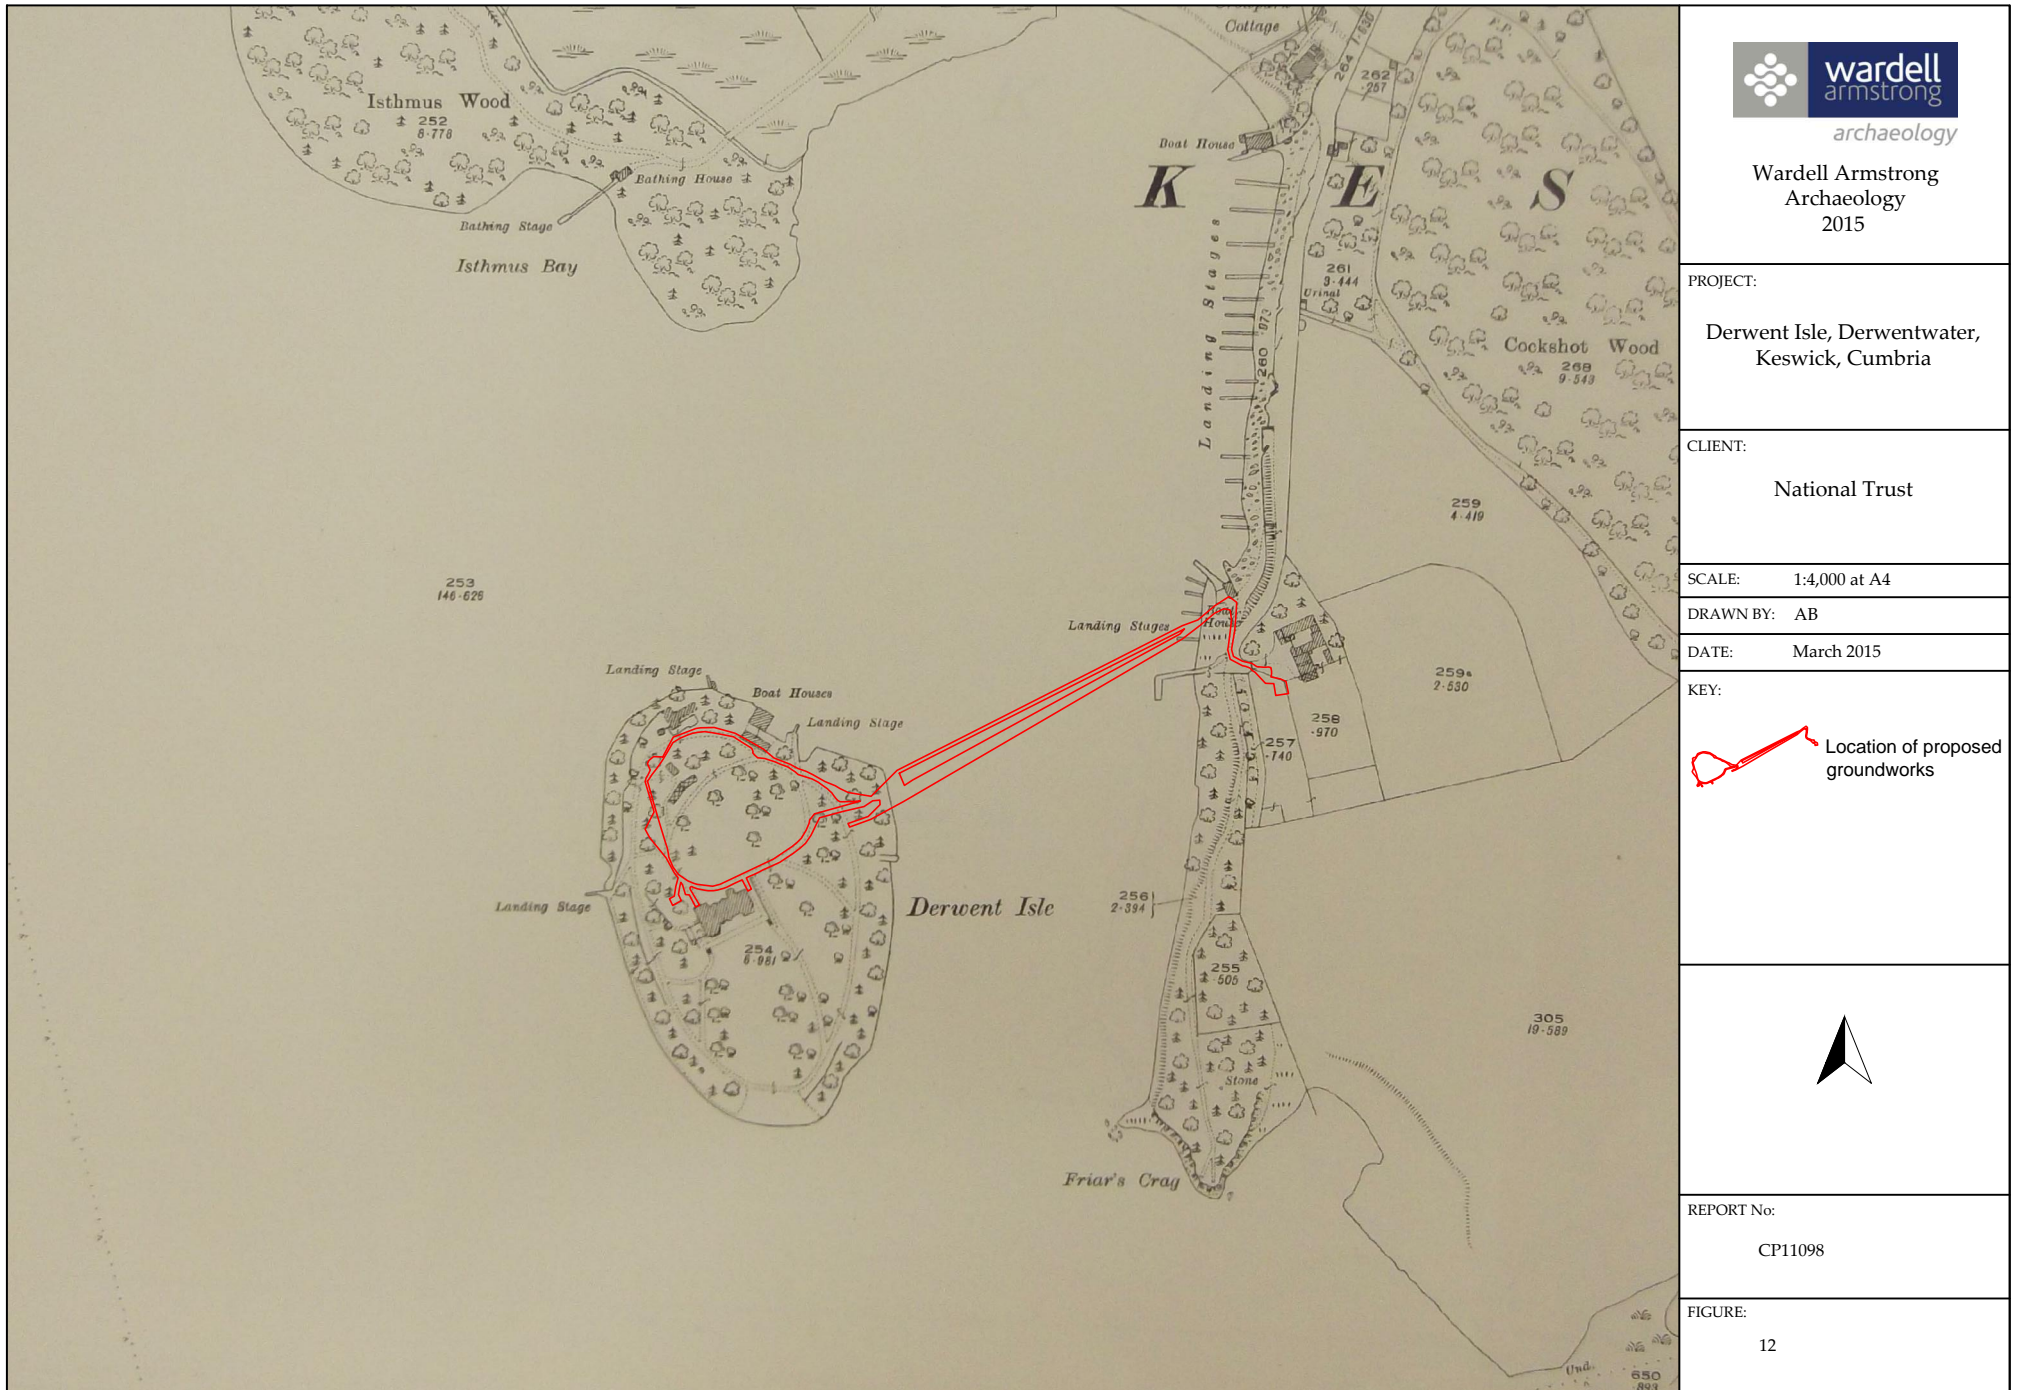
- 3.3.10 **Third Edition Ordnance Survey Mapping, 25 inch to the mile, 1925 (Figure 12):** this map shows the same layout as the earlier maps of 1899 and 1900 (Figures 10 and 11), although the boat house previously depicted beside the westernmost landing stage is no longer shown (Asset 45). On the mainland, the building to the south-west of the main buildings which was in area '257' is no longer shown (Asset 42).

Figure 12: Third Edition Ordnance Survey Map, 1925 (25" to 1 mile scale).

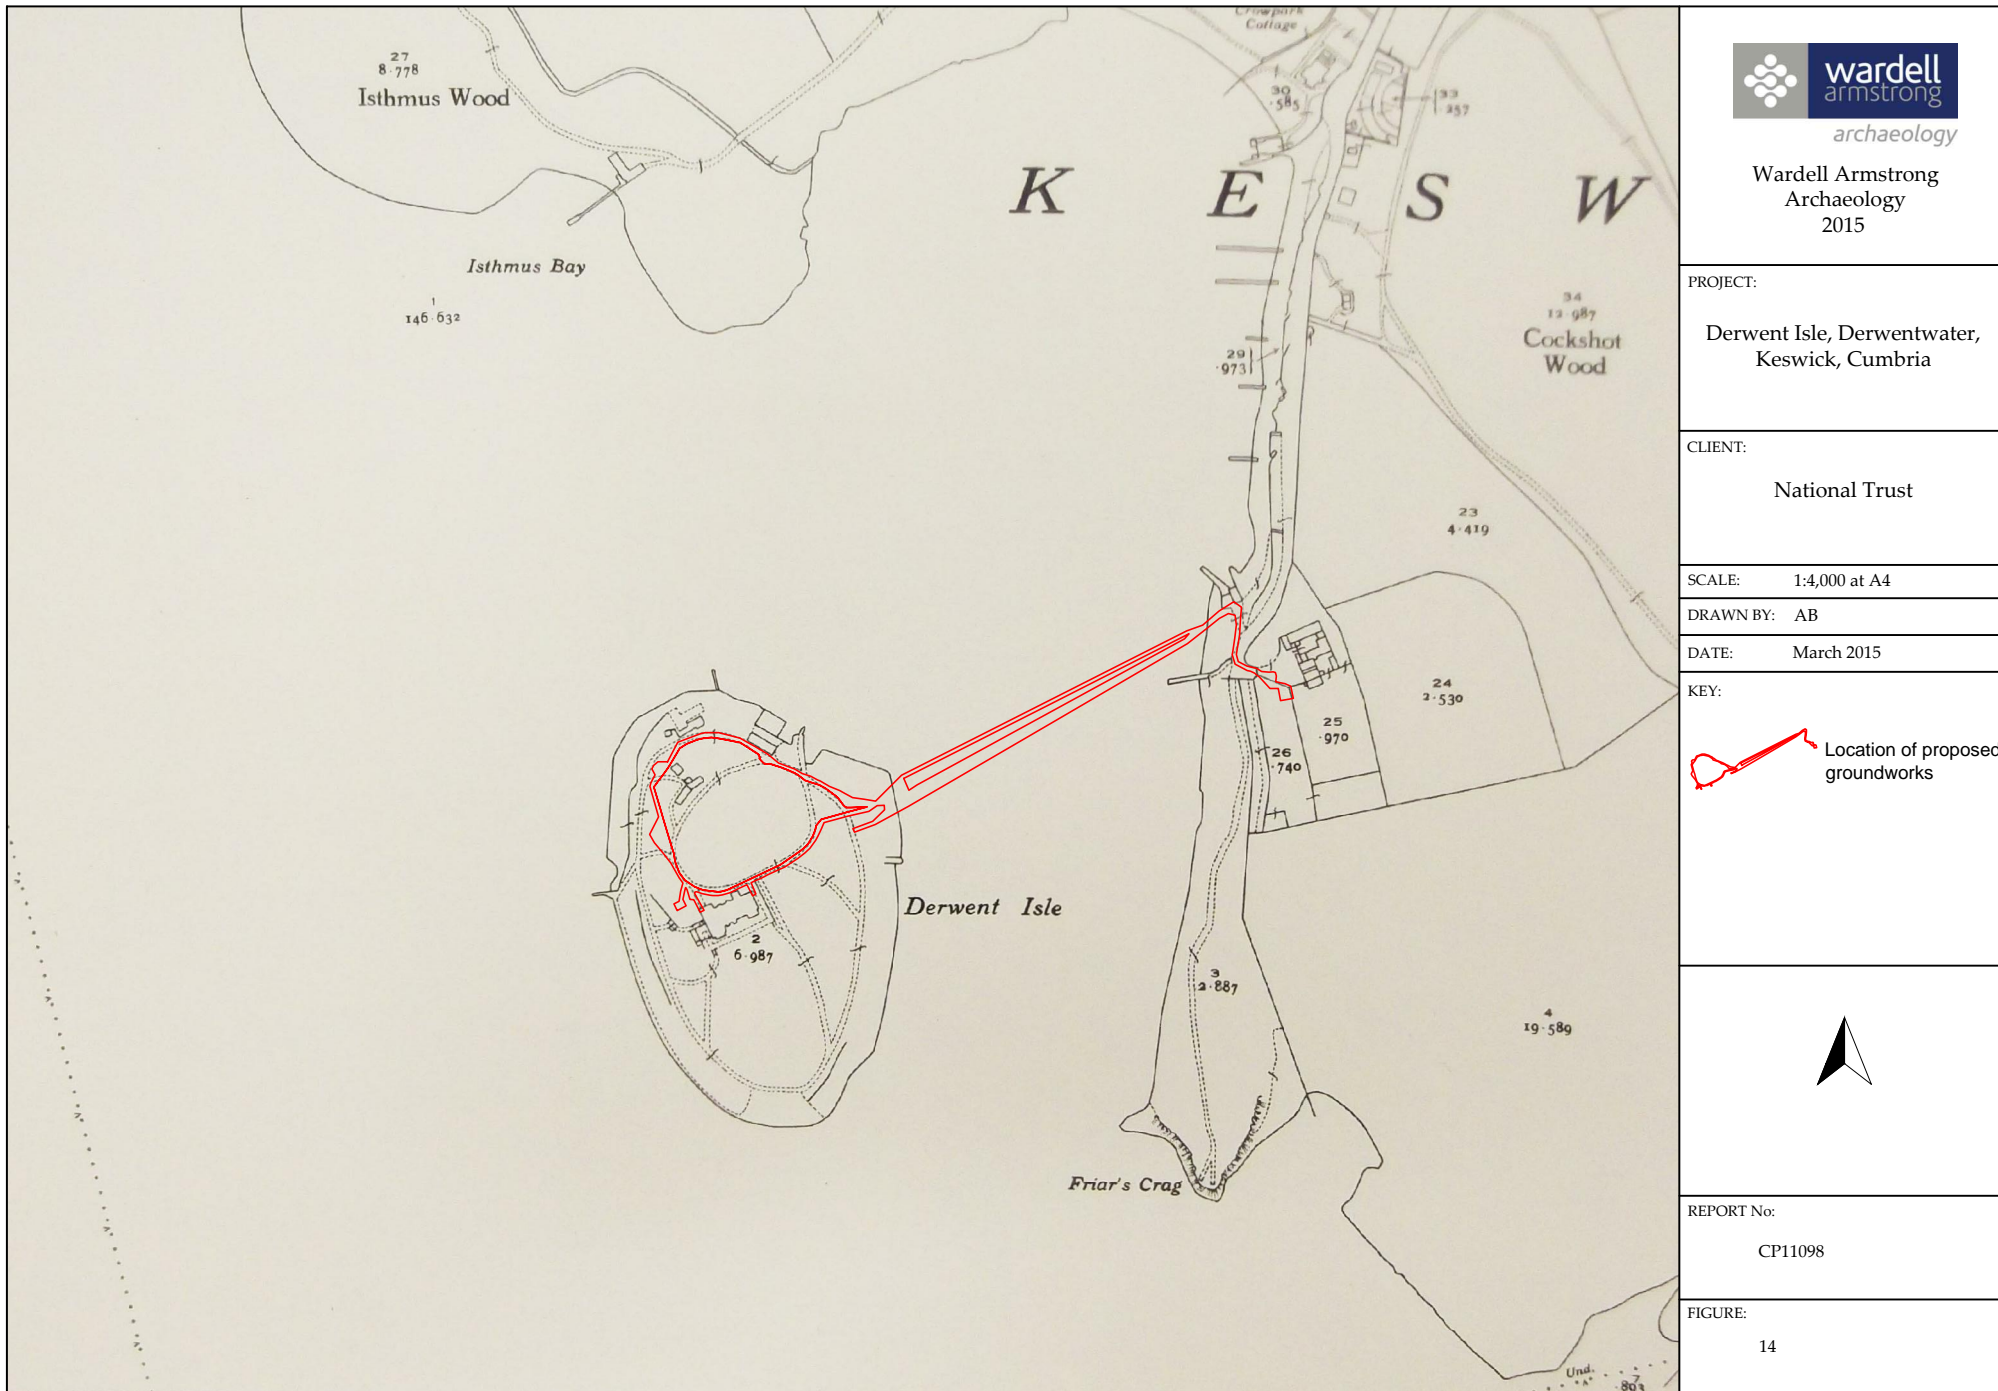
- 3.3.12 **Provisional Edition Ordnance Survey Mapping, 25 inch to the mile, 1938 (Figure 14):** this provisional edition of the Ordnance Survey map shows a similar layout to previous mapping, but with no annotations, or tree details. The two buildings previously shown as a T-shape to the north of the island are now dashed (Assets 38 and 43), suggesting that they were no longer complete buildings by this date.
- 3.3.13 **1968 Ordnance Survey Mapping, 1:2500 (Figure 15):** the only difference between the 1968 and 1938 map is at the north of the island. The previously dashed T-shaped building is now shown as just the easternmost north-west south-east aligned building, possibly the same building, but repaired, first shown in 1899 (Figure 10; Asset 38).

Figure 14: Provisional Edition Ordnance Survey Map, 1938 (25" to 1 mile scale).
