UNITED UTILITIES

KILNHILL TO PINGGY WOOD

ARCHAEOLOGICAL SURVEY

April 2015

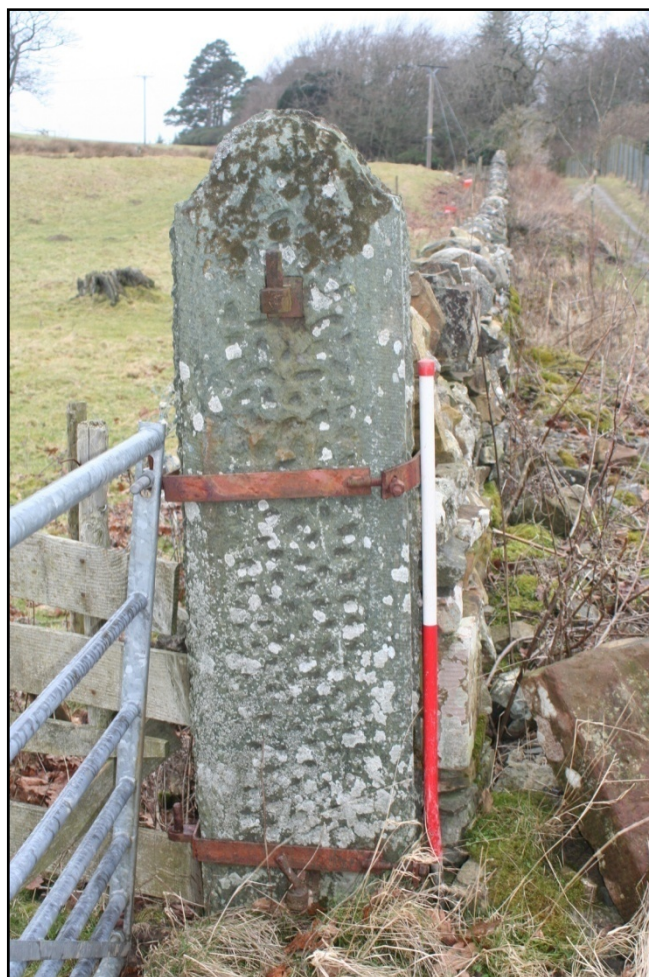
- 3.2.5 One unusual asset is a decorated, possibly re-used, gate post or stoop which forms part of an unmaintained field boundary, close to Armanthwaite Hall (Plate 1). The highly decorated nature of the gatepost suggests it has 19th century origins and formed part of the ornamental parkland landscape surrounding Armanthwaite Hall.

Plate 1: Possibly re-used decorated Gate Post.

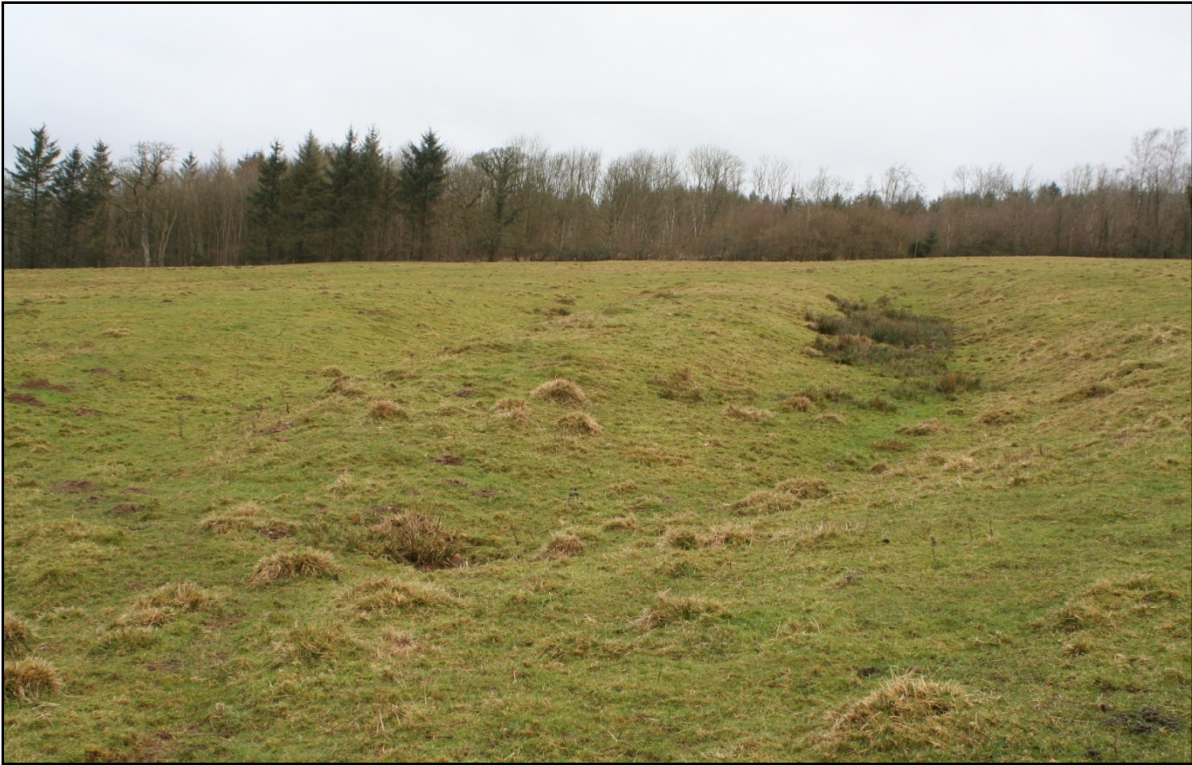
- 3.2.6 An earthwork of archaeological interest was recorded north west of Isel (plate 2). This feature measured approximately 45 meters long and was oval in shape; it was formed of a raised bank with a surrounding ditch measuring approximately 3 meters wide and with a depth of 0.5 meters. A worked stone located at one end of the feature (plate 4) could highlight a previous use with two small circular holes approximately 0.2 meters deep clearly visible; these appeared to be solution hollows rather than rock art. The mound's use or significance is unknown, however its most likely interpretation is as a pillow mound probably associated with the wider hunting landscape of Isel Hall. The date of the mound is uncertain but it may be medieval in origin.

Plate 2: Possible pillow mound north-west of Isel.(site 13)

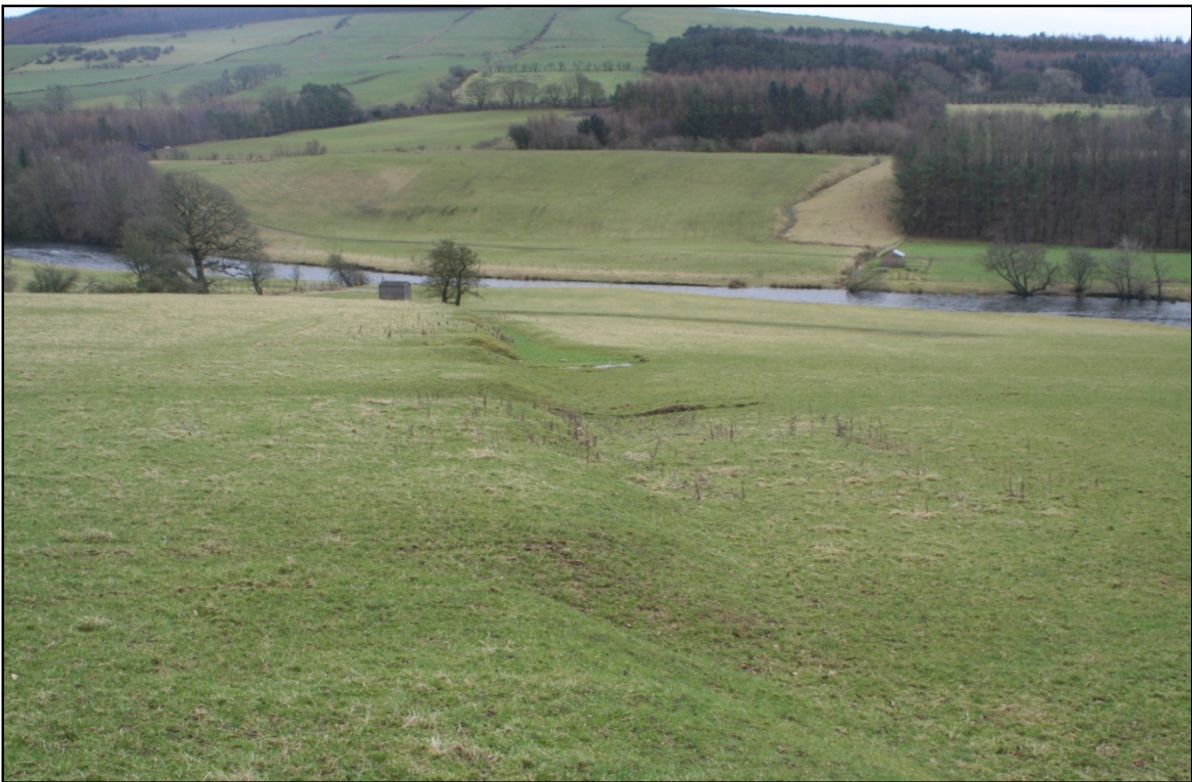
- 3.2.7 Several possible ancient field boundaries were also visible during the walkover survey. These were grouped around the area closest to the villages of Blindcrake and Redmain with the majority south of the latter. These sites included a relic field boundary including mature Oak trees bordering onto a trackway (Plate 3) and distinct field boundary south of Redmain possibly linked with an enclosed field system.

Plate 3: Possible relic field boundary or track way connected to enclosed field.

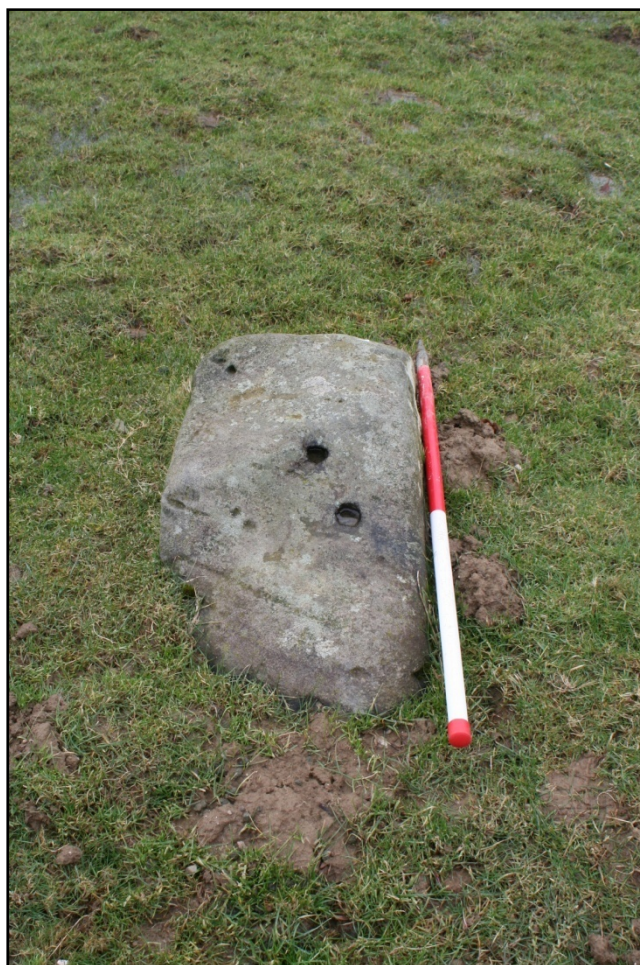
Plate 4: Worked stone on the site of possible archaeological feature North-West of IseI.

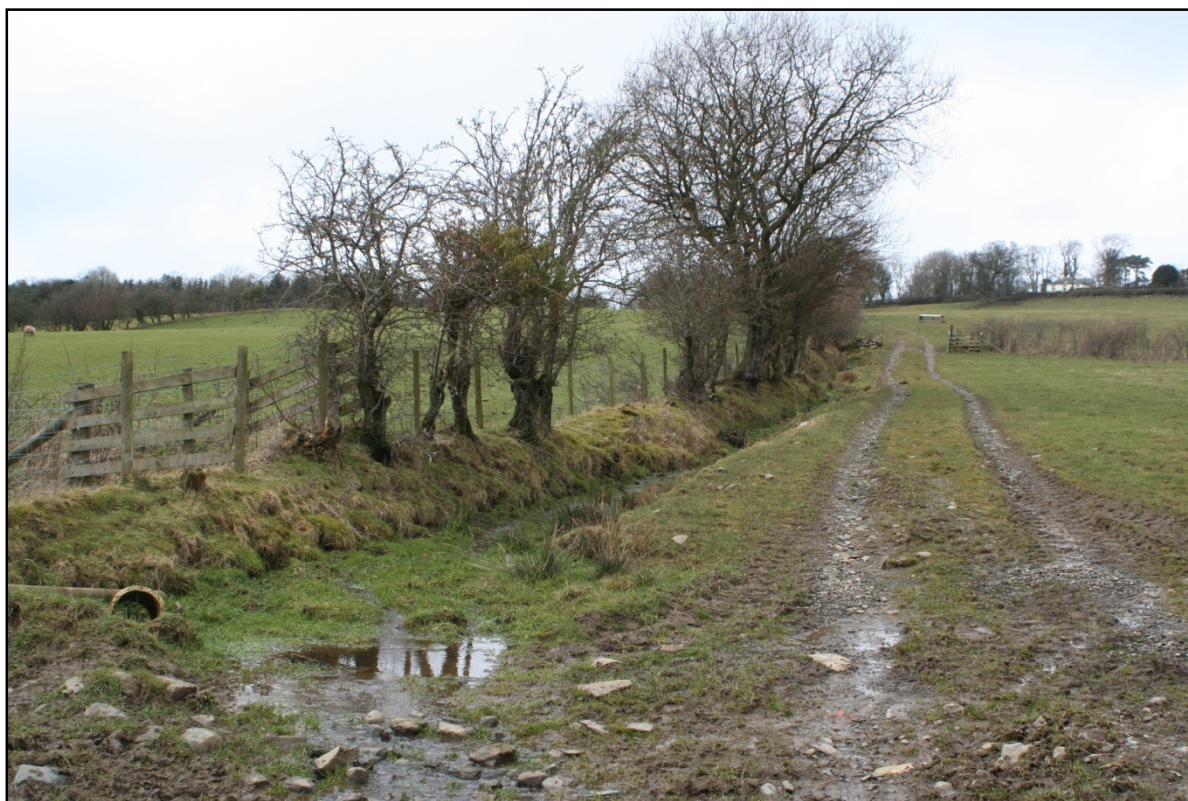
Plate 5: Possible Ancient Hedgerow and Trackway south of Redmain
