FOULSYKE FARM, SILLOTH, CUMBRIA

Archaeological Building Recording

May 2015

DATE ISSUED: May 2015
JOB NUMBER: CP11302
OASIS REFERENCE: wardella2-211202
PLANNING APPLICATION REF: 2/2013/0785

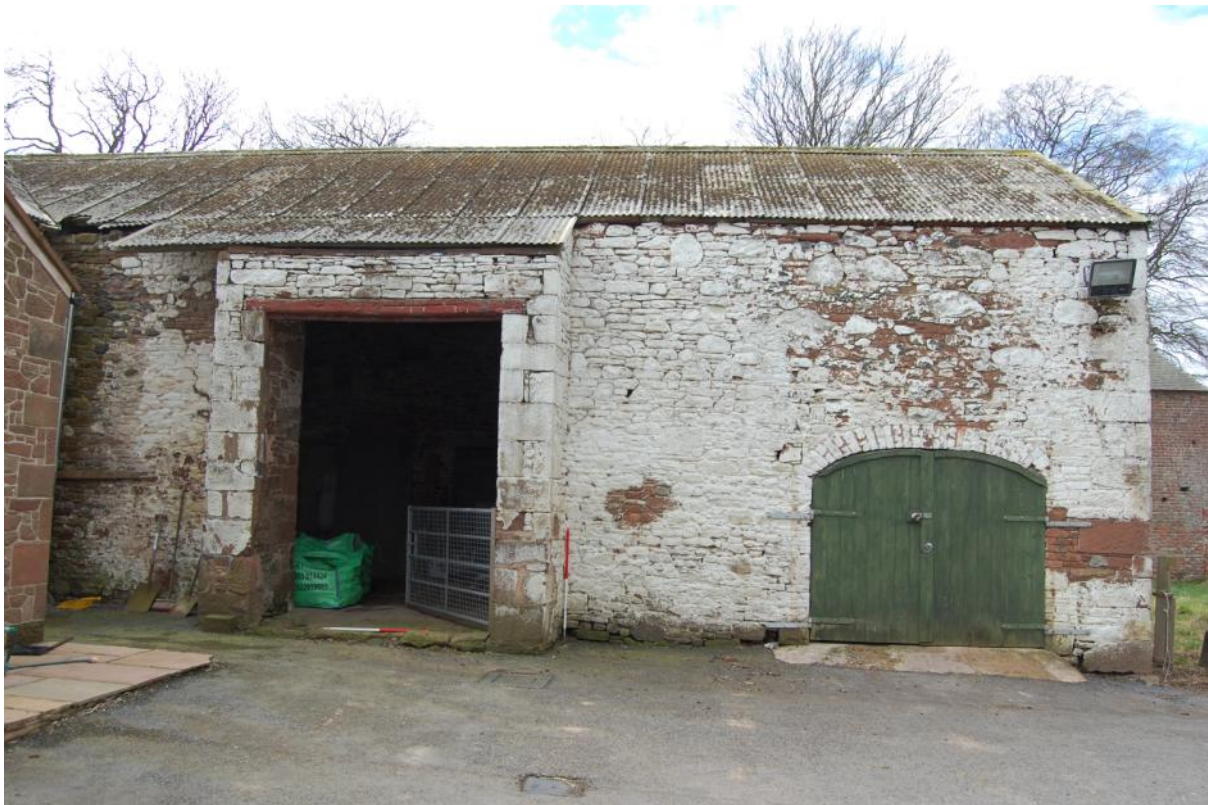
Plate 1: Unit 4 the barn

4.2.1 This consists of two now joined but clearly distinct structures, a barn (4a) to the east with a byre (4b) to the west. The byre was built against the rear flanking wall of the barn and incorporated into it under a cat slide roof. Map evidence indicates that the byre was added between 1847 and 1868 (CA DRC8/93/2; OS 1868 1st ed sheet XXVII.8). The barn is built of crudely-coursed roughly-shaped sandstone rubble with occasional large boulders, whereas the byre is built of quite well coursed shaped sandstone blocks. Both have alternate long and short sandstone quoins at the corners (see Plates 1 and 2).

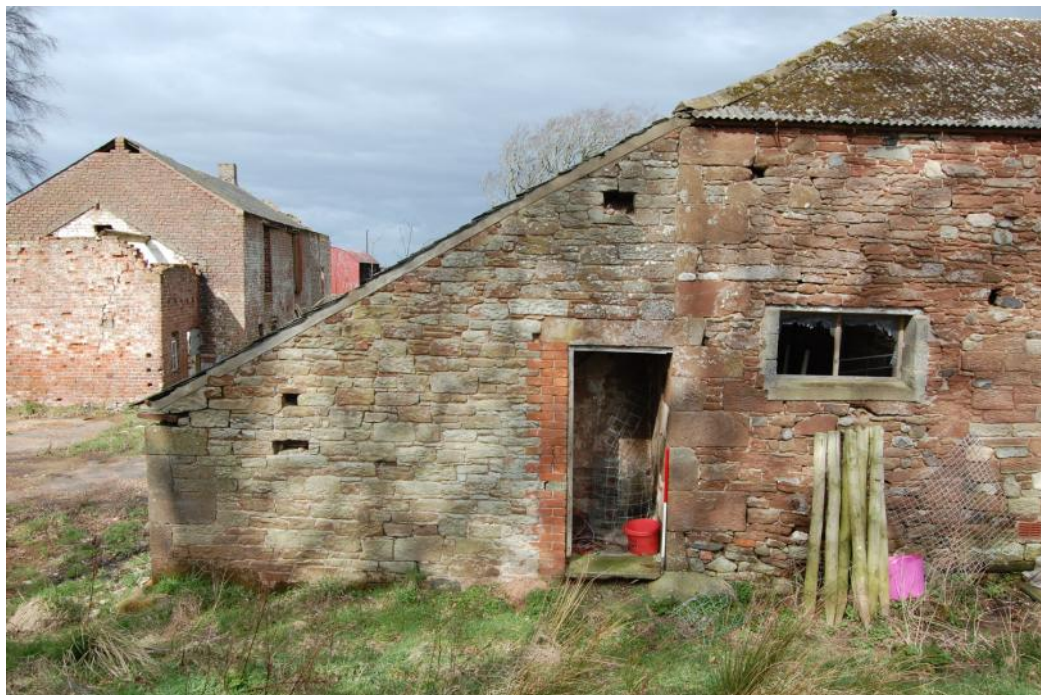
Plate 2: Unit 4; southern gable of the barn with attached byre to the west

lintel (Plate 7). This more southerly doorway is clearly not original to the structure. The northern and southern gables both have doorways in their eastern corners which allowed unhindered movement and airflow directly through the byre. The northern gable doorway has a sandstone surround and is likely to be part of the original build (Plate 5). The southern gable doorway, however, appears to be a later insertion or replacement with machine made bricks forming the western side of the doorway but with a seemingly uninserted sandstone lintel above (Plate 2).

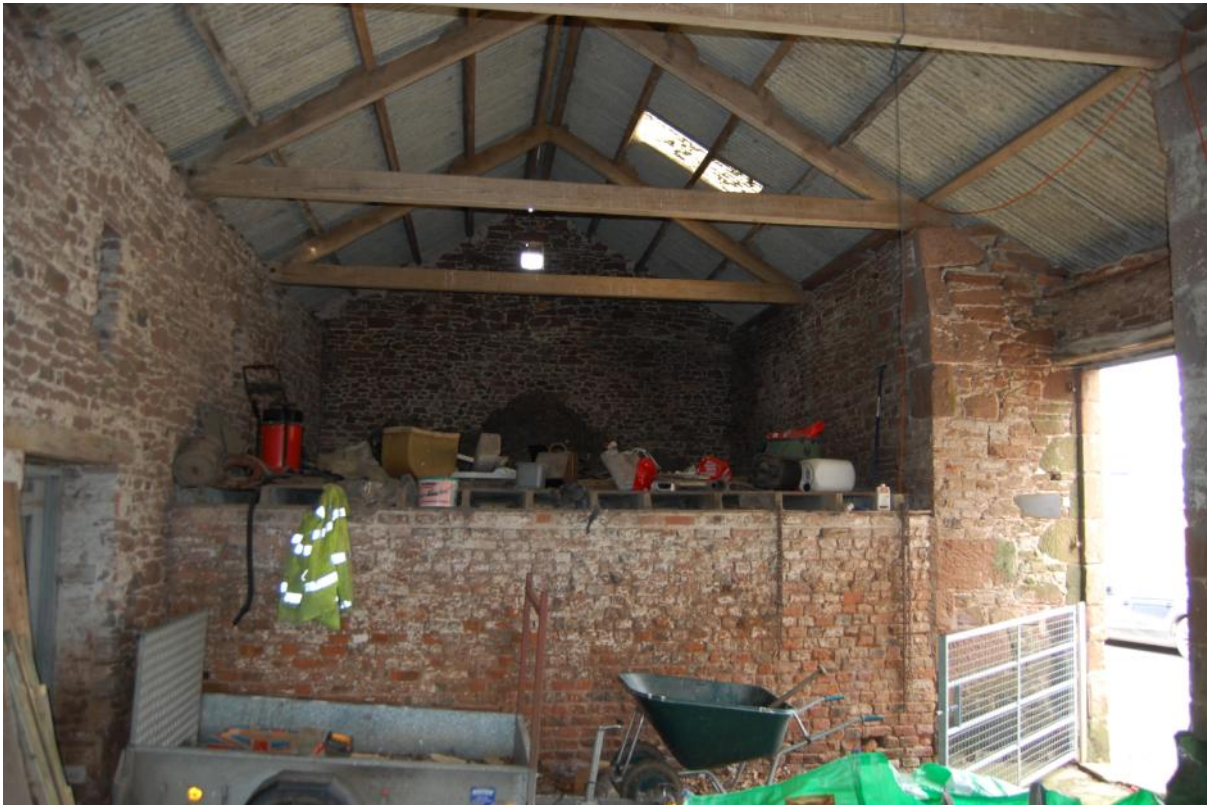
Plate 3: Brick partition wall within barn section of Unit 4

4.2.2 The eastern elevation of structure 4a, the barn, is lime washed. It has a central double width doorway with a porch. The porch front elevation is made of possibly reused sandstone quoins with clear tool marks. To the north is another double-width doorway with a hand-made brick surround and an arched brick lintel formed of stretchers (Plate 1). This doorway is clearly an insertion and probably relates to a change of use of the northern end of the barn which is also evidenced by the internal insertion of a half height hand-made brick partition wall, which blocks the north end of the barn from the rest of structure 4a (see Figure 6 and Plate 3). The space

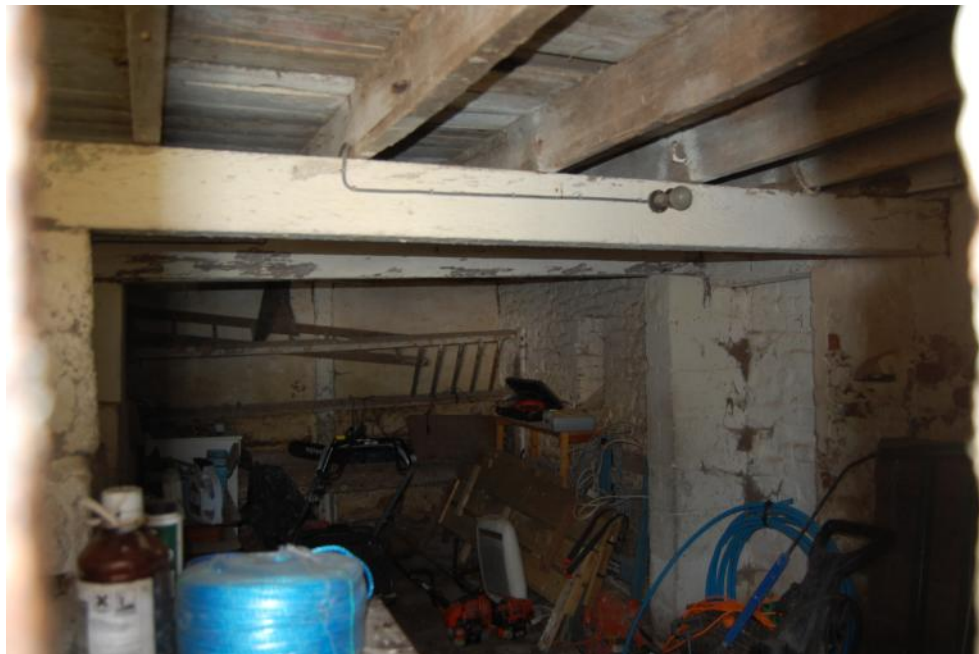
Plate 4: Interior of northern portion of barn Unit 4

created was floored over, creating a half loft above and storage below. This portion of structure 4a is currently used for storage (Plate 4). It is likely that the doorway and partition wall date to the mid-19th century. The southern third of structure 4a has been recently rebuilt along the eastern elevation in block work with a stone outer skin to match the original stone wall. There are no window openings in the eastern elevation of the barn. The western elevation contains seven ventilation slits. The northern gable end has a windowless window opening and an owl hole in the apex (Plate 5). The southern gable end has two recently inserted window openings and has been partially rebuilt recently in conjunction with the southern end of the eastern elevation.

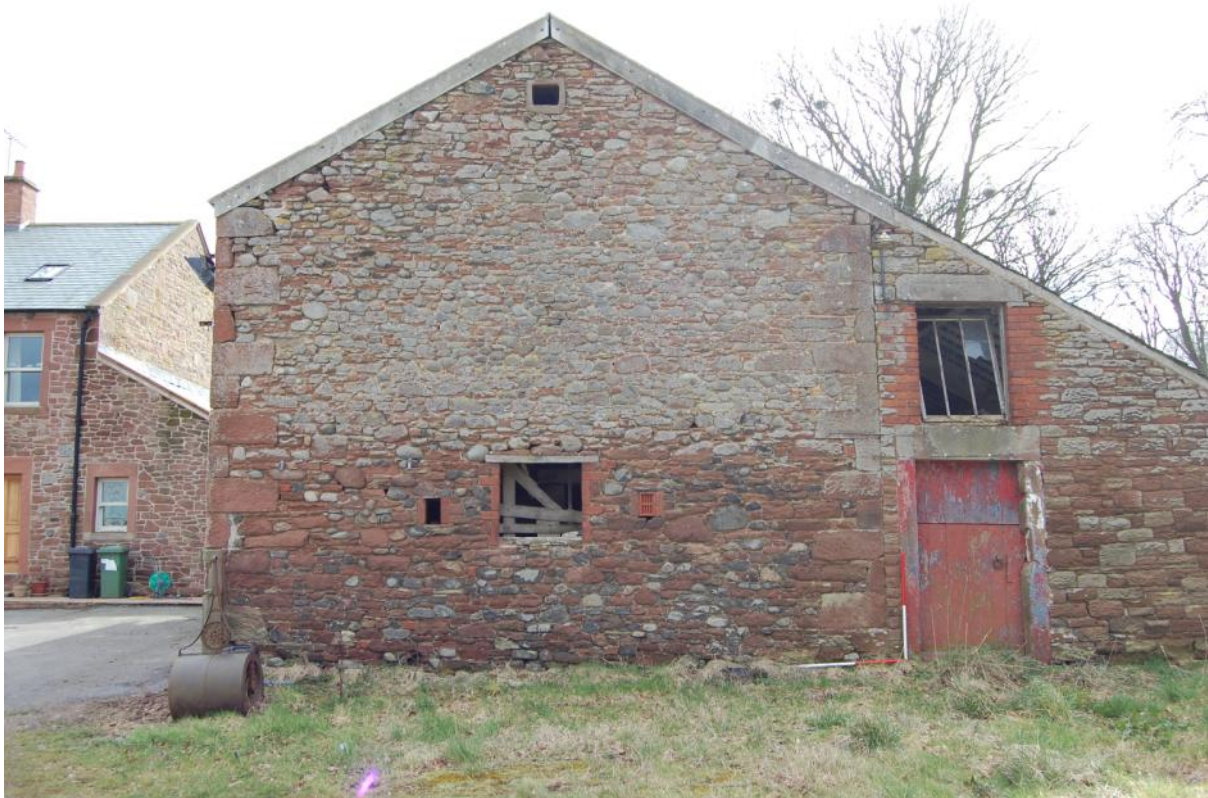
Plate 5: Northern gable of Unit 4

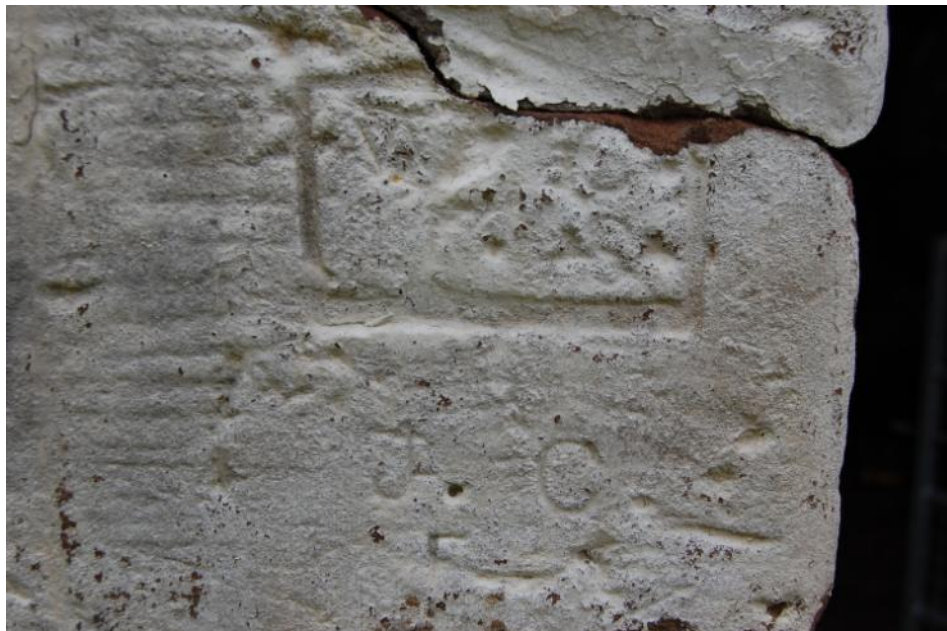
Plate 6: Graffiti on porch of barn of Unit 4

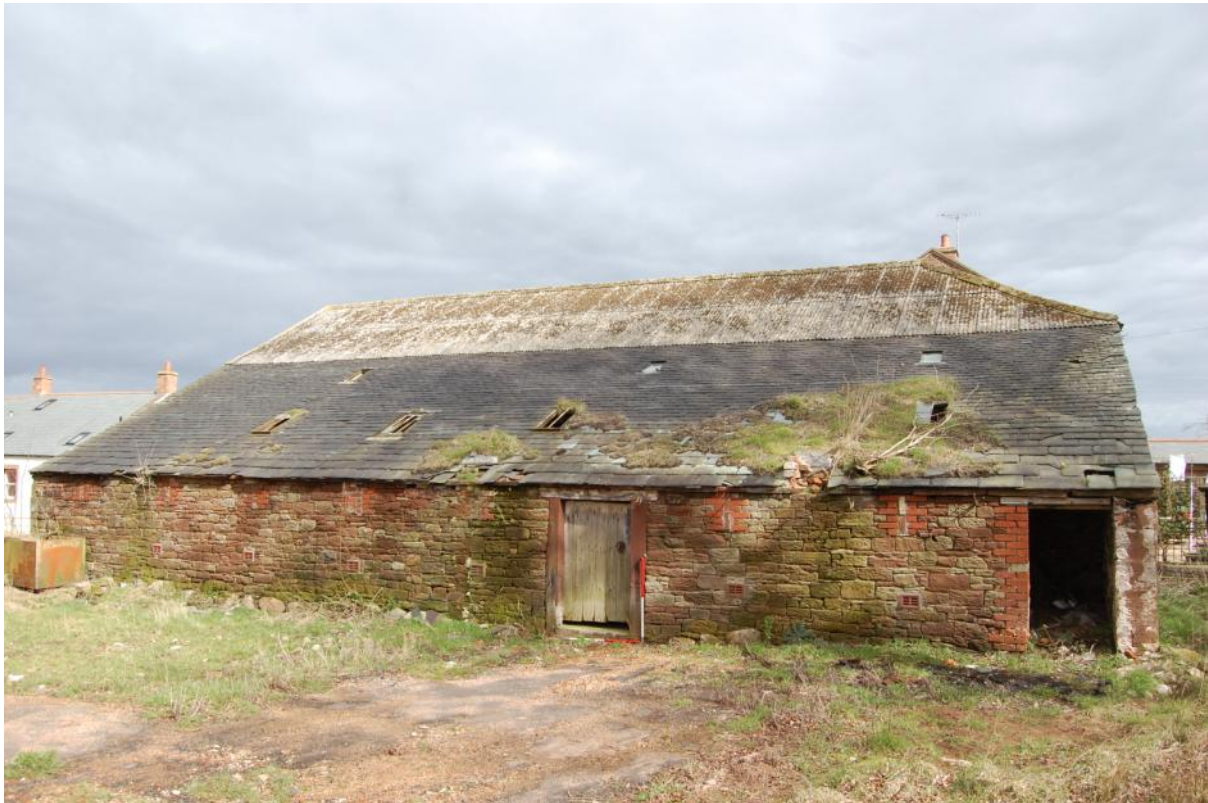
Plate 7: Western elevation of the byre, Unit 4

- 4.2.5 Structure 4b, a byre, has an off centre doorway in its western elevation with sandstone surrounds and a wooden lintel. To the south, in the south-west corner of the building is another doorway with machine-made brick surrounds and a wooden

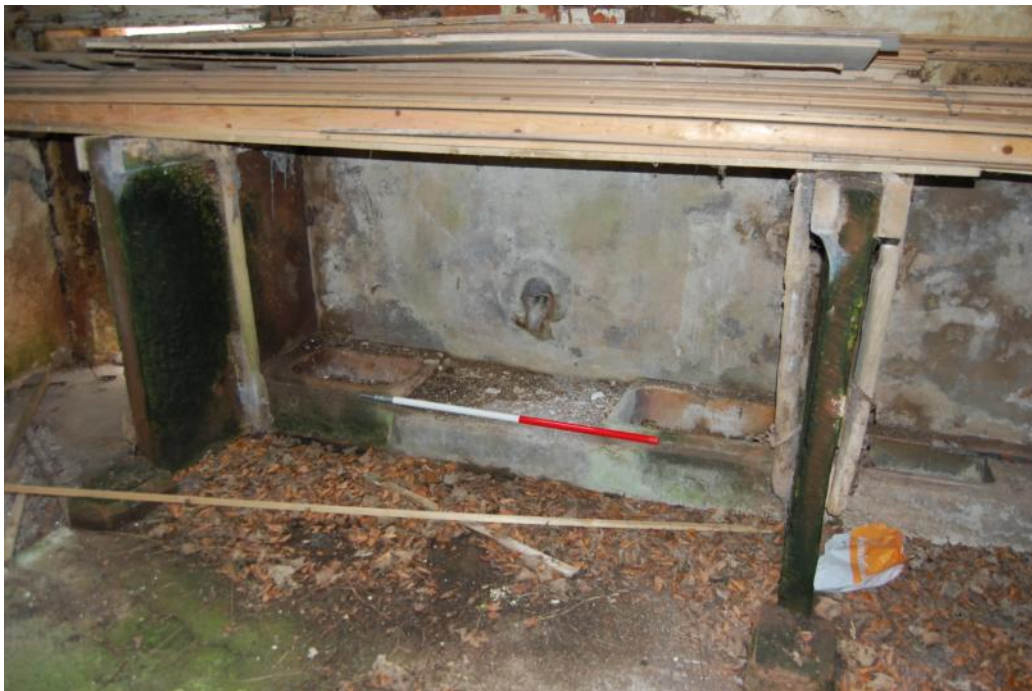
Plate 8: Stalls within the byre, Unit 4

4.2.6 Internally structure 4b has a concrete slurry floor with sandstone slabbed cattle stalls. Lead piping and integral earthenware feeding/drinking troughs may be part of the original design (Plate 8). The roof is relatively modern and made of machined timbers though the slate roof covering is in a poor condition (Plate 9).

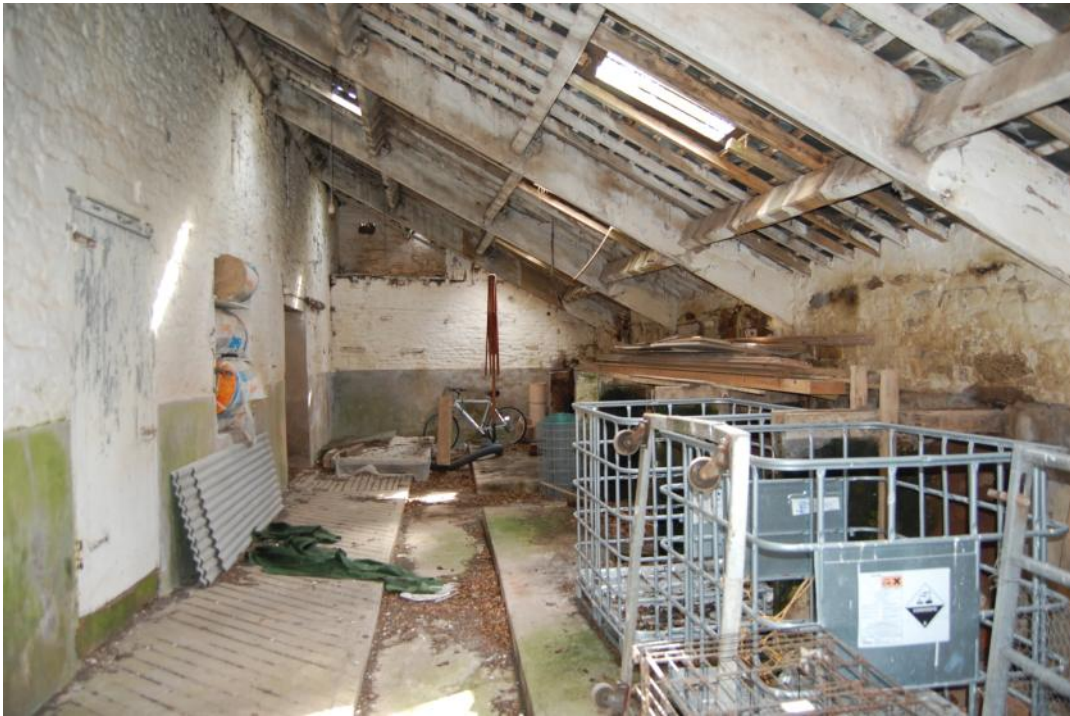
Plate 9: Interior of cat slide roof of byre, Unit 4

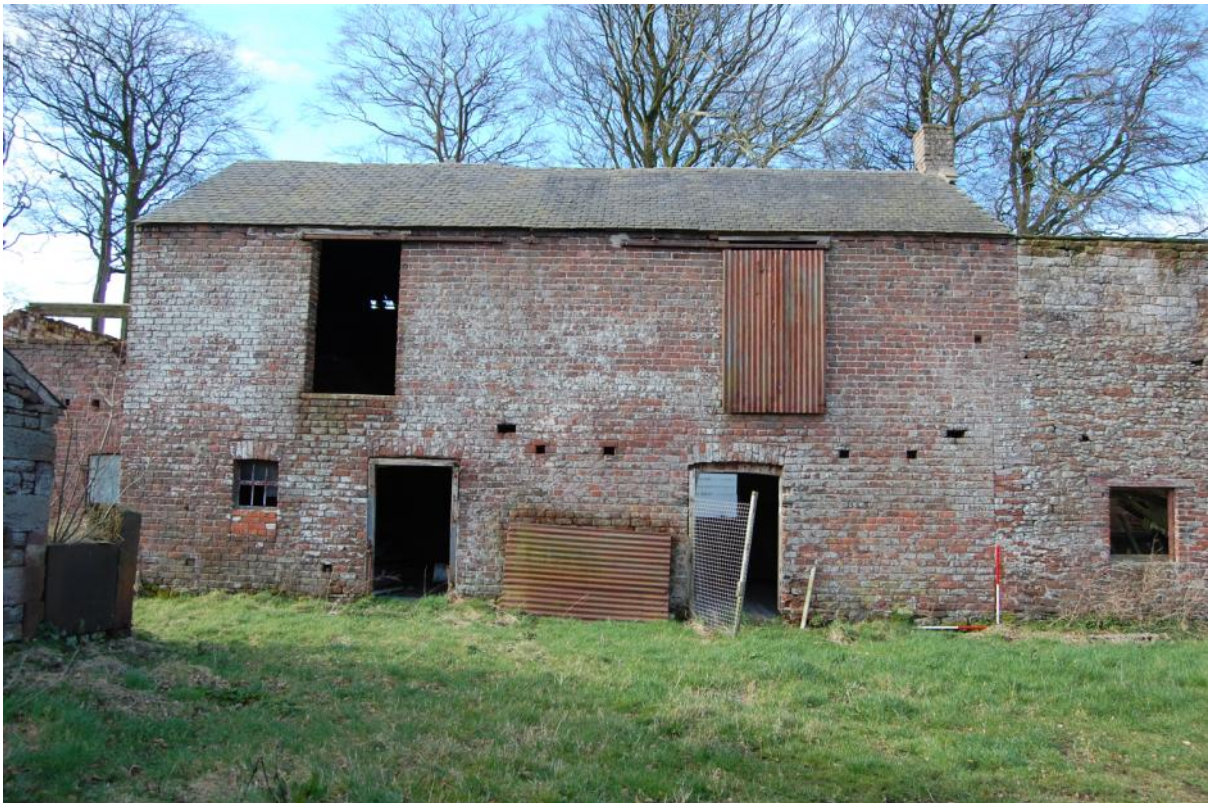
Plate 10: The byre, Unit 5 showing brick bonding style

4.3.1 Unit 5 is located to the north-west of the farmhouse and unit 4, and is orientated north-west to south-east (Figure 2). The Byre (5b) is a two-storey structure constructed of handmade, unfrosted bricks which measure approximately 22cm in length, 6.5cm in height and are 11cm deep, laid in 'Common Bond' (see Plate 10). This consists primarily of overlapping courses of stretchers (the long edge of the brick), but with an occasional course of headers, in this case at around every ten courses. The store (5c) is single-storey and built of similar brick in the same bond as 5b, whilst the domestic dwelling (5a) is two-storey, originally built of local sandstone but with a 20th century rebuild in machine made brick at the northern end of the eastern flanking wall (Plate 11). These bricks were again coursed in 'Common Bond'. The original stone work was roughly coursed mainly of cobbles but with occasional larger roughly squared blocks. The upper storey at the southern end of the eastern flanking wall appears to have been rebuilt using coursed and squared blocks of stone. The bonding matrix for all of unit 5 is a lime mortar except for the machine-made bricks which are fixed with a more modern sandy cement-based mortar.

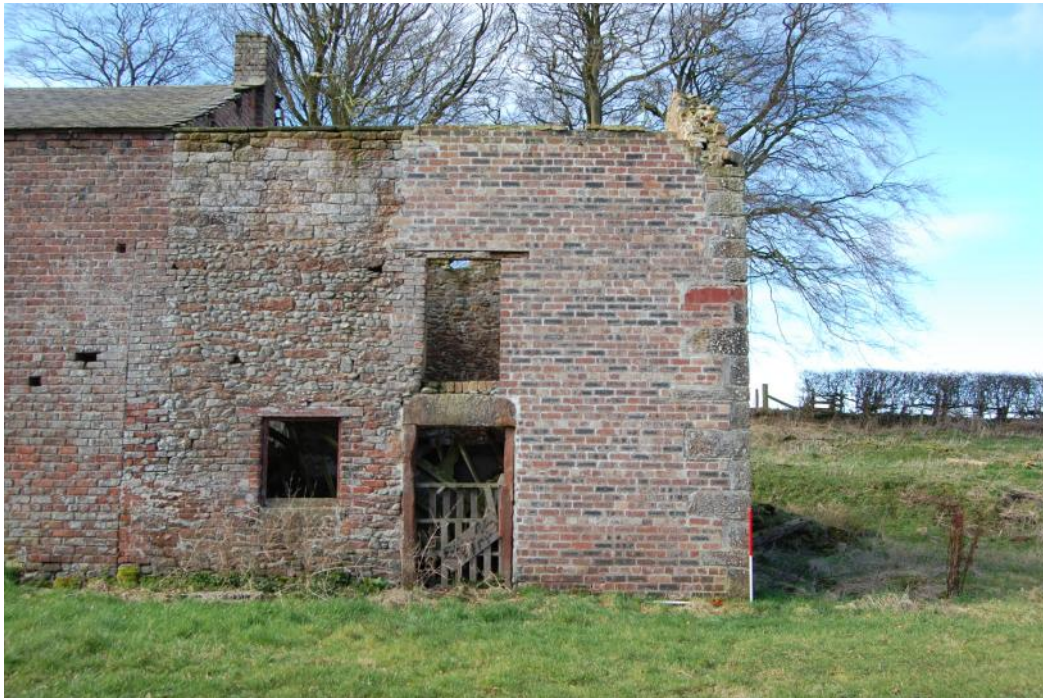
Plate 11: Farm worker's dwelling with hay loft above, Unit 5

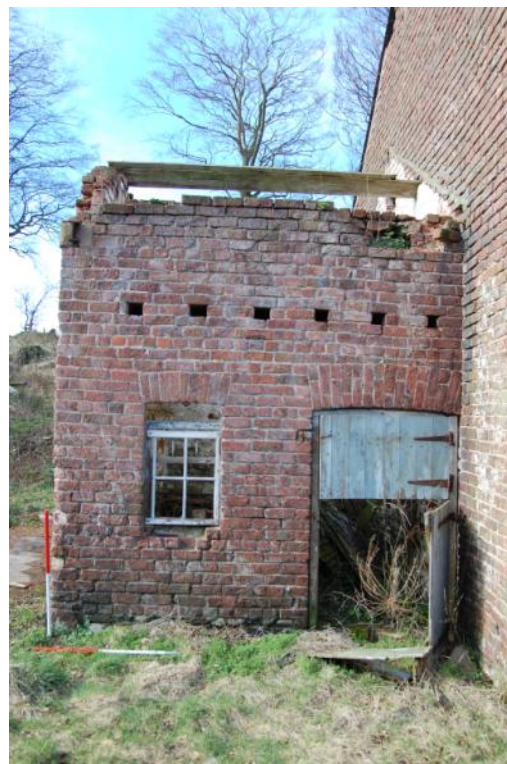
Plate 12: Store/office, Unit 5

4.3.2 The store (5c) is narrower than the byre to which it is attached to the north, being offset on its eastern elevation by about 1m. It is roofless. Its eastern face contains a wooden framed door in the northern corner and a wooden window frame surrounding a sliding sash window (Plate 12). The store has little to distinguish it as a structure other than the sash window which indicates a function that was not purely agricultural. Whilst it may have been used in more recent times as a store, it may

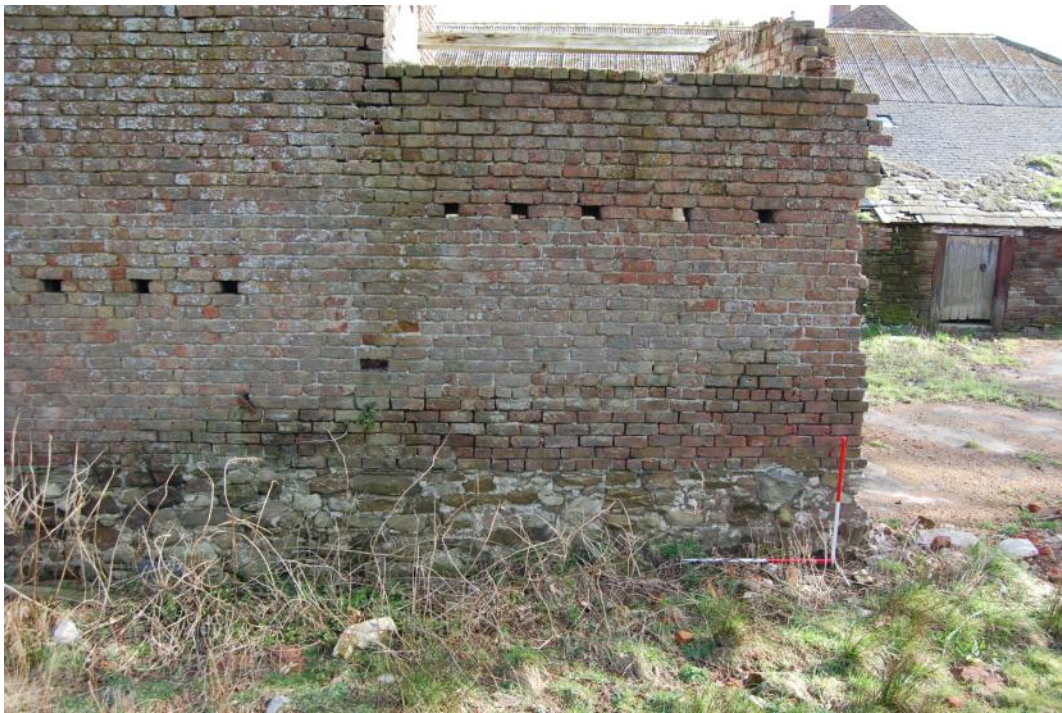
Plate 13: The bonding of structures 5c and 5b, Unit 5

have originated as an office. The western flanking wall shows structure 5c to be integrated seamlessly with structure 5b with the brick courses interlocked and made of the same materials and the foundations consisting of crudely coursed large rubble (Plate 13). A foundation trench stretching to the south indicates that structures 5c and b were once part of a larger structure stretching to the south for an additional 25m (Plate 14). The map evidence shows this larger now demolished building to the south of 5c as in existence by 1900 (OS 2nd edt sheet XXVII.8). The map evidence shows that structures 5b and 5c were erected between 1868 and 1900 (OS 1st edt sheet XXVII.8; OS 2nd edt sheet XXVII.8; Figures 4 and 5).

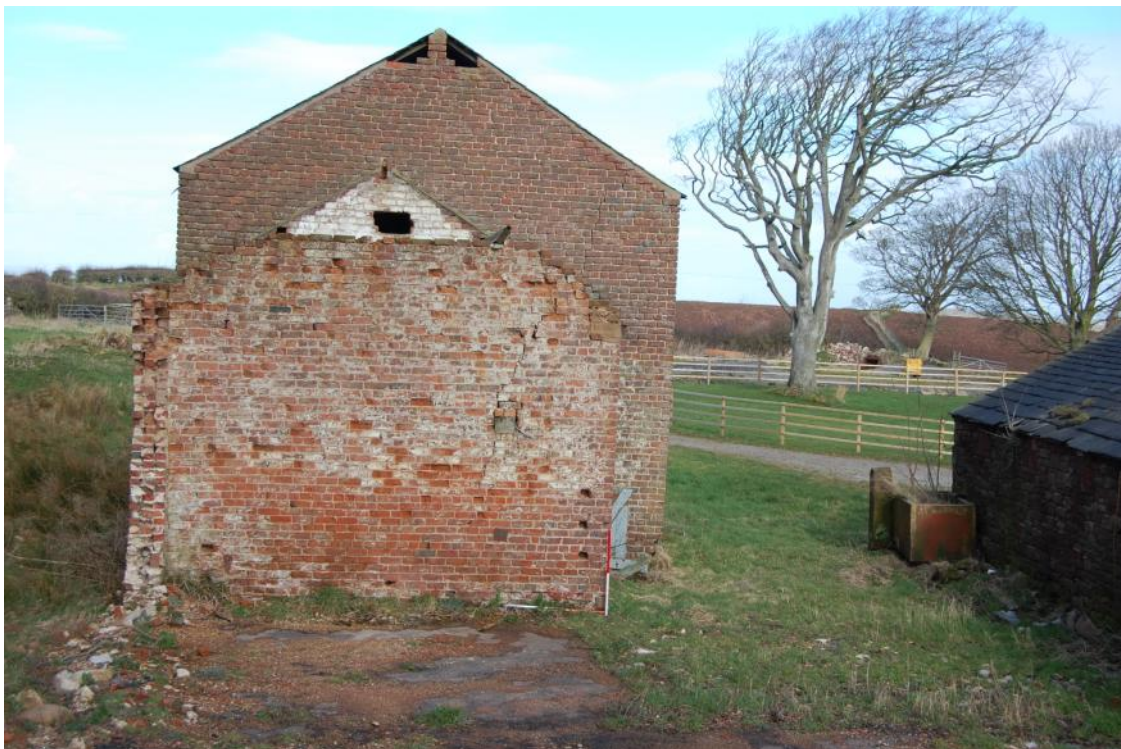
Plate 14: Foundations of building to the south of structure 5c, Unit 5

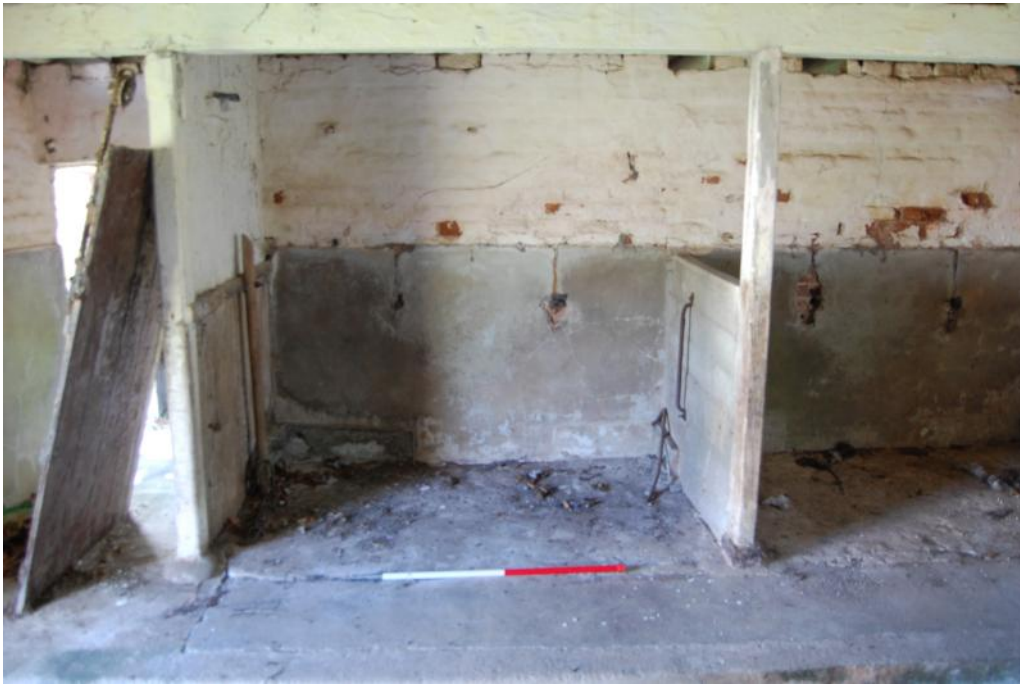
Plate 15: Northern room of structure 5b showing stalls, Unit 5

- 4.3.3 Structure 5b, the byre, consists of a ground-floor byre divided into two rooms with a hay loft above (Figure 7). The eastern flanking wall has on the ground floor two doorways with wooden surrounds and brick alternating header and stretcher built arches above the lintels, as well as a six light wooden framed window with brick stretcher built arch above the lintel (Plate 10). The second floor hay loft has two taking in doors with no surviving surrounds and a sandstone sill visible on the southern of the doors. Internally the ground floor consists of two rooms with five animal stalls in the northern room. The stalls are on both gable walls and are made of concrete (Plates 15). They are divided by a concrete slurry floor and feature ceramic and stone feed/water troughs. The northern room also has a concrete floor but with two, probably original 19th century plank built animal stalls (Plate 16). The loft is accessed by a fixed ladder formed of a notched plank. For reasons of safety the loft was not accessed but the roof structure was visible from the ground floor and seems to be a relatively recent replacement with new purlins attached to the original 'A' frames (Plate 17). The roof covering is small slates.

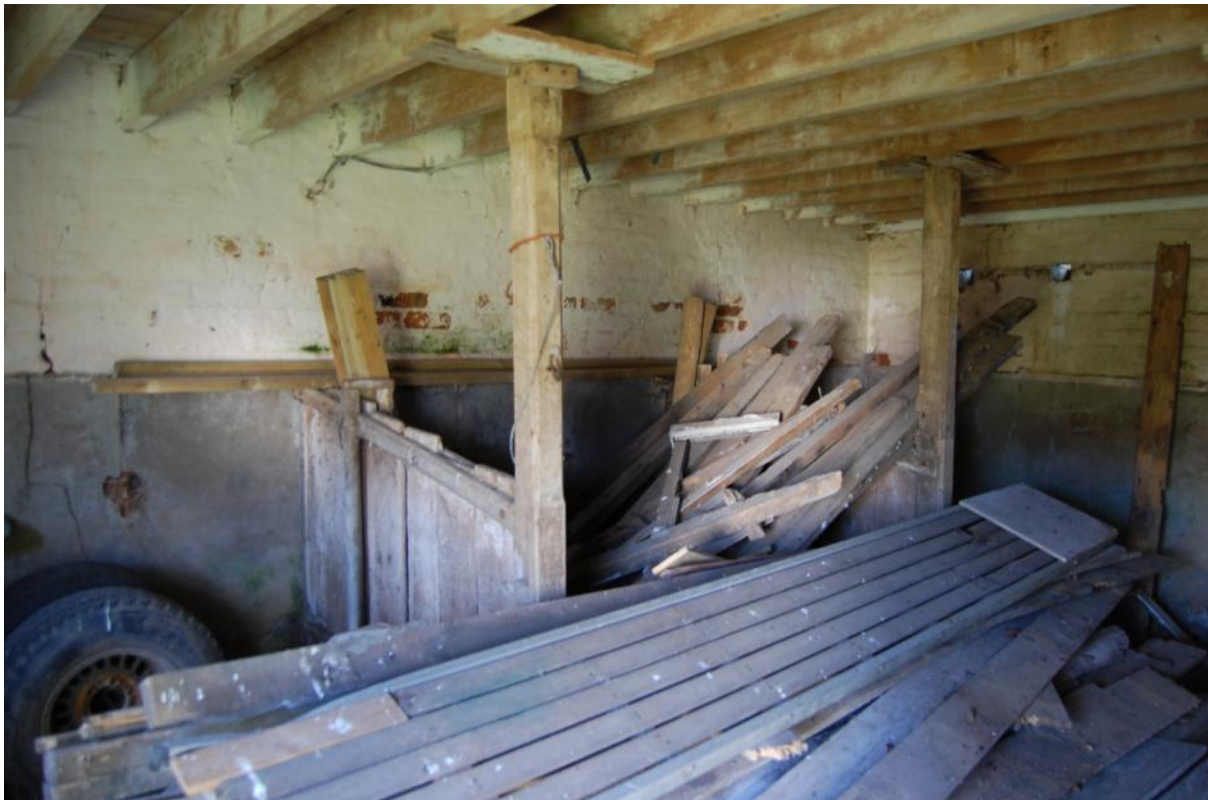
Plate 16: Southern room of structure 5b showing possible 19th century stalls, Unit 5

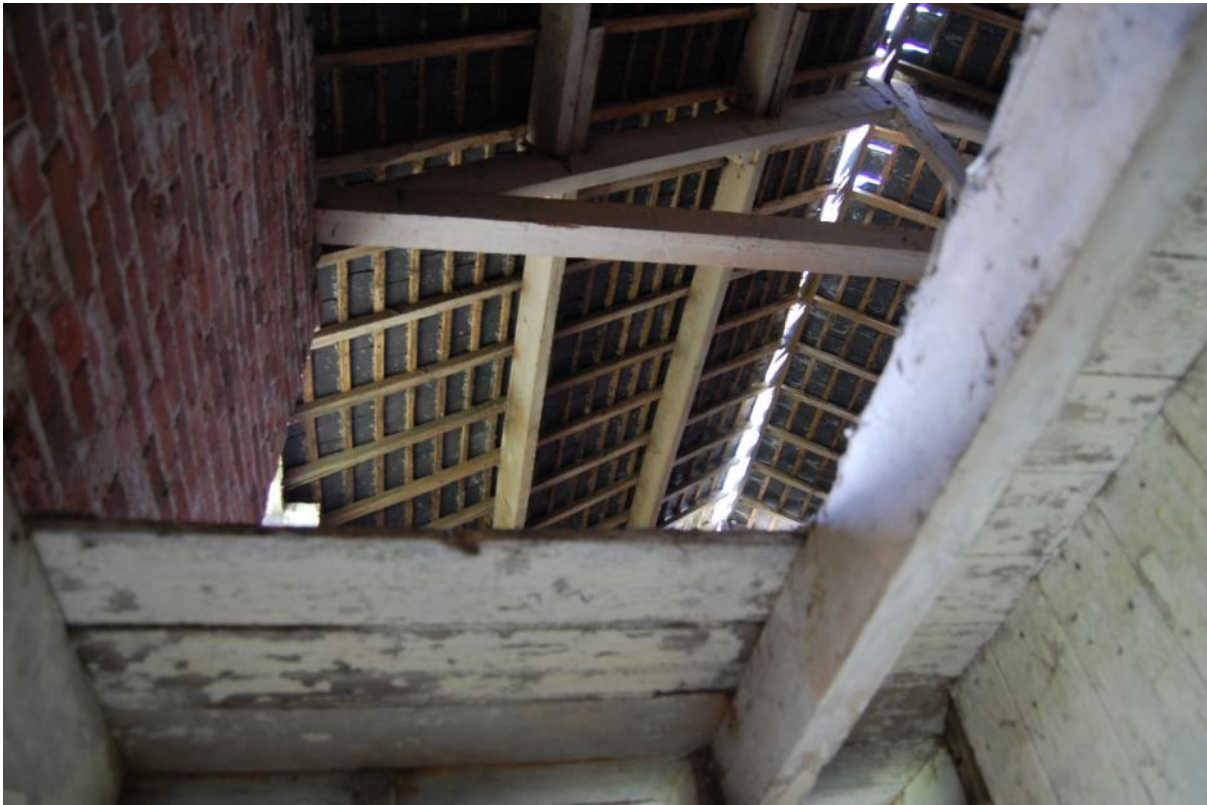
Plate 17: Interior of roof of structure 5b, Unit 5

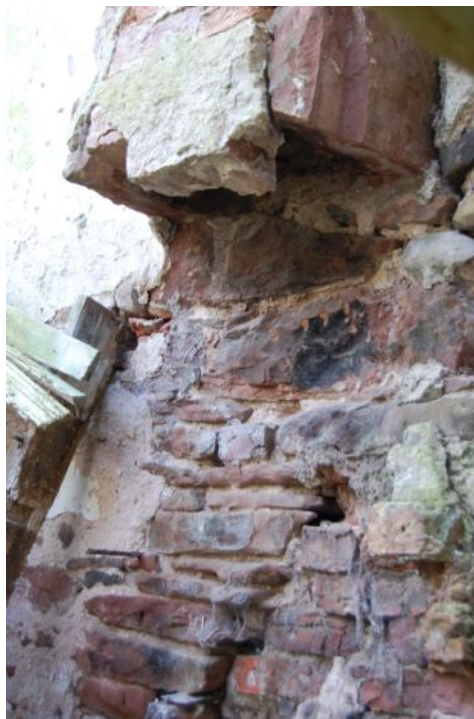
Plate 18: Base of flue in structure 5a, Unit 5

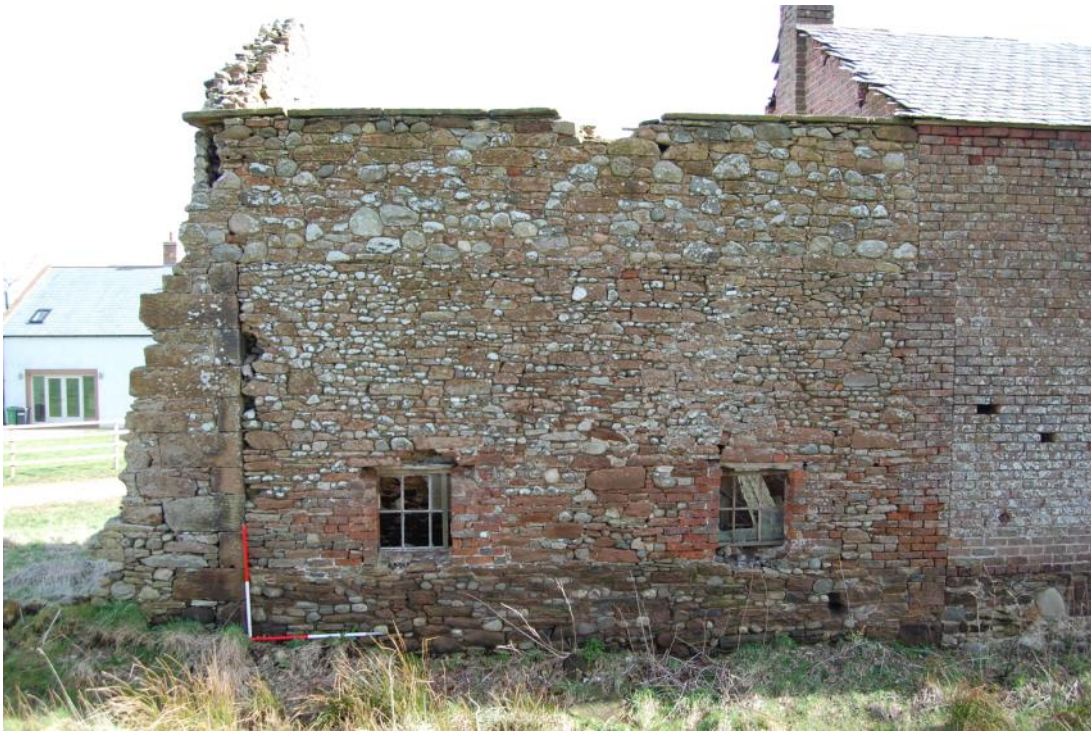
Plate 19: Western elevation to structure 5a, Unit 5

bedrooms. It would appear that domestic accommodation was only on the ground floor because the first floor was accessed via a taking in door on the eastern elevation which, along with the lack of windows to the first floor, suggests that the first floor was used as a hay loft. Rather than a farmhouse, as labelled on the CDL Architectural plan (Figure 7), structure 5a was an agricultural building that incorporated domestic accommodation for a farm worker. This type of accommodation is sometimes colloquially known as a 'paddy house' because it was the type of accommodation used to house poor immigrant Irish farm workers in the mid-later 19th century. This interpretation fits with the documentary dating evidence that indicates that it was probably in existence by 1847 (CA DRC8/93/2). The structural evidence contained in the western elevation suggests that structure 5a was built before structure 5b and that the building of 5b necessitated the rebuilding of the uppermost levels of 5a (see Plate 19).

- 4.3.5 A wall fragment to the north of 5a (Plate 19) indicates that it was abutted by a further stone constructed building that has since been removed. This building is clearly shown to be in existence in both 1847 and 1868 (CA DRC8/93/2; OS 1st edt sheet XXVII.8, Figures 3 and 4). Its demolition post-dates 1900 (OS 2nd edt sheet XXVII.8, Figure 5).

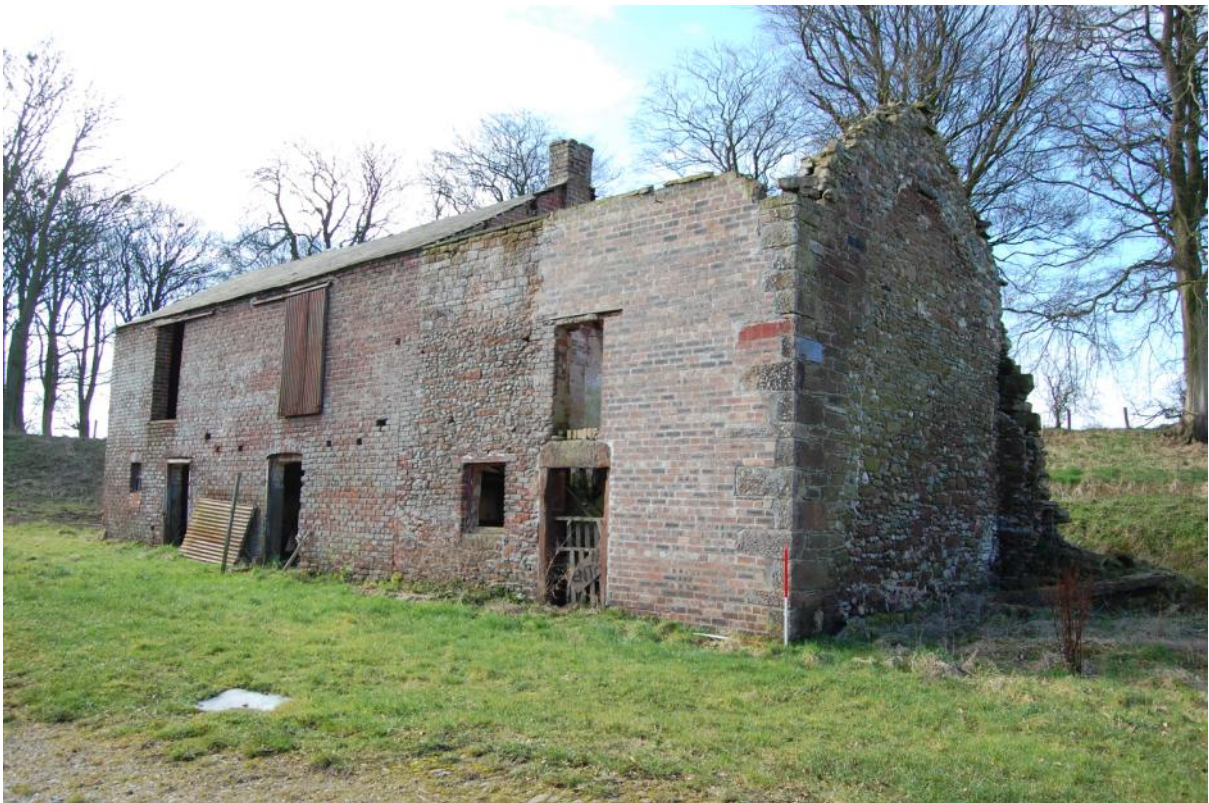
Plate 20: Unit 5

- 5.3 Unit 5 in 1900 was part of a long range of buildings built at different periods and using a variety of construction materials. Unit 5 today is a composite remnant of this building range (Plate 20).

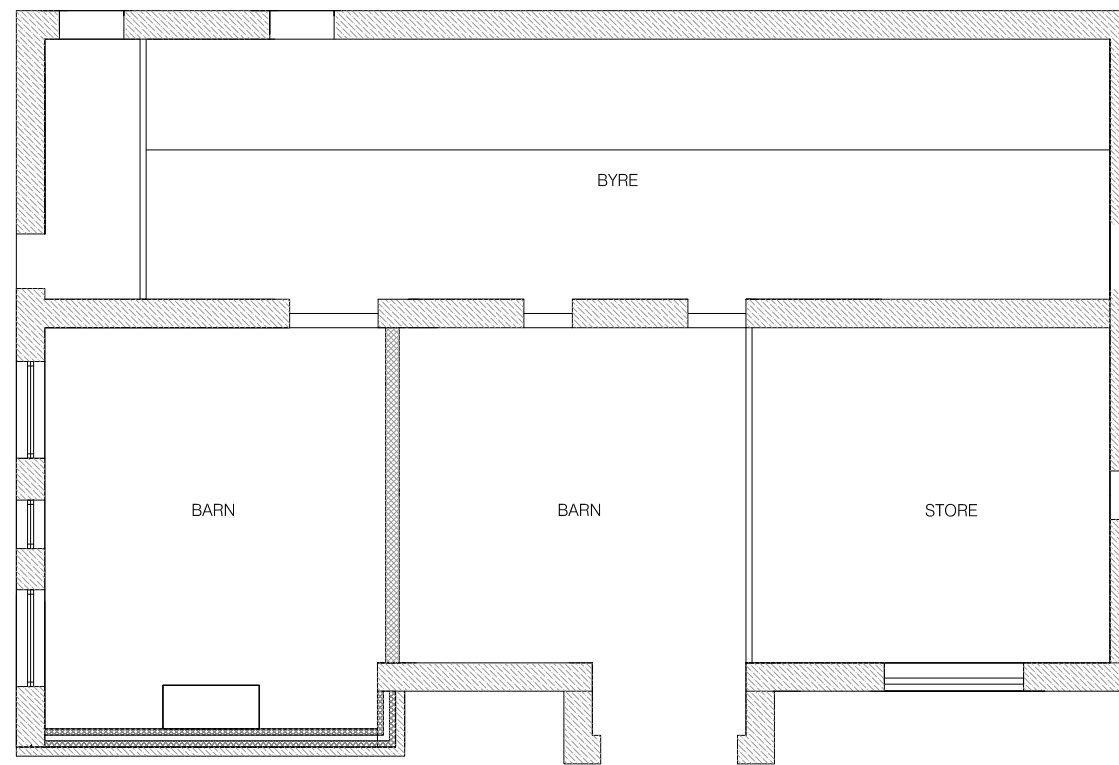
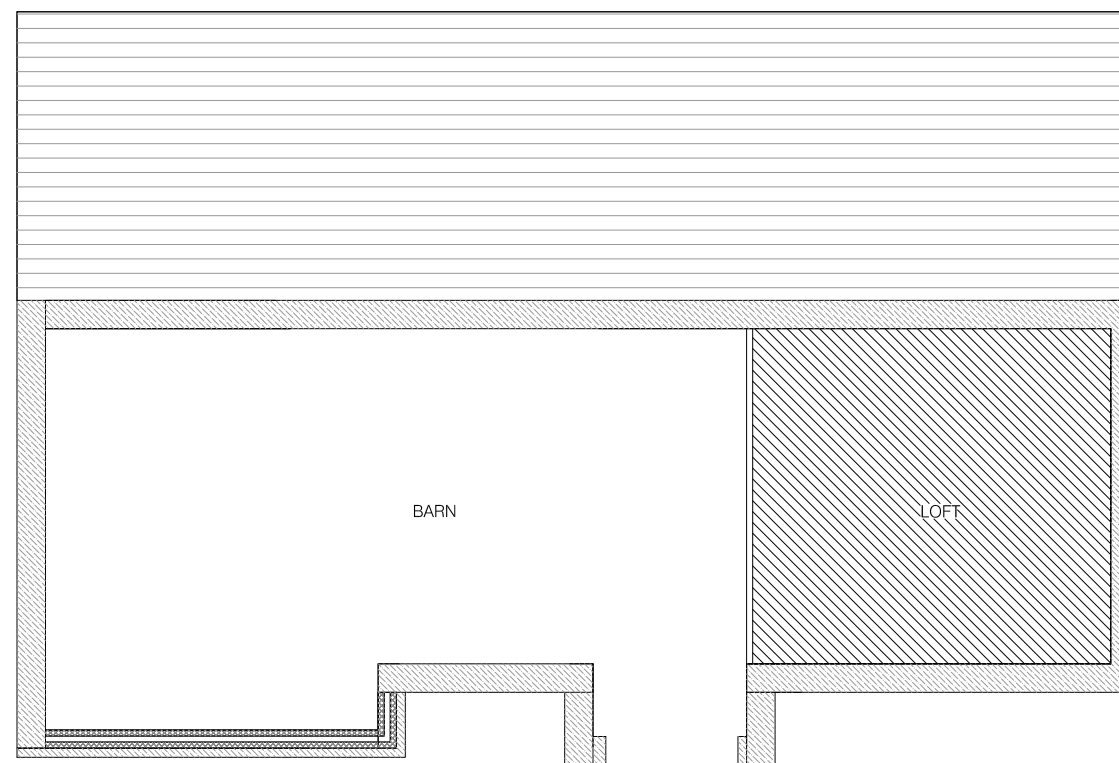
Figure 6: Architect's Plan of Unit 4.

Existing ground floor plan.

Existing first floor plan.

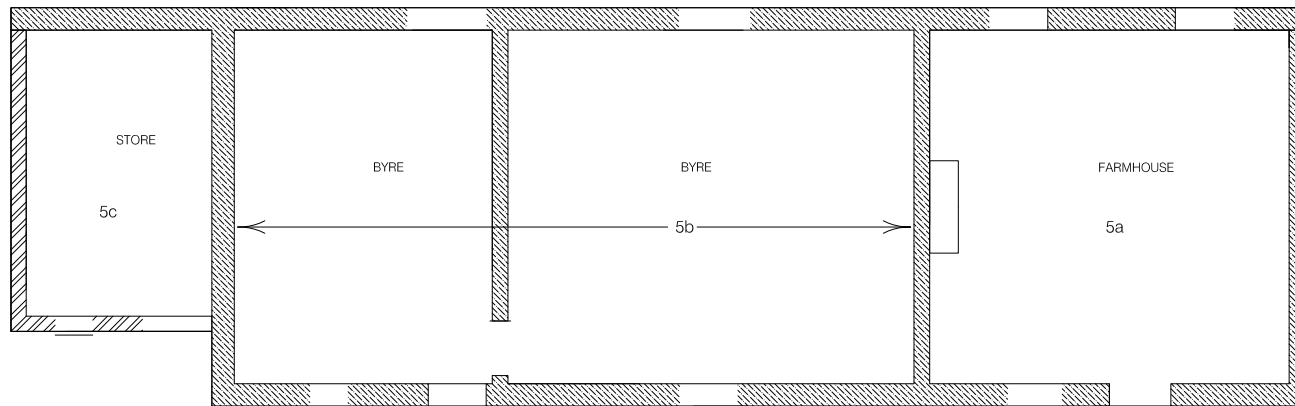
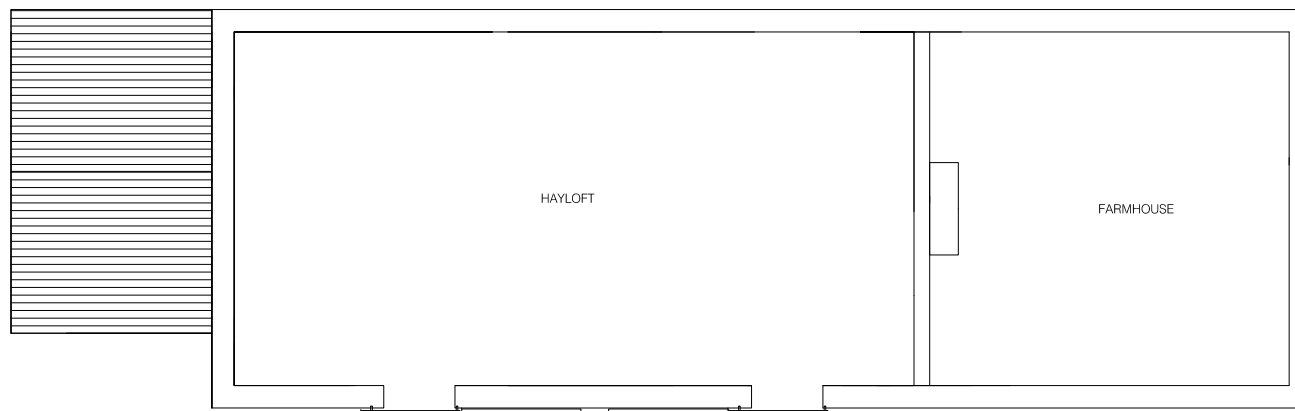
Figure 7: Architect's Plan of Unit 5.

Existing ground floor plan.

Existing first floor plan.
