UNITED UTILITIES

SOUTH EGREMONT PIPELINE, CUMBRIA

ARCHAEOLOGICAL WATCHING BRIEF REPORT

DATE ISSUED: July 2015
JOB NUMBER: CP10973
OASIS REFERENCE: wardella2-218597
GRID REFERENCE: NY 0040 0850 to NY 0855 1531
REPORT NUMBER: RPT-001

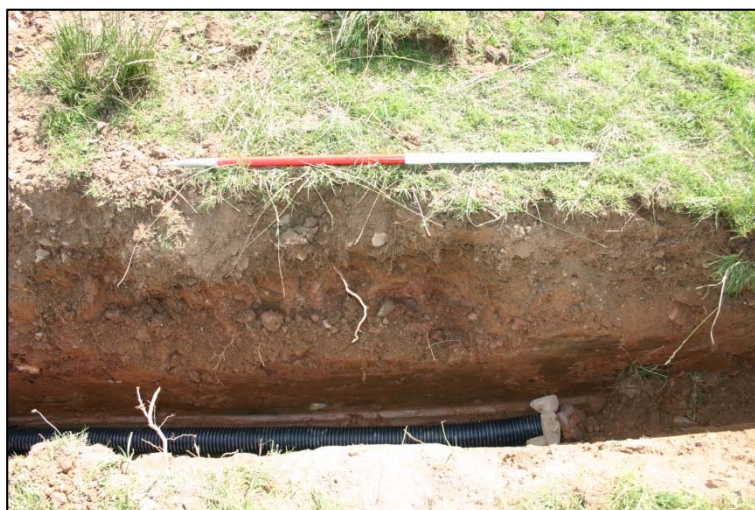
4.2.2 **Fields east of Egremont (Figure 2):** the work at fields to the east of Egremont concentrated on two hedgerow field boundaries, cut through for the pipeline route. The watching brief was maintained to identify and record any associated archaeological features or dating evidence relating to these possible medieval boundaries, or 'kestings'. Excavations for a small drainage ditch 0.4m wide were monitored in July 2014 which ran on a north-south alignment through the fields adjacent to the hedgerows, in areas not targeted by earlier trial trenching. This revealed a mid-brown sandy topsoil averaging 0.35m in depth overlying an orange sandy natural (Plate 1).

Plate 1: North facing section of drainage ditch excavation

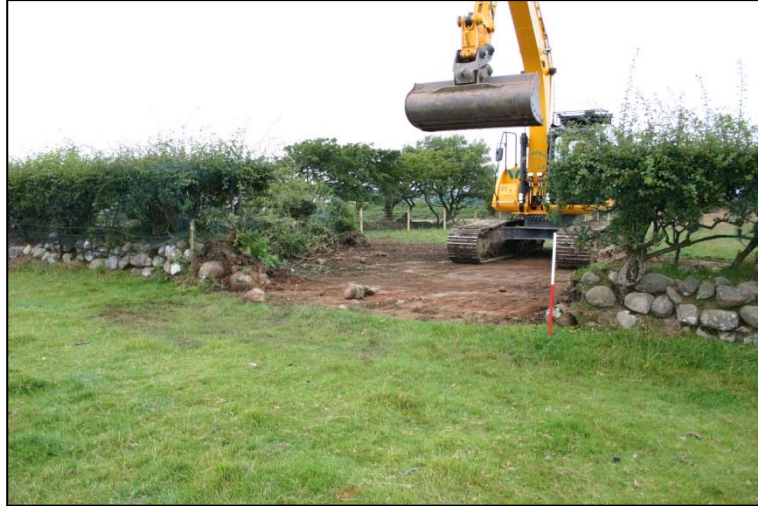
4.2.3 Two of the field boundaries were also cut through as part of the groundwork operations to provide an easement for the pipeline (Figure 2; Plate 2). No features or finds were encountered during this monitoring.

Plate 2: Northernmost hedgerow, facing south-east

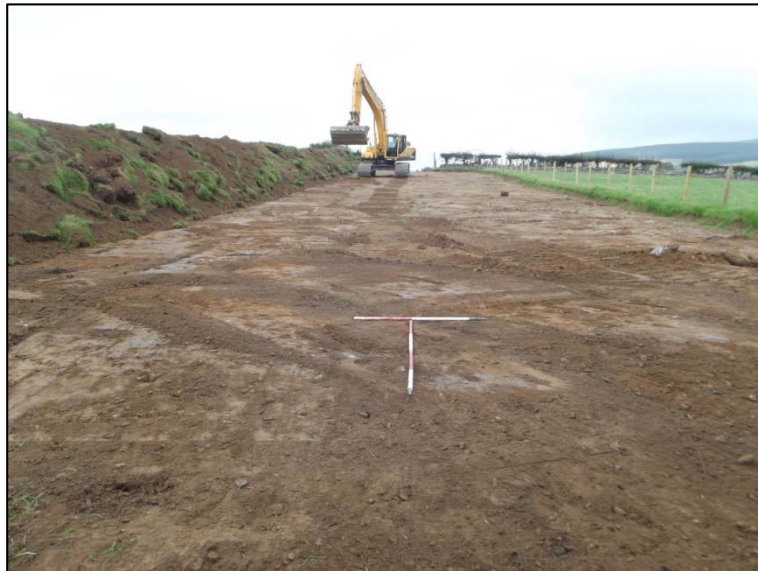
4.2.4 In September 2014, the three fields surrounding the two hedgerow field boundaries were stripped of topsoil to provide an easement area for the water pipeline route. This area was 10m wide stripped to a maximum depth of 0.4m (Plate 3).

Plate 3: Northern extent of topsoil stripped area facing south

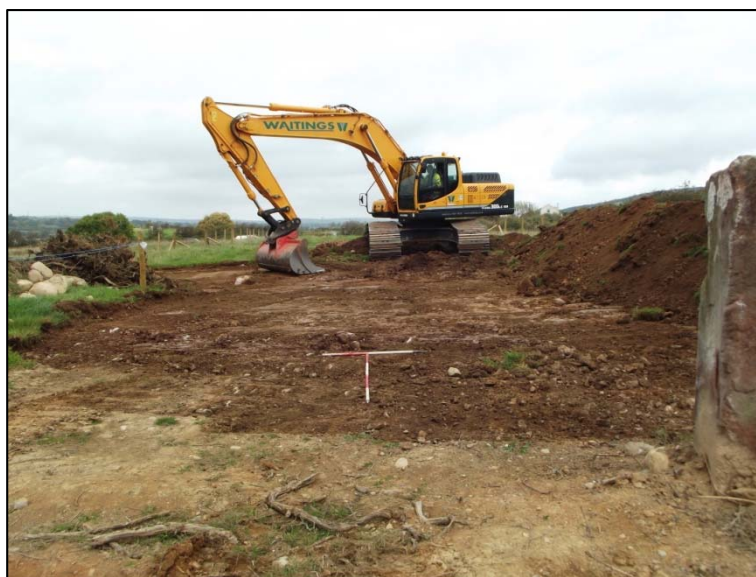
4.2.5 Two areas of disturbance, consisting of linear areas of pink clay and broken brick and tile backfill, were encountered to the immediate north of the northernmost hedgerow field boundary, and these related to the locations of previous pipelines inserted 16 years earlier running parallel to the hedgerow field boundary (Plate 4). Some fragments of pottery were observed from within the topsoil, of late 19th or early 20th century origin, and these were not retained. No finds or features of archaeological interest were encountered during the archaeological monitoring of the works undertaken in the fields to the east of Egremont.

Plate 4: Area of disturbance to north of northernmost hedgerow field boundary, facing north

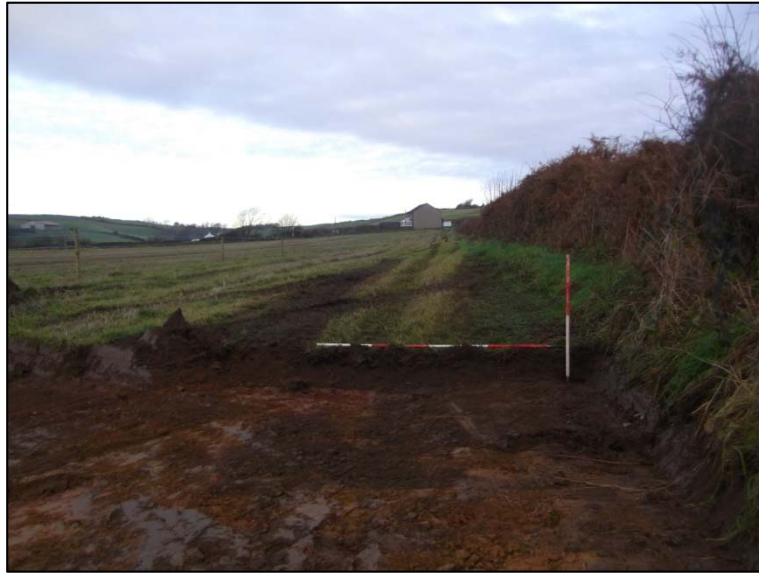
4.2.6 **Land at Snellings Farm:** the archaeological monitoring at Snellings Farm was undertaken in November 2014, in the south-east corner of the field to the north of the farm buildings (Figure 3). The works required the stripping of topsoil across an area 20m wide along the southern boundary of the field, widening at the eastern extent to meet an existing entrance into the field. The depth of topsoil removed varied between 0.2m and 0.35m and consisted of a mid-brown loose soil. Beneath, was a mixed sandy orange-brown natural (Plate 5).

Plate 5: Soil strip in south-eastern corner of field north of Snellings Farm, facing north

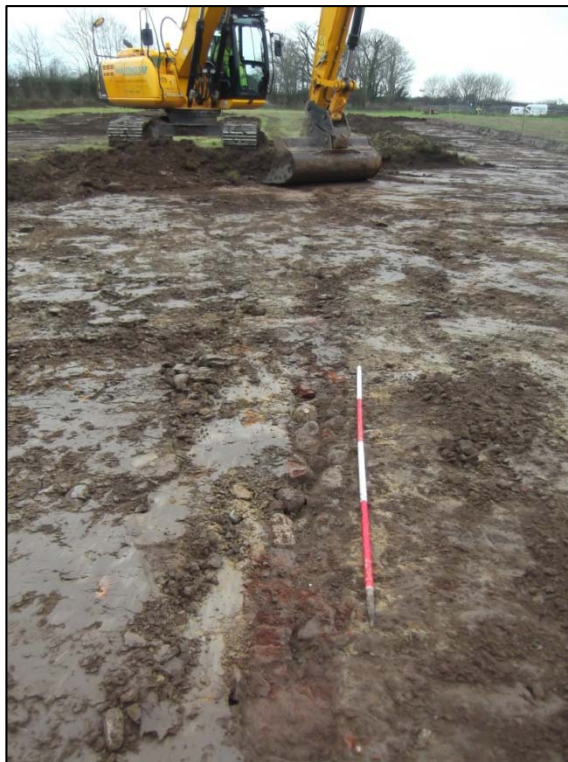
- 4.2.7 Four north-east south-west orientated field drains of mixed rubble and brick make-up were encountered in the south-eastern part of the field of between 0.27m and 0.37m width and 5.5m apart (Plate 6).

Plate 6: Second northernmost field drain, facing west-south-west

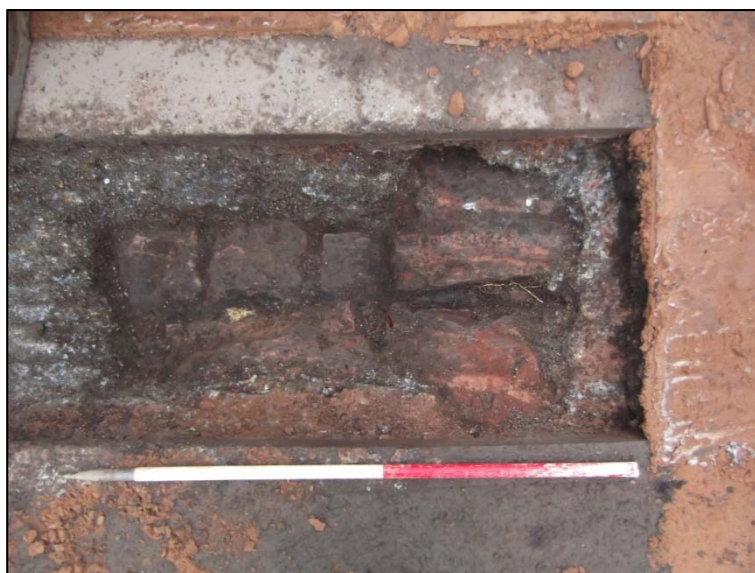
4.2.8 **Church Street, Cleator:** the works on Church Street initially involved the excavation of seven test pits to find out where existing services and obstructions were along the street to inform on the route for the pipeline. Test Pit 1, towards the western extent of Church Street, had been started prior to archaeological supervision beginning. This measured 2m in length and 0.64m wide, and had exposed some sandstone blocks on a north-south orientation at 0.15m below the tarmac ground surface, with smaller sandstone blocks to the west (Plate 7). The excavations had stopped at this level once these structures were encountered. The test pit was extended eastwards across the entrance to the United Utilities water works, uncovering a further section of the possible southernmost edge of a sandstone wall at 0.5m below the tarmac road surface on an east-west orientation (Plate 8). The final depth reached at the eastern side of the test pit was 1.1m, and the area to the south of the archaeological features consisted of a mixed backfill.

Plate 7: Features in western part of Test Pit 1, facing north

Sandstone features encountered at the western extent of Church Street in Cleator line up with walls shown on early mapping, predating United Utilities entrance to their water works. It is likely that these remains or similar, may exist in other neighbouring areas. No other archaeological remains were encountered during excavations on the Church Street site.

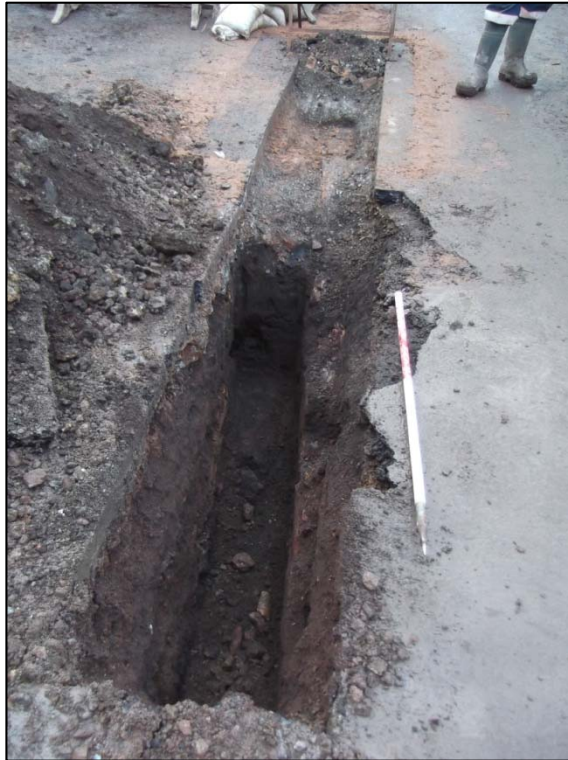
Plate 8: Features in eastern part of Test Pit 1, facing west

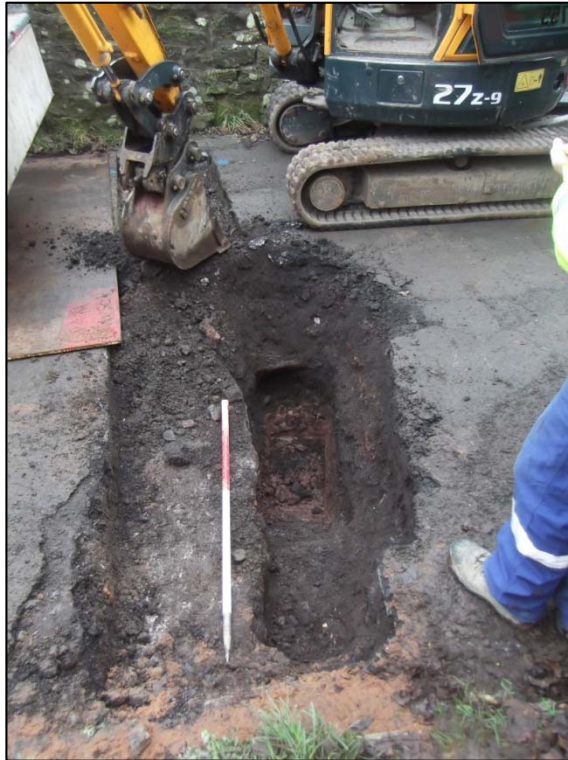
4.2.9 Six further test pits were excavated, spaced at irregular intervals along Church Street, spanning its width, and measuring 0.64m in width (Figure 4). All revealed a high level of disturbance through existing services and back-fill deposits beneath the road make-up deposits, with an orange natural clay or sand noted at varying depths between 0.65 and 0.85m beneath the existing tarmac road surface (Plate 9). No features or finds of archaeological note were observed in these test pits.

Plate 9: Natural revealed in southern part of Test Pit 2, facing north

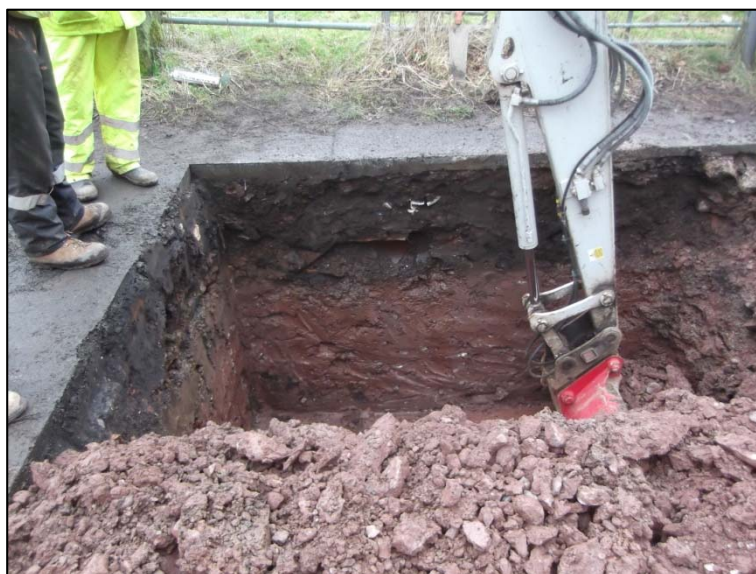
4.2.10 In January 2015, three drill pits were excavated along Church Street, for drill launch and inspections for the drilling of the pipeline route along the street. Drill Pit 1 was located by the entrance to the United Utilities water works entrance towards the western extent of Church Street (Figure 4). This measured 2.55m north-south, 3m east-west and to a final depth of 2m and revealed a natural consisting of a pink-orange clay at 0.9m, beneath road make-up deposits and existing services (Plate 10).

Plate 10: Natural revealed in Drill Pit 1, facing north

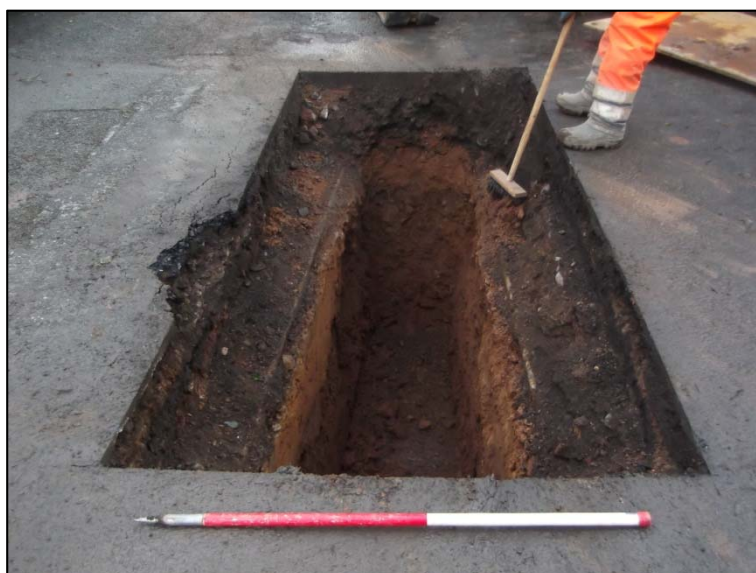
4.2.11 Drill Pit 2 was excavated to the north of the entrance to St Leonard's Church (Figure 4). This was 1.55m north to south and 3.25m east to west and excavated to a depth of 2m. Two service pipes were encountered at a depth of 0.45m, so only the central 0.8m was excavated to the final depth. Natural orange sand was exposed in this central area at a depth of 0.7m (Plate 11).

Plate 11: Drill Pit 2, facing east

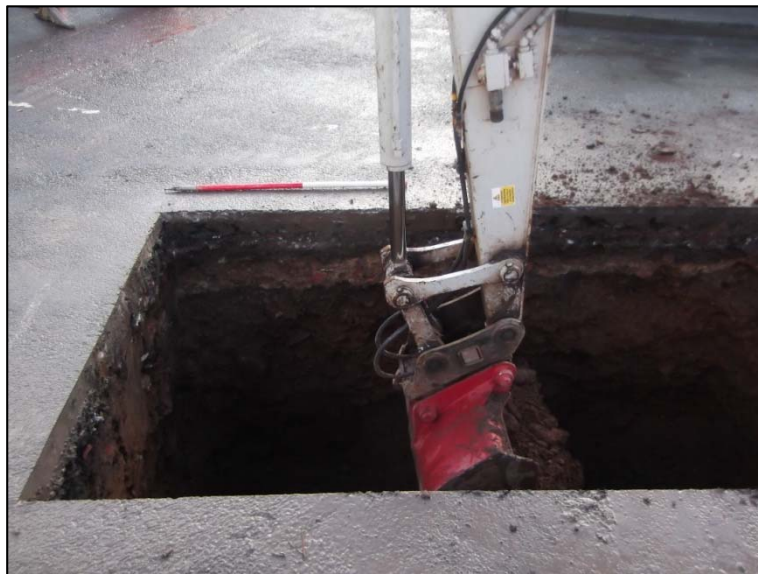
4.2.12 Drill Pit 3 was excavated at the eastern extent of Church Street, on the northern side (Figure 4). It measured 3.25m east to west and 1.5m north to south and was excavated to a depth of 2m. It revealed 0.1m of tarmac road surface, overlying 0.1m of hardcore make-up deposit above a thin black silty deposit of 0.05m, which in turn overlay 0.15m of crushed stone and brick make-up deposit which overlay an orange sandy natural at 0.6m depth (Plate 12). This area had not been disturbed by modern services.

Plate 12: North facing section of Drill Pit 3, facing south
