LAND AT CRAIGHOUSE, CRAIGHOUSE ROAD, EDINBURGH

ARCHAEOLOGICAL EVALUATION REPORT

AUGUST 2015

DATE ISSUED: AUGUST 2015
JOB NUMBER: CP11334/15
SITE CODE: CES-A
OASIS REFERENCE: Wardella2- 220140
GRID REFERENCE: Centred on NT 2343 7062
REPORT NUMBER: RPT-001

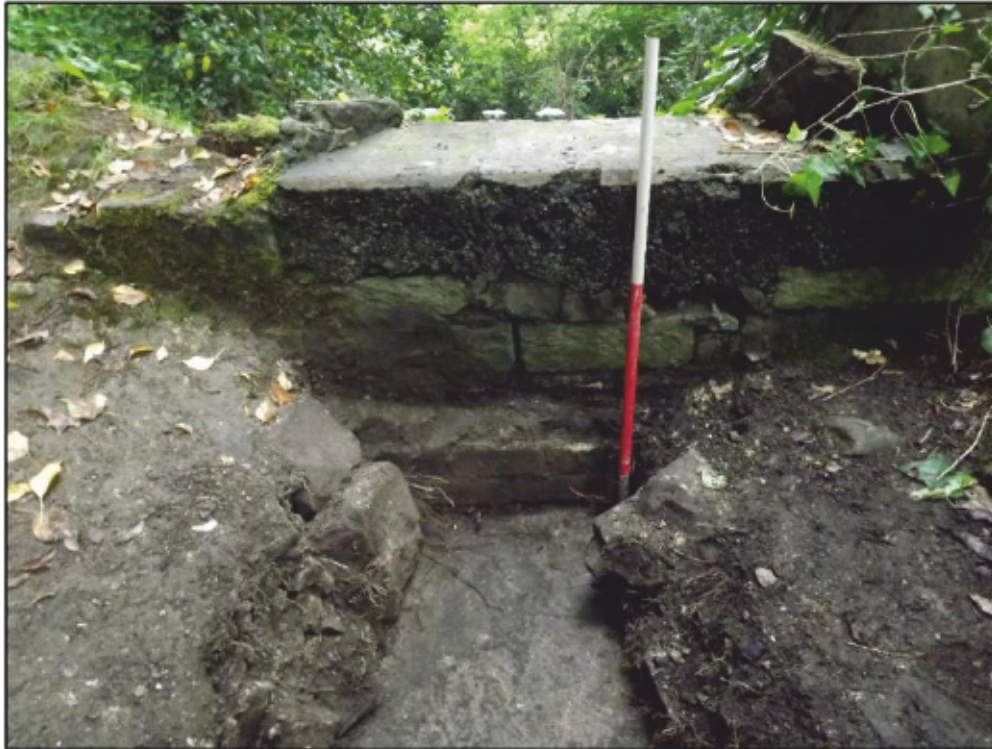
Plate 1: Structure {1200}; Trench 1, looking north

4.2.1 **Trench 1:** Trench 1 was located through the centre of a former dovecote to the north of Old Craig (Figure 3) (Plate 1). The trench was hand dug with the aim of finding any evidence relating to the date of the structure. The structure {1200} was rectangular shaped and measured 6.7m by 5.54m. Partial remains of the wall {1208} were observed of which the north and east sides were the best preserved. The west and south sides were in a poorer condition, though evidence of a doorway was observed in the southern wall. The wall consisted of roughly worked stone blocks and measured 0.60m – 0.75m thick by c.1.10m high. The outer and inner sides of the walls were rendered with a thin layer of concrete {1209}.

4.2.2 Within the interior of the structure there was a concrete floor {1202} that was sealed by a loose blackish/dark brown mix of redeposited soil, debris and rubble (1201) that measured c.6m by c.4.5m by 0.32m – 0.59m. The concrete floor and its construction cut [1203] were not fully excavated. The centre of the north side wall appeared to have been filled in with courses of brick and stone. At the base of the wall there were two courses of bricks {1207} that projected out from it and was abutted by {1202}. It measured 0.25m wide by 0.20m high. Above it, was a cement filler layer {1206} that was 0.10m thick. There were three rough courses of dressed stone blocks {1205} which were laid on top of {1206} that measured 0.3m high. This had a large concrete slab {1204} was placed on top of it that appeared to be a window sill. On the outer side of the north wall, the bottom courses of {1200} were observed. The stone base {1210} consisted of a

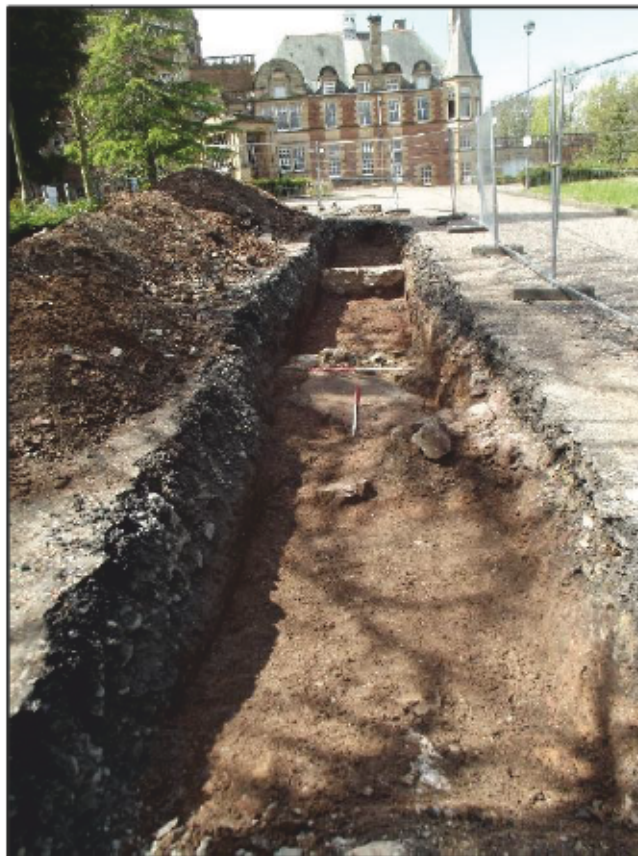
Plate 2: Trench 2, looking west

4.2.4 **Trench 2:** Trench 2 was located to the northwest of Old Craig, in the small car-park on the southern side of the road that leads up to New Craig and was aligned east-west (Figure 4) (Plate 2). The trench was excavated to a maximum depth of 1m, revealing firm mid purple/brown sandy clay (209) with a patch of purple/brown bedrock (208) below c.0.5m of loose mid brown hardcore/backfill (205). This deposit contained pottery, glass, bone, CBM and coal waste and c.0.18m of loose light brown hardcore (204). These deposits were on the northern side of the trench, separated by a thin concrete footing (203) which ran the length of the trench below the tarmac. This footing, which originally had kerb-stones laid above it, separated deposits (204) and (205) from a later deposit laid down during the construction of the car-park. At the western end of the trench, there was a thin concrete footing which was aligned north to south and measured 0.5m in height. It appeared to be part of the construction of the car-

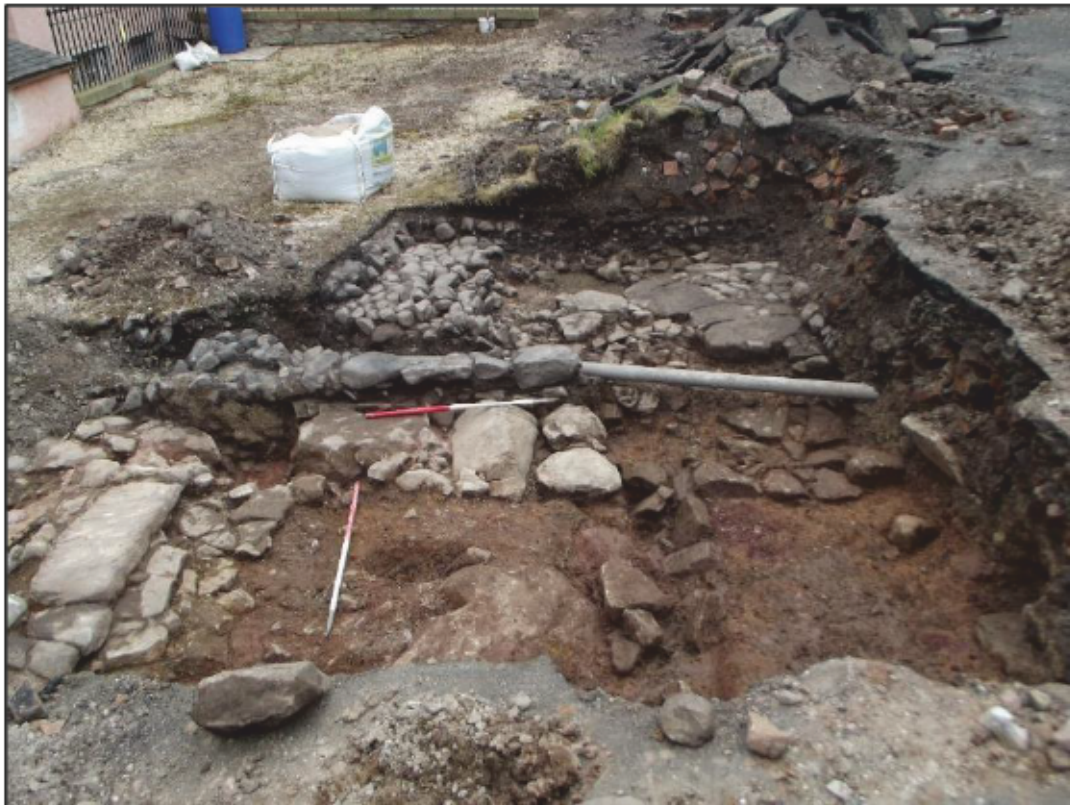
Plate 4: Structure {430}, surfaces {429} & {413}; Trench 4, looking south

4.2.12 Parts of a surface {429} (Plate 4) making up the inner stone floor of structure {430} remained, abutting walls {418} and {419}, which was visible in section in the northwest corner with the central part missing. It consisted of roughly hewn sandstone slabs laid flat and side by side and measured 2.3m by 1.8m. The floor was above layer (414), which consisted of friable mid red/brown sandy clay that contained occasional mortar fragments, coal pieces and stone along with some sherds of pottery. This deposit measured 3.05m by 1.88m by 0.07m and it appeared to have been used as a bedding layer for the stone surface. In the northwest corner of the trench there was the remains of a stone culvert {431} that had been cut into the natural clay. The cut [432] for the culvert, which was aligned north to south, measured 2.1m by 0.52m by 0.32m, with sharp, very steep sloping sides, a narrow rounded base and a V-shaped profile. The culvert was made up of roughly hewn sandstone slabs that were placed flat against the sides of the cut and covered over by stone slabs that were part of surface {429}. The narrow channel was filled with a deposit (437), which was comprised of loose mid brown sandy clay that contained several sherds of pottery.

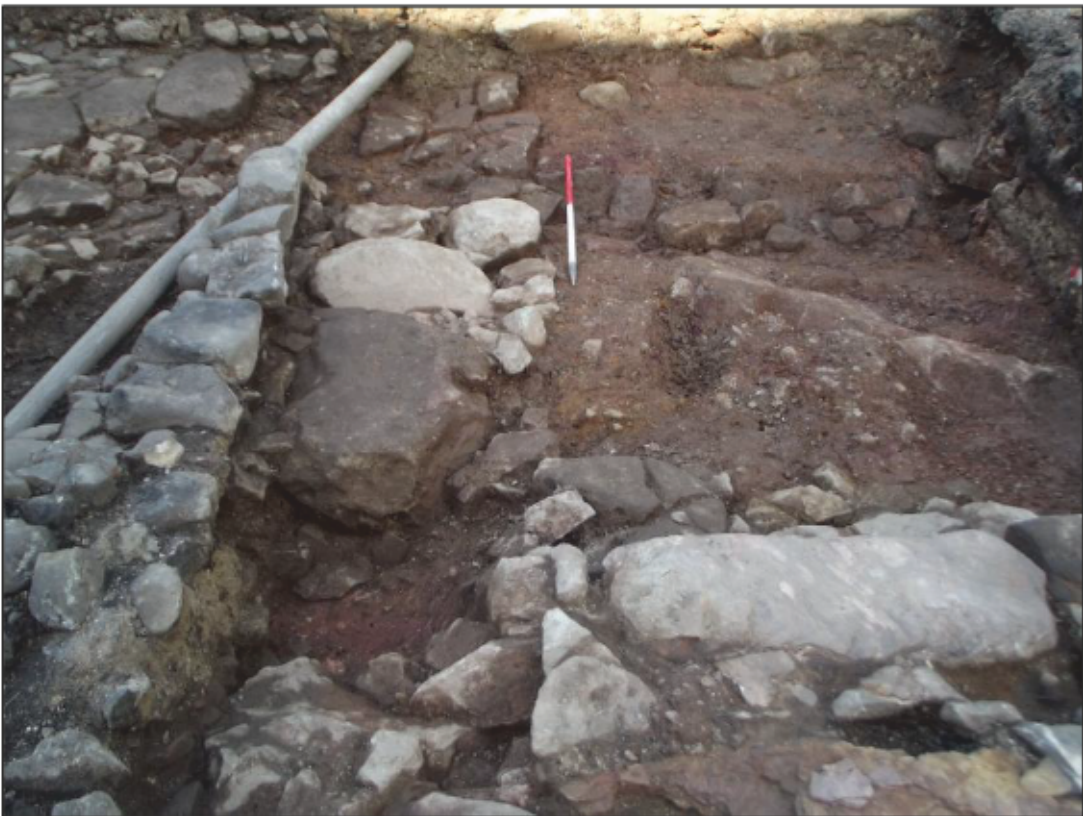
Plate 6: Walls {418} & {419} – Structure {430}; Trench 4, looking west

4.2.13 Robber trench [415] was located at the junction between the southern end of wall {418} and the eastern end of wall {419} (Plate 6). It was sub-oval in plan and measured 0.65m by 0.6m by 0.44m with sharp near vertical sloping sides and a flat base. The primary fill (416) of the robber trench comprised friable mid/dark brown sandy clay with occasional stone and coal pieces. This deposit measured 0.6m by 0.4m by 0.1m and produced some sherds of pottery and pieces of glass. This was sealed below a secondary fill (420), which was comprised of loose mid brown sandy clay that contained occasional stone and mortar fragments. The deposit measured 0.65m by 0.6m by 0.25m that produced several pieces of glass.

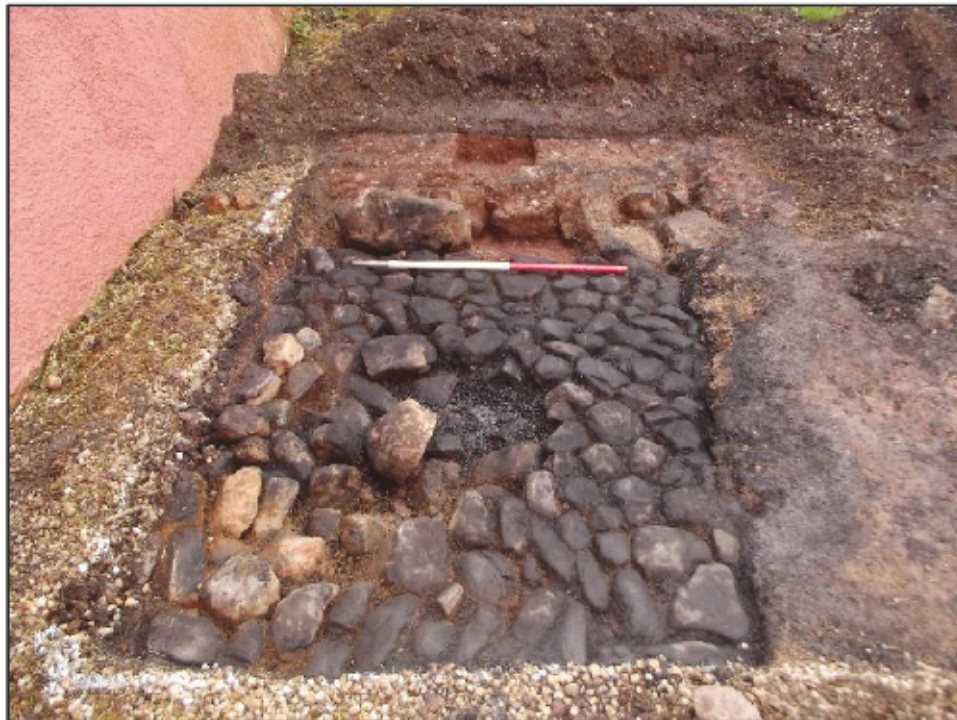
Plate 8: Surface {507}, hearth {511} & wall {518}; Trench 5A, looking west

4.2.15 A stone surface {507} (Plates 8 & 9) was observed across the centre and east side of the trench. It consisted of medium to large sized un-worked sub-rounded cobbles that were irregularly placed on top of the natural substrate. The surface measured 2.2m by 1.6m by 0.17m and continued beyond the limits of excavation on the north, south and east sides of the trench. The bonding material between the cobbles was a loose mid yellow sand (512) which measured 0.15m in thickness. The surface appeared to be an inner floor for an earlier, demolished structure that originally extended westwards from the existing boiler room. On the west side of the trench, the remains of a stone wall {508} were observed (Plate 9). The wall consisted of the bottom course of un-worked and roughly hewn sandstone blocks that were randomly laid and bonded with a firm mid brownish red/light grey clay mortar mix (509) that measured 2m by 0.3m by 0.1m and contained occasional small stones. Some animal bone fragments and pieces of glass were also recovered from this deposit. The stone wall {508} was aligned north to south and measured 2m by 0.6m by 0.25m with its western edge pressed into the natural clay. The wall appeared to be an internal wall of the demolished structure and was contemporary with the cobble surface {507}. There was a 0.48m wide gap between the eastern edge of the wall and the edge of the cobble surface. Some of the sandstone blocks appeared to have fallen into this gap, presumably when the structure was demolished.

4.2.17 In the eastern side of the trench, an area of cobbles were removed which revealed a sub-circular shaped depression [511] that measured 0.9m by 0.7m and 0.2m in depth (Plate 8). The depression was vertically sided with an undulating base and contained a layer of loose greyish red clayey ash (510), which measured 1.2m by 1.1m and 0.1m in thickness, filling the depression and covering some of the surrounding cobbles. It appears that the feature [511] may have been a hearth. Above deposits (510) and (513), was a layer (504) which consisted of a firm dark grey/black ash/clay mix that measured 3.3m by 1.6m by 0.05m – 0.1m. This deposit, which was also visible within trench 5B, was sealed by layer (500).

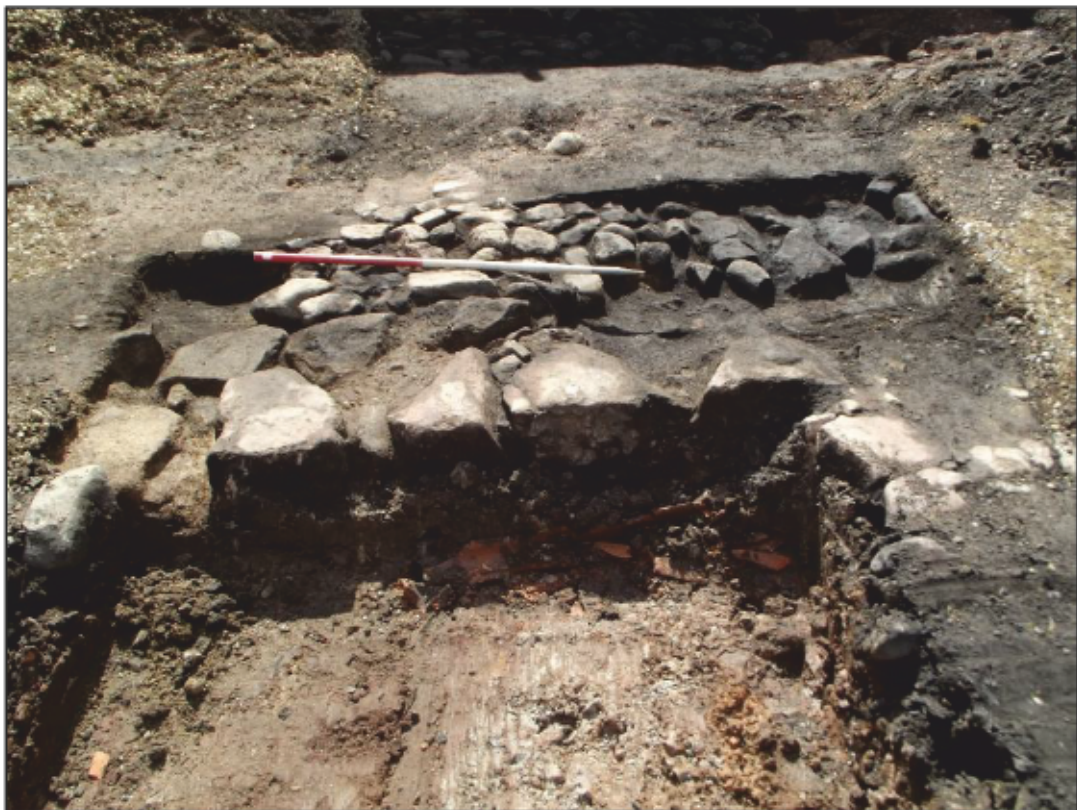
Plate 10: Wall {518} & surface {503}; Trench 5B, looking south

4.2.19 A cobble surface {503} (Plate 10) was observed in the southern end of the trench and consisted of un-worked sub-rounded cobbles that were irregularly laid on top of the natural substrate and measured 2.5m by 0.6m by 0.25m. The surface was sealed by layers (502) and (504) as discussed above (paragraphs 4.2.15 & 4.2.16). The surface appeared to be a continuation of {507} that was observed in trench 5A. It was cut by a modern ceramic land drain that was next to, and ran parallel with wall {518}. The wall {518} (Plates 10 & 11) consisted of a bottom course of un-worked and roughly hewn sandstone blocks that were laid in a random course and measured 2.5m by 0.67m by 0.19m. It was bonded with a sandy loose mortar and a small lead pipe was found to extend under the wall. The wall followed the line of the northern wall of the existing boiler room and was part of an earlier section of Old Craig that appears on 19th century OS maps.

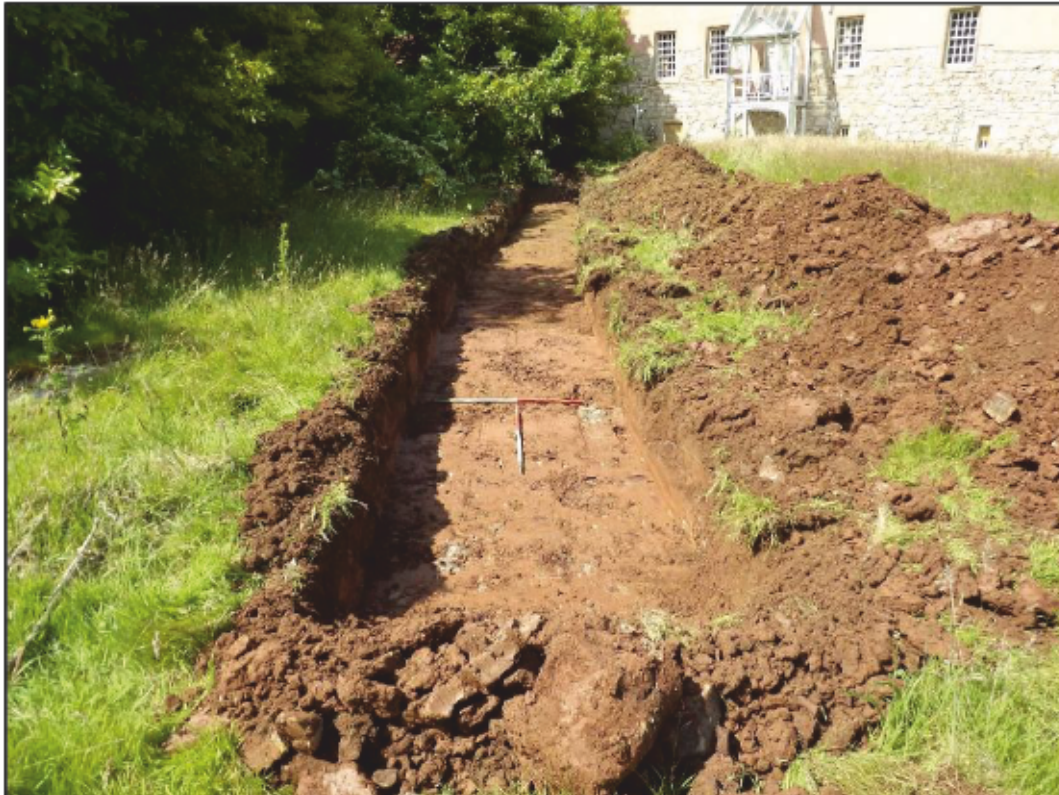
Plate 12: Trench 6, looking northeast

4.2.20 **Trench 6:** Trench 6 was aligned northwest-southeast across the field to the south of Old Craig (Figure 2) (Plate 12). The trench measured 15m by 1.6m and was excavated to a maximum depth of 0.5 revealing loose light brown/grey clay silt natural (602) below c.0.25m of loose mid brown silty sand subsoil (601) and c.0.25m of a mid greyish brown silty topsoil (600). No archaeological features or deposits were encountered within this trench.

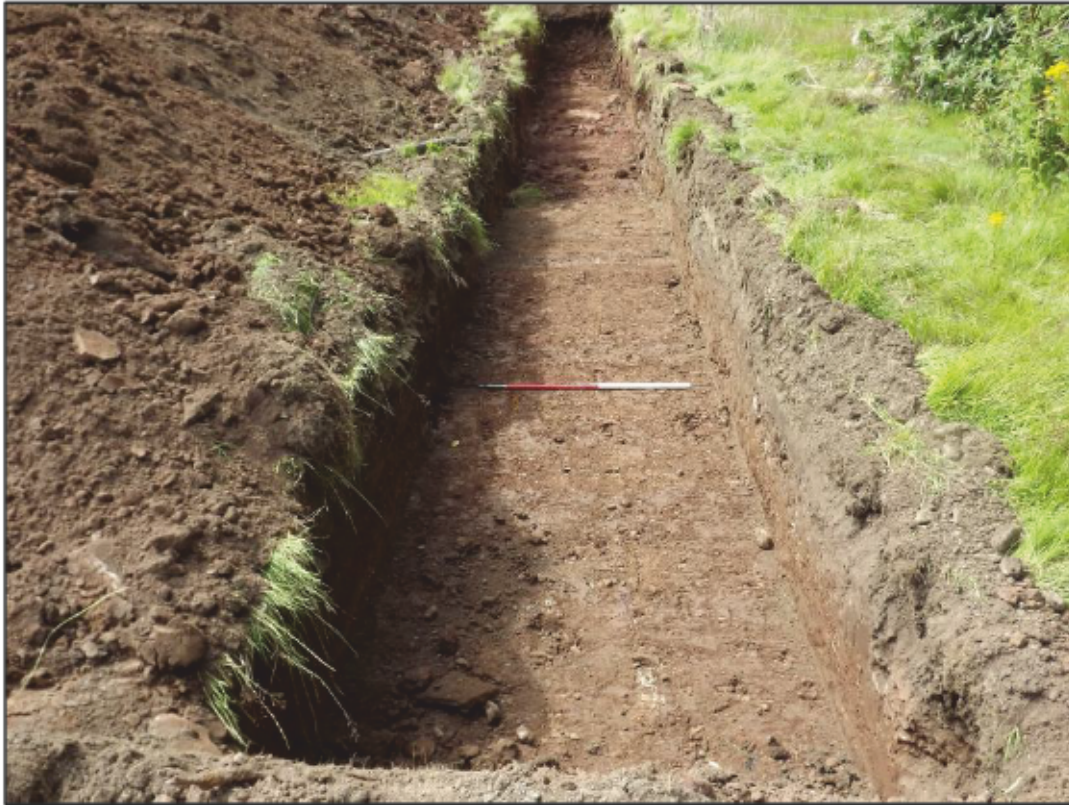
Plate 13: Trench 7, looking west

4.2.21 **Trench 7:** Trench 7 was located directly to the south of Old Craig, aligned east to west (Figure 2 & 8) (Plate 13). The trench measured 15m by 1.8m and was excavated to a depth of 1.2m revealing orange/brown silty natural clay (703). At the east end of the trench, the natural substrate was sealed by a c.0.8m deposit of mid brown loose sandy silt (702) whilst at the western end, the ground became more rubble filled. The rubble contained significant boulders and rounded cobbles with patches of white mortar.

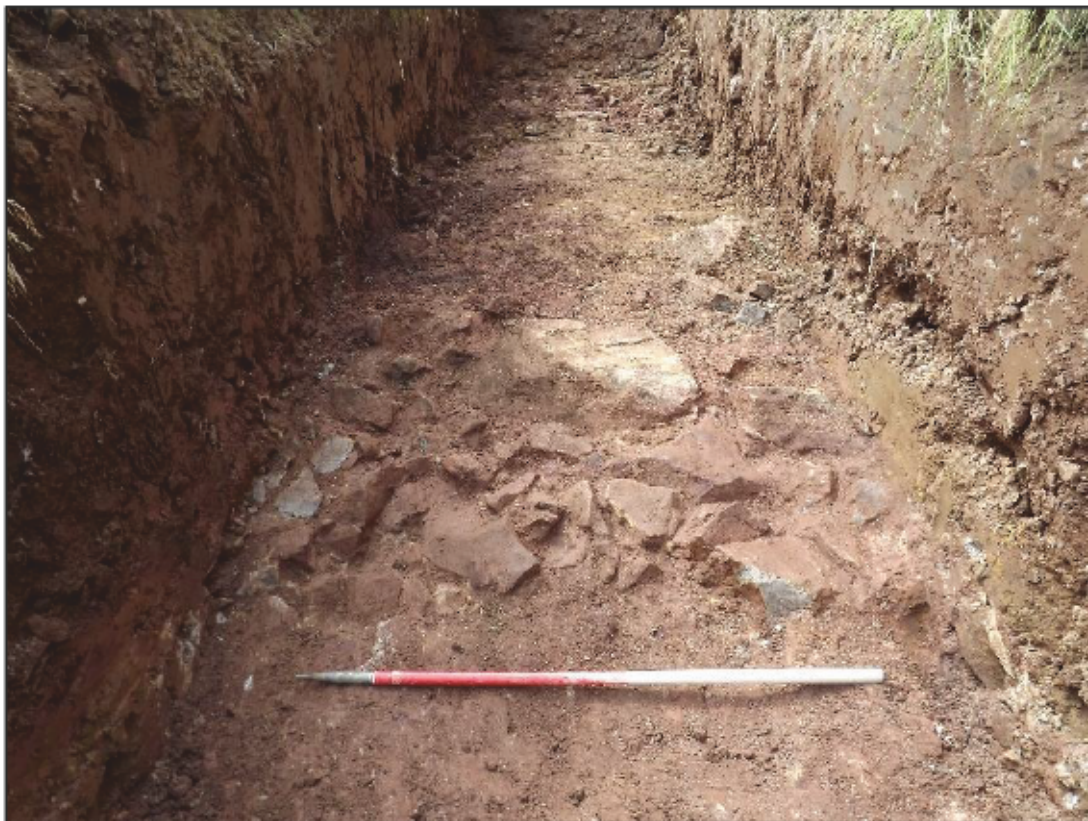
Plate 14: Wall footing {700}; Trench 7, looking west

4.2.22 At the western end of the trench a significant wall footing/foundation {700} was found at a depth of 1.1m (Plate 14). This end of the trench was subsequently extended by 5m to record as much of the feature as possible. The north to south aligned wall foundation was comprised of large boulders, rounded cobbles and sandstone fragments and measured over 1m in length by approximately 1.5m in width. The stones were undressed and un-bonded. No dating evidence was retrieved in order to accurately date the feature.

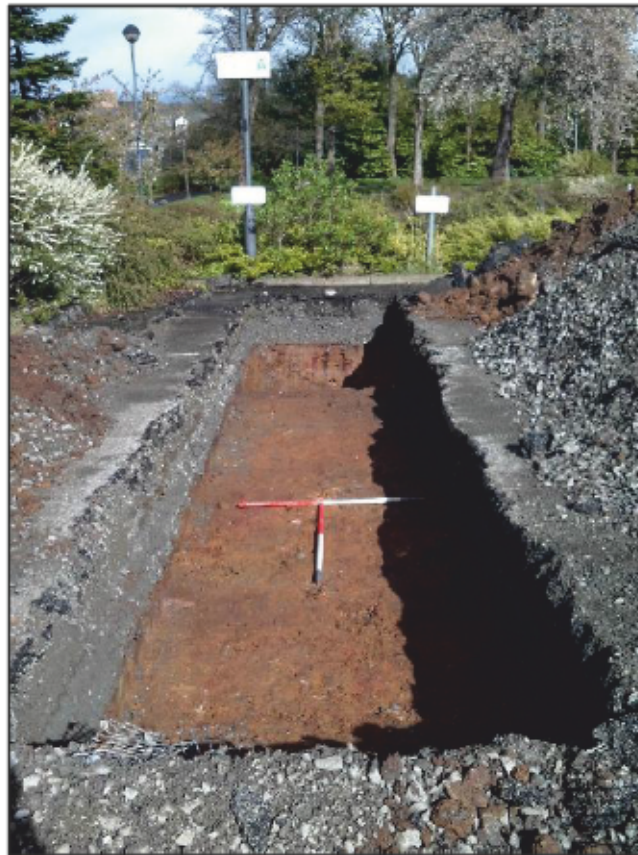
Plate 17: Trench 10, looking east

4.2.25 **Trench 10:** Trench 10 was located in the western car park to the east of Old Craig and was aligned east to west (Figure 2) (Plate 17). The trench was excavated to a maximum depth of 1.3m revealing firm mid reddish brown sandy clay natural (1004) below a plastic mesh (1002) with c.0.50m of loose mid grey stone hardcore (1001)/(1006), c.0.09m of greenish grey sand bedding layer (1005) and c.0.08m of black tarmac (1000). A thin layer (1003) was observed in the western side of the trench that consisted of soft reddish brown sandy clay and contained occasional coal flecks. This deposit, which measured 0.12m in thickness, was visible in trenches 11A and 11B and appears to have been a buried subsoil.

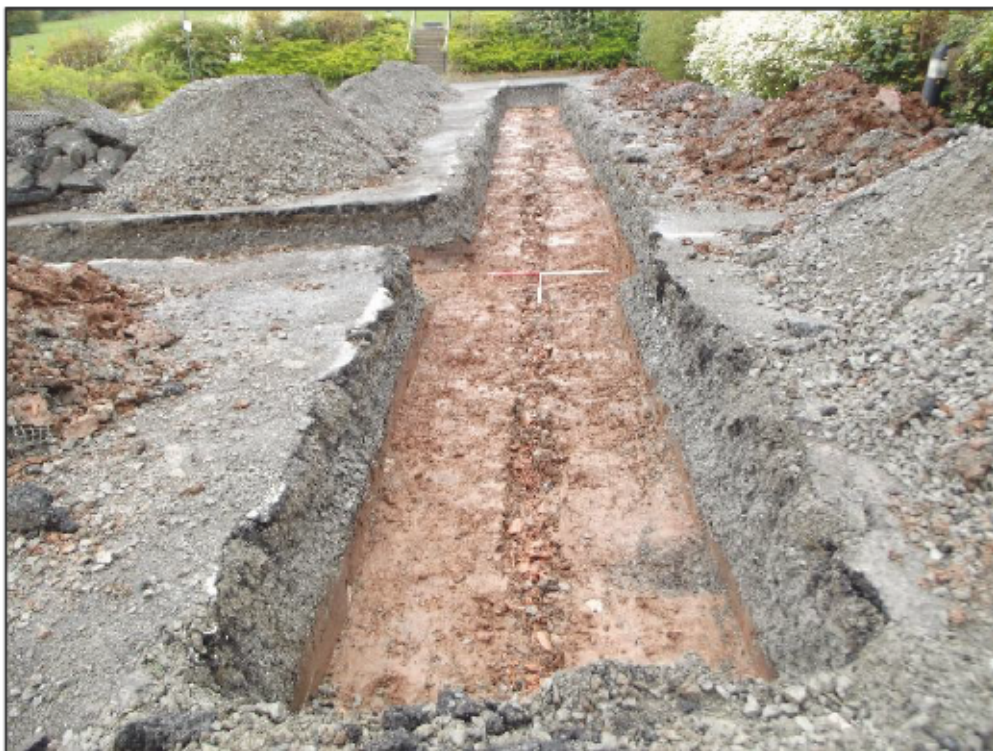
Plate 18: Trench 11A, showing trench 11B, looking south

4.2.26 **Trenches 11A & 11B:** Trenches 11A (Plate 18) and 11B were located in the western carpark to the southeast of Old Craig and to the southwest of trench 10 (Figure 2). Trench 11A was aligned north to south and 11B was aligned east to west, which adjoined the eastern side of 11A, roughly 5m from its northern end. The trenches were excavated to a maximum depth of 0.80m revealing firm mid reddish brown/yellow sandy clay natural (1104) below a black plastic mesh (1102) with c.0.6m of loose mid grey stone hardcore (1105), c.0.08m of greenish grey sand bedding (1101) and c.0.1m of black tarmac (1100).

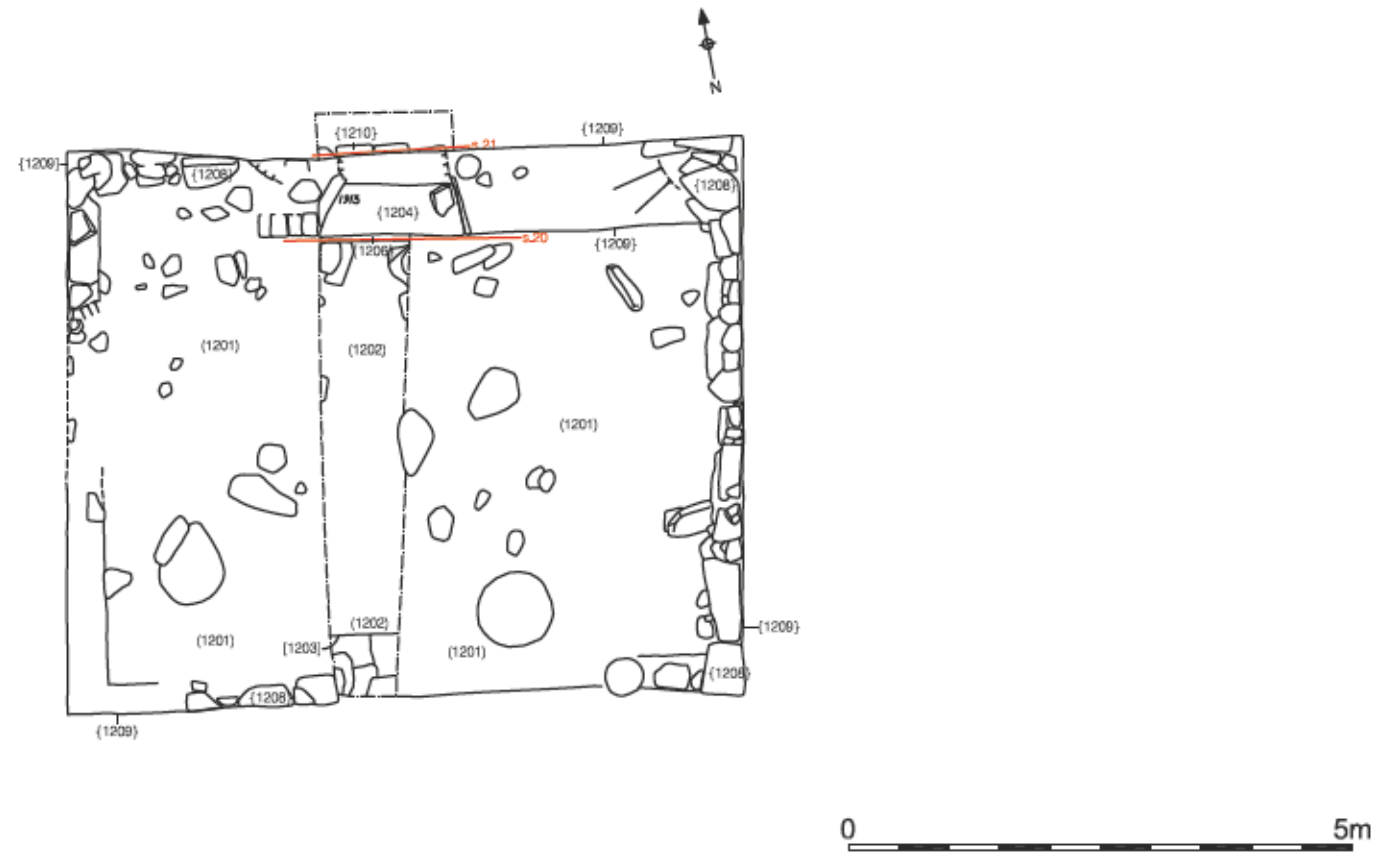
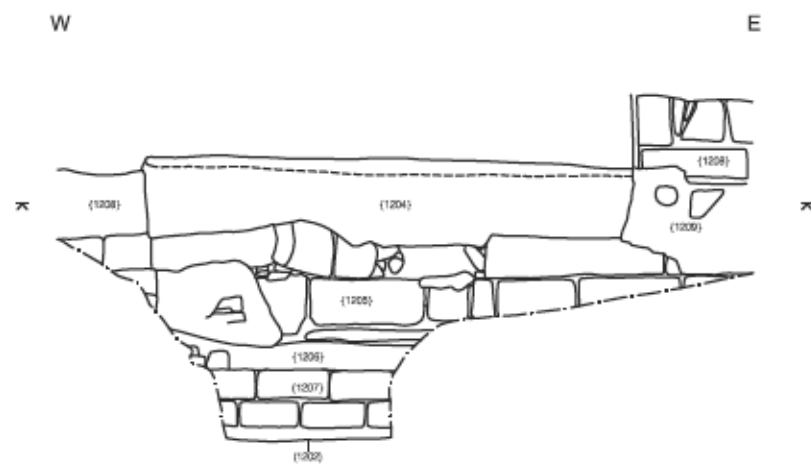
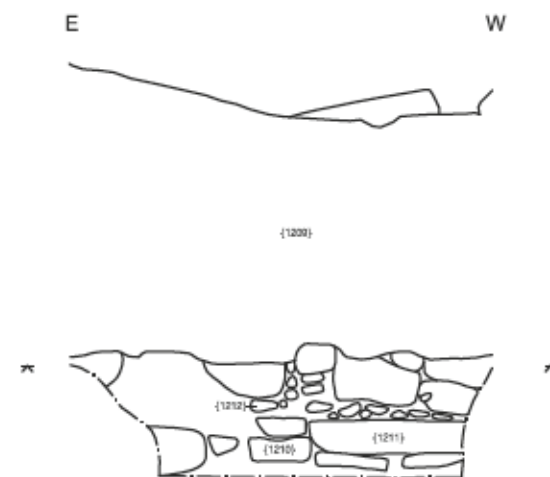
Figure 3: Trench 1; plan and sections.

Trench 1, Plan.

Section 20. South facing elevation of (1200).

Section 21. North facing elevation of northern wall of (1200).
