**UNITED UTILITIES**

**NETWORK MAINS FROM QUARRY HILL TO STAINBURN AND COCKERMOUTH,  
CUMBRIA**

**ARCHAEOLOGICAL DESK BASED ASSESSMENT AND WALKOVER SURVEY**

**August 2015**

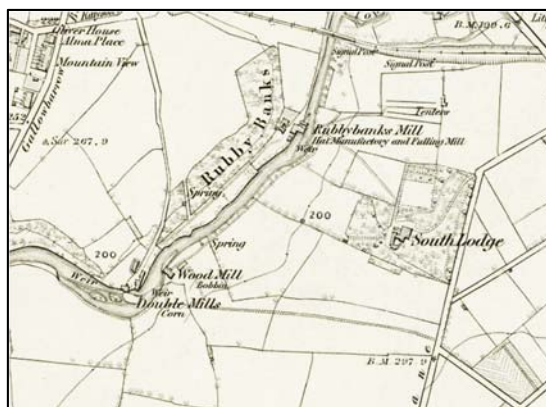
- 5.8.1 To the south of Cockermouth are three mill sites on the River Cocker that are all within the corridor of the pipeline route (Assets 23-25). The most southerly, Double Mills (Asset 25), is a still standing building and is grade II listed and thus accorded a district or county (higher) heritage significance. It is possibly within the vicinity of the site of a medieval corn mill. To the north are Wood Mill (Asset 24) and Rubbybanks Mill (Asset 23) neither of which are extant. Wood mill appears to have had medieval origins.

*Plate 1: Assets 23, 24 and 25, as shown on First Edition Ordnance Survey mapping*

- 5.8.2 Wood Mill and Rubbybanks Mill on the basis of current knowledge are defined as of local heritage significance.
- 5.9 **Individual Heritage Assets of Local Significance**
- 5.9.1 There are five heritage assets that have been recorded during this assessment which do not form part of a group or a wider association which may influence their

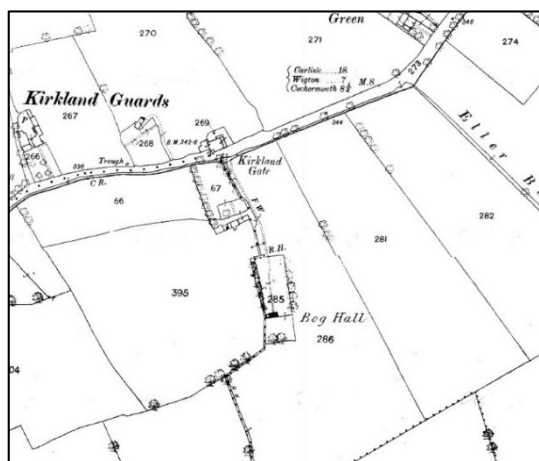
- 5.9.2 Bog Hall (Asset 30) is the site of a post-medieval farmstead which probably post-dates 1770. Its location is recorded on the First Edition Ordnance Survey map, but little else is known about it. The site of Bog Hall is defined as of local significance.

*Plate 2: Asset 30, as shown on First Edition Ordnance Survey mapping*

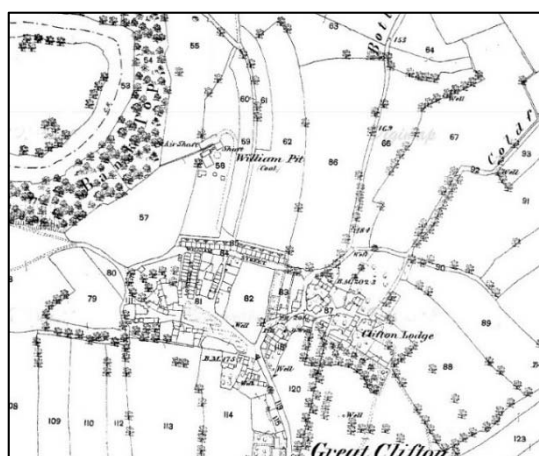
- 5.9.3 William Pit (Asset 204) was a colliery in existence by the later 19<sup>th</sup> century. It is unclear whether remains associated with the colliery will be impacted by the pipeline route. The archaeological remains associated with William Pit are defined as of local significance.

*Plate 3: Asset 204, as shown on First Edition Ordnance Survey mapping*

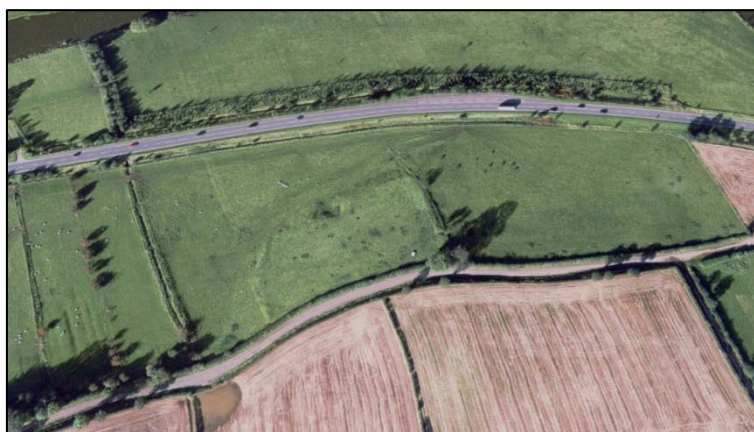
5.9.4 An earthwork enclosure in the Derwent valley (Asset 343) was noted from Google Earth™ imagery. The earthworks were noted also during the walkover. It is possible that the enclosure is a coincidental product of unconnected features, a natural slope, outcropping geology and field banks, and further investigation will be needed to determine its authenticity. Its use and period are unknown but if an authentic enclosure it may be prehistoric. On the basis of current knowledge it is accorded a local heritage significance.

*Plate 4: Asset 343, Google Earth imagery*

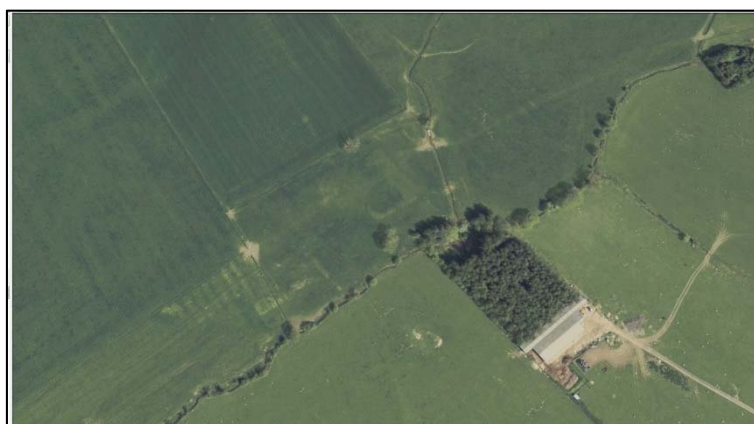
5.9.5 Earthworks at the Tarnties (Asset 375) were noted on both Google Earth™ imagery and during the walkover survey. They appear to be respected by adjacent curvilinear ridge and furrow which might indicate that they are medieval in origin. They occur in an area that during the Middle Ages was known as the Trinities and was held by Guisborough Priory, consequently, the earthworks may relate to the site of a monastic grange. Further investigation will be required to determine the nature and date of this site. On the basis of current knowledge it is considered to be of local significance.

*Plate 5: Asset 375, Google Earth imagery*

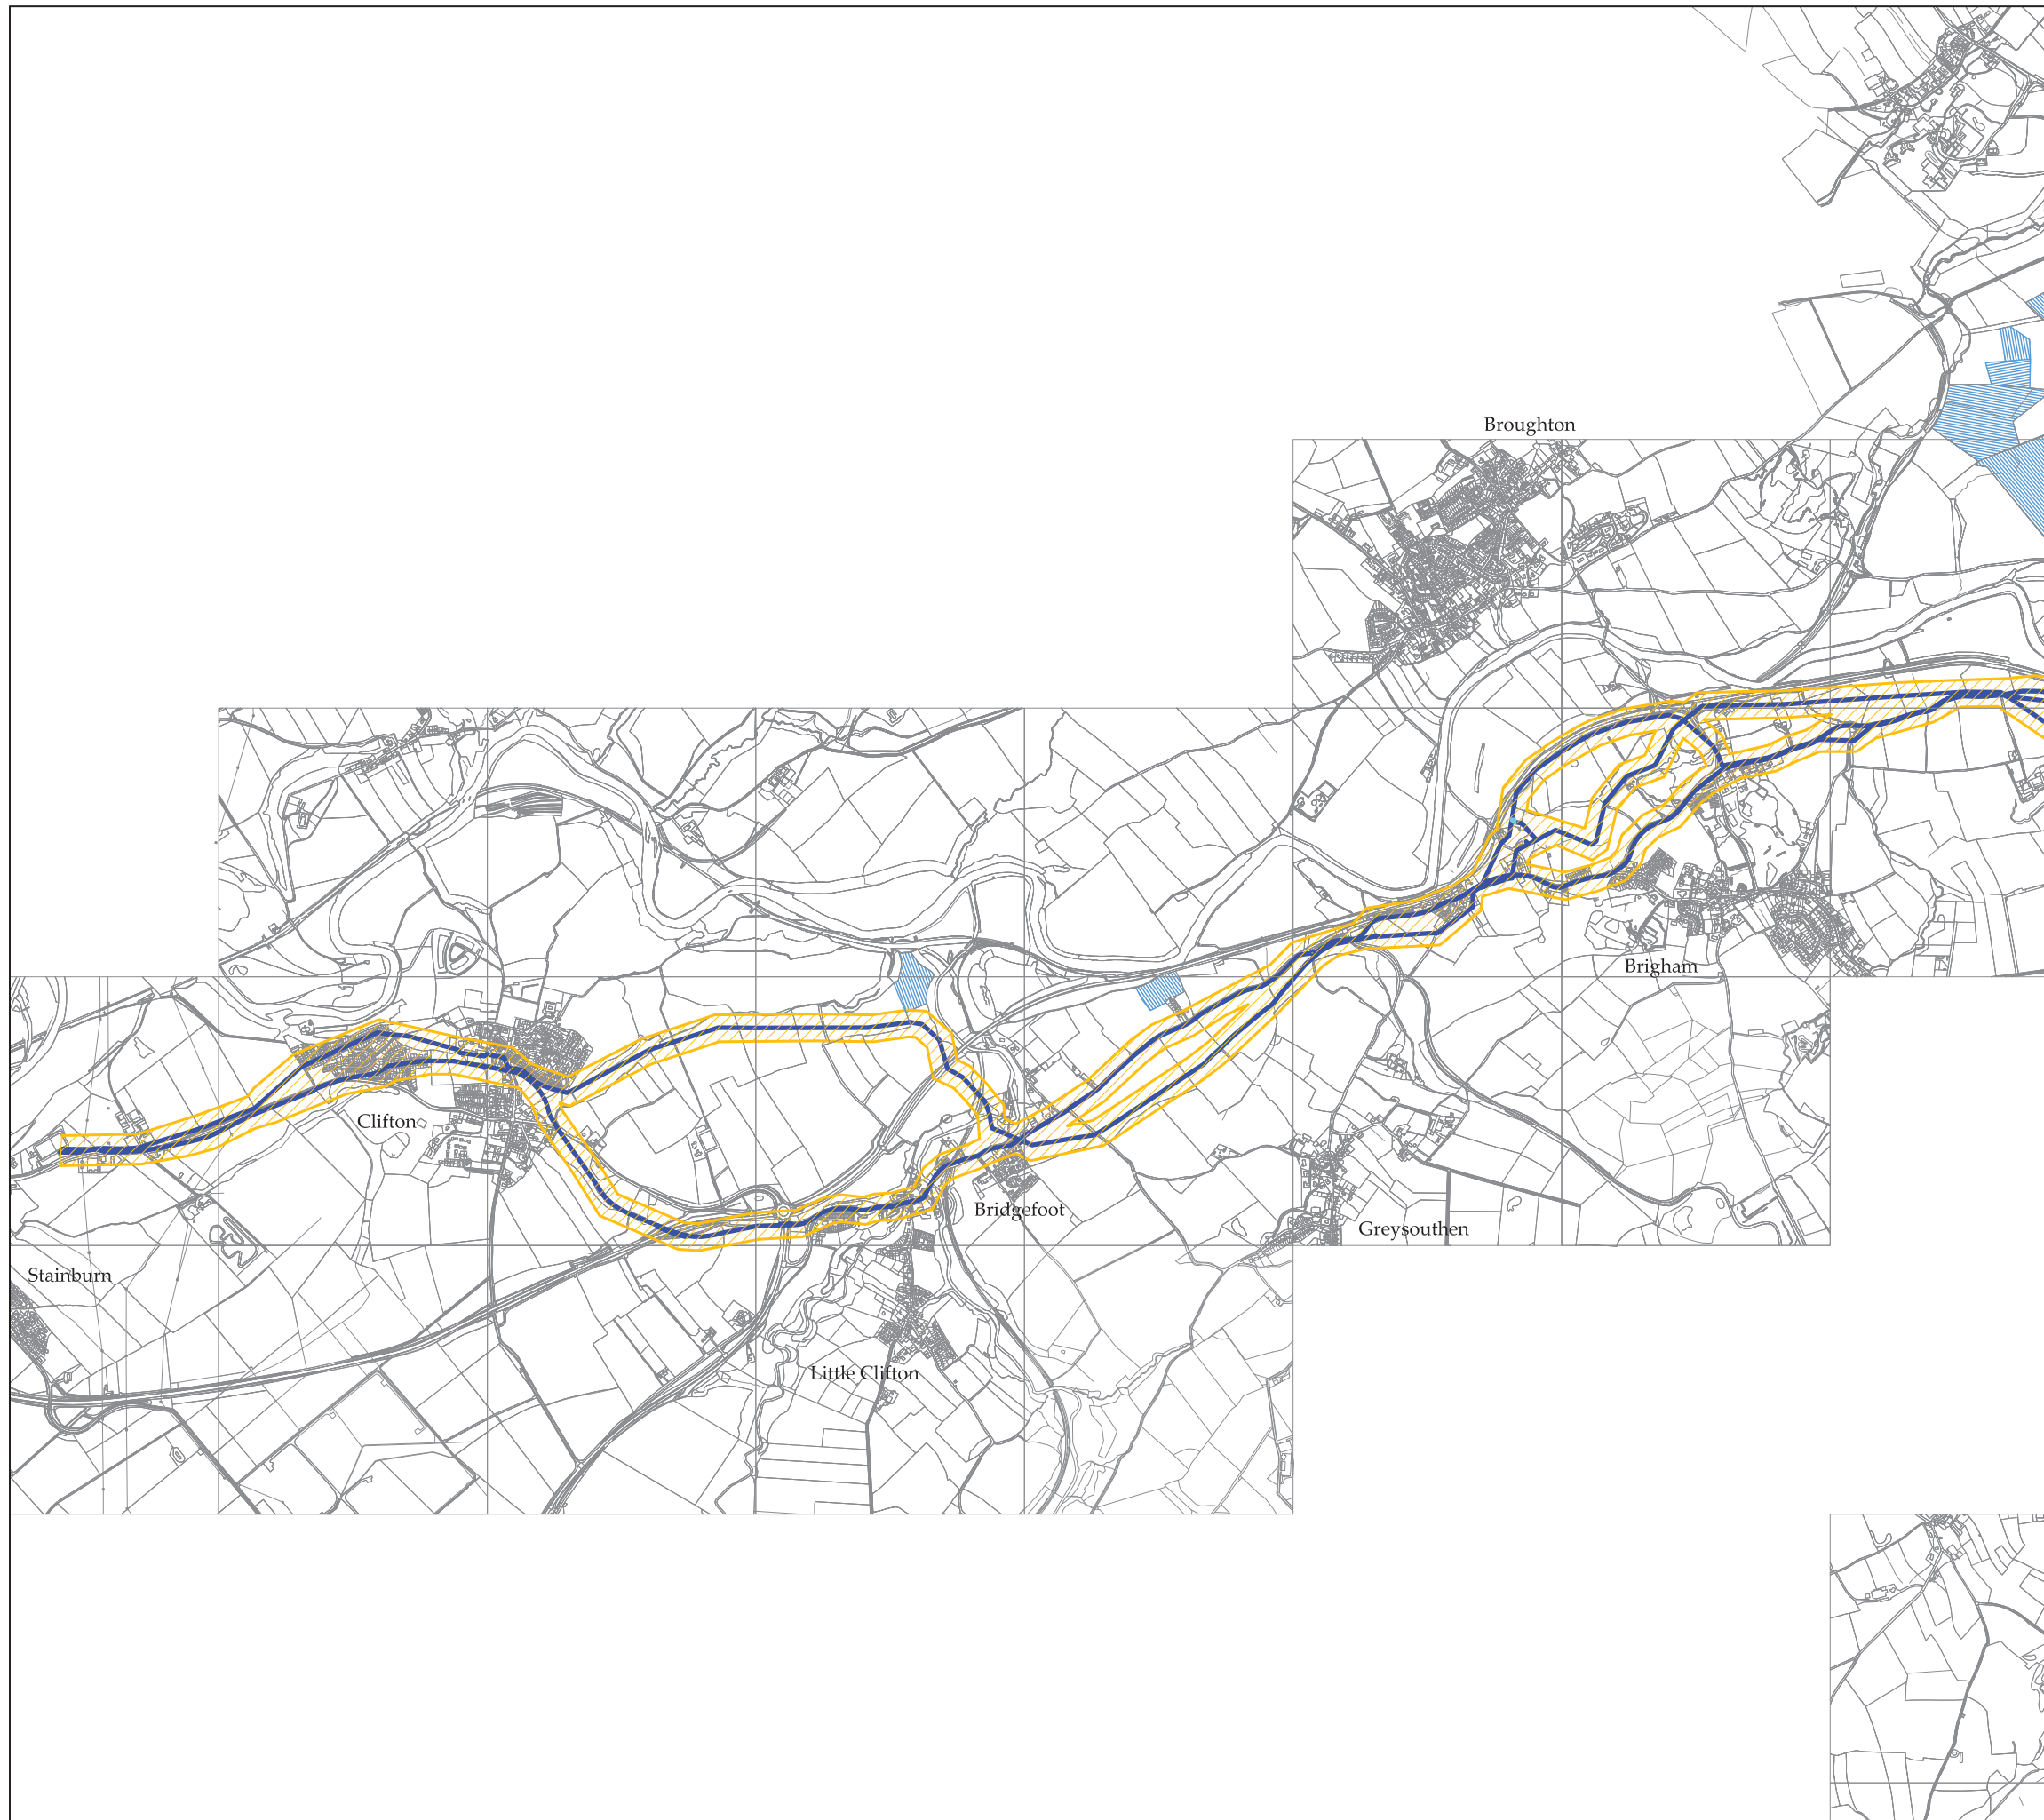
FIGURE:  
7

Figure 7: Location of observed ridge and furrow in the south west area of the pipeline route.

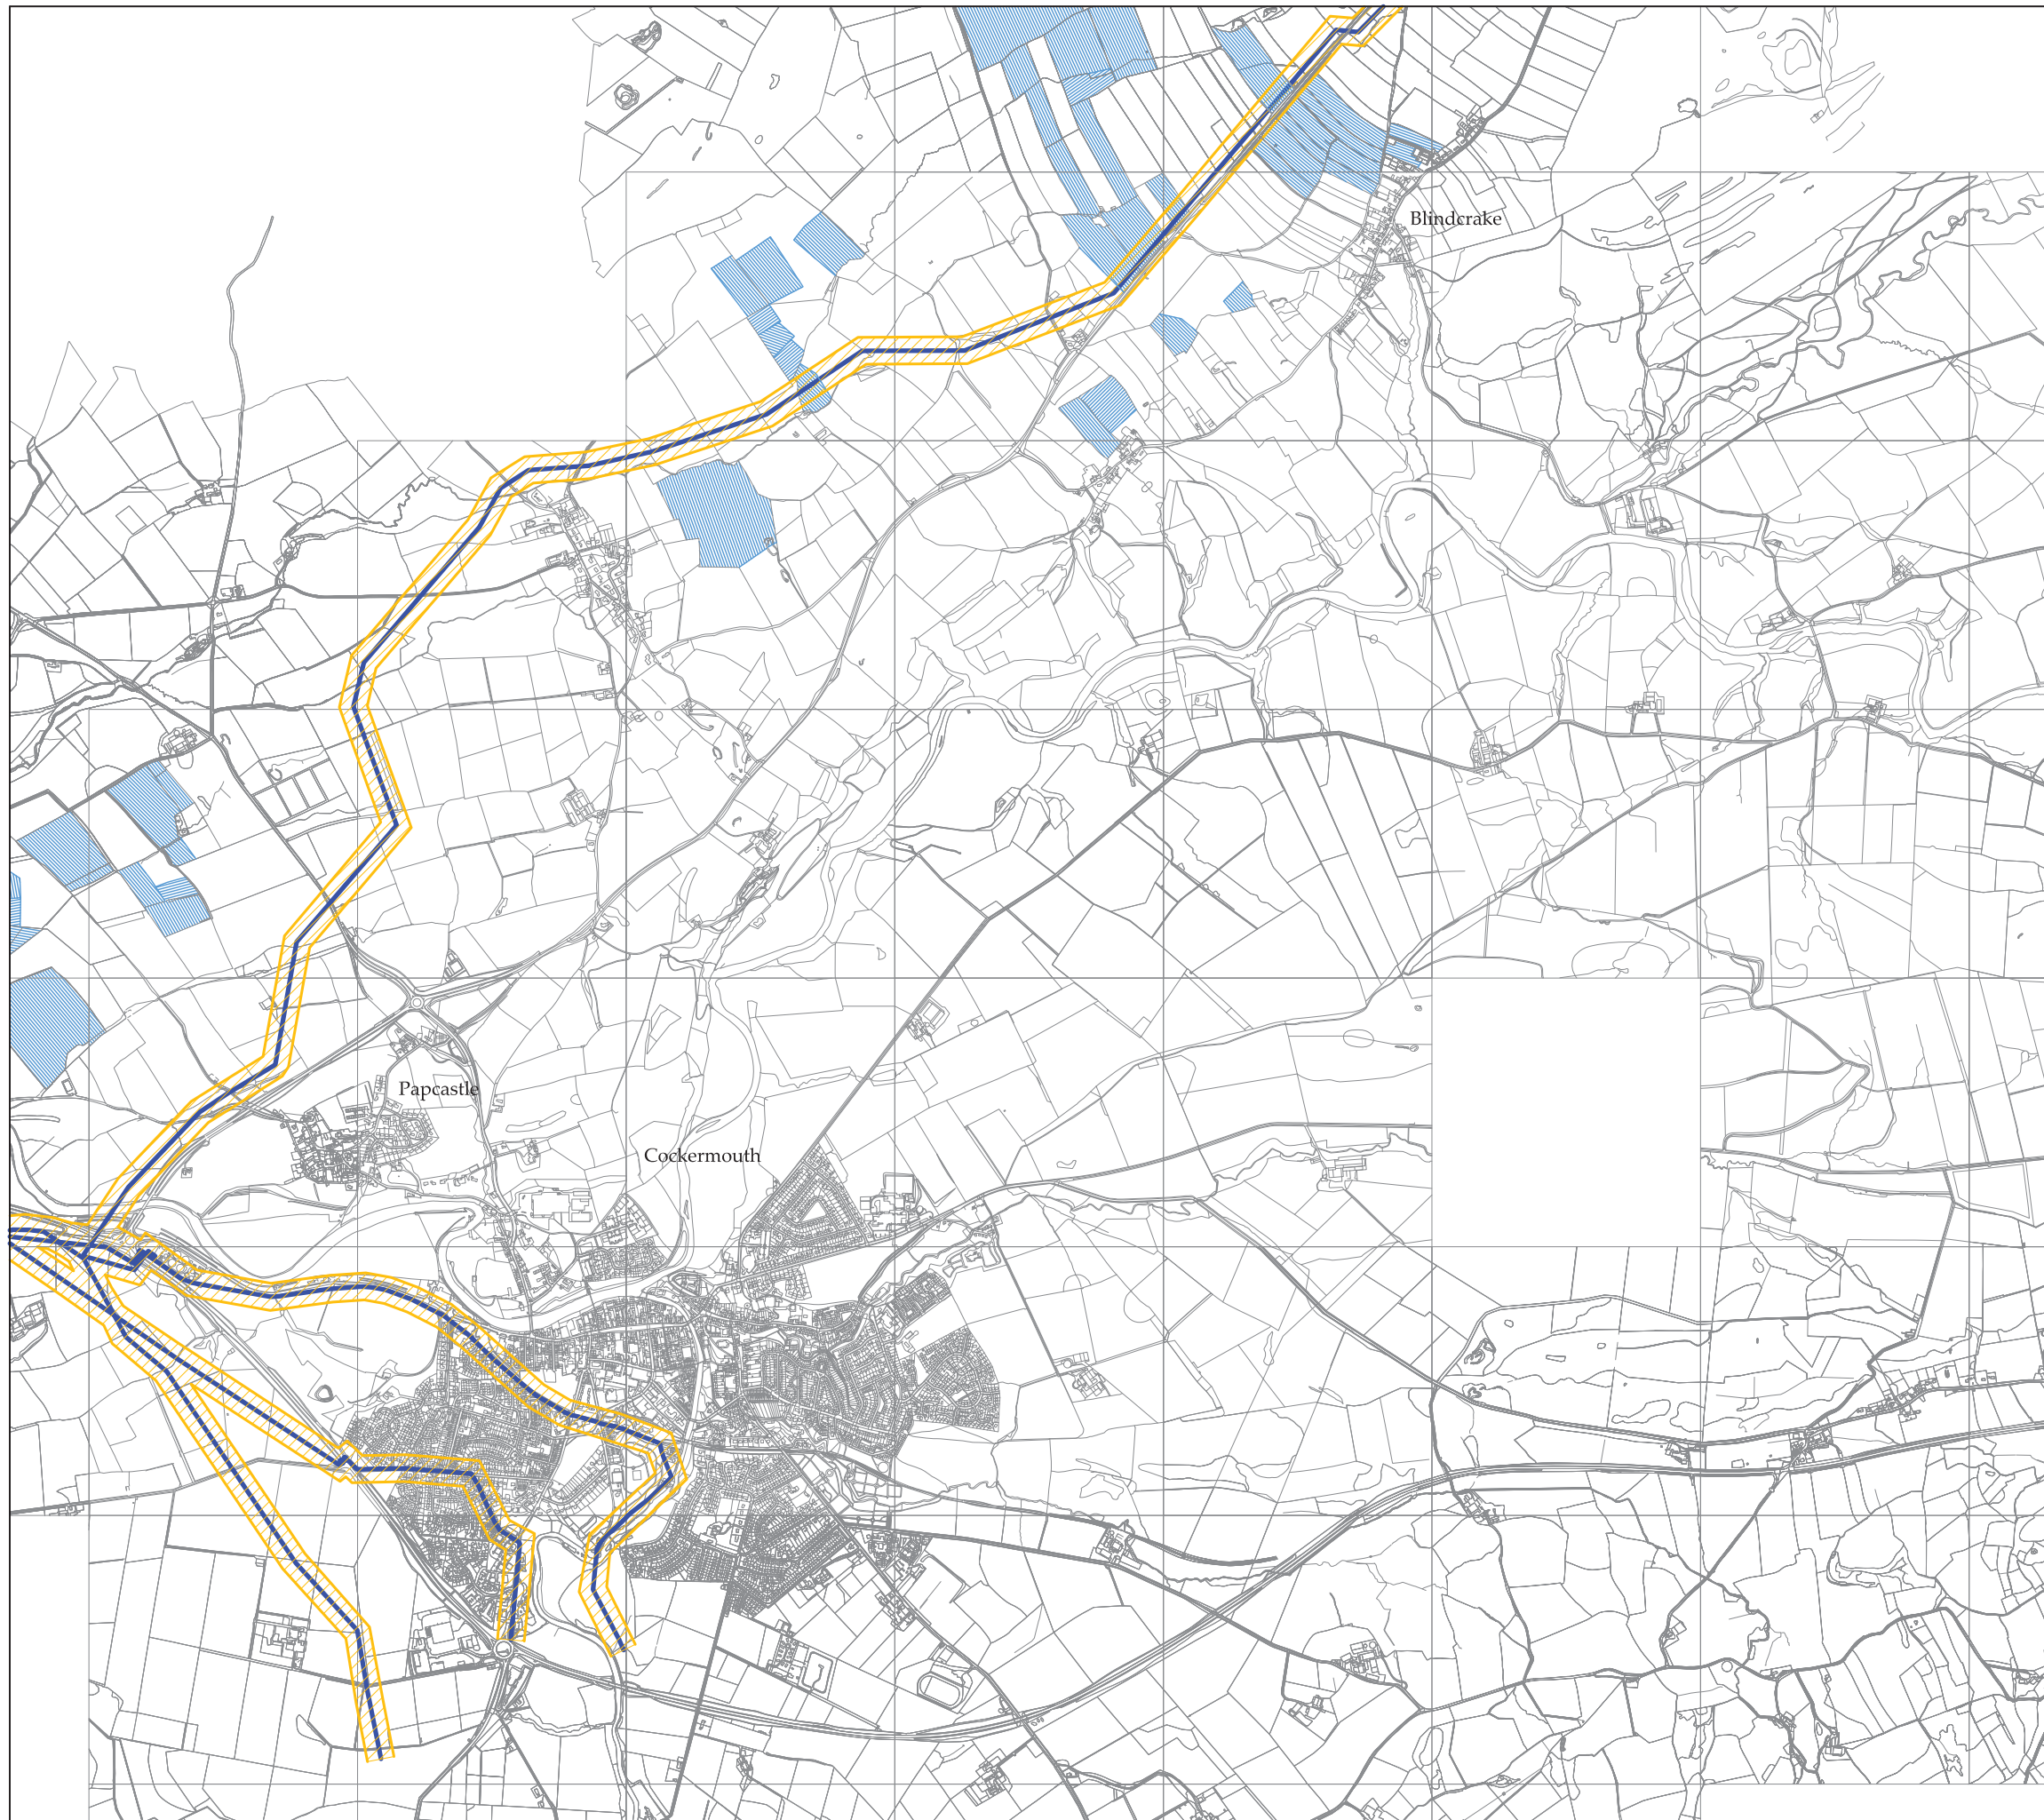
FIGURE:  
8

Figure 8: Location of observed ridge and furrow in the central area of the pipeline route.

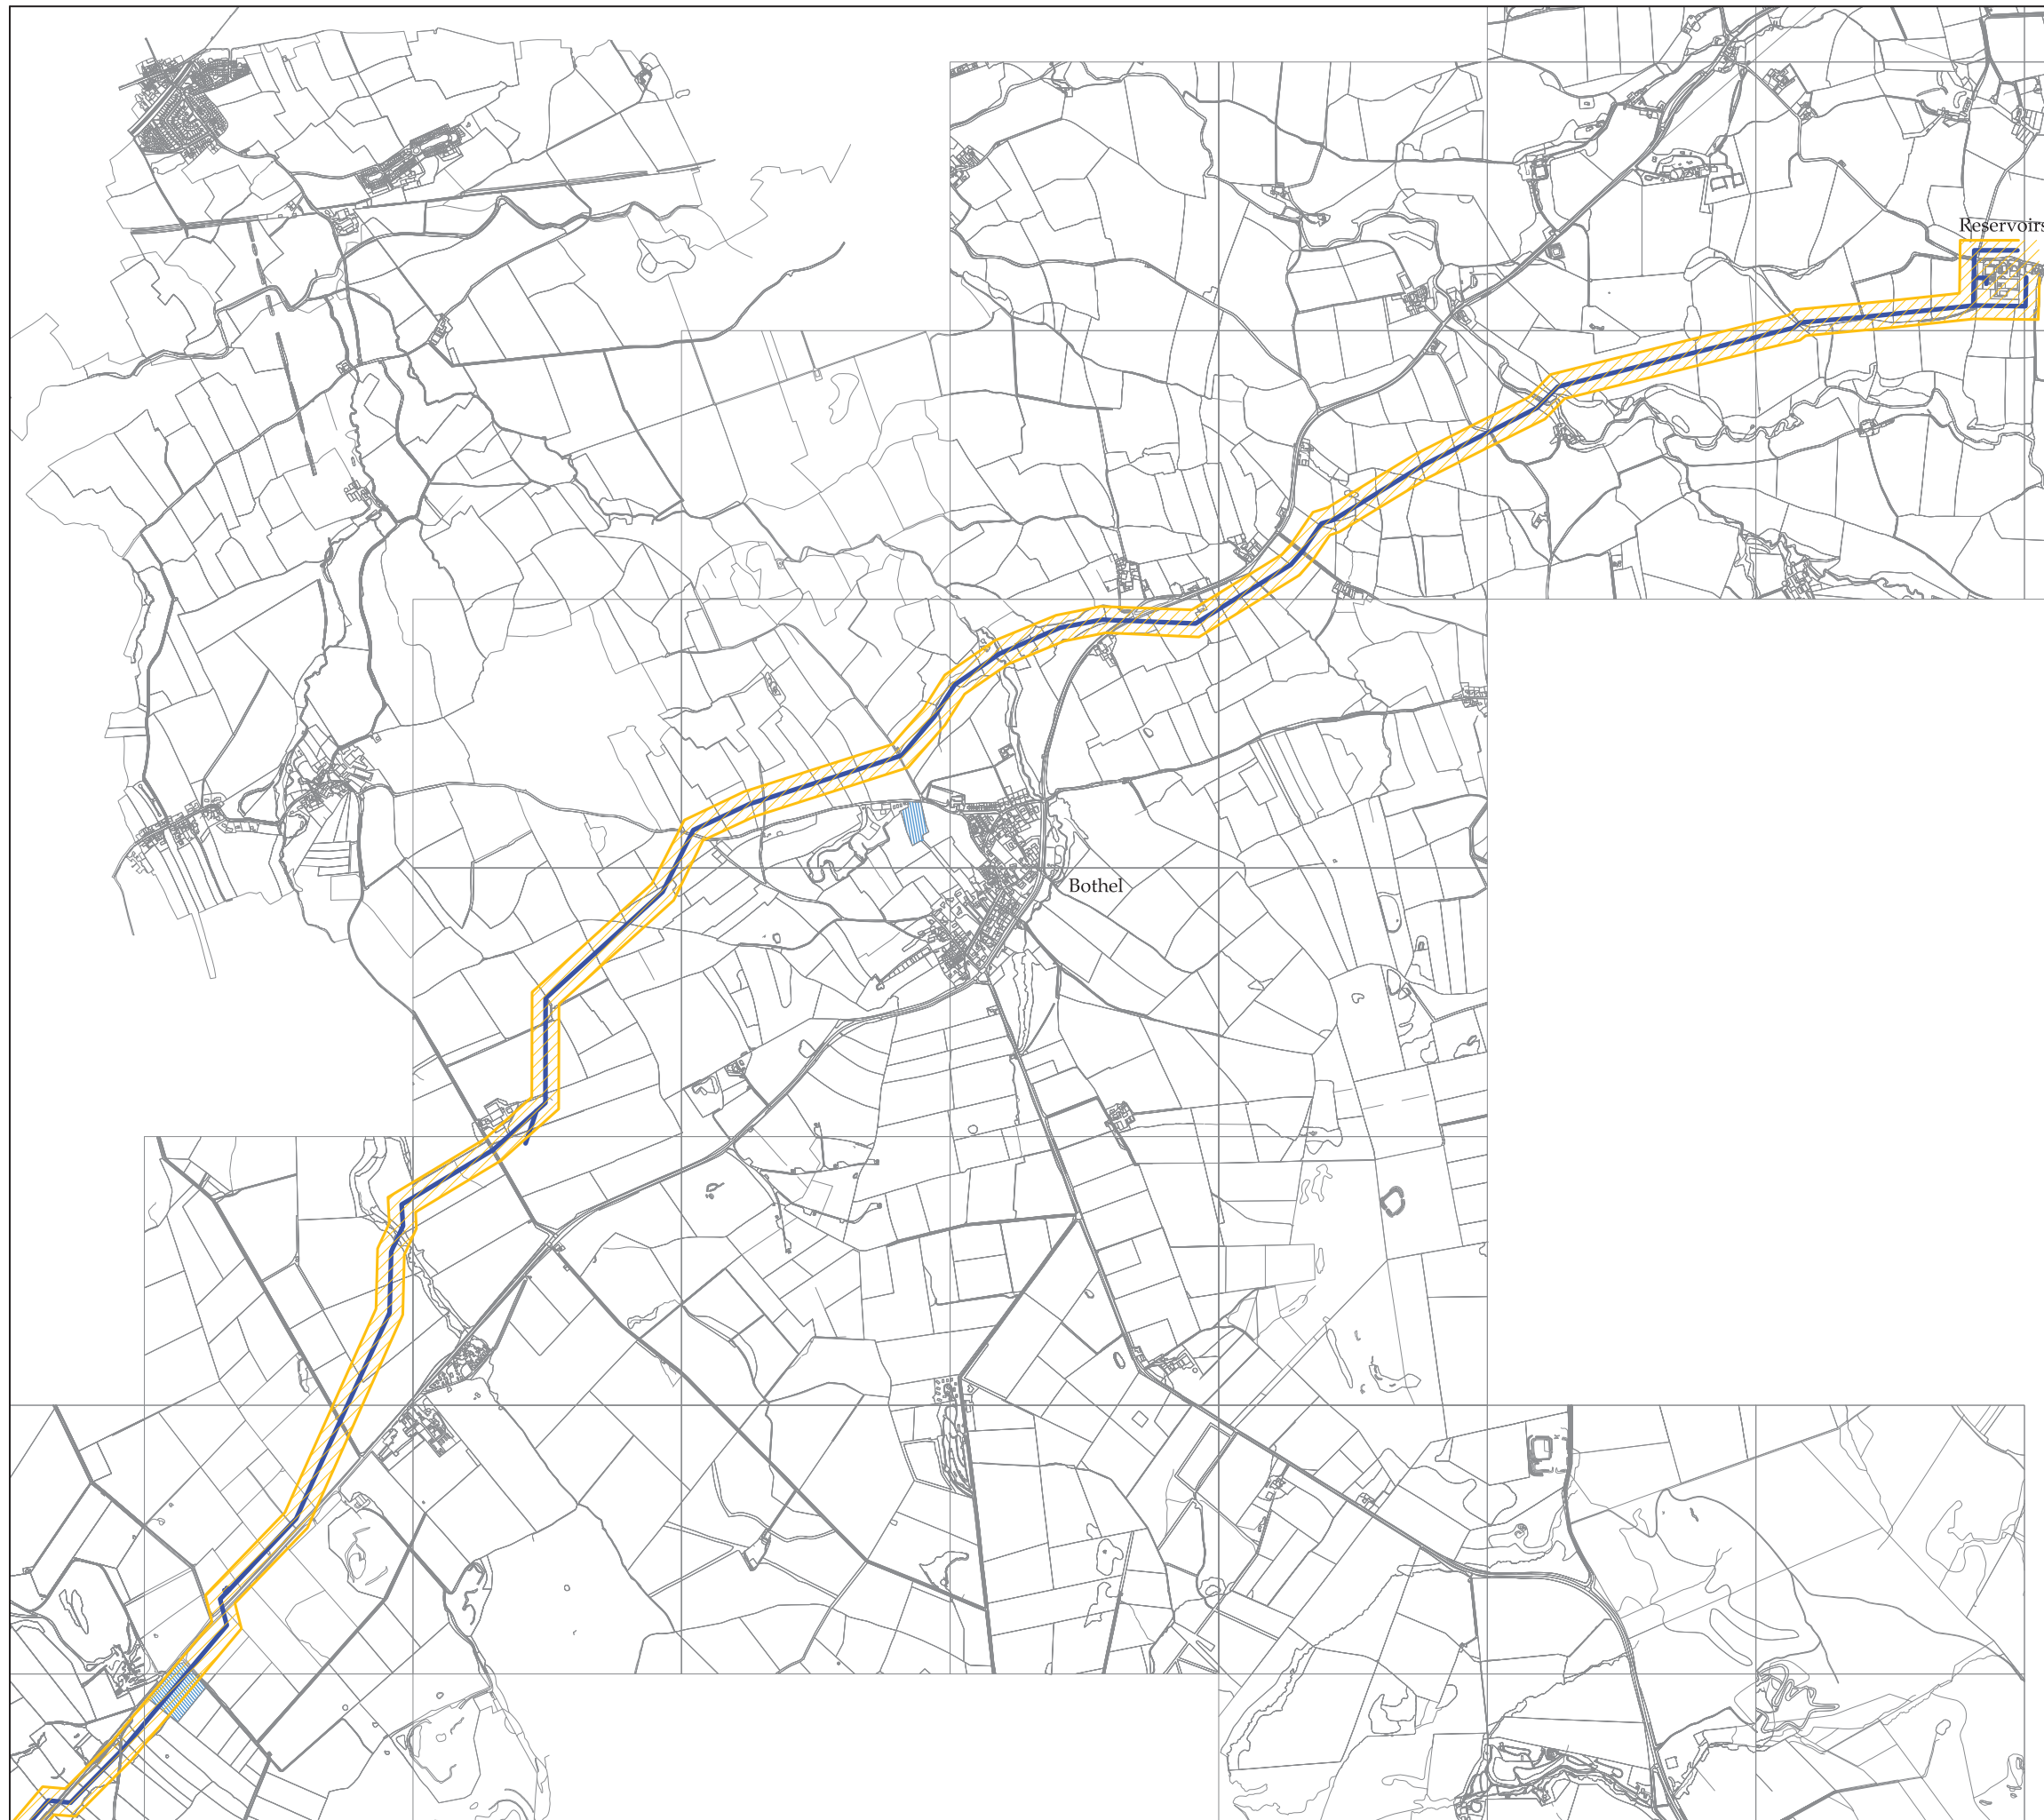
FIGURE:  
9

Figure 9: Location of observed ridge and furrow in the north east area of the pipeline route.

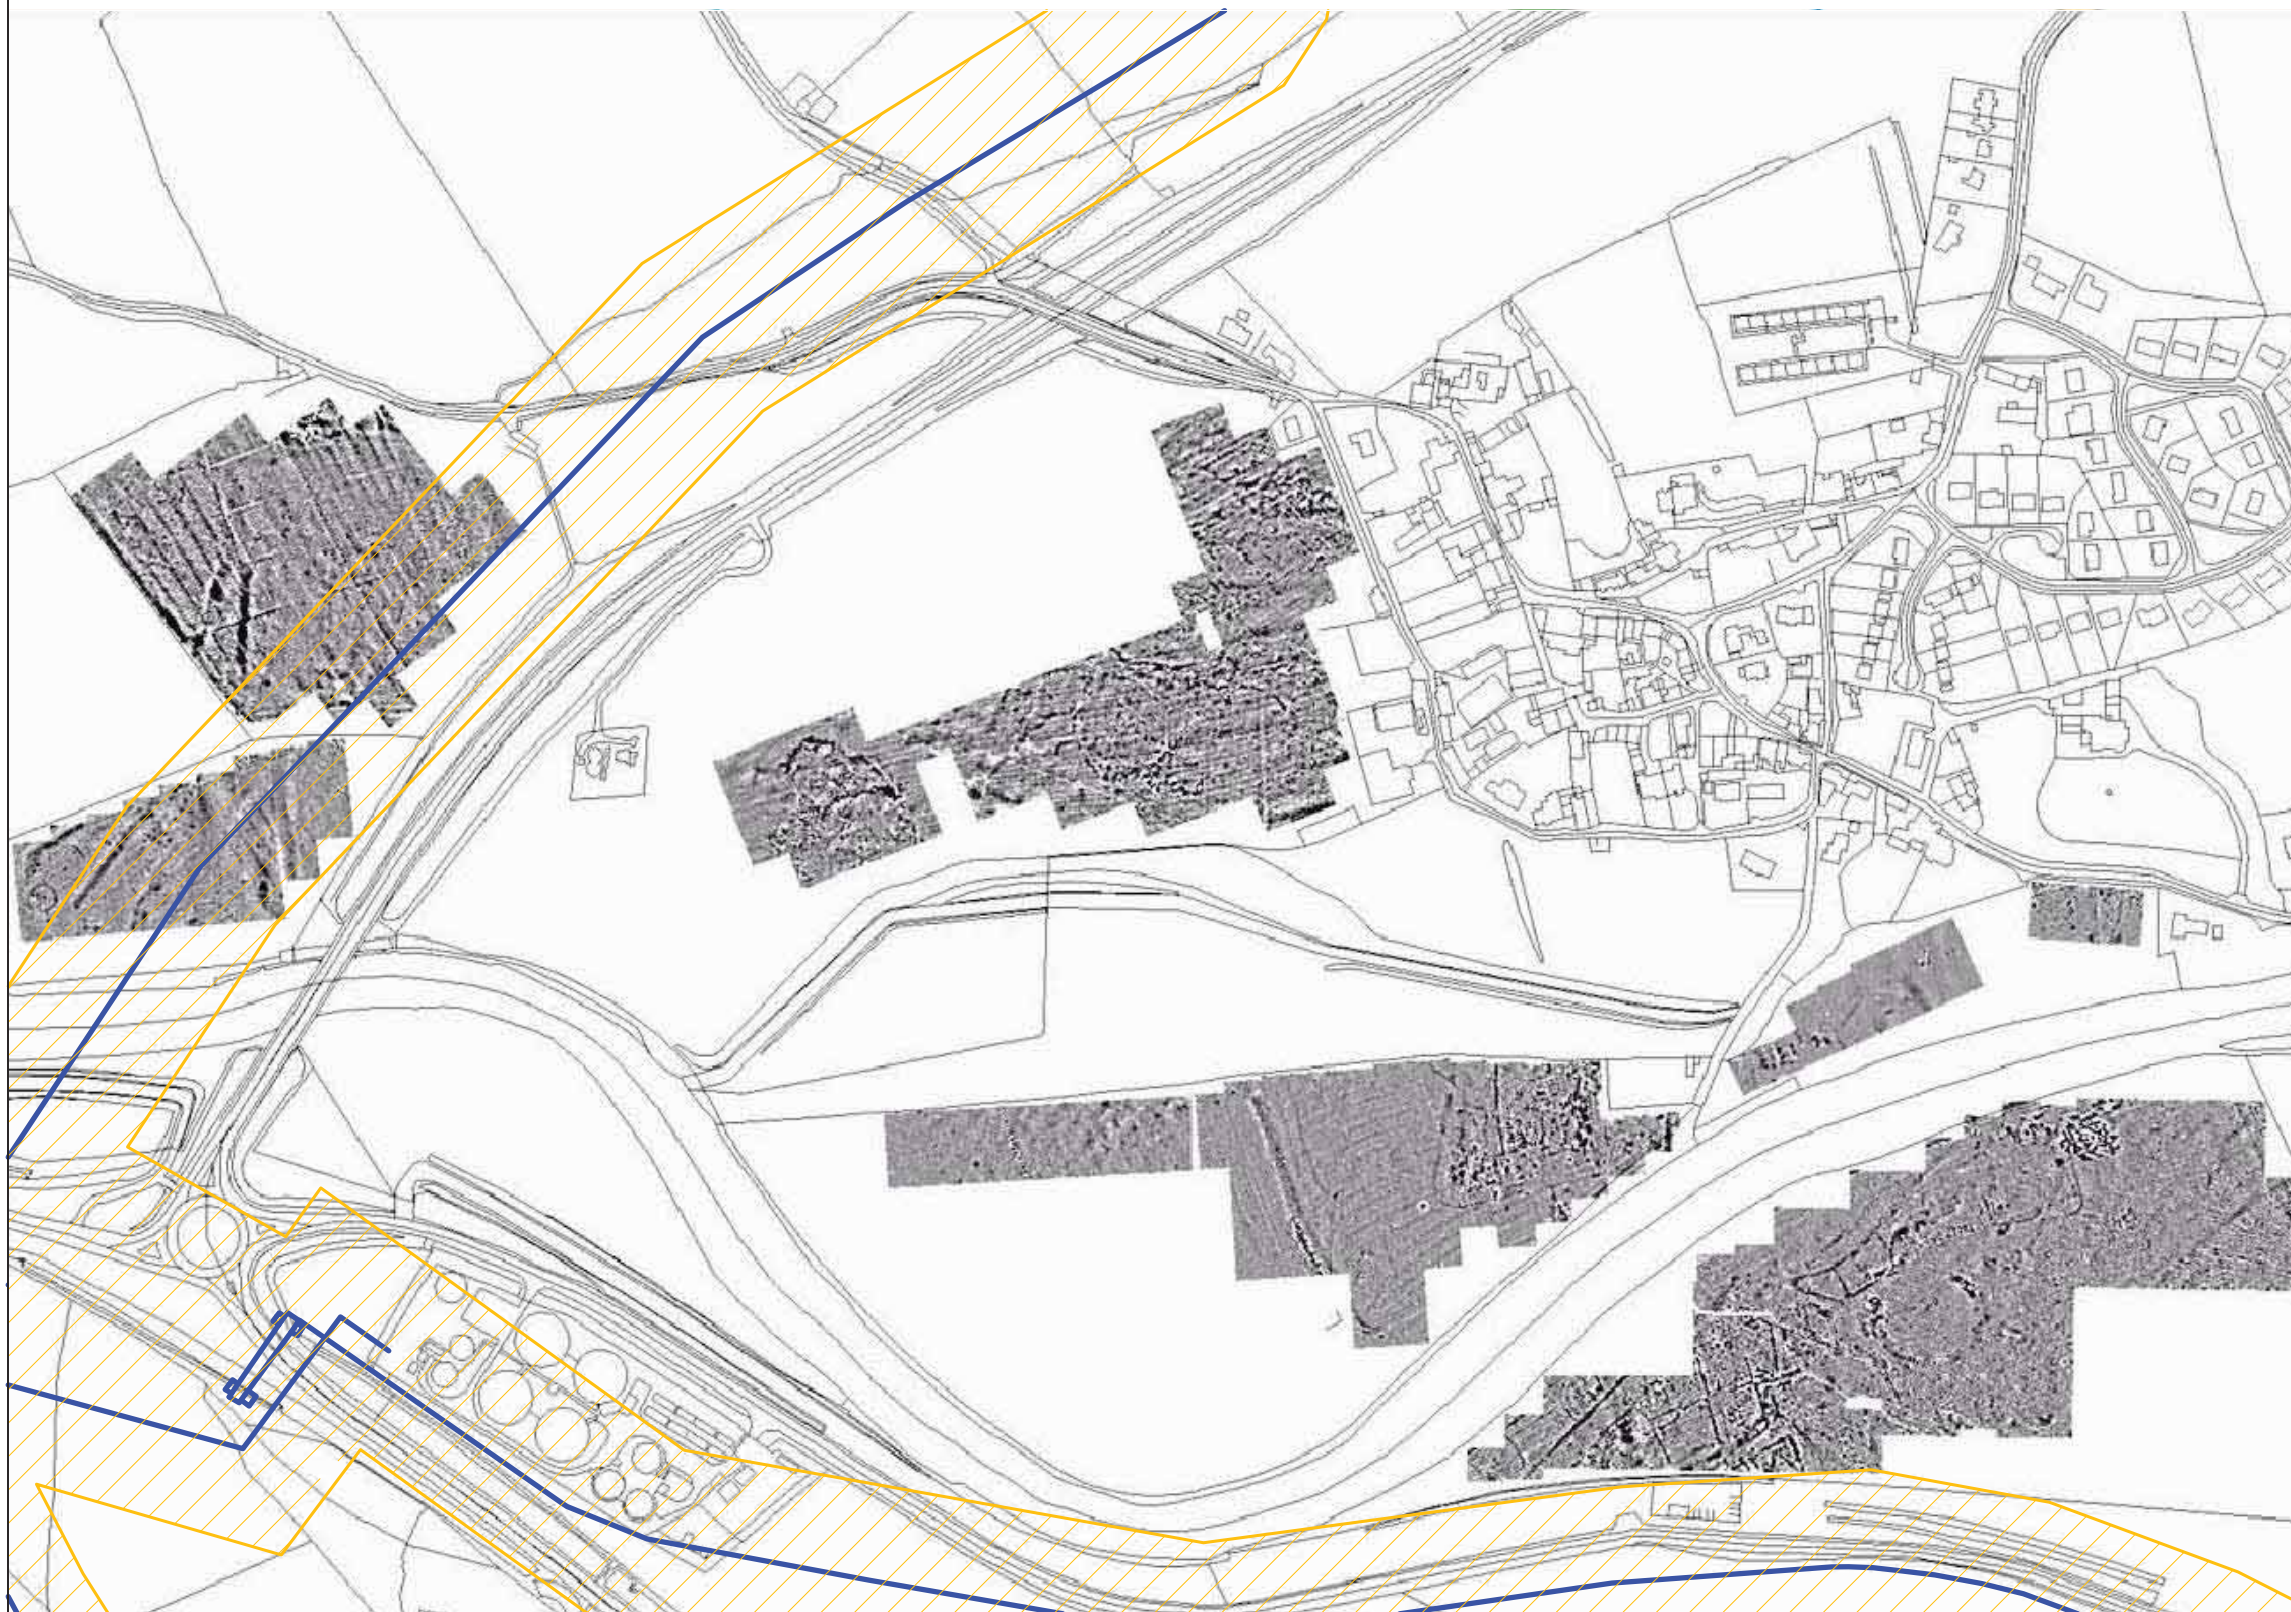
FIGURE:  
15

Figure 15: Results of geophysical surveys conducted around Papcastle.

- 3.4.10 These possible palaeochannels were targeted by an archaeological evaluation in January 2014 which encountered numerous fragments of prehistoric pottery within the palaeochannels. In the summer of 2014, an archaeological excavation was undertaken by Archaeological Research Services Ltd which found the channel to be well defined towards the western extent, though more ephemeral towards the east and it curved south-west to north-east (Williams 2014). Pottery sherds recovered were thought to be from one vessel, a carinated bowl of early Neolithic origin, possibly deposited in standing water (ibid, 4).
