ROBIN HILL FARM WEST

STANDISH

Archaeological Building Survey Report

Archaeological Building Recording

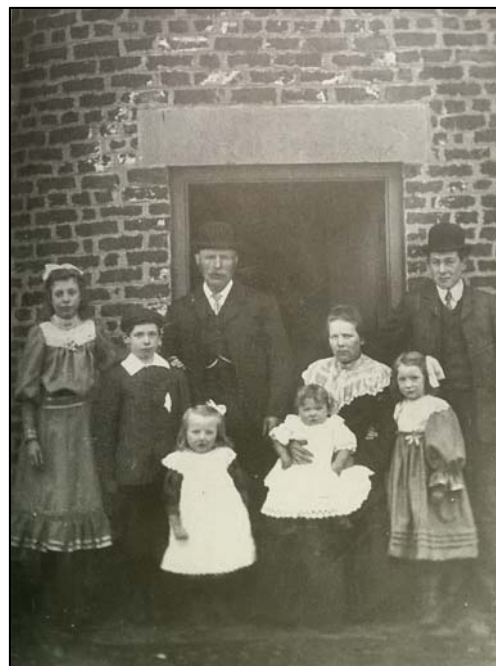
Plate 2: The Finch Family at Robin Hill Farm, c. 1914 (after Webb 1999, 119)

c. 1914	Finch family photographed outside farmhouse	Webb 1999, 119 (Plate 2)
Post 1914	Metal bracing attached to Building 1 (?) – not shown on Finch family photograph of c. 1914	Webb 1999, 119 (Plate 2)
1923	Henry Finch listed as farmer at Robin Hill	Smith 2003, 217

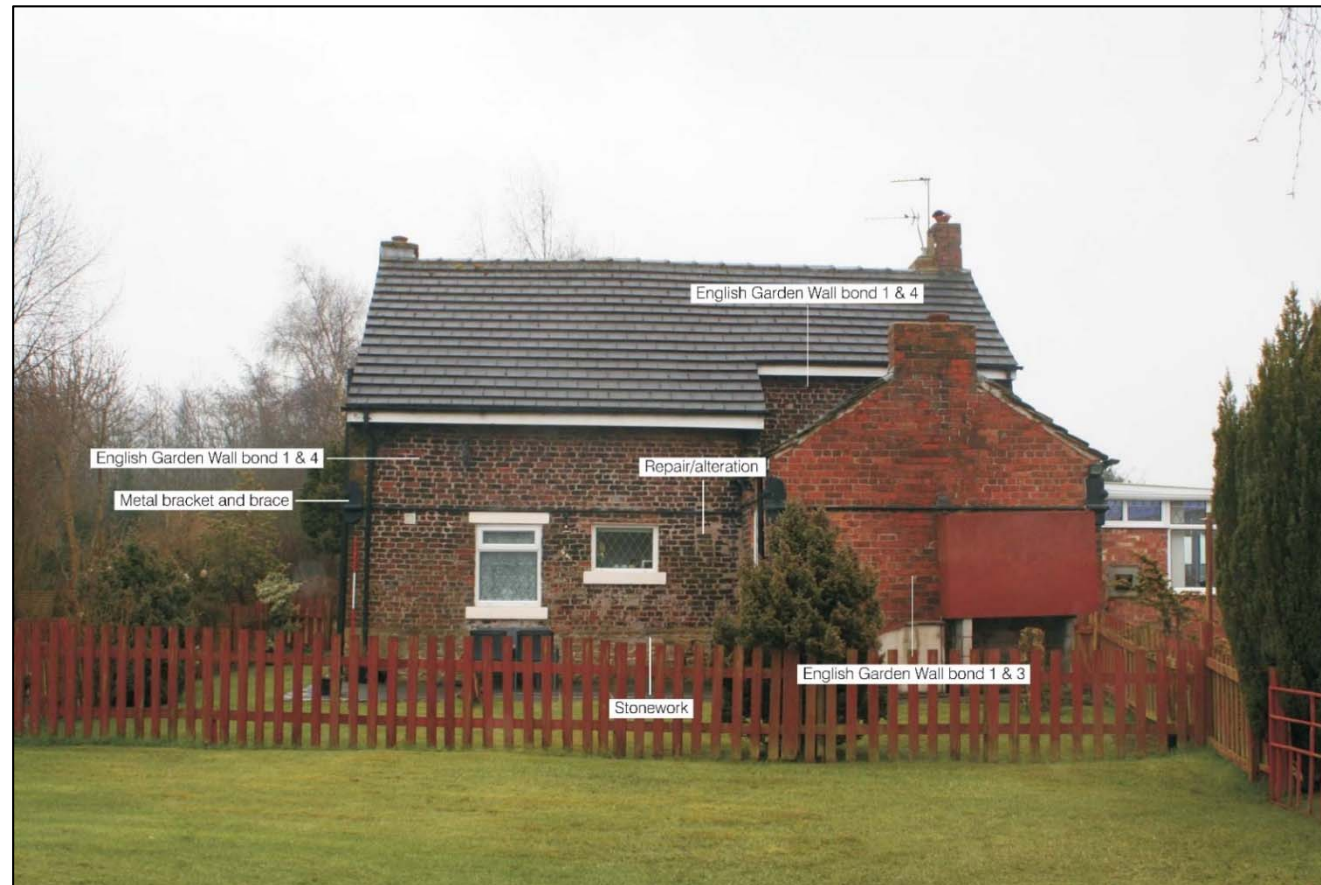
Plate 5: North-west facing elevation of Building 1

4.2.3 The north-west facing elevation of Building 1 (Plate 5) shows an extended roof line for the northernmost two thirds of the elevation. This extended area is also of brown brick in English Garden Wall Bond one and four, suggesting that it was part of the original design. The base of the wall is sandstone, the same as the south-east facing elevation. Two windows of differing sizes and heights exist in the oldest part of the building, and additional mortar and irregular brickwork to the south-west of the south-western window indicate an alteration or repair. The one-storey extension has a chimney at its northern extent, and a window on its north-east facing elevation. The metal brackets and brace bar continue around the one-storey extension, indicating that it was not part of the original build, but a later addition. It is not depicted on the photograph of the Finch Family c. 1914 (Plate 2).

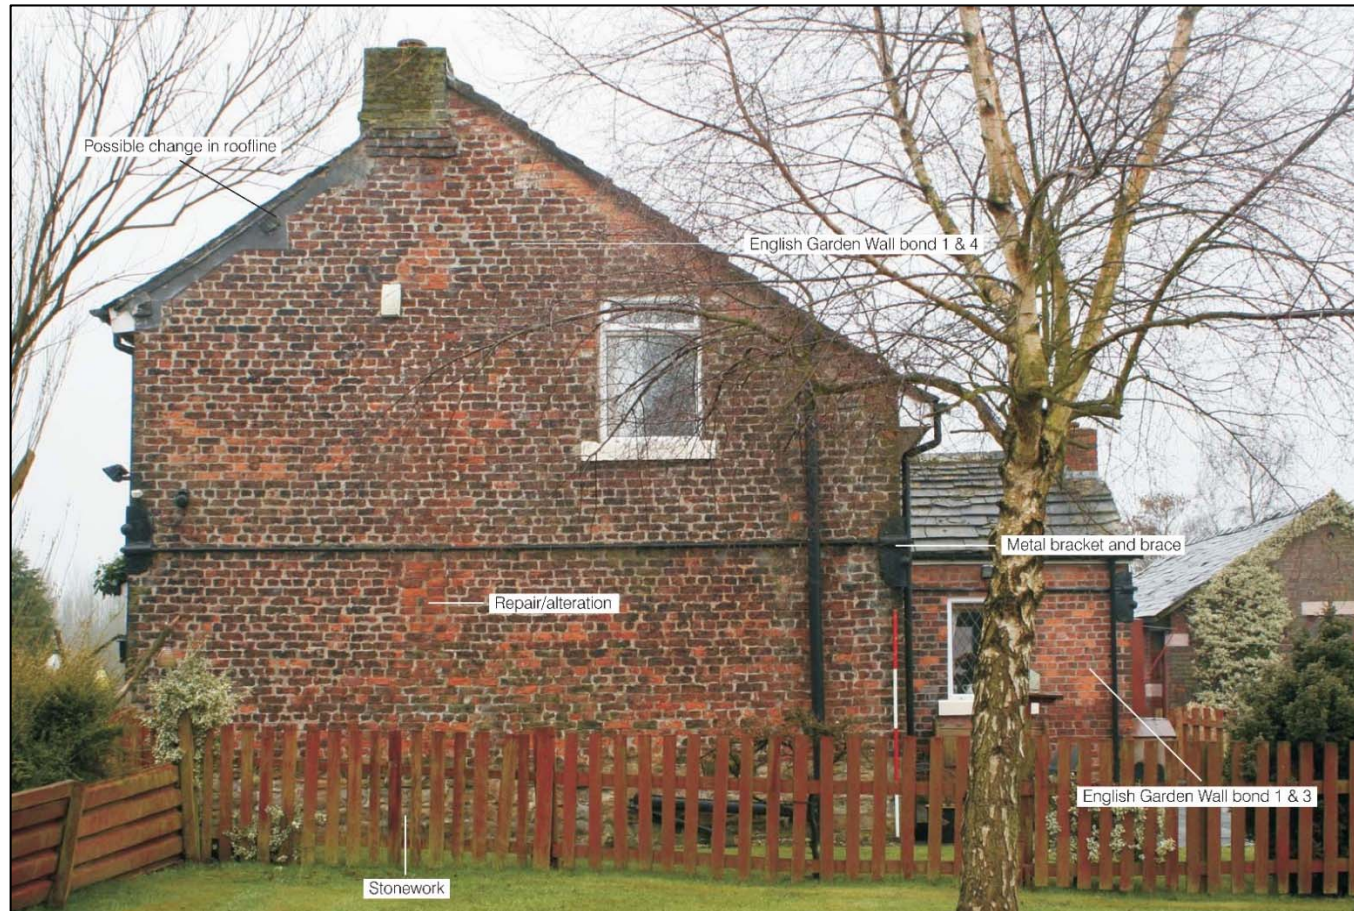
Plate 6: North-east facing elevation of Building 1

4.2.4 The north-east facing elevation of Building 1 (Plate 6) indicates a change in the roof level on the north-west edge, which may indicate that the wider extended part of the house at the western end was not part of the original design for the building. This part of the roof is at a higher level than the south-east facing roof, a feature not noted on the south-west gable of the building. The chimney on this gable may also have been altered, as it was not flush with the main wall, being stepped out slightly, and there were some red brick insertions in the wall slightly lower down. Timber trusses of the south-east facing roof were observed protruding from the roofline, and the whole area where the roof met the top of the wall on this side appears to have been rendered, perhaps evidence of later repairs. Towards the centre of the elevation, there was an area of red brick infill two bricks width and up to eight high, suggesting an alteration. A window was noted towards the northern half of the elevation at first

floor level, similar to that noted from the opposite gable end of the house. The same sandstone base of the wall, and metal bracket and bracing was observed spanning the breadth of the building.

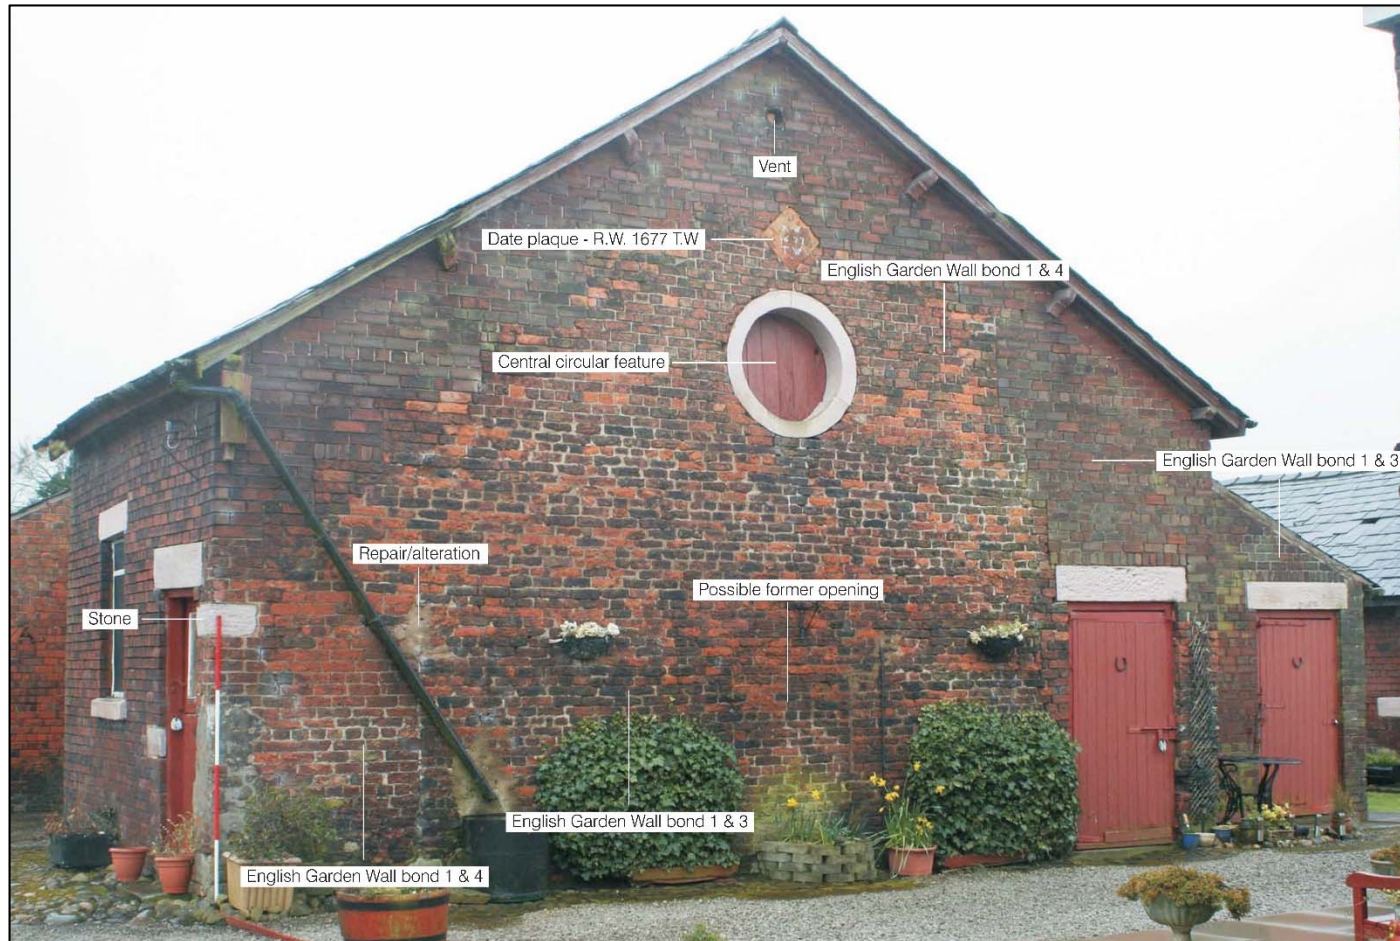
Plate 7: North-east facing elevation of Building 2

- 4.3.2 Above this was a date plaque, labelled ‘*R.W 1677 T.W.*’, and above this, and slightly off-centre was an air vent, of a similar style to that observed in the north-east and south-west elevations of Building 3 (*confer* 4.4.2 and 4.4.3; Plate 7). Interestingly, the south-eastern, north-western and top part of the elevation were constructed in red brick in English Garden Wall bond one and four, suggesting a later widening and heightening of the barn from its original size. A single door, with a stone lintel was noted towards the north-western extent of this part of the façade. Set back from this was a single storey small brick extension completed in English Garden wall one and

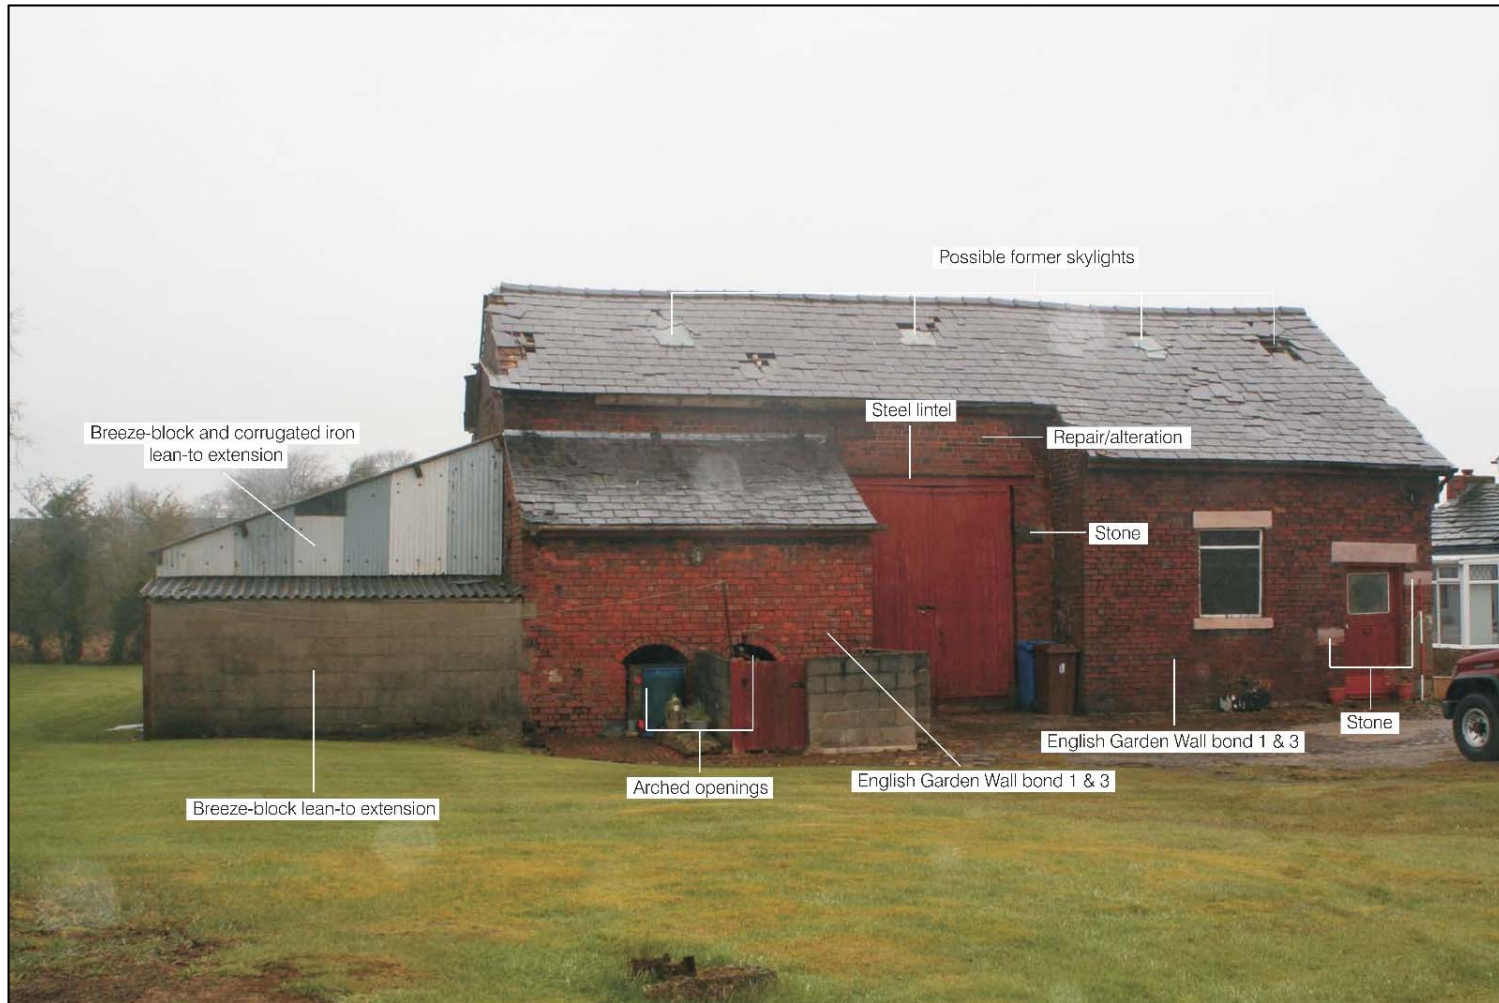
Plate 8: South-east facing elevation of Building 2

- 4.3.3 The south-east facing elevation also showed numerous alterations. It included two projections on the south-east and south-western extremes. All sections were completed in brick in English garden wall bond one and three. The main large door into the barn was located centrally, in the recessed section of the elevation (Plate 8). The brick above this was more modern in appearance, suggesting a repair or alteration, and there was a steel lintel for the barn door instead of the stone lintels provided for other windows and doors throughout the Robin Farm West complex. There was also the odd stone segment inserted next to the door openings on this elevation. One door and one two pane window was provided in the south-eastern protruding part of this elevation. The south-western protrusion included a door at a higher level and a triangular feature on the south-east facing elevation (Plate 9). The triangular feature is an air vent, though it has since been blocked, and the triangular form began to appear from the mid-18th century (Peters 2003, 15).

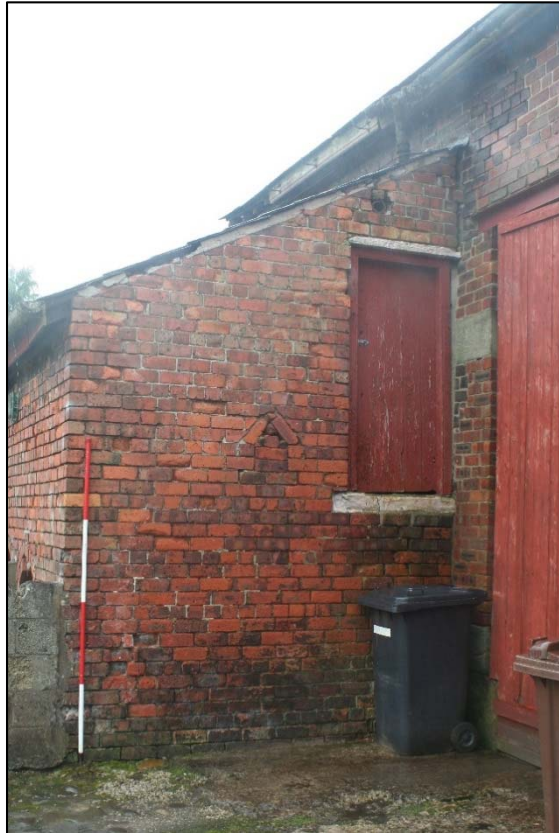
Plate 9: South-east facing elevation of south-west extension to Building 2

- 4.3.4 The appearance of a door at a higher level could not be explained by the study of the exterior, and more detail will arise from an interior study. This would also help to explain the use and development of the building. It is likely, however, that this extension, which includes arch openings on the south-east facing elevation (Plates 7 and 9), and cobbled enclosed area in front (Plate 9), was once used as a pigsty. The cobbles would have been easy to wash down and there was a drain at the south western corner (Plate 9). Pigs were found on most farms, and were particularly associated with dairying, as they were fed on the whey (Peters 2003, 72). The area at the front would have allowed the animals to take shelter at will, with the box, or interior area, large enough for one or two fattening pigs, or a sow with a litter (Peters 2003, 73). The building itself was low, reflecting the height of the pigs, and *“sometimes a hen loft put above, helping to keep both pigs and hens warm”* (Peters 2003, 73). Often pigsties were attached to other buildings, as is the case here. The fact that there is a door at a higher level above this, might suggest there was a hen loft above, though the door is rather large for a hen coop. There is a vent above it too. The south-west facing elevation of the pigsty, although obscured by a more modern breezeblock

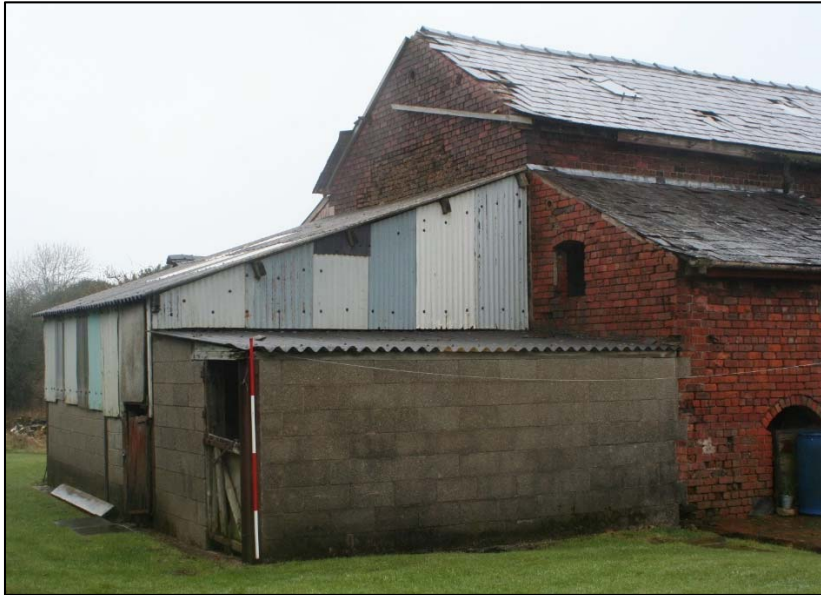
Plate 11: South-west facing elevation of Building 2, from the south

- 4.3.5 Very little of the south-west facing elevation of Building 2 was visible, as modern breeze block and corrugated iron lean-to buildings had been constructed against it. There was a vent towards the top of the elevation, in the same more modern brick observed in the north-east facing elevation (*confer* 4.3.2). More information may be possible once interior surveying can be arranged. A similar breeze block, corrugated iron and timber construction formed an extension in the form of a lean-to building at the north-west corner of Building 2 (Plate 12).

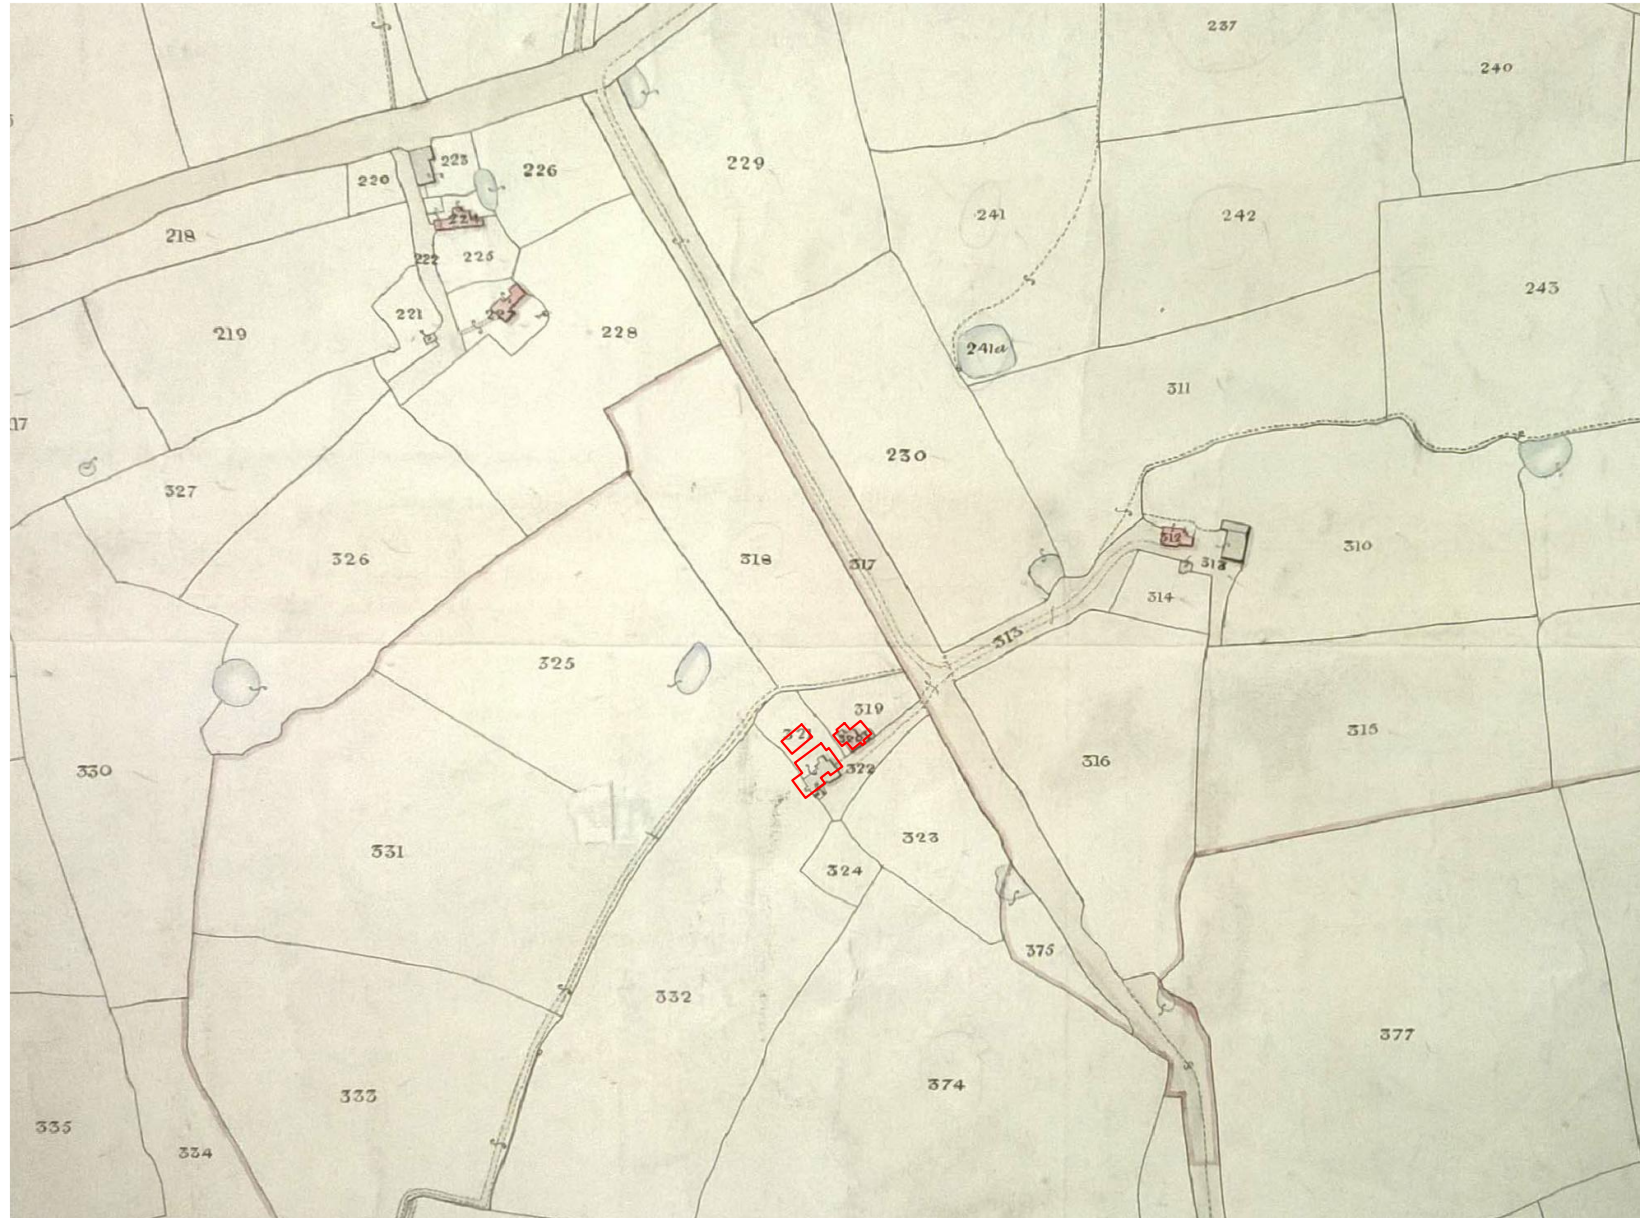
Figure 6: Extract from the Standish-with-Langtree Tithe Apportionment Map, 1842.

3.2.3 The Tithe Award Plan for Standish-with-Langtree of 1842 clearly shows the plot numbers for the immediate environs of the present Robin Hill Farm West as 319, 320,

- 3.2.12 The Tithe Award plan is the earliest to clearly show Robin Hill Farm West, and depicts two buildings forming the farmstead by this date, in the same locations at the present farmhouse (Building 1) to the east, and barn (Building 2) (Figures 6 and 2). Both are smaller than at present, but the accompanying award lists ‘320’ Building 1, as ‘Dwelling House & Yard’, and ‘321’, Building 2 and the land to the immediate north-west, as ‘Outhouse and Croft’. The use of the term croft may indicate a medieval origin for the plots. The parallel nature of the buildings, and presence of only two buildings, indicate a small farm (Peters 2003, 7). Both buildings are fairly irregular shapes by 1842, perhaps indicative of various alterations and extensions. The track shown heading south-westwards from the farmstead could be that shown on the Standish Manorial Plan of 1793 (Figure 3). Robin Hill Lane to the east of the farm, is shown extending southwards, and a pond is shown in a field to the north-west of the buildings.

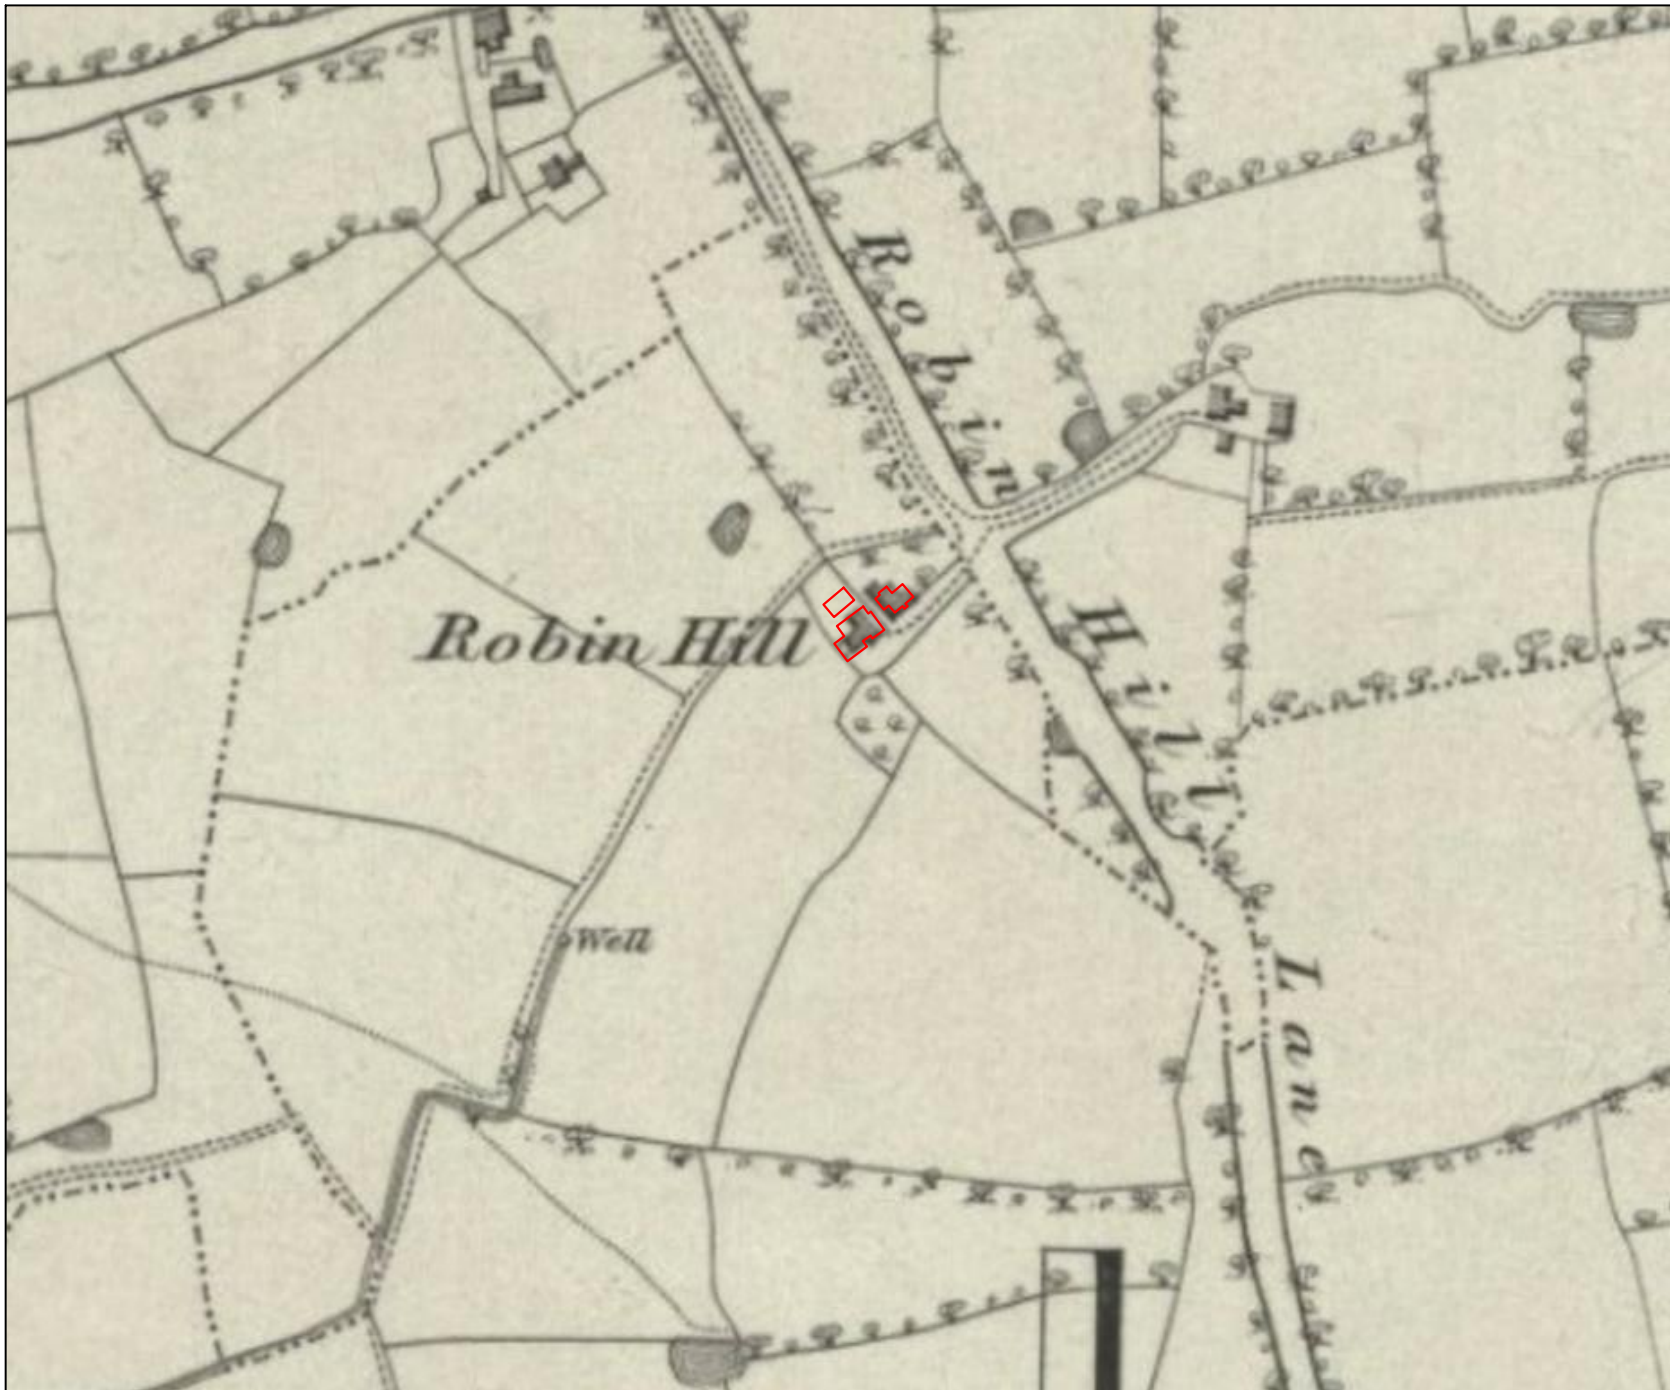
Figure 7: First Edition Ordnance Survey Map, 1849 (6 inches to 1 mile scale).

- 3.2.13 The First Edition Ordnance Survey Map, 6inch scale, of 1849 (Figure 7) shows a very similar layout to the Tithe Award plan of 1842 (Figure 6), although the land to the

immediate north-east of Building 1, and the square field to the south of Building 2 both appear to be orchards by this date, though both are described as such in the Tithe Award text and in the Terrier of 1864 (*confer* 3.2.3 and 3.2.4), indicating that no changes had occurred in the years between the publication of these maps.

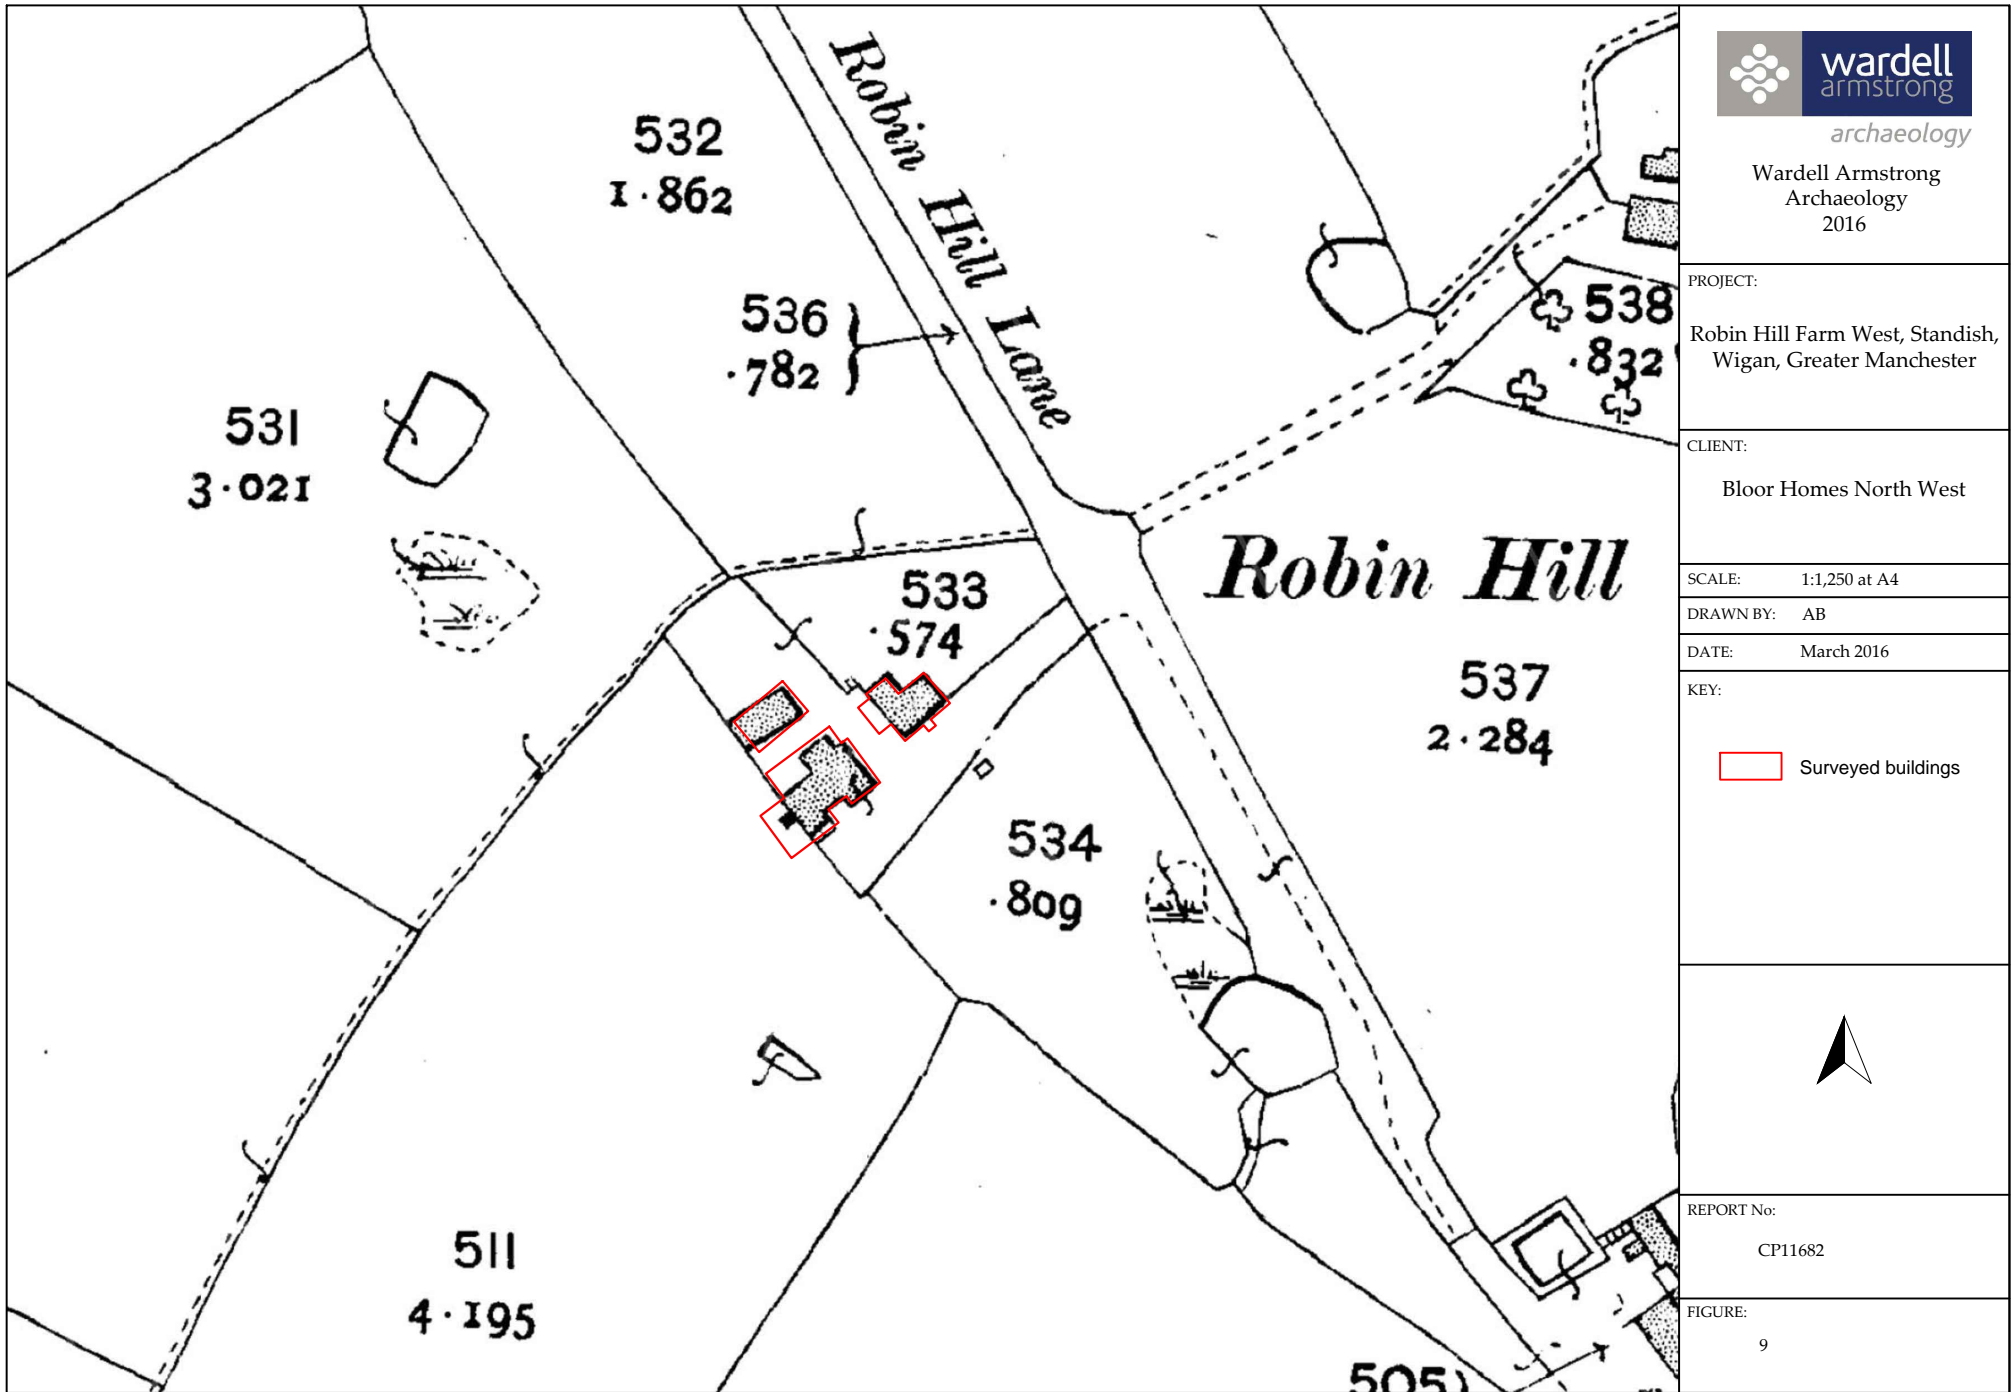
Figure 9: Second Edition Ordnance Survey Map, 1908 (25 inches to 1 mile scale).

- 3.2.15 By the publication of the Second Edition Ordnance Survey Map of 1908 (Figure 9), the square orchard formerly depicted to the south of Building 2 has disappeared and the north-west extension to Building 2 has been removed. In addition, a rectangular building is shown to the north-west of Building 2, in the exact position of the present cow shed (Building 3). The surrounding area has not changed between 1894 and 1908 (Figures 8 and 9).

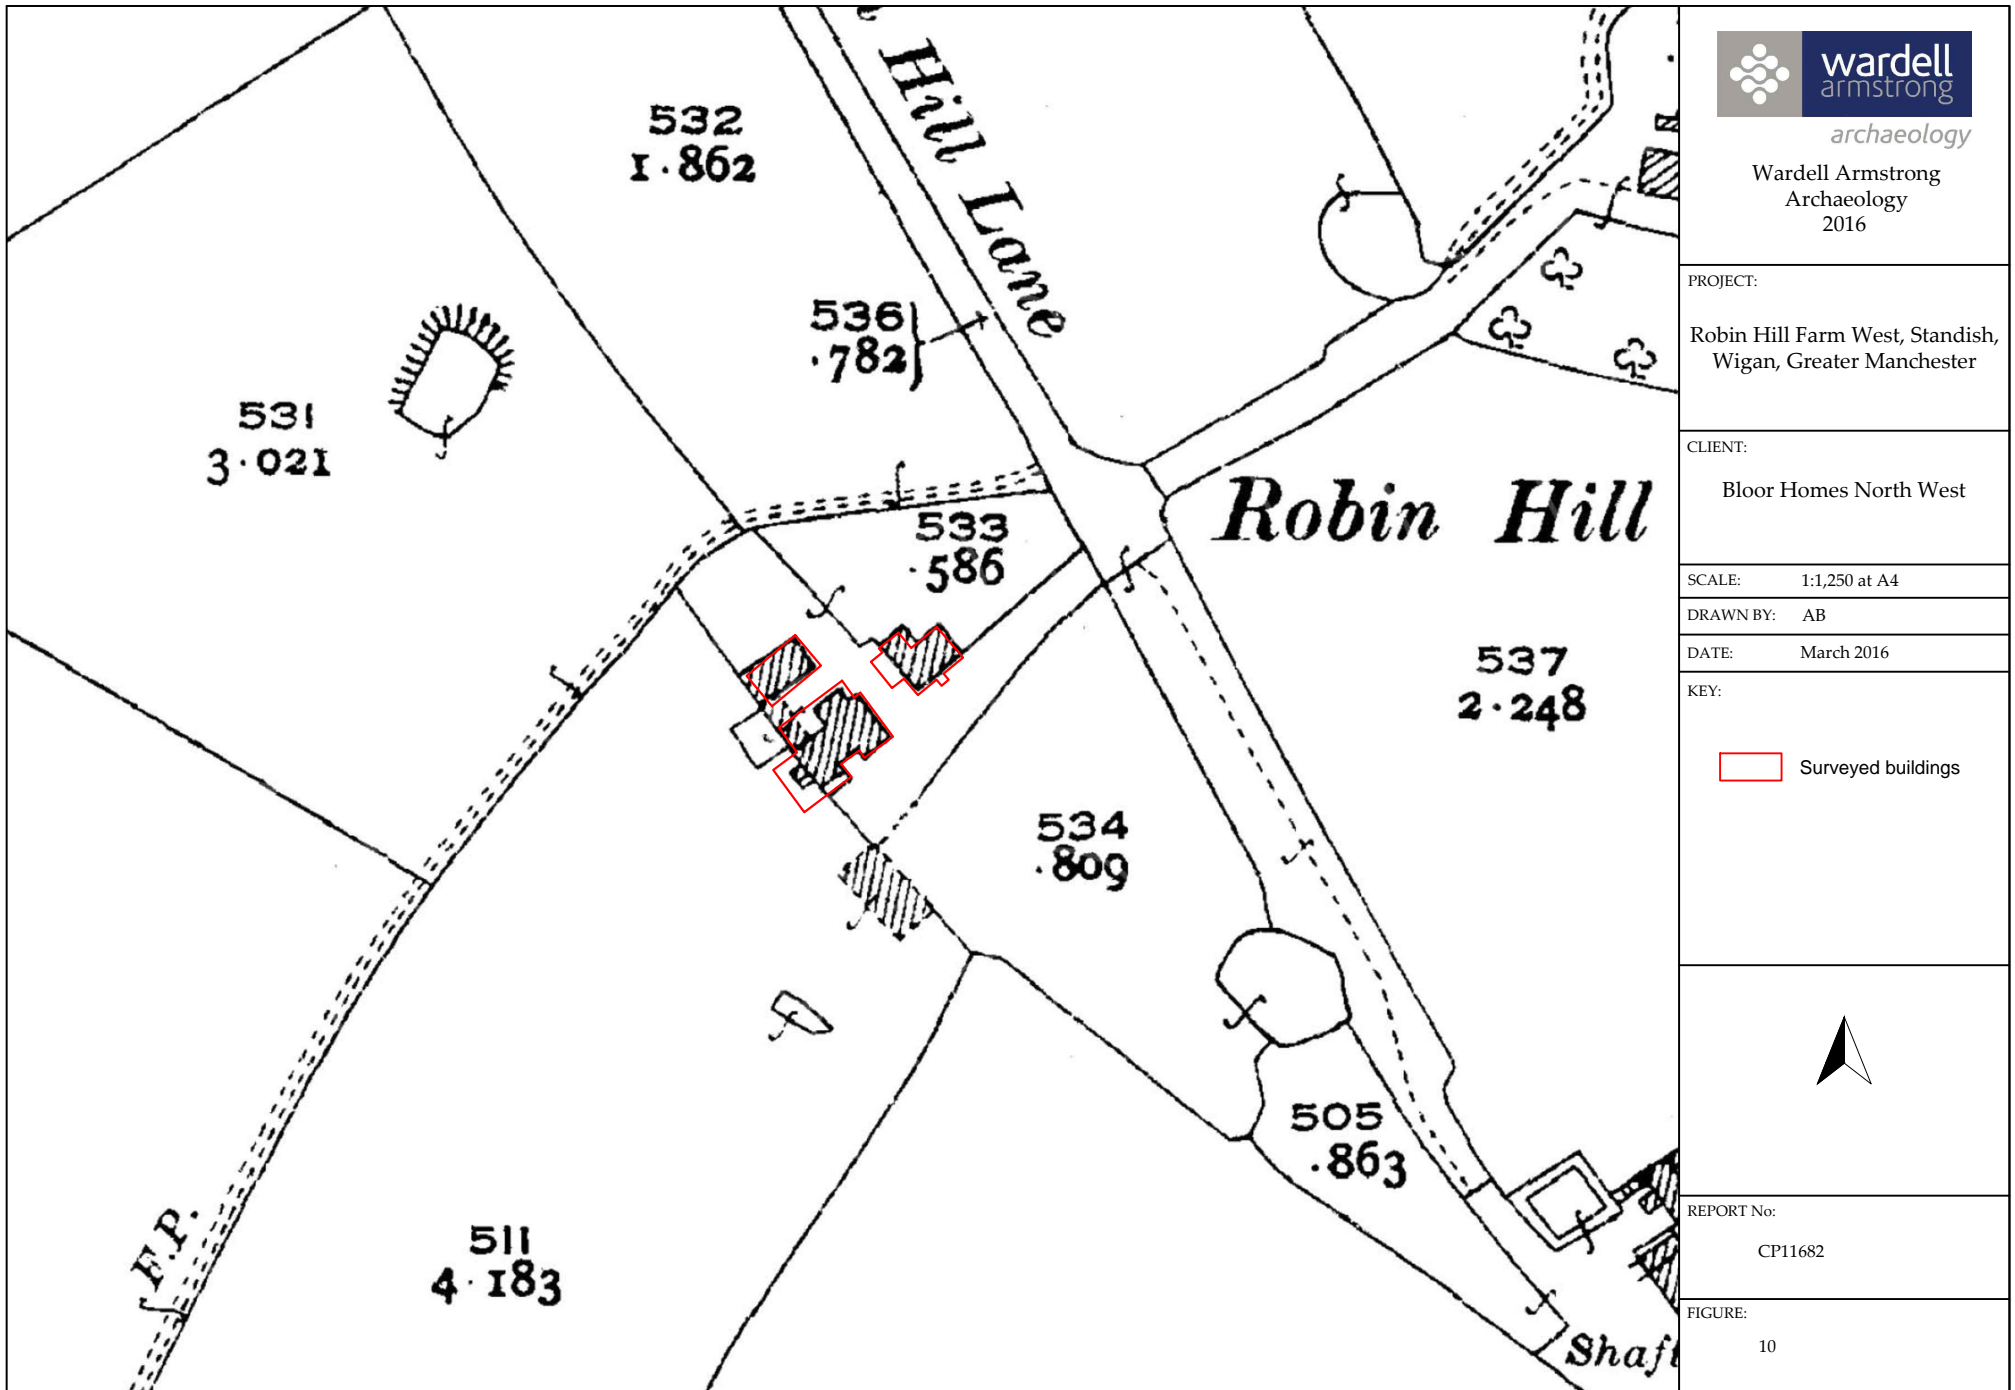
Figure 10: Third Edition Ordnance Survey Map, 1928 (25 inches to 1 mile scale).

- 3.2.16 Between 1908 and the publication of the Third Edition Ordnance Survey Map of 1928 (Figure 10), few changes have occurred in the vicinity of Robin Hill Farm West. However, a dashed rectangular structure linking Buildings 2 and 3 is depicted on the later map, perhaps suggesting an open temporary lean-to link building, and a dashed rectangular structure is also shown to the south of Building 2. In addition, to the west of the dashed structure linking Buildings 2 and 3, an enclosure is depicted at the western extent of the field. The small rectangular structure first shown on First Edition Ordnance Map 25inch edition of 1894 to the south-east of Building 1 (Figure 8) no longer survived by 1928.

4.5.1 To the south of Building 2, the remains of a series of concrete circular supports were observed regularly spaced to form a rectangle. This is likely to relate to a dashed structure depicted at this location on the Third Edition Ordnance Survey Map of 1928 (Figure 10; *confer* 3.2.15).

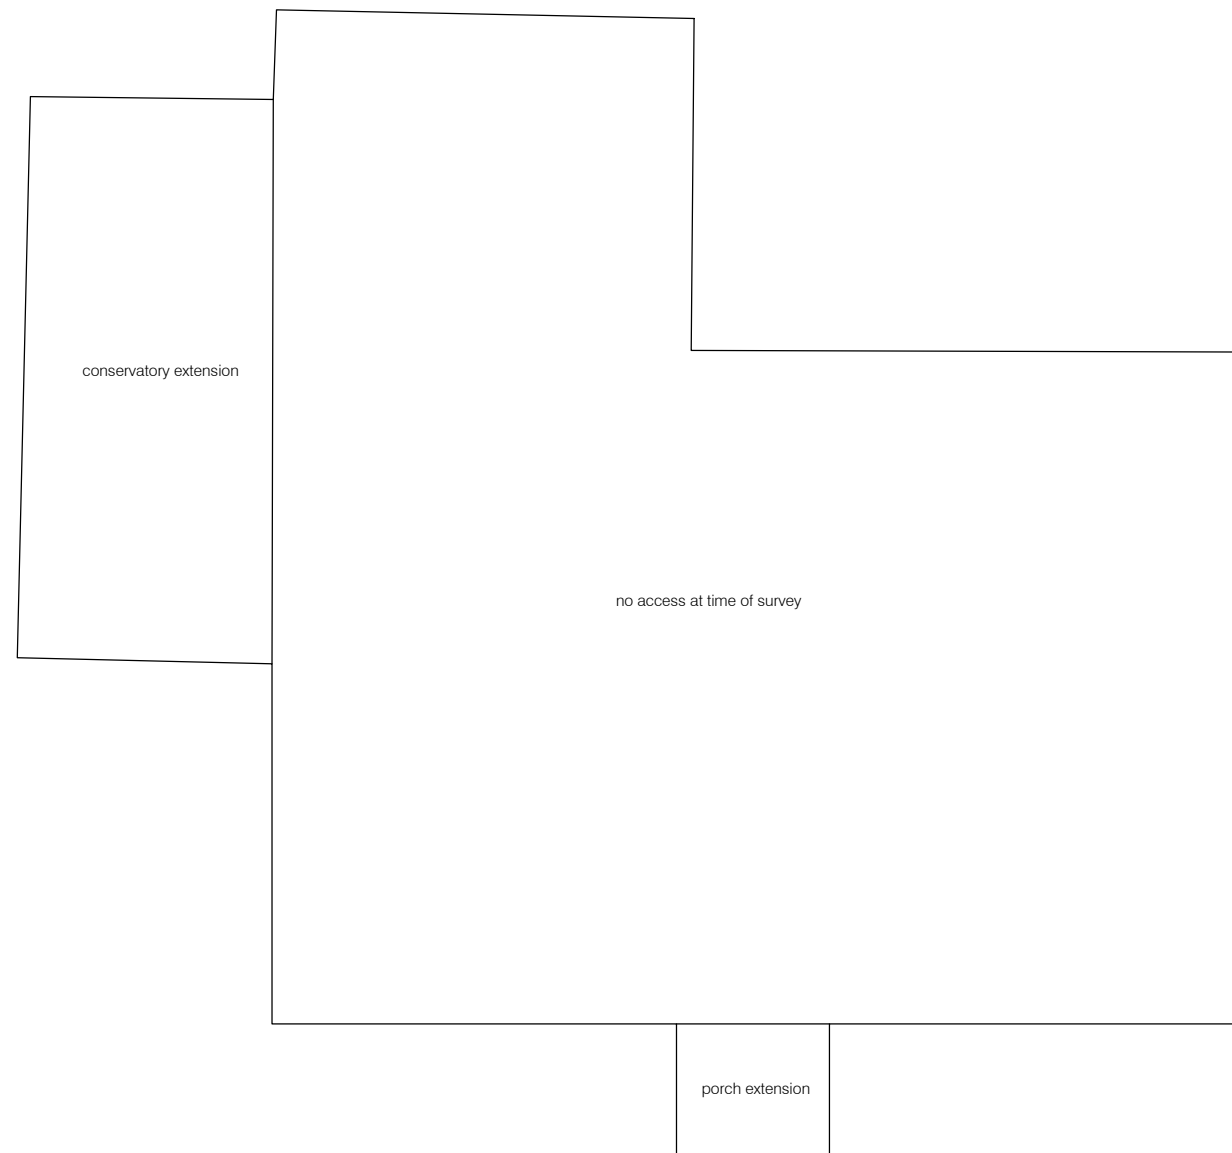
Figure 13: Plan of Building 1 - the farmhouse.

4.2.1 Building 1 was the easternmost of the three buildings targeted by the survey. At the time of the survey it was the farmhouse (Figure 13). It was a two storey brick-built building, with sandstone foundations up to 0.7m in height, of brown brick in English Garden Wall Bond one and four. The same brown brick in English Garden Wall bond is depicted on the Finch farm building behind the Finch family c.1914 (Plate 2), further indicating that this farm was once Finch Farm. The entrance was on the south-east facing façade (*confer* Plate 3), and was through a modern (post 1967; *confer* 3.2.18) porch extension. Five windows were provided on this south-east facing elevation, one on the ground floor and one on the first floor either side of the door, and a central one above the door. The windows were UPVC replacements. The south-western window at first floor level was not directly above the ground floor window. Metal brackets had been attached to the corners of the house, with supporting horizontal bars straddling the elevations, half way up, suggesting a supportive role. This surrounded the whole building, except the porch and western extensions first shown on the 1967 map (*confer* 3.2.18). There was evidence of alterations or repair at the far eastern extent of the south-east facing elevation, revealed by red brick amongst the brown brick and the presence of cement or render instead of sandstone at the wall base by the downpipe.
