LAND AT DEADWATER FARM, KIELDER, NORTHUMBERLAND

HERITAGE IMPACT ASSESSMENT AND WALKOVER SURVEY

May 2016

DATE ISSUED: May 2016
JOB NUMBER: CP11723
OASIS REFERENCE: **wardella2-246456**
REPORT NUMBER: RPT-002
GRID REFERENCE: NY 61126 95421

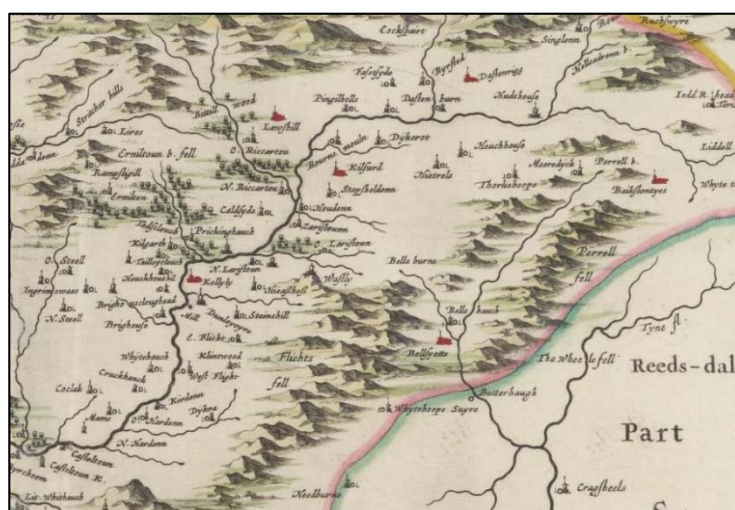
Plate 2: Extract from the Blaeu map of 1654

- 3.3.7 The Blaeu map of 1654 (Plate 2), based on Timothy Pont's late 16th century map, shows the site of Bells Chapel, this time as 'Bells hauch' with a settlement to the south-west, labelled 'Bellsyetts'. This suggests that by 1600, there was a separate settlement to the south of Bells Kirk. This appears to represent two small settlements, one by the church, and another on the opposite side of the burn. No other settlements further up the valley within the site boundary are shown, though it may be that these early cartographers concentrated on mapping churches.

- 4.1.6 The Blaeu map of 1654 shows '*Bells haugh*' (the chapel site) and '*Bellsyetts*', to the south, on the southern side of Bells Burn (Plate 2). This same settlement is shown on Roy's Military map of Scotland of 1752-5 (Plate 3) as '*Bells*' consisting of a number of buildings and associated cultivated land. Only '*Bells Rig House*' is shown on the estate map of c. 1762, however, suggesting that this settlement had been largely abandoned (Plate 4). Certainly, no buildings are shown on Armstrong's map of 1769 (Plate 5).

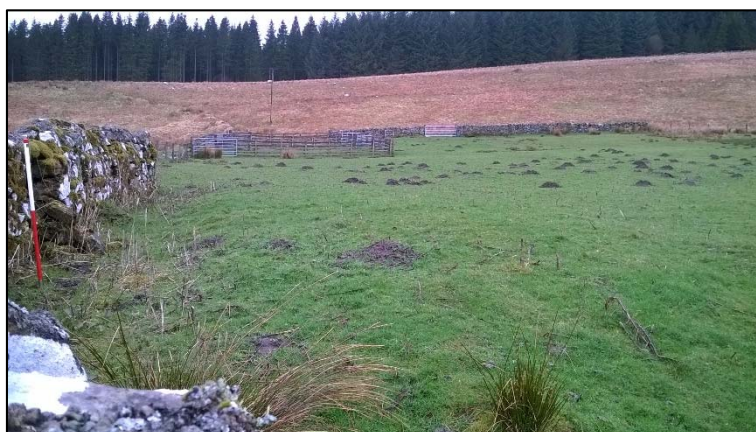
Plate 8: Former site of Lightpipe Farmstead (Asset 36), facing north-west

- 4.1.3 ***The South-Eastern Area- Lightpipe area:*** Kerseyclough Cottage (Asset 18), seen on the First Edition Ordnance Survey Map of 1863 (Figure 4) was still in existence as a dwelling at the time of the walkover survey, but is now known as Lightpipe. Historically, Lightpipe (Asset 36), first depicted on Fryer's Plan of Northumberland of 1820 (Plate 6) was located to the south-east of the present Lightfoot/previous Kerseyclough Cottage (Asset 18) in the south-east corner of an enclosed area. The field boundary remained the same as it appeared on the First Edition Ordnance Survey map of 1863 (Figure 4) at the time of the walkover survey, although only a slightly raised area of ground was noted at the location of the former Lightpipe farmstead (Asset 36; Plate 8). A break in the drystone wall forming the southern boundary, noted during the walkover survey, may indicate a former entranceway for the farmstead (Plate 9).

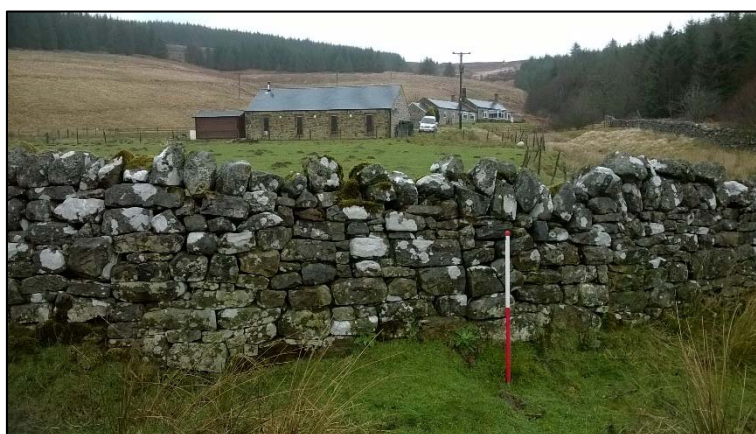
Plate 9: Break in boundary wall south of former site of Lightpipe Farmstead (Asset 36), facing north

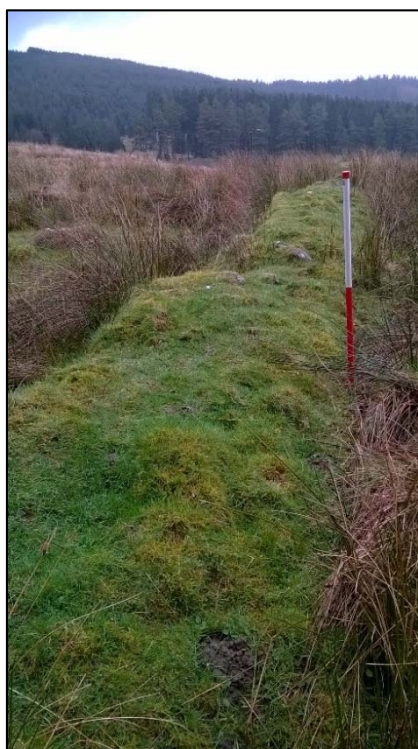
Plate 10: Northernmost bank forming part of Asset 38, facing south-east

- 4.1.4 To the south-west of the buildings in the Lightfoot area, no trace was found of the former small rectangular enclosure shown on Ordnance Survey mapping of 1952 (Asset 47). Two banks were noted (Asset 38), either side of a modern forestry track, and presumably cut by it, following the route of a track and field boundary shown on the First Edition Ordnance Survey map of 1863 (Figures 4 and 5; Plates 10 and 11). This may represent the remains of a track which once led beyond the site boundary, to the former farm of Kerseycleugh (Asset 35) to the west.

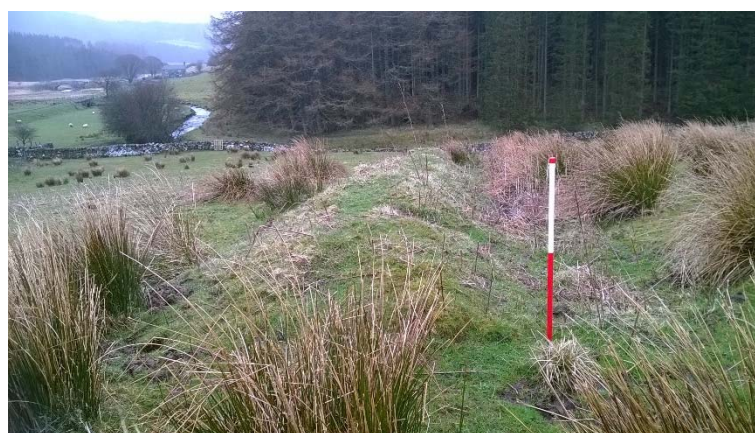
Plate 11: Southernmost bank forming part of Asset 38, facing north-west

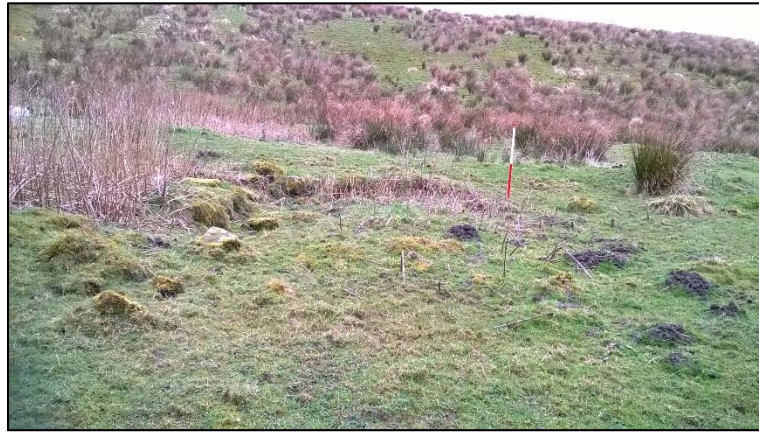
Plate 12: Possible former chapel (Asset 10), facing south-west

- 4.1.7 A number of features were encountered in this area during the walkover survey, including the possible remains of the chapel itself, appearing as a series of raised overgrown stone banks forming a roughly rectangular plan (Plate 12) to the south-east of the surviving stone cross shaft socle (Plate 13). A further boundary surrounded this area, perhaps formerly the garden or graveyard for the chapel (Plate 14). Further features in the vicinity included two banks, possibly representative of a former Holloway or sunken track heading north-westwards from the complex (Plate 15), with a semi-circular enclosure to the west of that, which, along with the features noted from Google Earth, suggest that the area utilised extended northwards onto Bells Moor (Assets 59 and 50). The Holloway is likely to be the trackway shown on old mapping, which once led to the former settlement of Blackhope, just north of the western extension to the survey area. In fact, '*Old Road, Blackhope*' (Asset 68) is included within the Scottish online Sites and Monuments Record, Canmore, though Blackhope itself is not. In addition, '*Old roads in Liddesdale*' (Asset 69) is included within the Scottish online Sites and Monuments Record, Canmore, just to the west of the site boundary, which covers the area to the west of the site and makes it clear that the settlement of Bells was part of a wider community which extended across the border.

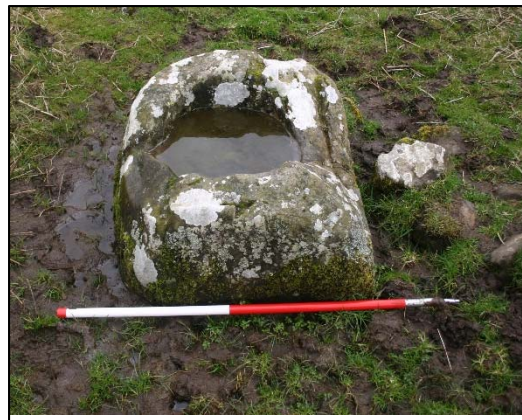
Plate 13: Possible cross shaft socle, part of Bells complex (Asset 10)

- 3.3.5 On the north side of Bellsburnhope, near the confluence of the Bells Burn with the Deadwater, the Northumberland HER records the site of Bells Chapel, and associated settlements (Asset 10). This is the site of a church and settlement recorded as Bells Kirk on post-medieval maps. It is first recorded on Christopher Saxton's map of Northumberland. This is the early Saxton County map which is undated, but all the county maps are known to have been completed between 1574 and 1578 (R. Newman *pers. com.*). It is highly likely that this settlement was of medieval origin, a likelihood further evidenced by the presence of an existing cross-shaft socle at the site (Plate 13).

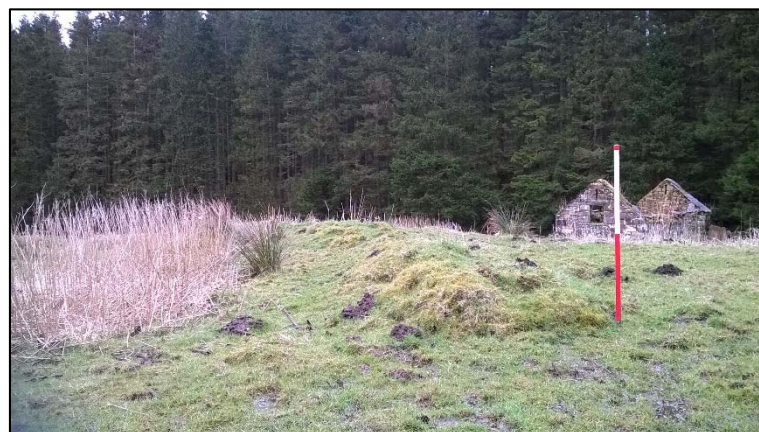
Plate 14: Possible entrance in boundary wall of chapel complex (Asset 10), facing south-east

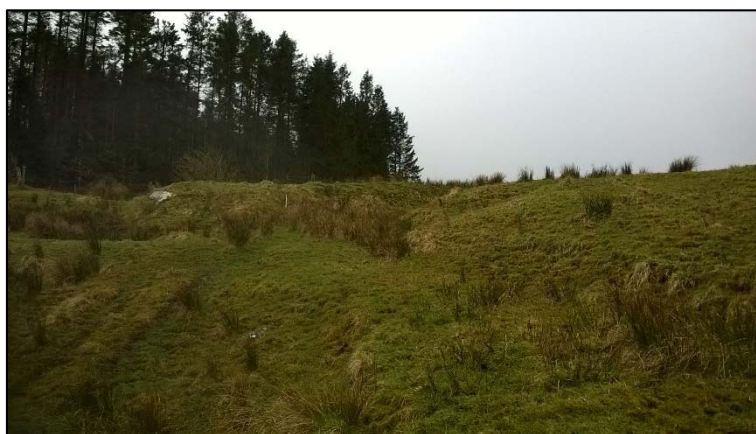
Plate 15: Possible former Holloway (Asset 10), facing west

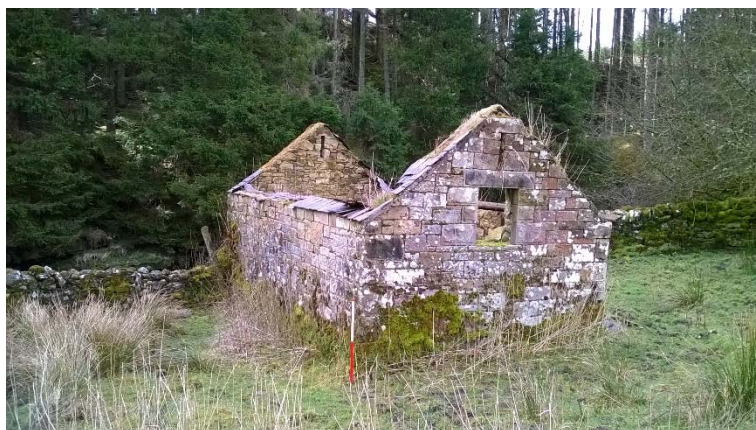
Plate 16: Ruined building (Asset 45), facing south

- 4.1.8 A further L-shaped field boundary, to the north-west of the existing building of Bellsburnfoot (Asset 39; Figure 5), and the ruined agricultural building first shown on Second Edition Ordnance Survey mapping (Asset 45; Plate 16) may relate to later activity at the complex.

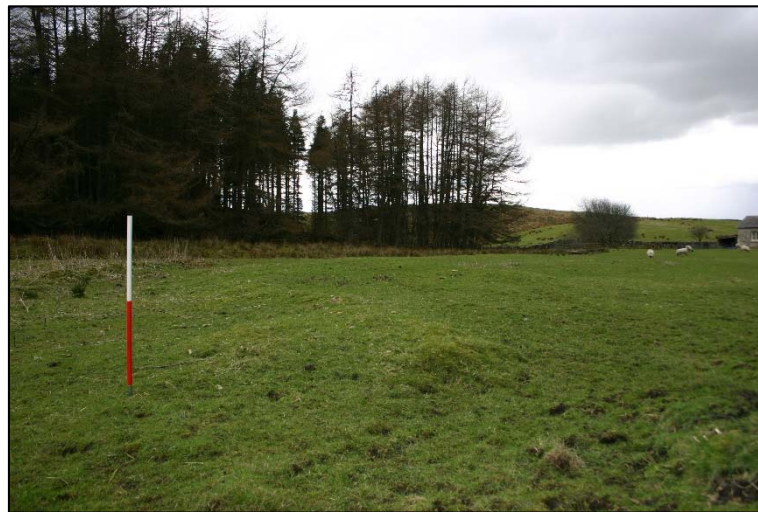
Plate 17: Bank, north of Bells Burn (Asset 10), facing south-west

- 4.1.9 Features were also identified to the south of Bells Burn during the walkover survey (Figure 5) and these extended eastwards towards the River North Tyne, east of the former railway line (Asset 32), beyond the proposed plantation areas. These included possible former buildings. Within the site boundary itself, to the west of the former railway line (Asset 32) and north-west of Bellsburn Cottage (Asset 17) were a series of features which may relate to early terracing of the area or division into individual plots. A bank and a raised area were also noted on the north side of Bells Burn (Figure 5; Plates 17 and 18).

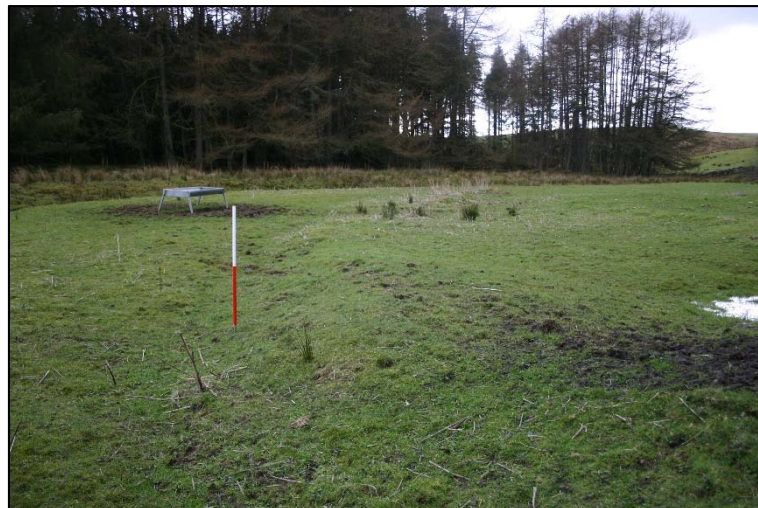
Plate 18: Raised area, north of Bells Burn (Asset 10), facing south-west

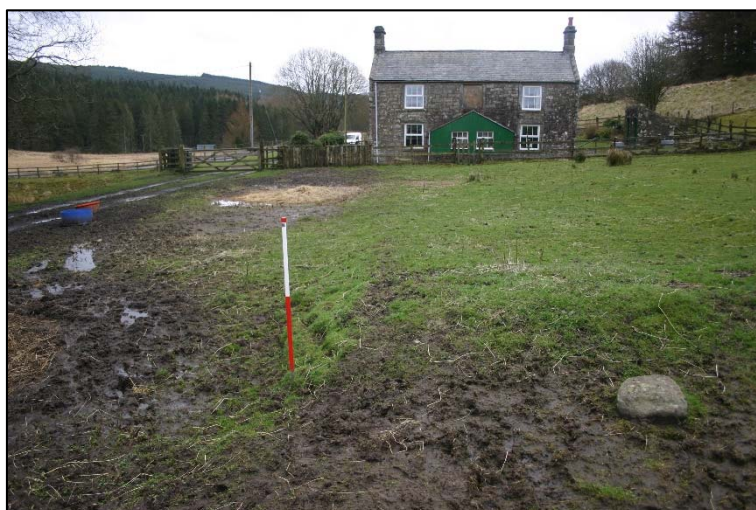
Plate 19: Former enclosure associated with Bellsburn Cottage, facing south-east

4.1.10 There were further features to the south, and north of Bellsburn Cottage which seemed to represent a rectangular area, likely relating to an earlier larger enclosed area, the former garden associated with the cottage (Plate 19). These are first shown on the Second Edition Ordnance Survey map of 1897

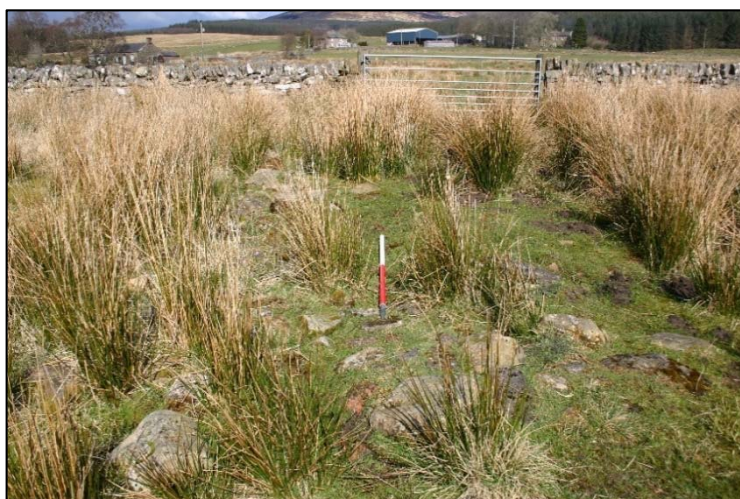
Plate 20: Former trackway (Asset 56), facing north-east

- 4.1.12 Other known assets were identifiable during the walkover survey. One of these, a rectangular structure seen on the Second Edition Ordnance Survey map of 1897 (Asset 46), survived well and was still in use, and appeared to be associated with a spread of rubble, thought to relate to a raised trackway which extended into the adjacent field (Plate 20), and likely to be of late 19th century origin. There was also a raised area of ground in the adjacent field, to the south-east, which may relate to an earlier site of an agricultural building, though none is known at this location from early mapping (Asset 55; Plate 21).

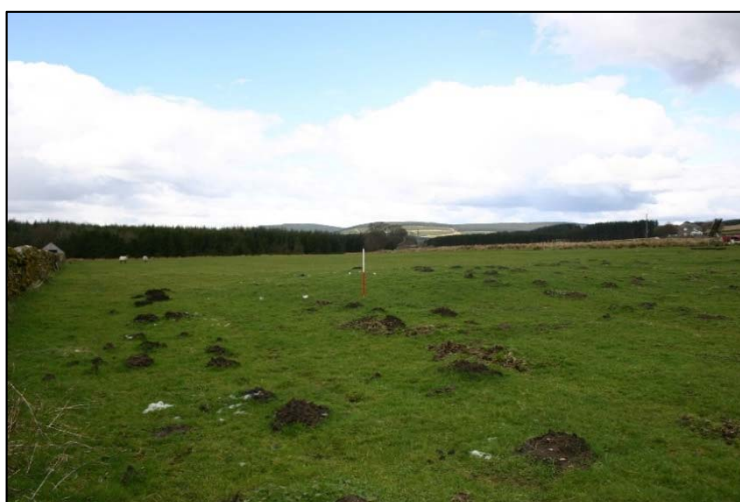
Plate 21: Possible former building (Asset 55), facing north-west

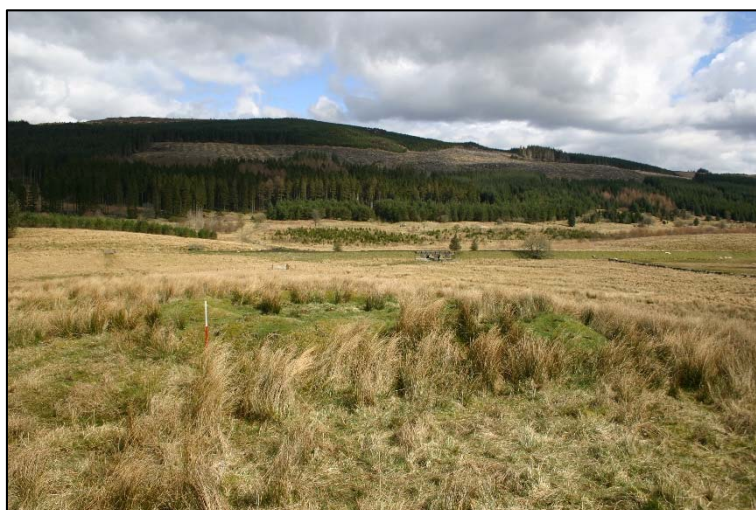
Plate 22: Former sheepfold (Asset 54), facing east

4.1.13 Further agricultural features in the form of a sheepfold (Asset 54; Plate 22), encountered towards the south-eastern part of Bells Moor (Figure 5) and a curvilinear bank, possibly an earlier boundary (Asset 53) were recorded towards the southern central part of the moor (Figure 5; Plate 23).

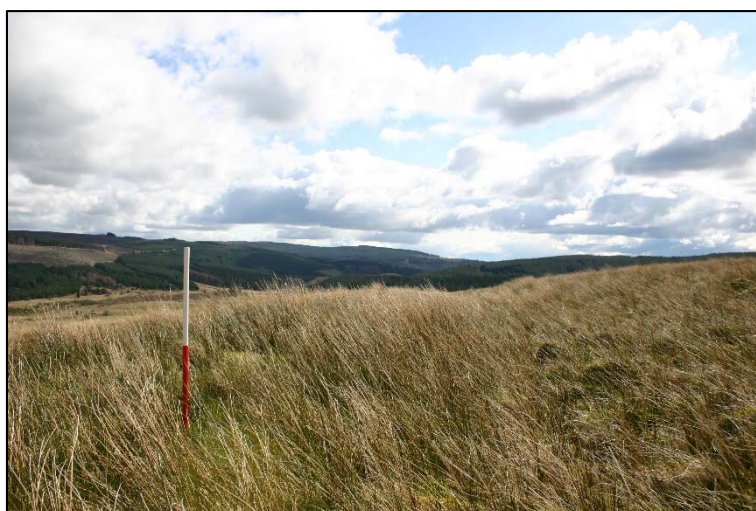
Plate 23: Curvilinear bank (Asset 53), facing south

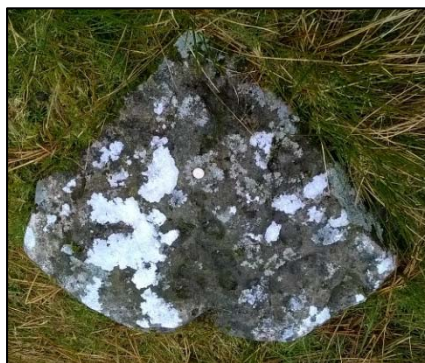
Plate 24: Possible rock art found on Bells Moor (Asset 61)

4.1.14 Another feature found on Bells Moor during the desk-based research, and confirmed during the walkover survey, was a large bank at the southern boundary of the site, that didn't extend beyond it, and may be a former boundary bank once forming the boundary between England and Scotland, perhaps relating to the Scots Dyke, depicted further to the north on earlier mapping (Plate 3; Asset 48; Figure 5). A possible example of rock art (Asset 61) was also encountered close to a stream on Bells Moor (Plate 24; Figure 5).

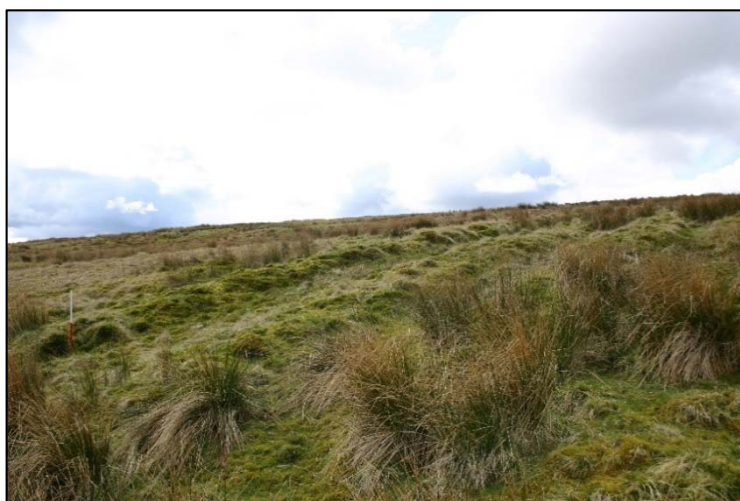
Plate 25: Area of rig and furrow within wider complex (Asset 2), facing south

4.1.15 Perhaps the most interesting feature encountered on Bells Moor was the known deserted post medieval village site (Asset 2). This is known from cartographic evidence (*confer* 3.3.9-3.3.10), and was surveyed in 1988 (Long 1988). Numerous banks and some areas of rig and furrow were noted in this area, some only identifiable on Google Earth (Asset 62), as well as the known sheepfold and associated enclosure, shown on modern mapping (Figure 5). These features differed slightly from Long's plan of 1988, logged with Northumberland County Councils HER (Long 1988). This included possible building structures, but not all of these were visible at the time of the walkover survey. Clear field systems were observable, on a roughly north-west south-east alignment, covering an area approximately 400m in length and 115m in width (Figure 5). In some areas, rig and furrow was clearly visible (Plate 25), and the banks forming the boundaries survived better in some areas than others (Plate 26). The mixture of buildings (probably including houses) and paddocks with little obvious plan form is both characteristic of post-medieval encroachment settlements and also of the Scottish settlement variant knowns as the '*fermtoun*'.

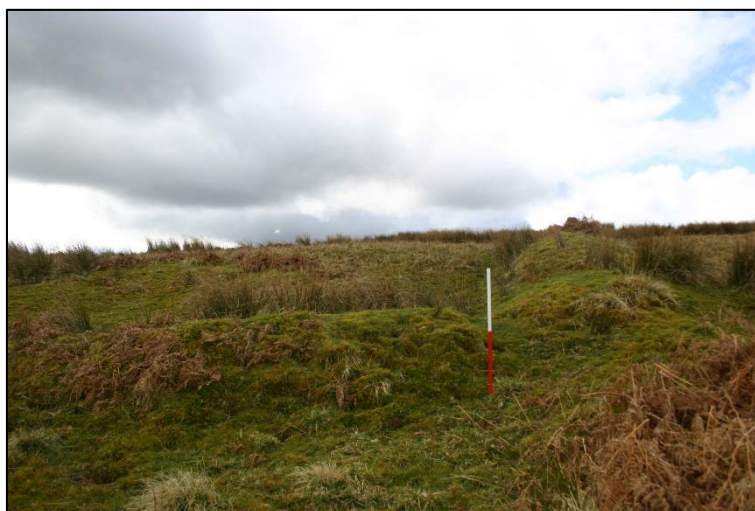
Plate 26: Area where bank survived quite well (Asset 2), facing south-west

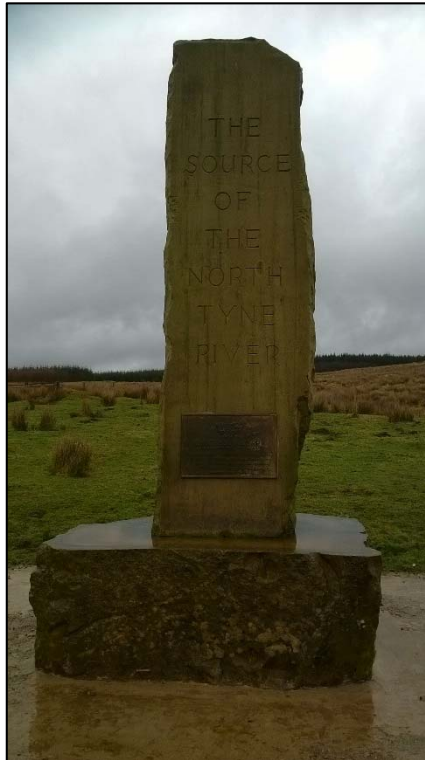
Plate 27: Monument to Source of North Tyne (Asset 57), facing north-east

4.1.17 The North-Eastern Area- Deadwater Farm area: the supposed site of a medieval village at Deadwater, cited by the Northumberland Historic Environment Record (HER) as in the vicinity of Deadwater Farm, was not located during the walkover survey (Asset 6), and neither was a former field boundary, known from First Edition Ordnance Survey mapping (Asset 40) or sheepfold (Asset 22). Buildings at the site of the present Deadwater Farm are shown on Roy's Military Map of Scotland of 1752-5 (Plate 3), suggesting that at least a farmstead was in existence by this date. This plan also shows a settlement annotated as '*Scots Dyke*' to the north-west, a site referenced in the HER as Deadwater Rigg (Asset 9) and it could be that these have been confused, and the medieval village was actually at the latter's location. Certainly the settlement '*Scots Dyke*' at Deadwater Rigg is not shown on any subsequent mapping. The area was planned by Long in 1988, and the walkover survey noted similar findings (Figure 5), although the area had been affected by modern post and wire fencing on a north-west to south-east alignment across Deadwater Rigg and along the western boundary, and by the erection of a monument (Asset 57; Plate 27) and associated trackway to reach it heading south-eastwards from it adjacent to the boundary to meet the road. A stone upright was also recorded nearby, perhaps a former gate stoop (Asset 58; Plate 28).

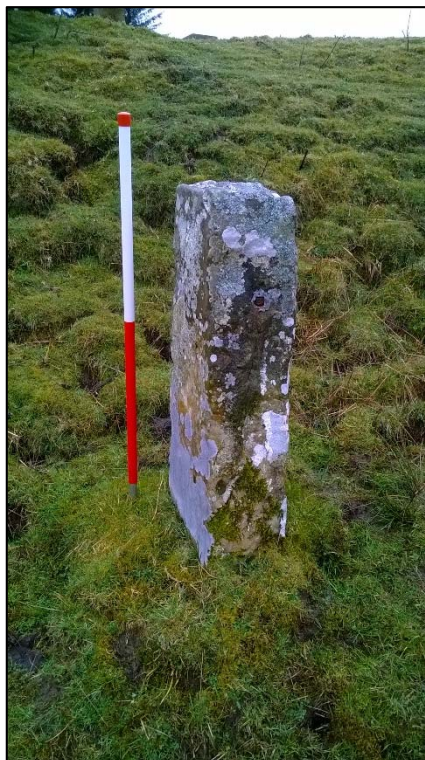
Plate 28: Possible former gate stoop at Deadwater Rigg (Asset 58), facing north-west

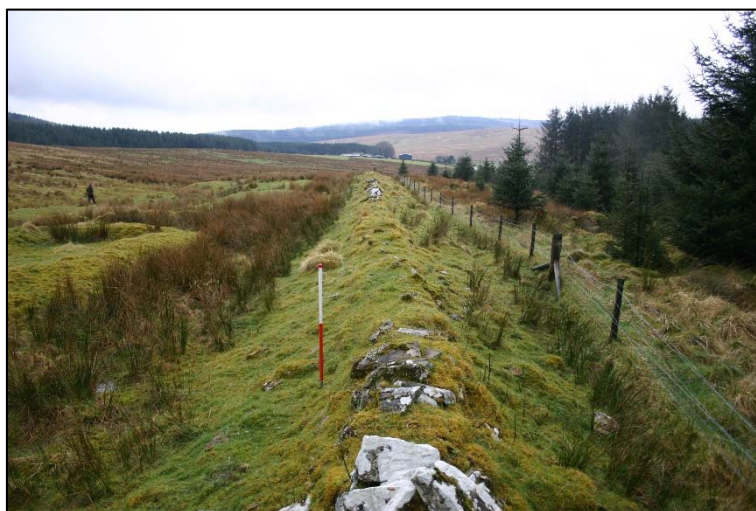
Plate 29: Boundary wall at Deadwater Rigg area to left (Asset 9), facing south-west

4.1.18 The boundary wall in the area of Deadwater Rigg, since replaced with post and wire fence, was respected by the settlement features and may be of some antiquity, and

although ruined and grown over in most places (Plate 29), some areas with capping stones still survived, but the wall tended to be better preserved when it was west of the modern boundary fence, beyond the present site boundary (Plate 30). It is possible that this relates to 'The Scots Dyke', marked on 18th century (Plates 3 and 4).

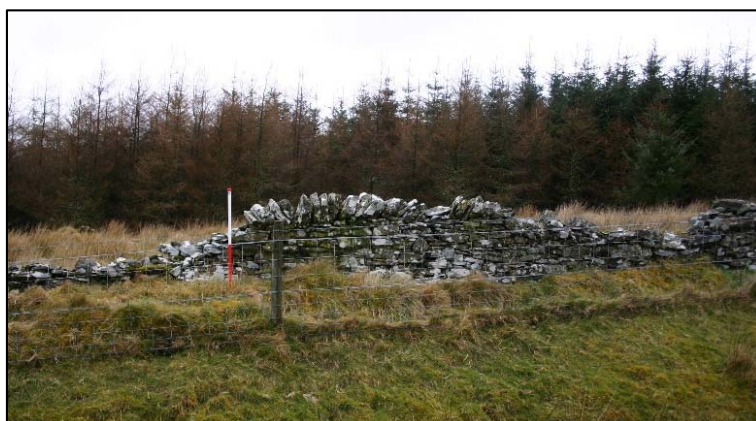
Plate 30: Boundary wall with capstones in vicinity of Deadwater Rigg (Asset 9), facing north-west

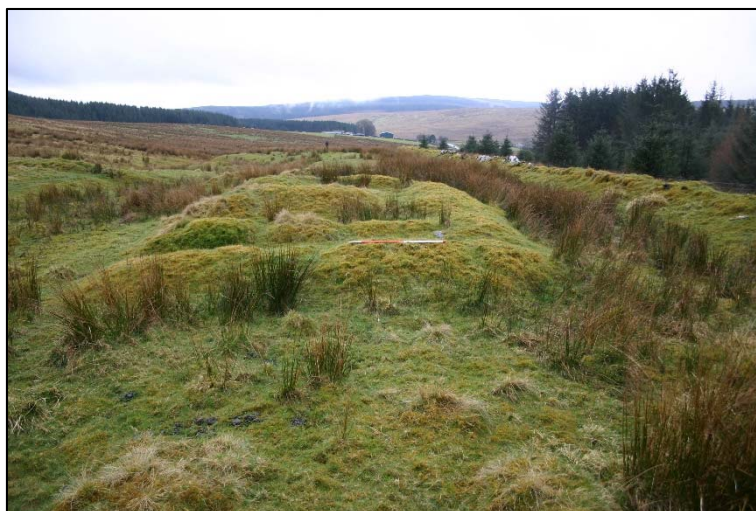
Plate 31: Possible remains of building (Asset 9), facing south

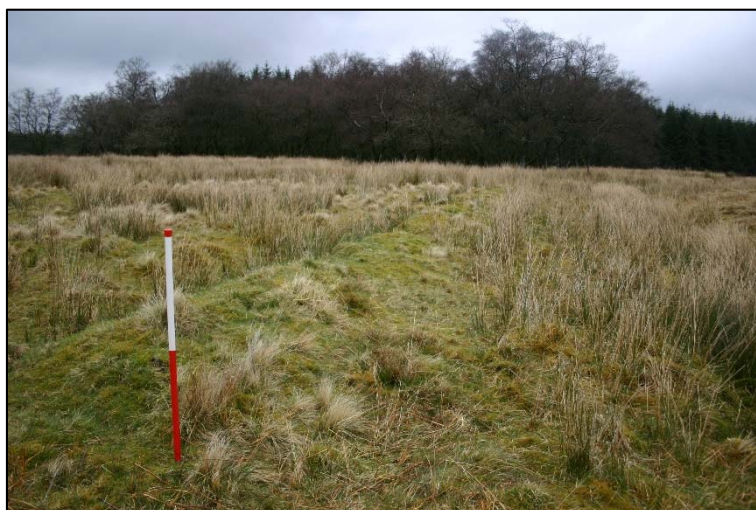
Plate 32: Bank (Asset 60), facing north-east

towards the northern extent of the site (Asset 60; Plate 32), though traces of rig and furrow identified by Long in 1988 were difficult to locate.

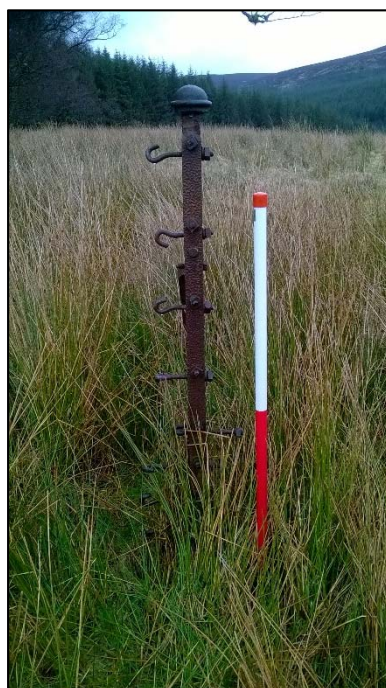
Plate 33: Fencepost (Asset 59), facing east

4.1.21 More recent use of the area was represented by a decorative iron fencepost, located at the northern extent of the site at the southern end of a small copse of older trees of a variety not seen elsewhere. Perhaps the post is indicative of a 19th century forestry plantation (Asset 59; Plate 33).

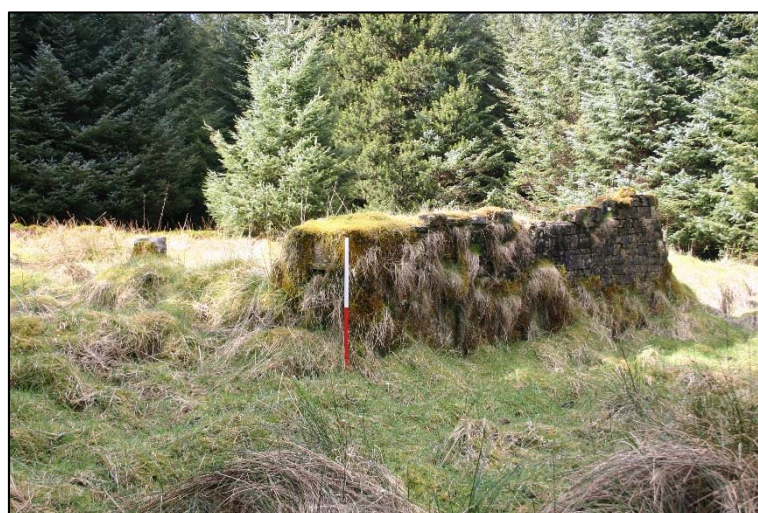
Plate 34: Former bathing house (Asset 41), facing north-west

4.1.22 In the valley, at the foot of Deadwater Rigg, the known site of Deadwater Railway station was still inhabited at the time of the walkover survey (Asset 33), and the former bathing house (Asset 41), first shown on Armstrong's plan of 1769 (Plate 5; *confer* 3.3.18) survived in a ruinous state amongst an area of plantation just to the west of the site boundary (Plate 34).

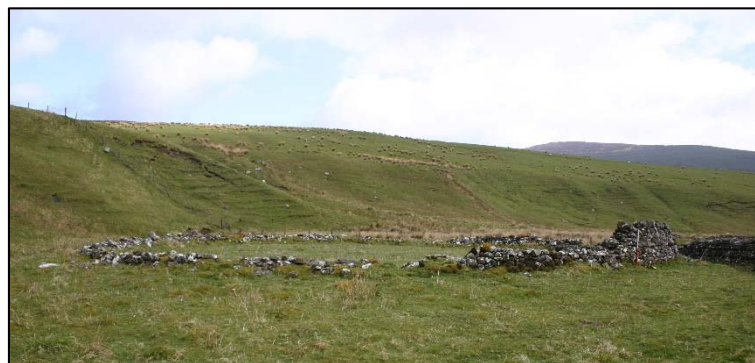
Plate 35: Sheepfold (Asset 70), facing north-east

site boundary was noted during the walkover survey as surviving, but in a state of disrepair (Plate 35). It survived to a maximum height of 1.4m, though much of it was only up to 0.3m in height, and had two entrances. It was in a low-lying valley area just to the north of Bells Burn (Figure 5), but with steep rising ground to the immediate north.

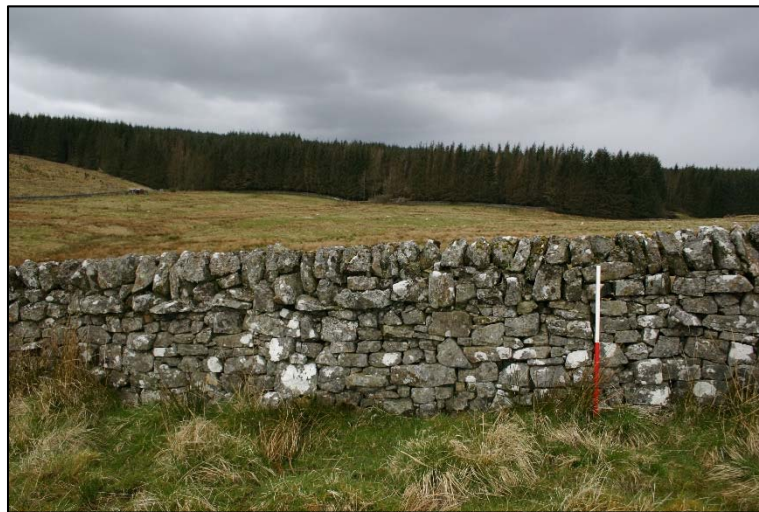
Plate 36: Central stone wall (Asset 75), facing north-west

4.1.24 At the northern end of the Scottish part of Bells Moor were two roughly square enclosures formed by dry stone walls (Asset 75). These walls about the English/Scottish boundary wall to the unenclosed part of Bells Moor and mark the Anglo-Scottish border. The walls are located just to the south of Blackhope (Asset 69), a settlement known to have existed in the 18th century (*confer* 3.3.9). They are likely to have been agricultural enclosures for livestock control, and been associated with the settlement. The walls themselves (Asset 75) were well-preserved, surviving to an average height of 1.2m and with surviving coping stones (Plate 36). The build of these walls, was very similar to the build of the Anglo-Scottish border wall, to the east, and may have been contemporary. The build is typical of parliamentary enclosure period walls (late 18th to mid 19th century) Noted within the boundary wall, at two locations, were sets of stepped stones extending from the wall (Plates 37 and 38), observed on both sides of the wall at this location, clearly stiles to allow people to access both sides. Both of these sets of stiles occurred at locations shown on the First Edition Ordnance Survey map of 1863 (Figure 4) to be where a trackway led to the wall, and continued on the other side, suggesting that this track was merely a footpath to allow access to their local chapel at Bells (Asset 10) and to access their lands. The archaeological evidence suggests that this area was enclosed within its existing enclosures in the later eighteenth century.

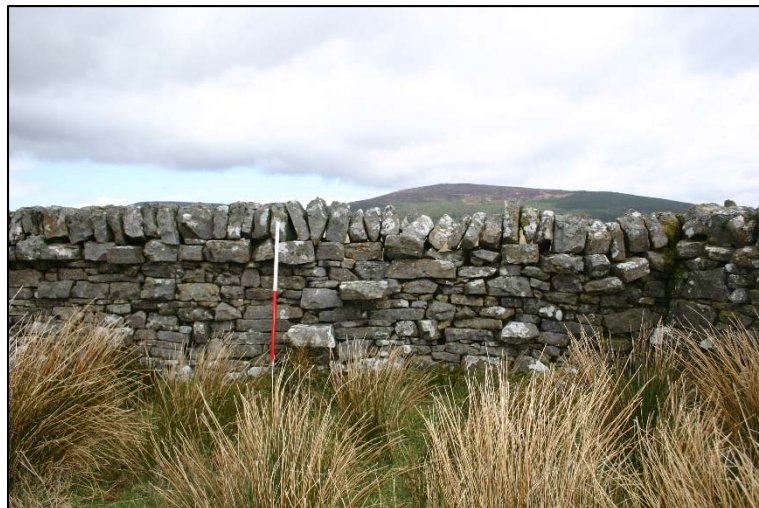
Plate 37: Stone Stile near Blackhope (Asset 73), facing north-east

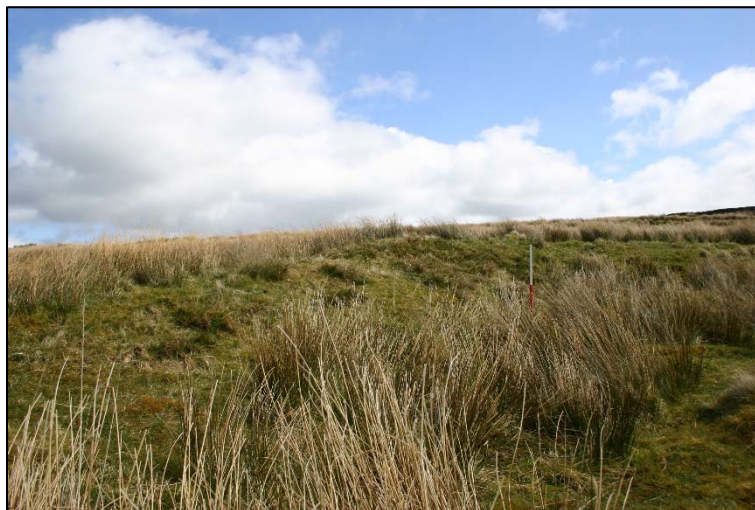
Plate 39: Wide bank feature (Asset 71), facing east

4.1.25 Within the northern enclosure formed by the walls (Asset 75) was a 1.5m wide bank feature, forming an approximate u-shape 20m north-west to south-east and 12m north-east to south-west (Plate 39), and located on the north side of the Day Sike (Asset 71). Just to the south-west was a low bank formed of stone, perhaps an earlier wall (Plate 40). These are likely to relate to earlier agricultural use of the now enclosed area.

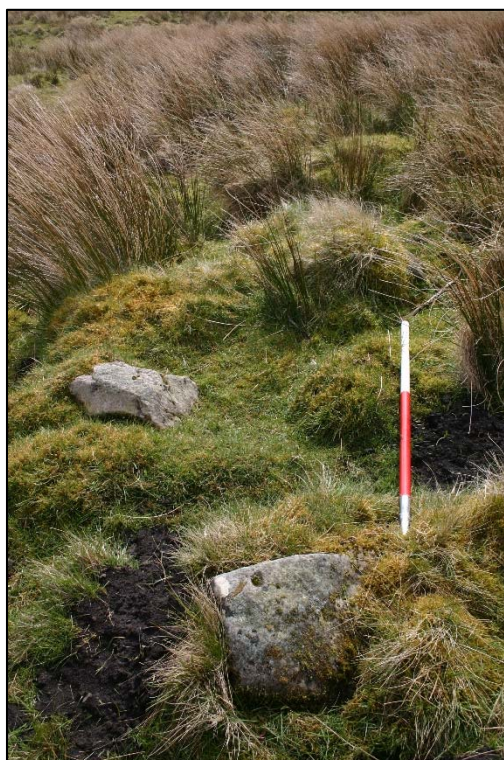
Plate 40: Low stone bank (Asset 71), facing south-east

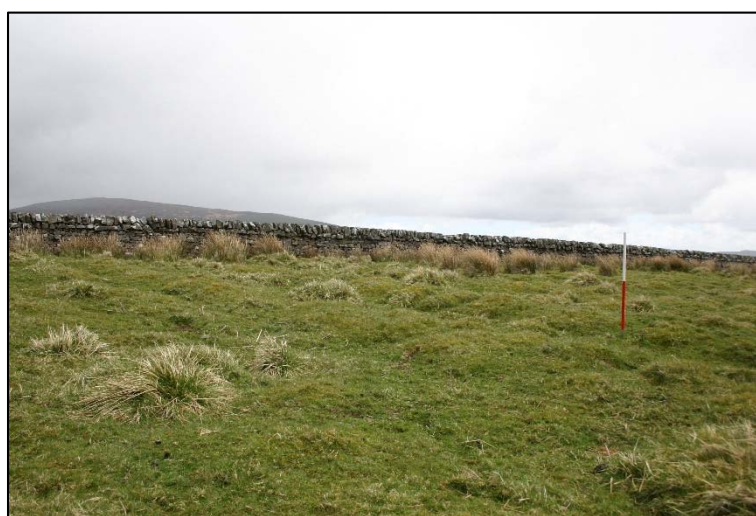
Plate 41: Area of rig and furrow (Asset 72), facing north-east

4.1.26 At the northern corner of the site, just to the south-east of Blackhope (Asset 69), an area of rig and furrow was noted next to the English/Scottish border wall (Asset 72). The rigs were quite wide, averaging 1-1.2m, and measured 2m apart from the top of one rig to the next rig (Plate 41). As the ground got boggier, it became much less clear, but appeared to only run approximately up to 25m from the border wall. This is roughly in line with where the track, shown on the First Edition Ordnance Survey map of 1853 (Figure 4) ran, to the stile in the boundary wall (Asset 73). The location of the rig and furrow suggests it was associated with Blackhope and was formed to allow the growing of crops, possibly root vegetables.

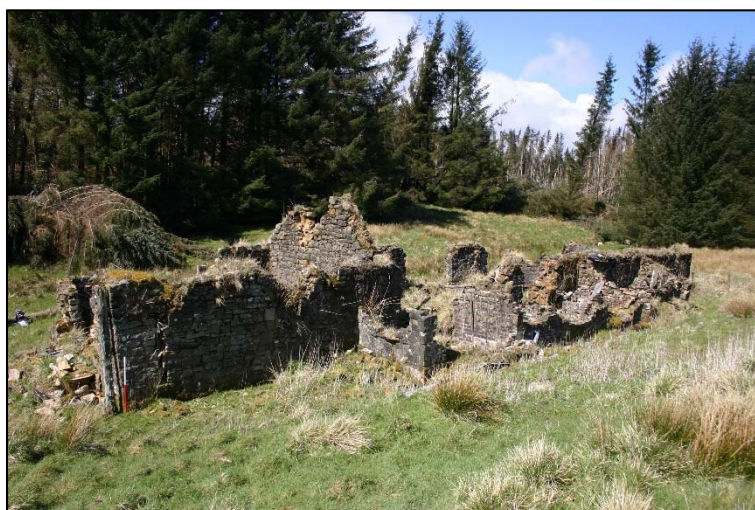
Plate 42: Blackhope (Asset 69), facing north-west

4.1.27 Though shown and annotated on modern mapping, Blackhope itself was in a ruinous state at the time of the walkover survey. It survived as a linear row of buildings, possibly three, though some could have been formerly for livestock, so it may only represent one farmstead, or family's, dwelling (Plate 42). A fireplace survived in the second most north-easterly part (Plate 43). Modern brick in stretcher pattern was visible, for repairs and alterations, suggesting a relatively modern habitation or use (i.e. into the 20th century).

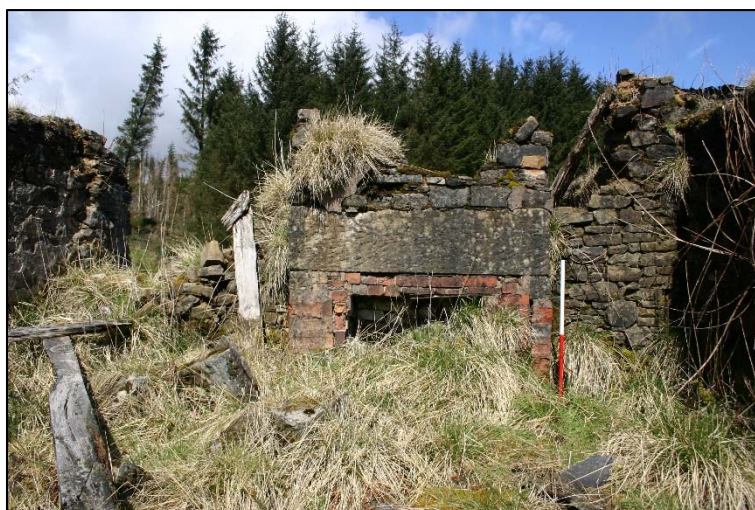
Plate 43: Fireplace in Blackhope (Asset 69), facing north-north-west

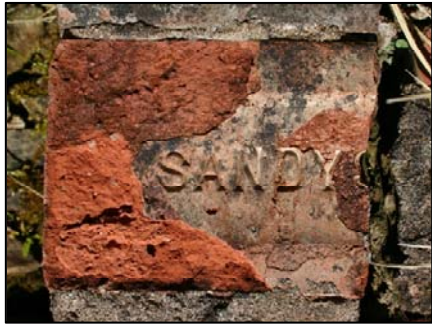
Plate 44: Brick at Blackhope (Asset 69)

4.1.28 Some bricks, visible in the surrounding rubble, were observed, once reading 'Sandysike', seen in the building, and 'Whitehill', by an area of repair on the south-west facing elevation (Plates 44 and 45). Sandysike Brickworks was one of a number of tile and brickworks south of Longtown, based at Arthuret, Cumbria, and shown on maps dating to between 1863 and 1948 (www.solwaypost.co.uk; www.geog.port.ac.uk). Whitehill Brickworks was at Rosewell, or Lasswade, Midlothian and was formed from the Newbottle and Whitehill Pits. It dated from the 1890s (www.scottishbrickhistory.co.uk/whitehill). In 1938-9 the brickworks were rebuilt and

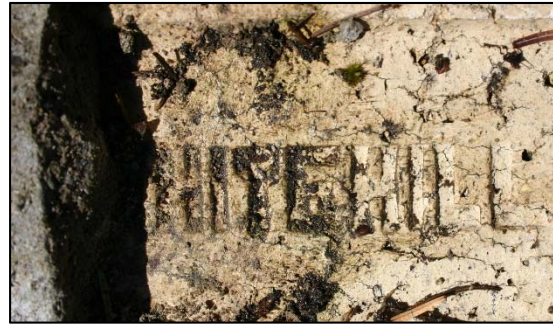
Plate 45: Brick at Blackhope (Asset 69)
