ULPHA WATER TREATMENT WORKS, CUMBRIA

HERITAGE IMPACT ASSESSMENT

June 2016

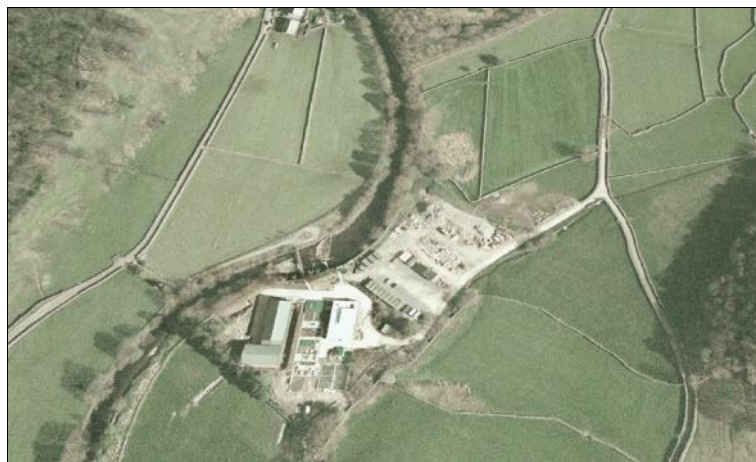
Plate 1: Google Earth Imagery, 31/12/2004

- 3.2.8 By 1977 (Figure 7), the former ‘settling pond’ had become a narrow rectangular ‘Settling Tank’ with rectangular building to the east. The banks of the former settling tanks appear to have survived, and the south-western boundary wall of the field containing the proposed development site had been re-angled at its northern extent.
- 3.2.9 By the end of 2004, work was being undertaken at the water treatment works, as there were cabins and a car parking area covering most of the field containing the present proposed development site (Plate 1). These developments will have had some impact on the possible survival of any heritage related remains.

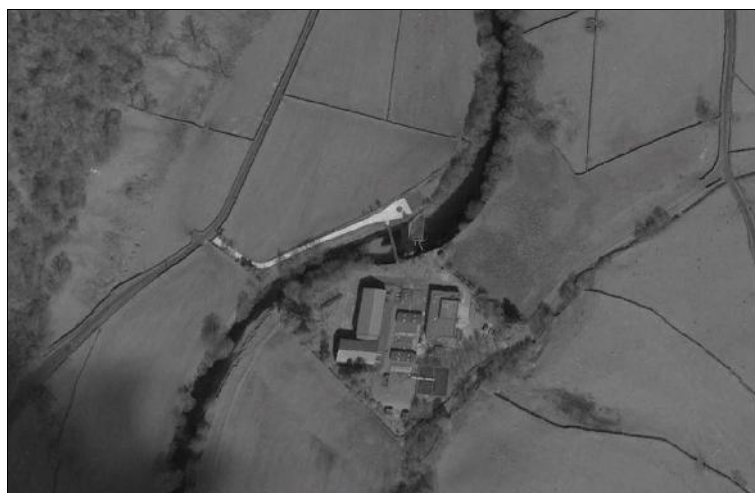
Plate 2: Google Earth Imagery, 31/12/2014

- 3.2.10 These developments had clearly been completed by 2014, when Google Earth imagery shows the field containing the proposed development site as a field again (Plate 2), as it appears on modern mapping (Figure 2).

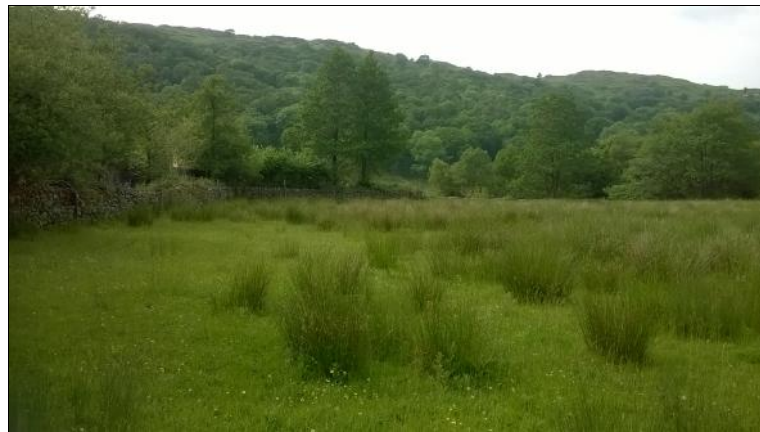
4.1.2 The land was relatively flat with rushes and divots suggesting an area of wetland (Plate 3). A curved stone wall separated the field from the water treatment works to the south-west, and from the River Duddon to the north-west (Plates 4 and 5). A track led through the field from the road to the east to the water treatment works (Plate 6).

Plate 3: General view of proposed development site in field, facing north-west

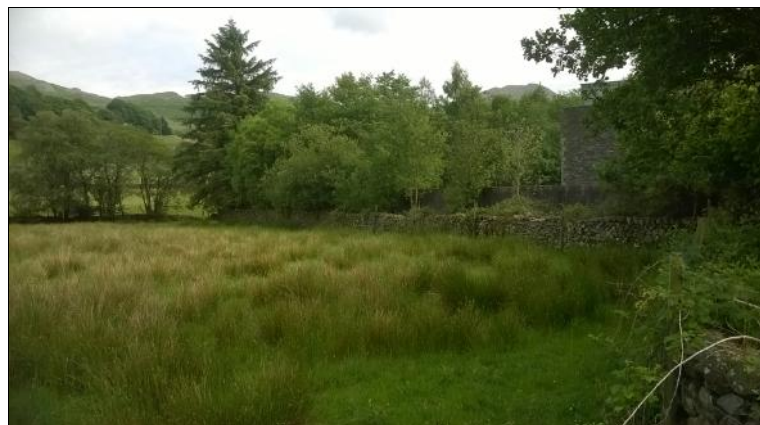
Plate 4: General view of proposed development site showing stone wall and water treatment works, facing south-east

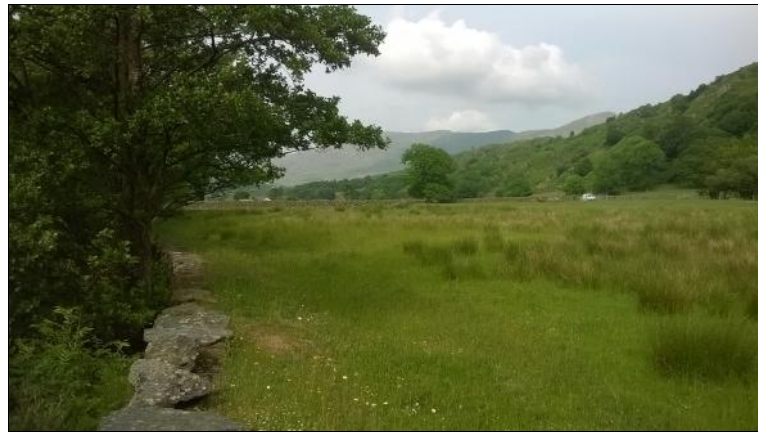
Plate 5: General view of field, facing north

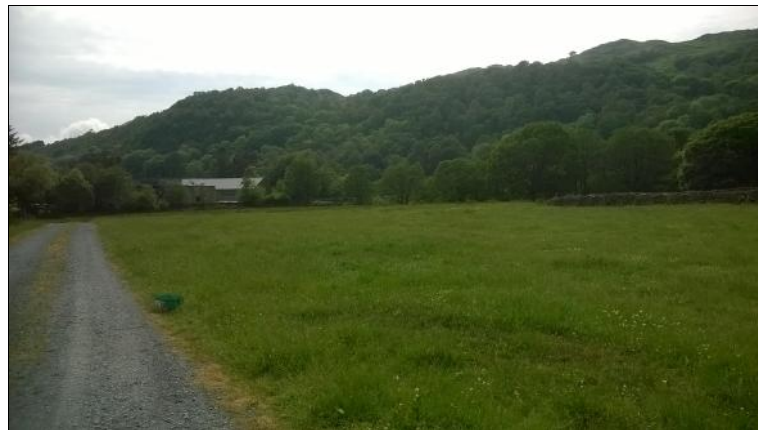
Plate 6: Track along south-eastern edge of field, facing south-west
