ADDITIONS TO NETWORK MAINS FROM QUARRY HILL

TO STAINBURN AND COCKERMOUTH, CUMBRIA

**ARCHAEOLOGICAL DESK BASED ASSESSMENT
AND WALKOVER SURVEY**

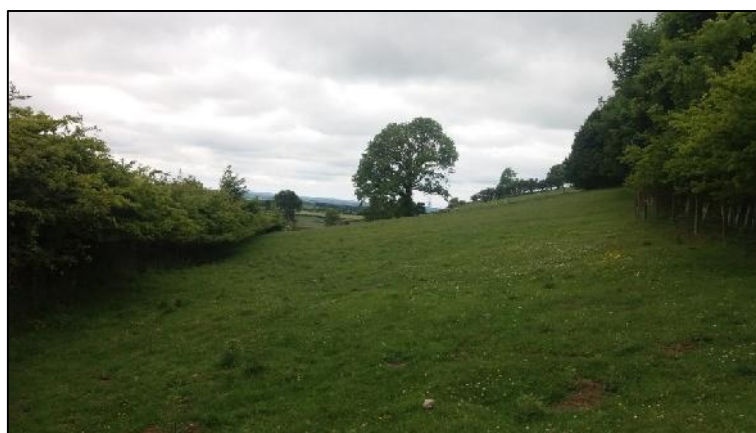
Plate 1: Area 106, view looking west

4.2.15 Area 106 is a triangular area of land formed by the creation of the access road to Moota Quarry (Figure 7; Plate 1). At the time of the site visit the land was under pasture and was being grazed by sheep. A small relatively modern brick structure is present against the western boundary. No features of note were observed, however historical mapping has indicated the former presence of a field boundary through this area (Asset 531).

Assessment: the heritage asset (531) is considered to be of negligible significance based on current knowledge.

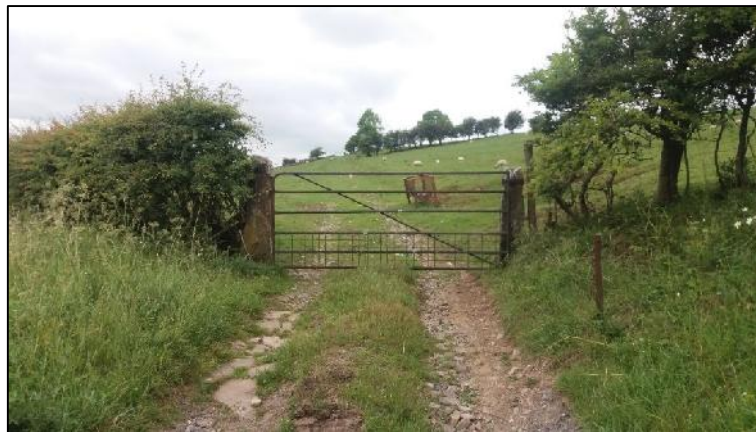
Plate 2: Area 107, view looking north-west from the A595, showing trackway (Asset 532)

4.2.16 Area 107 is located in the same field as Area 108, on the north side of the A595 (Figure 7). At the time of the site visit the field was under pasture and was being grazed by sheep. A trackway crosses the field in which this area and Area 108 are located; this trackway is present on the First Edition Ordnance Survey map of 1867 (Asset 532).

Assessment: The heritage asset (532) is considered to be of local significance based on current knowledge.

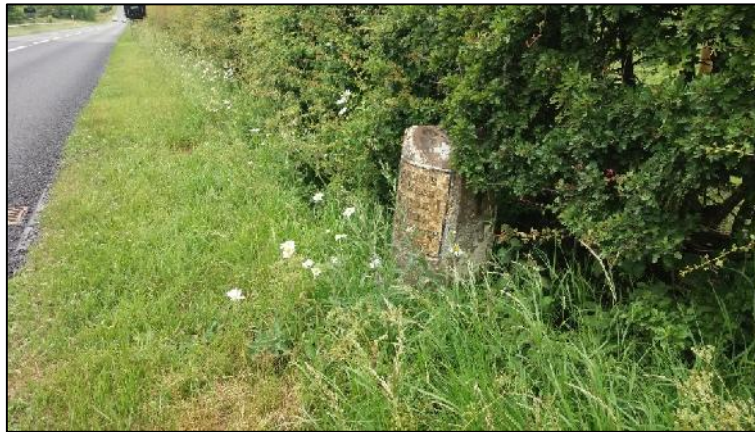
Plate 3: Detail of Milestone on the north side of the A595, adjacent to Area 108

4.2.17 Area 108 is located in the same field as Area 107 (Figure 7). At the time of the site visit the field was under pasture and was being grazed by sheep. A trackway crosses the field in which this area, and Area 108, are located; this trackway is present on the First Edition Ordnance Survey map of 1867 (Asset 532, and is referred to above). A Grade II listed milestone of late 18th/early 19th century date is present on the south side of the field boundary at this location (Asset 533; Plate 3).

Assessment: The heritage asset (532) is considered to be of local significance based on current knowledge. The Grade II listed post-medieval milestone (Asset 533) in the verge of the A595 will need to be protected should it be encompassed within the area of groundworks in order to avoid disturbance. It is of district or county (higher) significance.

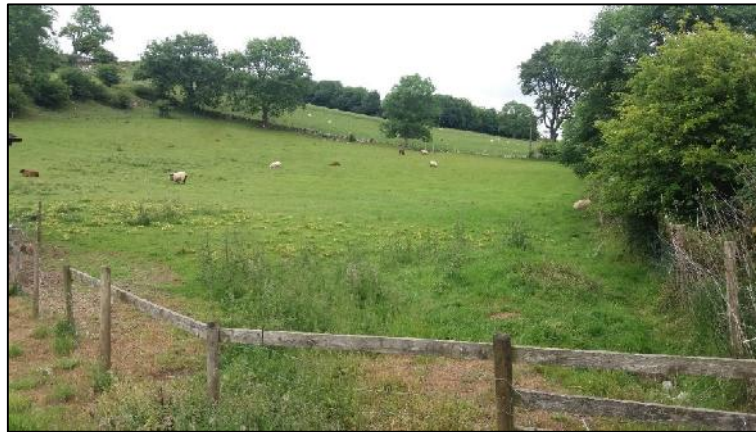
Plate 4: Area 109, view looking east showing linear earthworks indicative of ridge and furrow

4.2.18 Area 109 is located on the north side of the A595 near Moota Quarry (Figure 7). Area 109 was under pasture at the time of the site visit, with sheep grazing. Trees line the limestone escarpment to the north. A drystone stone wall forms the eastern boundary; this boundary is present on the First Edition Ordnance Survey map of 1867 (Asset 534). There are linear earthworks, indicative of ridge and furrow, in this field, orientated north to south (Asset 535; Plate 4).

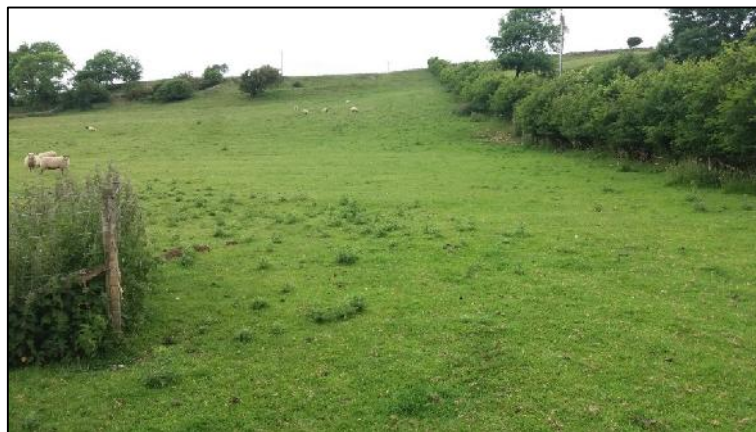
Plate 5: Area 110, view looking north showing linear earthworks

4.2.19 Area 110 is located on the north side of the A595 near Moota Quarry (Figure 7; Plate 5). Area 110 was under pasture and being grazed by sheep at the time of the site visit. There is a noticeable limestone escarpment in this field which extends into the field to the south-west (Area 111). The eastern boundary is formed by a hedgerow, and the western boundary by drystone walls; both these boundaries correspond with those shown on the First Edition Ordnance Survey map of 1867 (Assets 536 and 537). Towards the south side of this field, within Area 110, were traces of linear earthworks indicative of ridge and furrow (Asset 538). The location of these earthworks appears to correspond to the presence of the limestone escarpment.

Assessment: the heritage assets (536, 537 and 538) are considered to be of local significance based on current knowledge.

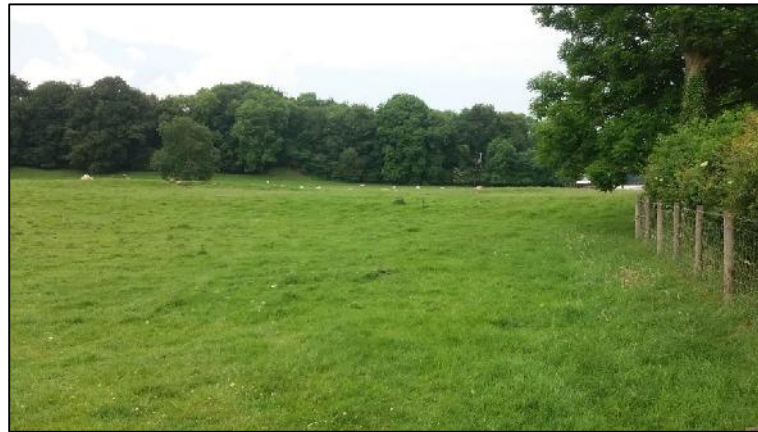
Plate 7: Area 137, view looking west showing linear earthworks of former field boundaries

4.2.49 Area 137 is located on the south side of Low Road, to the west of Cockermouth Lonning (Figure 12; Plate 7). Area 137 is located on the south side of Low Road, at the edge of Brigham. The previous work has identified former field boundaries in this area (Assets 268 and 278), however historic mapping shows that this field contained more boundaries, many of which are clearly visible on Google Earth™, and were noted during the site visit in June 2016 (Asset 540) (these earthworks are not currently recorded in the HER). It is possible these boundaries could represent earlier activity given the proximity of Area 137 to the church. The heritage assets (268 and 278) are considered to be of negligible significance based on current knowledge.

Assessment: The heritage asset (540) is considered to be of local significance based on current knowledge. Further archaeological work would be required in this area in order to clarify the presence, character and state of preservation of this heritage asset which survive above and below ground.

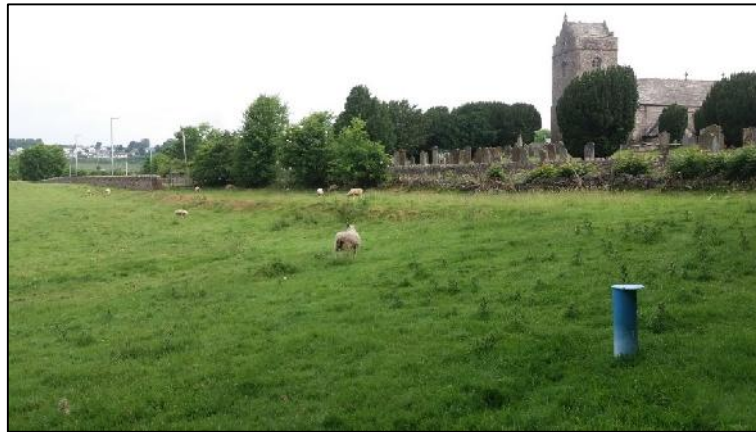
Plate 8: View looking north-east towards St Bridget's Church showing Area 142

4.2.54 Area 142 is located to the north of Low Road, and to the south of the A66, on land opposite St Bridget's Church, Brigham (Figure 13; Plate 8). Information derived from the county HER and historical mapping shows that there is a feature known as 'Chantry Well' in this area, possibly now located within an area of woodland, although historical references suggest that it was destroyed by quarrying. The HER entry refers to 'a mound supposed by some to cover the ruins of some ancient religious edifice' (Asset 542). A tramway which formerly linked Brigham Quarries with the Cockermouth to Workington Railway was located to the north and east of this area (Assets 9 and 86). Earthworks associated with this tramway were observed to the east of the area at the time of the site visit in June 2016. Groundworks in this area may also impact on the site of a former Railway Station (Asset 165) and a former field boundary (Asset 273). A modern borehole/monitoring station was observed in this area (Plate 8).

Assessment: the heritage assets (9, 86, 165 and 542) are considered to be of local significance based on current knowledge. The heritage asset (273) is considered to be of negligible significance based on current knowledge. Further archaeological work would be required in this area in order to clarify the presence, character and state of preservation of heritage assets which may survive below ground.
