**UNITED UTILITIES
THE MILL, ENNERDALE, CUMBRIA**

HERITAGE IMPACT ASSESSMENT

June 2016

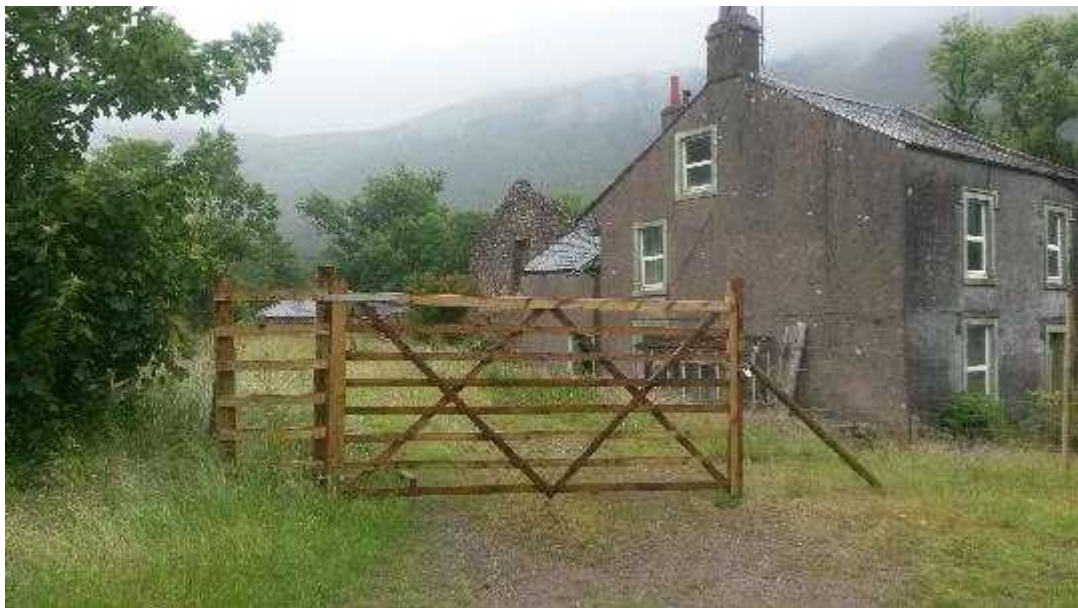
- 4.1.3 The two storey cottage has a modern cement-based render with lines etched in it to give the appearance of higher value ashlar masonry, while the remaining buildings consist of roughly coursed rubble stone masonry with slate roofs.

Plate 1: view of the cottage

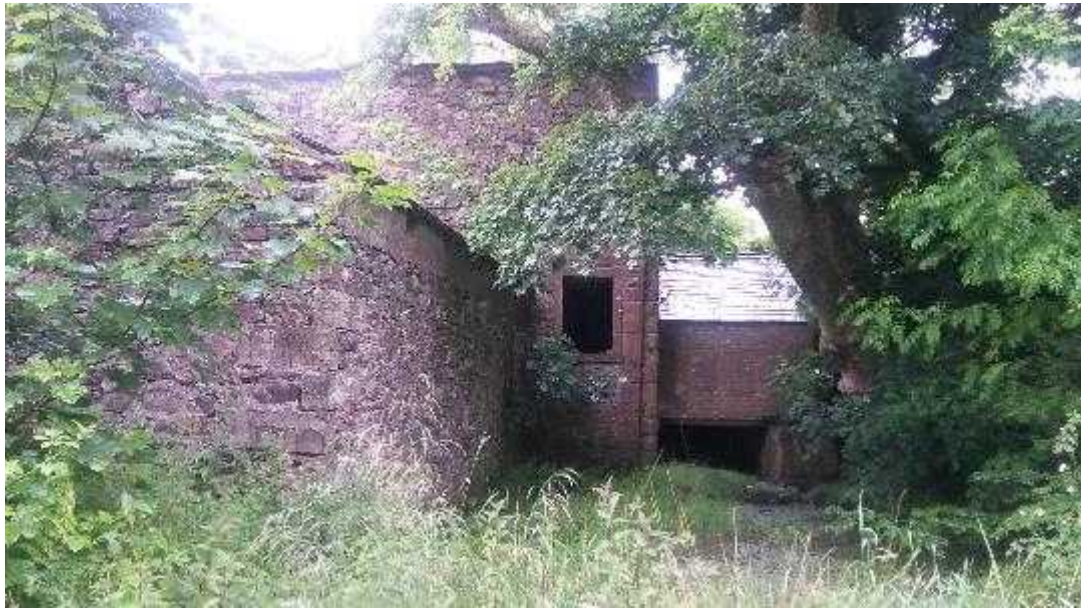
- 4.1.2 With the exception of the two storey cottage, the mill is in a mostly derelict state. Parts of the mill roof are missing, and some elevations appear to have collapsed. A public footpath leads north-south aligned along the east side of the buildings, with a footbridge crossing the mill race and river Ehen.

Plate 2: view of mill building

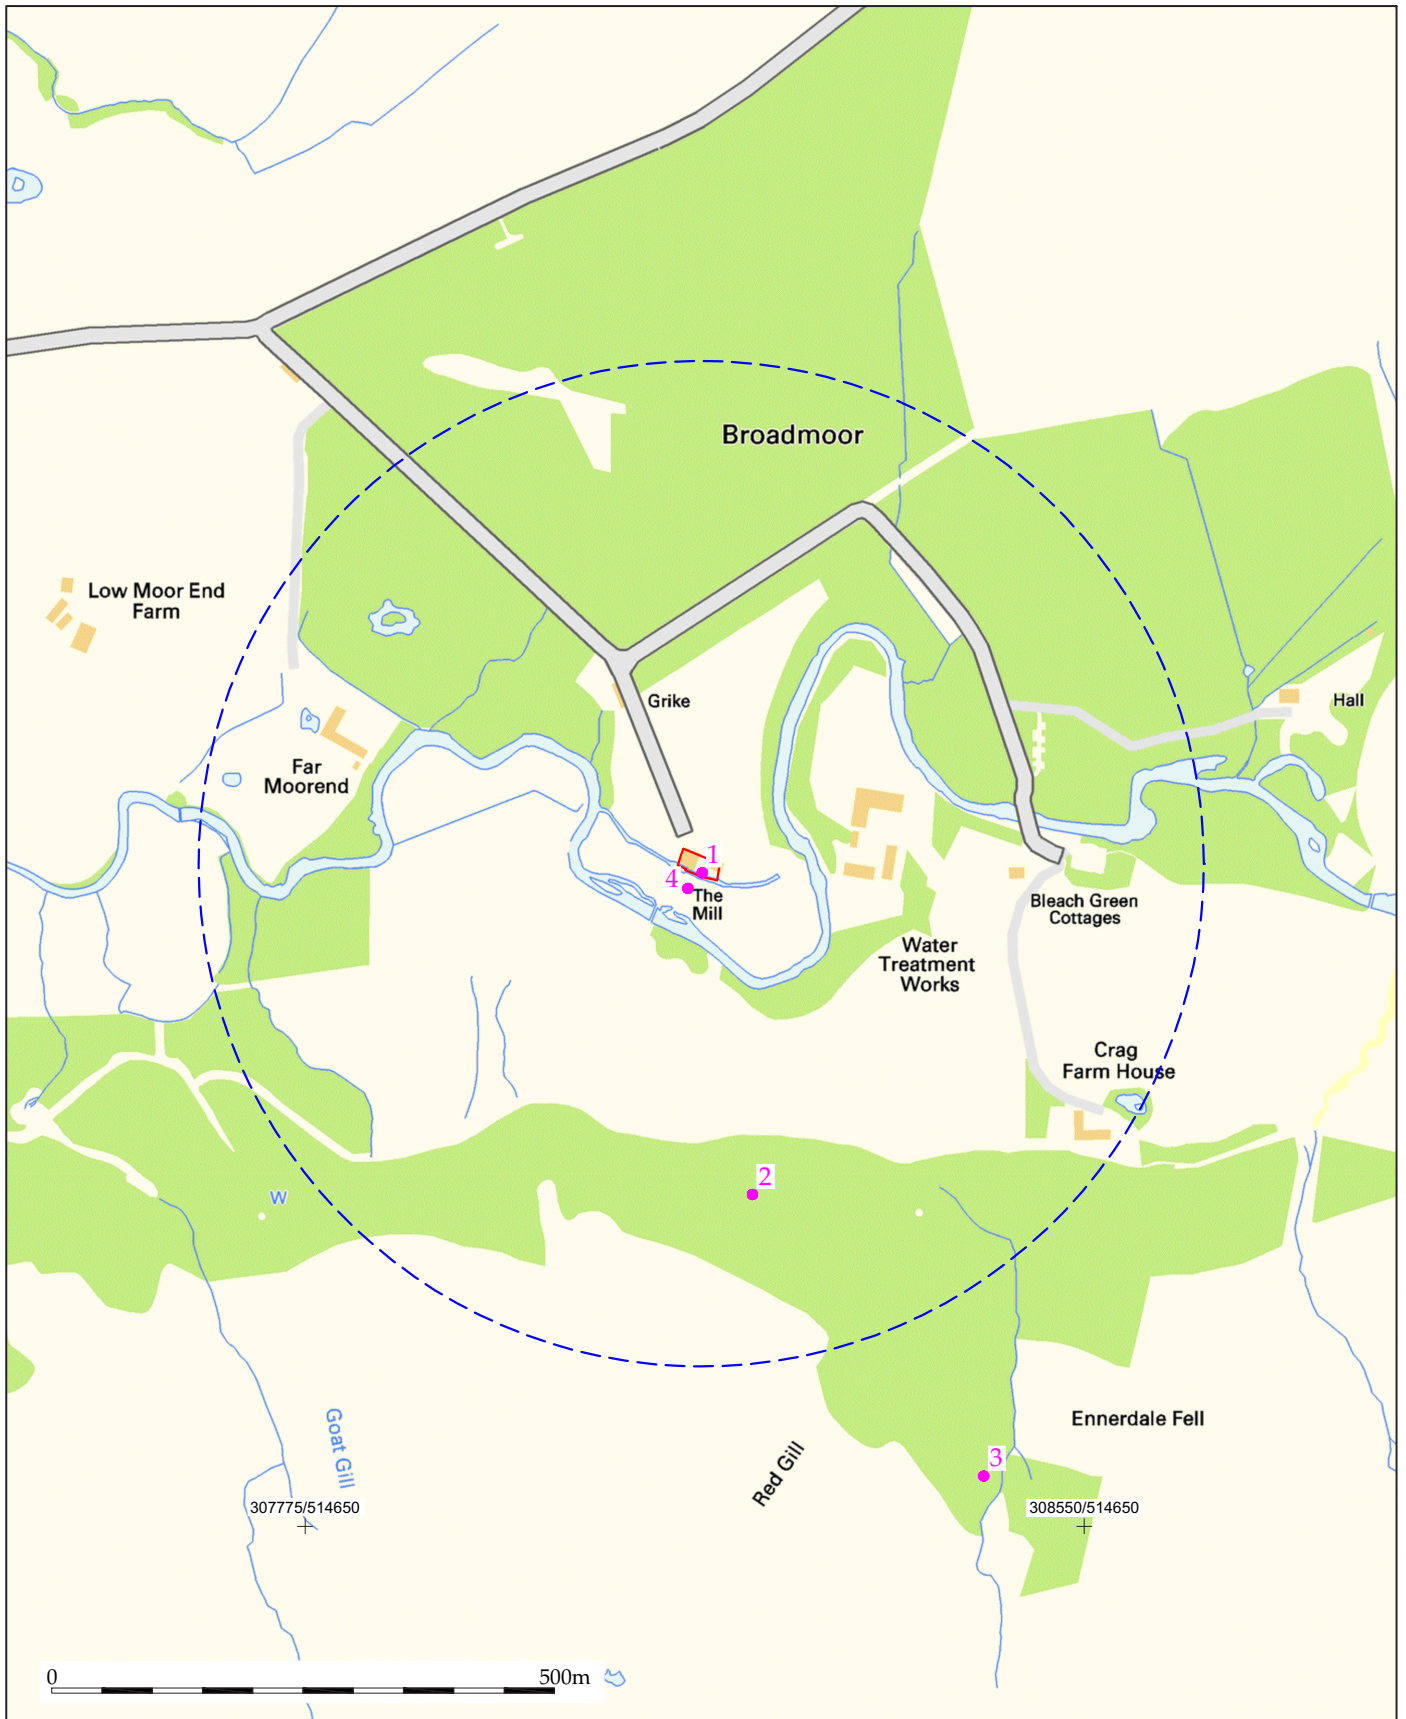
3.5.2 Beside the Corn Mill (Asset 1), there are two non-designated heritage asset recorded in the Historic Environment Record within the 500m search radius. This is the site of a potash kiln of uncertain date (Asset 2), and the site of three or more Iron Ore Levels, referred to as Kinney How Iron Ore Levels (Asset 3).

Figure 3: Heritage assets within 0.5km radius.

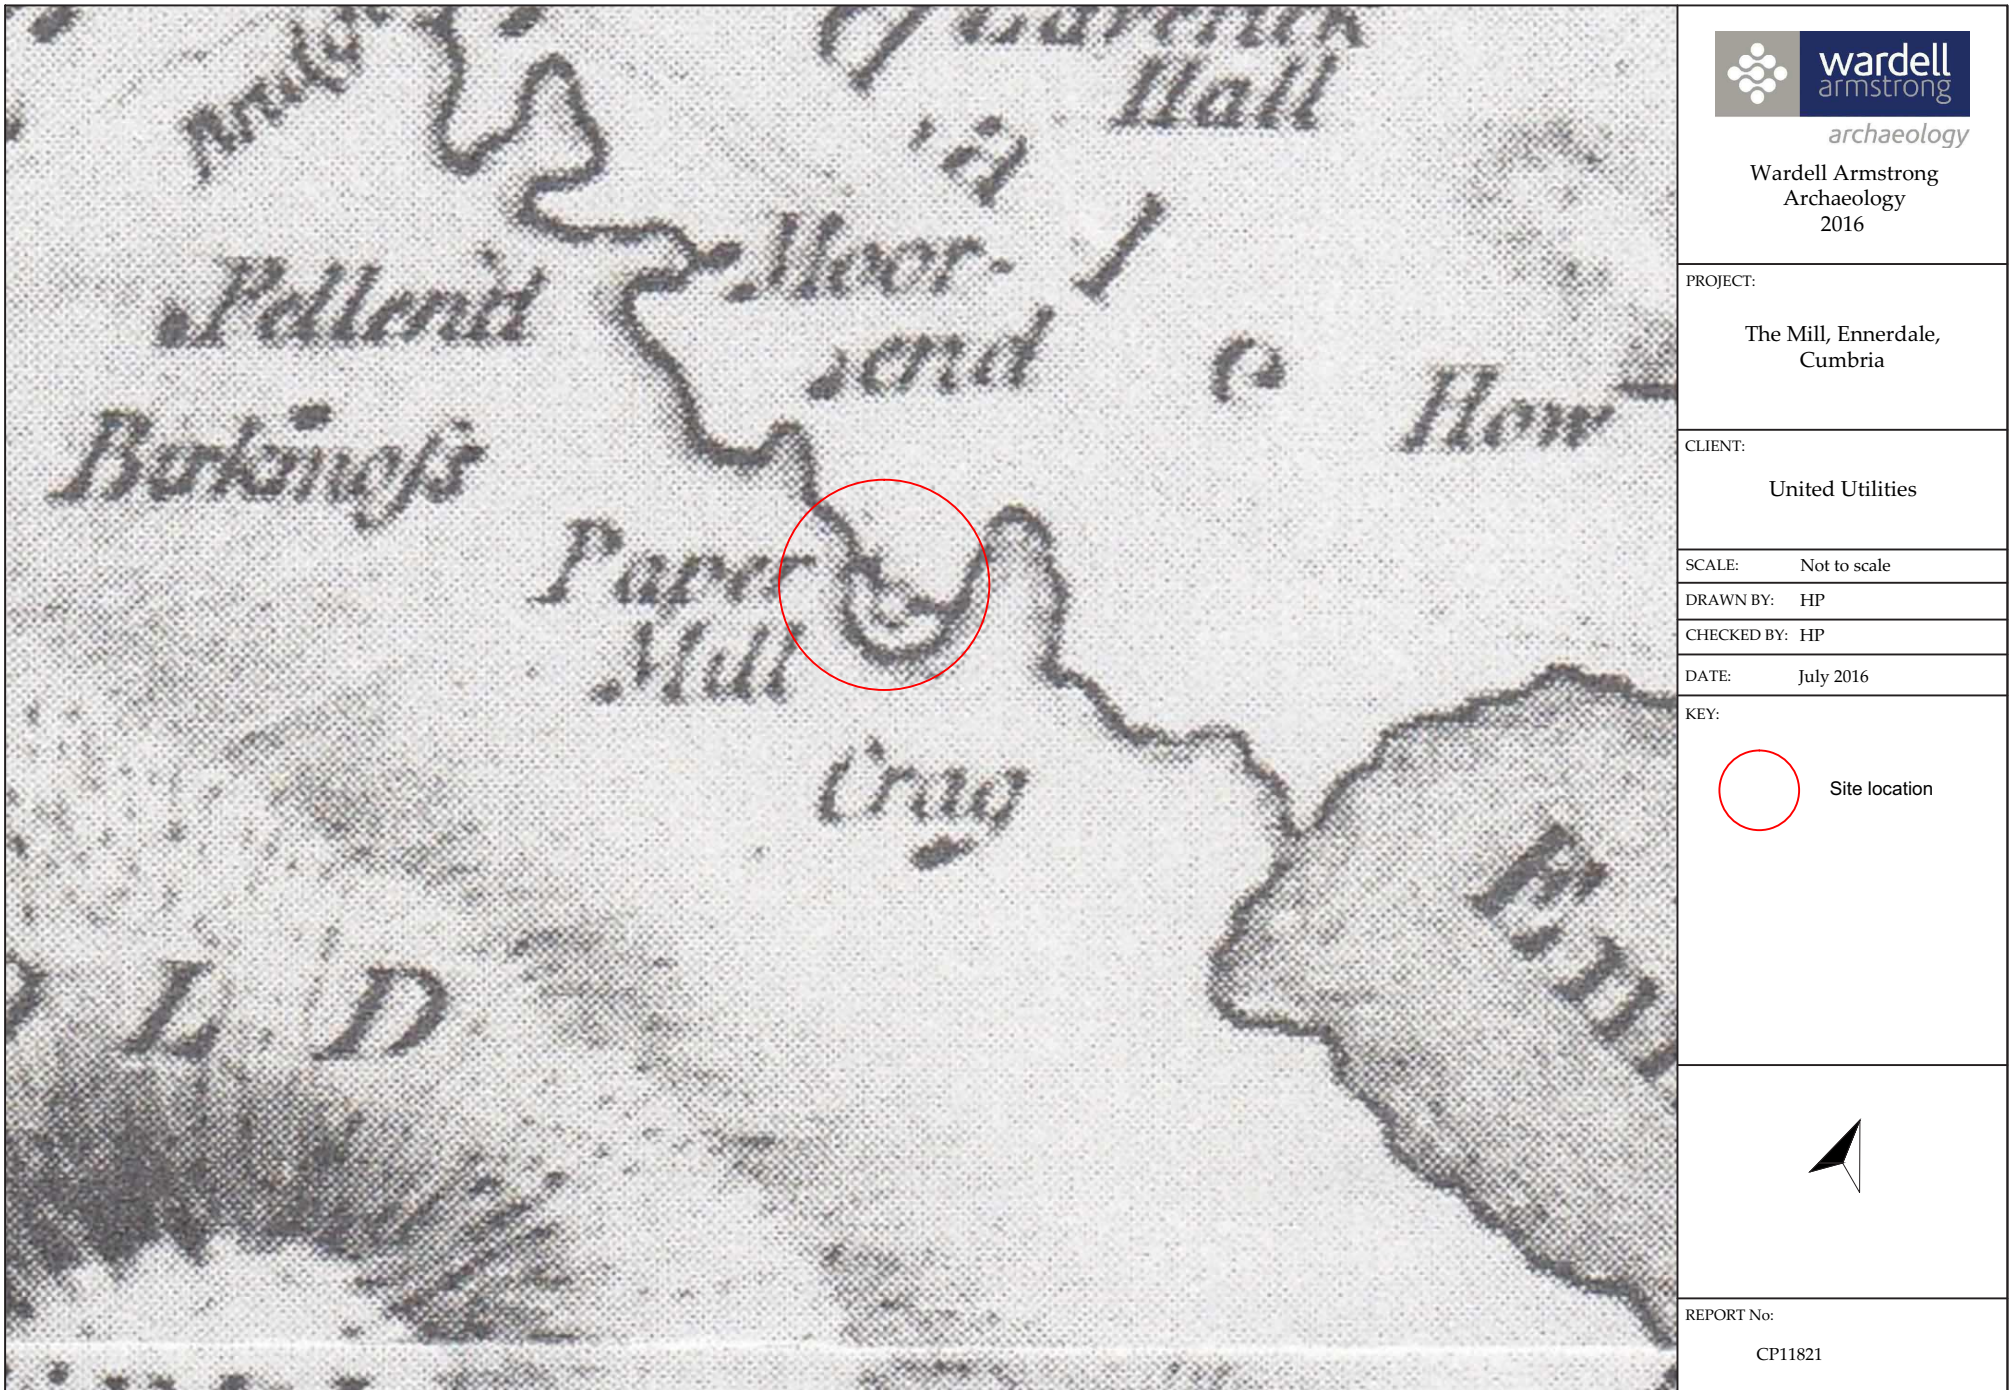
3.4.1 The earliest depiction of Ennerdale Mill is on the Hodkinson and Donald map of 1774 (Figure 4). The mill is clearly shown in a loop of the River Ehen with an east to west aligned millrace. It is labelled as 'Paper Mill'.

Figure 4: Hodkinson and Donald map of 1774.

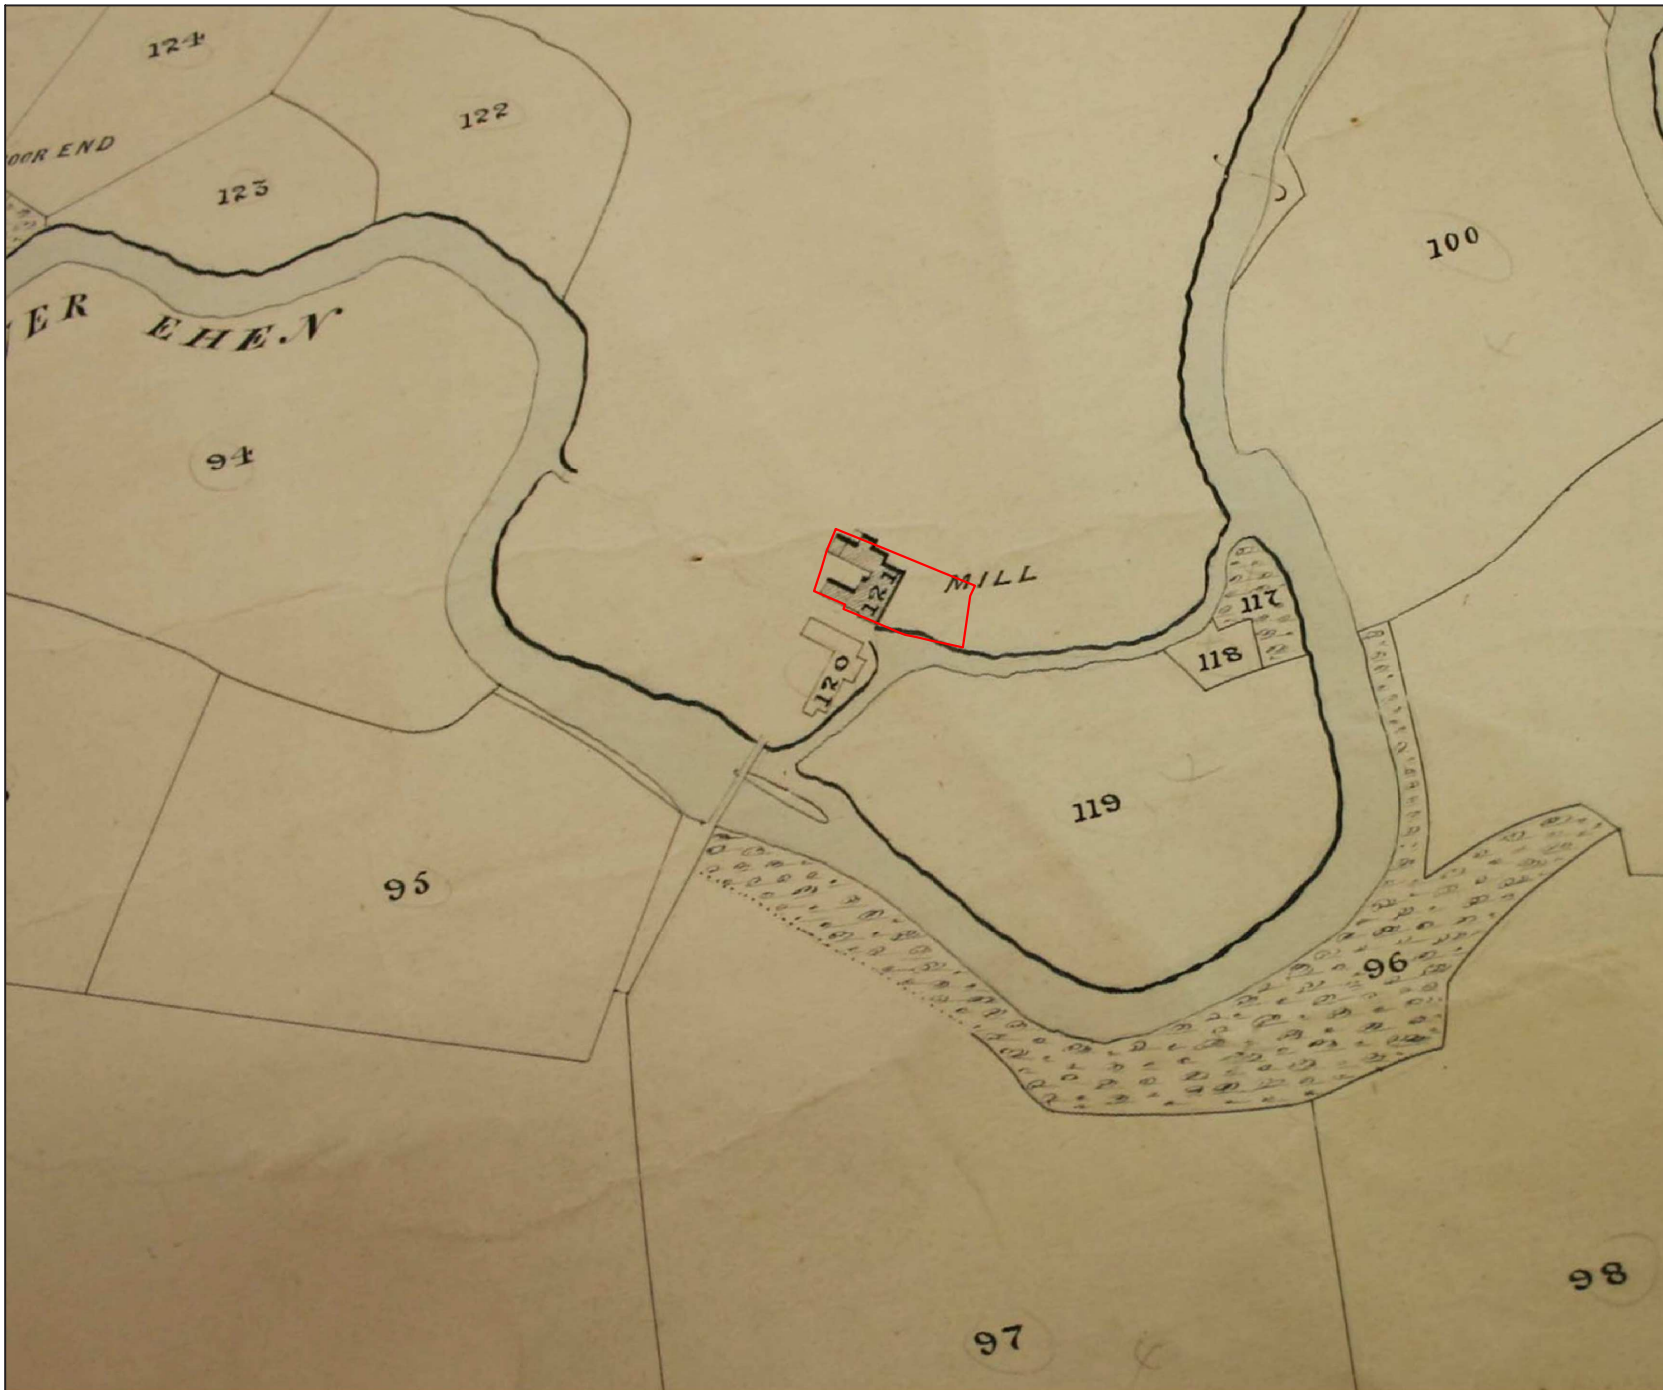
3.4.2 On the 1845 Tithe map two structures are shown: an L-shaped complex to the south-west and a U-shaped complex to the north-east, both to the north of the mill race (Figure 5). The U-shaped buildings complex appears to be in the position of the current mill building. The mill was destroyed in a fire in 1827, it is likely that this map shows the buildings just after its destruction. Ennerdale Mill, with the number 121, was noted down under the possession of 'Himself' in the Tithe Award (Whitehaven YPR 42/132), meaning John Dickinson, whose group of occupied properties the mill appears under. The surrounding land, including the mill garden and mill field, however, were named to be occupied by John Mossop.

3.4.3 The L-shaped building range numbered 120 is likely to have been the site of the corn mill on site in the 18th century when the paper mill was added. The building range was clearly a mill and fed by the same mill race as the former paper mill to the north. In 1845 the mill race outlet ran south from building 120 but by 1873 it also ran east from

Figure 5: Ennerdale Tithe Award Plan, 1845 (3 chains to 1 inch scale).
