THE CLOCK HOUSE, EDGE, MALPAS

HERITAGE IMPACT ASSESSMENT

September 2016

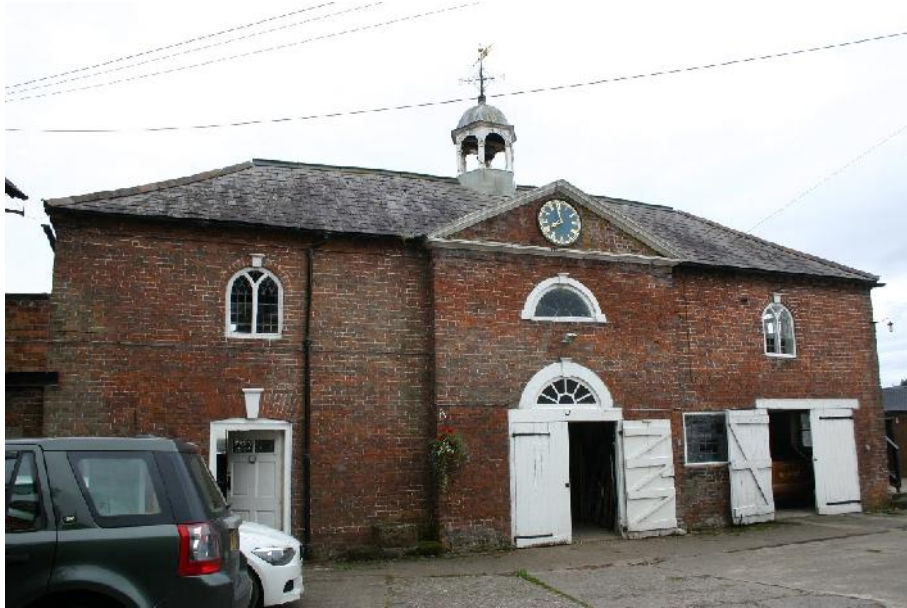
Plate 1: North-east facing elevation with clock face

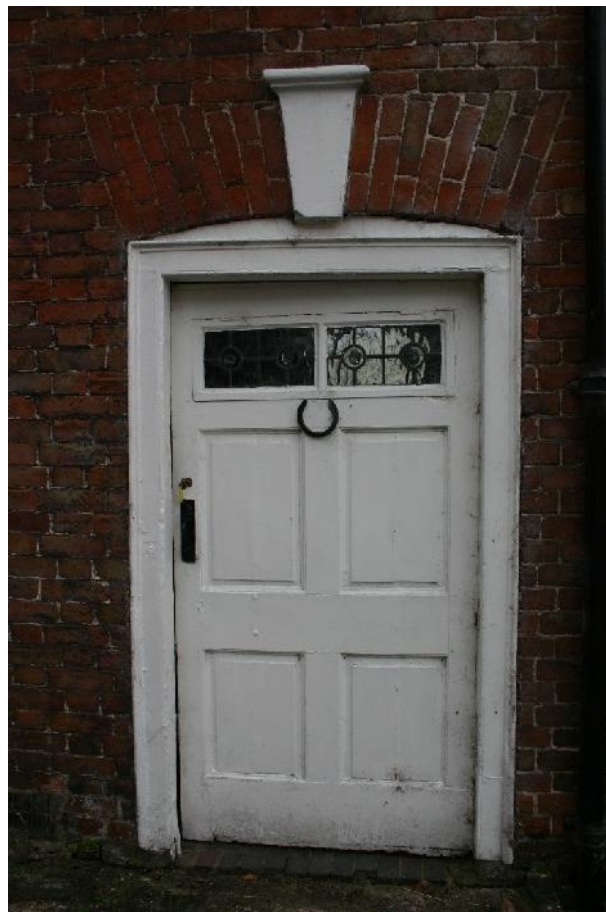
Plate 2: Detail door, to be retained at other position

4.7.1 The redevelopment will broadly comprise the conversion of the ground floor into a reception area, living room and kitchen-dining area, with a modern extension at the south-west corner. This will replace the large, modern indoor swimming pool area. Modern glass windows are proposed for the north-east facing elevation doorways, although the five fielded panel door with one panel containing replaced glazing in a rectangular moulded door-case will be reset in the central doorway. A new doorway

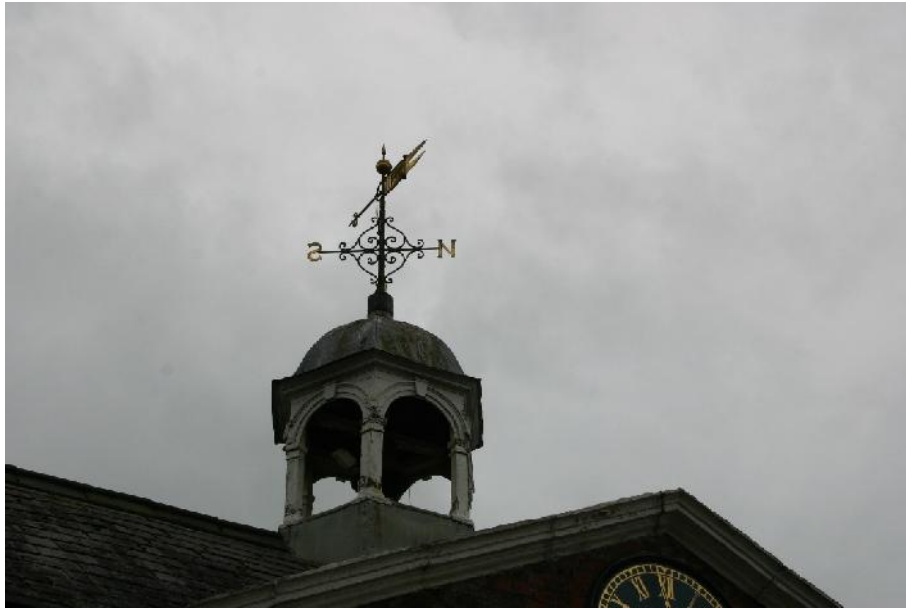
Plate 3: detail cupola/ridge turret, date 1975

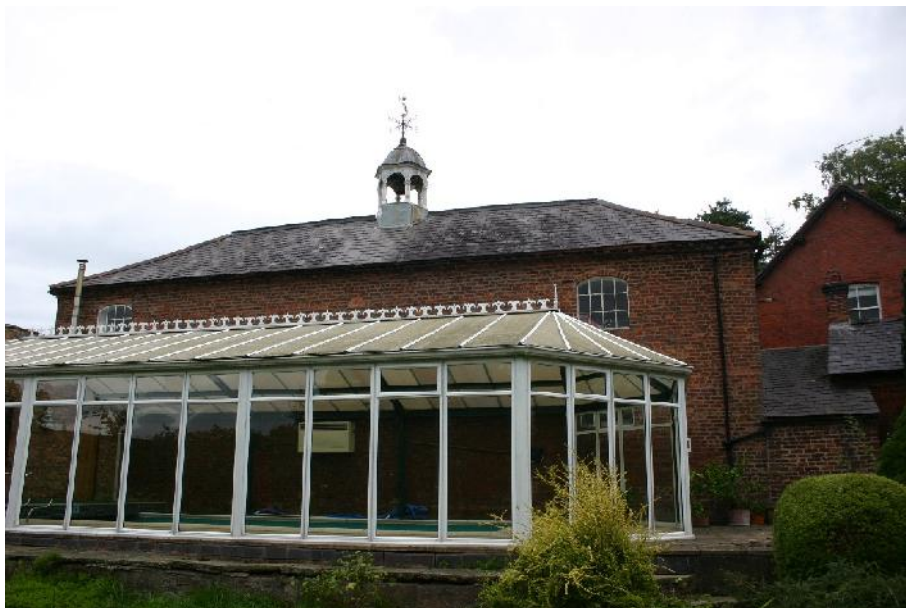
Plate 4: South-west facing elevation, with modern pool extension

6.4.6 The proposed extension to the south-west of the building is smaller than the current uPVC structure that it will replace. The replacement of the uPVC structure will be beneficial with regard to the overall external appearance of the Clock House,

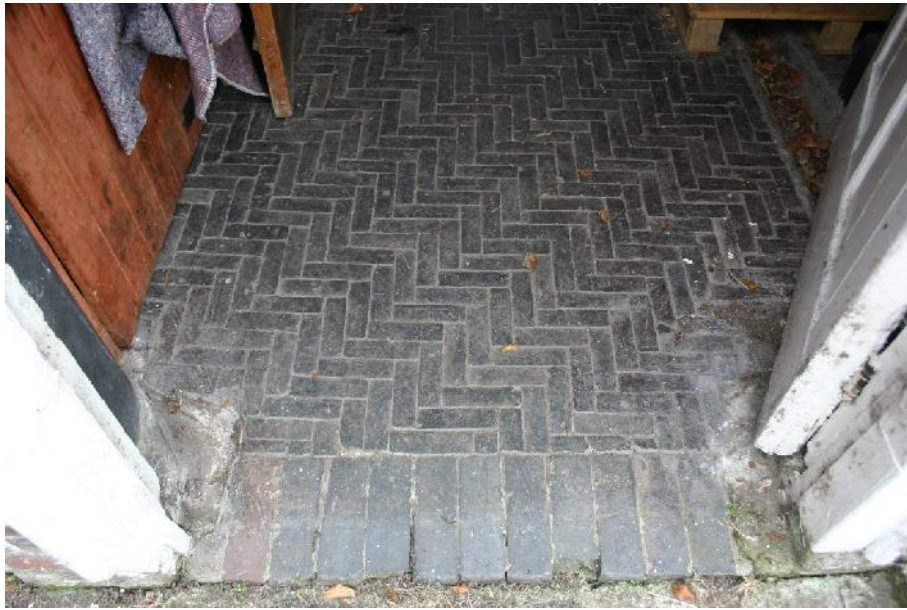
5.3.2 The easternmost ground floor room was once a stable and is now in use as a storage room. It contains black, fishbone design set flooring (Plate 5) with drainage channels. The room contains timber loose box partitions and an iron hayrack and a Ruabon brick manger. The central and westernmost room are interconnected via a small timber framed doorway. They are both plain rooms with no visible historic features.

Plate 5: fishbone tile flooring in easternmost ground floor room

6.4.3 As the interior of the stable room is specifically mentioned in the listing description of the building, its features should be preserved as much as possible. To retain the flooring, but also install sufficient insulation, it may be recommended to remove and number each tile, raise the floor and reset the tiles in the same position. If any damage to the flooring can be avoided, a raised floor covering the space may be possible. The staircase appears to be contemporary with the building, thus its removal represent a significant negative impact on the integrity of the historic fabric. In mitigation it may be worth considering using this room as the entrance space rather than as a living room. All new fittings and fixtures should be applied appropriately, with consideration to the historic building, reflecting its character and age. The removal or relocation of historic fittings should be avoided where possible. The manger, whilst a fixed asset, is a redundant and portable feature. Consequently, it should be possible to move it to another location within the building, thus referencing the buildings past use as stables, but not inconveniencing future usage.

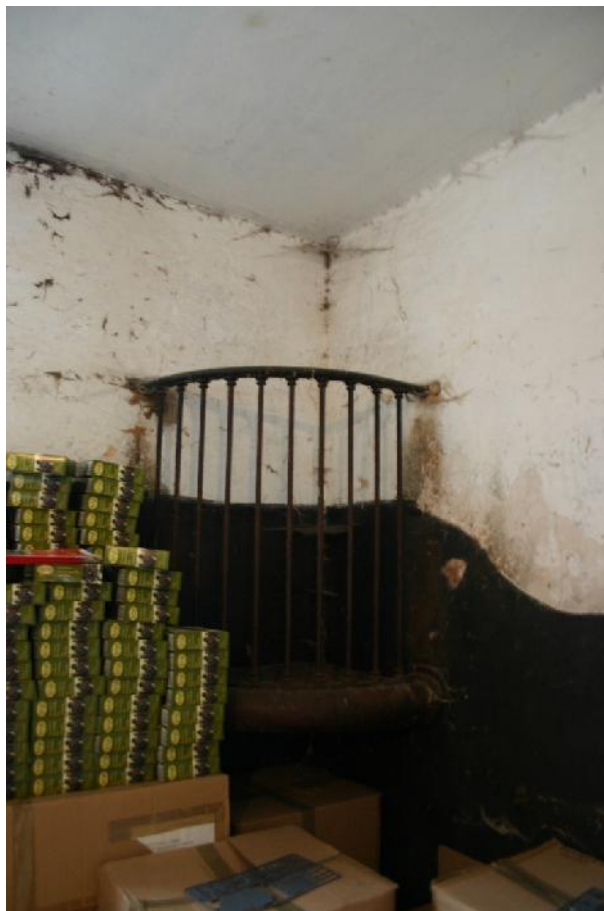
Plate 6: ground floor easternmost room, detail manger

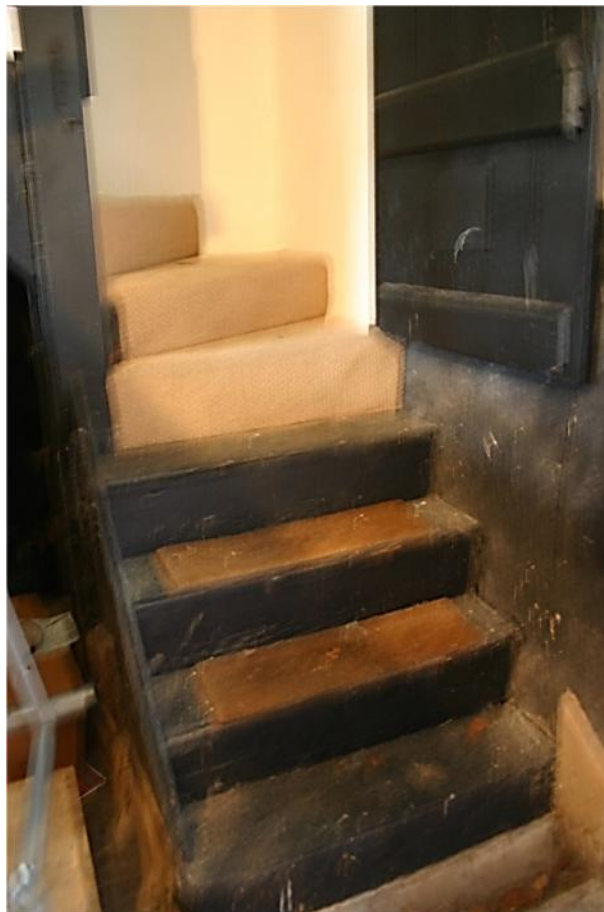
Plate 7: ground floor easternmost room, detail staircase

is planned in the eastern section of the south-west facing elevation, by taking down the level of the sill of the existing window to floor level. It is proposed to move the staircase from the easternmost stable room to the central room.

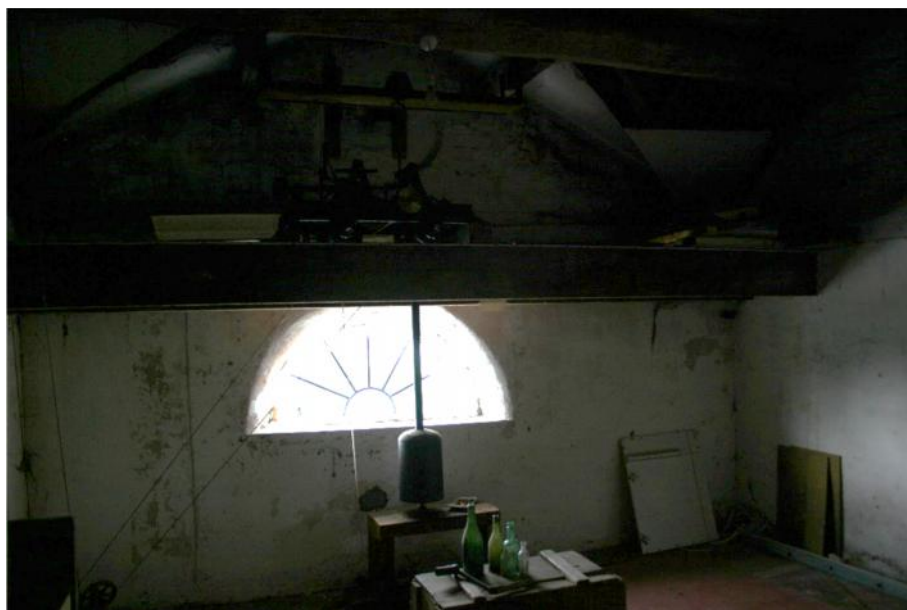
Plate 8: clockwork in central first floor room

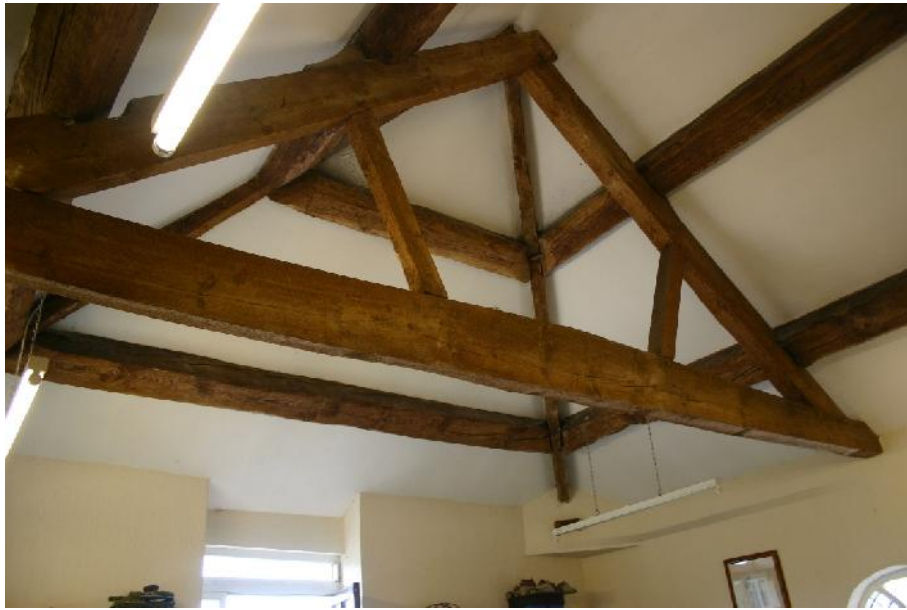
5.3.3 While the ceiling of the westernmost first floor has been taken up to expose the full roof height, the ceiling of the easternmost and central room are still very low. The central room ceiling is partially opened for the clock work. A blocked off window is

Plate 9: exposed roof timbers in westernmost first floor room

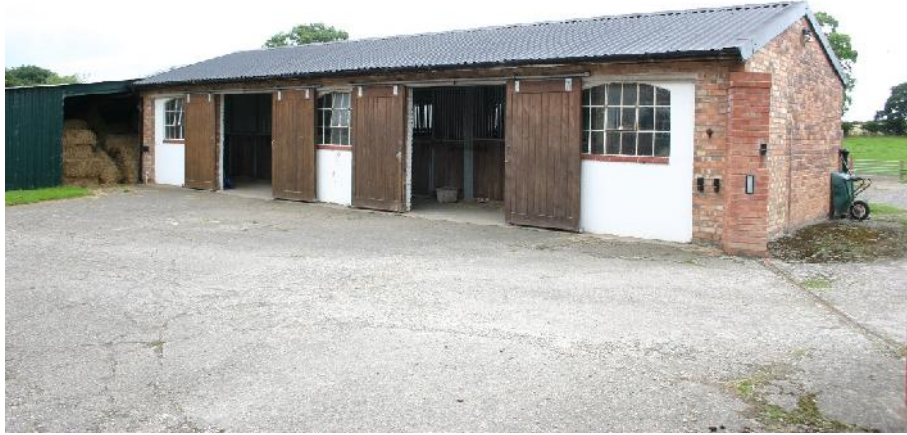
Plate 11: stables to the north-west of building

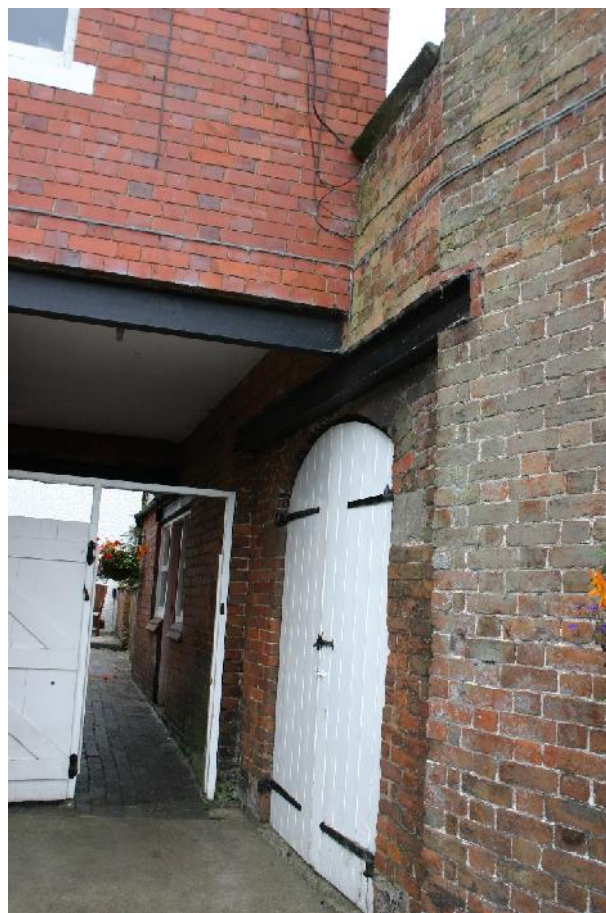
Plate 12: Extension shed partially to be demolished

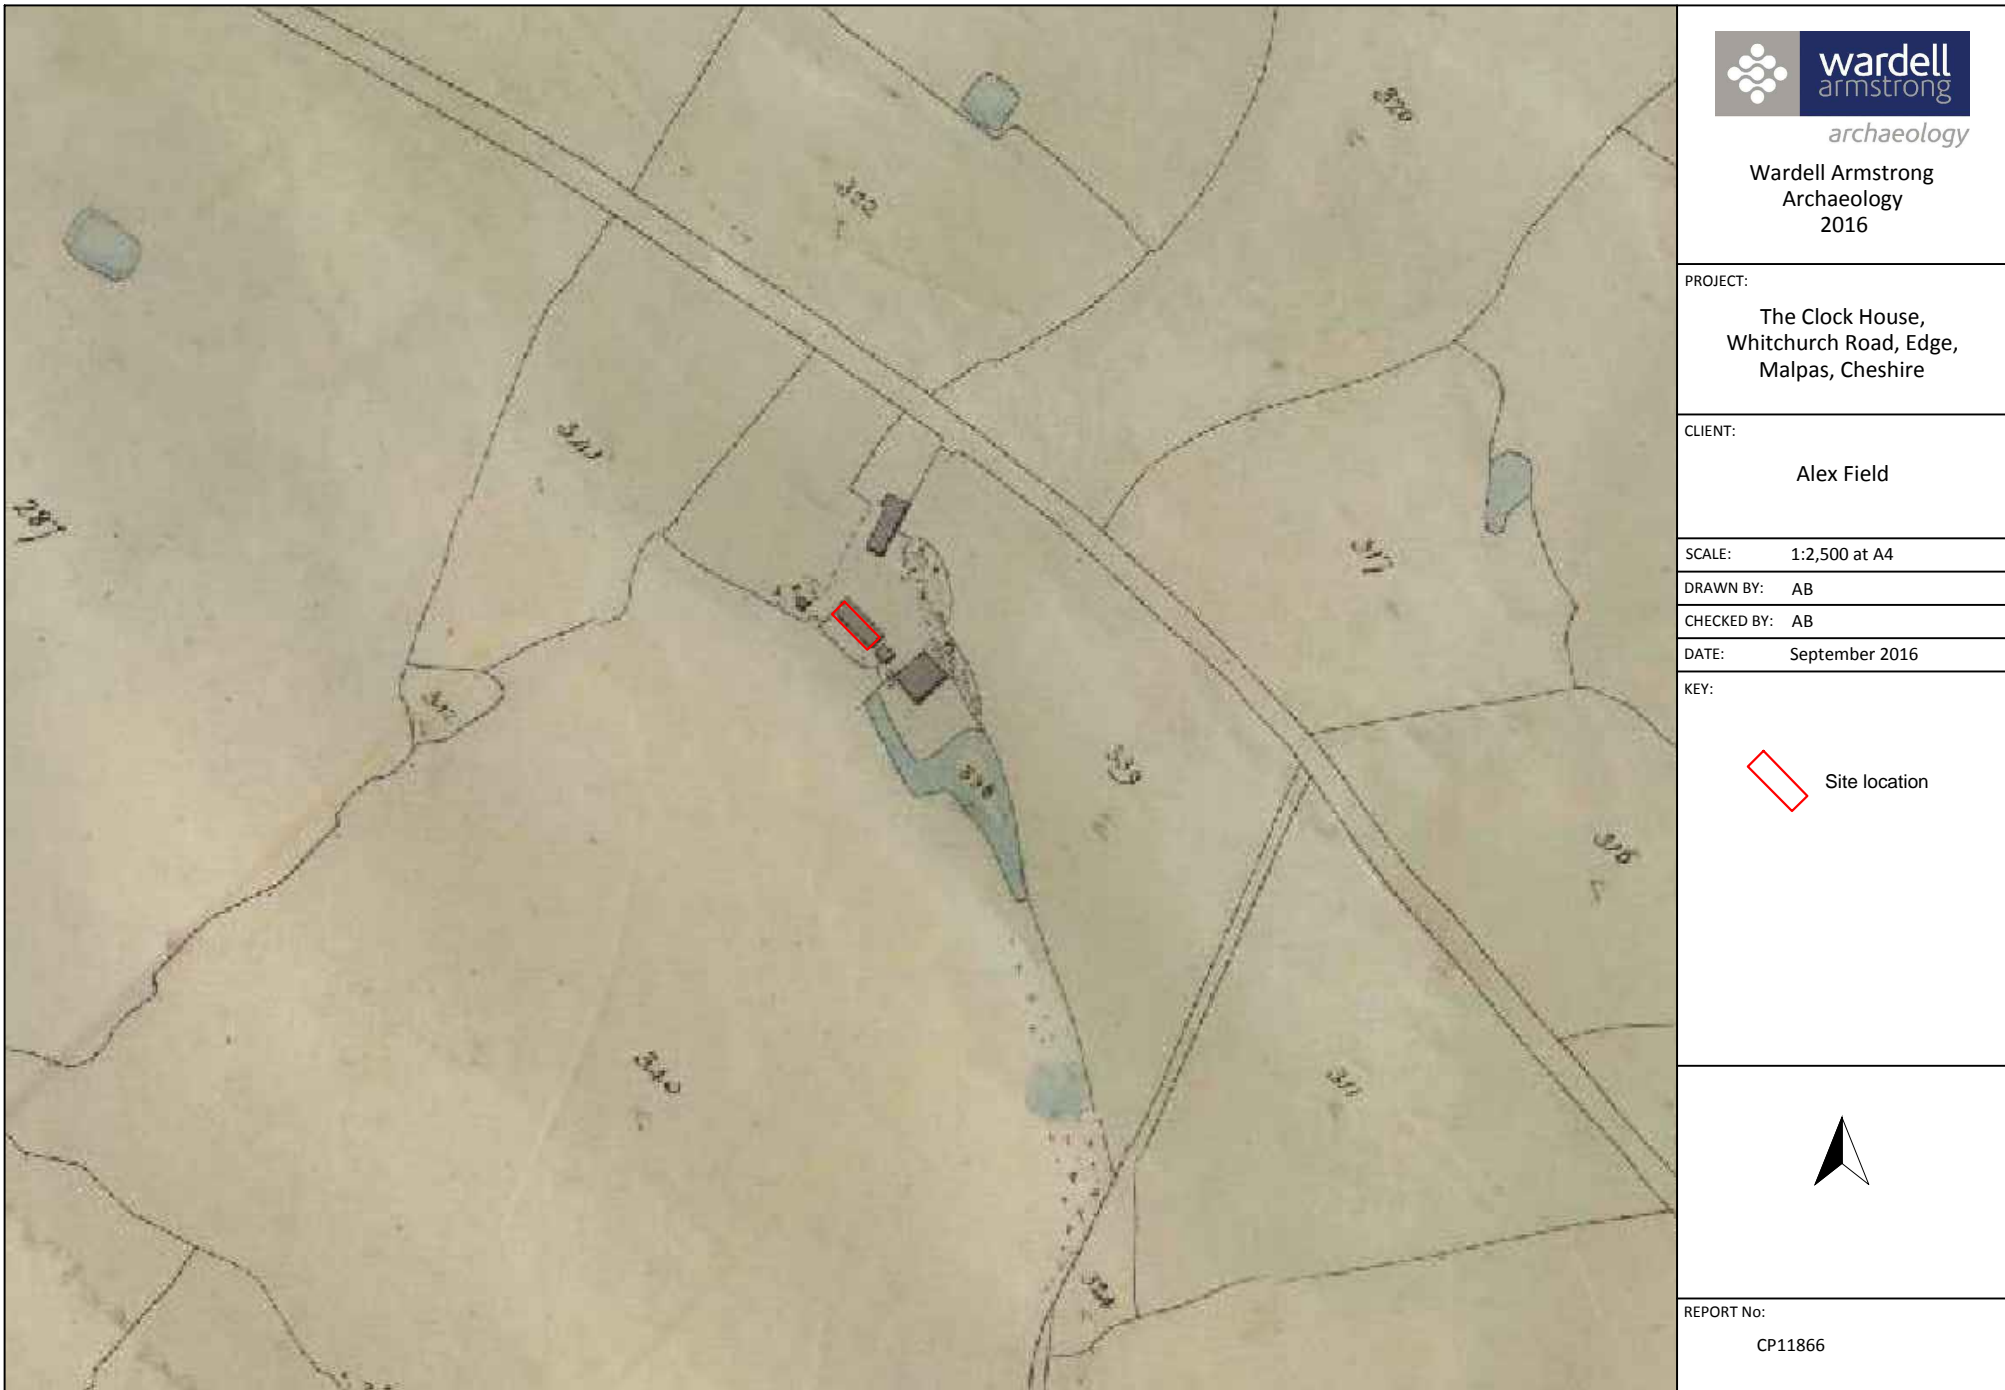
Figure 4: Tithe Map, 1839.

- 4.5.8 **The Clock House:** The tithe map from 1839 (Figure 4) names a Mrs Margaret Smith as the owner of Edge House, including the Clock House, and the surrounding properties (<http://maps.cheshire.gov.uk/tithemaps/Search.aspx>). Overall, 40 properties are listed in her name, with the greater part rented out to several people. Edge House, however, was inhabited by her. It is described as a 'house, outbuildings, yard, garden, barn, croft and plantation'. The site consisted of one rectangular house at the south-east corner, three outbuildings to the north-west, including the Clock House, and a slightly L-shaped barn to the north. The rectangular, north-west to south-east aligned building of the Clock House was used as carriage house, stables and ostler's quarters.

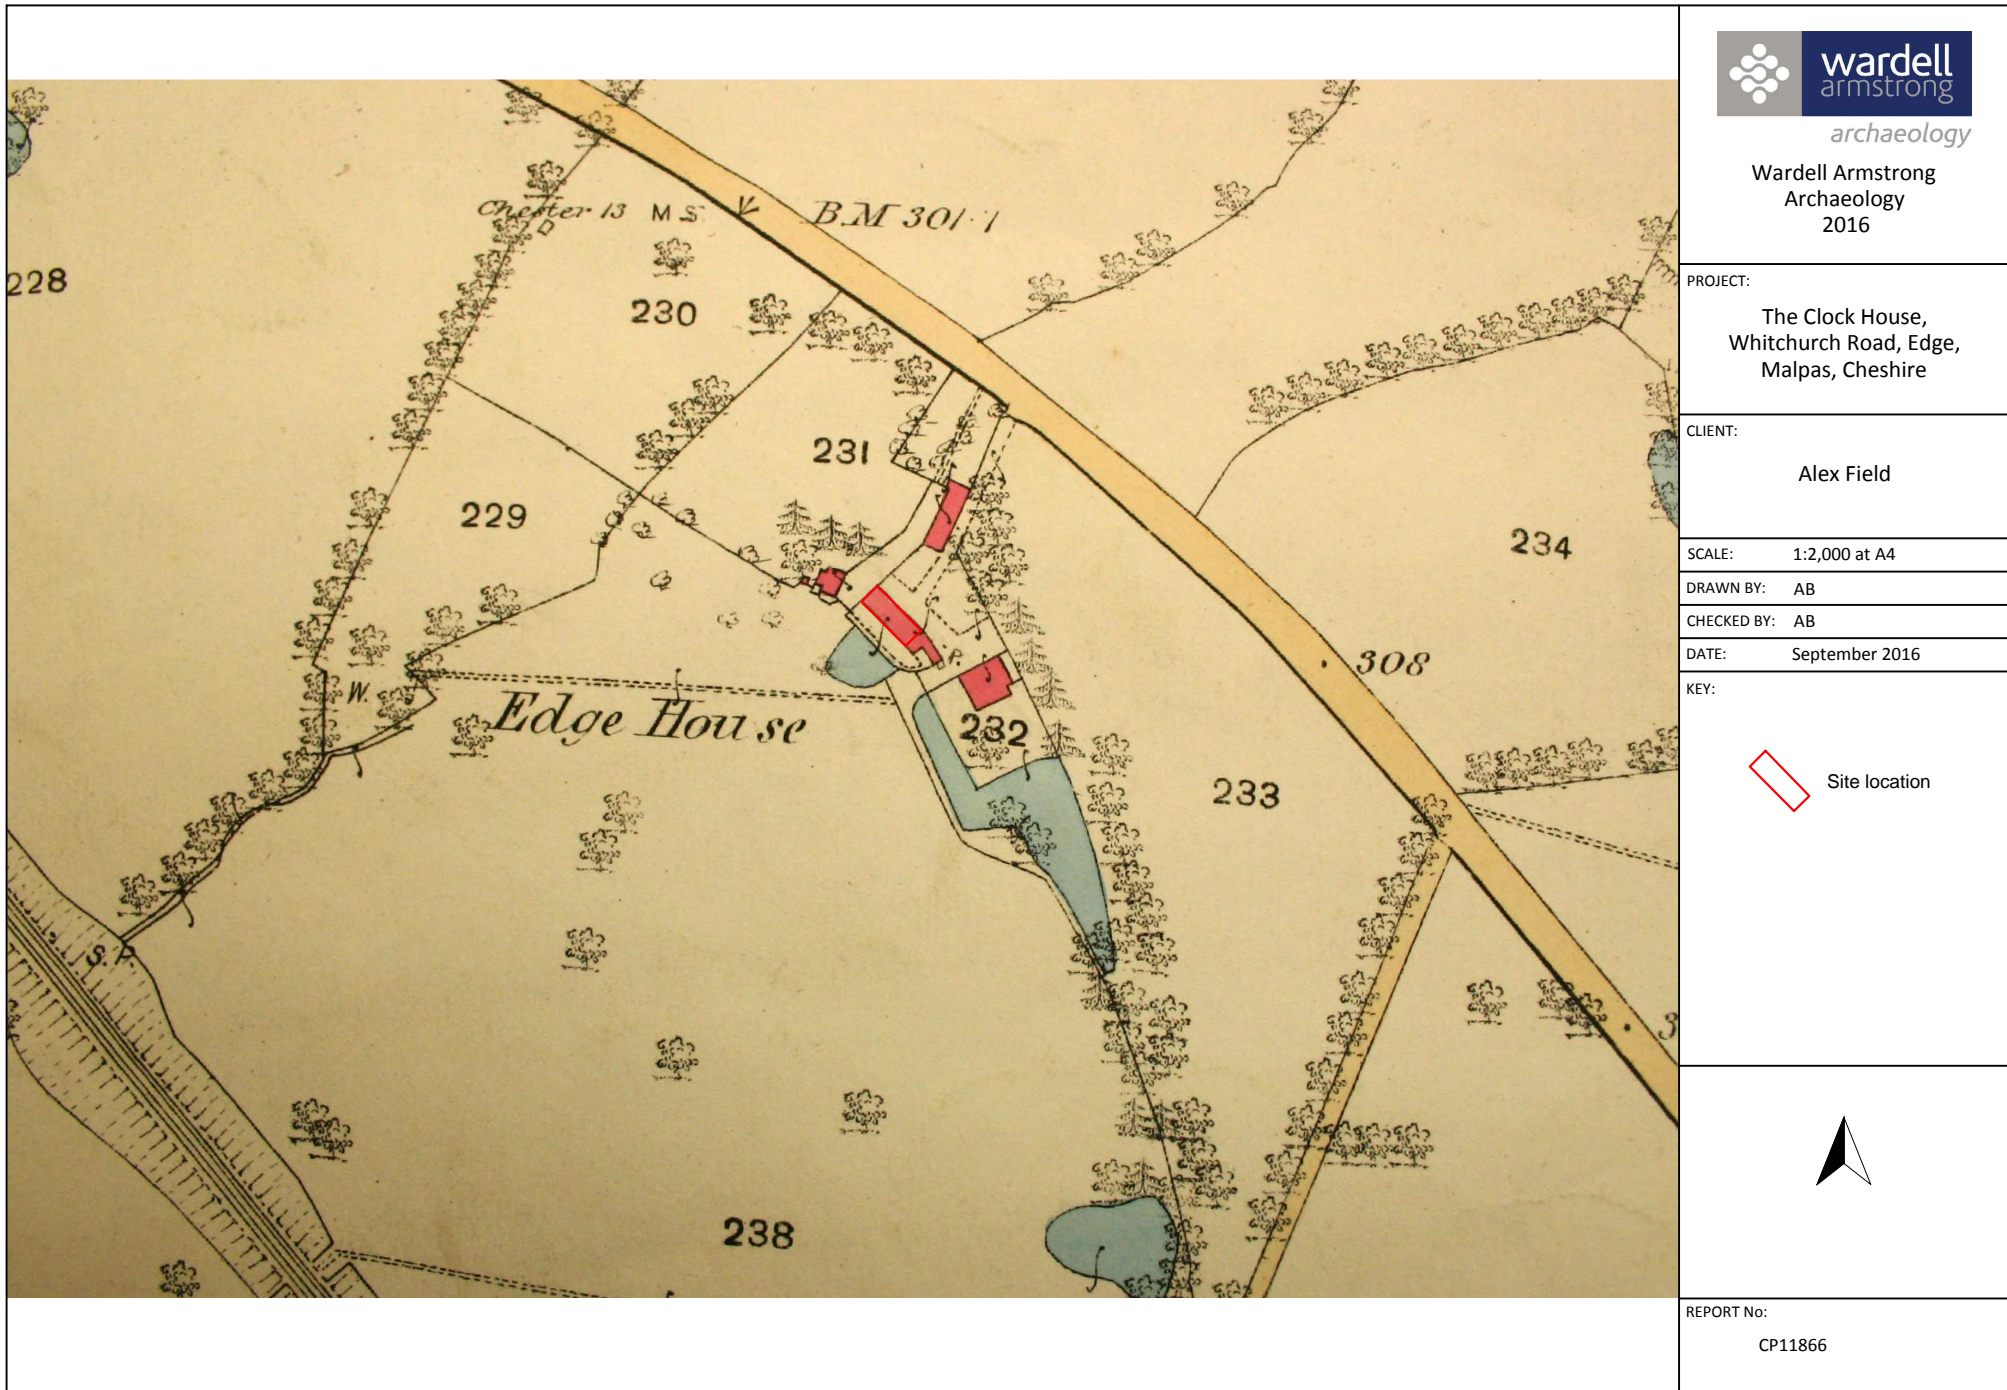
Figure 5: First Edition Ordnance Survey Map, 1874 (25 inches to 1 mile).

- 4.5.9 By 1874 (Figure 5), a narrow, north to south extension had been built at the south-east corner of the Clock House, and a small pond had been established to the south-west of the building. A glasshouse had been attached to the south-west elevation of

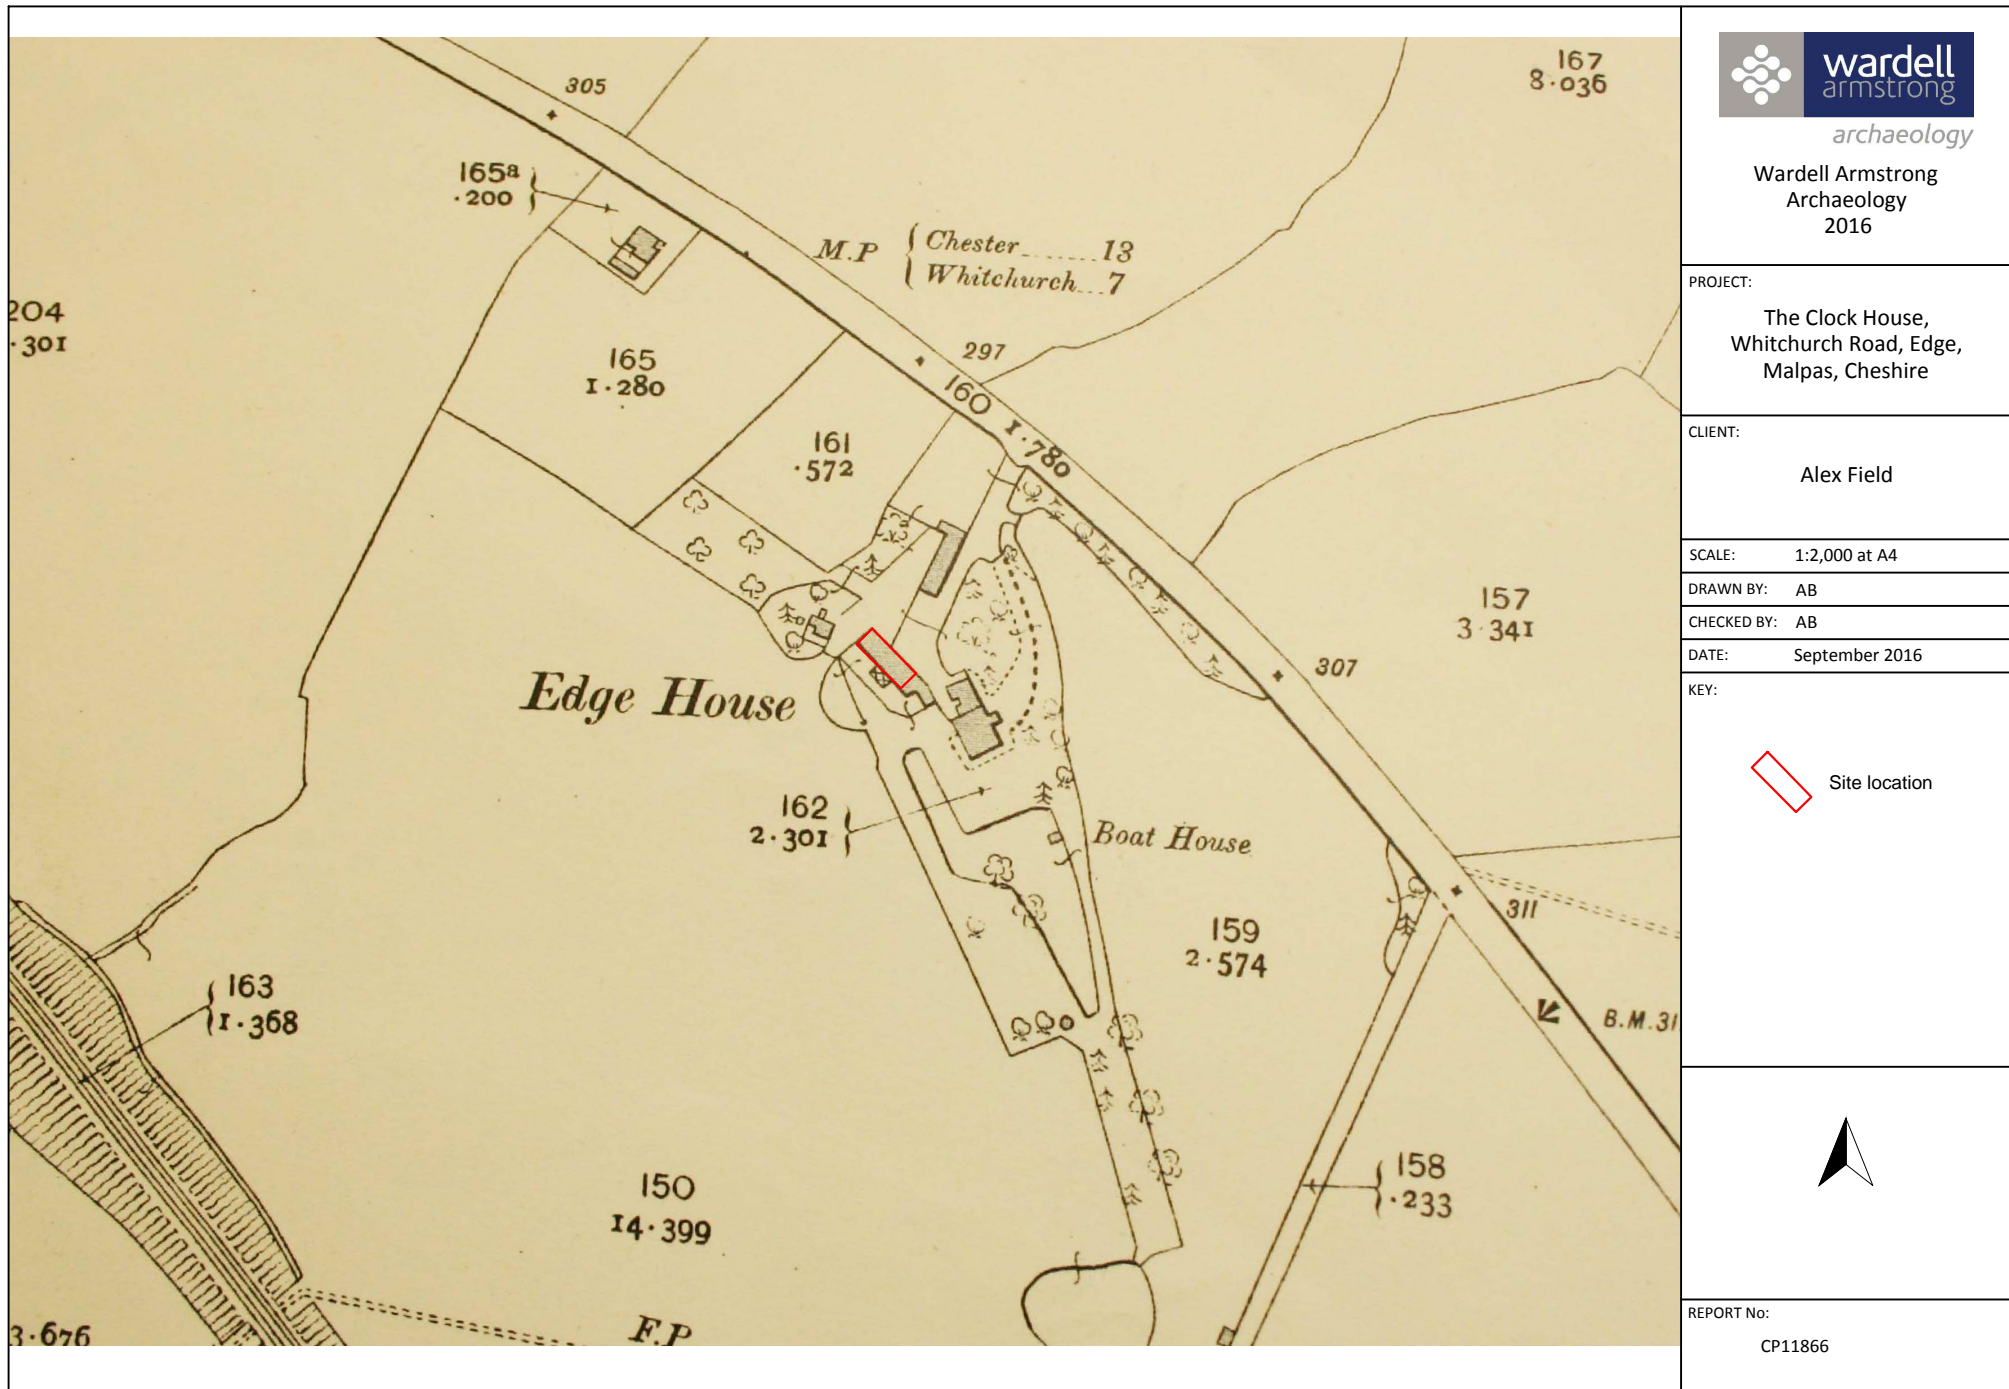
Figure 7: Ordnance Survey Map, 1911 (25 inches to 1 mile).

the building between 1898 and 1909 (Figure 6 and 7). All traces of the glass house were removed before the building extension pre-dating 1972 (Figure 8). The small pond to the south-west of the building had been reduced in size by 1898. Furthermore, by that point, the small outbuilding to the north-west of the site had been removed and a south-west to north-east aligned stable block had been erected. By 1972, the small pond to the south-west of the site was converted into a garden area.

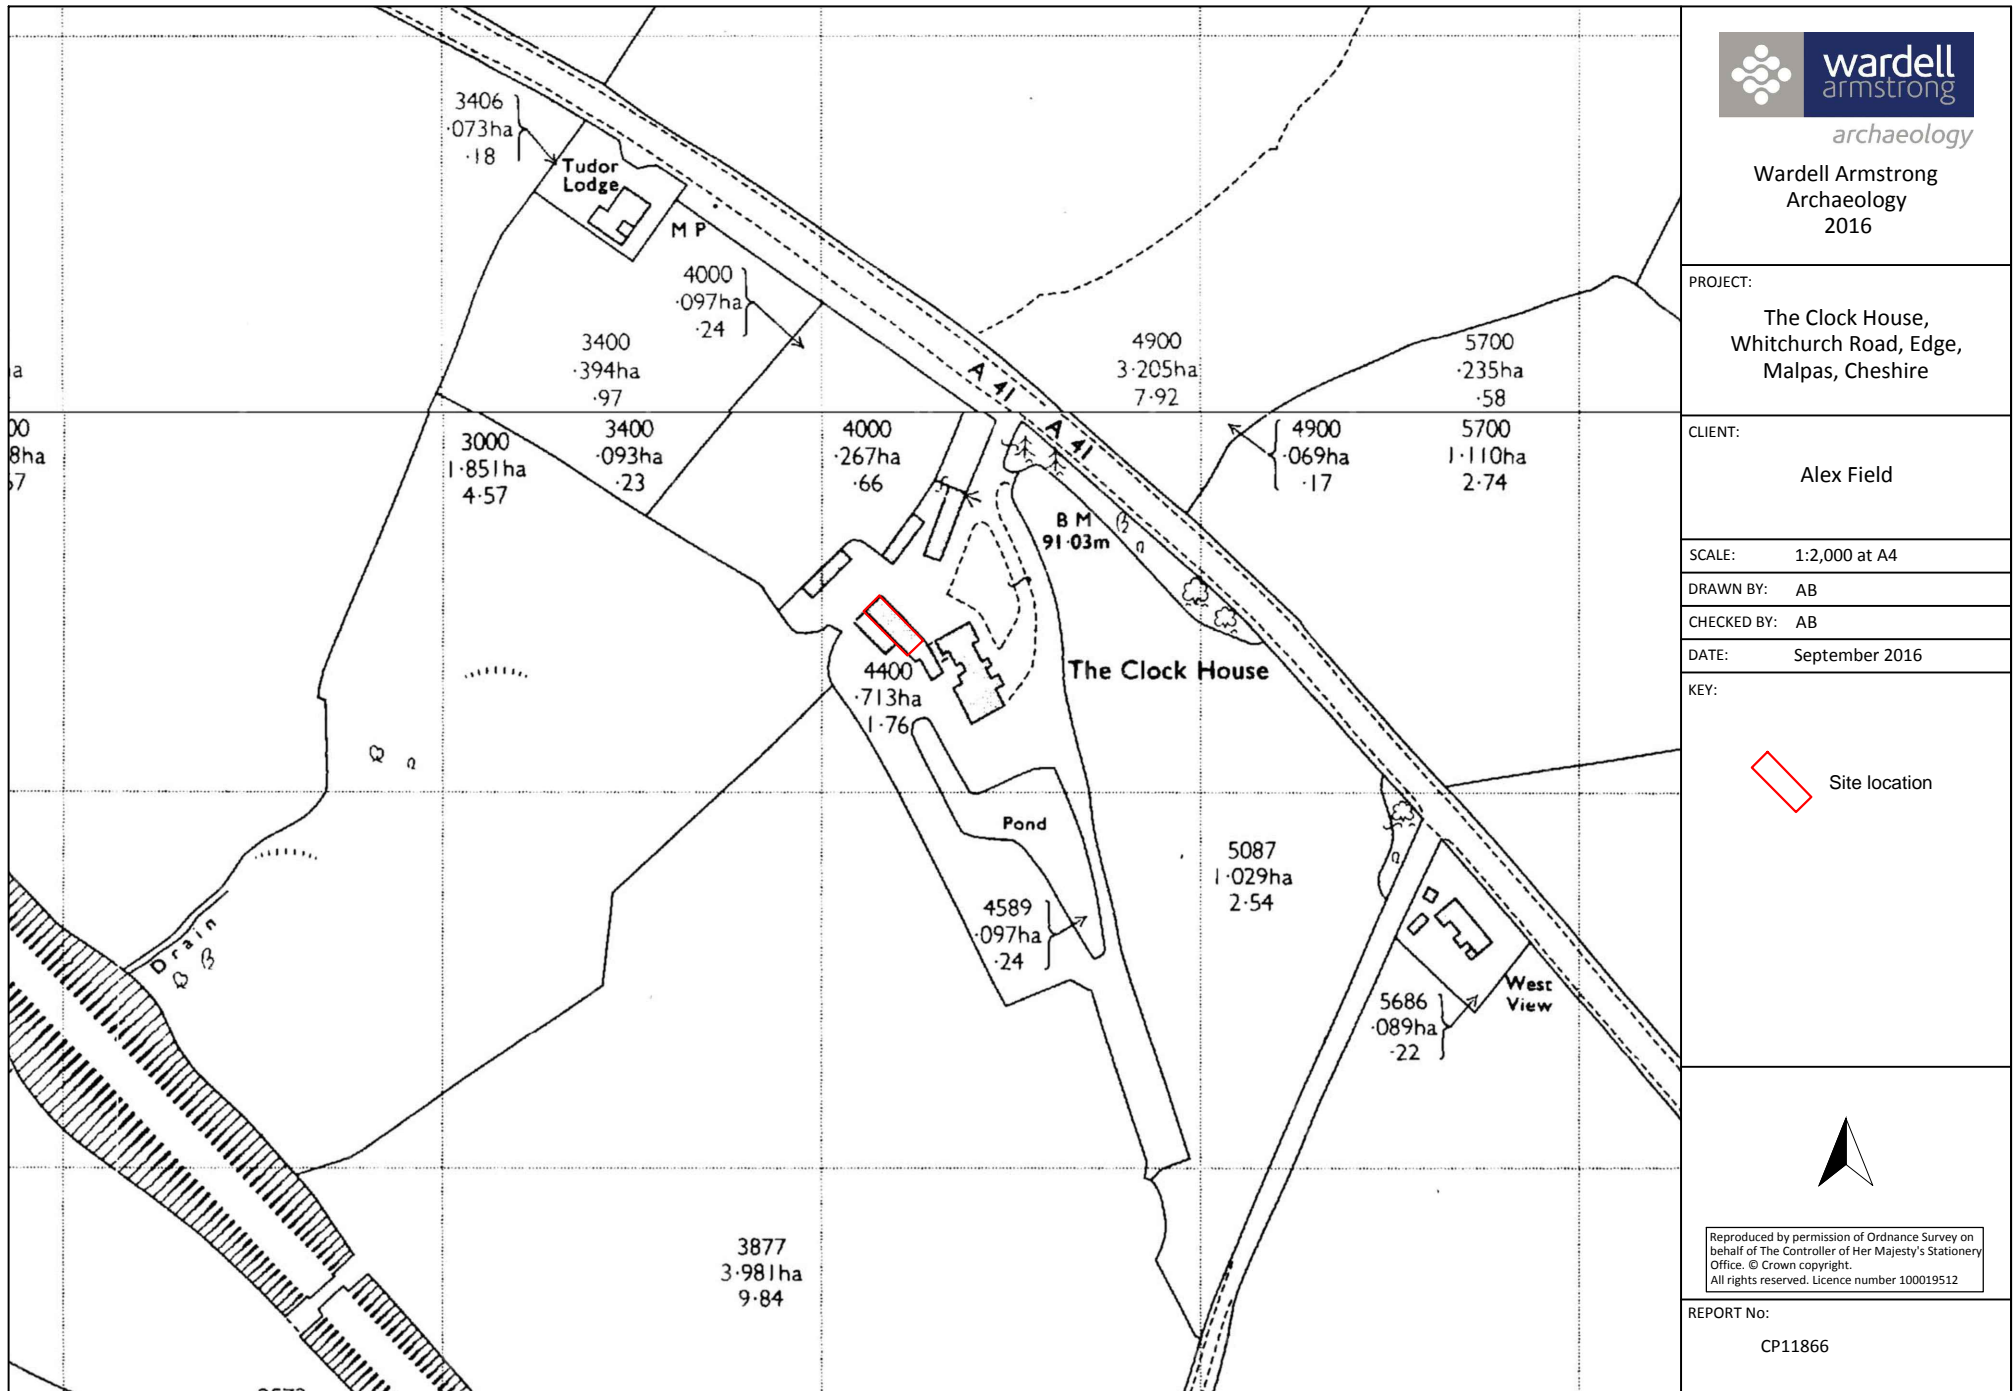
Figure 8: Ordnance Survey Map, 1972 (25 inches to 1 mile).
