PERSIMMON HOMES (LANCASHIRE)

ST. GEORGE'S QUAY

LANCASTER

PHASE 2 ARCHAEOLOGICAL EVALUATION REPORT

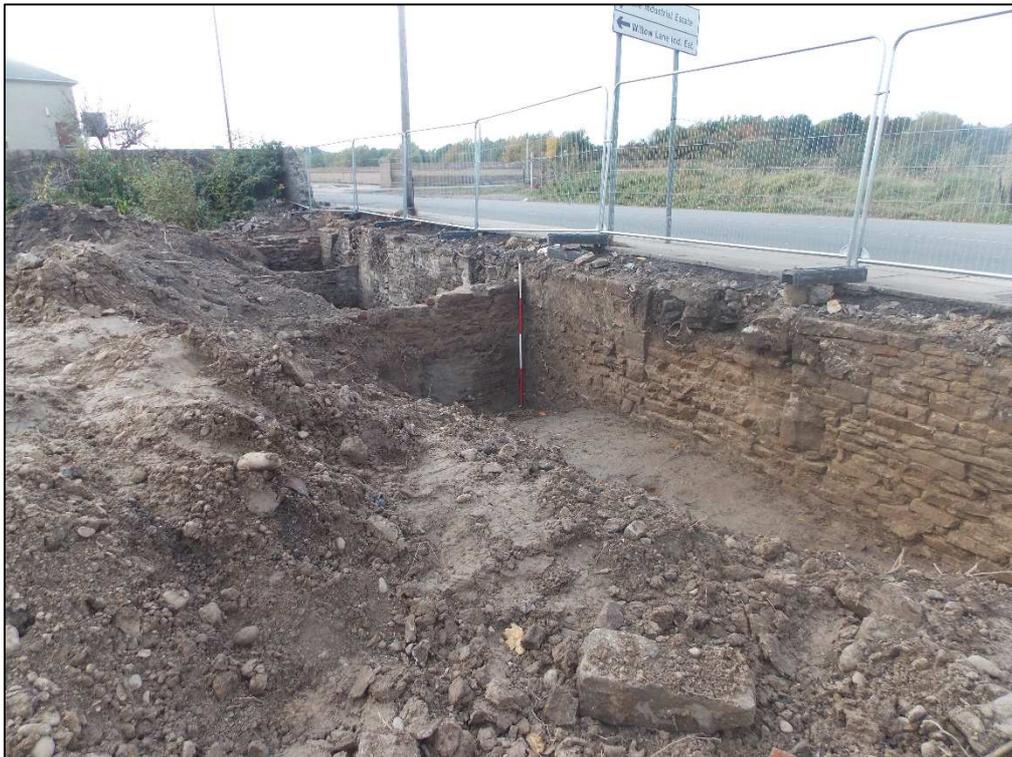
Plate 1; Overview of Trench 1

4.2.2 Trench 1 was aligned east-northeast to west-southwest and measured 27m in length by 3m in width. The trench was excavated to a maximum depth of 1.9m, revealing the remains of the pothouse's front wall (Plate 1) which had been utilised as a firm foundation for a later boundary wall. Only the south facing (interior) elevation of the wall was revealed however, as the exterior elevation now lies below the present pavement. The front wall (**120/123/126**) was found to be of a single construction and measured over 1.9m in height and over 25m in length, equating to the entire width of the pothouse. The wall was constructed from medium to large roughly hewn sandstone blocks, bonded with lime mortar.

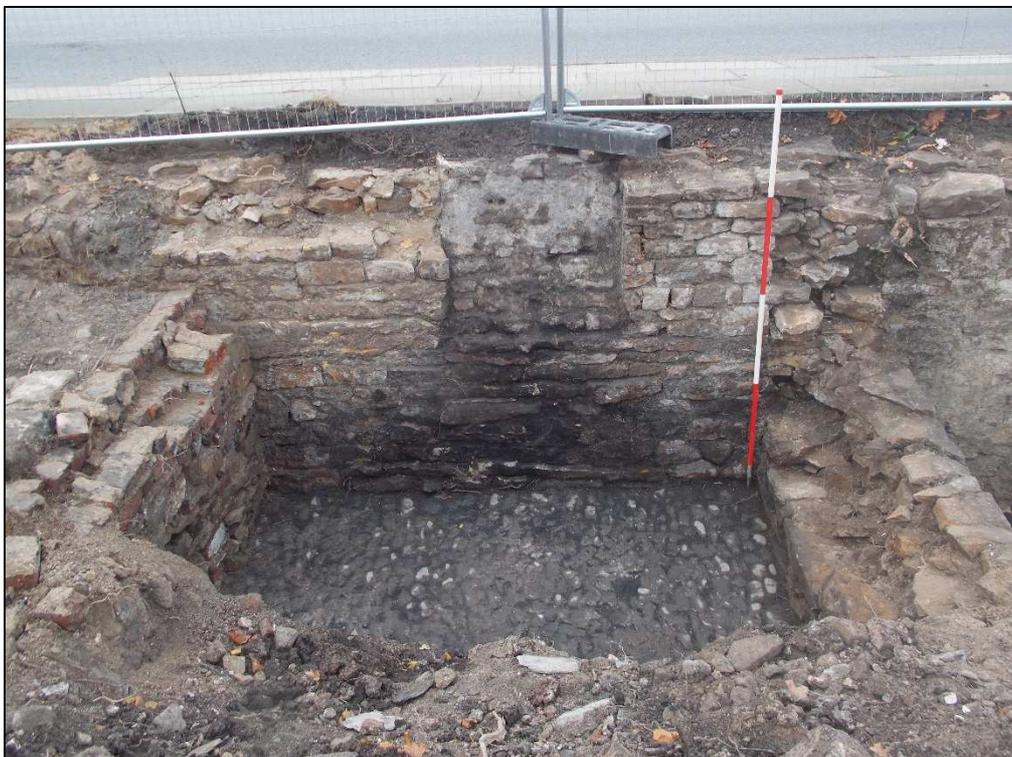
Plate 2; View north-northwest of Cellar 1

- 4.2.4 The western most cellar revealed within Trench 1 (Cellar 1; Plate 2) measured 2.6m in width, 1.6m in height and was formed by the eastern wall of the pothouse's western building to the east and a later brick and sandstone wall to the west. Cellar 1 also retained a well laid cobbled surface (**110**). The eastern wall of the cellar **{124}** measured over 1.7m in height, 0.7m in width and comprised roughly hewn sandstone blocks, bonded with lime mortar. This wall was clearly keyed into the front wall of the pothouse, highlighting that it was part of the original ground plan of the complex. The west wall of Cellar 1 was clearly a later addition however, as it not only abutted the front wall of the structure, but had also been constructed directly above the cobble surface (**110**). This later wall **{125}** measured 1.1m in height, 0.4m in width and comprised a mixture of roughly hewn sandstone blocks and both frogged and un-frogged bricks. This wall likely represents a subdivision within the cellars when the pothouse buildings were in use as tenements. Also of note within Cellar 1 was the presence of a chute within the north wall **{123}**, which measured c.1m in width, 0.85m in height and retained an outward sloping gradient of <math><20^\circ</math>. This chute appears to have been an original feature of the structure, indicating that goods were deposited within the cellar via the front of the building. It is likely that this area was utilised for the storage of fuel for the kiln, such as wood or peat, although it was clear that the area had been later used for the storage of coal given the amount of coal dust around the chute and the cobbled floor.

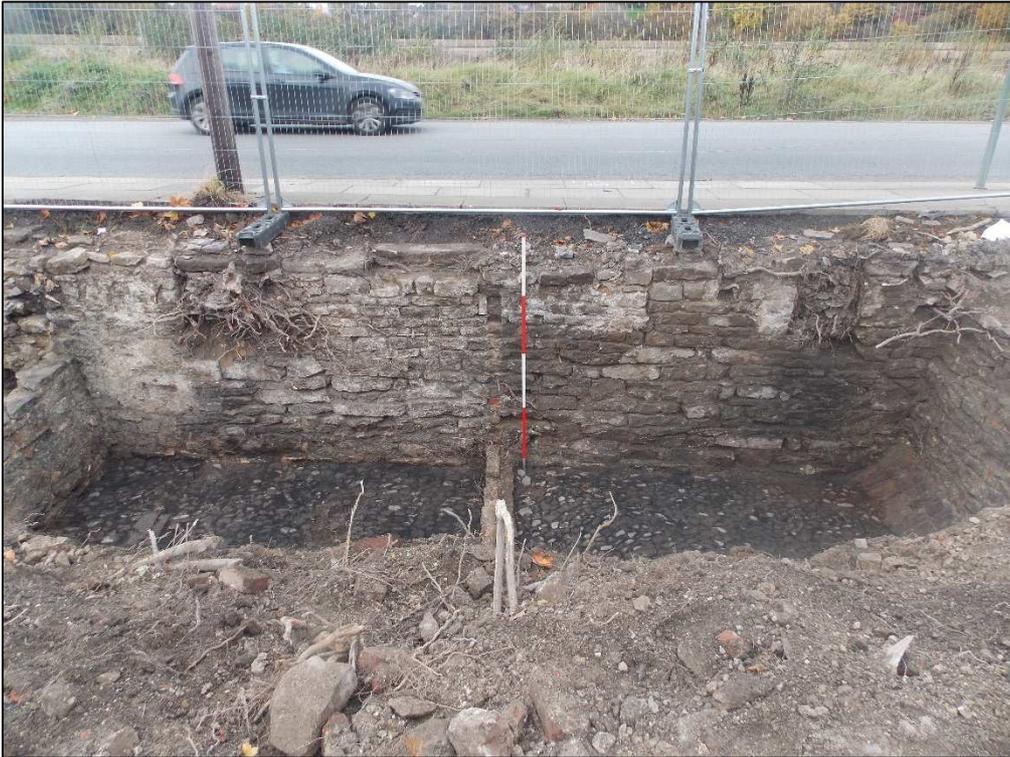
Plate 3; View north-northwest of Cellars 2a and 2b

- 4.2.5 Immediately east of Cellar 1 was a large central cellar (Cellar 2; Plate 3), which measured 7.3m in width, 1.9m in height and was formed by the eastern wall of the pothouse's western building to the west and the west wall of the eastern building to the east. The east wall of Cellar 2 **{127}**, which measured over 1.8m in height and 0.6m in width, was similar to wall **{124}** to the west, comprising roughly hewn sandstone blocks, bonded with lime mortar and forming part of the original ground plan of the pothouse complex. Cellar 2 had been further subdivided by a central single skin wall **{128}**, which measured c.1.5m in height and 0.11m in width and

comprised un-frogged red bricks. It appears that this wall was an original feature of the pothouse, as it was keyed into the front wall of the cellar {126}. This wall was not a supporting structure however, and appears to have been utilised as an internal dividing wall, effectively separating Cellar 2 into two areas (Cellar 2a and Cellar 2b). Both of these sub-divided cellars retained well laid cobbled surfaces (111 & 130), which were approximately 0.2m lower than the floor surface observed within Cellar 1. Both Cellars 2a and 2b also retained openings within the north wall, which appeared to represent windows. It is unclear whether these were original features of the cellars, although the eastern most opening within Cellar 2b appears to have been utilised as a coal chute at some point. Cellar 2b also retained a later brick-built feature at its eastern extent. The feature {129} comprised two courses of frogged bricks, which measured 0.48m in width and extended from the northeast corner of cellar for 1.2m. The brick feature had been laid in such a way as to form a c.45° slope, which probably aided with the shovelling of material within the corner of the cellar. Also of note was the presence of an excessively worn sandstone step, which had been laid above the north wall of Cellar 2a. It is possible that the step marks the level of the former ground surface and indicates that Cellar 2a was approximately 1.8m in height.

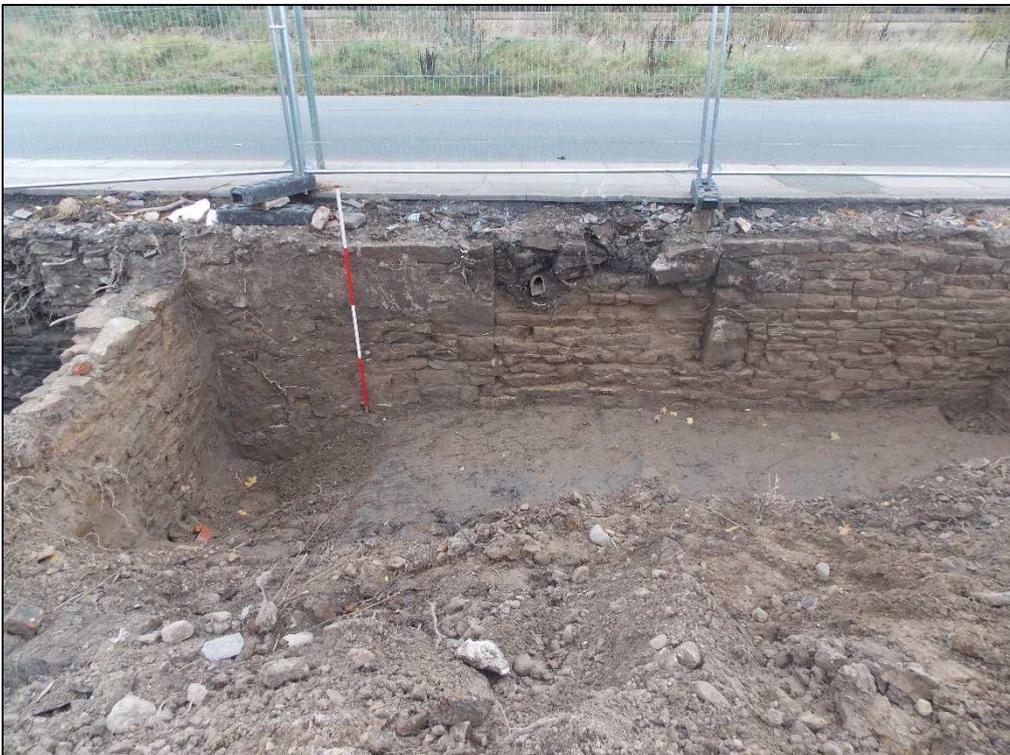
Plate 4; View north-northwest of Cellar 3

- 4.2.6 The eastern most cellar of the building (Cellar 3; Plate 4) measured 6.9m in width, over 2.4m in height and was formed by wall {127} to the west and the outer wall of the pothouse's eastern building to the east. This outer wall {119} measured over 1.65m in height, 0.85m in width and comprised roughly hewn sandstone blocks, bonded with lime mortar. Interestingly, no floor surface was observed within Cellar 3, the area being made up of thick deposits of clay. The lowest observed deposit of clay (121) was mid-blueish grey in colour and measured over 0.5m in depth. This was sealed by a deposit of mid-light brown clay (122), which measured 0.5m in depth. Given the presence of these deposits, it would appear that Cellar 3 was utilised for the storage of clay which was obviously fundamental to the production of pottery. The use of this area for the storage of clay was supported by the north wall of the cellar {120}, which retained a large central opening measuring c.1.8m in width and c.1.1m in height. Such a large opening would likely be needed to deposit clay within the cellar, which was likely transported as large blocks from vessels moored on the river bank straight into the front of the building. At some point this opening was blocked up by large sandstone blocks {131} and sand (132), probably when pottery production ceased at the site.

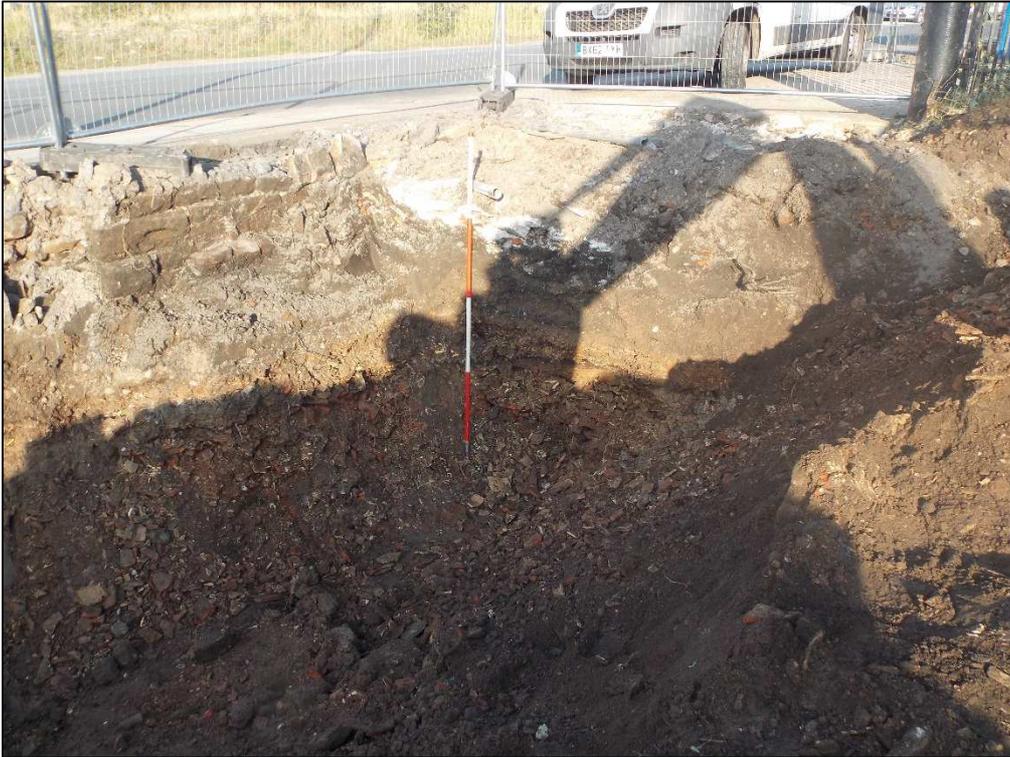
Plate 5; View northeast of northern shardruck deposits (104)

- 4.2.7 Trench 1 was also extended approximately 6.8m east of the pothouse's eastern building, in order to investigate the pottery dumps within that area. This area was excavated to a maximum depth of 2.5m, revealing the dark grey natural clay (**101**). This was sealed by an extensive pottery dump (**104**), which measured c.2m in depth and extended from the eastern wall of the pothouse to the eastern extent of the trench. Although the pottery dump comprised several visible tipping layers, these individual deposits could not be accurately recorded due to the depth of the trench and the unstable nature of the sections. The pottery dump was sealed by c.0.1m of mid-brown silty clay (**103**) and 0.45m of dark greyish brown garden soil (**102**) (Plate 5).

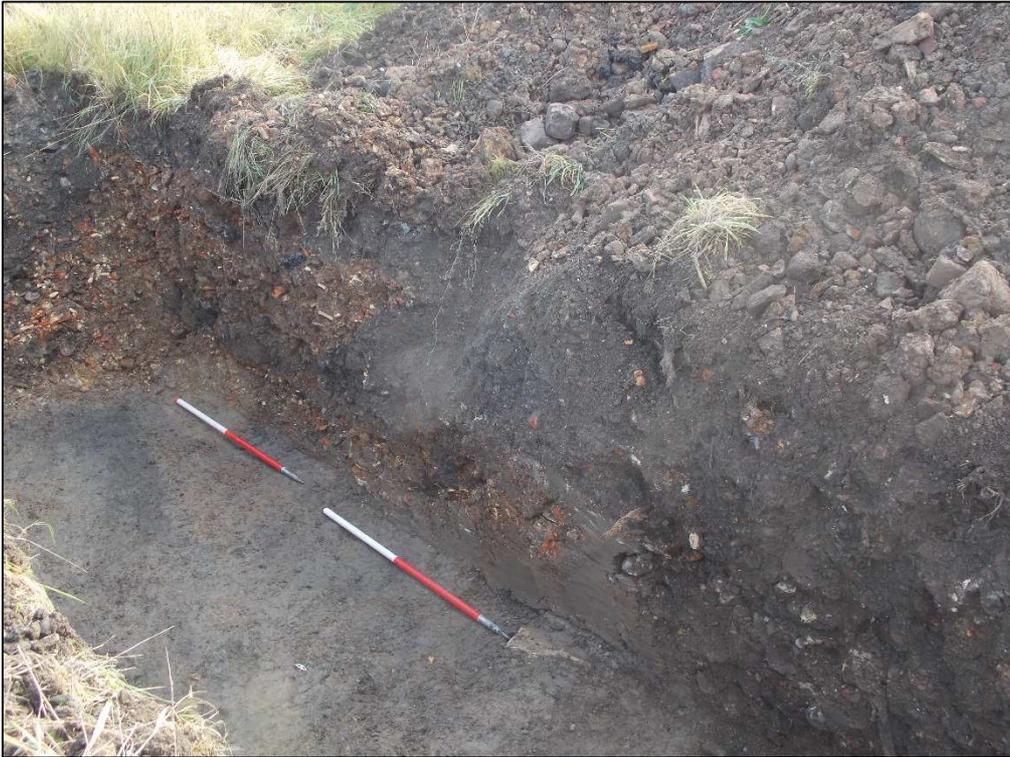
Plate 7; North-northwest facing section of Trench 5 showing northern extent of shardruck deposits (108)

4.2.16 Trench 5 was aligned east-northeast to west-southwest and measured 7.5m in length by 1.6m in width. The trench was excavated to a maximum depth of 1.35m, revealing the heavily stained natural grey clay (509). This was sealed by the northern extent of the pottery dump (Group no. 108), which measured 1.1m in depth and comprised up to six clearly visible tipping layers (503 -508). The western observed extent of the dump had been cut by a large U-shaped pit [502], which measured 2.1m in width, 0.9m in depth and had been filled by a deposit of silty clay and modern rubbish (501). The pit had been sealed by a c.0.25m deposit of greyish brown silty clay topsoil (500) (Plate 7).

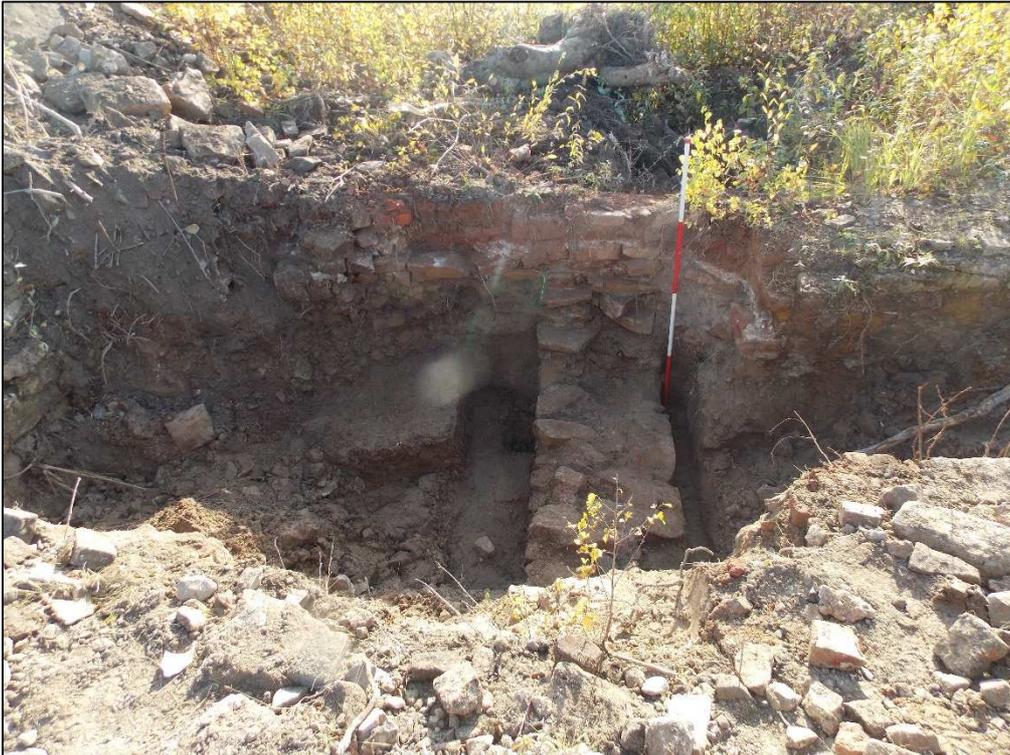
Plate 9; View south-southeast of Trench 7 showing central spine wall {118}

4.2.20 Trench 7 was aligned east-northeast to west-southwest and measured 4.4m in length by 2.8m in width. The trench was excavated to a maximum depth of 1.7m, revealing further information about the construction of the kiln (Plate 9). No lower level below the firing chamber was observed within the trench, making it highly unlikely that one ever existed. The trench did however, reveal a substantial wall foundation below the kiln which had not previously been observed. The north-north west to south-southeast aligned wall **{118}** measured over 2.5m in length, 0.9m in width and over 1.3m in height, and was comprised of large, roughly hewn sandstone blocks bonded with mortar. Interestingly, the wall did not correspond with the alignment of the known foundations of the kiln and instead, appeared to be situated centrally to the feature. It is probable that this wall formed a central spine for the kiln, which would have been needed to support the immense weight of the structure.

4.2.21 The wall had been encased within a lower deposit of dark grey clay (**117**), which measured over 0.65m in depth, and a c.0.6m upper deposit of light brown clay (**116**), similar to the other observed foundations associated with the pottery complex (see Town 2009, Jackson 2009). These deposits and the wall **{118}** formed part of the foundations for the kiln floor, which were noted to be comprised of a lower

foundation course of roughly hewn sandstone blocks {115} and a severely heat affected brick surface {114}.

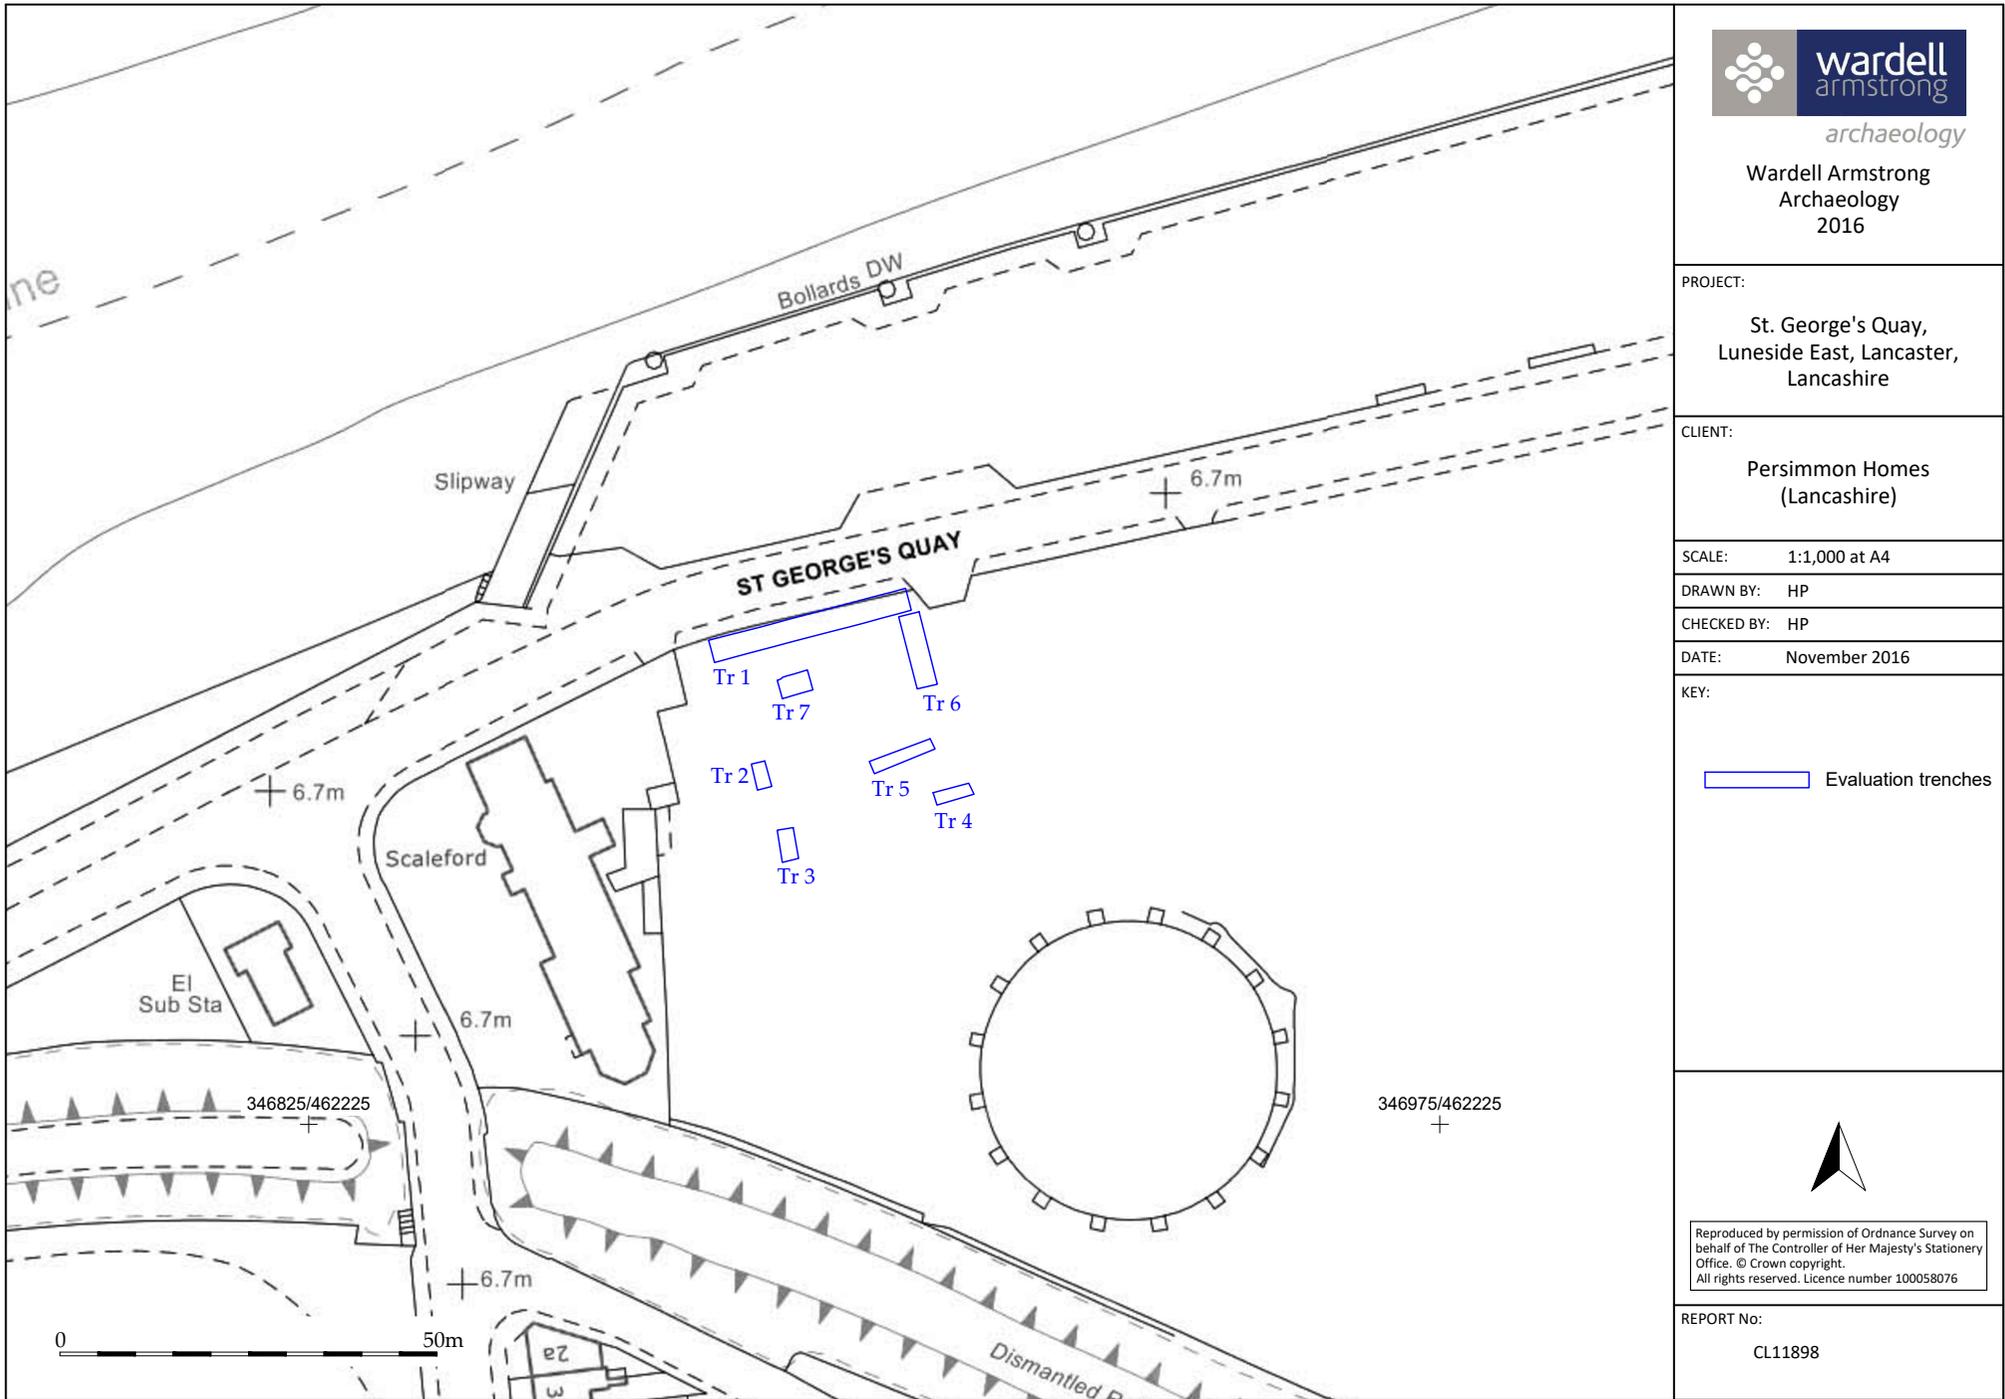
Figure 2: Trench location plan.

2.2.1 The evaluation comprised the excavation of seven trenches, located within and immediately adjacent to the pothouse (Figures 2 & 3), in order to obtain the maximum amount of information possible within the constraints of the project. The initial WSI stated that the evaluation should include a trench targeting the previously unexcavated frontage of the pottery complex, as well as two 20m by 1.6m trenches located to the rear of the pothouse, in order to identify and investigate potentially unknown shadruck deposits. However, it was not possible to fully achieve the requirements of the WSI to the rear of the pothouse, due to the presence of several abandoned cabins/containers and extensive tracts of contaminated ground within that area. Therefore, it was deemed appropriate to separate the two 20m long trenches into several smaller investigation areas and relocate these within areas of the site with greater archaeological potential. The locations and results obtained from each trench are outlined in Section 4 below.

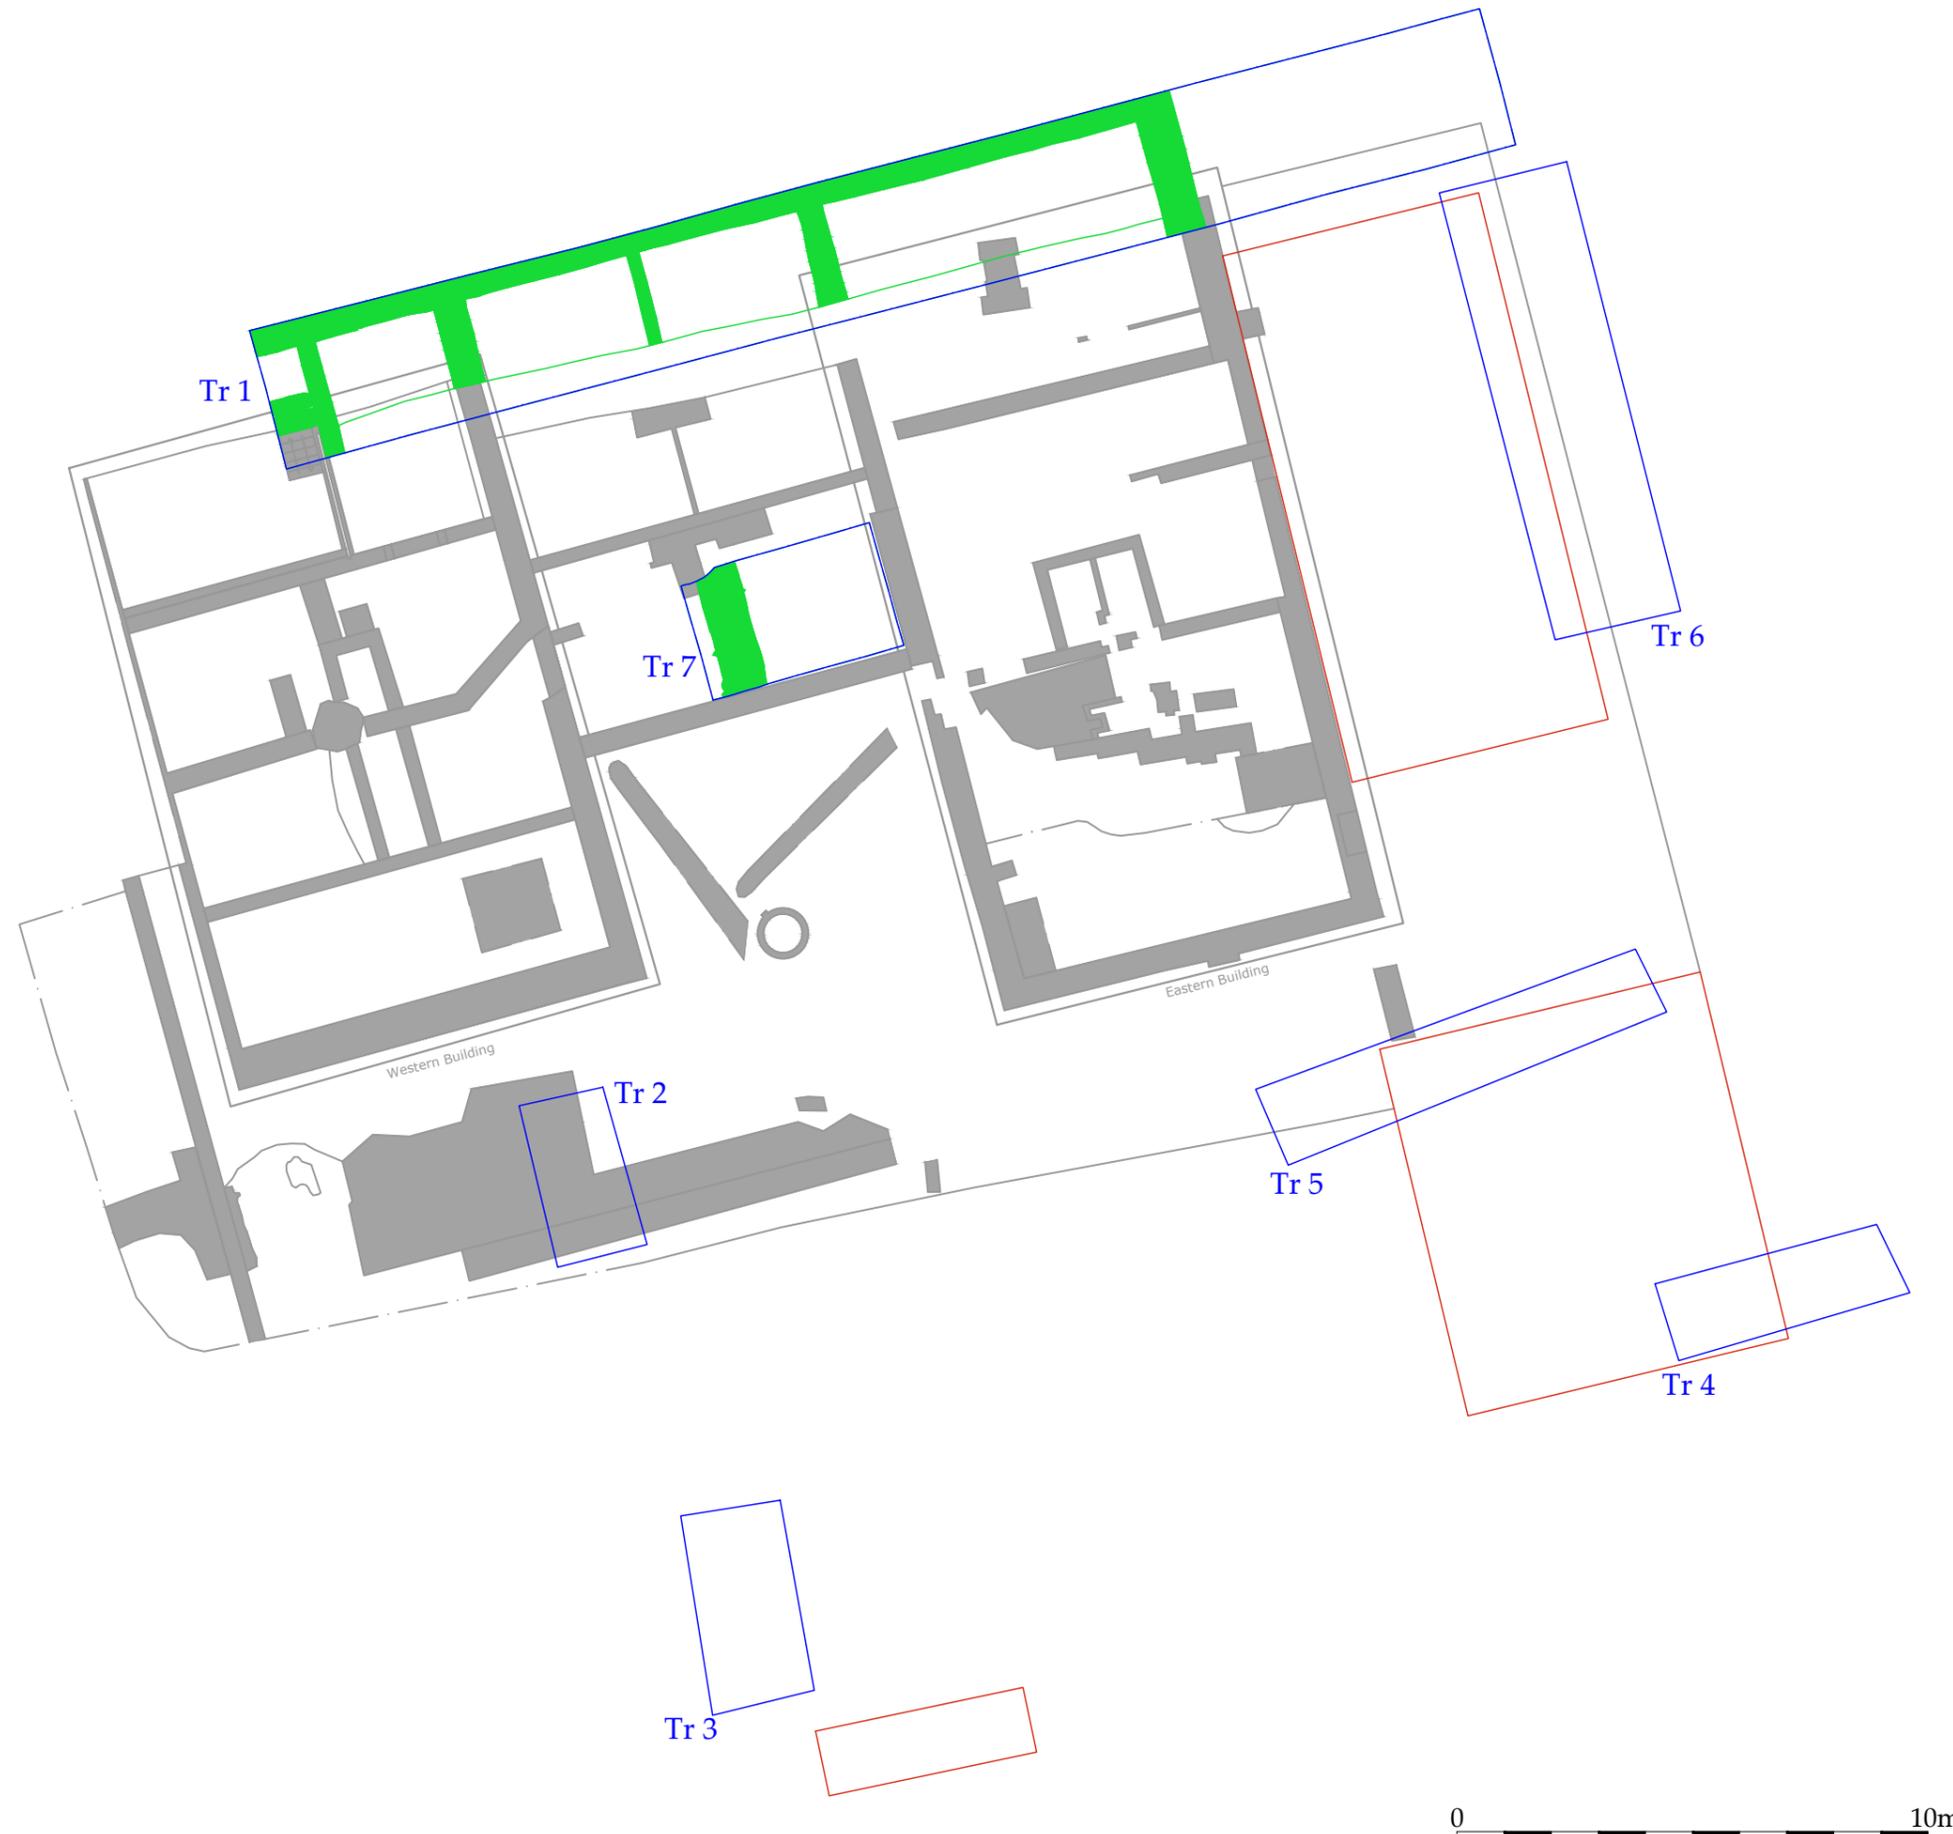
Figure 3: Plan showing full extent of Pothouse complex.

4.2.19 **Trench 7 (Figure 6):** Trench 7 was located immediately north of the kiln working floor, in order to answer specific questions about the construction and extent of the kiln structure (Figure 3). The kiln structure was investigated during both the 2007 and 2008 phases of work, which established that the entire floor plan of the kiln was constructed on substantial foundations forming a separate structure nestled within the rest of the pottery complex. However, there has been some speculation about the actual form of the kiln and the possibility that the structure retained a lower level beneath the firing chamber (Barbara Blenkinship *pers. comm.*). No evidence for such a lower level was observed during the previous archaeological work, although the northern elevation of the kiln, where access into a lower level would most likely be situated, was never investigated due to the presence of structural elements associated with the feature. It was noted at the onset of the present investigation however, that these structural elements, which included cobbled passageways and a brick lined loading area, had been severely damaged at some point since the last investigation in 2008. Therefore, the opportunity was taken to investigate the northern side of the kiln in order to confirm or refute the possibility of there being an additional level within the structure.

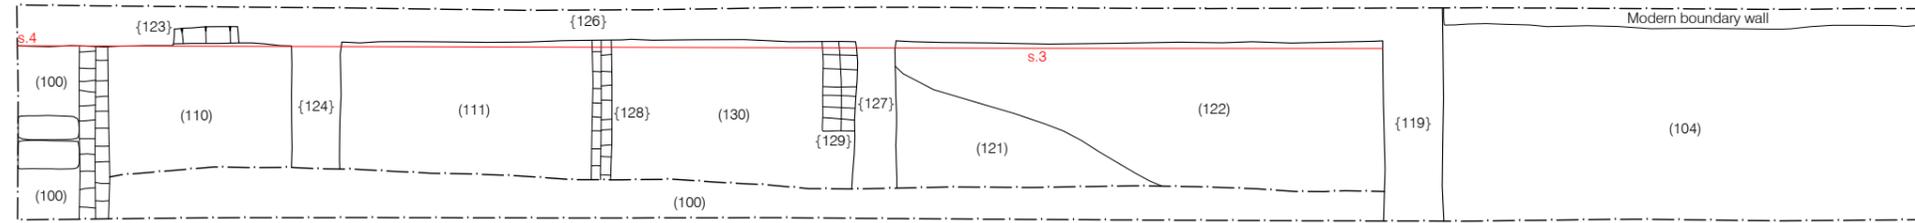
Trench 1. Plan.

4.2.1 **Trench 1 (Figure 4):** Trench 1 was located at the northern extent of the site, in order to locate the front of the pothouse and produce a full plan of the pottery complex (Figure 3). This particular area of the site could not be accessed previously, due to the presence of a later boundary wall. It was considered critical to reveal the front of the pothouse however, as questions still remained regarding the construction and form of this part of the pottery complex (see Town 2009).

- 4.2.3 Trench 1 revealed the northern extent of a number of cellars at the front of the pothouse which were initially identified during the 2007 investigation, although the western most cellar could not be investigated due to the extant remains of the boundary wall. The northern extent of each cellar was marked by the north wall (**120/123/126**) of the pothouse complex, with the eastern and western extents of each cellar demarcated by the major north-northwest to south-southeast aligned walls of both the eastern and western buildings of the complex.

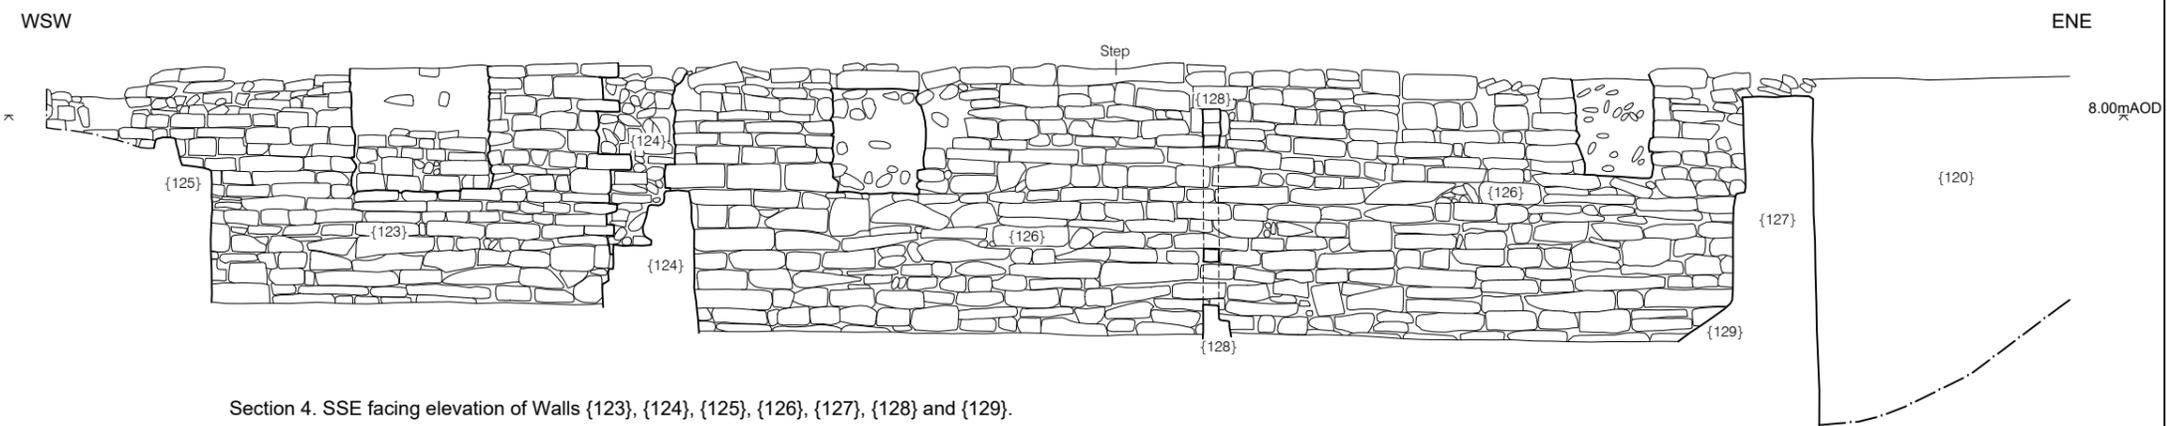
Section 4. SSE facing elevation of Walls {123}, {124}, {125}, {126}, {127}, {128} and {129}.

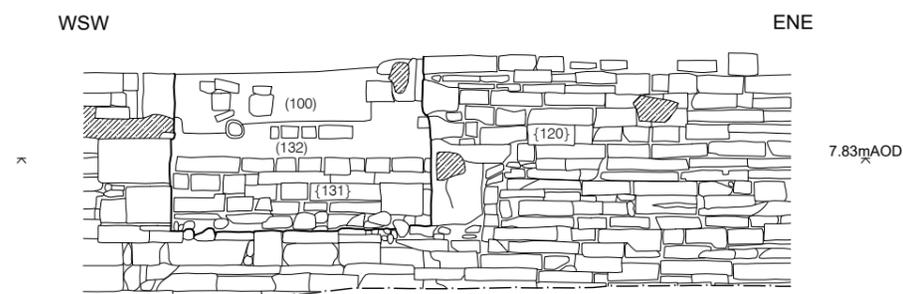
Section 3. SSE facing elevation of Wall {120}.

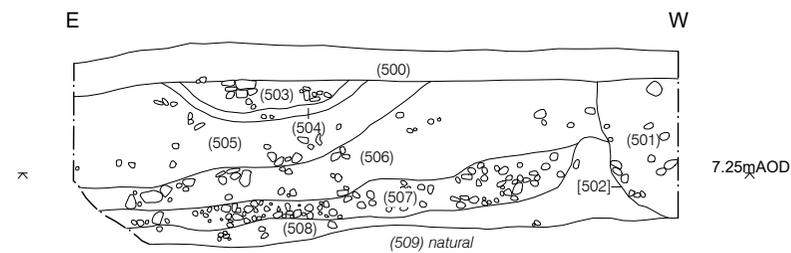
Section 1. North facing section of Trench 5 showing [502].

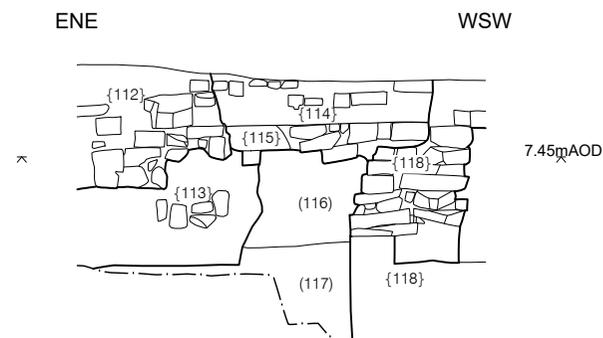
Section 2. NNW facing section across Kiln {114}.
