**ORREST HEAD FARM, WINDERMERE, CUMBRIA**

**Desk-based Assessment and Landscape Survey**

**November 2016**

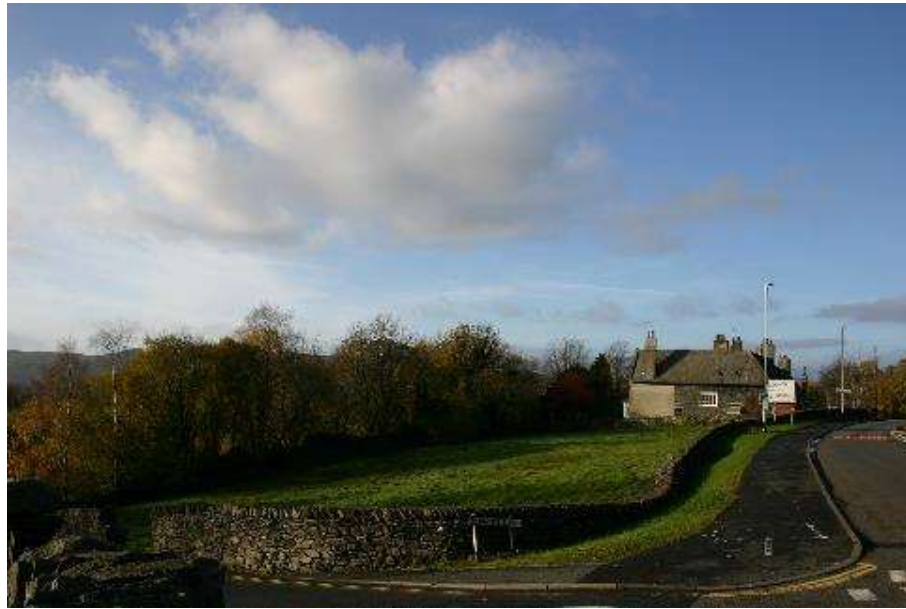
4.3.2 A rectangular field without any noticeable features is situated to the far north-west of the main farmland. It is bound by a dry stonewall. The field itself was not accessible, but a clear view was possible across the area. A row of trees forms the southern boundary of the field.

*Plate 1: General view across the north-western field*

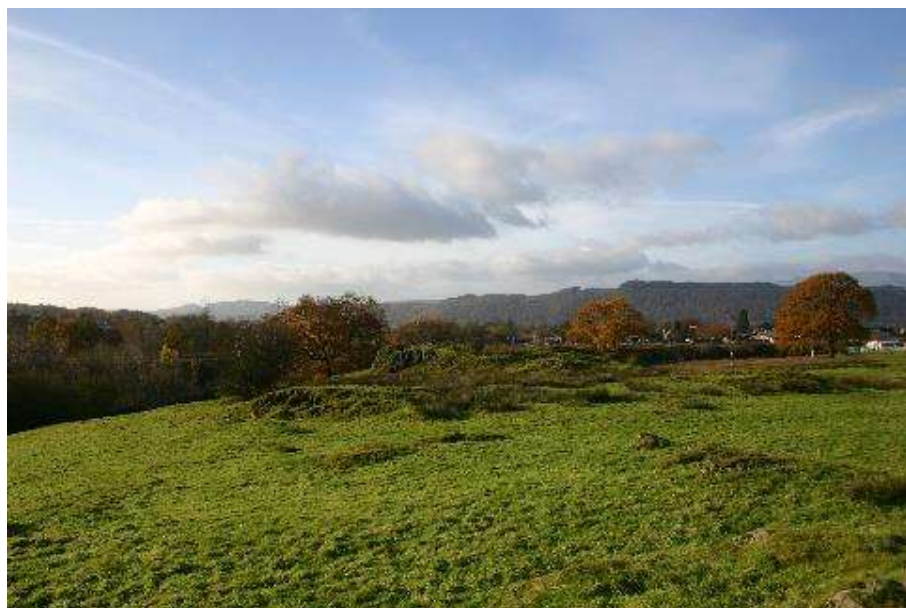
*Plate 2: General view to the west, possible traces of the boundary are visible in the right corner*

4.3.3 **Asset 1:** This asset is described in the HER as a relict wall and hedgerow running east to west aligned in the southern end of the site (HER27461). A small line of tree growth was visible, in line with a larger quarry site (Asset 6) of unknown date. No traces of a boundary stone wall are visible, although a slightly raised earthwork may be associated with it (Plate 2). The boundary was extant until at least 1947 but had been removed by 1968 (Figures 12 and 13).

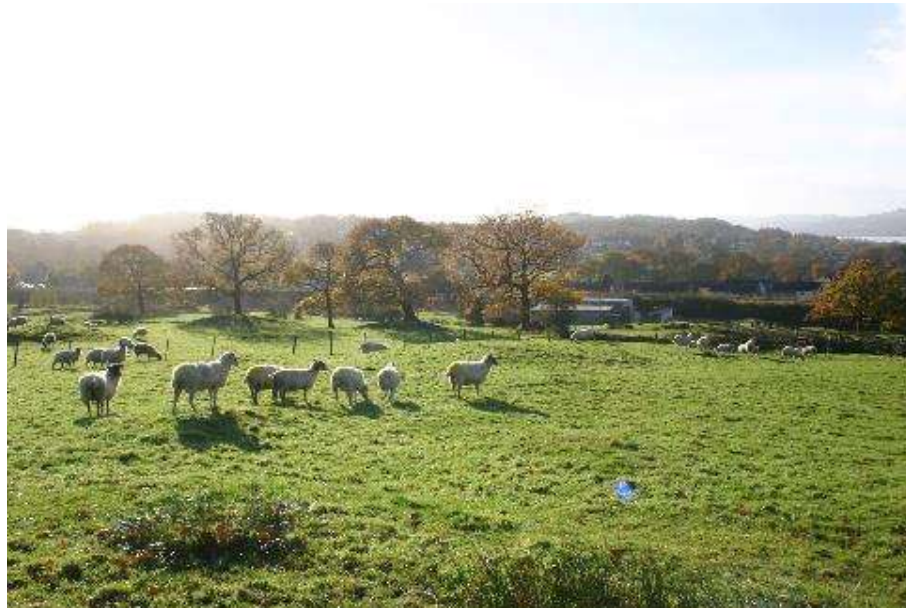
*Plate 3: General view across the site, with sparse tree growth*

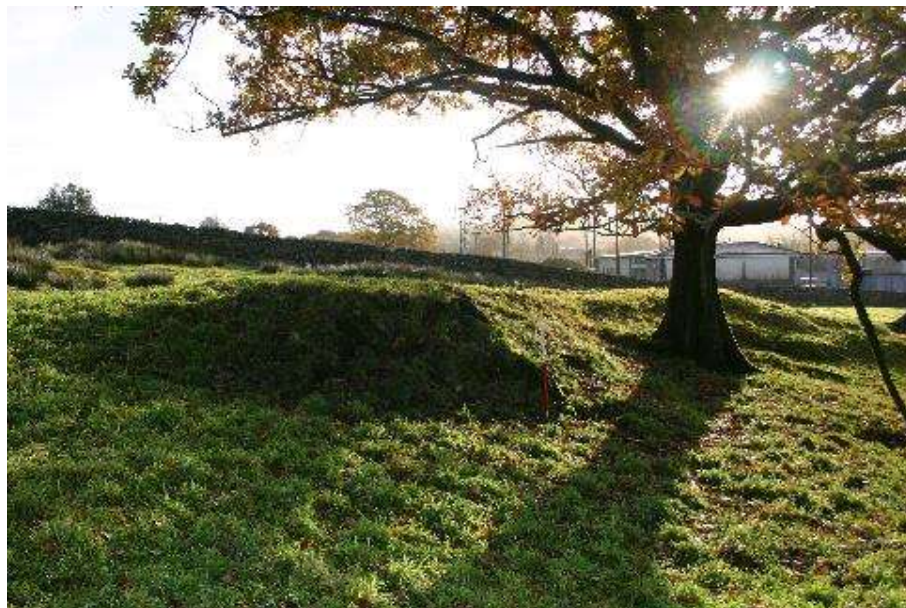
*Plate 4: View of Asset 2, a possible quarry site*

4.3.4 **Asset 2:** Is a small, semi-circular earthwork situated in the southern end of the south-western field. It is a possible small scale quarry site of approximately 1.5m height, 4m long and 3m wide. It is of unknown date, but may be related to the construction or repair of the surrounding drystone wall boundaries. It is completely grass covered and is not shown on any maps.

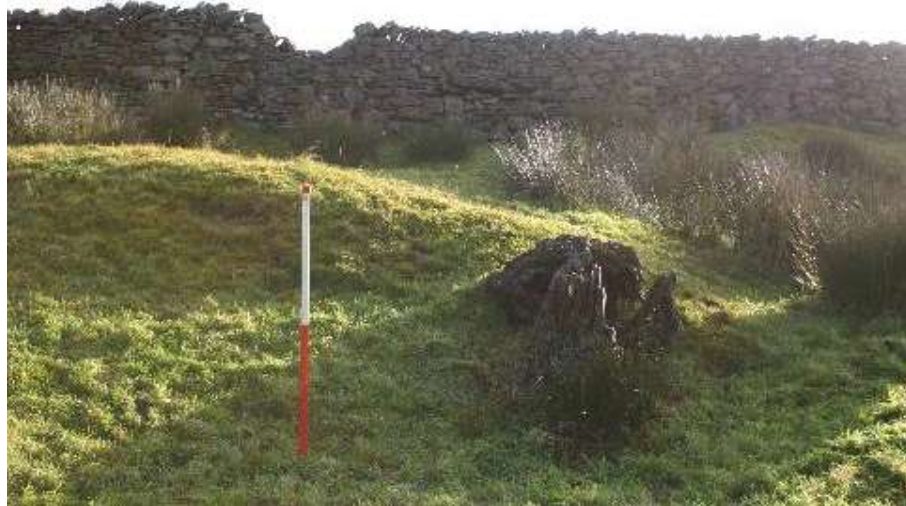
*Plate 6: View of Asset 3, possible part of a bank*

- 4.3.5 **Asset 3:** This small earthwork with water feature is located at the western side of the north to south aligned boundary wall to the south of the barn (Plate 6). It is 1m high, 13m long and 4m wide. It may be a section of a previous bank in the position of the current drystone wall. The feature can be associated with the bank seen in asset 4.
- 4.3.6 A partially culverted stream (asset 14), running approximately east to south aligned within the bank, is covered with modern stone slabs (Plate 8). It turns southwards into the open field. It is not shown on any maps.

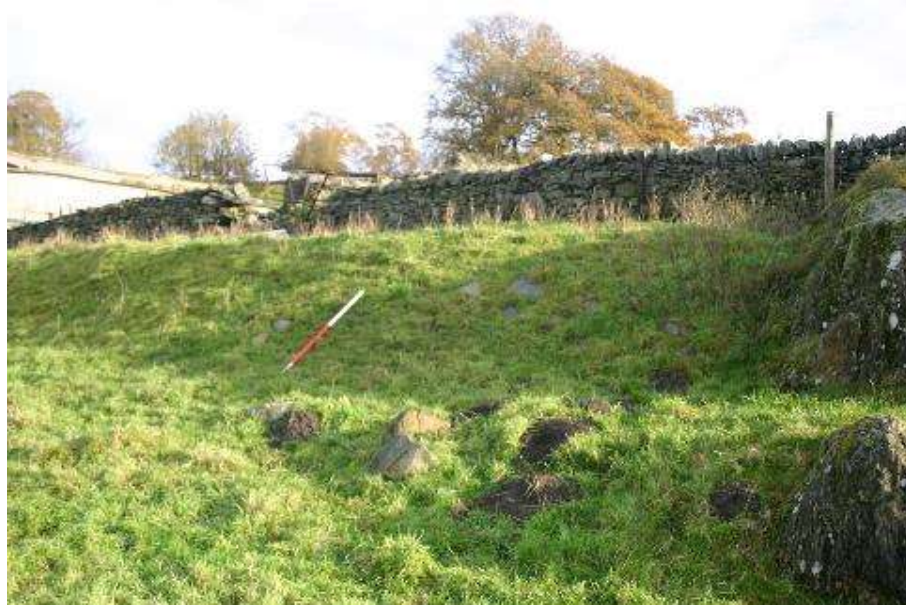
*Plate 9: View of asset 4, large bank parallel to boundary wall*

4.3.7 **Asset 4:** This earthwork is situated along the north to south aligned boundary wall to the south of the barn, and to the north of Asset 3. It runs parallel to west side of the drystone wall boundary, thus it can be assumed to be a remainder of a previous bank boundary. The bank is approximately 1m to 1.5m high and 15m long. Its southern extend ends in a large stone boulder.

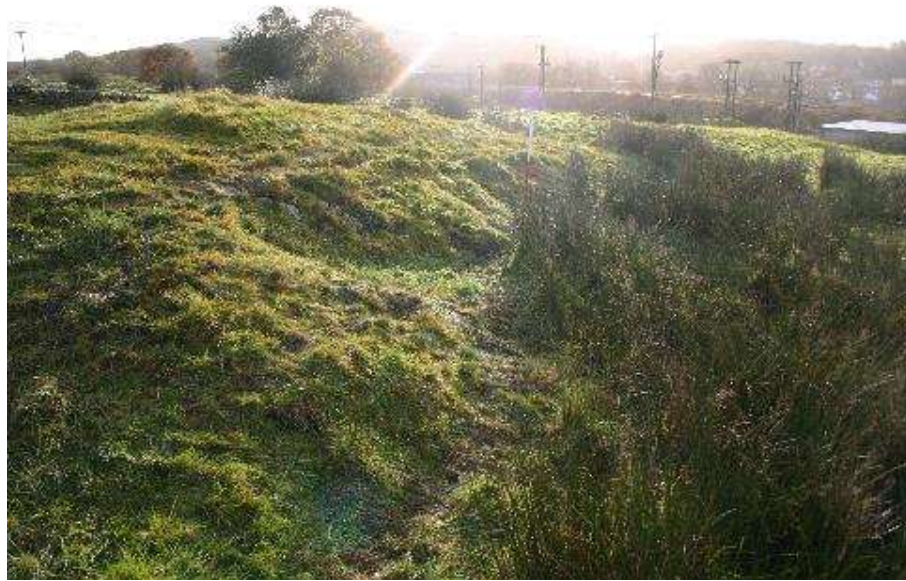
*Plate 11: View of asset 5, possible small quarry site*

4.3.8 **Asset 5:** This semi-circular earthwork is a possible former small quarry. It is approximately 1m to 1.5m high, 4m long and 3m wide. It is situated to the east of the north to south aligned drystone wall boundary to the south of the barn. The area is grass covered, and the lowest point of the asset is covered in rush. It is not shown on any maps.

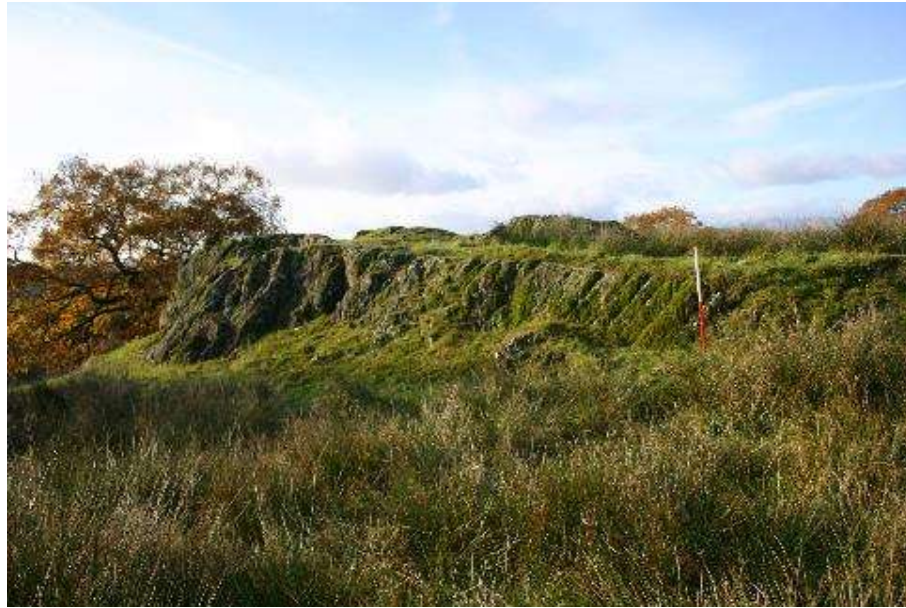
*Plate 13: View of asset 6, larger quarry site*

4.3.9 **Asset 6:** This larger quarry site is situated along the line of asset 1, the relict wall and hedge-line seen on the earlier maps (Figure 5 to 12). While it may be associated with the boundary wall, clear areas of quarrying are visible along the southern side of the earthwork. The stone may have been used to build or repair the surrounding drystone wall boundaries. It is not shown on any maps.

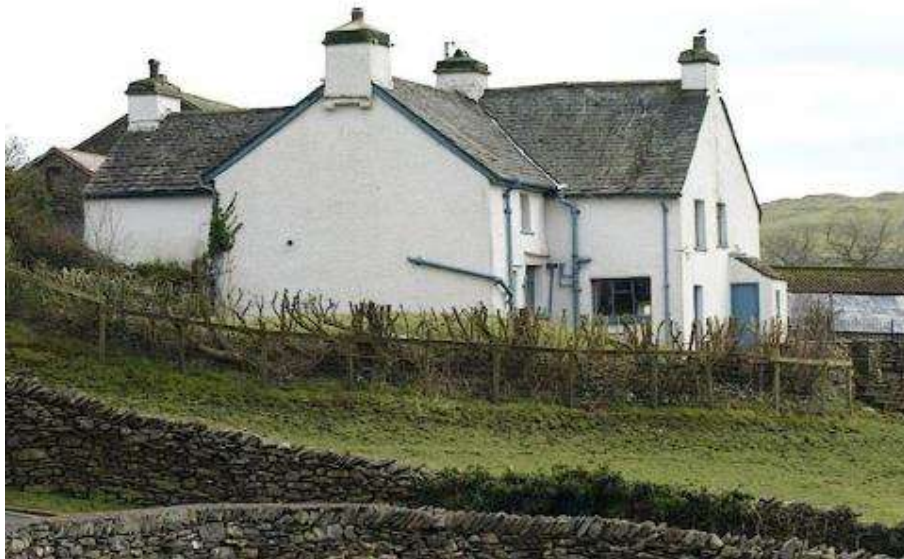
*Plate 15: east view of the farmhouse, asset 7,*  
<http://www.geog.port.ac.uk/webmap/thelakes/html/lgaz/lk20636.htm>

4.3.11 The main farm building appears to be in good condition. It is covered in plaster and whitewashed. The 18<sup>th</sup> century barn attached to its southern end is covered in roughcast plaster.

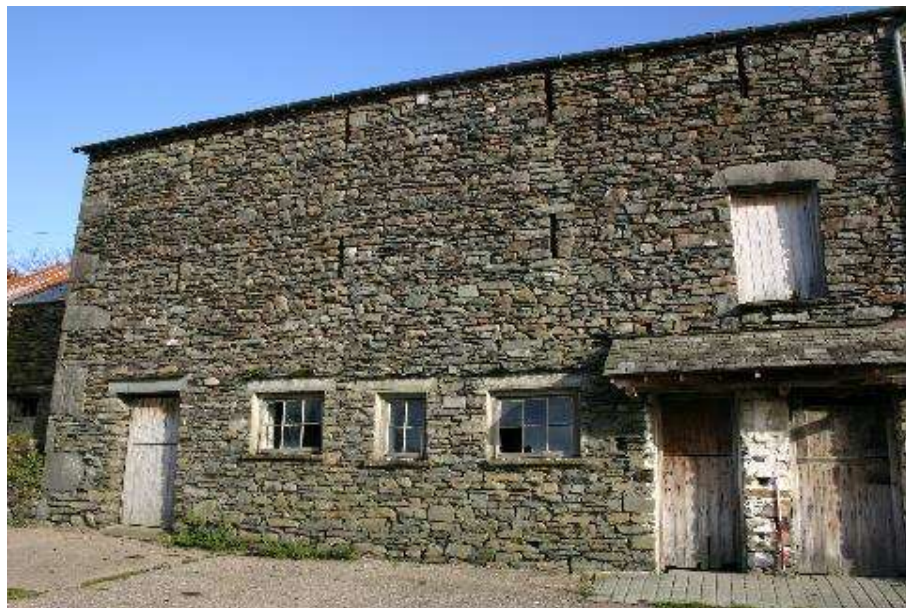
*Plate 17: General view of the three storey barn*

4.3.12 The large three storey barn to the east of the main building was greatly altered on the interior in the mid-20<sup>th</sup> century. The exterior appears to be in good condition. This roughly coursed rubble stone building with ashlar quoins and timber doorways has several smaller outbuildings abutting it to the north and south. They comprise a possible small pigsty to the south and a workshop to the north.

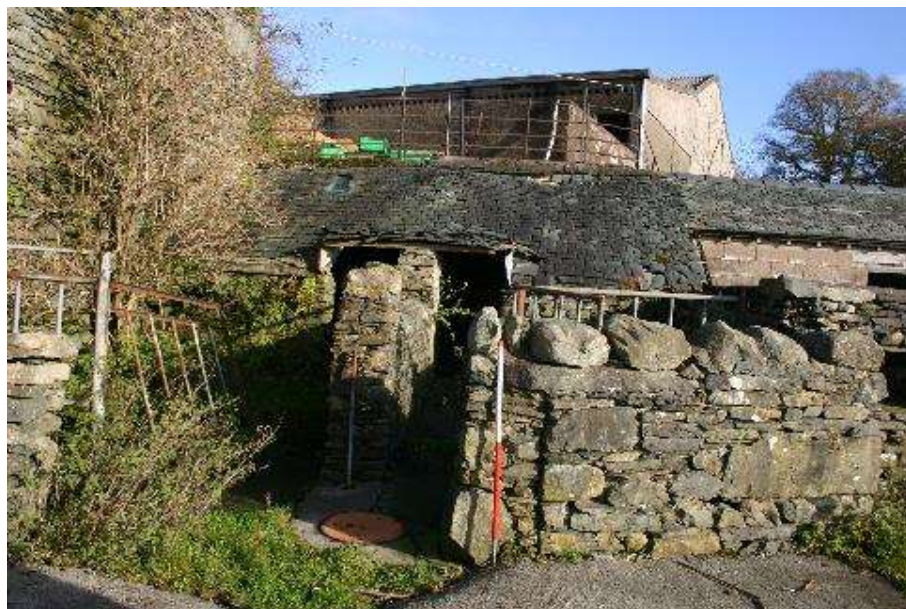
*Plate 19: Small pigsty to the south of the barn*

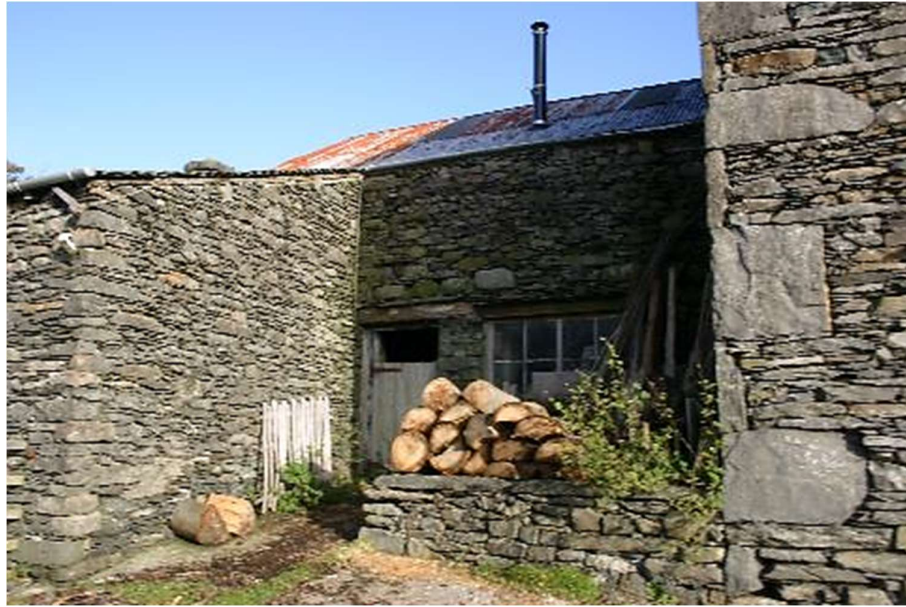
*Plate 20: General view of the workshop to the north of the barn*

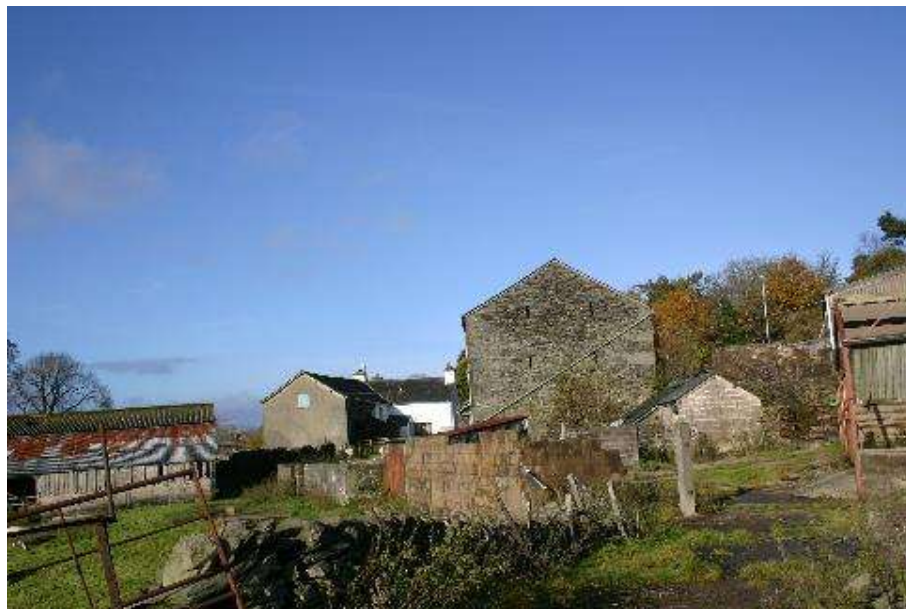
4.3.13 To the east of the large barn is a large modern structure with corrugated iron walling. Another large, roofless barn or shed structure sits to the south of it. To the south of the main farmhouse is a third, large modern shed with corrugated iron walling and roofing.

*Plate 21: General view of the farmstead*

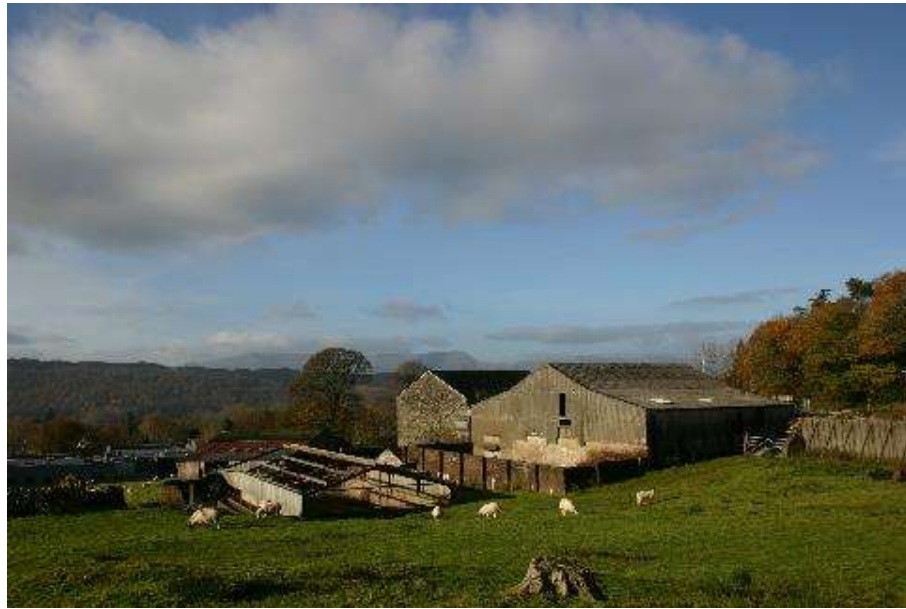
*Plate 22: General view of the farmstead, with modern buildings in the foreground*

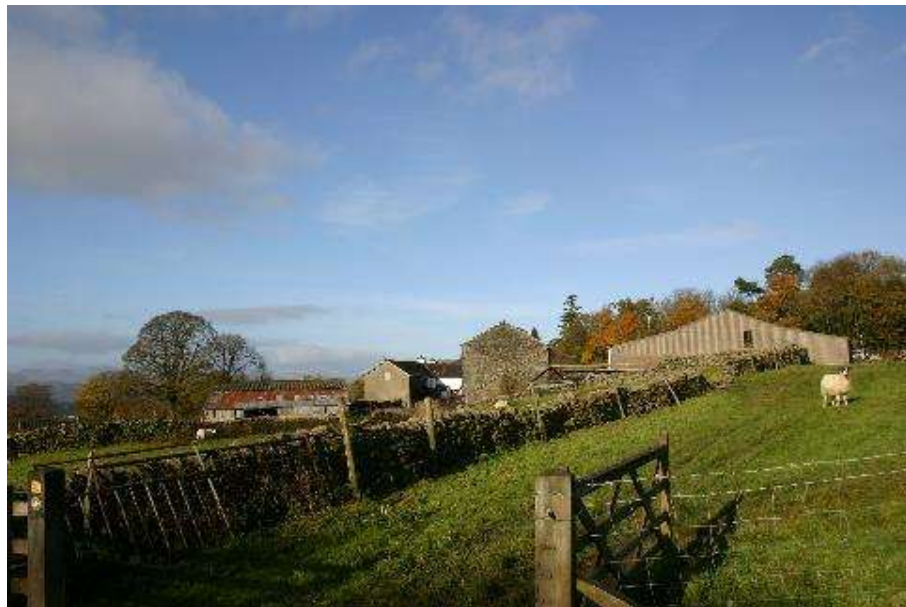
*Plate 23: General view of the farmstead*

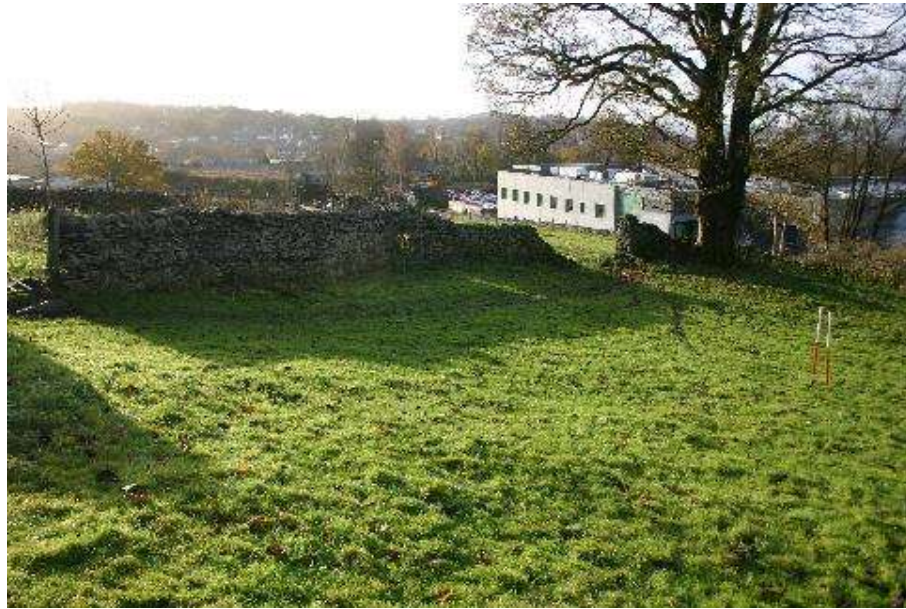
*Plate 24: Boundary wall, several phases of construction visible, possible site of previous outbuildings*

4.3.14 **Asset 12:** This north-east to south-west aligned boundary wall to the west of the farmhouse shows traces of several phases. It appears as some structures once abutted it. Following cartographic evidence, several outbuildings were once situated along this boundary dating from 1911 to 1968 (Figure 9 to 13). The wall is now in a mediocre state, with several areas of destruction visible along the wall.

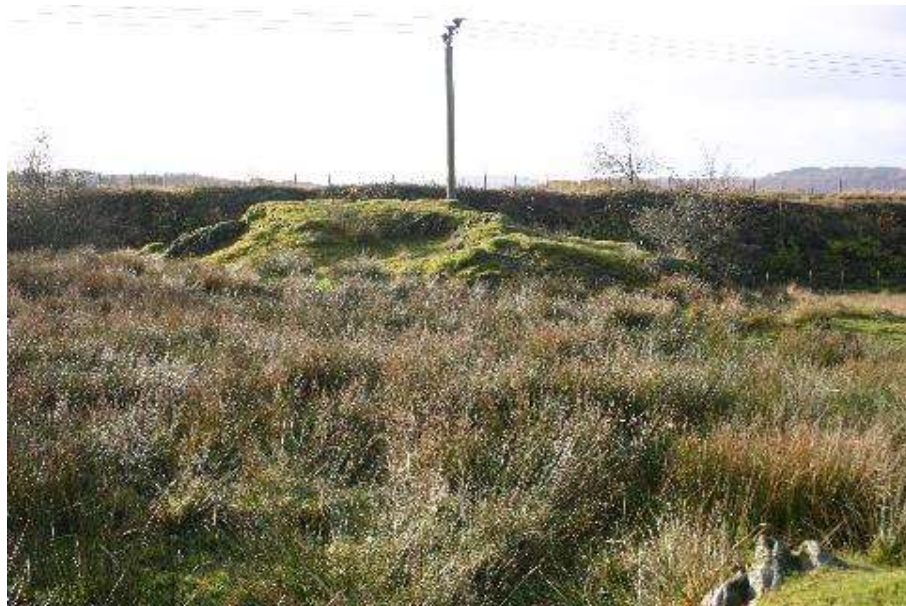
*Plate 25: General view of asset 13, possible quarry site*

4.3.15 **Asset 13:** This asset can also possibly be associated with small scale quarrying. The site is approximately 10m wide and 2m high. It is situated at the southern end of the site, directly to the east of the railway and between the pylons leading to the electricity sub-station. It is not shown on any maps.

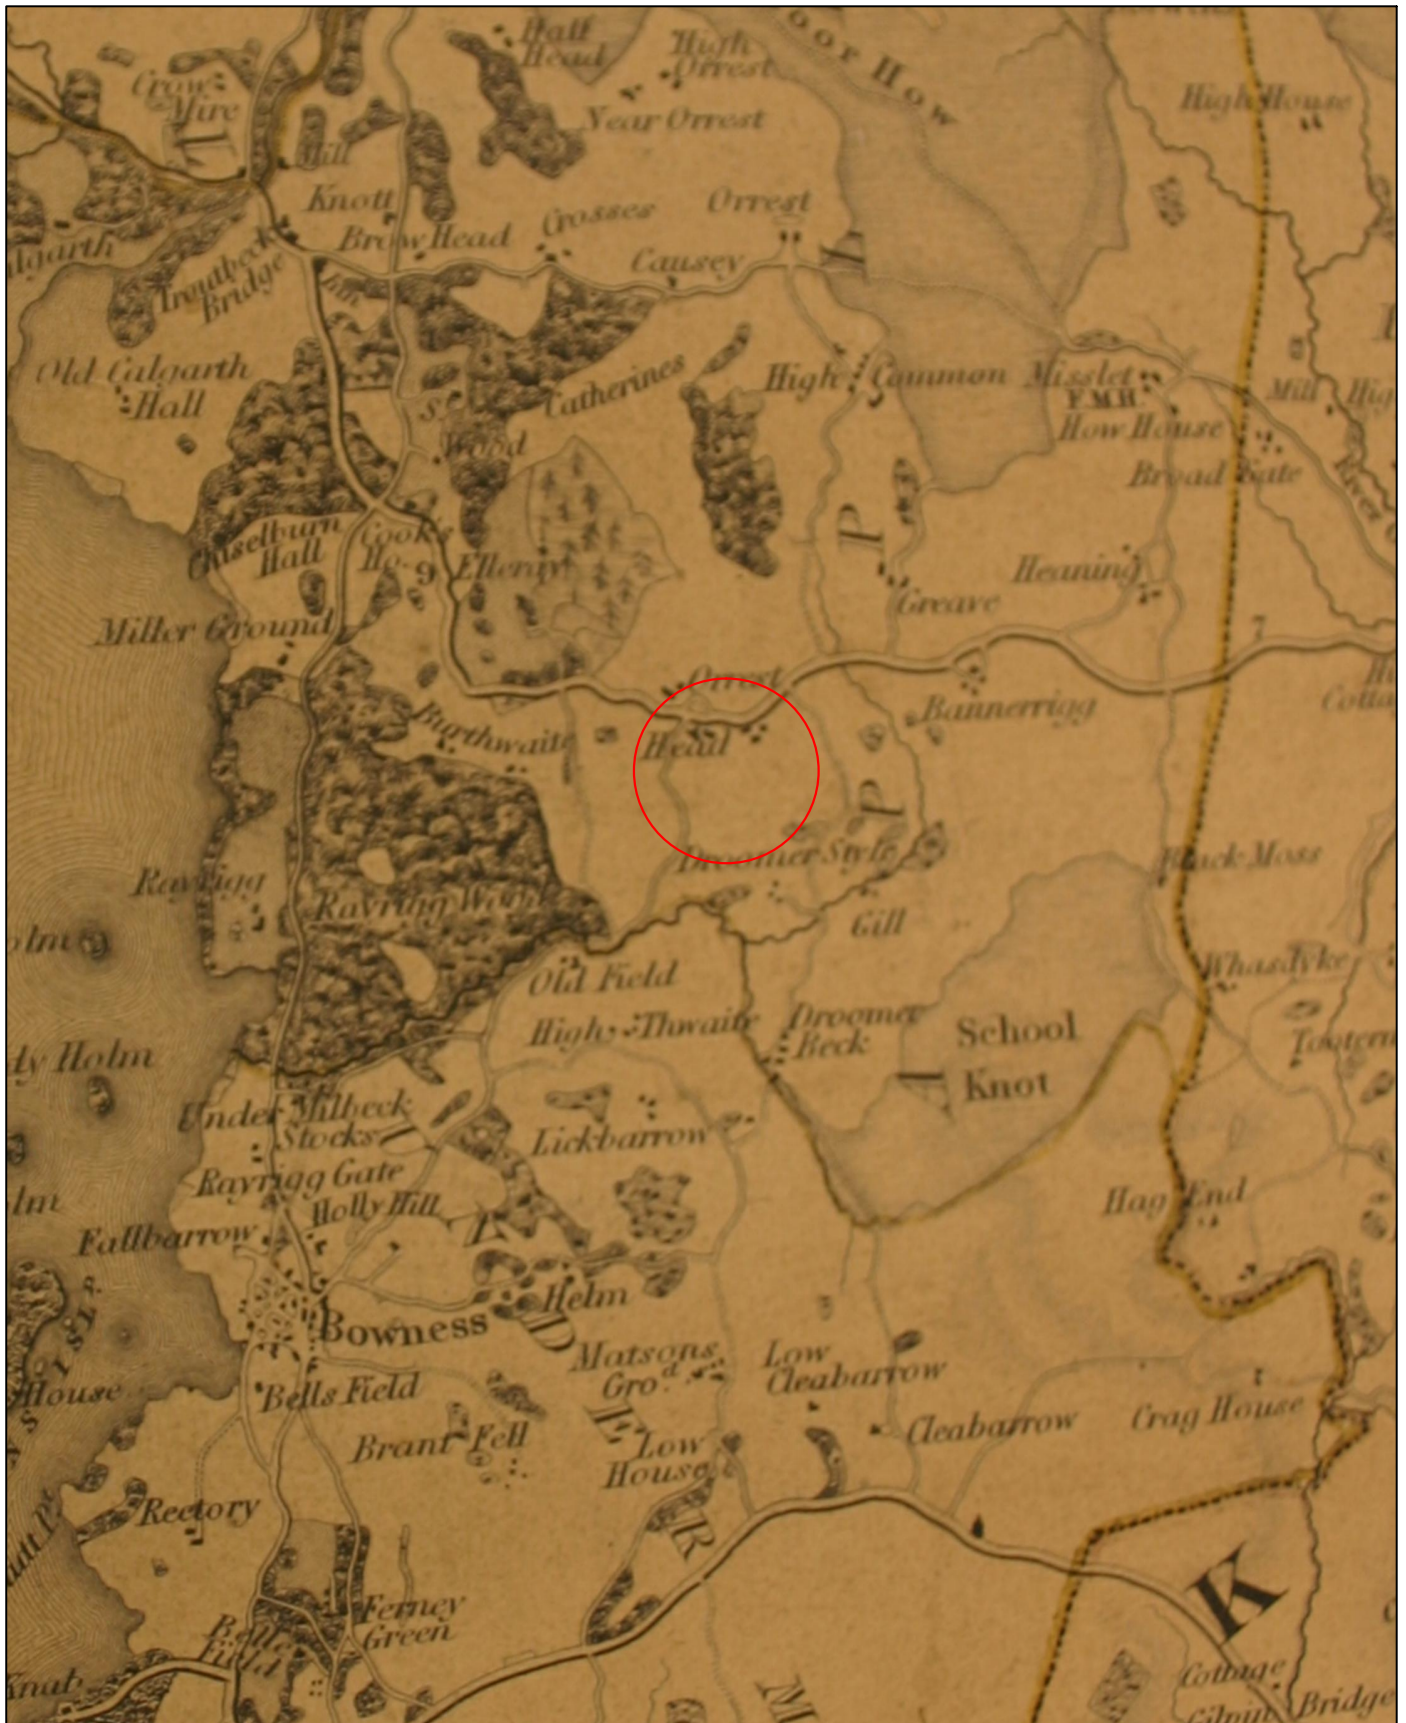
Figure 5: Orrest Head Estate, 1827 (2 chains to 1 inch scale).

3.5.2 A detailed auction advertisement plan of *Orrest Head Estate* dating from 1827 (Figure 5) presents a large scale property, with its main buildings comprising the cross-shaped farmstead and large L-shaped barn of Orrest Head Farm, to the south of the main road to Kendal. A small outbuilding is situated to the south of the farmstead within a small enclosed garden area. The fields surrounding the property are referred to as follows: the *Paddock* to the immediate south west of the farmstead, *Addy Land* – a large enclosed field to the east of the barn, the field of *New Close* immediately abutting it to the south, while the large L-shaped section of the *Great Mire Close* and the small *Low Mire Close* take up the remainder of the site. The now small field to the north-west of the site once comprises a large enclosed space referred to as *Hollow Croft*. The property extended further to the north, containing fields referred to as *Big Fold*, *Cherry Brow*, *Jenny Close*, *Great Shaw*, *Shaw Brow*, *Little Shaw*, *Wood Top*, *Hagg* and

*Oak Stack*. They are surrounded by properties of John Braithwaite Esq, John Wilson Esq, George Gardener Esq, and Reverend John Fleming. A small section of the current property, to the east of *Thwaites Lane* (Figure 2) was not included in the auction, and was owned by *John Braithwaite* Esq. No other structures are noted within the estate.

3.4.5 The large barn to the east of farmhouse also possibly originates from the late 17<sup>th</sup> century to early 18<sup>th</sup> century (National Trust 1988). It was extended and altered several times over the centuries, most noticeably in the 20<sup>th</sup> century (Figure 11 and 12). From 1729 the Dixon family appears to be renting the property to the Browns. In 1763, a *Rowland Brown* is noted as having signed over a customary deed of the estate at Orrest Head to *Josiah Brown*, possibly his son (CAC(K) WDNT/81). A *Josiah Brown* is noted to have lived at Orrest Head in the late 18<sup>th</sup> century. He was known for “amusing himself with welcoming beggars, whom he supplied with meat and lodging” (Martineau 1884, 6). In 1829, Orrest was regarded as a district of the township of Applethwaite, 1½ miles to the north-east of the village of Bowness, in the parish of Windermere. The Earl of Lonsdale was the lord of manor. The township was said to contain “two bobbin mills, with Orrest-Head, Elleray, Rayrigg, Birthwaite, The Wood, Calgarth Park, Belle Isle, and several other pleasant villas” (Parson and White 1829, 677). The Orrest Head estate was inherited by *Margaret Fisher*, *Josiah Brown*’s granddaughter, in 1812. She married a *John Soulby* in 1818, who sold the property between 1824 and 1828 to *John Braithwaite*, possibly related to the Braithwaite who previously owned the property in 1770. At this point, the property was leased to a *Joseph Grisdale* (CAC(K) WDNT/81). This would correlate with the *Map of the Orrest Head Estate* (see 3.5.2, Figure 5), dating from 1827, which accompanied the sale of the property by auction.

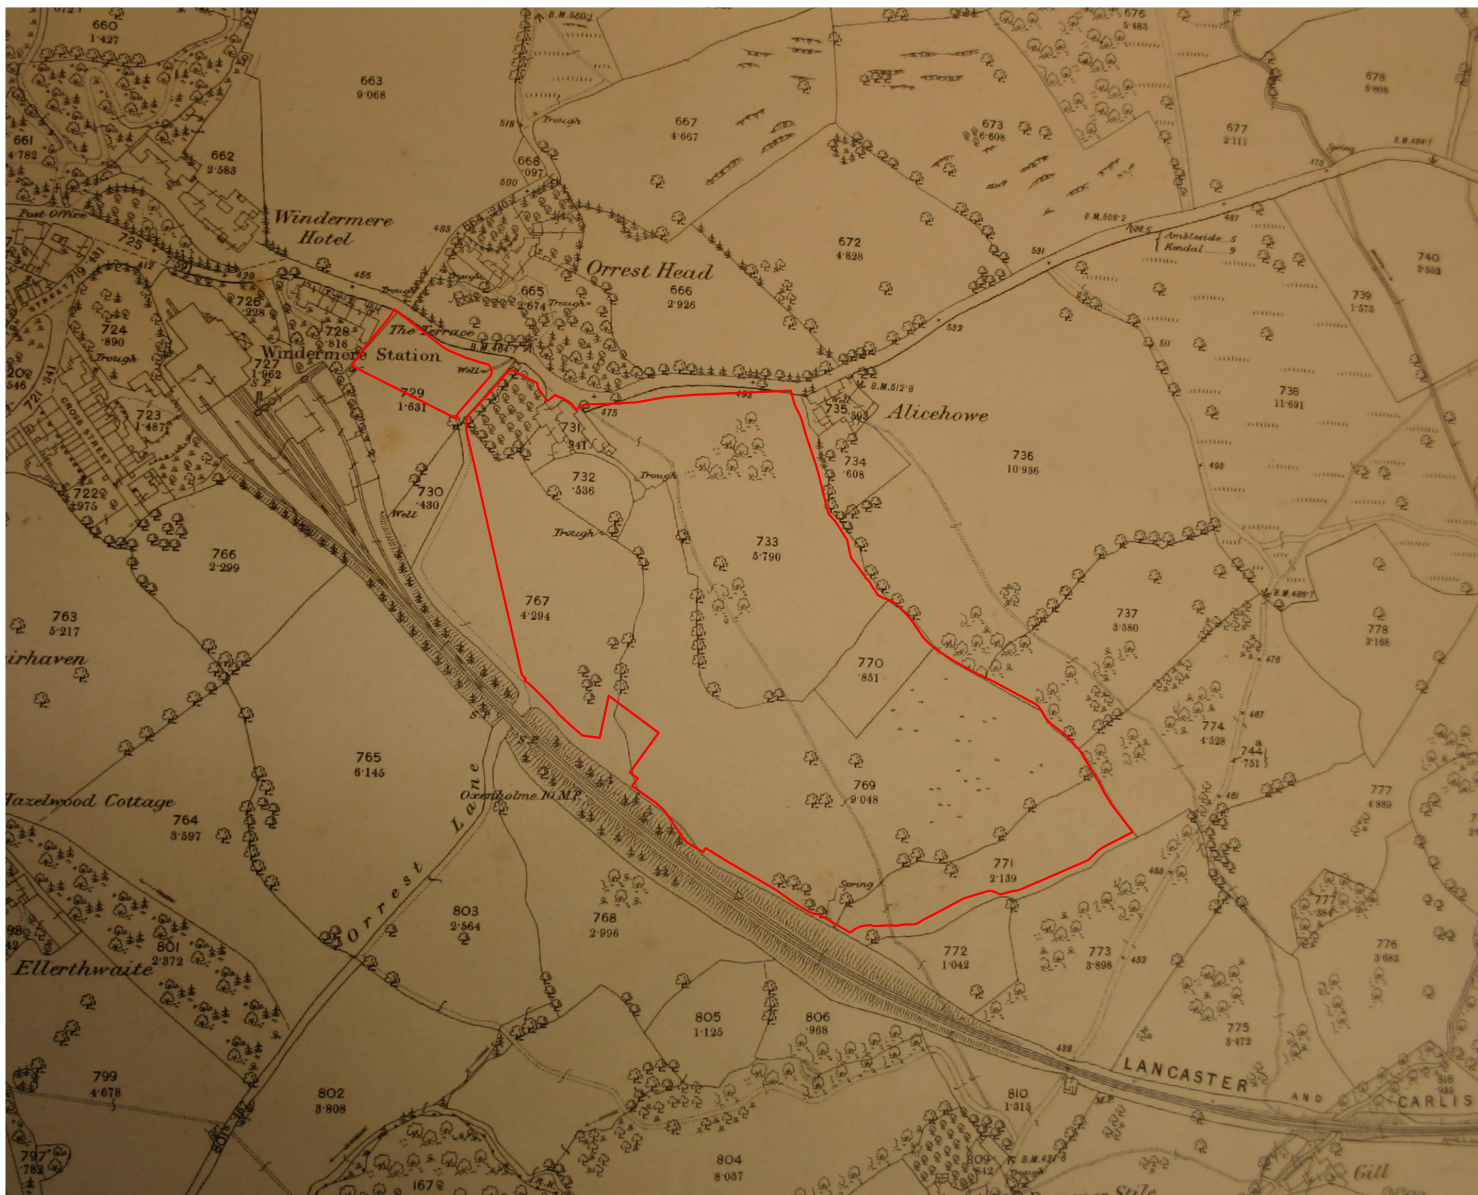
Figure 7: First Edition Ordnance Survey Map, 1858 (25 inches to 1 mile).

- 3.5.4 On the 1860 First Edition Ordnance Survey Map (surveyed 1858, Figure 7), the site is displayed as a large agricultural area with the cross-shaped farm house and large barn to the north. An L-shaped extension had been added to the south of the barn, and several smaller extensions are visible along the main building. The field system consists of seven fields of various size with trees scattered in clumps throughout the fields, as well as along the boundaries. Two troughs are noted along the boundary of the fields previously referred to as *Paddock* and *Addy Land*. The south-western boundary of the site is now formed by the railway lines leading to the Windermere Station. A pathway leads roughly north to south aligned from the northern end to the southern end across the site. A small orchard is situated to the north-west, abutting the farm house. A well is located at the western corner of the site, in *Hollow Croft*, while a small spring is situated at the southern end of the site.

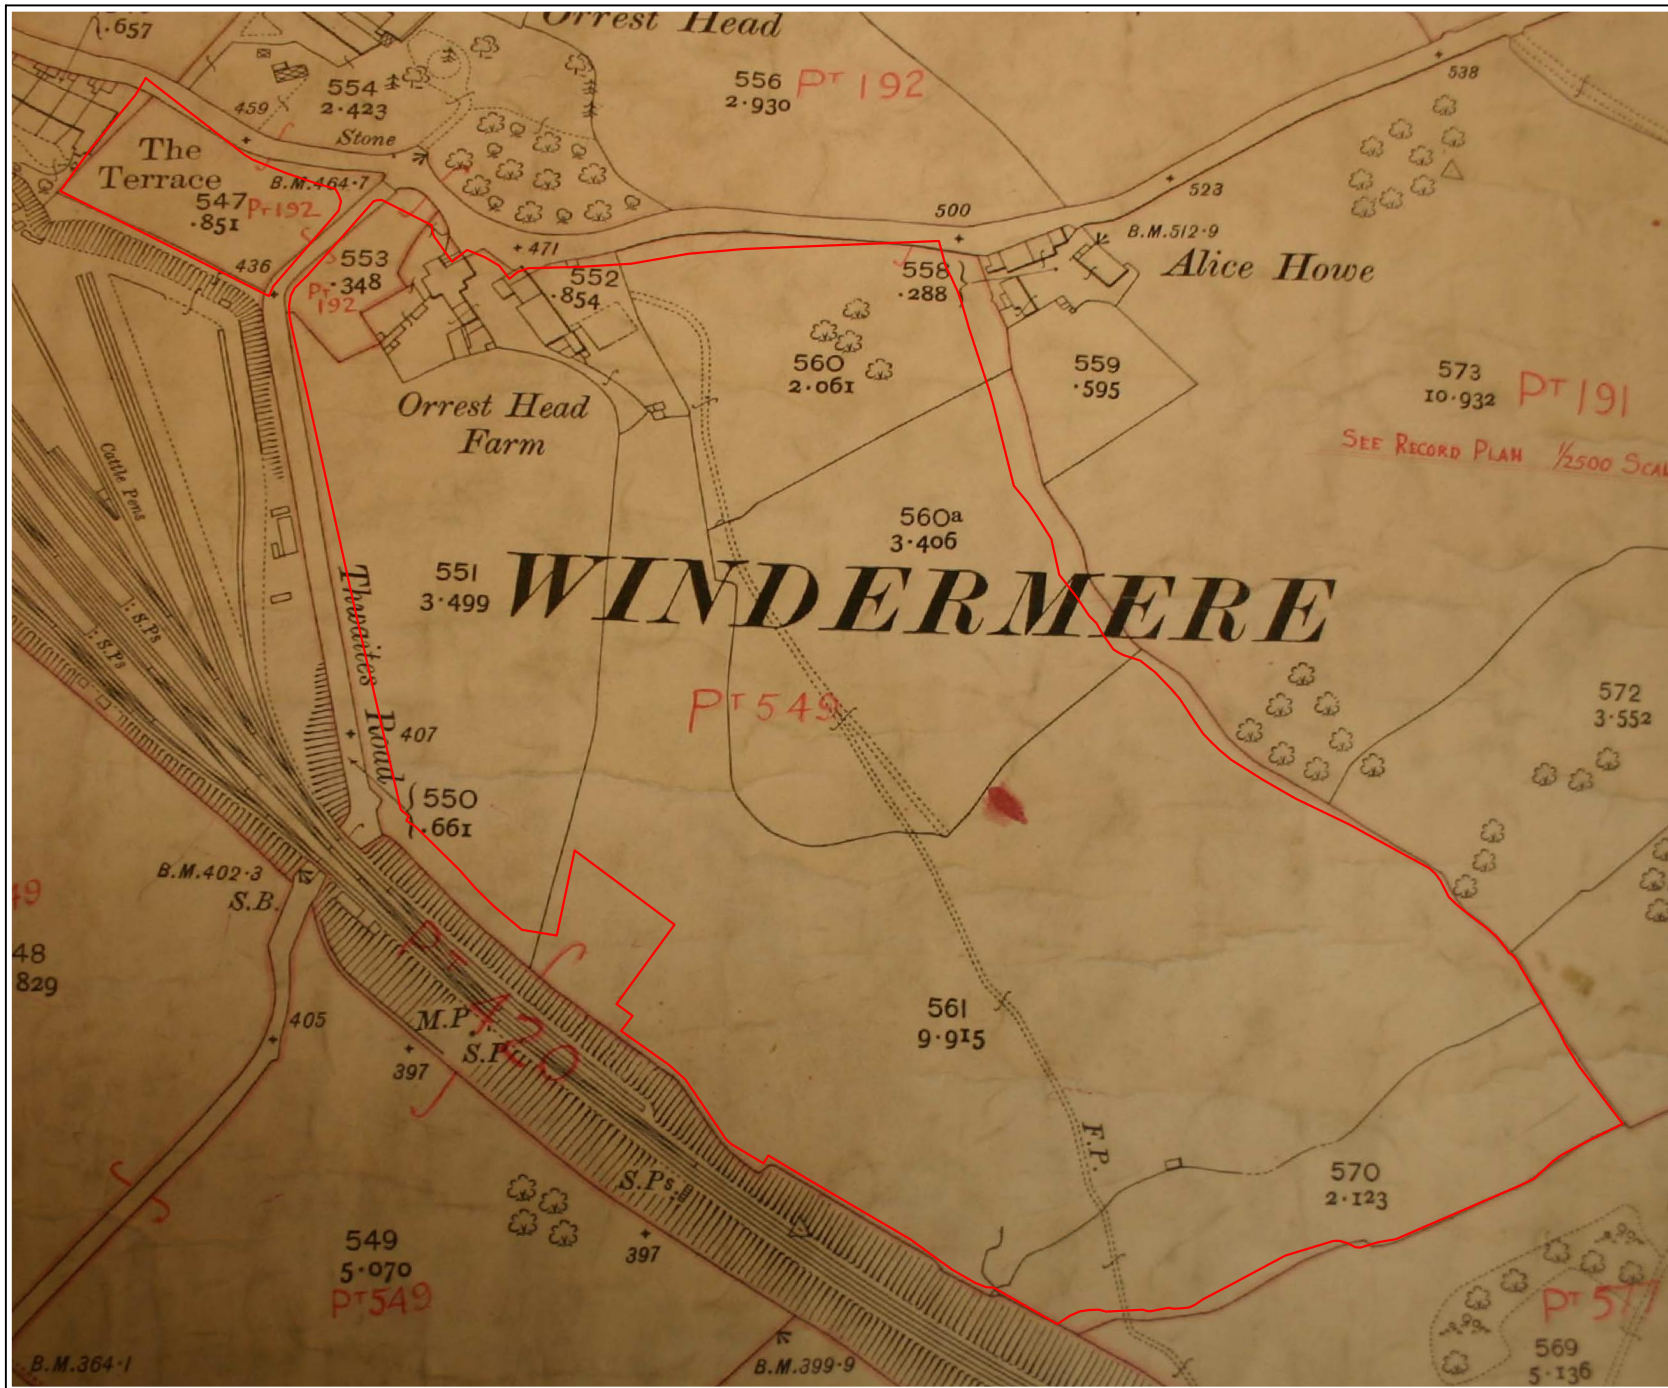
Figure 8: Second Edition Ordnance Survey Map, 1898 (25 inches to 1 mile).

- 3.5.5 By 1898 (Figure 8), much of the tree growth had disappeared from within the site. Several boundary had been removed, creating four larger field parcels. To the west, *Thwaites Road* formed the boundary of the site. The buildings were referred to as Orrest Head Farm. While the farmhouse remained unchanged from 1860, the barn had been extended to the north-west. The small, rectangular garden with the outbuilding to the south of the farmhouse had been sectioned into three parcels. The field of *Hollow Croft* was greatly reduced in its size by the extension of the train station.
