COMMON ROAD
NEWTON-LE-WILLOWS
MERSEYSIDE

ARCHAEOLOGICAL EVALUATION REPORT

January 2017

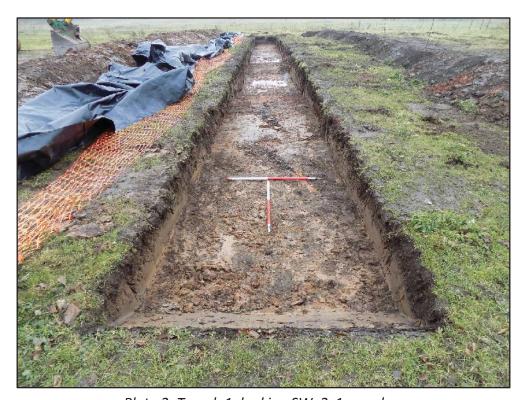
Plate 2; Trench 1, looking SW, 2x1m scales.

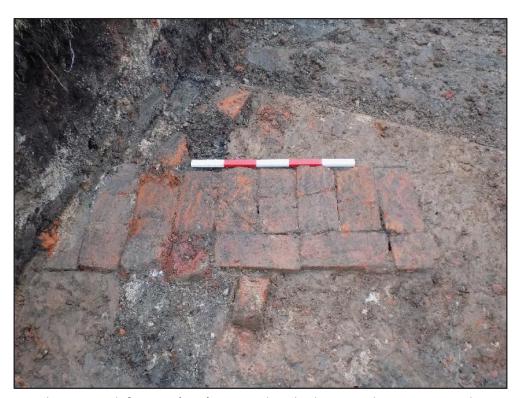
- 4.2.3 The trench revealed a small brick structure **{103}** and two lines of possibly associated ceramic drains, set into and surrounded by a redeposited clay **(104)**. The brick structure (Plate 3) comprised two courses of handmade bricks in a random brick bond, a brick and half wide, very loosely consolidated with a lime mortar and sand mix. First observed at a height of 36.55m aOD, it extended out of the north-west facing section of the trench in an east to west orientation for 1m, being 0.44m wide. The bricks

measured an average of 240x110x70mm in size. Two large ceramic drains, orientated north to south, were immediately north of **{103}**. They were in very poor condition and set into the redeposited clay **(104)** layer. One drain appeared to butt the north face of the brick feature, though the function of this could not be determined.

Plate 3; Brick feature {103} in Trench 1, looking south, 1x0.50m scale.

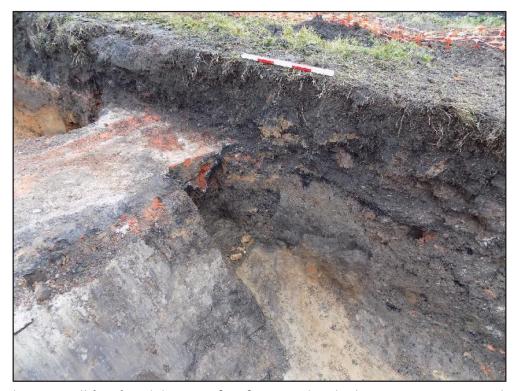
- 4.2.7 The wall **{209}** was aligned northwest to southeast and first observed at 38.45m aOD, standing at a height of 0.30m and with a width of 1.18m (Plate 4). This thick foundation wall had been badly truncated and damaged from later ploughing, however it comprised up to three courses of handmade bricks in a simple stretcher bond, with mid grey coarse sandy lime mortar bonding. The southwest face of this wall had traces of plastering.

Plate 4; Wall {209} and drain cut [211] in Trench 2, looking ENE, 1x0.50m scale.

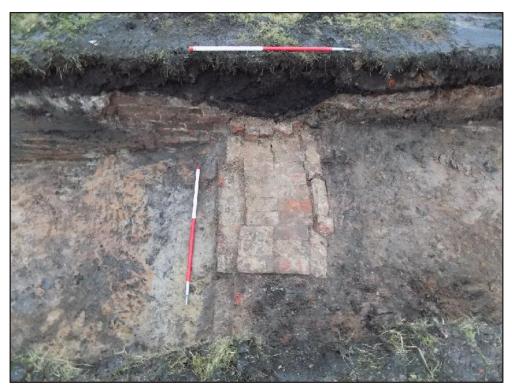
- 4.2.13 Of identical construction, wall **{223}** was aligned northwest to southeast, to a height of three courses and was three bricks thick with a width of 0.90m, first being observed at 38.07m aOD (Plate 5). Wall **{223}** was within cut **[220]**, which had then been packed with a soft, mid reddish brown clay **(221)**. It should also be noted that immediately north of both these walls, and cutting deposit **(217)**, was another cut **[215]**, filled by a compact, dark grey clayey coarse sand **(216)**. This is probably the truncated end of a cut for another unseen wall.

Plate 5; Walls {222} and {223} in Trench 2, looking south, 2x1m scales.

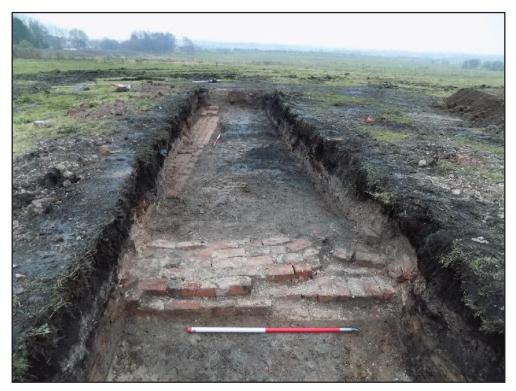
- 4.2.15 Towards the southwest end of the trench were a further two walls {229} and {230}, and a possible surface (239)/(240) (Plate 6). Also cutting deposit (224), immediately south of shallow linear feature [225] which it is also truncated by, was wall cut [227] containing wall {229} and packing fill (228) which was a loose, light orangey brown sand.

- 4.2.16 Wall **{229}** was first observed at a height of 38.17m aOD, and was aligned northwest to southeast, parallel with wall **{223}** and constructed in an almost identical manner, being up to five courses high and three bricks thick, measuring 0.78m wide. Adjoining this was wall **{230}** running northeast to southwest out of the northwest facing trench section, likewise parallel to wall **{222}**. Wall **{230}** was narrower, being only two bricks thick, though constructed of identical materials as the previous walls.

- 4.2.18 To the south and east of walls **{229}** and **{230}** respectively, were deposits relating to a possible surface. Directly sealed by demolition layer **(231)**, was a thin firm mid yellowish brown clay **(239)** overlying a metalled, heavily compacted dark grey gravel **(240)**, first observed at a maximum height of 37.88m aOD.

Plate 6; Walls {229} and {230}, also showing deposits (239) and (240) in Trench 2, looking SW, 2x1m scales.

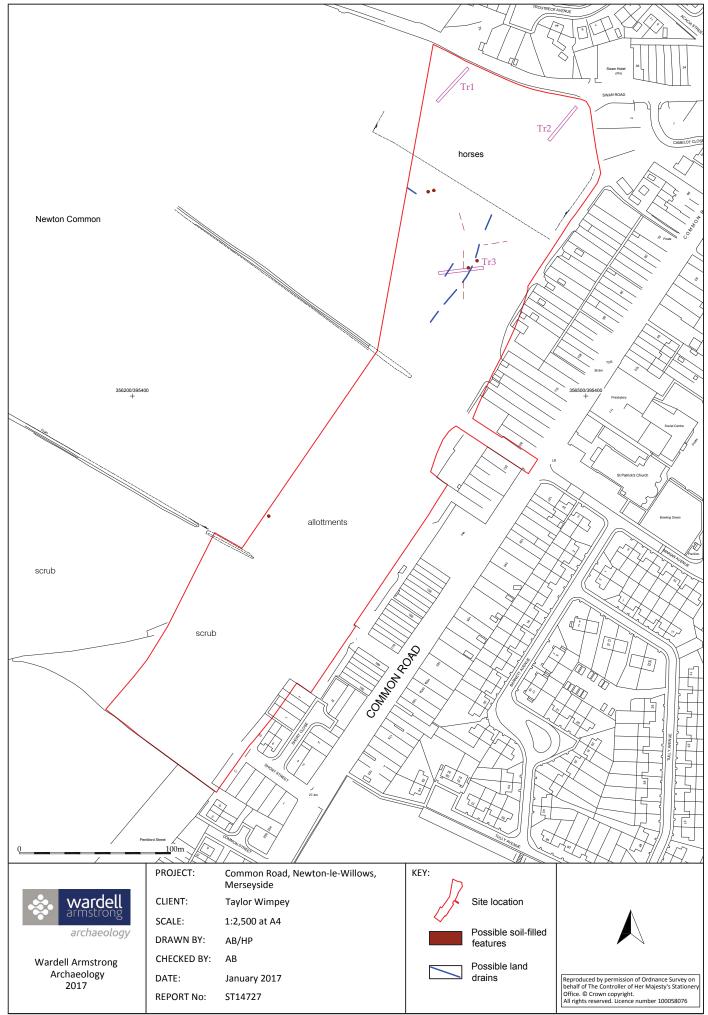
Figure 2: Location of evaluation trenches and geophysical anomalies.
