**ELECTRICITY NORTH WEST**

**LAND NORTH OF ELLENBOROUGH PLACE,  
MARYPORT,  
CUMBRIA**

**ARCHAEOLOGICAL WATCHING BRIEF REPORT**

**May 2017**

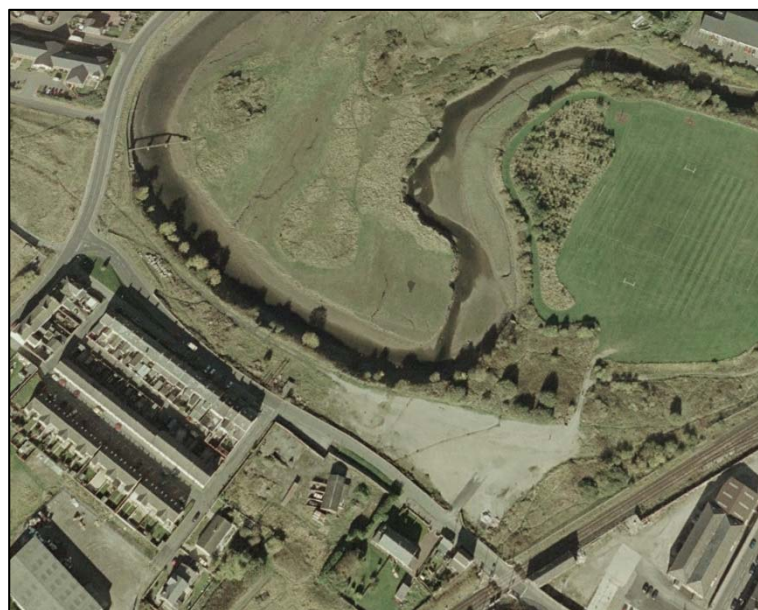
*Plate 1: Google Earth imagery, January 2003*

3.3.13 Google Earth imagery from January 2003 seems to indicate that the area between the River Ellen and Ellenborough Place had been levelled, and shows tracks giving access to football pitches to the north-east (Plate 1). This is also shown on Google Earth imagery of May 2008 (Plate 2).

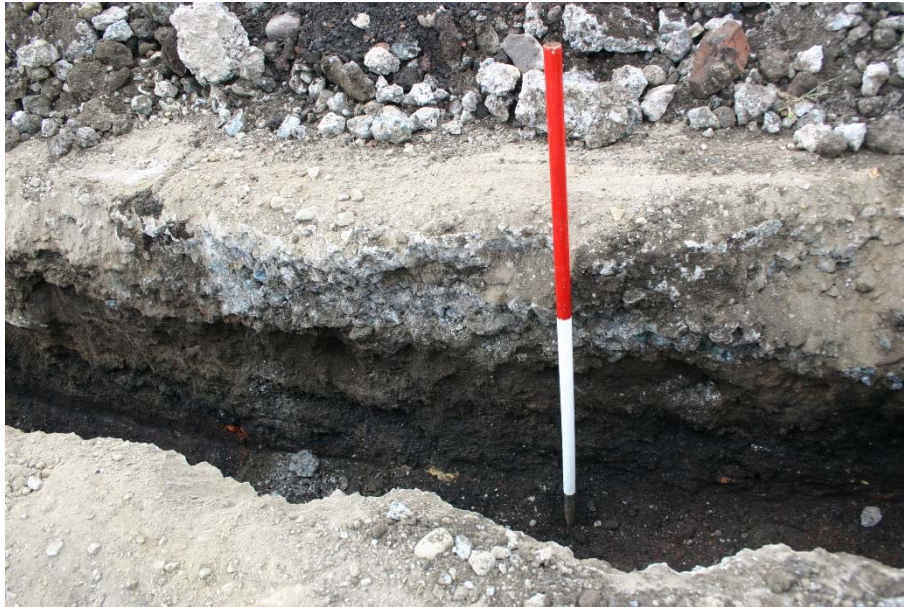
*Plate 3: Layer of slab (101) followed by black levelling deposit (103)*

4.2.2 The cable trench was excavated to a maximum depth of 1m, revealing a levelling deposit (103) comprising black charcoal, slag and a large number of brick, brick fragments and sandstone fragments (Plate 3-6), measuring between 0.2 – 0.6m in depth. No writing could be seen on the bricks, but they appear to date to the 20<sup>th</sup> century. The sandstone fragments might be associated with the construction or repair works at the nearby railway bridge at Curzon Street in the 19<sup>th</sup> and 20<sup>th</sup> century. The extent of this deposit was not reached. This was sealed by 0.2m subsoil (100). The subsoil was below c. 0.25m of hardstanding. Centrally within the eastern part of the trench, a concrete platform was revealed at the base of the trench (Plate 5). The platform was approximately 3m long and was left in situ. The full extent of the platform is unknown.

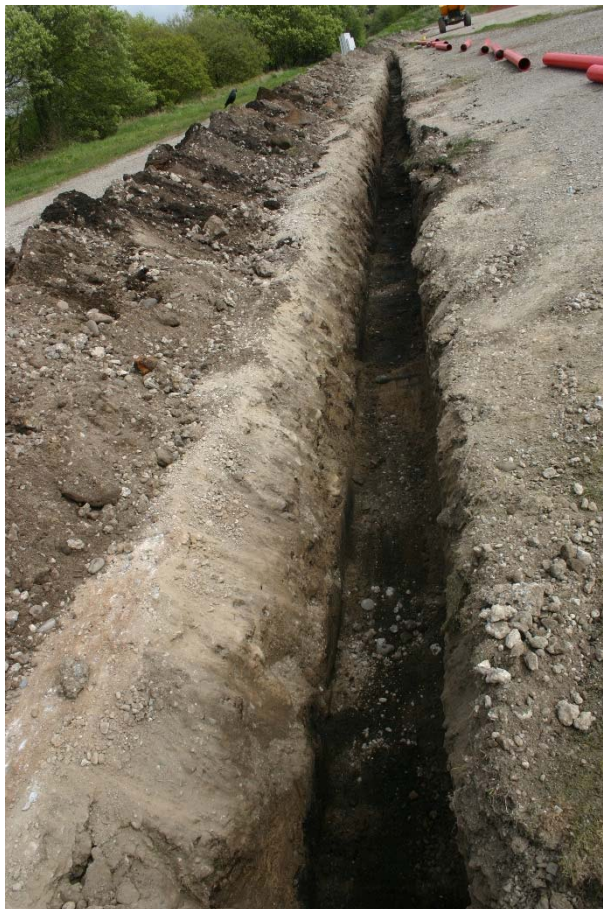
*Plate 4: view of the trench looking eastwards*

4.2.1 A service trench was excavated under archaeological monitoring as part of the watching brief. The trench was aligned east to west, between a boundary wall and footpath, then curved northwards towards the recreational grounds in the north-east. The trench measured 0.5m in width and 260m in length.

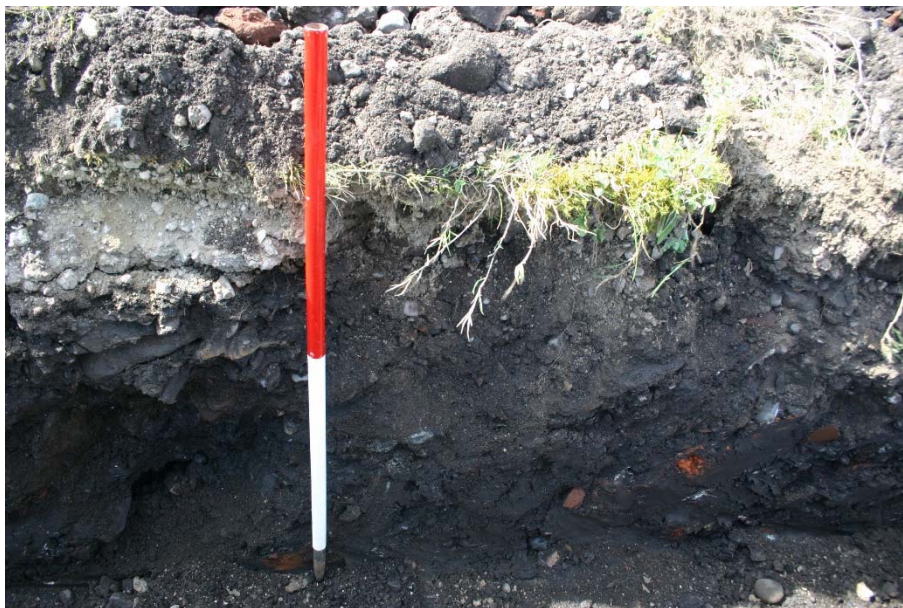
*Plate 6: Black deposit layer (103)*

5.1.3 The levelling deposit (103) comprising slag, brick and sandstone fragments is most likely associated with the construction of the mineral railway in the mid-19<sup>th</sup> century, and its subsequent expansion in the 20<sup>th</sup> century. The depth of the trench did not surpass the levelling deposit. The concrete floor encountered during the excavation, at the depth of 0.8m, may be associated with the small square building seen on the 1925 map (Figure 6). It had disappeared by 1961 (Figure 7). The entire area was covered in hardstanding after the railway went out of use in the mid-20<sup>th</sup> century, and converted into a parking area with recreational grounds and various footpaths. No archaeological features associated with the suspected Roman road were encountered. However, with the construction of the embankment and levelling of the ground, it may be possible that archaeological features are preserved below.

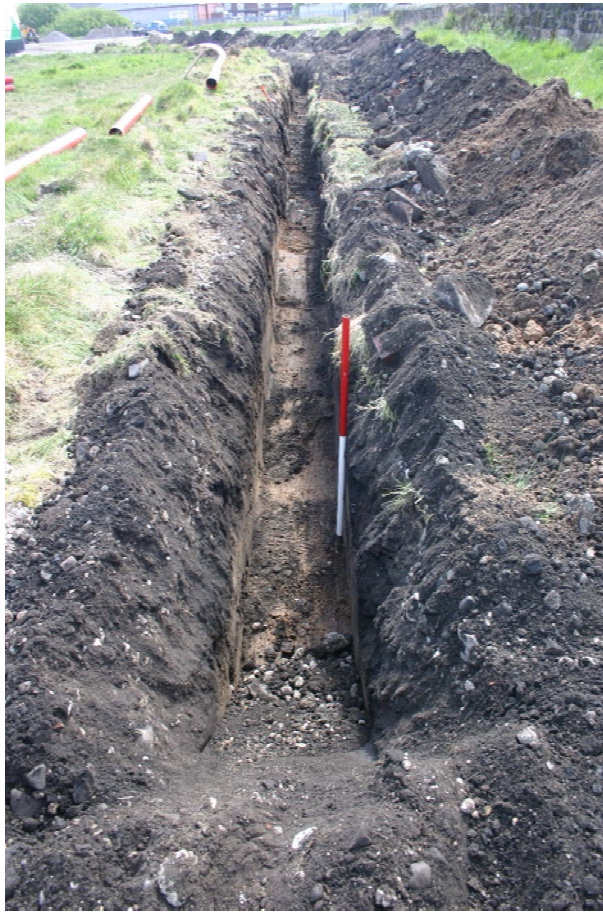
*Plate 7: view of the trench, begin of sand deposit*

4.2.3 At the western half of the trench, starting approximately 120m from the western end (starting at the height of Ropery Street), a sandy deposit (104) of c. 0.6m depth was revealed, covered by 0.2m topsoil. The level of the sand deposit rises westwards, to a height of approximately 0.6m, before declining again at the last 20m, with an increase in topsoil.
