**ERIC WRIGHT CONSTRUCTION LIMITED**

**FLEET STREET, CHORLEY, LANCASHIRE**

**ARCHAEOLOGICAL EVALUATION REPORT**

**May 2017**

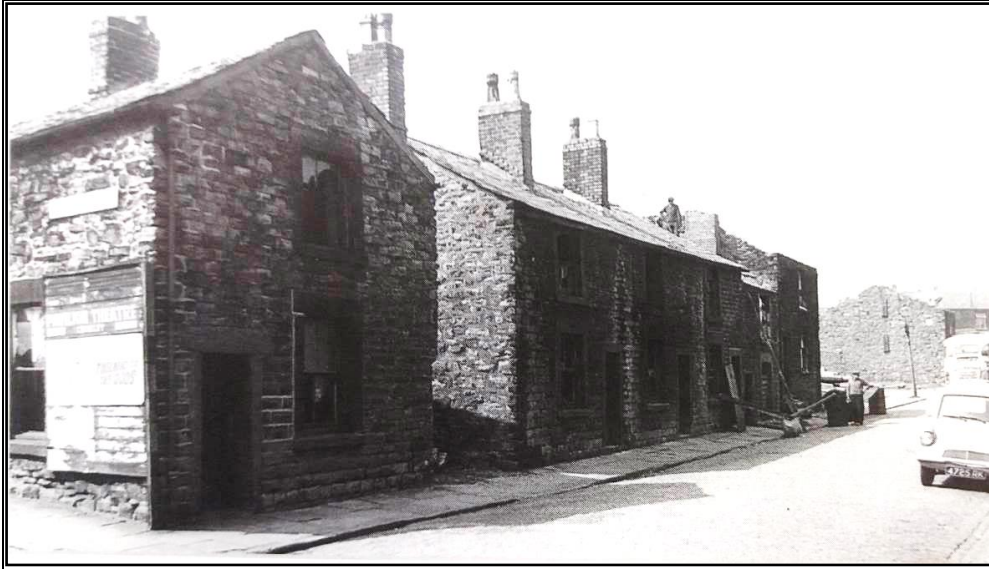
*Plate 1; Fleet Street, showing house numbers 1, 7, 9, 11 and 13 (view looking north from Gillibrand Walks), in the process of demolition in 1962 (Source: Smith 2002).*

3.2.15 The Ordnance Survey map of 1960 shows the housing still present along Moor Street and Fleet Street (Figure 5), although demolition work had begun two years later on Fleet Street as shown by the photograph reproduced in Plate 1. This photograph shows the form of the houses on the west side of Fleet Street and at the east end of Gillibrand Walks. The housing on Moor Street was seemingly demolished in the latter part of the 1960s, as a photograph taken at the end of that decade shows the gates to Primrose Cottage, with the housing on Moor Street gone and replaced by car parking (Plate 2).

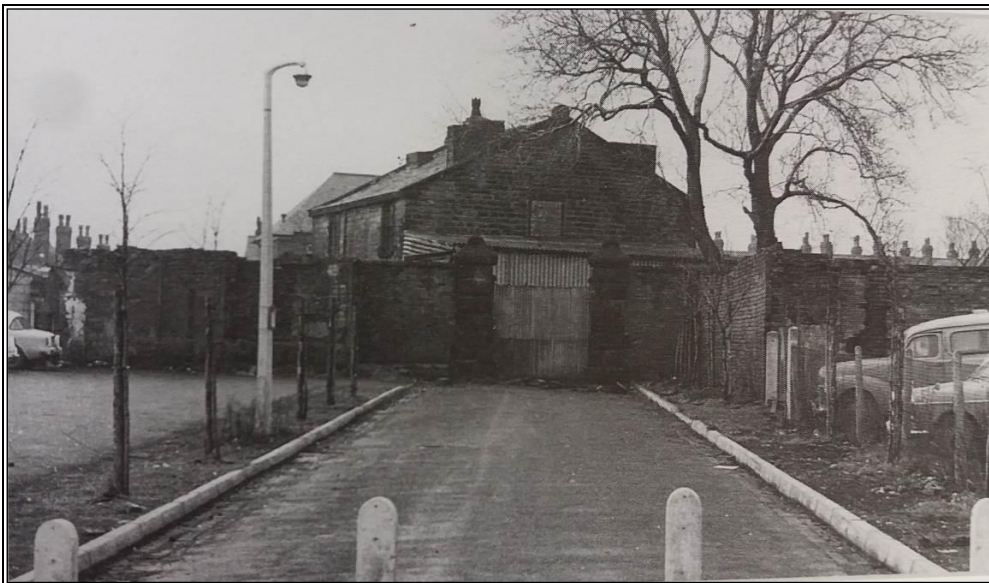
*Plate 2; 1960s view looking south-west showing the gates to Primrose Cottage, with Primrose Cottage beyond, and Moor Street devoid of housing (Source: Smith 2002).*

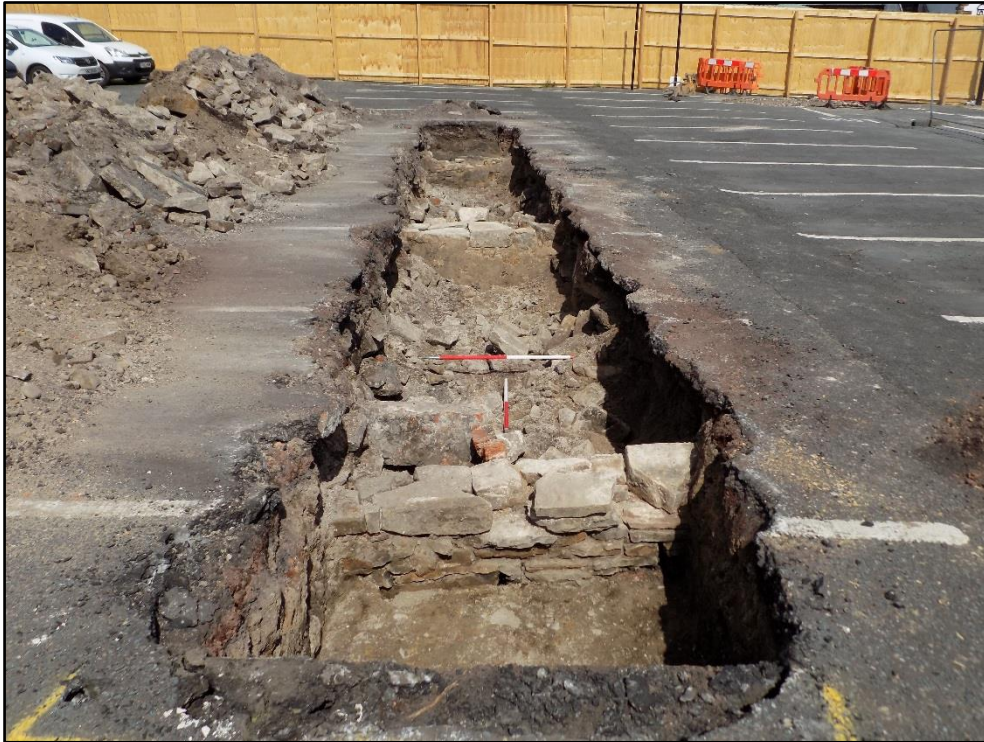
*Plate 3; Trench 1, looking north-east, 2x1m scales.*

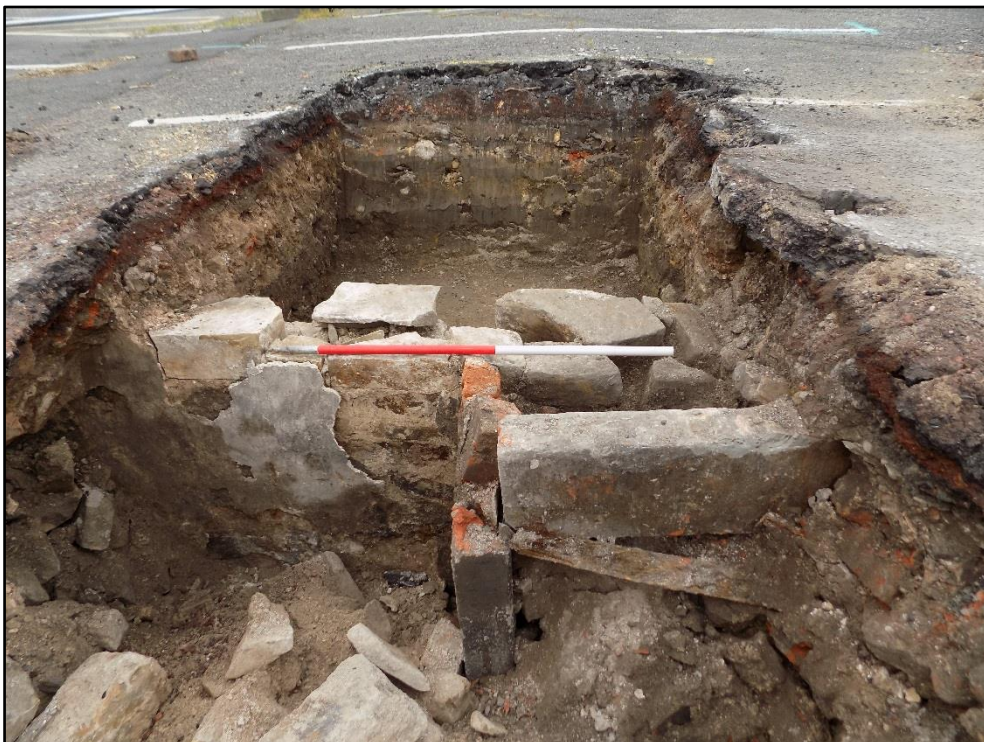
4.2.6 A wall comprising a single skin of handmade bricks **{104}** in stretcher bond and light grey mortar bonding was observed butting the north-east facing elevation of wall **{103}**, with a large sandstone block positioned partially atop this brick wall (Plate 4). The wall was aligned north-east to south-west and measured 0.51m in length and

- 0.13m in width, being the same surviving height as the foundation wall it abuts. It is unknown what the function of this internal brick and sandstone feature was though it may have been a cupboard or sink, or had some association with the stairwell into the cellar.

*Plate 4; Cellar wall {103} showing abutting brick and sandstone feature {104}, looking south-west, 1x1m scale.*

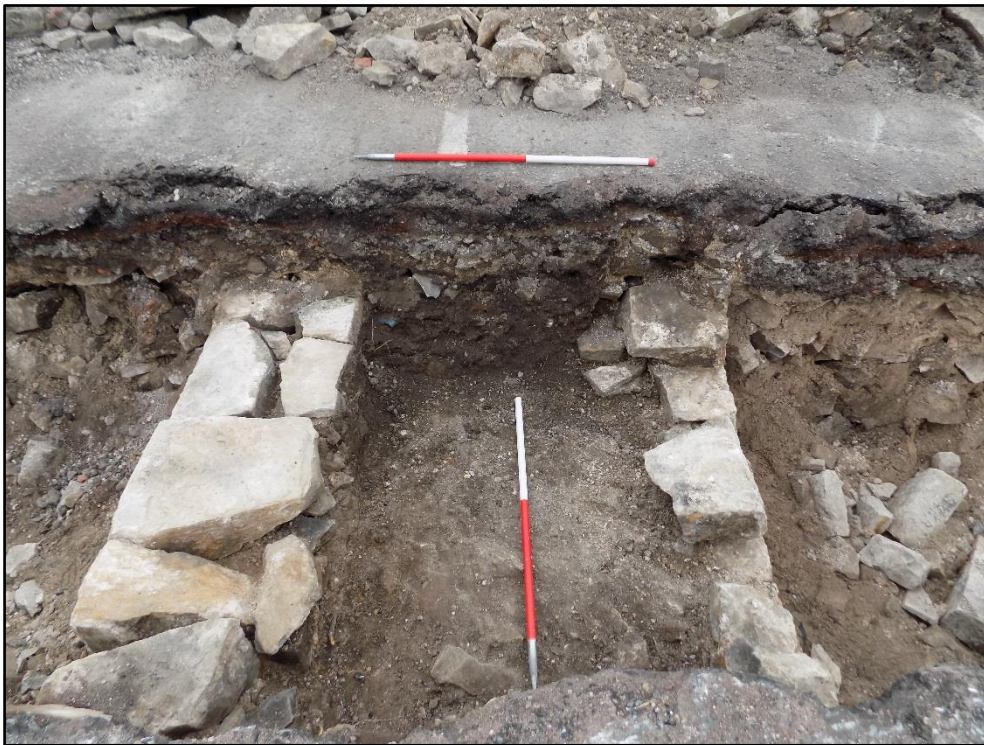
- 4.2.8 Following the construction of the foundation walls, redeposited natural **(108)** was used to make up the ground to the south-west of wall **{103}** which probably formed the base of the ground floor of that terrace. A redeposited fill **(109)** of dark greyish brown sandy silt, was observed between walls **{105}** and **{106}** was used to form the floor of the covered passage, or ginnel, between those two terraces (Plate 5). The ginnel measured approximately 1.35m in width.

*Plate 5; Cellar walls {105} and {106} showing made ground (109) of ginnel floor, looking north-west, 2x1m scales.*

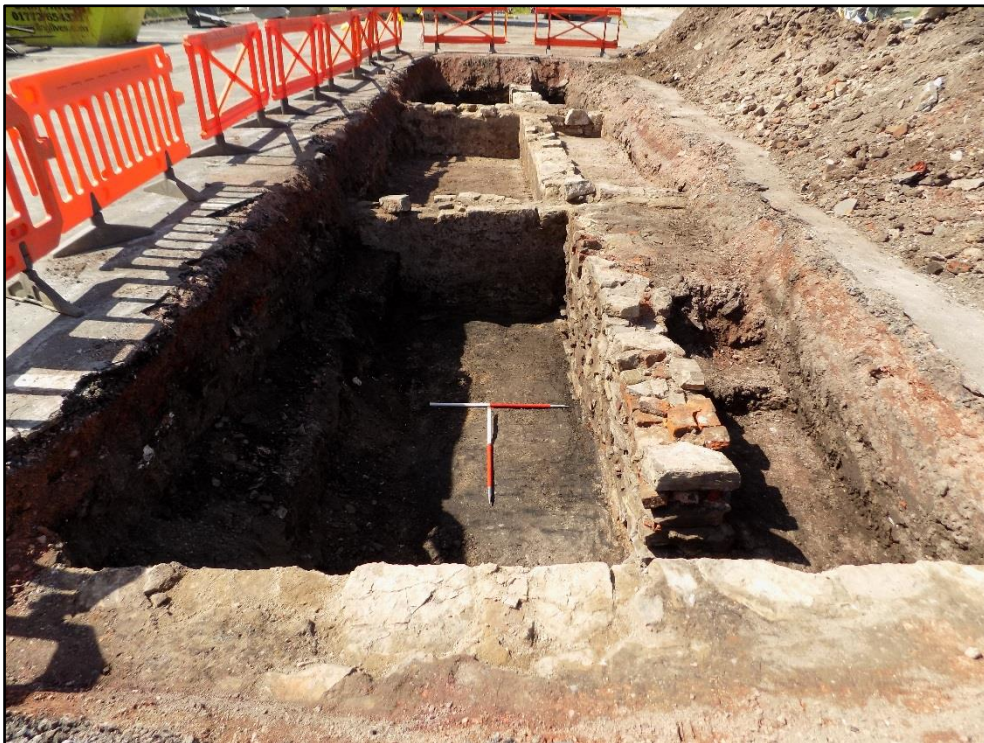
- 4.2.10 The partial remains of up to six cellar rooms belonging to three terraces were identified in Trench 2 (Figure 7, Plate 6).
- 4.2.11 Similar to the construction of the terraces in Trench 1, earth and natural substrate had been removed ahead of construction of the house foundations. Foundation walls **{203}**, **{205}**, **{206}**, **{207}**, **{208}** and **{209}**, first observed at a maximum height of 85.93m aOD, had then been constructed and the spaces between them made into cellars. Composed of the same sandstone blocks, rubble and mortar as the walls observed in Trench 1, each wall was also approximately 0.50m in width and up to 1.25m in height. Plaster had been added to every elevation of the exposed walls.

*Plate 6; Trench 2, looking south-west, 2x1m scales.*

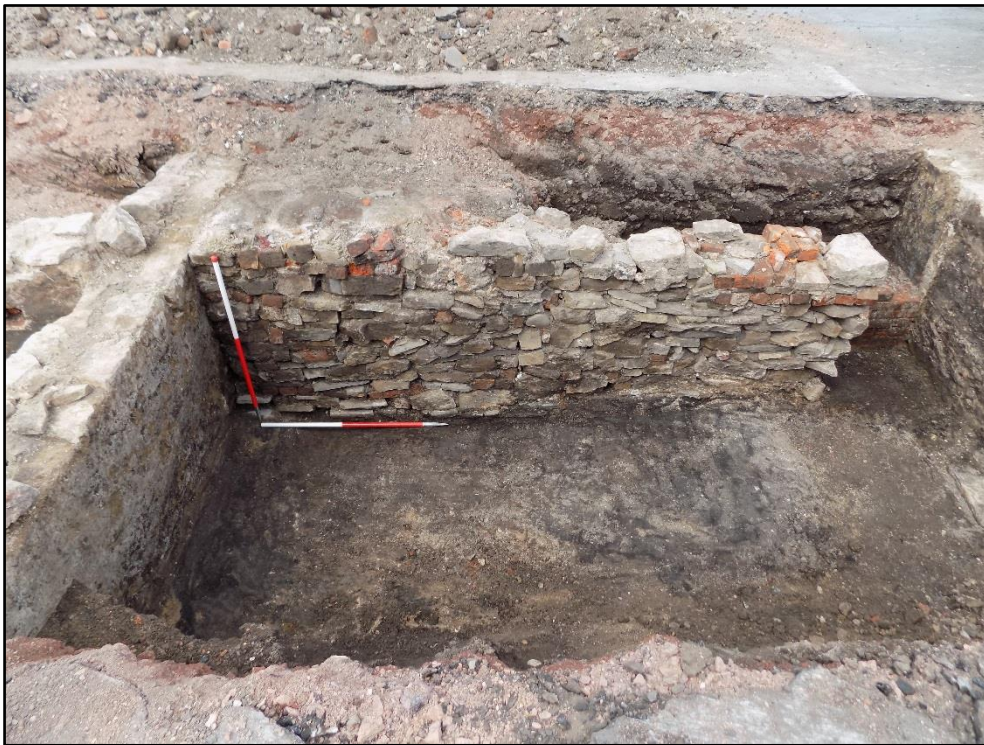
- 4.2.12 The cellar room to the north-east of the trench, bounded by foundation walls **{203}** and **{205}**, was reduced to its bare earth floor **(213)** observed at a height of 84.48m aOD (Plate 7). This floor deposit **(213)** was a heavily compacted mid greyish brown ashy sandy silt, and the internal span of the room this floor occupied was 4.52m.

*Plate 7; Cellar walls {203}, {204} (in the centre) and {205}, showing bare earth floor (213), looking north-west, 2x1m scales.*

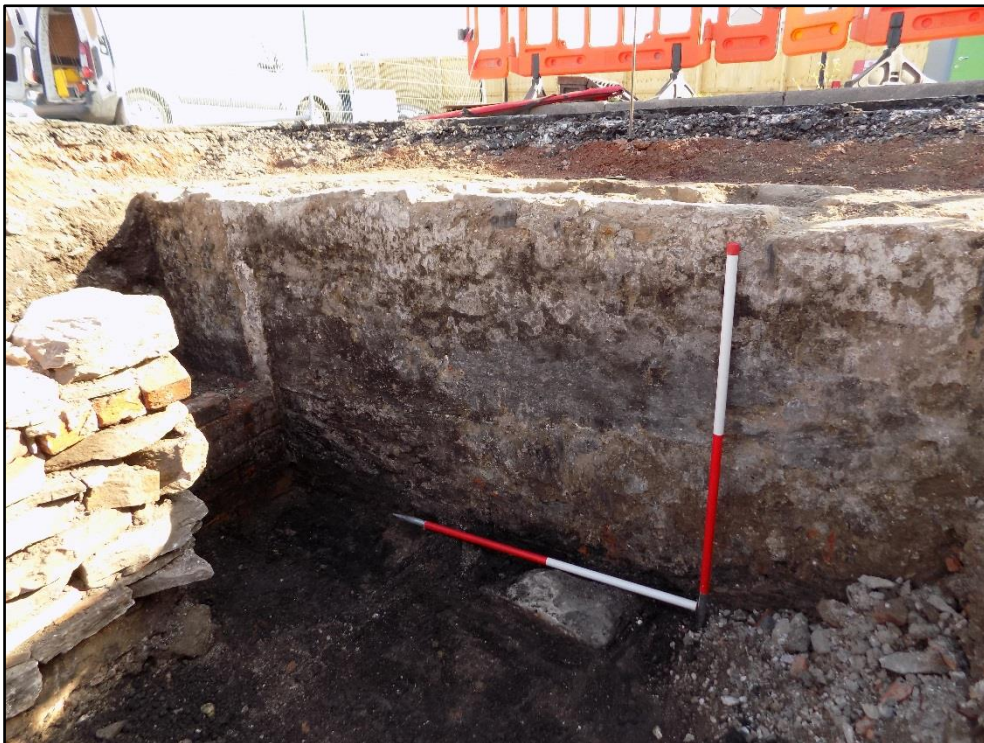
then its base consolidated with a packing fill **(215)** of dark orangey brown silty clay. Sometime later, a rubble sandstone wall **{204}** was constructed along the immediate south-west elevation of the brick wall, which butted foundation wall **{205}**, removing some of the wall plaster there. The wall was 0.42m in width and spanned 3.78m of the cellar room in a north-east to south-west alignment, leaving a gap of 0.75m between its north-east end and opposing wall **{203}**. It could be this gap was for the former entry into the cellar, as possible trace remains of former steps in the plaster could be faintly observed (Plate 8). It also appears that the brick wall was deliberately reduced in size, though it cannot be determined when this took place, or for what reason.

*Plate 8; Walls {203}, {204} and brick wall {212}, showing detail of wall plaster, looking north, 2x1m scales.*

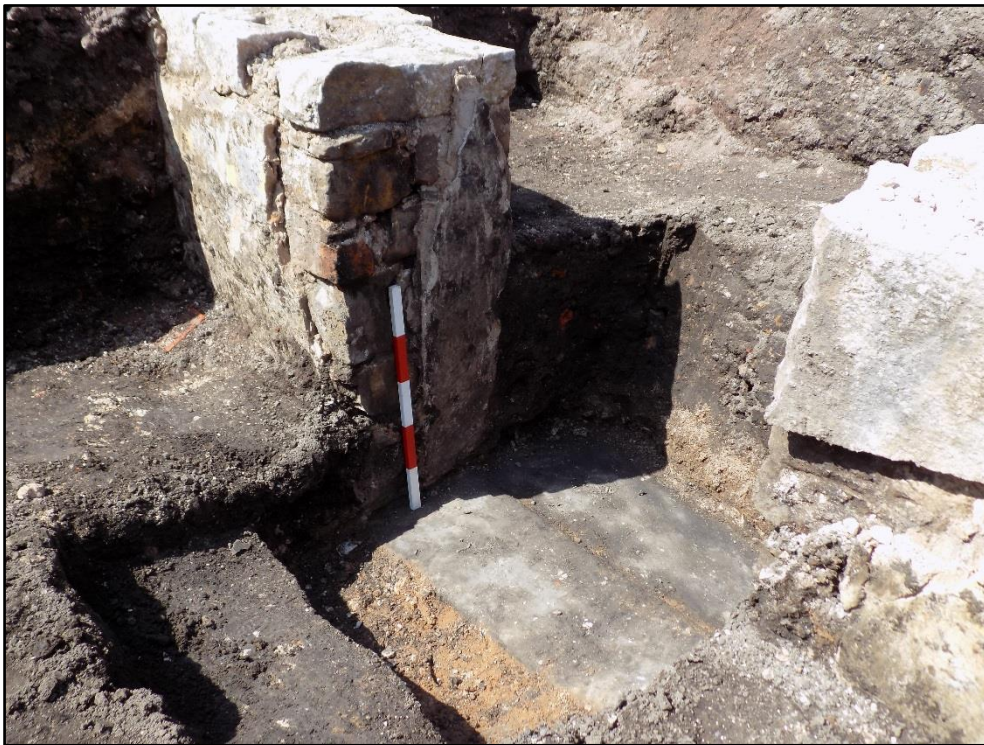
4.2.15 A doorway had been installed as part of the original construction of the south-westernmost cellars, between walls **{208}** and **{209}**. In the cellar to the south-east, the floor comprised of a light yellowish brown sand **(201)**, and in the cellar to the north-west, composed of Yorkstone flags on a sandy bed **{211}**, first observed at a height of 84.87m aOD. The doorway comprised a large sandstone sill **{210}** measuring 0.83m in length, 0.40m in width and 0.13m deep, and which appeared to have been inserted prior to the application of the wall plaster (Plate 9). The space into which the former jambs of a door may have been fixed were demonstrated by the wall plaster only partially sealing the ends of these walls.

*Plate 9; Doorway between walls {208} and {209}, showing sill {210} and flagged floor {211}, looking west, 1x0.50m scale.*

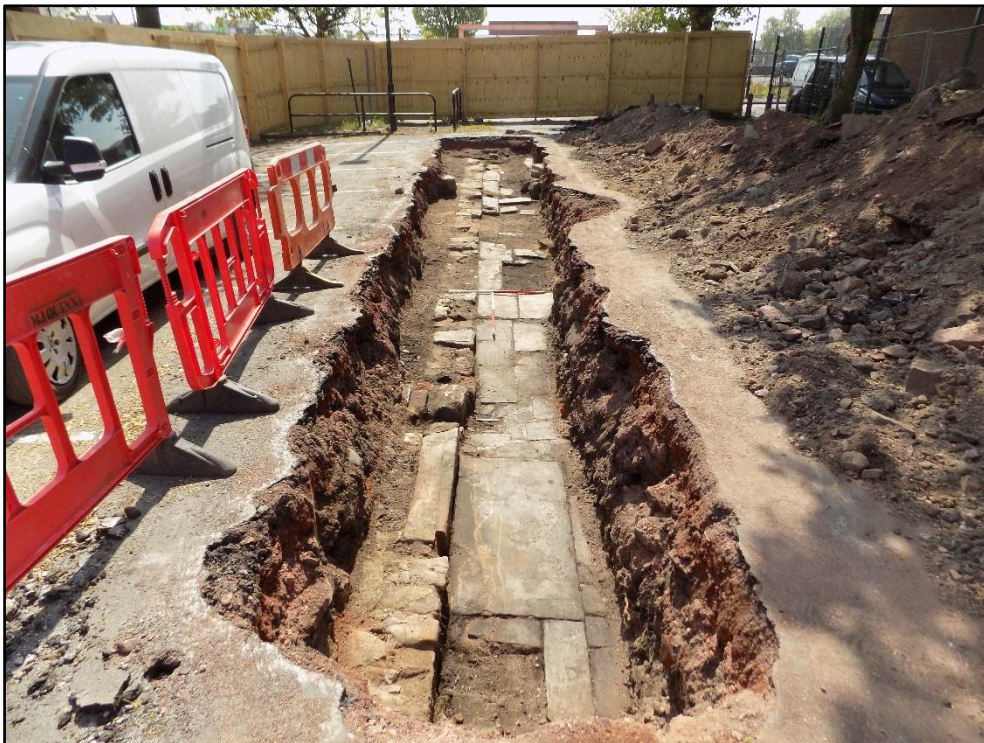
4.2.18 Following the removal of tarmac and overburden, the external rear sandstone rubble wall **{302}** was first observed at a height of 84.71m aOD. The wall had been constructed similarly to those found in Trenches 1 and 2 and was aligned north-west to south-east. The dividing terrace walls **{309}**, **{310}** and **{311}** aligned north-east to south-west were only partially visible, and again composed of rubble and coarse grey sandy lime mortar with the exception of brick repair work to the joins between the walls where lead piping for water had been added later.

*Plate 10; Trench 3, looking south-east, 2x1m scales.*

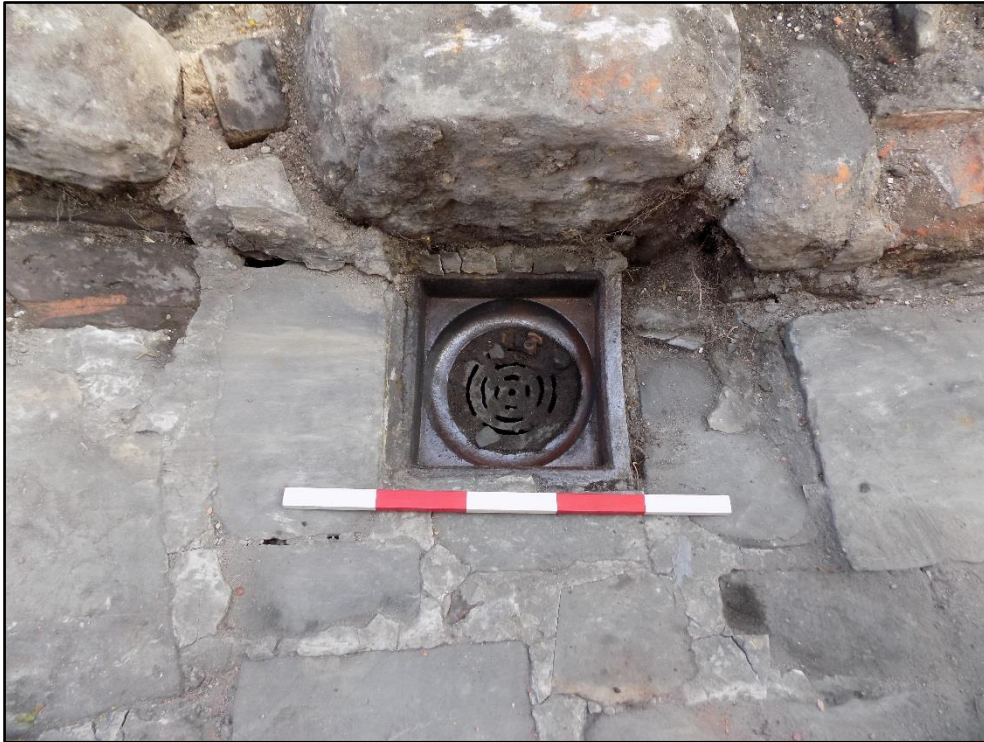
4.2.22 A later trench **[312]** had then been cut through the yard against the wall. The cut measured 13.50m in length, 0.30m in width and up to 0.45m in depth, running from the south-east end of the trench and ending at the dividing wall **{309}** between two of the terraces. A glazed ceramic drain, identified by up to three ceramic catchment tiles **{304}**, **{305}** and **{306}** observed at a maximum height of 84.42m aOD, had then been laid within this trench and backfilled with a mixed dark greyish brown sandy silty clay **(313)**. Yorkstone flags **{307}** had then been replaced over this trench to restore the yard once more. In places, cement had been added to these flag stones, particularly around the most north-westerly ceramic catchment tile **{305}** (Plate 11).

*Plate 11; Ceramic drain catchment {305}, looking north-east, 1x0.50m scale.*

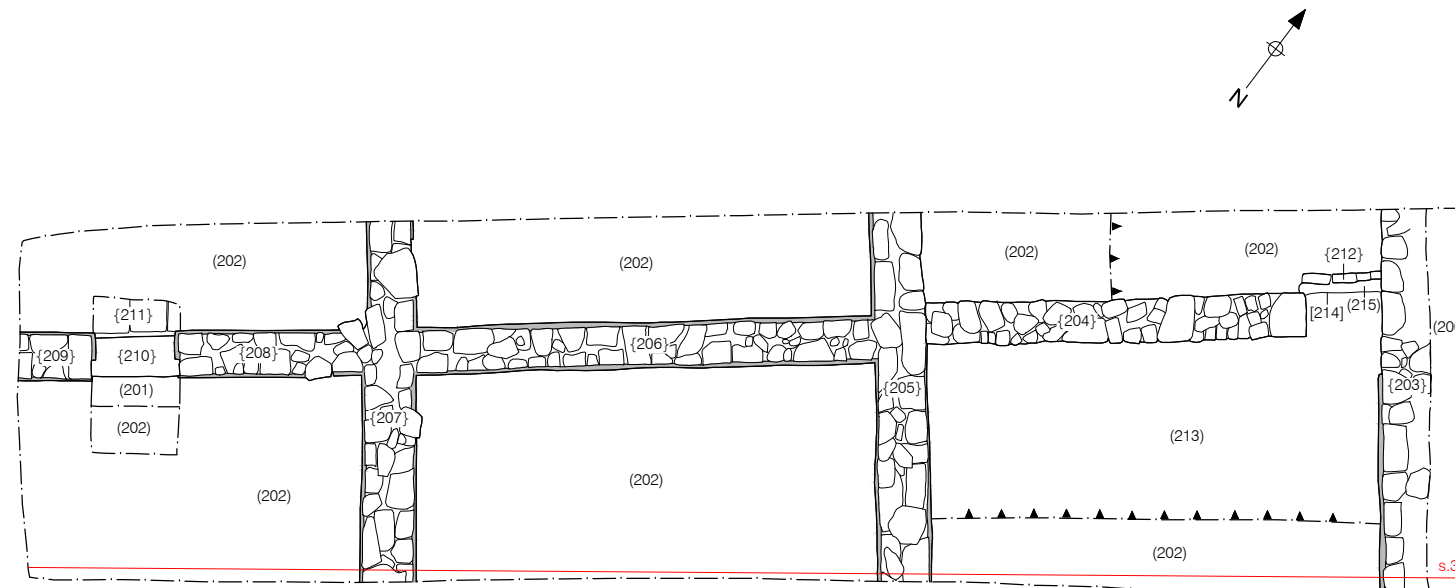
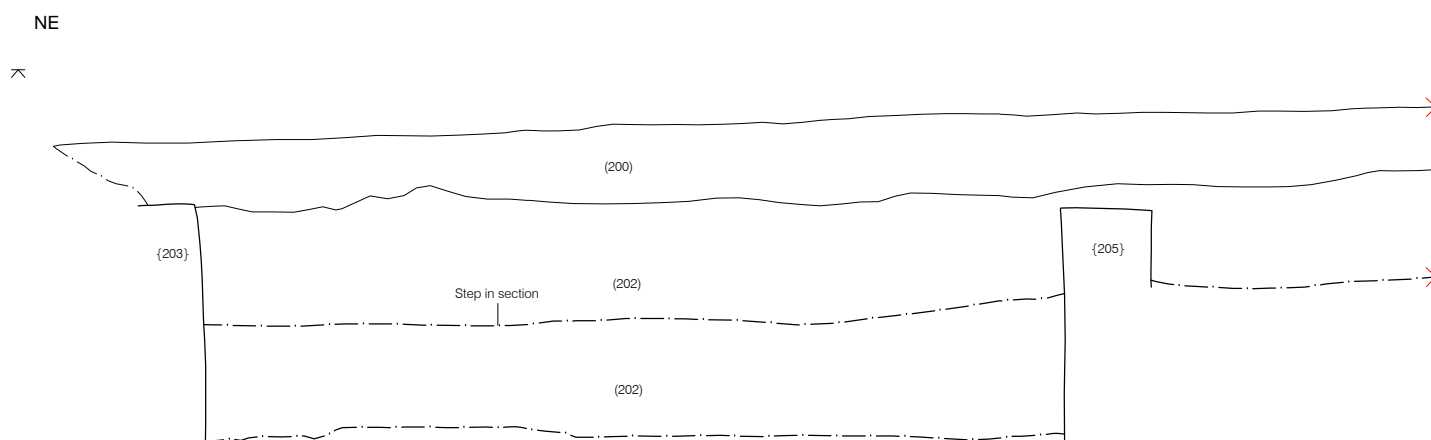
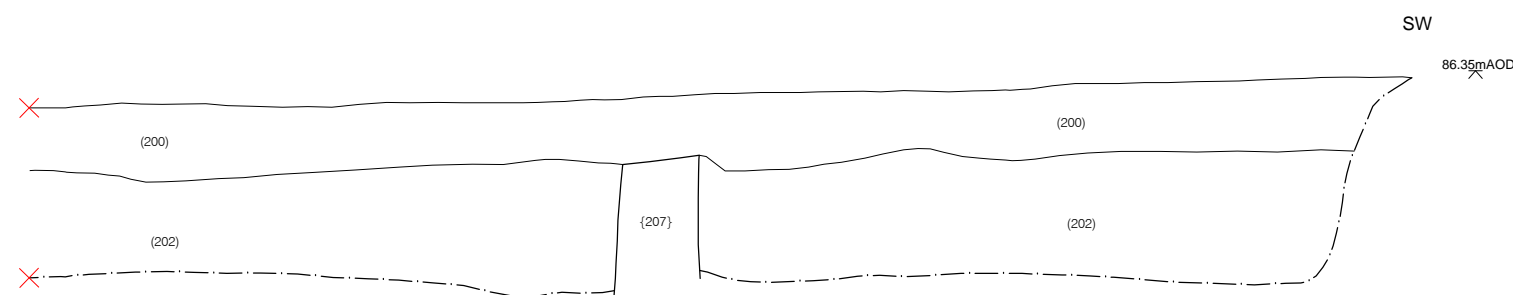
Figure 7: Trench 2; plan and section.

Trench 2. Plan.

Section 3. North-west facing section, Trench 2.

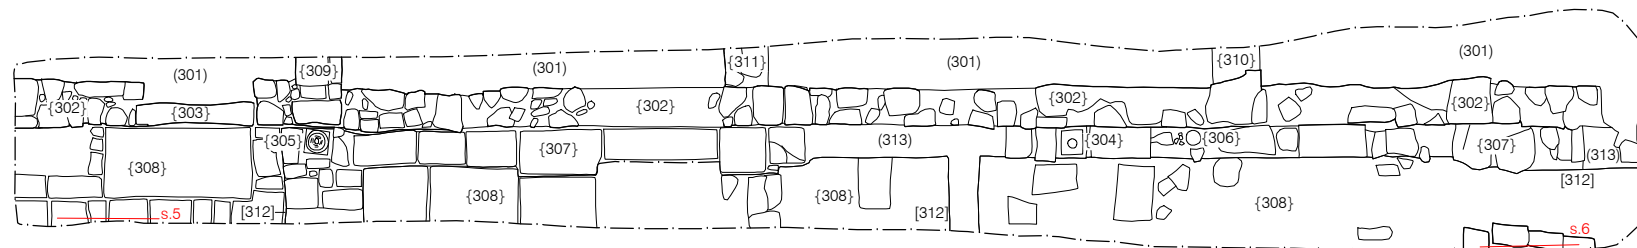
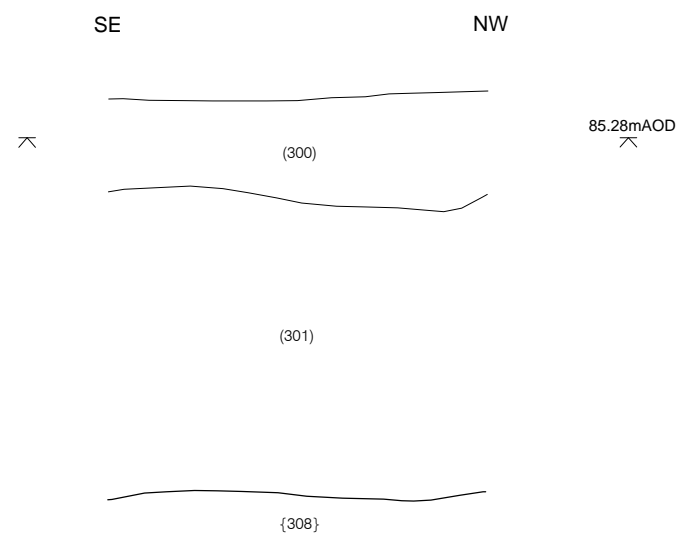
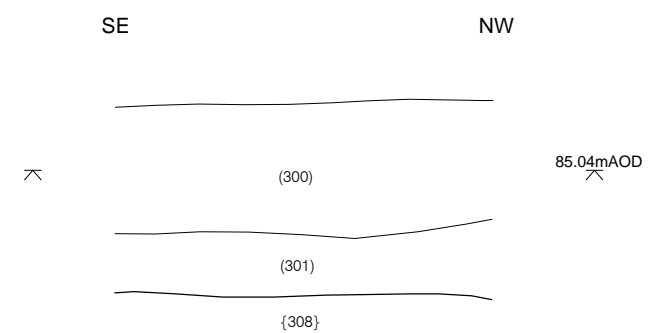
Trench 3. Plan.

Section 5. North-east facing section at NW end of Trench 3.

Section 6. North-east facing section at SE end of Trench 3.
