LAND AT LAYSIDE FARM, BARDON MILL, NORTHUMBERLAND

**ARCHAEOLOGICAL WATCHING BRIEF REPORT**

August 2017

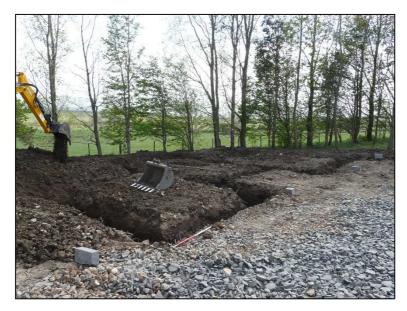
4.2.1 The watching brief monitored the excavations for the foundations for the easternmost planned bedroom module cluster towards the centre of the site (Figure 2) the western bedroom module cluster has been delayed and may be completed at a later date. These foundation trenches measured between 0.9m and 1.1m in width and between 1.1m and 1.4m in depth. A dark grey-brown loose topsoil which measured between 0.05m and 0.2m in depth was encountered overlying a mid-brown clay subsoil which overlay a dark grey clay with orange flecks and some stone inclusions (Plate 1). These deposits were mixed in places, probably as a result of 20<sup>th</sup> century planting of the tree copse in the area.

Plate 1: Foundation trenches for eastern bedroom module cluster, facing south-west

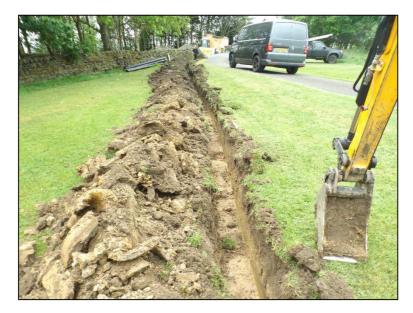
holiday accommodation. This trench showed signs of modern disturbance, in the form of a black plastic pipe and brick fragments. A dark grey-brown loose topsoil which measures up to 0.7m in depth was encountered overlying a mid-brown clay subsoil which overlay an orange clay (Plate 2).

Plate 2: Cable trench, facing west

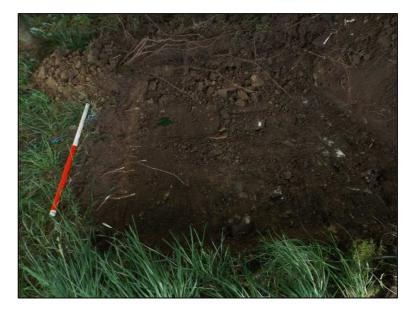
- 4.2.3 The new holiday accommodation also required sewage provision, and an associated pit for a new septic tank was excavated under archaeological monitoring (Figure 2). This measured 2.3m by 2.5m and reached a maximum depth of 0.5m, into the natural, as the tank would be above ground and the area would later be banked up to accommodate it. These groundworks revealed a mid grey-brown sandy silt topsoil up to 0.3m in depth overlying a light orange-brown sandy clay, with an orange clay at the base (Plate 3).

Plate 3: Pit for septic tank, facing south

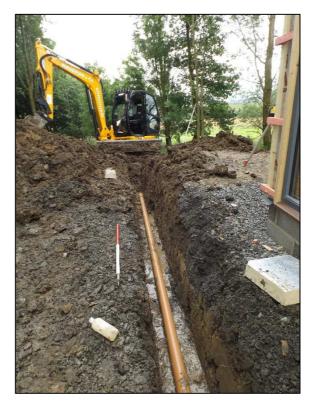
- 4.2.4 Service trenches were also excavated, surrounding the east bedroom module cluster and extending southwards to link with the new septic tank location, and into the field to the south, though this extension was later abandoned (Figure 2). The trenches measured 0.6m in width and had a maximum depth of 0.8m. The area around the module cluster encountered a make-up deposit which measures 0.4m in depth, overlying a mid brown topsoil/ subsoil deposit which measured 0.2m in depth. This overlay an orange-brown sandy clay natural (Plate 4). Further to the south, no makeup deposit was encountered, and the topsoil was heavily disturbed by roots and overlay the same orange clay natural (Plate 5).

Plate 4: Service trench east of east bedroom module cluster, facing south

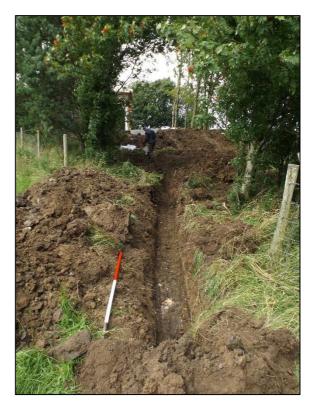
Plate 5: Southern extent of service trench, facing north

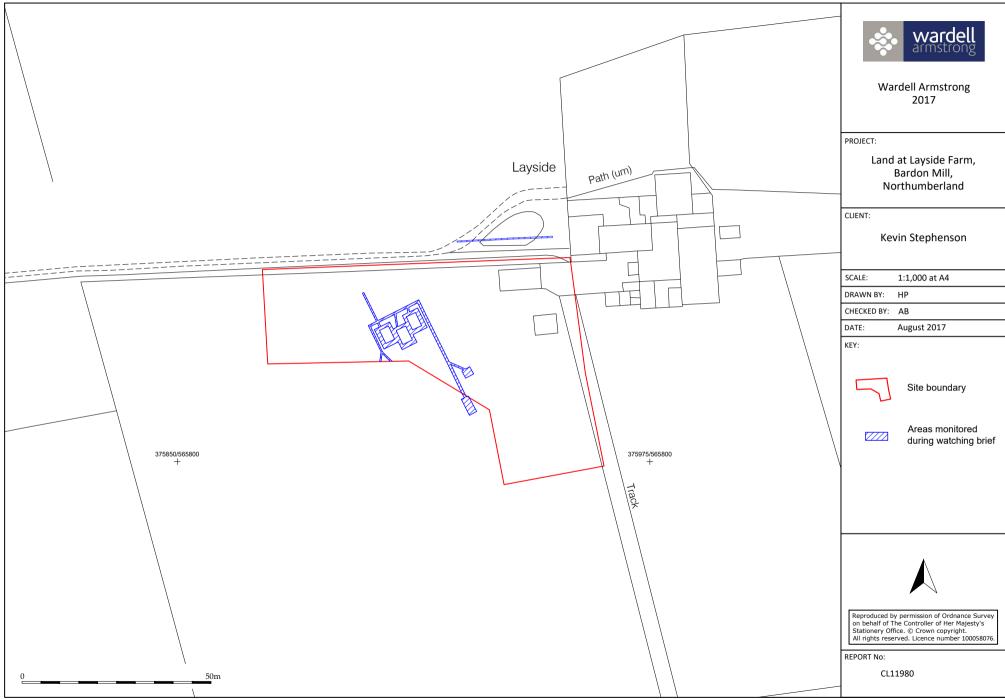
Figure 2: Detailed site location.

4.1.1 The archaeological watching brief was undertaken on Monday 8<sup>th</sup> May, Monday 5<sup>th</sup> June and Friday 4<sup>th</sup> August 2017. It monitored the excavation for foundation trenches for the eastern building block module, trenching for electricity and sewerage provision, and the excavation of a pit for a new septic tank. The locations of the watching brief monitoring are shown in Figure 2.
