WAINHOMES (NORTH WEST) LIMITED

**LAND NORTH OF PRESTON OLD ROAD,
CLIFTON, LANCASHIRE**

**ARCHAEOLOGICAL
EVALUATION REPORT**

August 2017

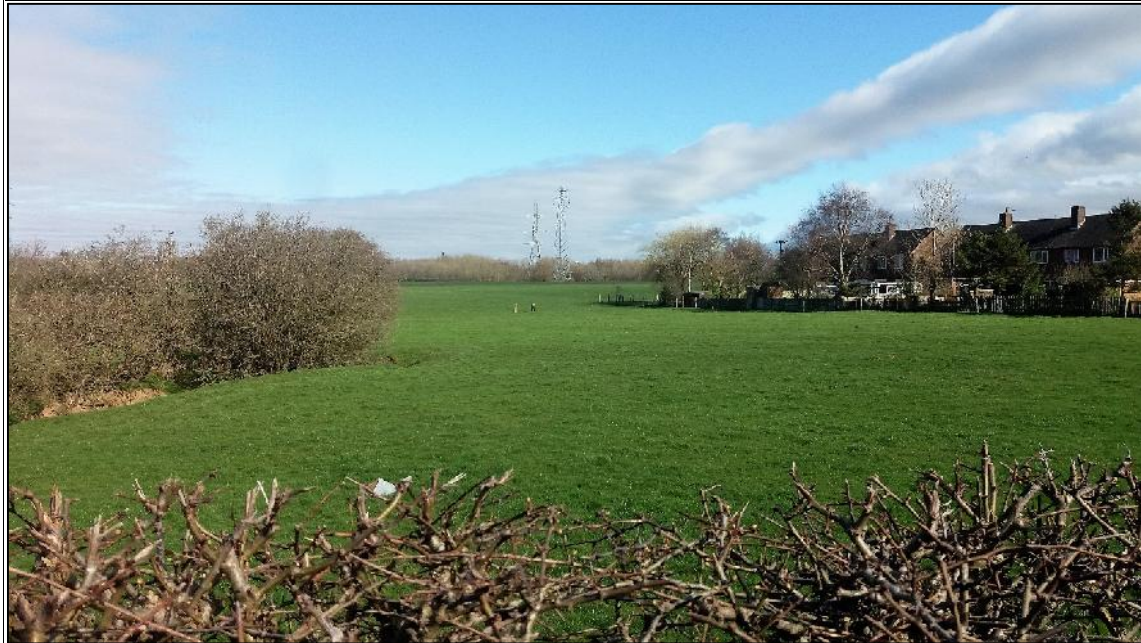
Plate 1: South side of the proposed development area, looking northeast

- 4.1.2 The survey area was bound by mature hedgerows with some post and wire fences present. Modern housing formed the eastern boundary of the site and a watercourse formed the western boundary, with the ground falling sharply towards the watercourse along the site boundary. Preston Old Road formed the southwest boundary subdivided by a further hedgerow. The northern boundary of the site was defined by overhead electricity lines, with a further set of overhead wires crossing the northwest side of the site, aligned northwest to southeast. Buried waste water pipes, with associated manholes were evident within the southern part of the site (Plate 1).

- 4.2.1 The southern part of the proposed development area was devoid of earthworks or other visible historic features (Plate 1), there being no visible evidence for the narrow ridge and furrow (Asset 31) which has been identified in this area on air photographs of the site (Figure 3). Similarly there was no visible evidence for the former road which had crossed the southern portion of the proposed development area (Asset 34).

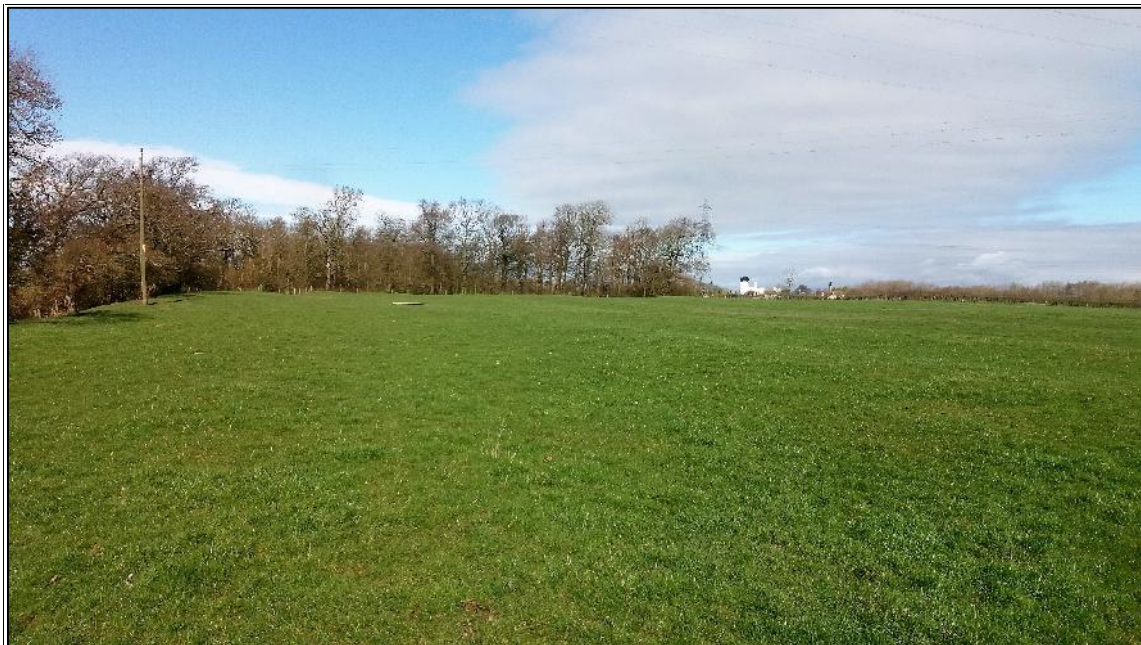
Plate 2: Northwest side of the proposed development area showing ridge and furrow earthworks, looking north

- 4.2.2 A series of linear earthworks were identified crossing the northwest portion of the site, which were typical of ridge and furrow cultivation of probable medieval date (Plate 2). A series of five ridges, with corresponding furrows, were identified which measured between 9m and 11m across and approximately 0.3m high, aligned north to south. In plan, the ridges and furrows exhibited a slight curvature, which is typical of medieval ploughing, continuing outside of the survey area into the field to the north. These earthworks were identified on air photographs as part of the desk-based assessment as Asset 30 (Wardell Armstrong 2017a).

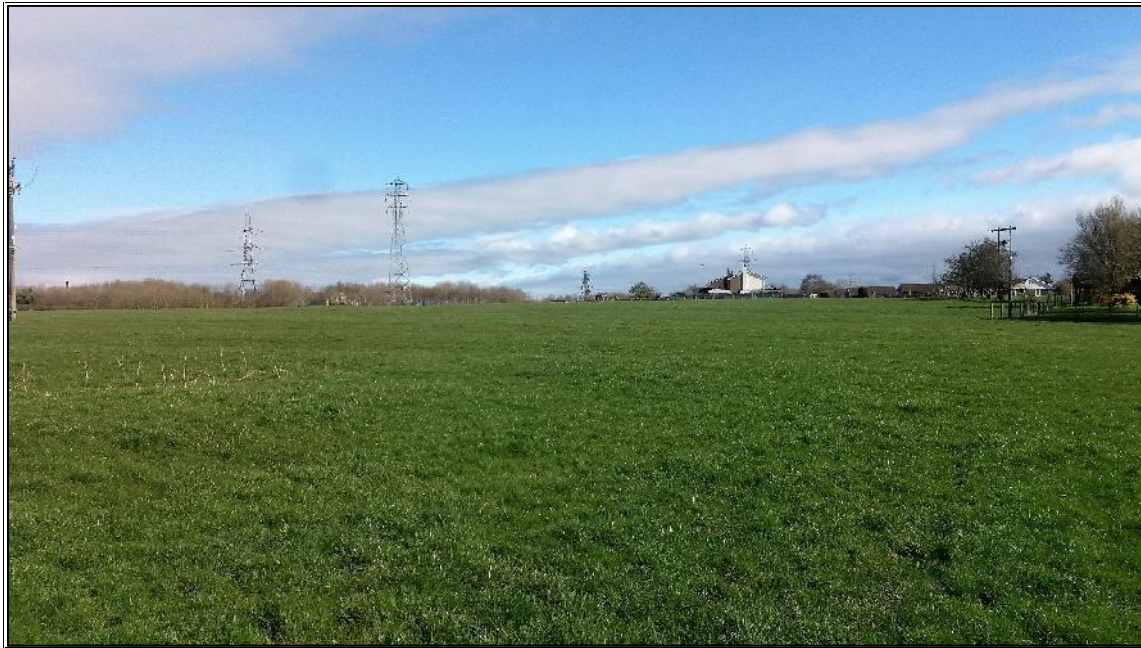
Plate 3: Northeast side of the proposed development area, looking northeast

- 4.2.3 The ridge and furrow earthworks appeared to be defined to the east by a former north-south field boundary, as depicted on historic maps of the site (Asset 32), with the easternmost furrow aligning with the location of the former field boundary. No further features were visible to the east of this boundary (Plate 3).

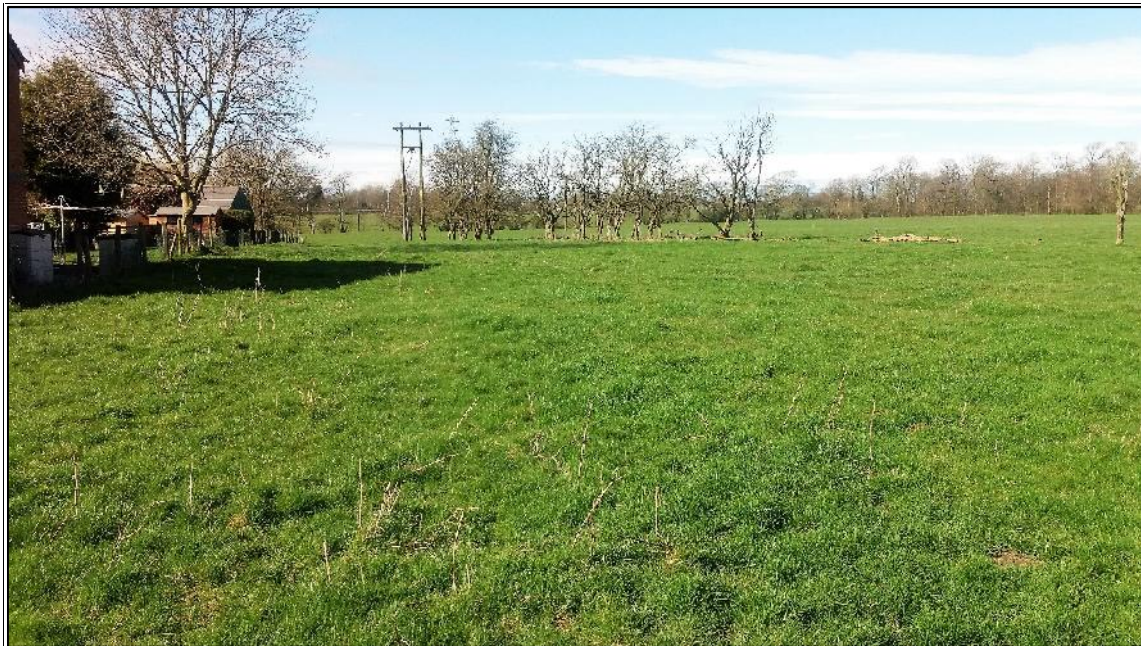
Plate 4: Southeast side of the proposed development area showing relict field boundary, looking northwest

- 4.2.4 Another former field boundary has been identified crossing the southeast corner of the site, aligned east to west (Asset 33). This boundary was still extant in the 1960s as it is visible on an aerial photograph from that period, and a section of the boundary was present on the southeast side of the site at the time of the survey. This comprised a 40m-long section of former hedgerow, which had been partially removed (Plate 4).

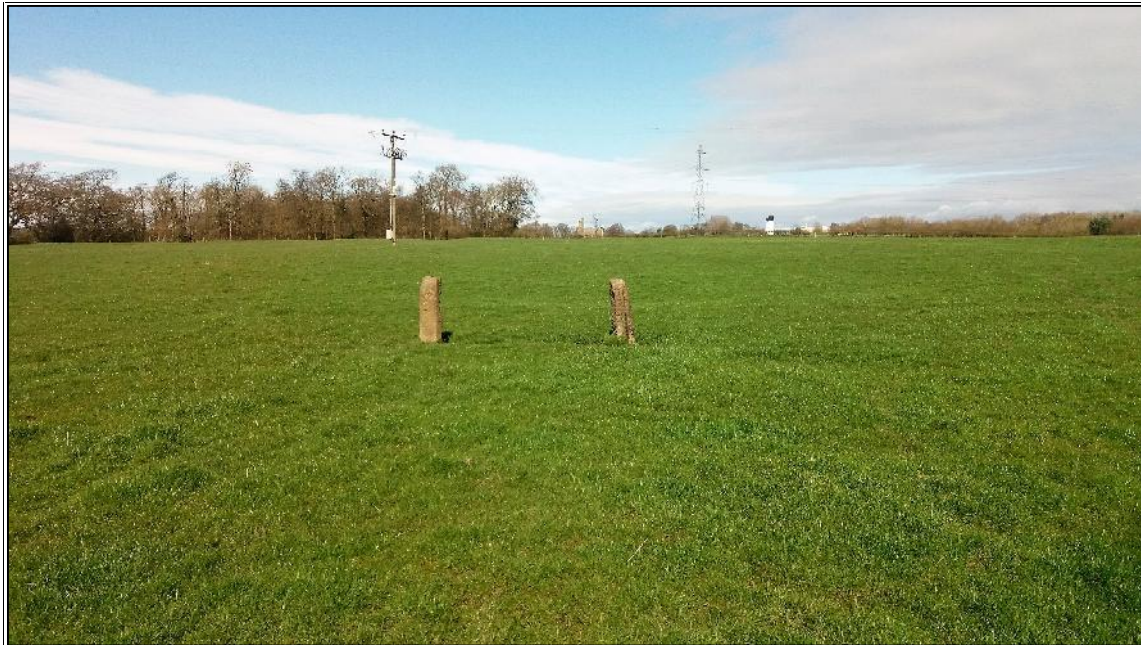
Plate 5: Gate posts associated with relict field boundary, looking north

- 4.2.5 Two free-standing stone gate posts were identified on the west side of the proposed development area, which are believed to be associated with an entrance through the former field boundary (Asset 33). These were spaced 2.4m apart and stood 1.1m high, comprised of roughly hewn sandstone. The easternmost post exhibited grooves on the north and south sides to house fencing (Plate 5).

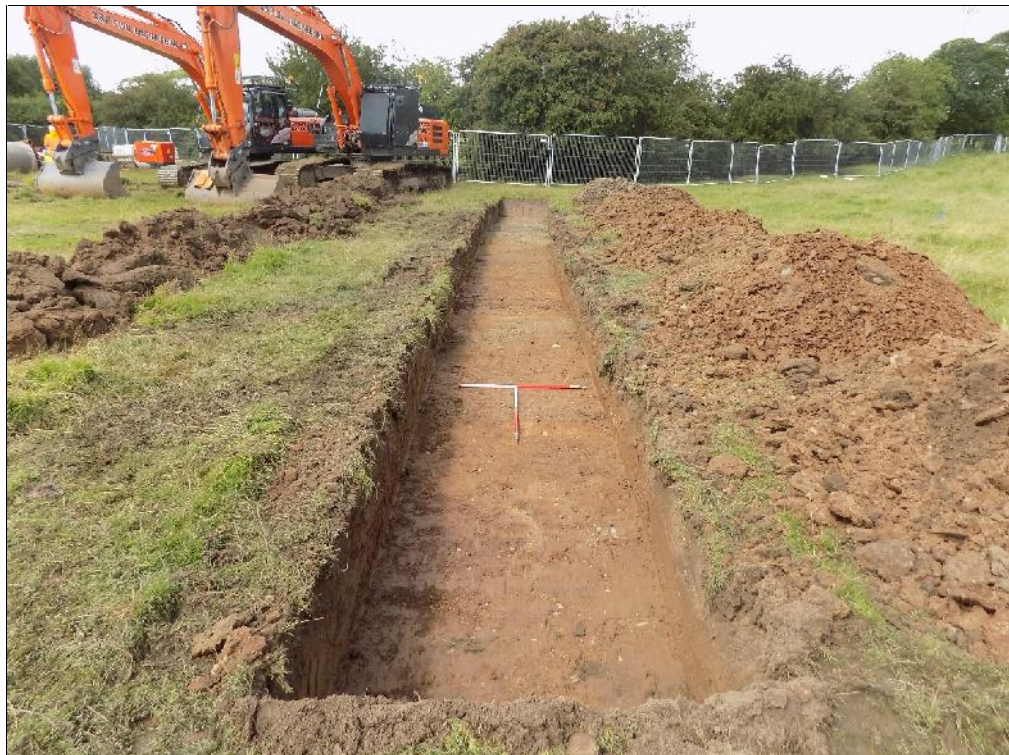
Plate 6: Trench 1, looking northwest

5.2.5 The natural geology (**101**) was identified at a depth of 0.55m in Trench 1 which was cut by two modern land drains aligned north to south (Plate 6). This was overlain by a 0.25m-depth of orange/brown sandy clay subsoil (**102**) and 0.3m of topsoil (**100**).

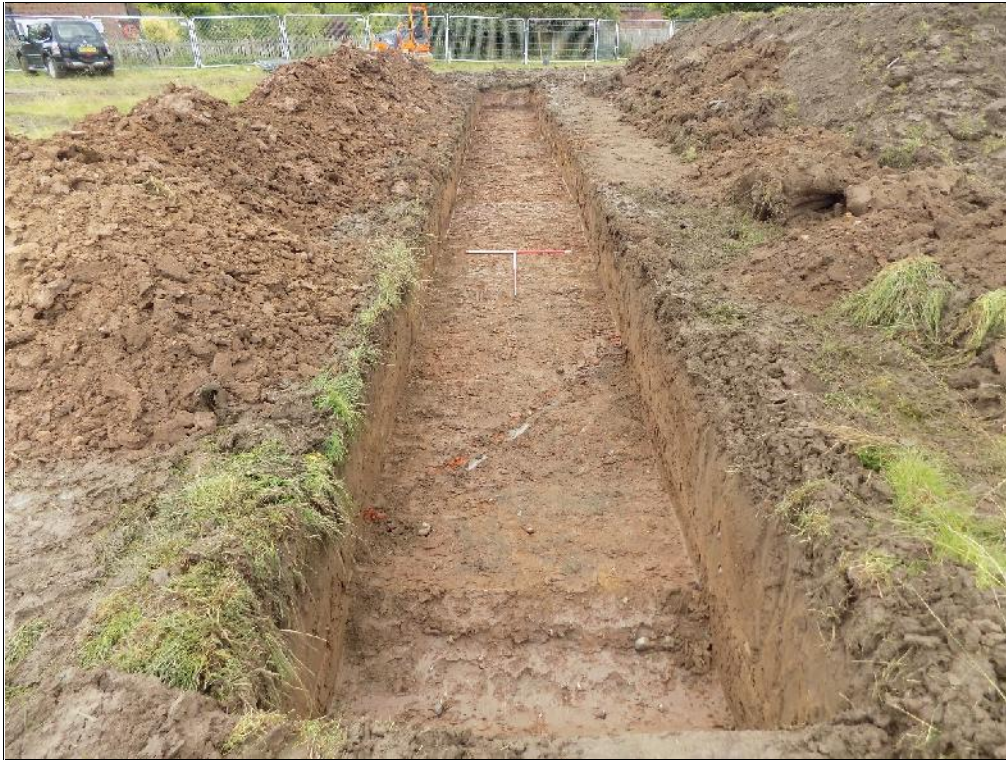
Plate 7: Trench 2 showing land drains, looking southeast

- 5.2.8 The natural geology (**201**) was identified at a depth of between 0.55m and 0.9m which was also cut by three modern land drains aligned north to south (Plate 7). This was overlain by a 0.7m-depth of orange/brown sandy clay subsoil (**202**) and 0.2m of topsoil (**200**). No archaeological features were identified in this trench and there was no evidence of ridge and furrow cultivation.

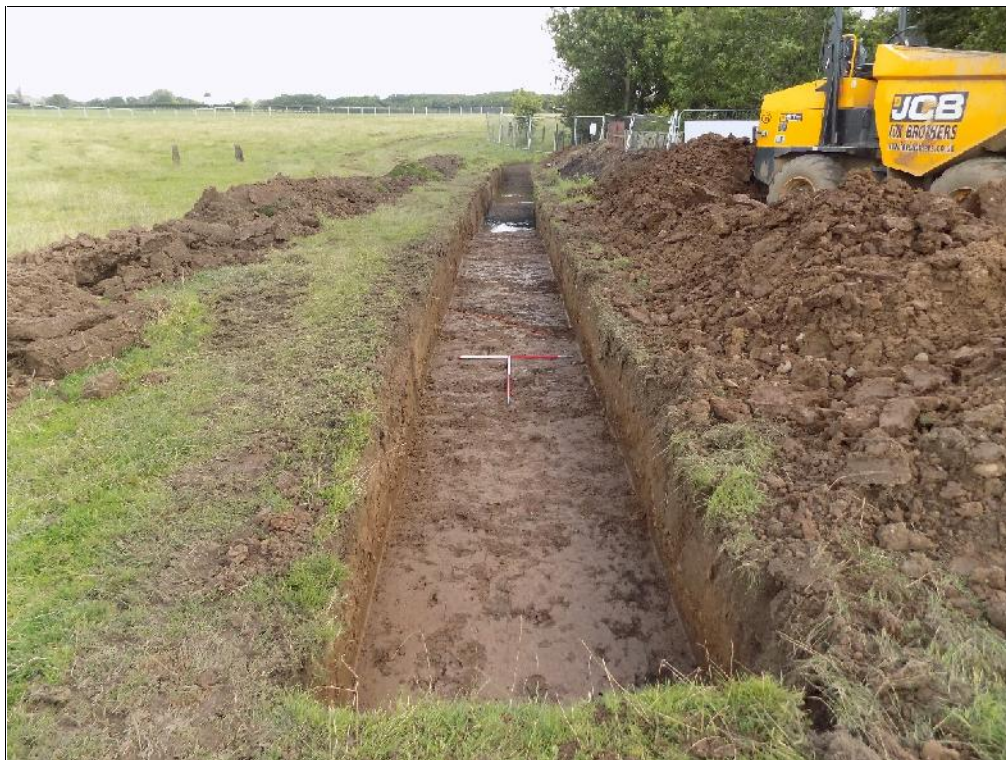
Plate 8: Trench 3, looking northeast

- 5.2.10 The natural geology (**301**) was identified at a depth of 0.56m which was also cut by a modern land drain aligned north to south (Plate 8). This was overlain by a 0.3m-depth of orange/brown sandy clay subsoil (**302**) and 0.25m of topsoil (**100**) in the southwest end of the trench.

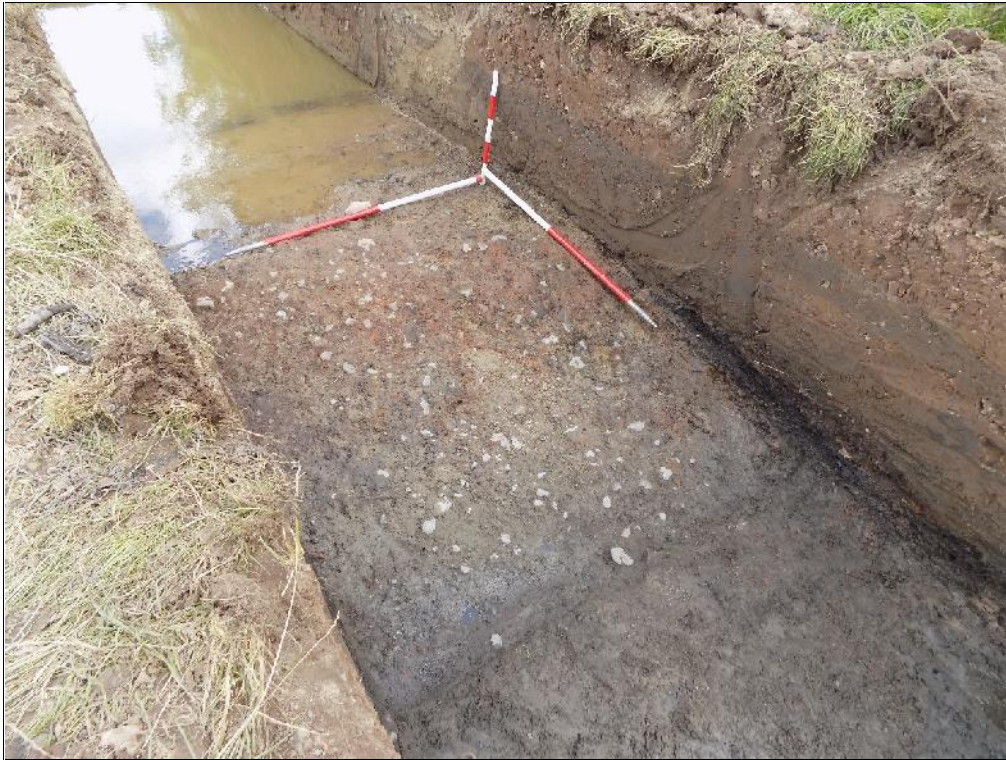
Plate 9: Possible road surface (307) in Trench 3, looking east

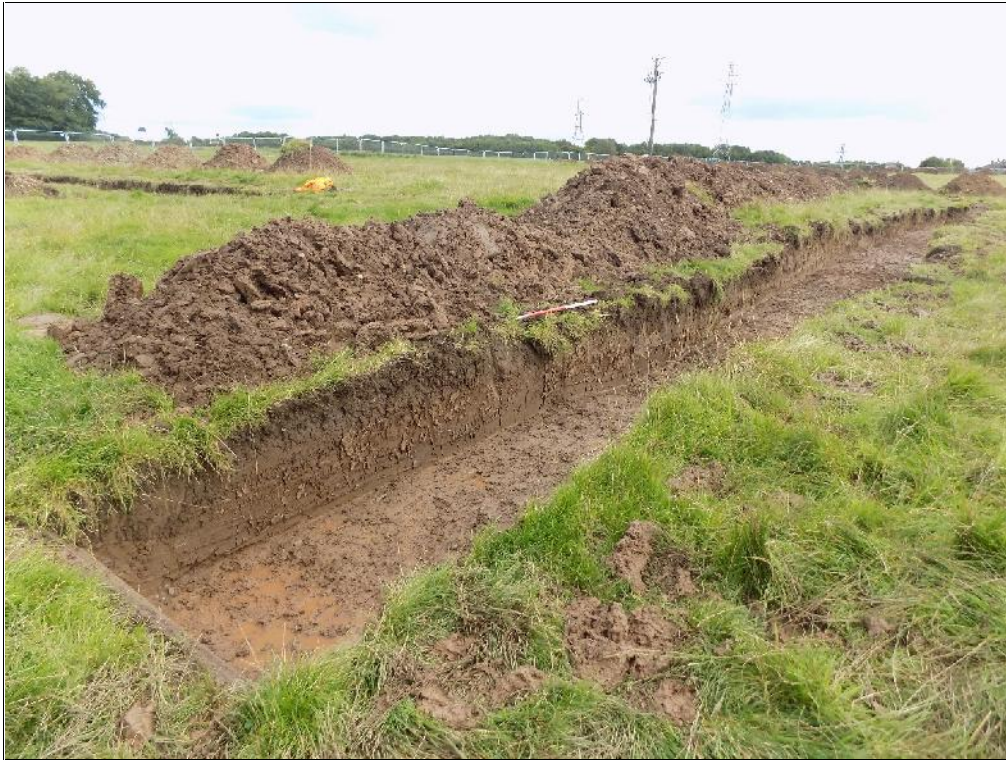
Plate 11: Trench 5 showing ridge and furrow earthworks, looking northeast

- 5.2.21 No archaeological features were identified in the bottom of this trench, but the trench section provided a profile across the ridge and furrow earthworks (Figure 6). The ridges were noted to be approximately 10m wide and 0.3m high. No dating evidence was recovered from the trench to assist with dating the earthworks.

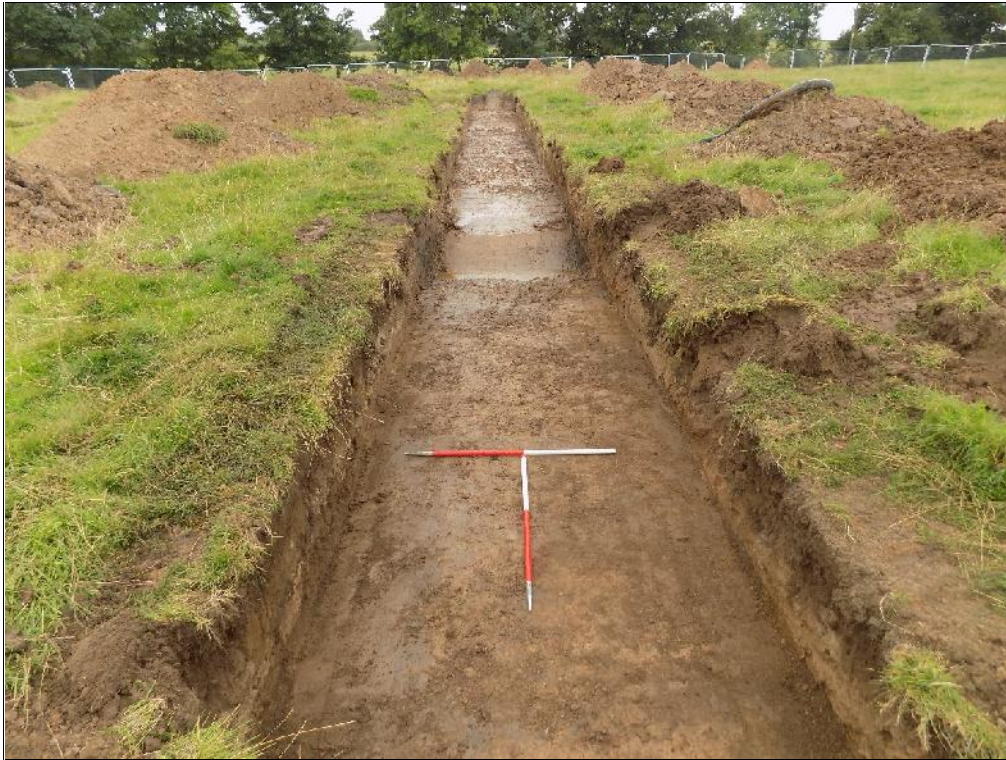
Plate 13: Trench 7 showing former field boundary [703] crossing the trench, looking northwest

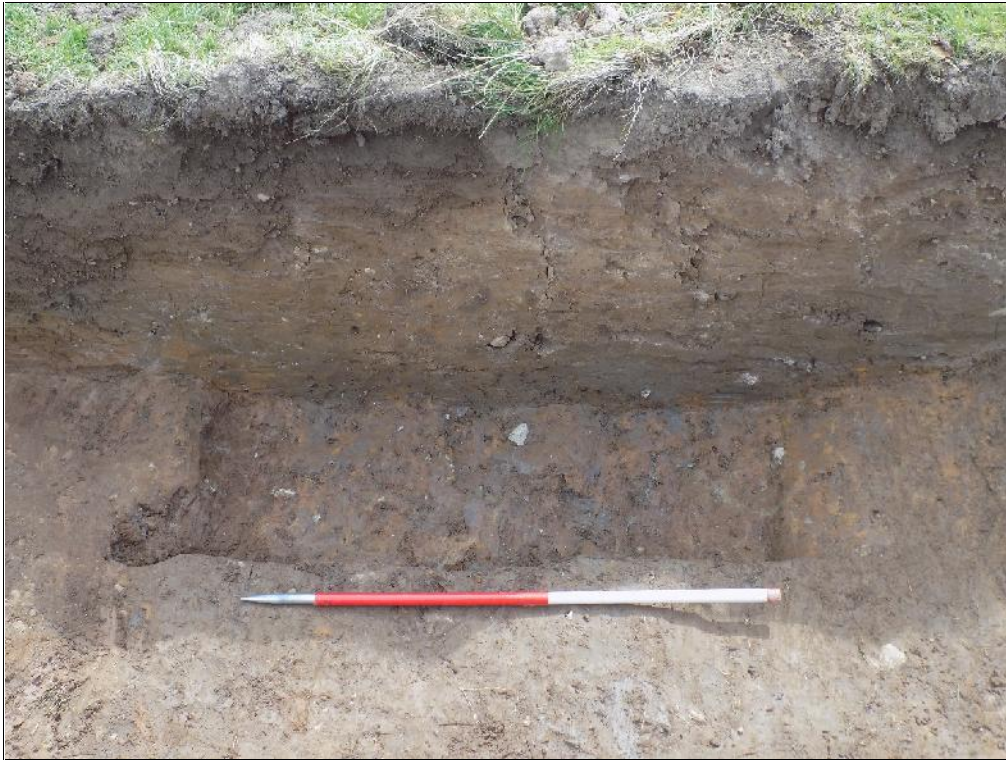
Plate 15: Section through field boundary (**803**) in Trench 8, looking south

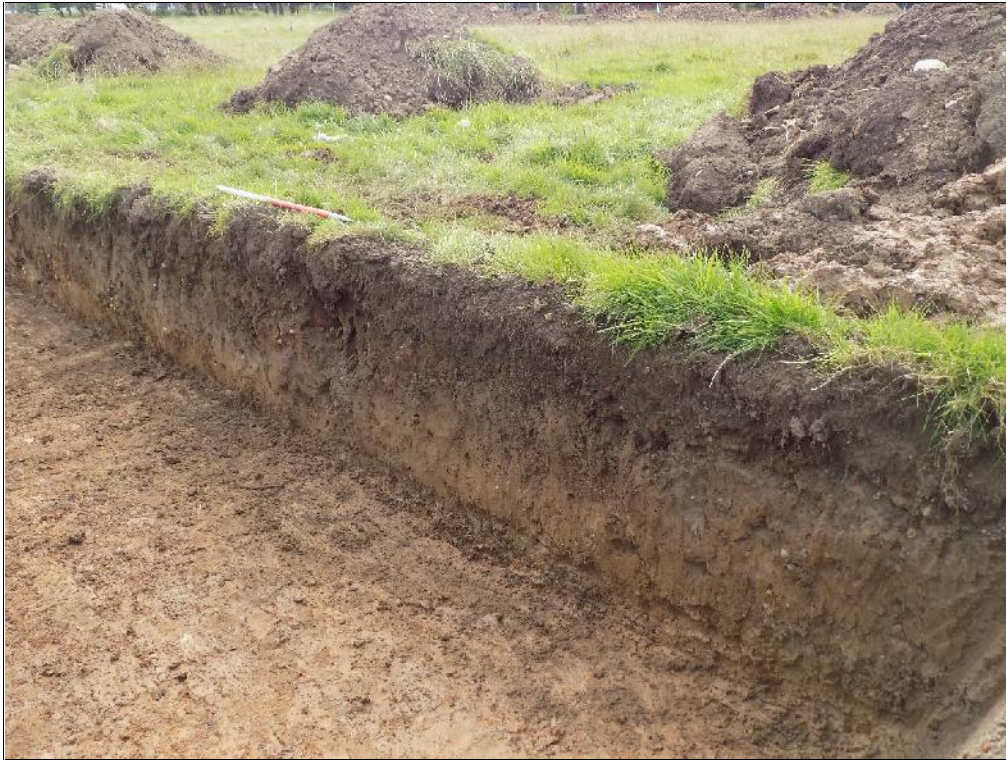
Plate 17: Trench 9 section showing crushed brick deposit (903), looking south

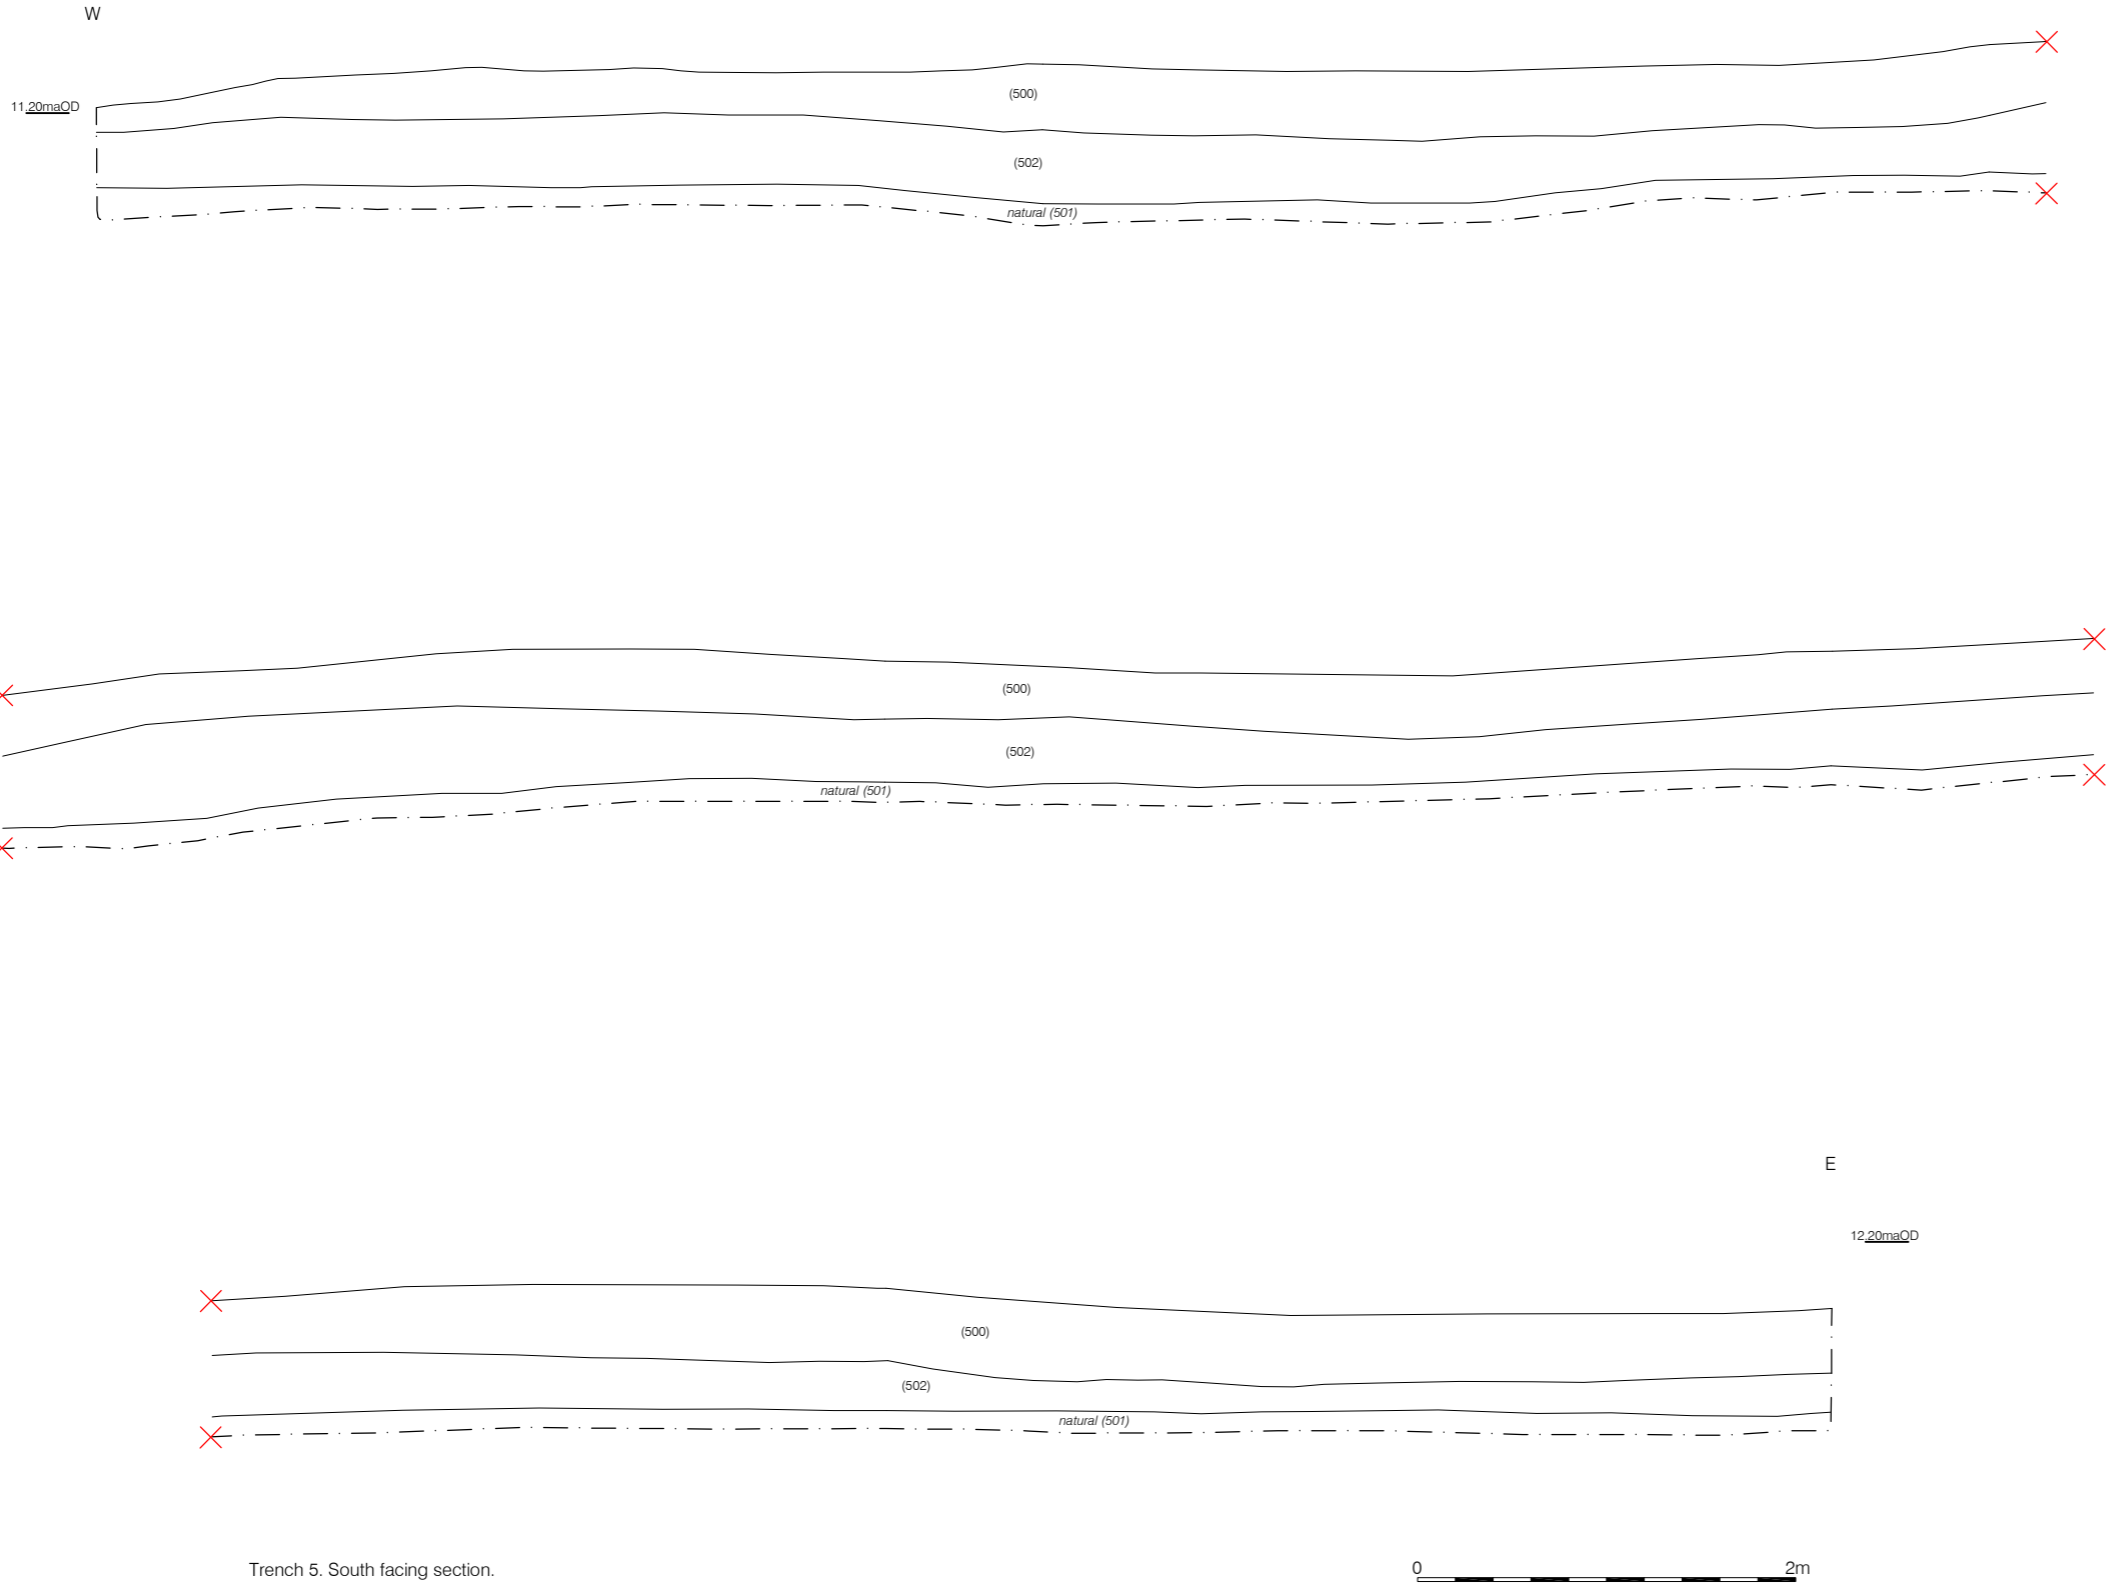
Figure 6: Trench 5 section.

Trench 5. South facing section.

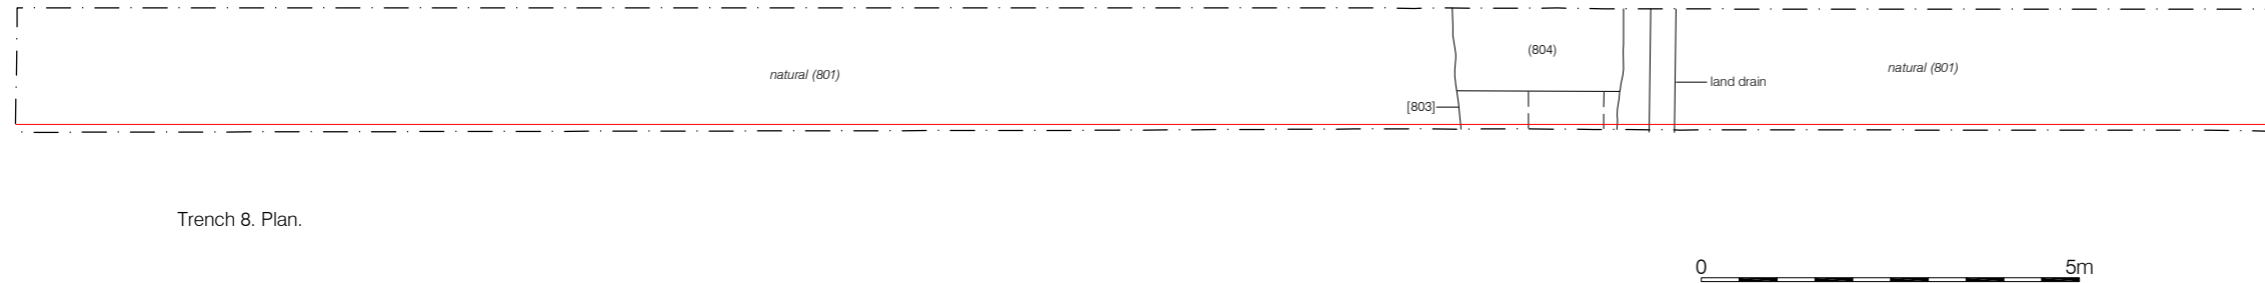
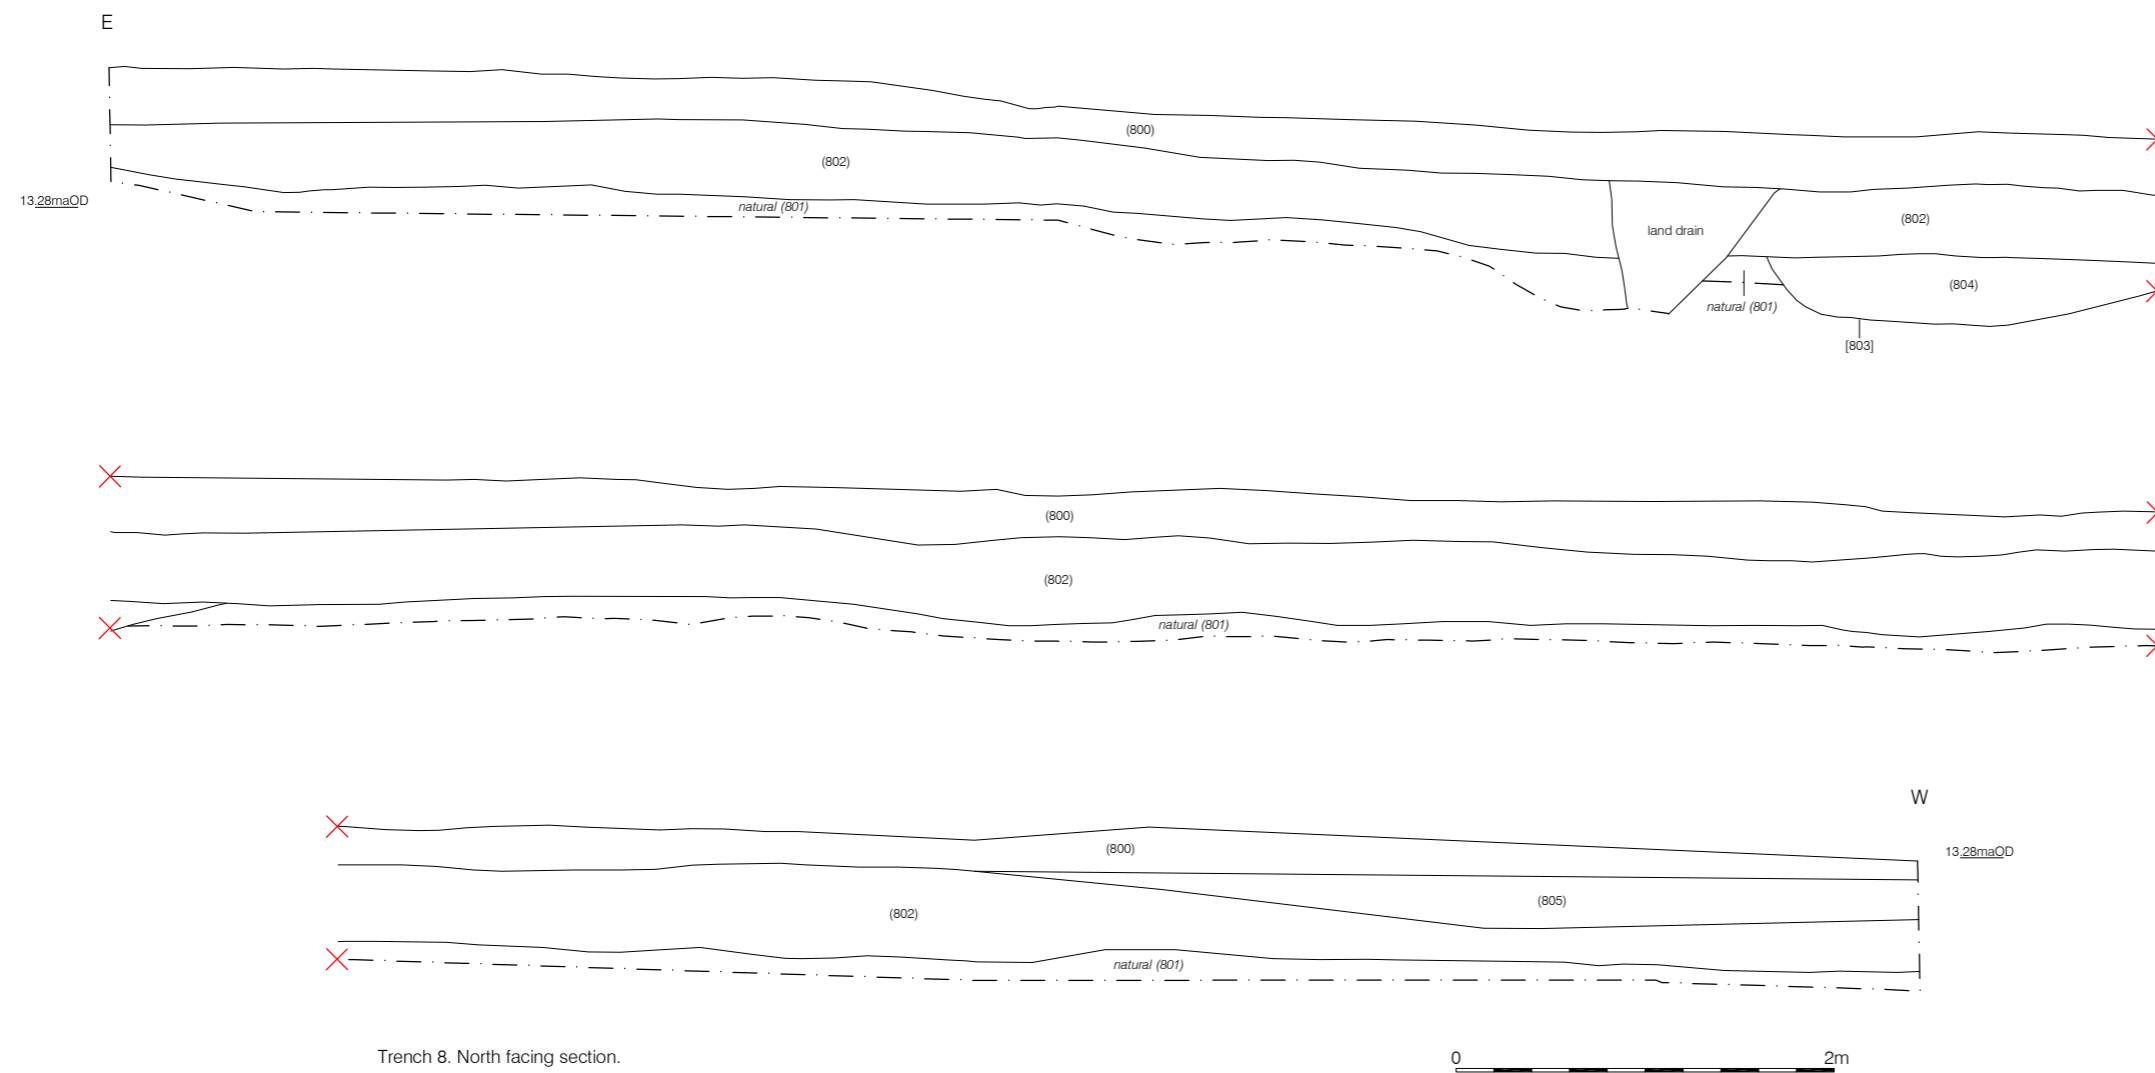
Figure 8: Trench 8 plan and section.

Trench 8. Plan.

Trench 8. North facing section.
