ELECTRICITY NORTH WEST

ELECTRICITY REFURBISHMENT SCHEME, DRUMBURGH, CUMBRIA

ARCHAEOLOGICAL EVALUATION REPORT

DATE ISSUED: August 2017
JOB NUMBER: CL11997
OASIS REFERENCE: wardella2-294498
GRID REFERENCE: NY 26386 59864
REPORT NUMBER: RPT-001

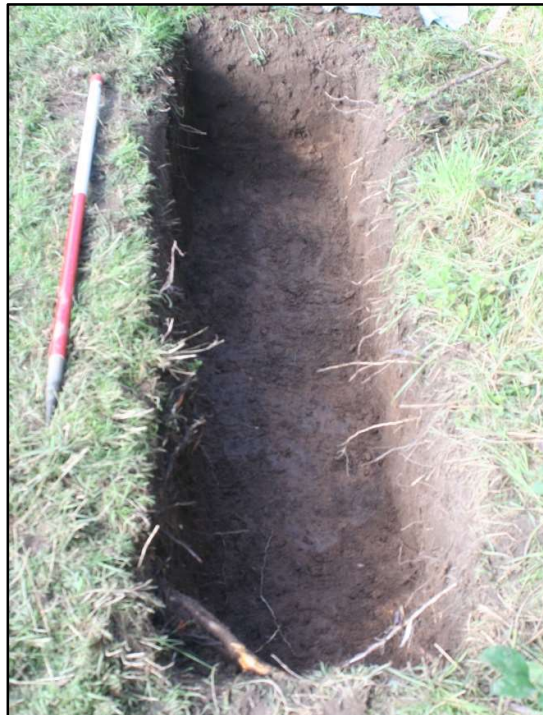
Plate 1: Test Pit 1 - West facing

4.2.2 Test Pit 1 was excavated to a maximum depth of 0.56m, revealing 0.30m topsoil (**100**) comprising soft dark grey brown sandy silt overlying a mid-grey brown sandy silt subsoil (**104**) (Plate 1). The natural geological sub-state of a soft orange sandy clay was reached at a depth of 0.50m.

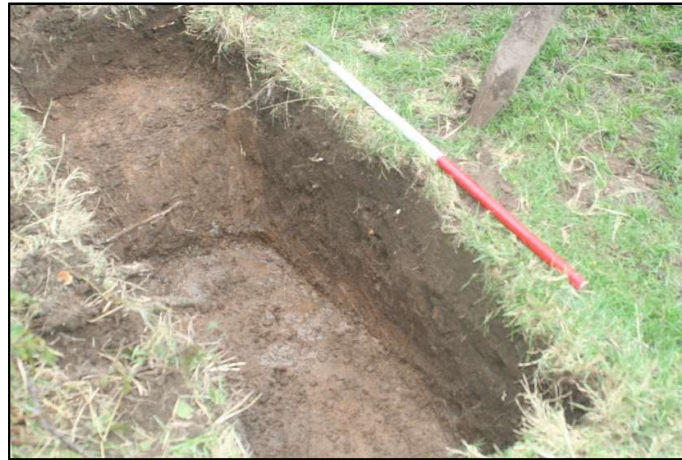
Plate 2: Test Pit 2 showing cut [102] – South-east facing

4.2.3 Test Pit 2 was excavated to a maximum depth of 0.60m, revealing a steep, almost vertical cut [**102**], filled with a single deposit of mid grey brown humic silty clay (**103**) and sealed by 0.30m topsoil (**100**) (Plate 2). A single fragment of post medieval

pottery was recovered from the base of the feature.

6.2 A steep sided feature [102] was noted in Test Pit 2 to the east of the former school house, running at 90° to the projected line of Hadrian's Wall (Plate 2). While historic mapping does not show anything in this location, this is likely that this may be the remains of a post medieval field boundary or pit. A single sherd of red earthenware pottery dating to the 18th-19th century was recovered from the base of fill (103).

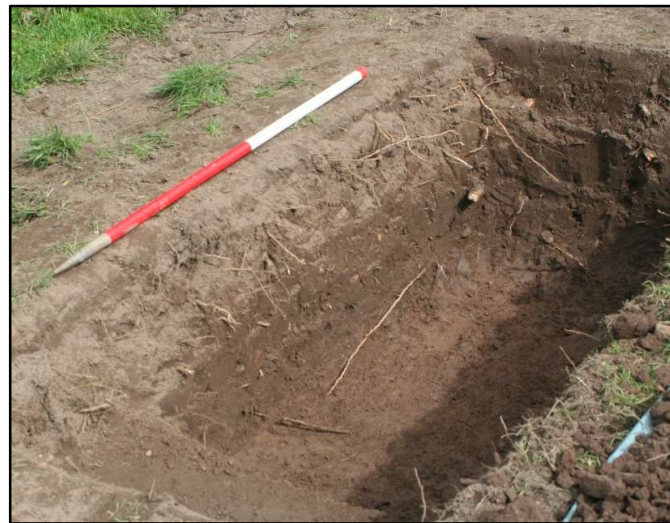
Plate 3: Test Pit 3 – North-east facing

4.2.4 Test Pits 3 and 4 were located to the south of poles 63001LO3933 and 63001LO3931 and orientated east – west (Figure 6). They measured 1m x 2m and were excavated to a maximum of 0.65m revealing a maximum of 0.30m topsoil (**100**), sealing an average of 0.30m subsoil (**104**), which overlaid the orange brown natural substrate (**101**) (Plate 3 and 4).
