CUMBRIA

HERITAGE DESK BASED ASSESSMENT

DATE ISSUED: December 2017
JOB NUMBER: CL12049
OASIS REFERENCE: wardella2-299398
REPORT NUMBER: RPT-001

PROJECT:
Cumbria Flood Alleviation Scheme

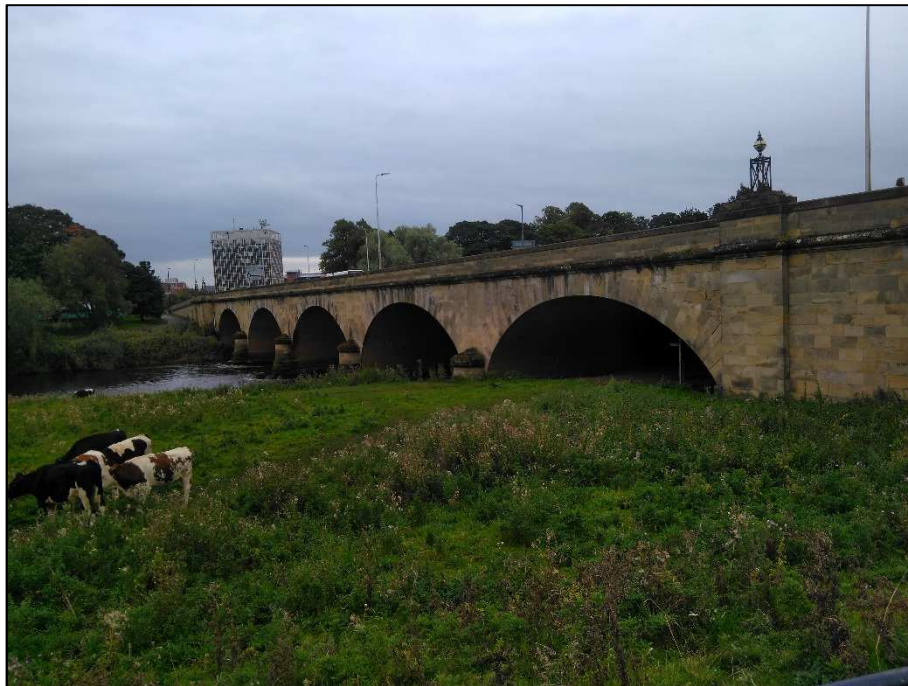
Plate 1: Grade I listed Eden Bridge (A3.2, Asset 116), possibly affected by the arch clearance

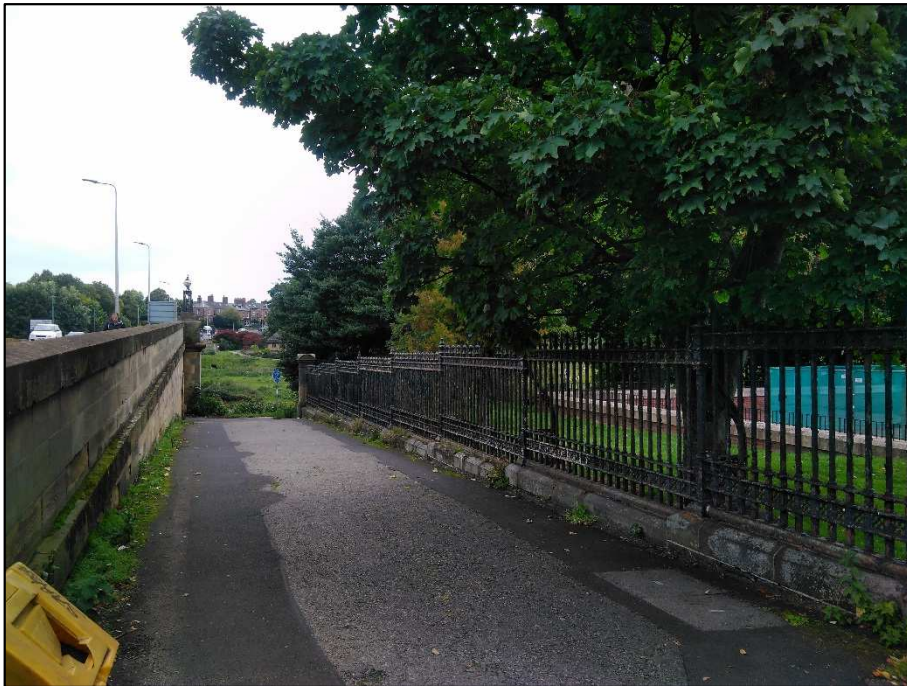
Plate 2: Grade II listed Wall & Railing to the west of the Sands Centre (A3.2, Asset 115)

piers and railings to the Sands Centre, formerly associated with the Cattle Market (A3.2 Assets 115 and 188), that are to be improved, this will have a potentially large impact, especially if it involves replacing them.

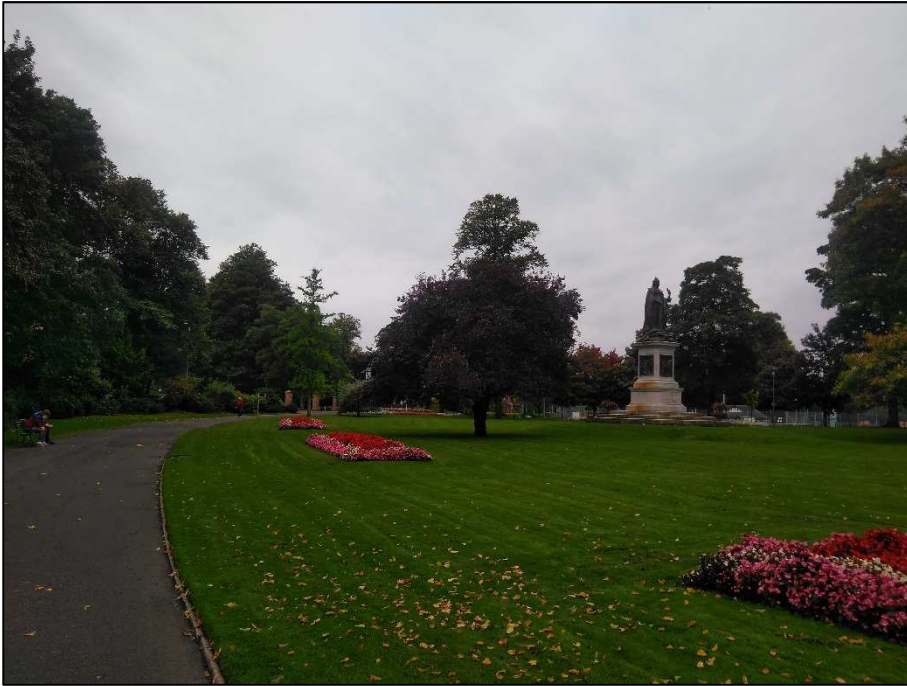
Plate 4: Grade II listed Statue of Queen Victoria (A3.2, Asset 14)

- 4.2.25 There may be some impact upon the setting of the grade II listed statue of Queen Victoria (A3.2 Asset 14, Plate 4) caused by the proposed Bitts Park wall and embankment improvements. As this will presumably involve a larger wall than presently, and larger embankments, this impact is not expected to be large, as it is merely improving defences that are already in existence.

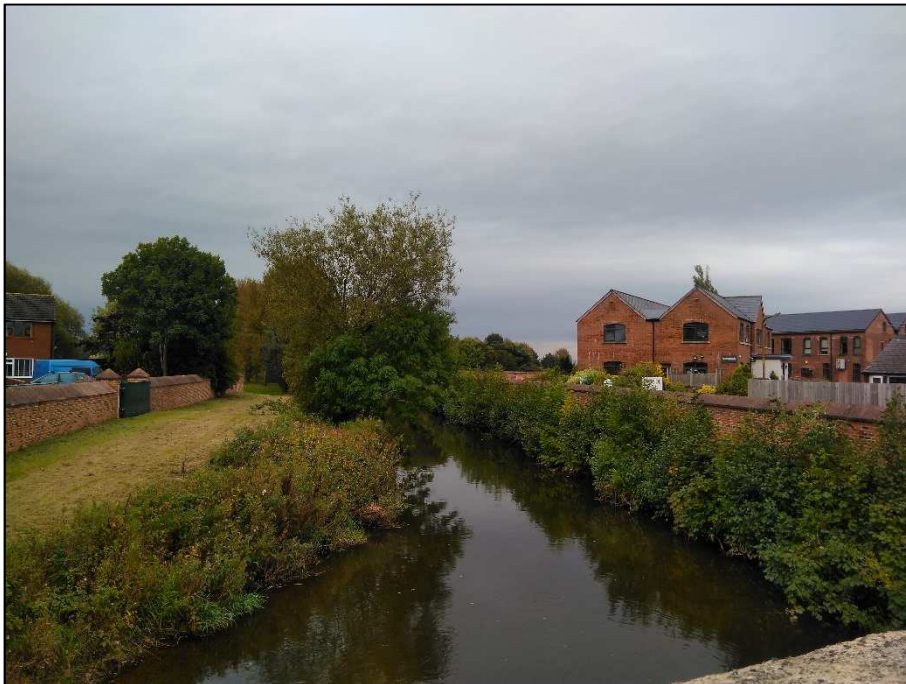
Plate 6: View from Botcherby Bridge towards WHS section (A3.3, Asset 8)

- 4.3.13 **Potential Impacts:** the proposed works at Botcherby Bridge (A1.3, Asset 6) is located slightly within the buffer zone of the Hadrian's Wall World Heritage Site (A3.3, Asset 8, Plate 6). Although it is a heritage asset of very high value, this is only a small section of work which would have low impact overall on the heritage asset. Furthermore, these works would not impact upon its outstanding universal value.

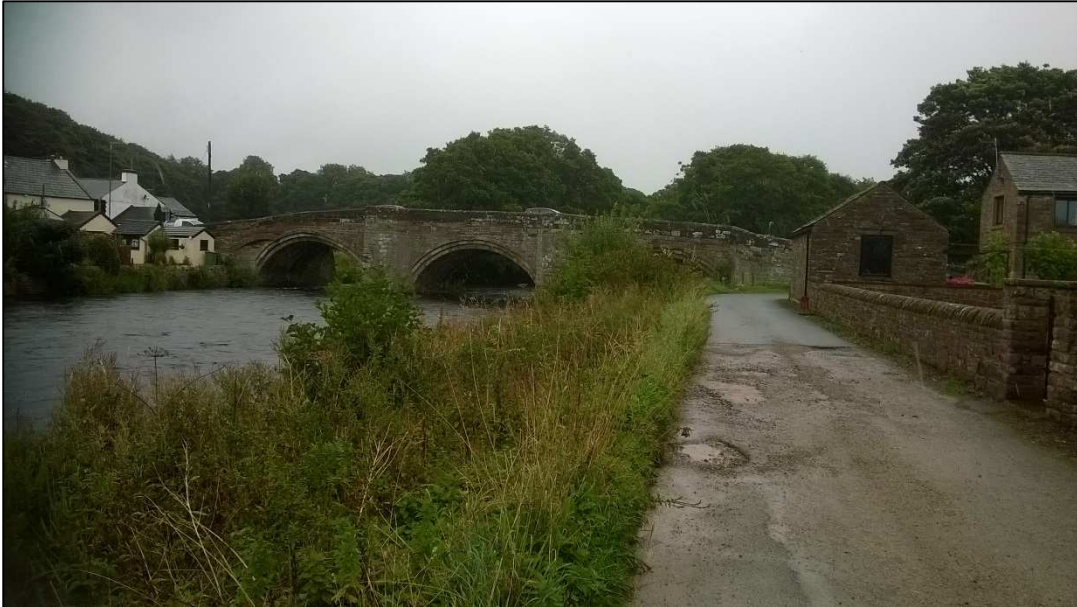
Plate 7: Eamont Bridge (A3.5, Asset 1/11) with Bridge End to the south (A3.5, Asset 2)

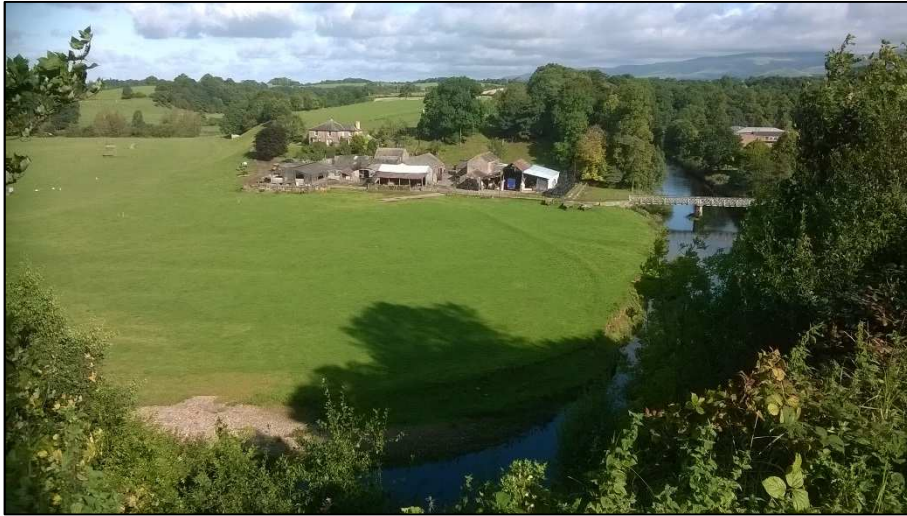
Plate 9: Holme Farm from The Banks facing north, showing bank (A1.6, Asset 23)

- 4.6.14 Two banks of unknown date and function were observed during the site visit. These are a bank at Holme Farm (A1.6, Asset 23; Plate 9) and a bank at Rampkin Pasture (A1.6, Asset 24; Plate 10). They have also been noted on LiDAR images (Plate 11). A small structure was seen to the west at Rampkin Pasture on the 1899 Second Edition OS map (A1.6, Asset 25), but not visible during the walkover survey.

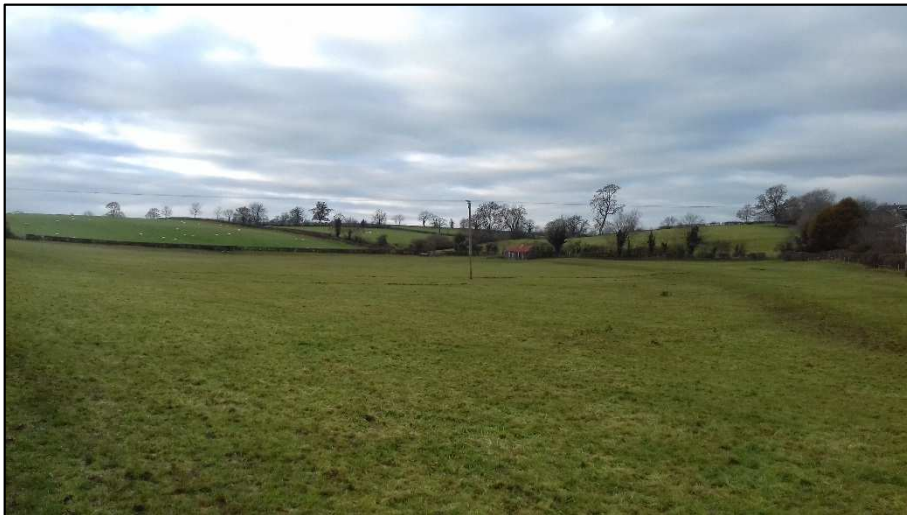
Plate 10: Bank at Rampkin Pasture (A1.6, Asset 24), facing west-south-west

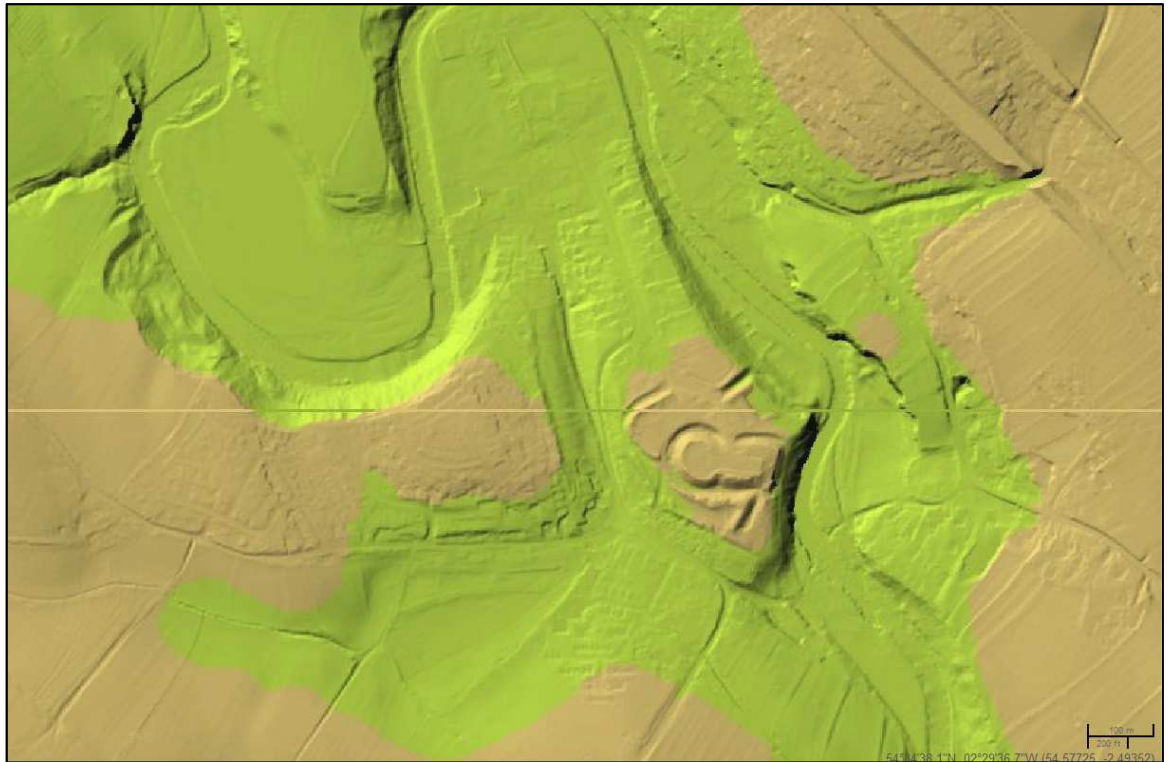
Plate 11: Lidar image, banks at Holme Farm and Rampkin pasture (A1.6, Assets 23, 24)

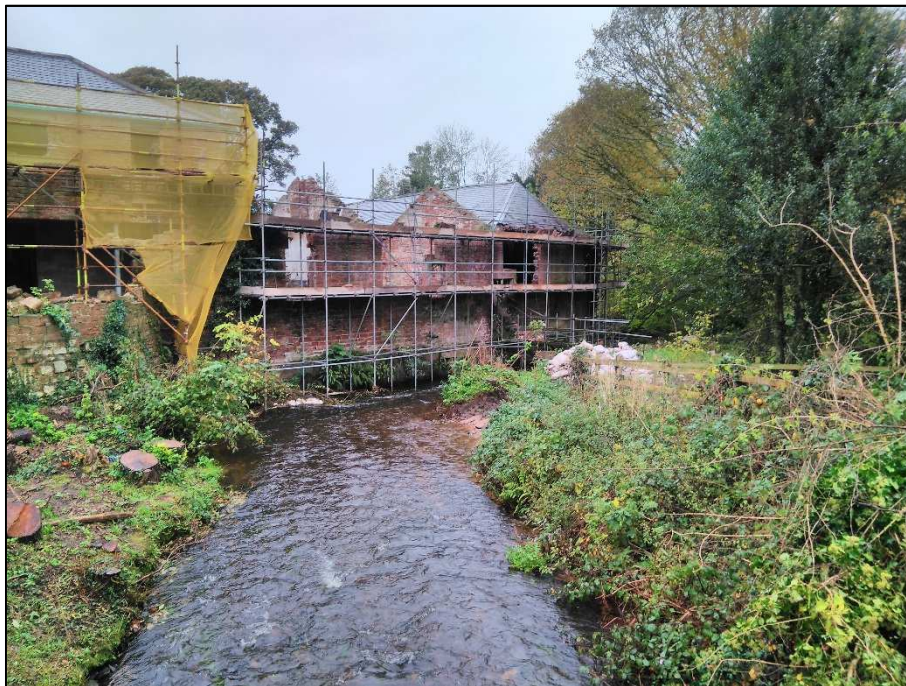
Plate 12: Location of Holme Eden Farm (A1.7, Asset 1)

- 4.7.17 Also, some minor impact is possible for archaeological remains of Holme Eden Farm (A1.7, Asset 1, Plate 12), although this structure of low value only.
- 4.7.18 Any below ground works may impact upon thus far unknown below ground archaeology.

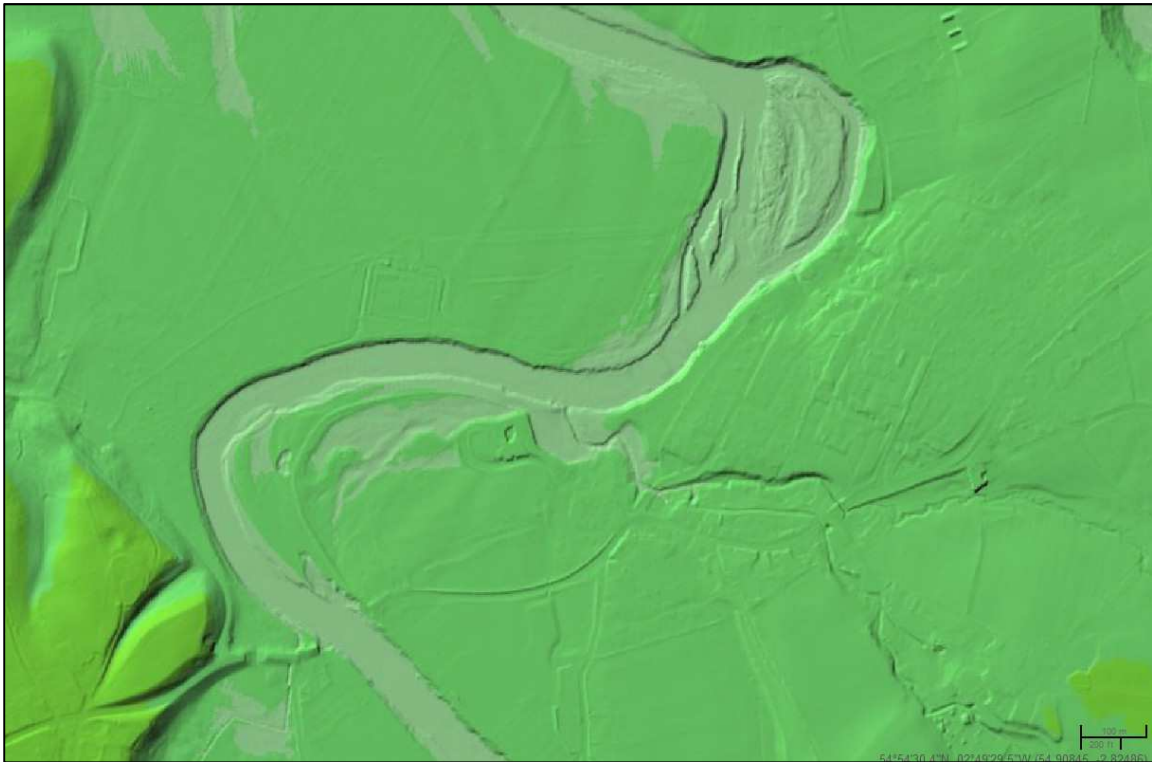
Plate 13: Warwick Park with a north to south aligned bank (A1.7, Asset 4)

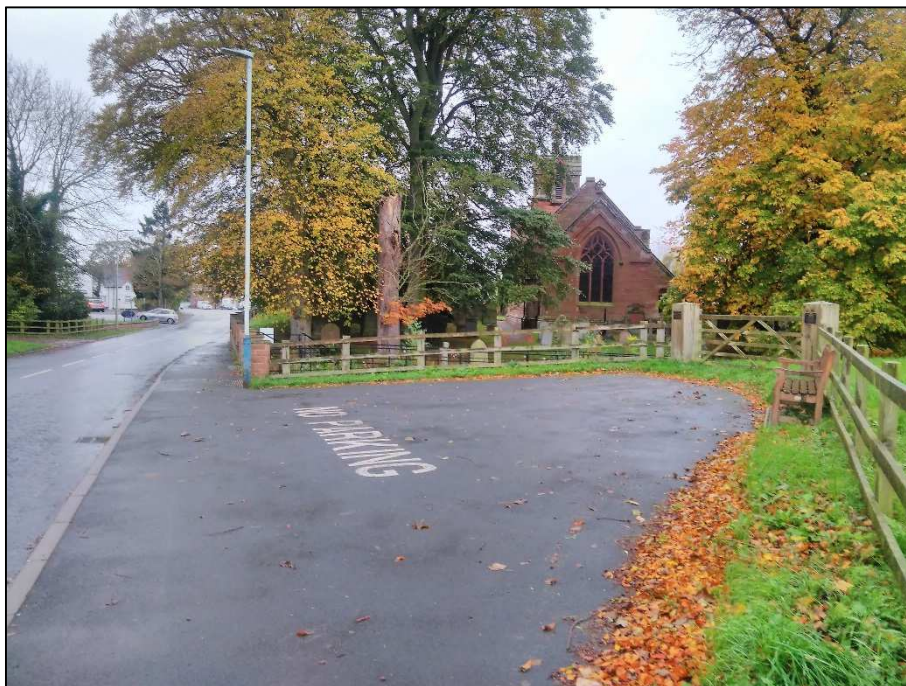
Plate 15: Church of St John (A3.8, Asset 9) opposite to the proposed site of a barrier

(A3.8, Asset 9, Plate 15) by the proposed installation of a demountable barrier.

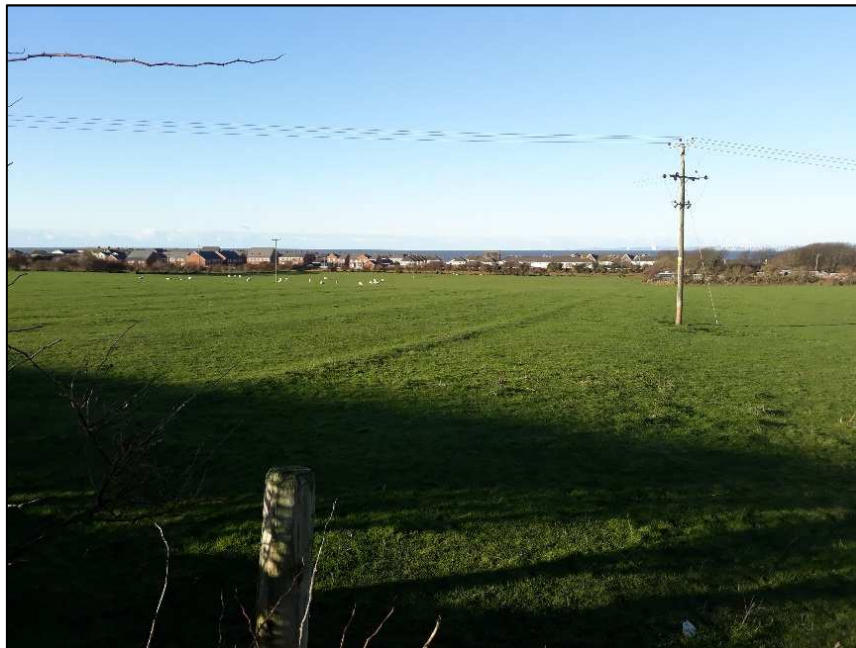
Plate 20: Pennygill Lane direct impact area and A1.10, Asset 4 with possible plough lines to south-west noted during site visit, facing west

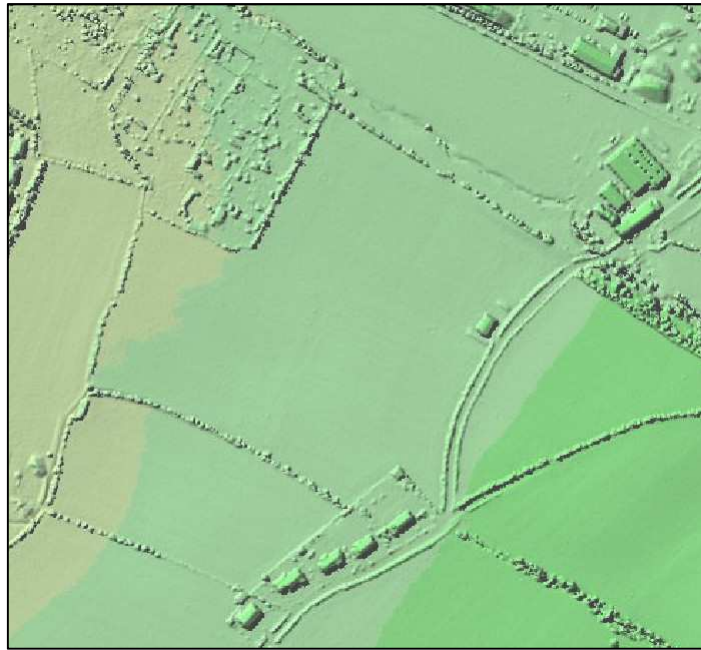
Plate 21: Lidar imagery showing Penngill Lane direct impact area and A1.10, Assets 3 and 4

4.10.13 A former field boundary is known from First Edition Ordnance Survey mapping in the area of direct impact south of West Lane (A1.10, Asset 1, Figures 20 and 21). This was not detectable on Lidar imagery, although another, north-east south-west aligned one is discernible (A1.10, Asset 2, Figures 20 and 21; Plate 18). Neither are visible on Google Earth imagery or were noted during the site visits. Two former field boundaries also lie within the area of direct impact at Pennygill Lane, known from First Edition Ordnance Survey mapping (A1.10, Assets 3 and 4). The north-west south-east orientated one is visible on Google Earth imagery of 2003 and was noted during the site visits (A1.10, Asset 4; Plates 19 and 20), and both seem to appear on Lidar imagery, as do possible plough lines adhering to these boundaries (Plate 21).

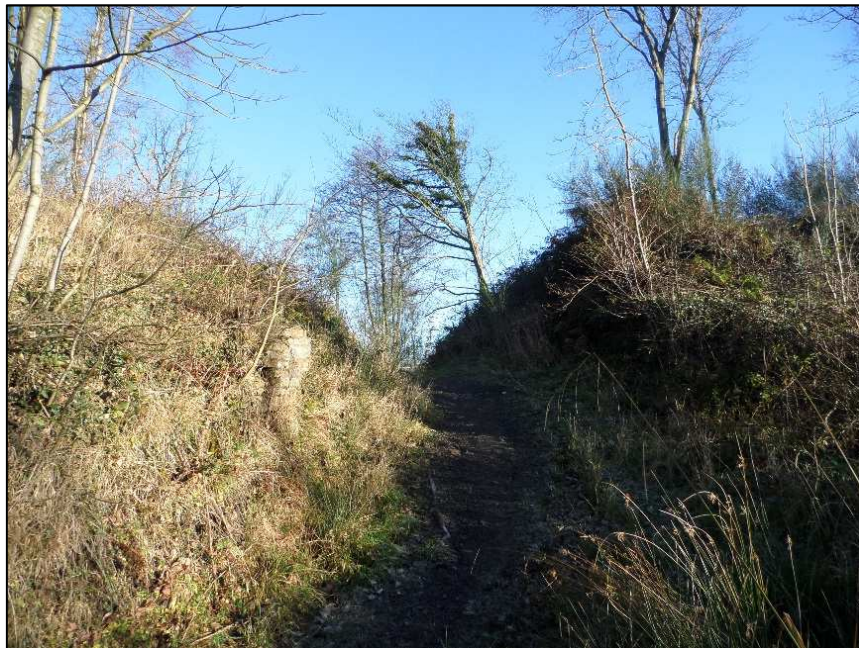
Plate 22: Bridge Abutments (A1.10, Asset 95) at site visit, facing north-east

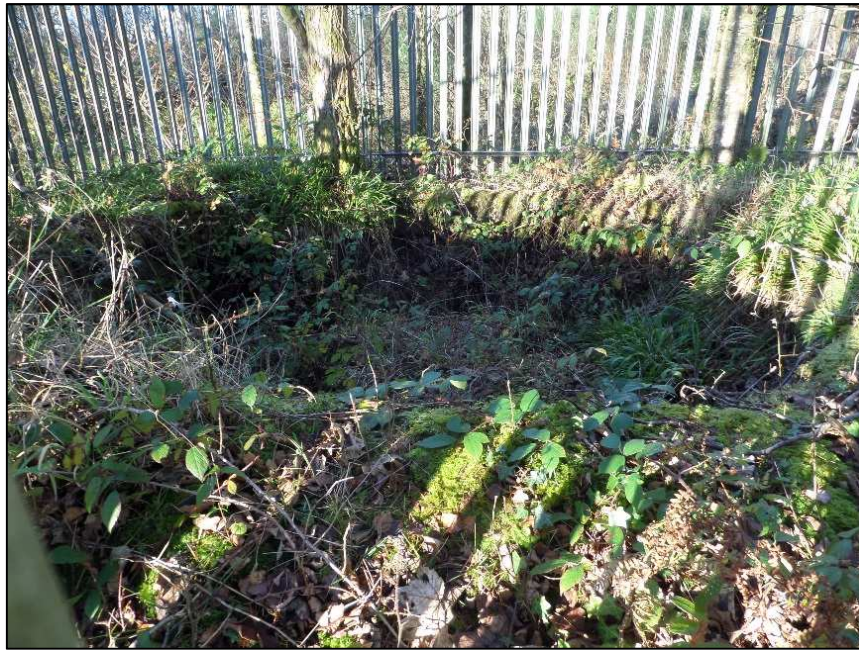
Plate 23: Shaft (A1.10, Asset 89) at site visit, facing north-west

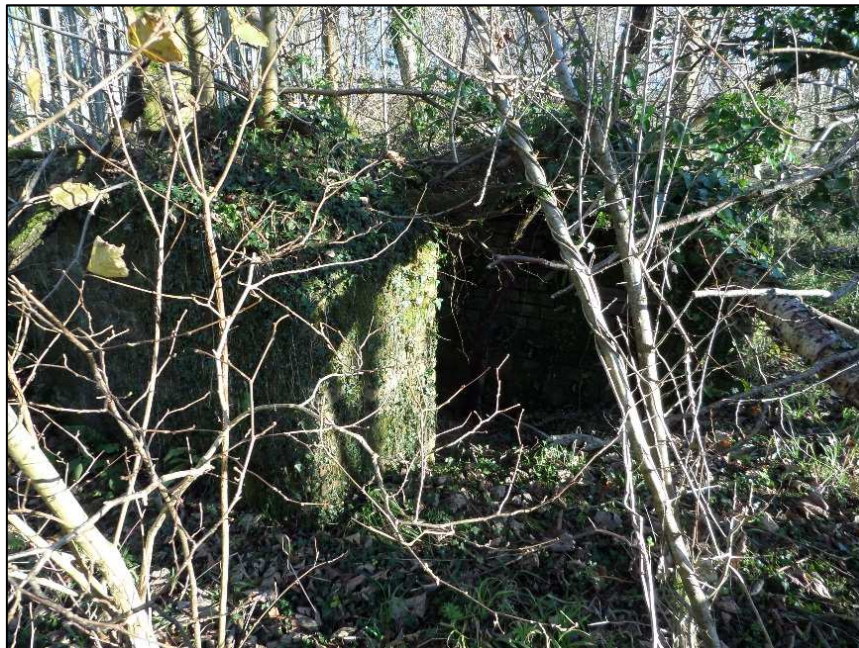
Plate 24: Shaft (A1.10, Asset 90) at site visit, facing north-east

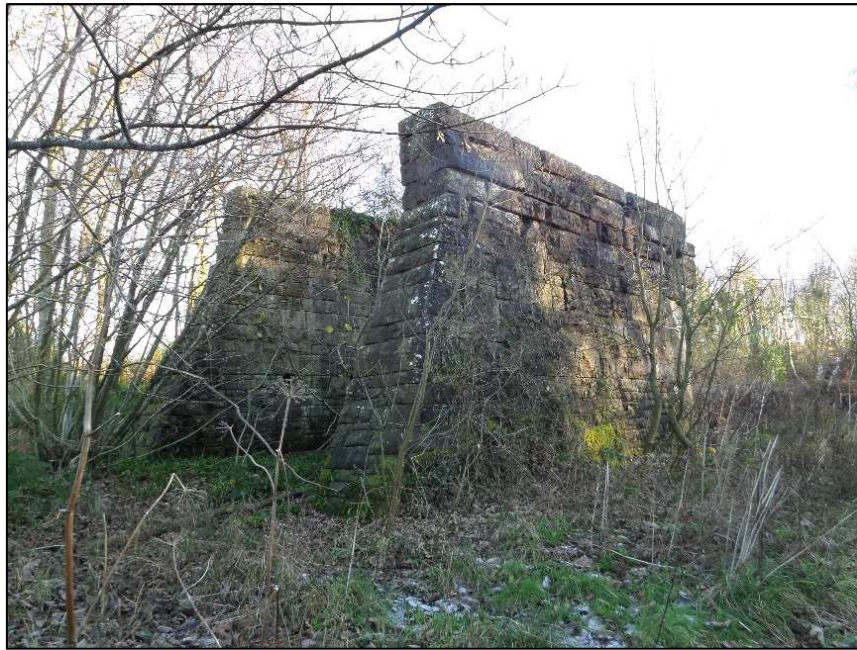
Plate 25: Remains of former buildings (A1.10, Asset 88) at site visit, facing north-west

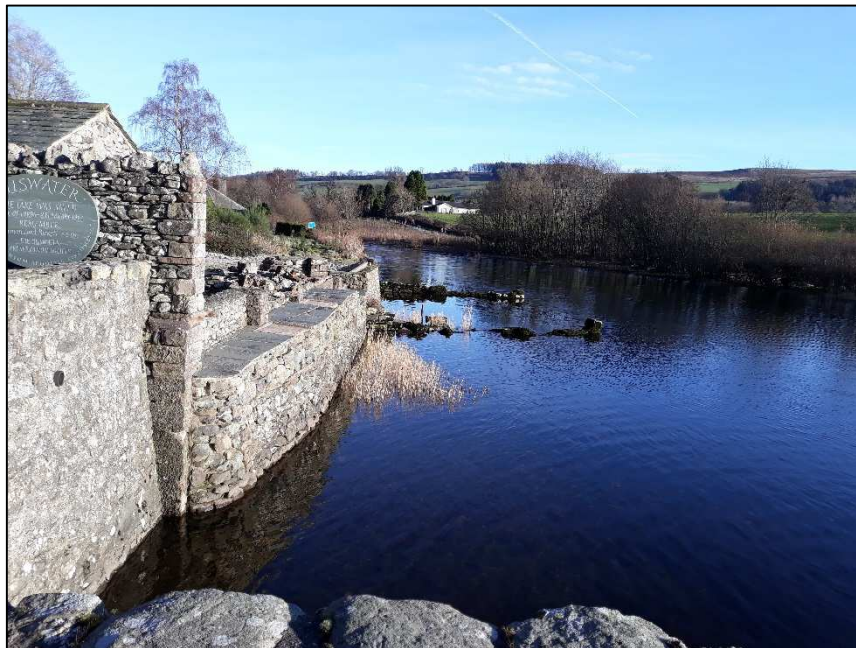
Plate 26: The remains of the jetties (A1.2, Asset 13)

- 4.11.20 There is a possible direct or indirect impact upon the remains of Pooley Bridge (A3.11, Asset 5) and the jetties (A1.11, Asset 13) to the south of it, although any impact is probably of minor magnitude. The bridge has been replaced by a temporary bridge, after the floods of 2015. Assessing the impact of the proposed works on this site is thus difficult. Below ground works may also impact upon the remains of the outbuildings at Ash Howe (A1.11, Asset 14).

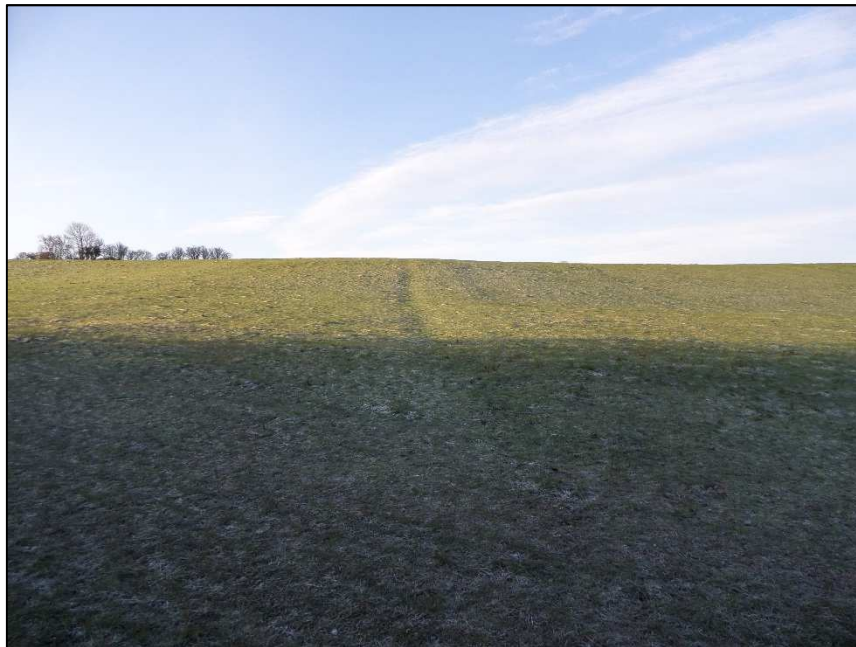
Plate 27: Possible previous field boundary (A1.12, Asset 68)

- 4.12.15 A possible former field boundary (A1.12 Asset 68) was observed during the site survey within the proposed works of upstream storage at Wiza Beck (Plate 27).

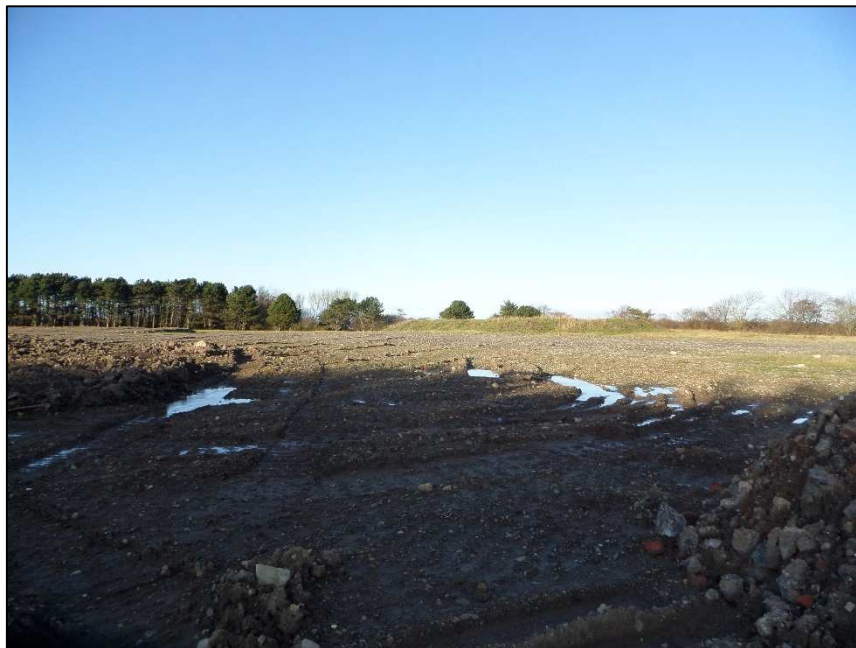
Plate 28: Levelled area at the proposed upstream storage at Eel Syke

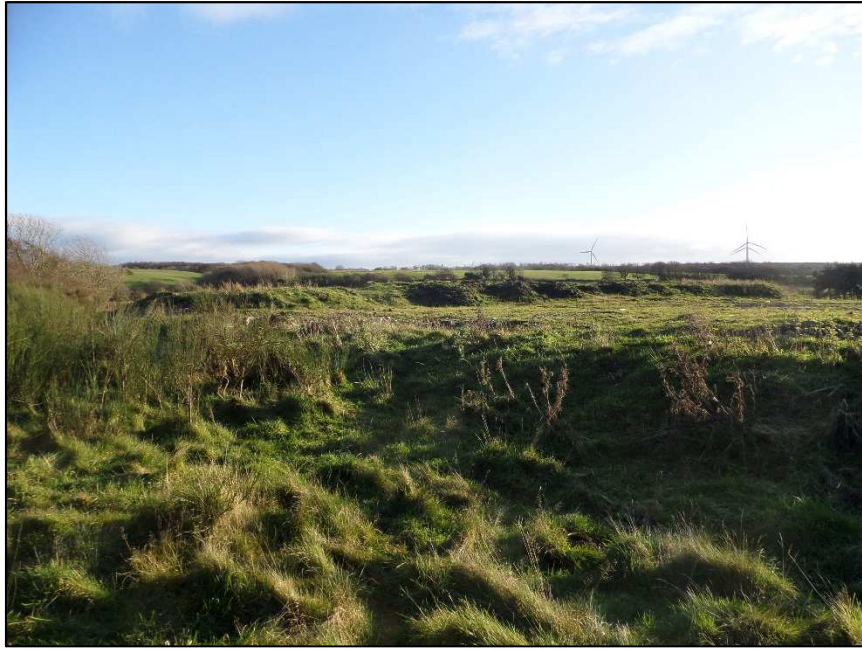
Plate 29: Soil bund at the proposed upstream storage at Eel Syke
