**ELECTRICITY NORTH WEST**

**LAND AT CARLISLE CASTLE,  
CARLISLE,  
CUMBRIA**

**ARCHAEOLOGICAL WATCHING BRIEF REPORT**

**FEBRUARY 2018**

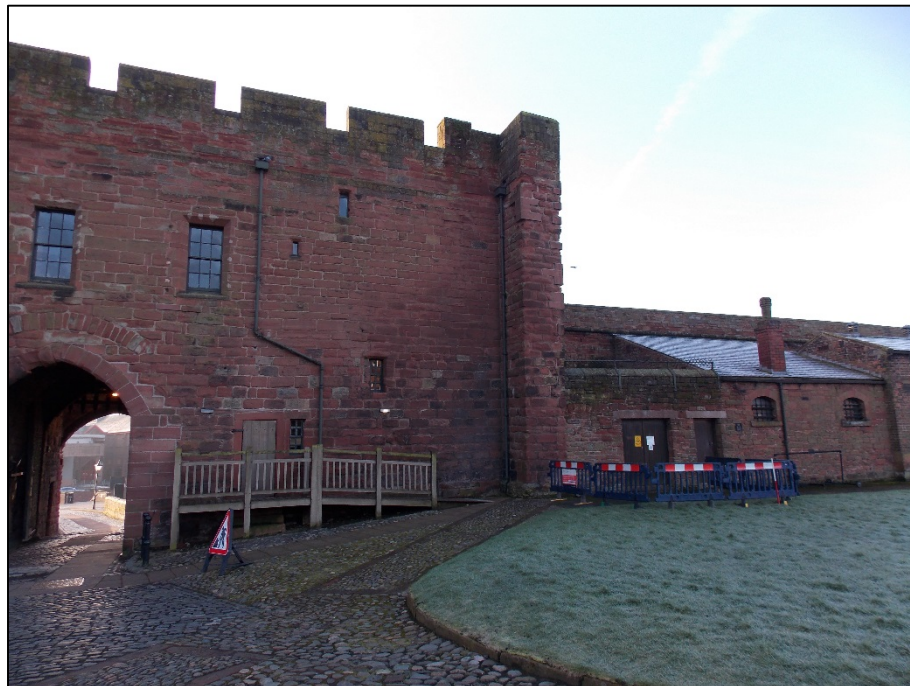
4.2.1 The groundworks carried out to repair a faulty high voltage electric cable were situated on the southern side of Carlisle Castle adjacent to the outer gatehouse (Figure 2; Plate 1). A tracked mini excavator using a straight edged bucket excavated a L-shaped trench adjacent to the wooden doors leading into a small compound for an electric substation.

*Plate 1: Location of groundworks. Safety barriers are to the front of the electric substation access doors, facing south-west*

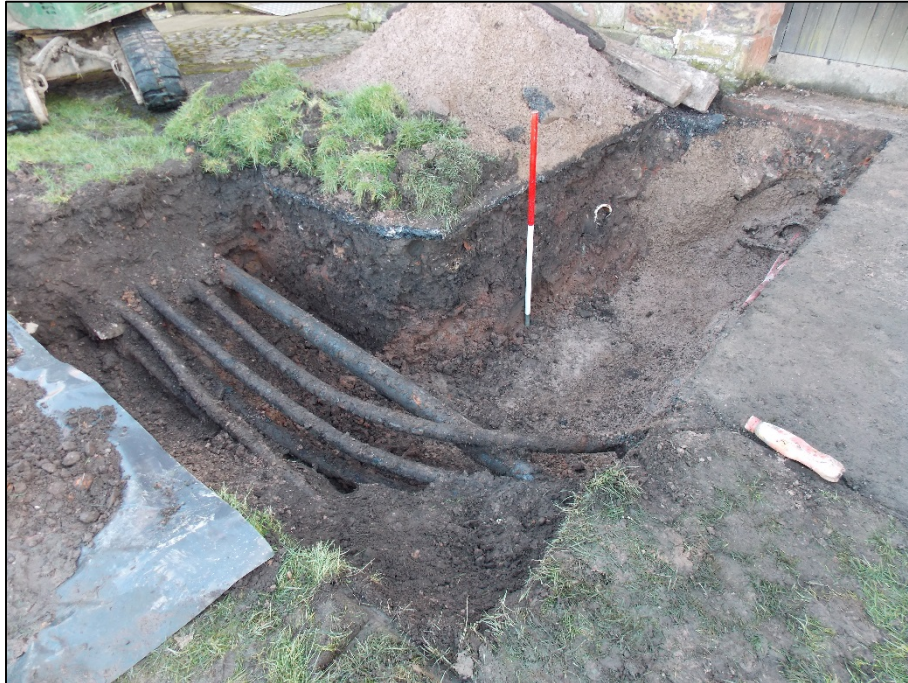
4.2.2 The west, south-west to east, north-east arm of the trench was situated on a grass covered area within the Castle grounds. It measured 2.33m in length and 0.90m in width and was excavated to a maximum depth of 0.70m. Made ground (**101**) consisting of a silty / clay matrix containing red sandstone fragments and sub-rounded stones

was excavated to a depth measuring 0.40m in depth. This was sealed by 0.30m of dark brown, silty, grass covered, topsoil (**100**). Several high voltage electric cables were observed within this trench at a depth of 0.40m (Plate 2).

*Plate 2: L-shaped trench showing exposed high voltage electric cables, facing south-east*

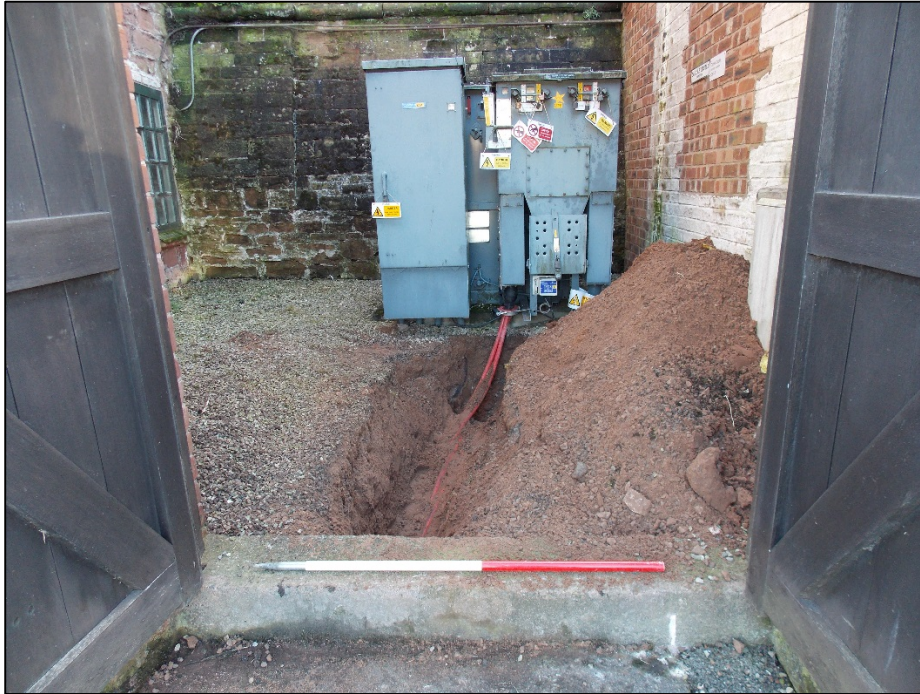
4.2.4 As the north, north-west to south, south-east arm of the trench entered into the substation compound it passed under a concrete threshold and extended for a distance measuring 2.80m up to the substation apparatus. The trench here again measured 0.70m in depth. Orange sand (**105**) measuring 0.58m in depth and

shrouding the electric cables, was sealed by 0.12m of grey, 15mm gravel (104) forming the surface (see plate 3).

*Plate 3: trench showing exposed high voltage electric cables and substation, facing south*

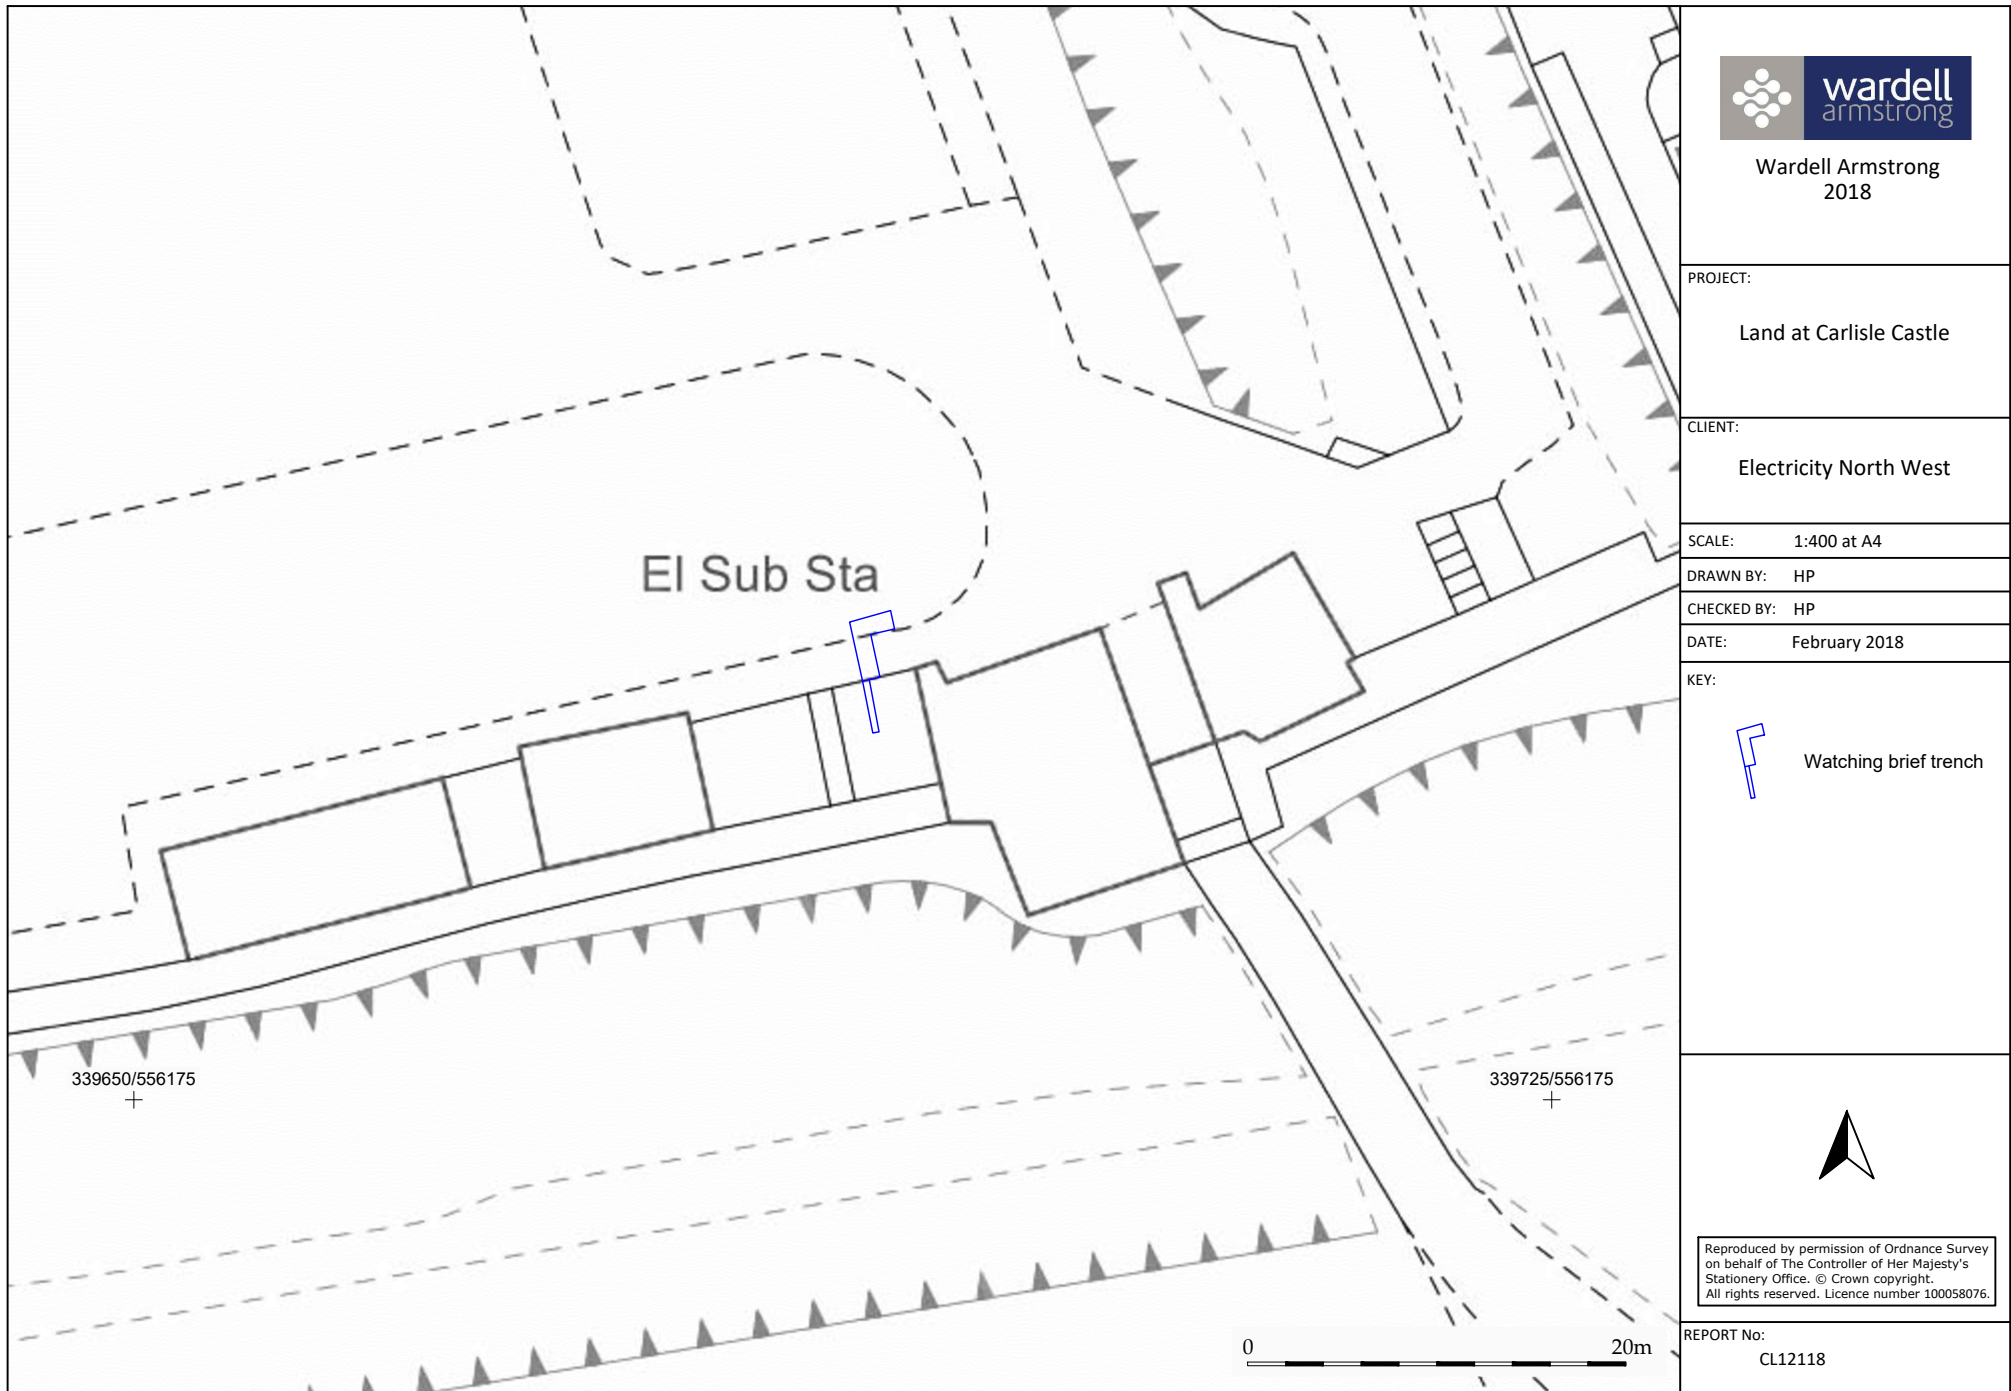
Figure 2: Trench location plan.

2.3.1 The watching brief comprised the monitoring of all groundworks occurring as part of the repair work carried out to a sub-surface high voltage electric cable situated adjacent to and immediately to the north of an existing substation within the grounds of Carlisle Castle (Figure 1). The groundworks involved the excavation of a L-shaped trench, exposing a series of high voltage electric cables (Figure 2).

3.1.1 Carlisle Castle is located close to the confluence of the River Eden and River Caldew to the north-west of the historic core of the city of Carlisle (Figure 1). The area affected by the groundworks lies towards the southern extent of the castle complex, west of the gatehouse and to the immediate north of an existing electricity substation (NY 39690 56198; Figure 2).
