ARCHAEOLOGICAL STRIP AND RECORD EXCAVATION REPORT

MARCH 2018

Rear of 14-18 The Calls, Leeds, West Yorkshire

Archaeological Strip, Map and Sample Excavation Report

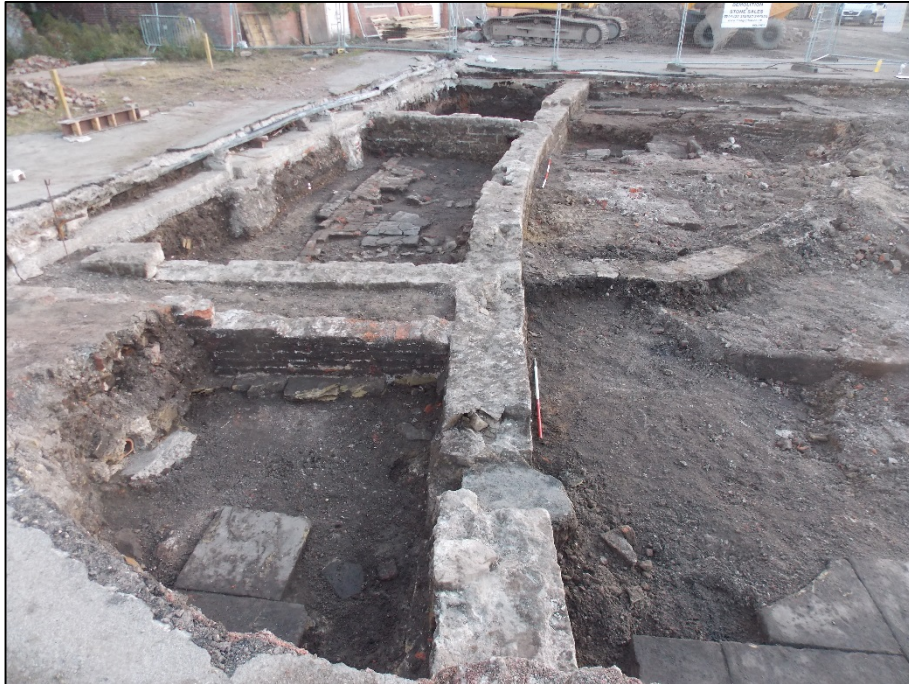
Plate 1; phase 4 sandstone walls (108) (curving), (110), (111) and red brick wall (109); facing east

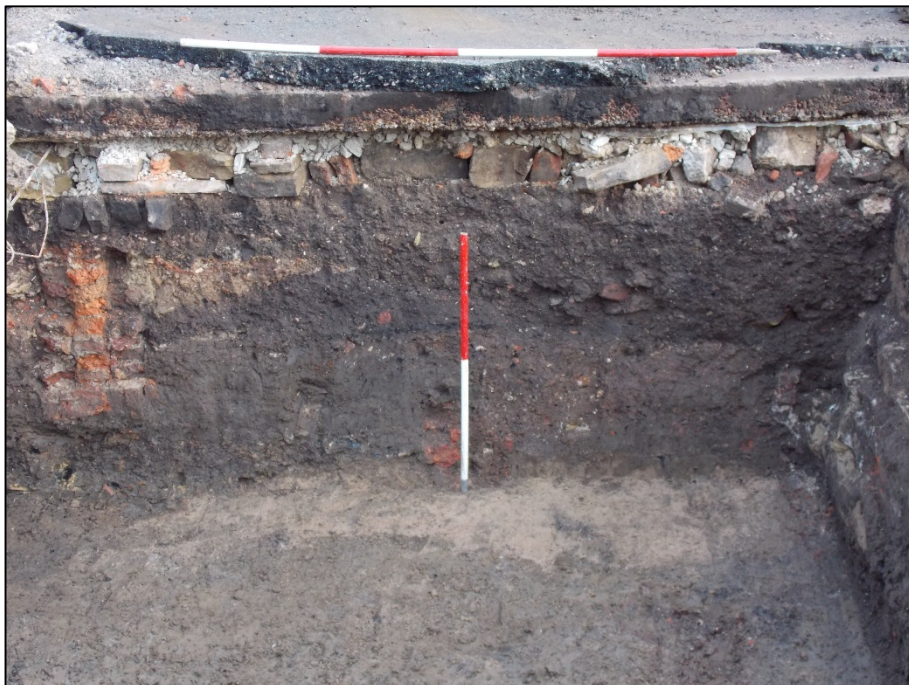
Plate 2; west facing section showing excavated depth to river sands (101) and (143); facing east

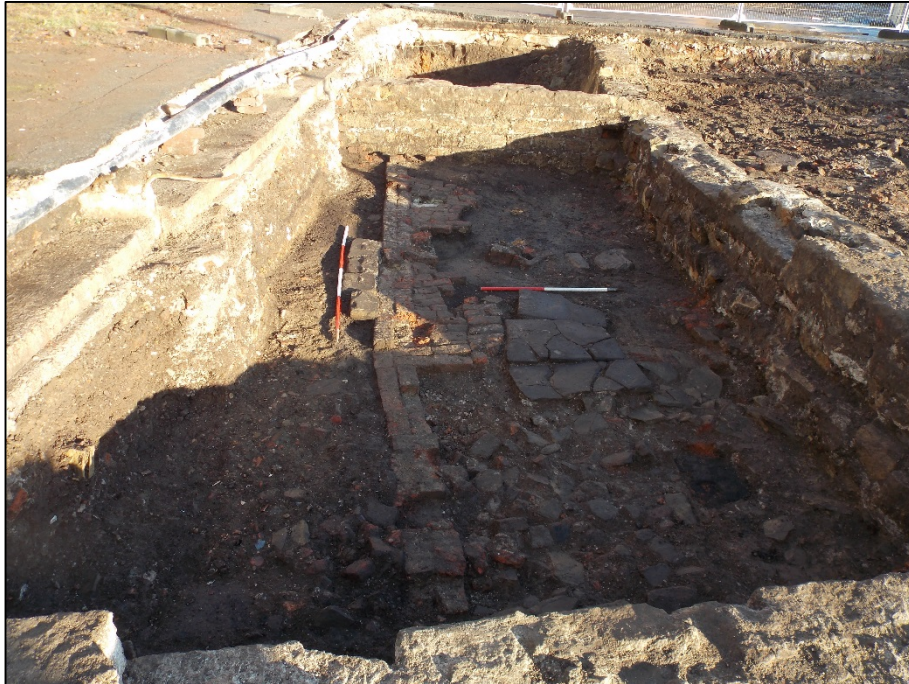
Plate 3; phase 2 structure (232) after initial cleaning; facing west

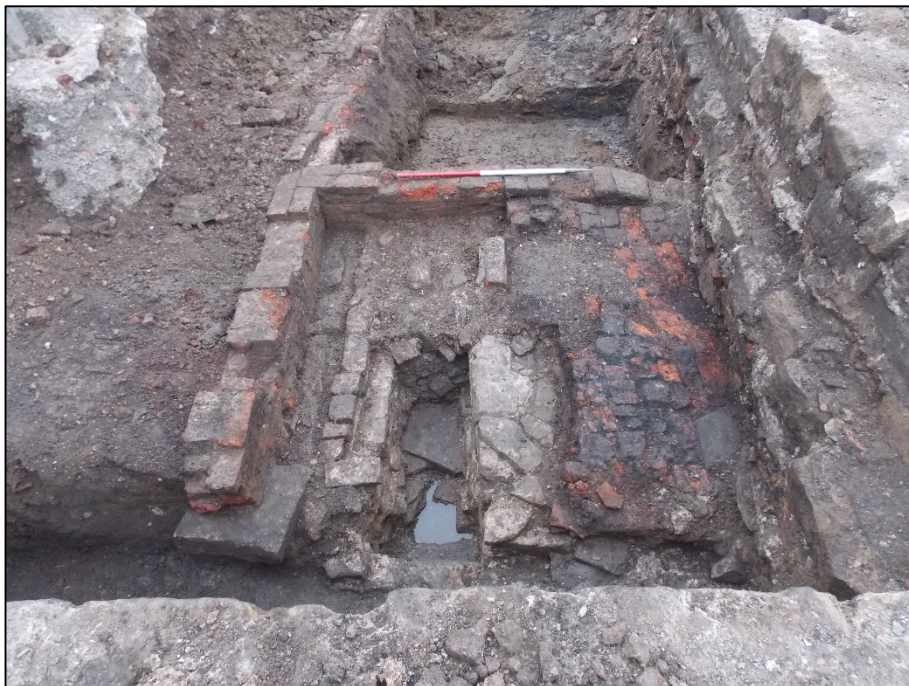
Plate 4; phase 2 possible early stoke hole/ash pit (137), (138), (233) and red brick surface (135); facing east

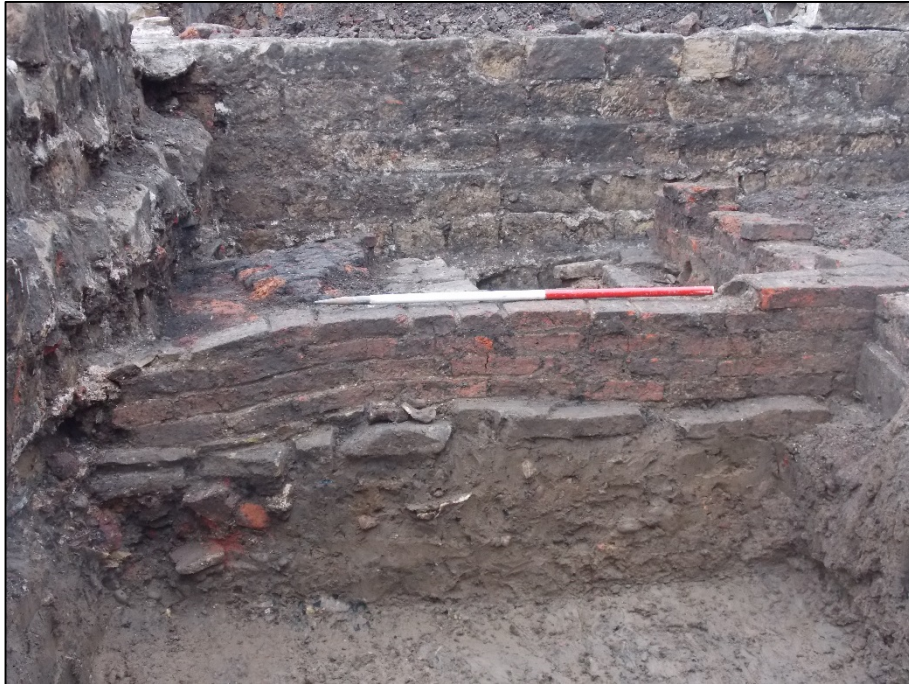
Plate 5; slump in Phase 1 wall (119) over Phase 1 ditch [140] cut into river sand (123); facing east

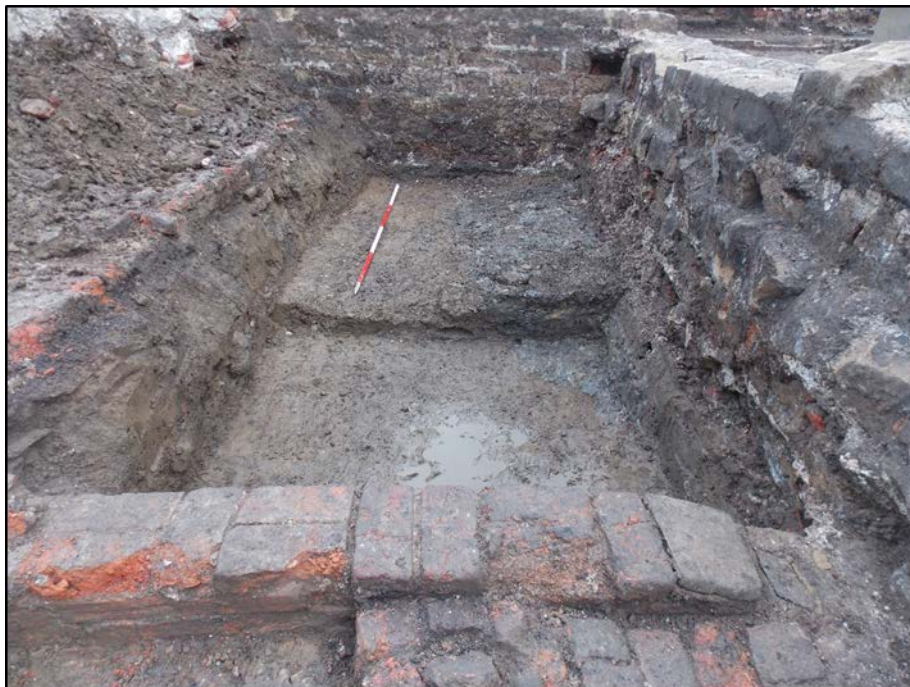
Plate 6; phase 2 wall (119) (foreground) and river sand (123) cut by remains of Phase 1 ditch [140], (141) (background); facing east

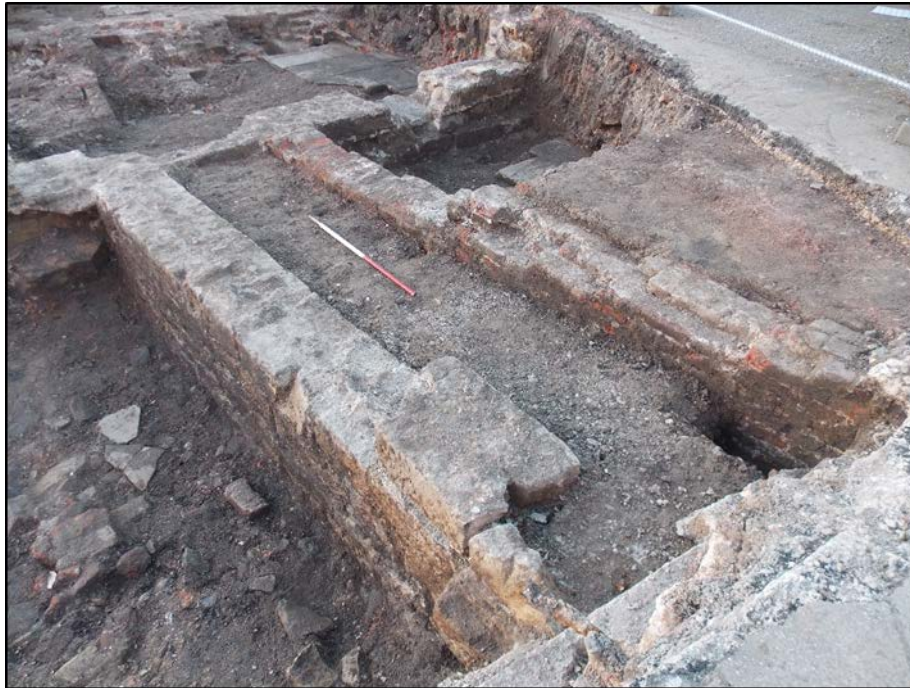
Plate 7; phase 4 sandstone wall (110), brick wall (109) and compacted floor surface (118); facing south-west

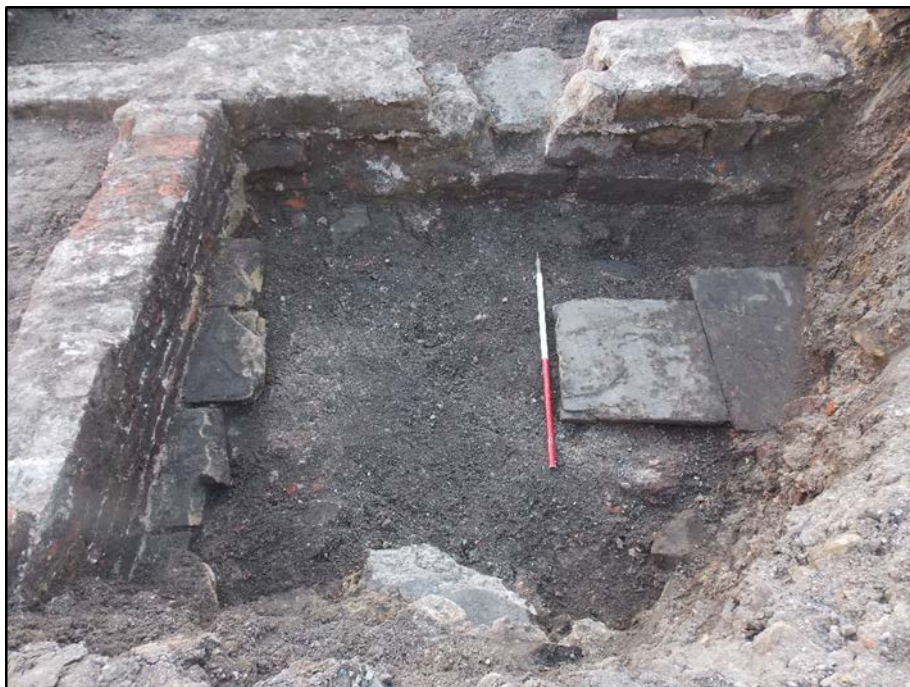
Plate 8; red brick wall (109) with slabbed foundation (234) and remains of slabbed floor surface (114); facing south

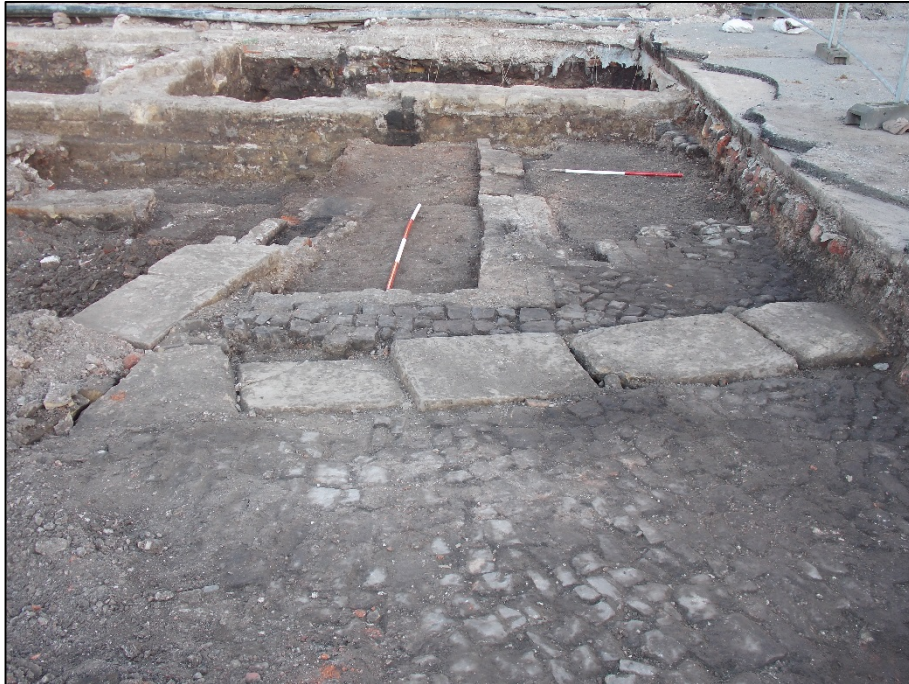
Plate 9; brick wall (131) (background) with stone sets and culverts (129) and (130) (foreground); facing north

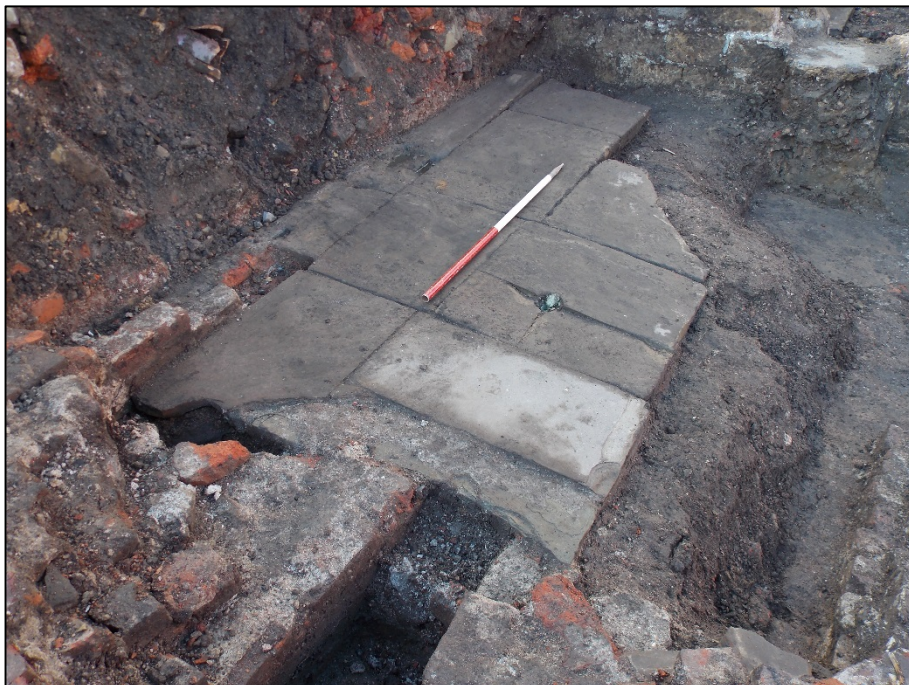
Plate 10; sandstone blocks (148) and sandstone slabs (146); facing north-west

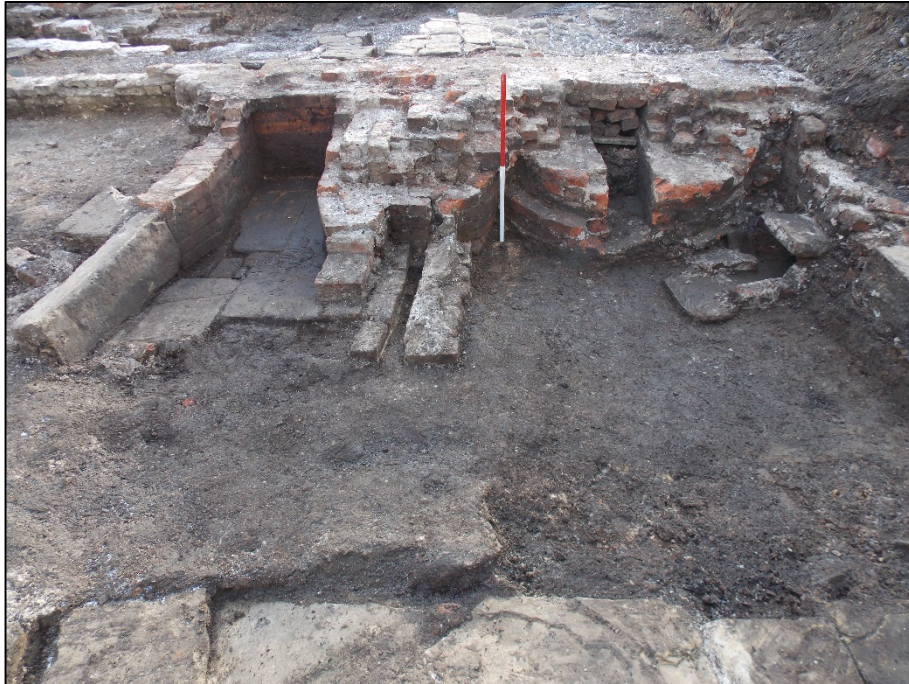
Plate 11; structure (147). Blocked, redundant stoke hole/ash pit (166,) (right) and later stokehole/ash pit (156) (left); facing south

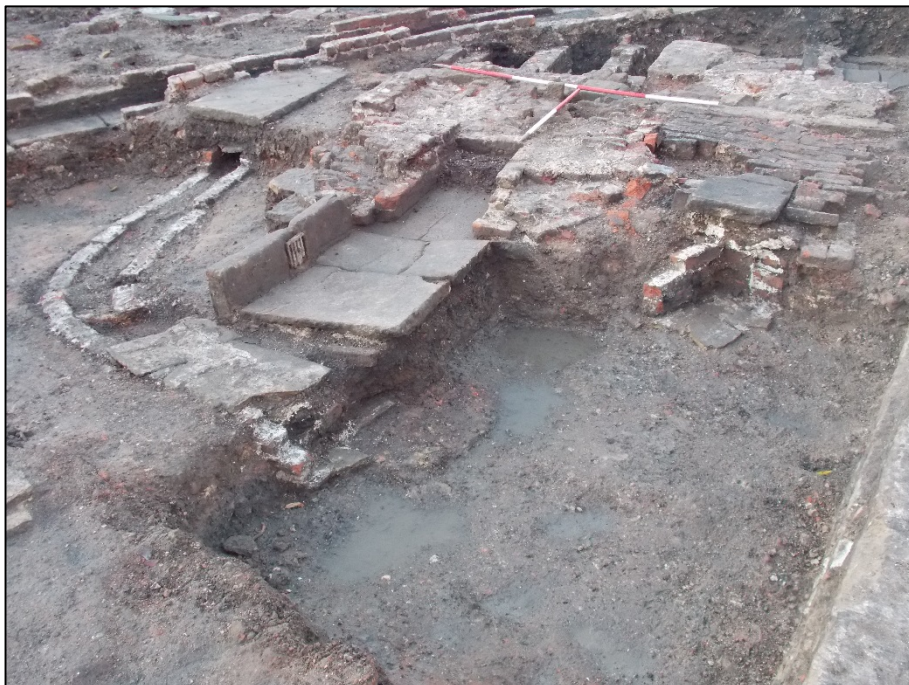
Plate 12; structure (144). Culvert (167) and drain (169) in foreground; facing south-west

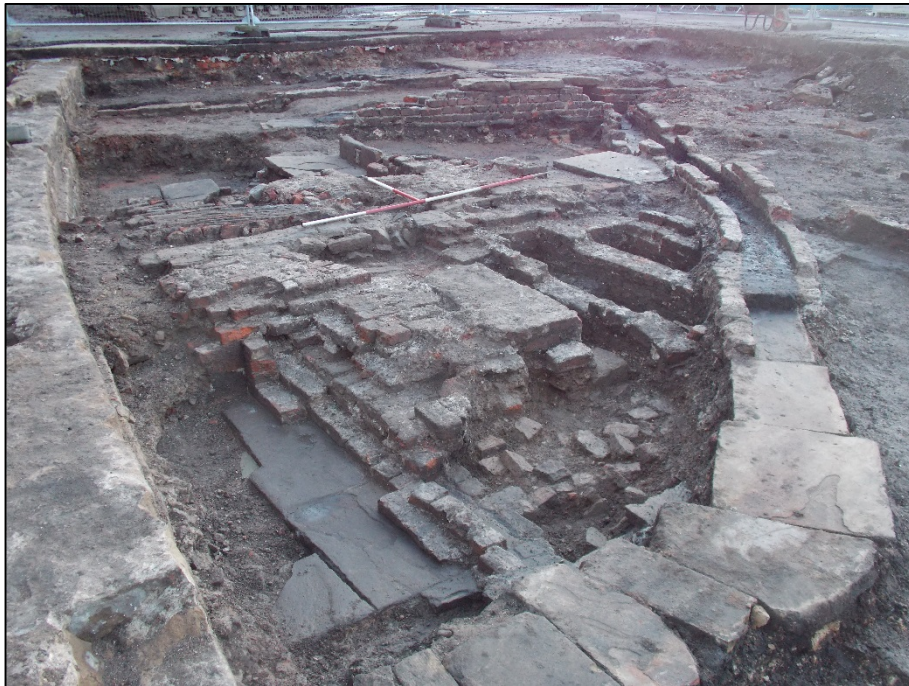
Plate 13; structure (144). Culvert (167) in foreground; facing south-east

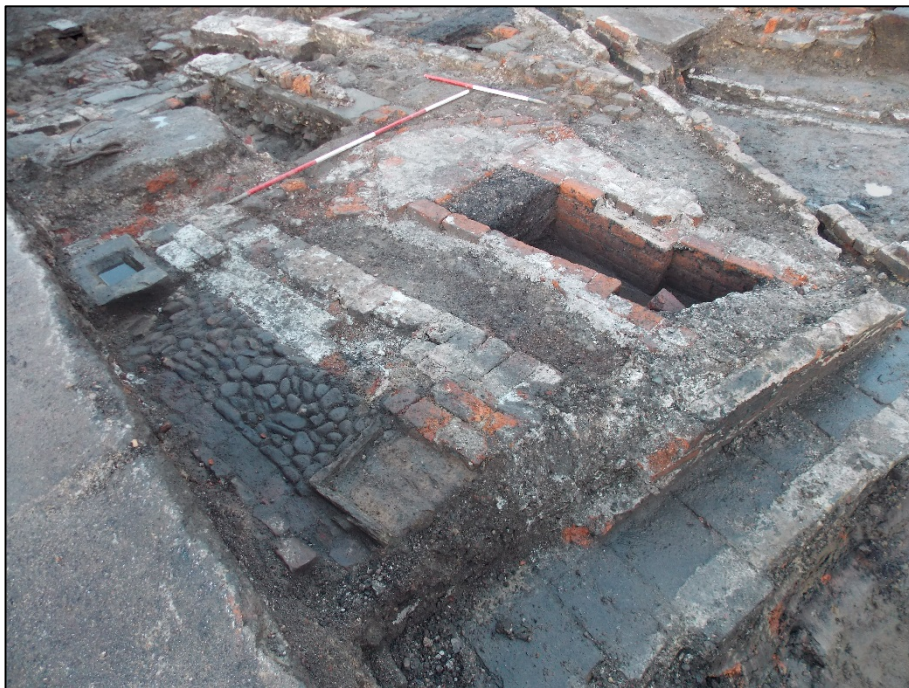
Plate 14; structure (184). Stoke hole/ ash pit k(193) evident; facing north-west

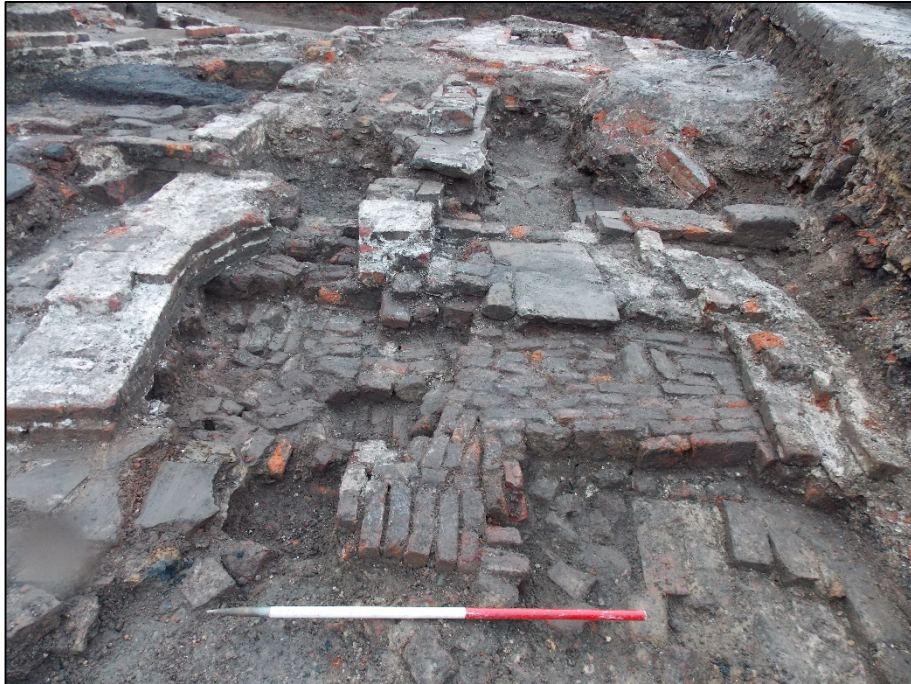
Plate 15; structure (184); facing east

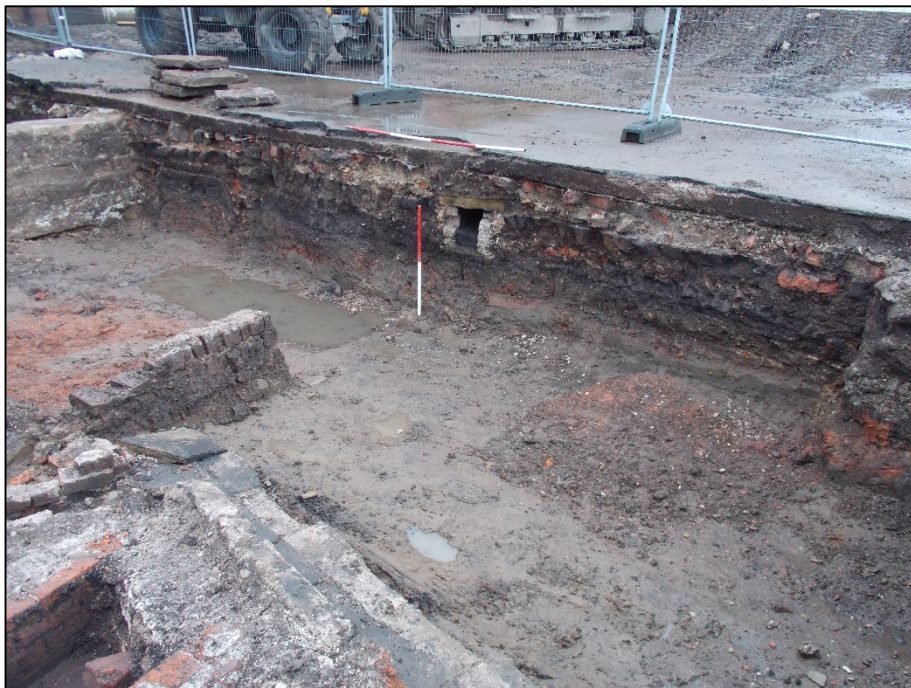
Plate 16: river sand (143) and west facing section

4.2.22 **Site Reduction:** on the eastern edge of the site a trench measuring 2.50m wide at the north end and 4.50m wide at the south end was excavated across the site (Plate 16). The western edge of the trench was defined by the Phase 4 culvert {129}. The Phase Three features were excavated out and the ground reduced to 24.11m aOD, 1.60m below ground level. The grey/ brown, river sand (143) was exposed at the base of excavation. Although there was some light scattering of fine rubble no significant earlier archaeological features were observed.

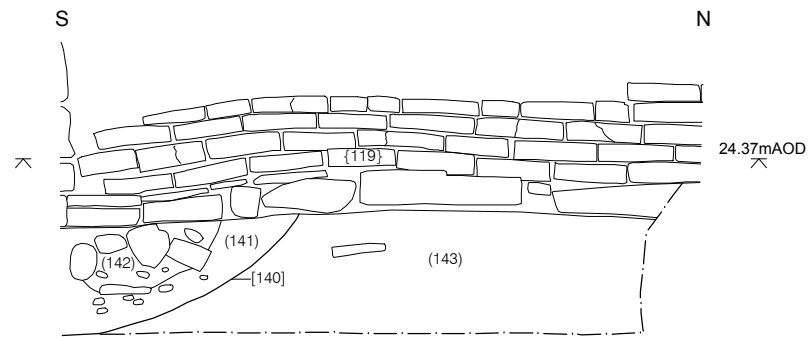
Section 1. East facing elevation of wall {119}, showing ditch [140].
