**QUARTERMILE**

JAMES NORIE PAINTING, OLD CRAIG CRAIG HOUSE EDINBURGH

**Painting Survey report**

JOB NUMBER: ED11878

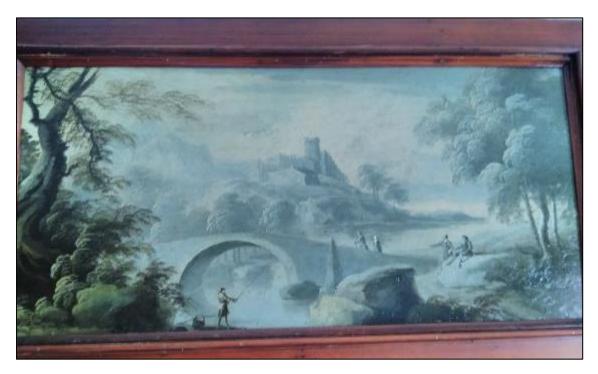
- 4.1.2 The painting by the painter James Norie (1684 1757) displays a mostly monochrome landscape with a bridge and castle in the background (Plate 1). There are hints of green paint in the left section of the painting. A fisherman is at the front central position (Plate 2), with four further people at the right section of the painting.

- 4.1.4 The oil painting is in good condition, with only little surface dirt. It appears structurally sound, although three nails with square heads have at some point been driven through the panel, with two left and right at the top edge and one centrally at the lower edge of the painting (Plate 3). They have been painted to blend in with the painting, but are assumed not to be original.

- 4.1.5 There are some discolouration of the glossy varnish, which darkens the painting.

Plate 1: General view of the semi-monochrome painting

- 5.1.2 The nails within the picture may have been a later measure to secure the painting further onto the wall.
- 5.1.3 In the course of an initial inspection of the painting by the conservation specialist Sylvia Krauss, she assessed that the painting is structurally stable and in a good condition. The slightly darkened varnish might be considered aesthetically unsatisfying and removal might therefore be considered. The painting does however not necessarily require any treatment, unless a varnish removal is desired. (Krauss 2018).

- 5.1.4 Sylvia Krauss recommends three variations of preservation and supplied an estimate of cost for each treatment (without VAT):
  - A) Preferred recommendation: The painting should be kept visible in situ as part of the historical interior and integrated with the refurbishment design. If a varnish removal is desired to brighten the overall appearance and get rid of the somewhat patchy appearance, this should be carried out in situ. The three nails driven through the panel from the front are currently fairly well integrated. To treat the painting off the wall in the conservation studio would necessitate removal of those nails as well as the frame ledges. Whilst the frame is likely to come off fairly easily, the nails through the panel are likely to cause damage to panel and paint layer during any attempt to remove them. This option will not risk any inadvertent damage to the painting and ensure its continued appreciation as historic part of the interior in future being aesthetically refreshed after varnish removal.

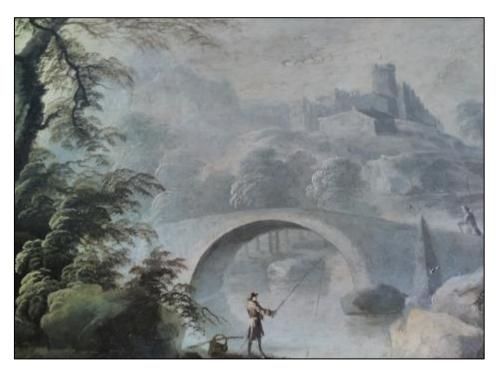
Plate 2: Detail of the greenery to the left and the fisherman

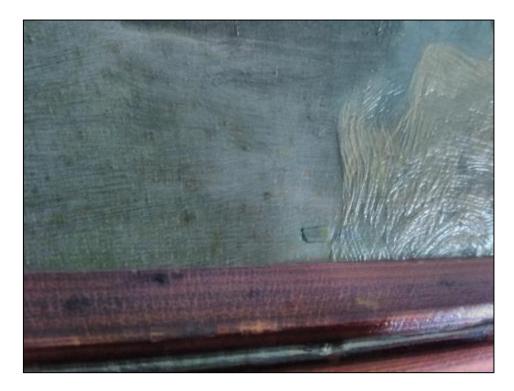
Plate 3: Detail of lower, square headed nail

and kept as historical part of the interior either or display elsewhere in the building or in storage, but accessible on request. Removal of the varnish would be optional and could be carried out in the conservation studio. The holes left by the nails and any other damage possibly caused during removal from the wall, should at least be structurally repaired and possibly restored. This option accepts any slight damage caused during removal from the wall, whilst keeping the painting accessible in future and allowing the refurbishment to go ahead independently.
