**LIMETREE GROVE  
SEBERGHAM  
CUMBRIA**

**Archaeological Roof Survey report**

**DATE ISSUED:** September 2018  
**JOB NUMBER:** CL12199  
**OASIS REFERENCE:** wardella2-328189  
**PLANNING APPLICATION REF:** 2/2017/0500

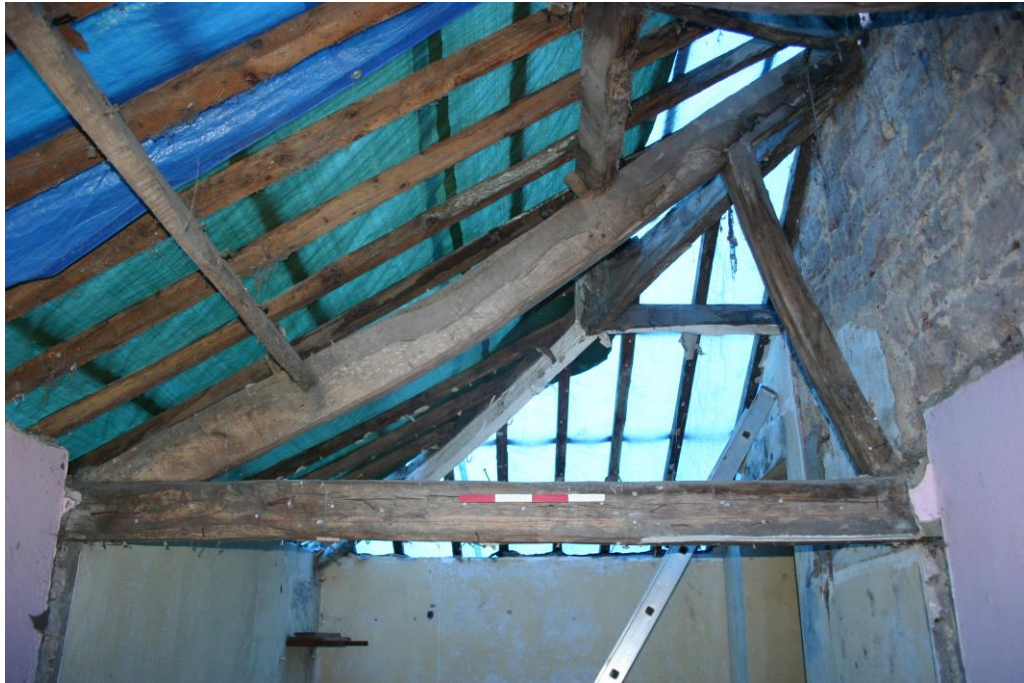
4.2.2 The hip-rafter (d and e), principal (c), purlins (f, g, h, i, j), the principal tie-beam (a) and interconnecting strut (b) comprise re-used and hand-worked timber of unknown origin (Plate 1). Beside the squared tie-beam (a), they are all of uneven shape. There are no carpenters marks visible on any of these timbers. There is noticeable deterioration of the timber, which may impact upon its structural stability.

Plate 1: General view of the truss, with tie-beam (a), strut (b), and principal (c)

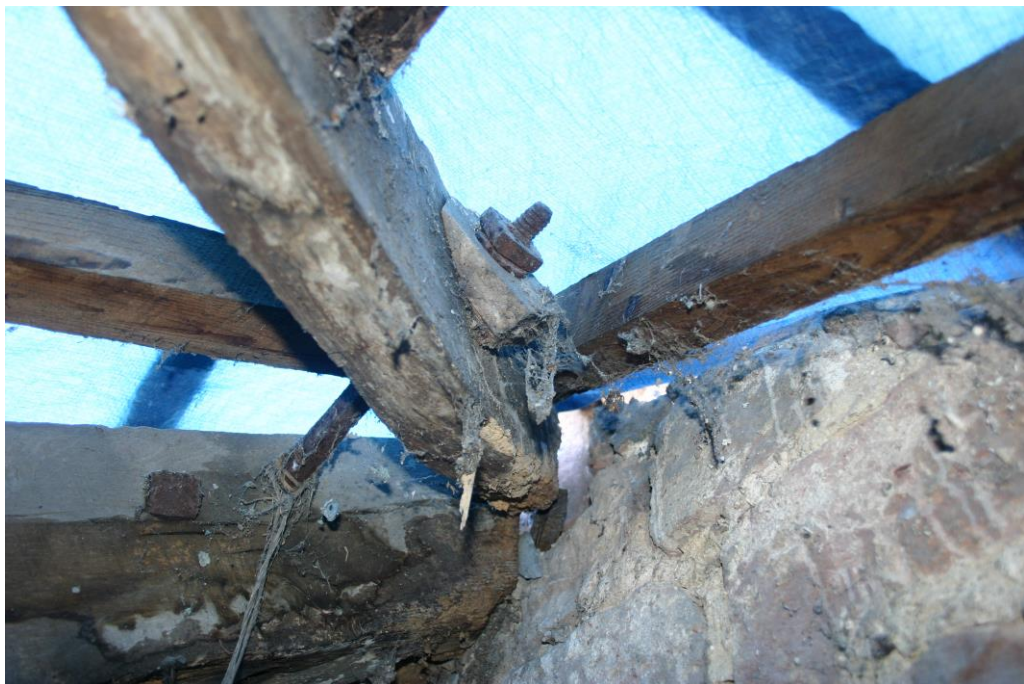
4.2.4 The hip-rafters (d and e) are fastened to the upper end of the principal (c) with two 20<sup>th</sup> century metal rods (Plate 2). They are in uneven positions, with e being noticeably lower than d. They are not attached to the wall itself (Plate 3).

Plate 2: Upper end of principal (c) with hip-rafter (d) fastened to it with a 20th century rod

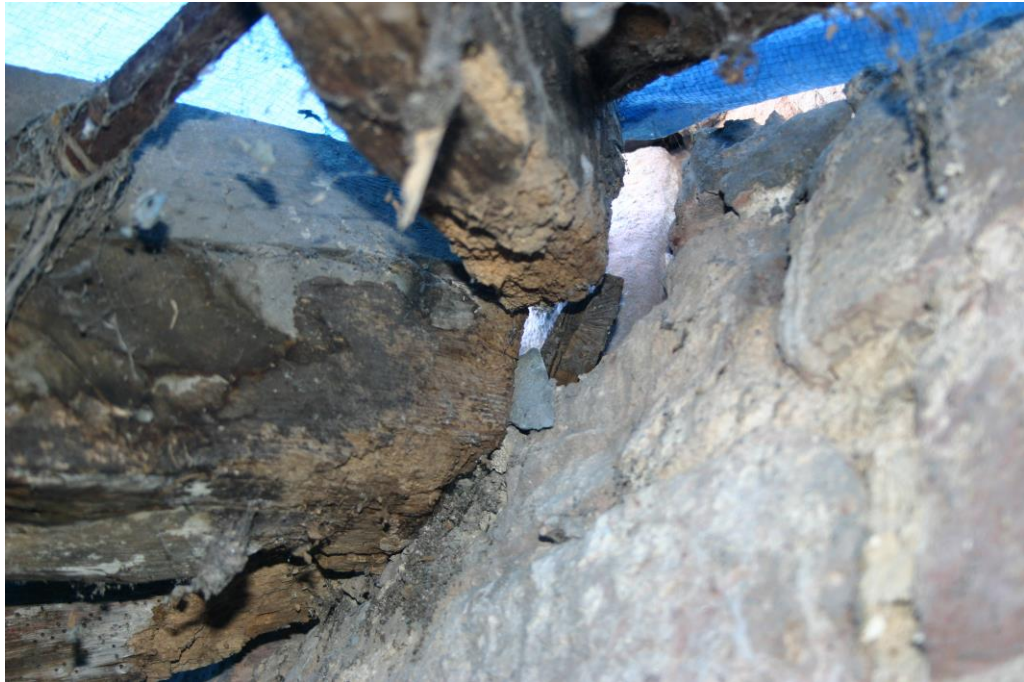
Plate 3: The upper end of roof is not attached to the elevation

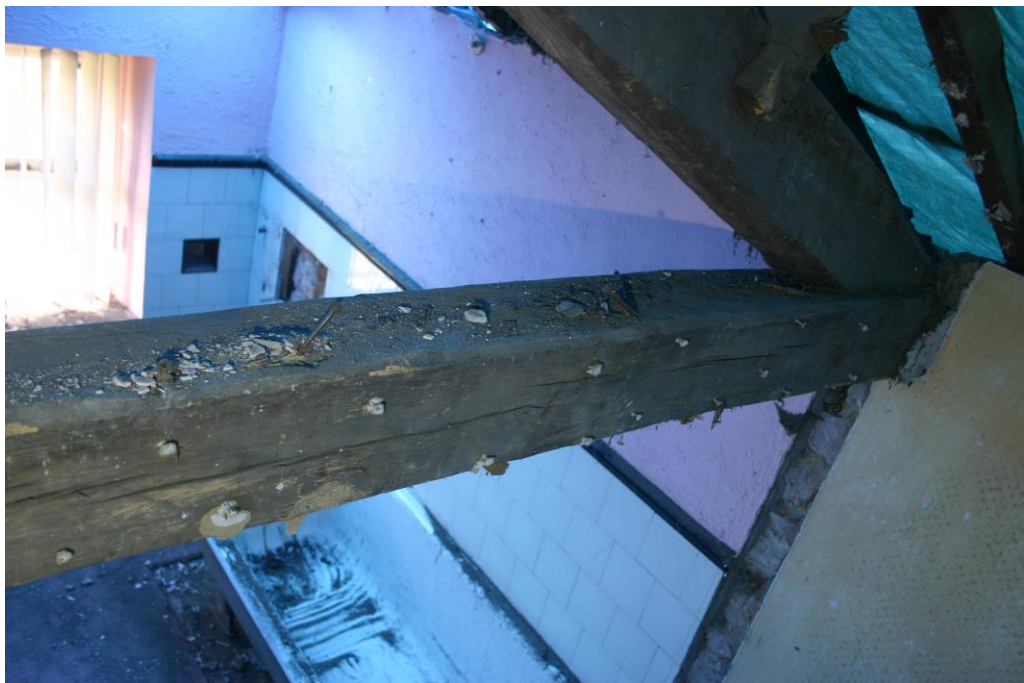
4.2.3 The tie-beam (a) and the principal (c) are chamfered (Plate 4). While the tie-beam (a) is secured into the sandstone masonry wall, the upper ends of the principal (c) and both hip-rafters are not attached to the wall they are abutting. The principal is slightly curved in its centre. There are many nails of various age within all sides of the tie-beam.

Plate 4: Various nail of different size and age within tie-beam (a)

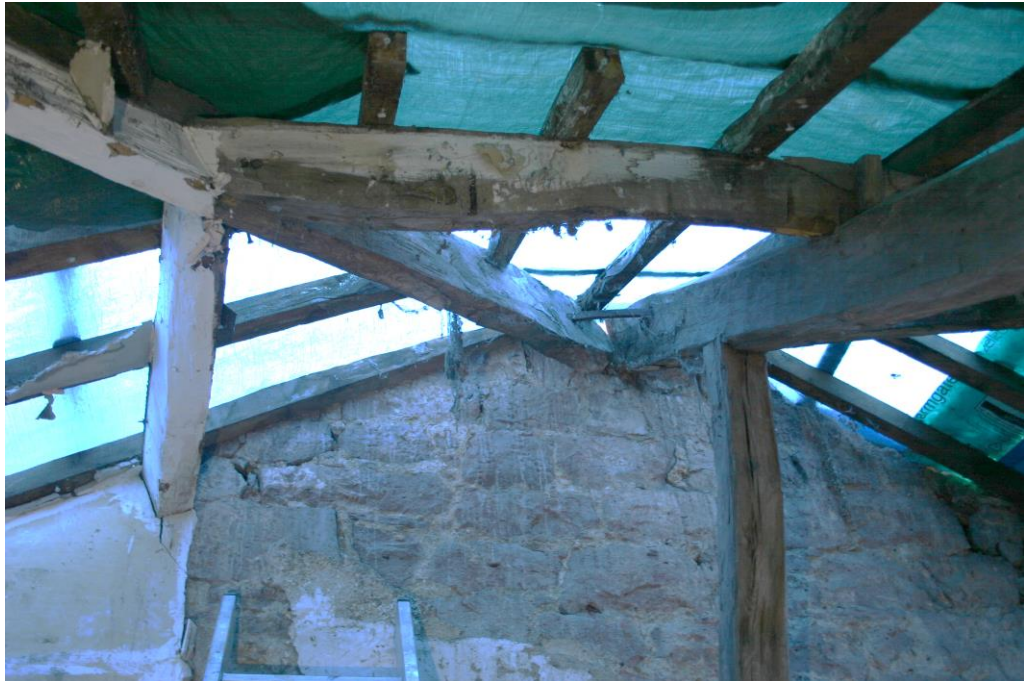
4.2.5 There are four circular dowel holes within the purlin (f), which indicates that the timber has clearly been reused (Plates 5 and 6). There are a further six dowel holes, partially still filled with dowels along the bottom edge of the purlin (j). Purlin (h) tapers down from a height of 0.19m to 0.14m where it abuts the hip-rafter (d). Similarly, purlin (i) narrows from 0.2m where it abuts the principal (c), to 0.14m where it abuts the hip-rafter (d).

Plate 5: Dowel holes in purlin (f)

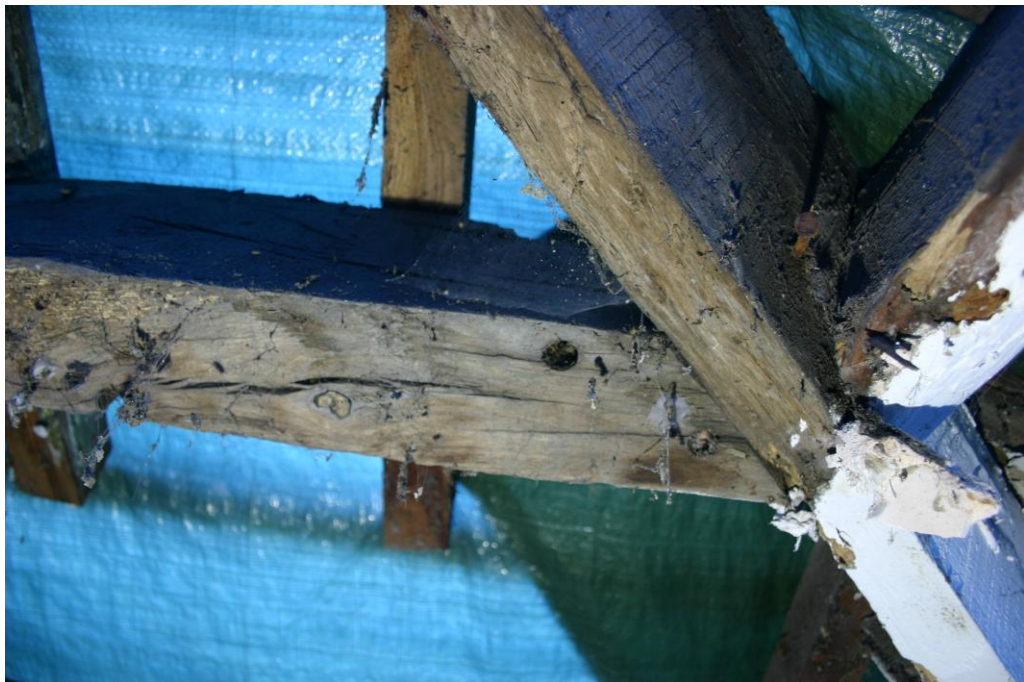
Plate 6: Dowel hole in purlin (f)

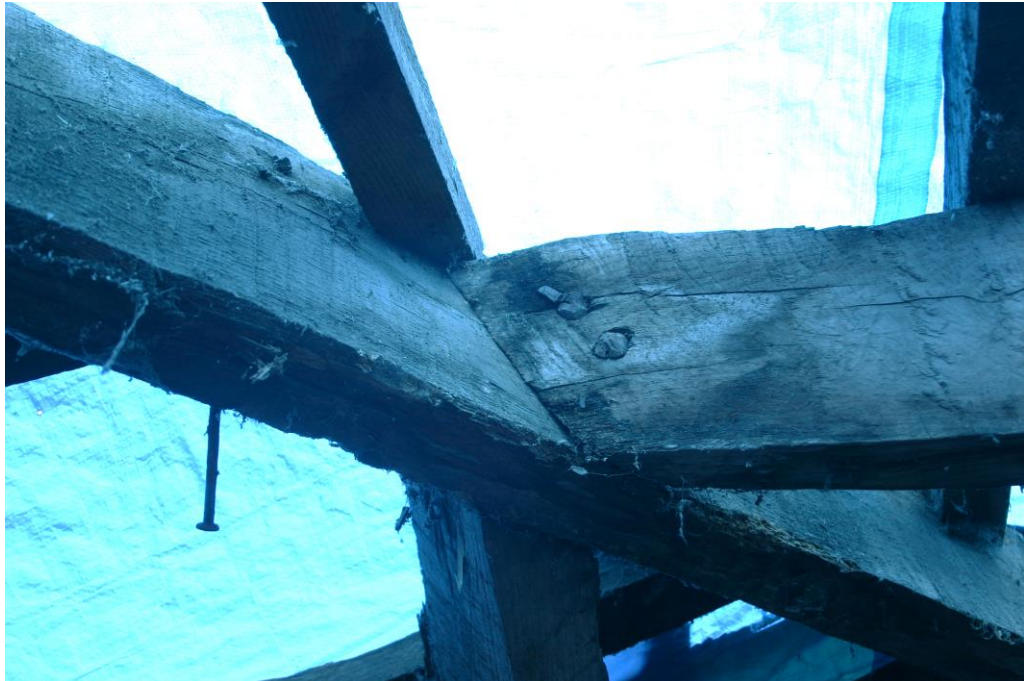
4.2.6 The purlin (f) was most likely shortened to its current length in the process of the insertion of a sky-light to the north of it. The purlins (h) and (i) are secured to the hip-rafter (d) with large cast iron nails, which are most likely contemporary with the

construction date of the extension in the 19<sup>th</sup> century (Plates 7 and 8).

Plate 7: 19th century metal nails at purlin (f) to hip-rafter (d)

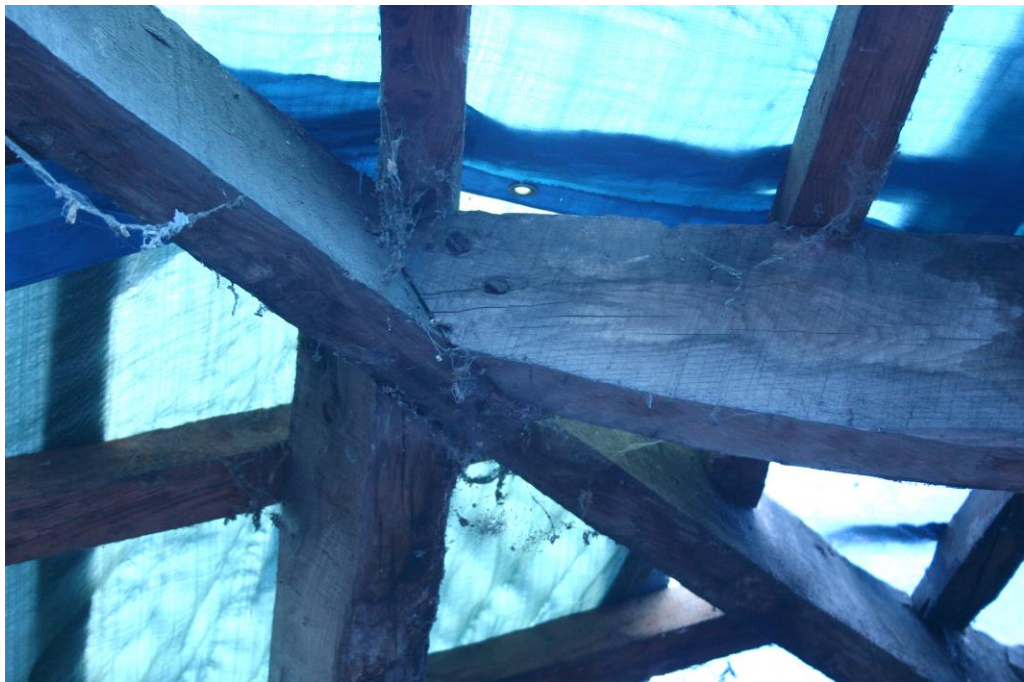
Plate 8: 19th century metal nails at purlin (h) to hip-rafter (d)
