PERSIMMON HOMES (LANCASHIRE)

LAND AT THE FORMER CHEMICAL WORKS, WHITEHAVEN, CUMBRIA

HERITAGE IMPACT ASSESSMENT

October 2018

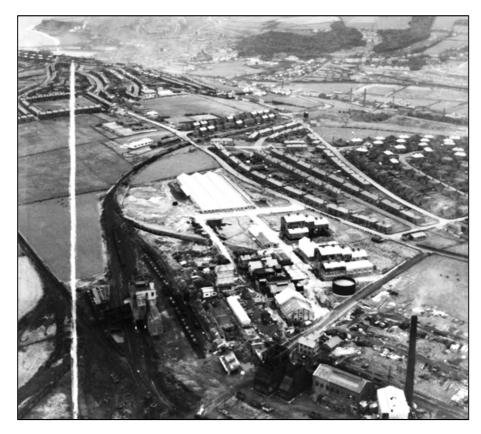
Plate 8: Aerial photograph showing the Marchon Works, 1948, facing north-east (Britain from Above 2018)

initiated at the Sandwith site. This extended southwards, and can be seen by comparing aerial photographs of the site from 1948 and 1950 (Plates 8 and 9) with Ordnance Survey maps of the 1960s (Figures 10 and 11). Overseas developments up until 1968 played a major role in this expansion and by 1975, there were six sectors within the Marchon and Industrial Chemicals Division of what had by now become a massive international company (Hay 1988, 139). In 1976 a new sodium tripolyphosphate plant was commissioned, making the site the largest producer of this material in the work, and in 1977, 'the largest investment in Albright and Wilson's history was announced', a £19.5 million expansion for the construction of a further two new plants (Hay 1988, 139). In this year the site employed 2,250 people. No maps have been encountered of the area post-1968, though an aerial photograph of the site in 1995 (Plate 14) and Google Earth imagery of 2003 (Plate 15), show the site in its later years, after the move from railway to road transport. These show the establishment of the octagonal building in the north-west corner of the site, as well as other additions. It is clear from these images that at some point after 1968 and before 1995 any upstanding remains of earlier heritage assets within the area were demolished (e.g. the Croft Incline Engine House (Asset 23), Croft Pit/Ladysmith Colliery (Asset 24), Lingdale Head (Asset 28), Barrowmouth (Asset 29), Barrowmouth Cement Works Factory (Asset 36), the Croft Waggonway (Asset 41), the Croft Incline (Asset 42), the Corkickle Waggonway (Asset 43) and the Barrowmouth Waggonway (Asset 44)).

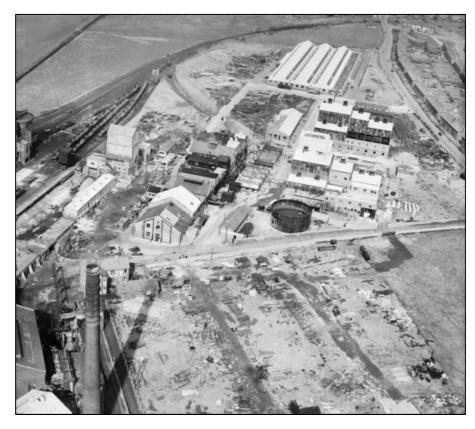
Plate 9: Aerial photograph showing the Marchon Works, 1950, (Britain from Above 2018)

3.3.16 The introduction of the chemical industry to the area was initialised by a Londonbased company's desire to escape the Blitz, relocating to the 7 acre Ladysmith Colliery site (Asset 24) in 1943. The impact of the Second World War did not spare the study area, however, as demonstrated by the presence of an air raid shelter (Asset 38). The chemical company, Marchon, retained some of the former colliery buildings, converting them to industrial use, and added new buildings when needed (Asset 25). Aerial photographs of 1948 show this venture in its early days with a large whiteroofed unit at the northern extent of the site, smaller east-west aligned buildings further south, the former colliery buildings to the west and south-west and the retention of the waggonways/railway (Plate 8). By 1950 there seems to have been the intention to extend the works southwards (Plate 9).

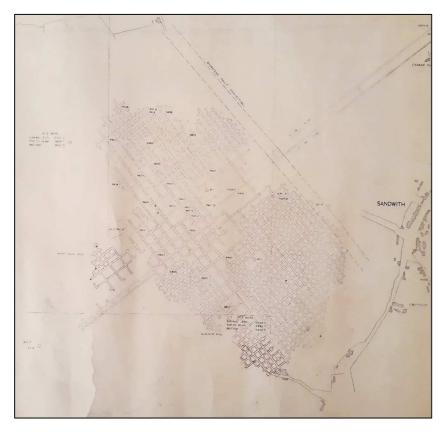
Plate 12: Plan of Sandwith Anhydrite Plan (CACW YDGO/FIRM/PLANS)

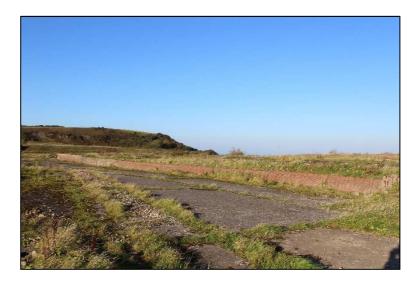
Plate 18: Surviving evidence of terracing at former Marchon Works (Asset 25)

4.1.1 The site was visited on Wednesday 10th October 2018, and, despite the recent demolition and clearance of the Marchon Works (Asset 25) some extant remains survived in the form of terraces (Plate 18), building platforms (Plates 19 and 20), access roads (Plate 21), floor surfaces (Plate 22) and rubble mounds.

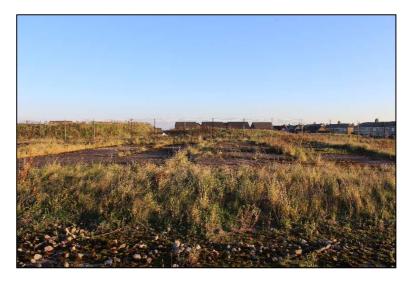
Plate 19: Former building platform at Marchon Works (Asset 25)

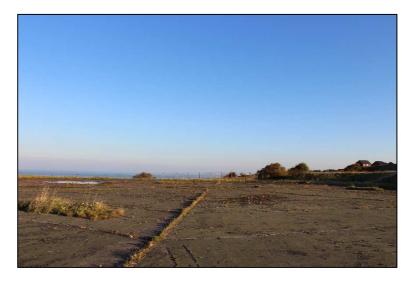
Plate 20: Former octagonal building platform at Marchon Works (Asset 25)

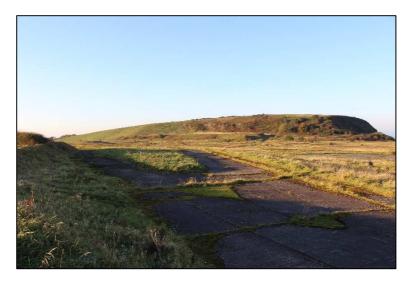
Plate 21: Example of surviving access roads at Marchon Works (Asset 25)

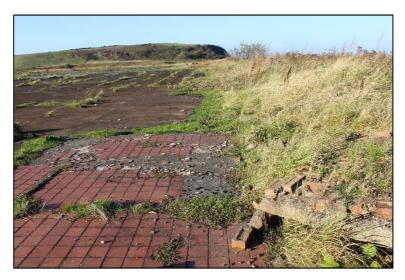
Plate 22: Example of surviving former floor surface at Marchon Works (Asset 25)
