**STEEL WORKS HOUSE (FORMER J & RILEY CARR OFFICES AND SHOWROOM),
BAILEY LANE, SHEFFIELD**

ARCHAEOLOGICAL BUILDING RECORDING REPORT

DATE ISSUED: DECEMBER 2019
JOB NUMBER: ST16524
REPORT NUMBER: HBR-001
OASIS REFERENCE: wardella2-376253
PLANNING APPLICATION REF: 18/02170/FUL
VERSION: V1.0
STATUS: FINAL

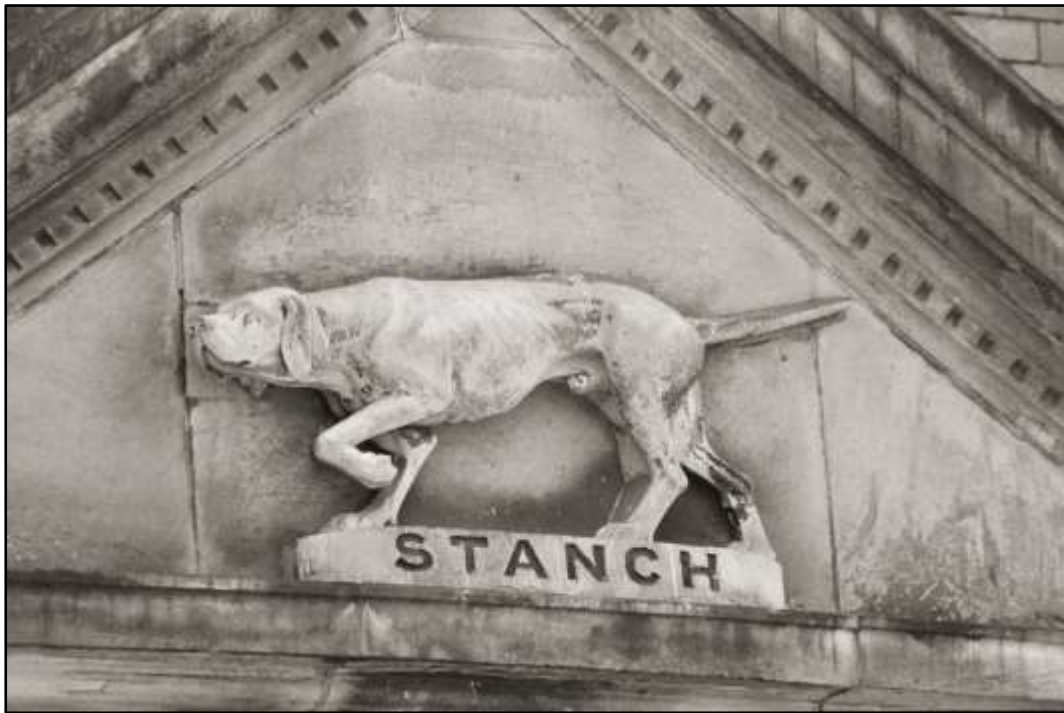
Plate C - Trademark logo for J and Riley Carr with pointer dog and 'STANCH' inscription (Feature of Interest Ref 100)

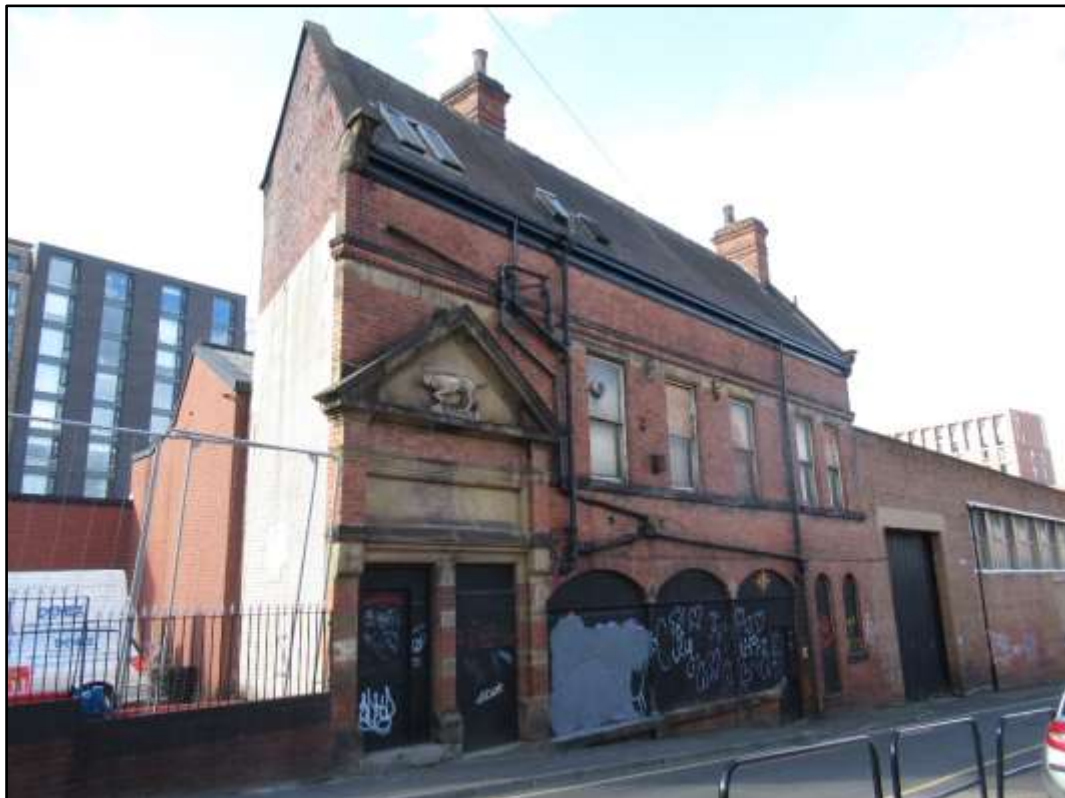
Plate D - East Elevation (Bailey Lane)

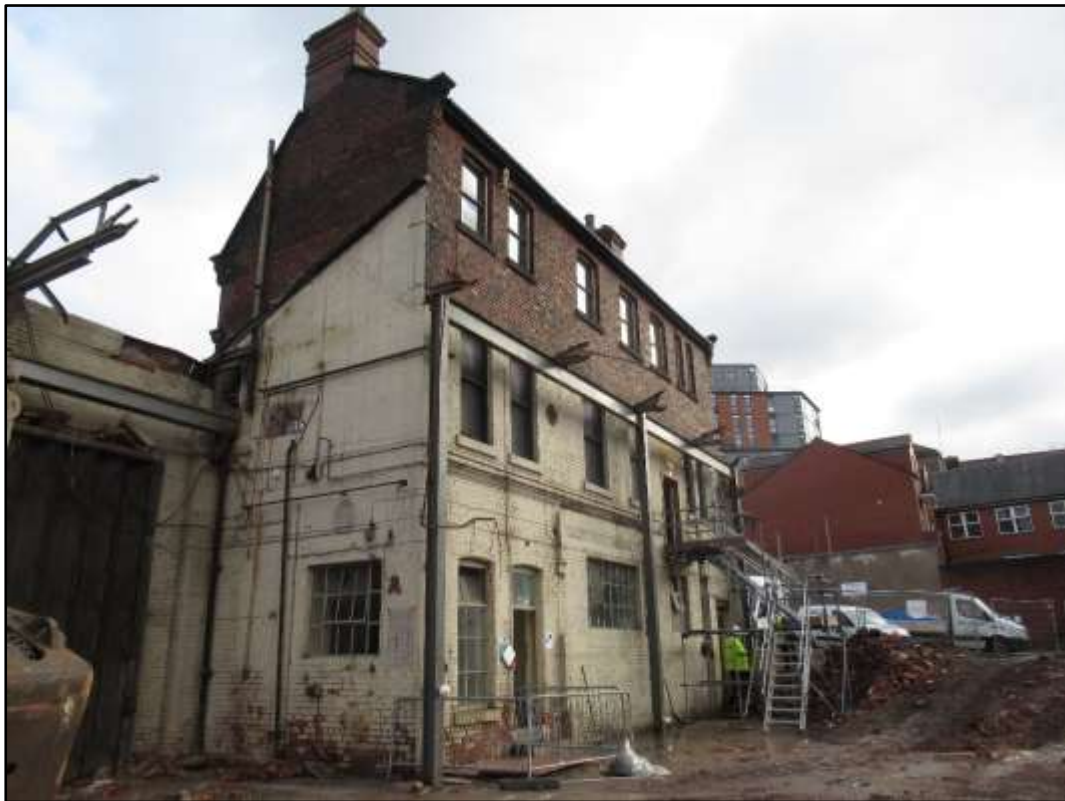
Plate F – North Elevation

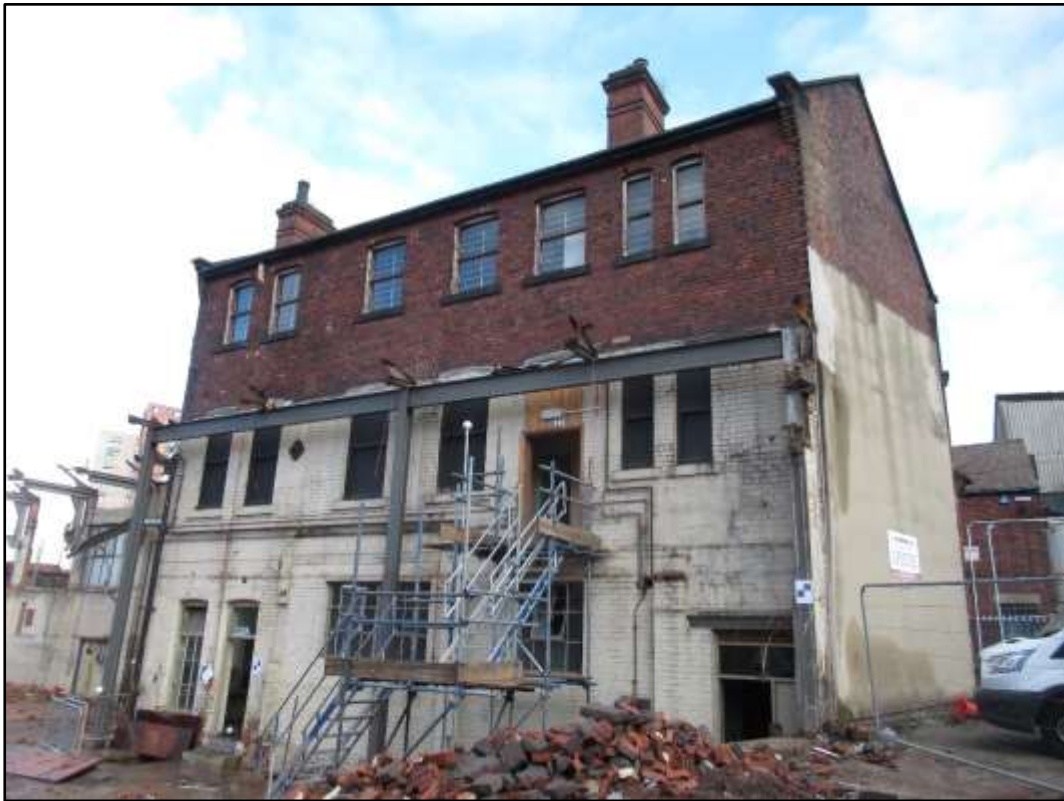
Plate H - West Elevation

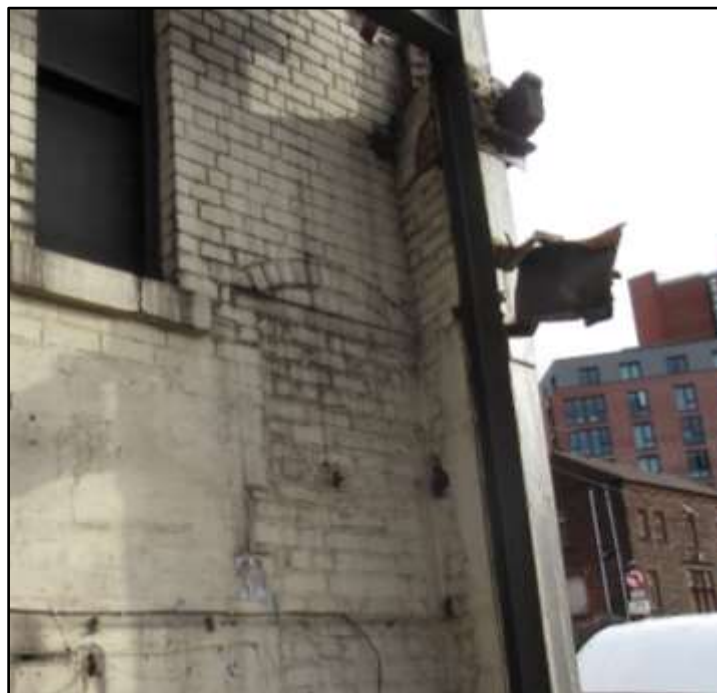
- 4.2.35 A blocked opening, infilled with brickwork, is present to the south of the smaller window (feature 105), Plate I below. The opening is positioned at a lower level between ground and first floor and corresponds to a half landing of the main staircase to the interior; the window was therefore likely a stair window offering illumination to the original stairwell prior to erection of the warehouse addition which encased the west and north ground and first floor elevations. The opening retains the segmental brick arch with timber lintel inserted below.

Plate I - Blocked opening present to the first-floor south corner of the west elevation (feature 105)

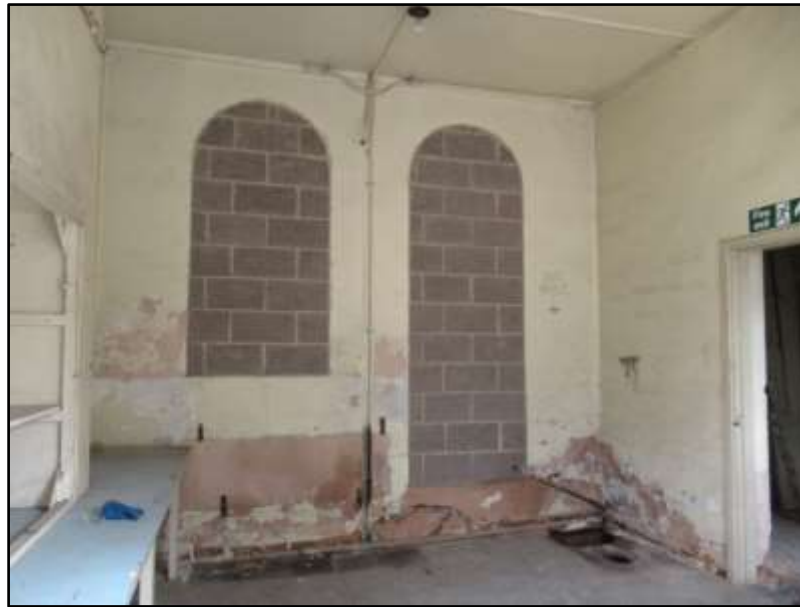
- 4.3.4 Within the east wall the outline of the round arched window openings observed to the exterior of the east elevation are clearly visible being infilled with modern block work.

Plate J - Infilled former opening to the ground floor east elevation viewed from the interior

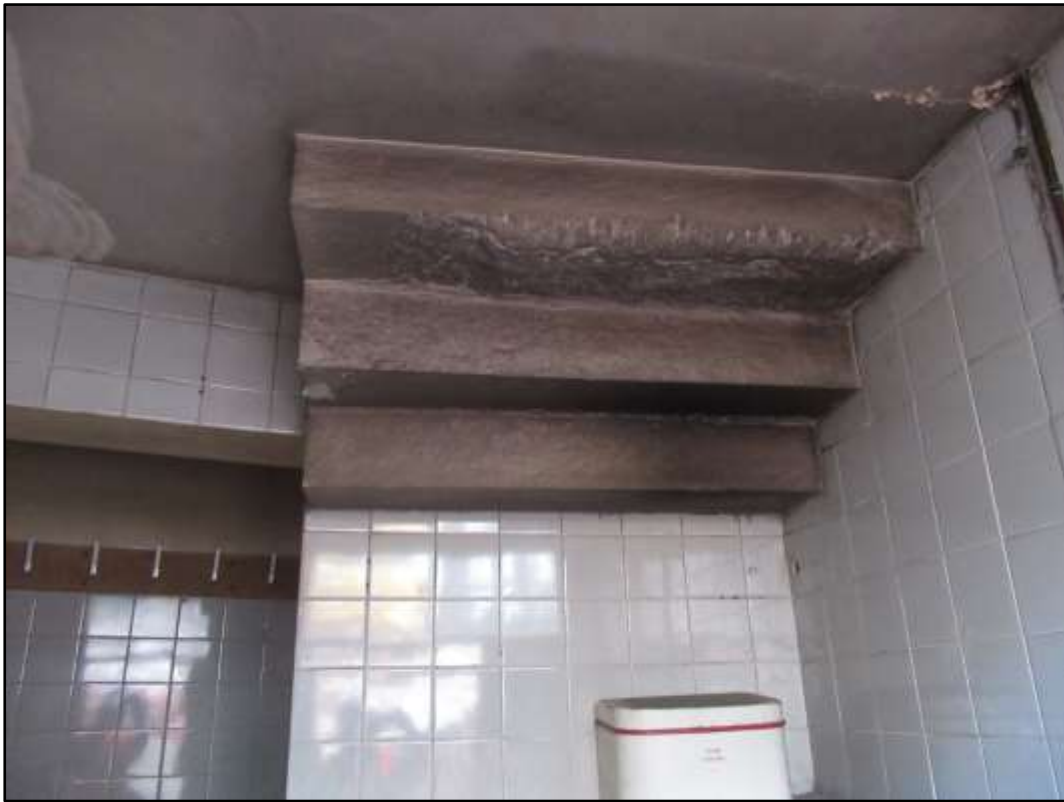
*Plate K - Underside of cantilevered stone stair observed from the ground floor of the south bay
(feature 108)*

- 4.3.15 The main staircase (feature 108) is a straight flight with winder and small half landing and consists of a wide, cantilevered stone treads built into the angled south wall and part of the west wall where the staircase winds around. The half landing area would have been served by the blocked window observed to the west elevation (feature 105,

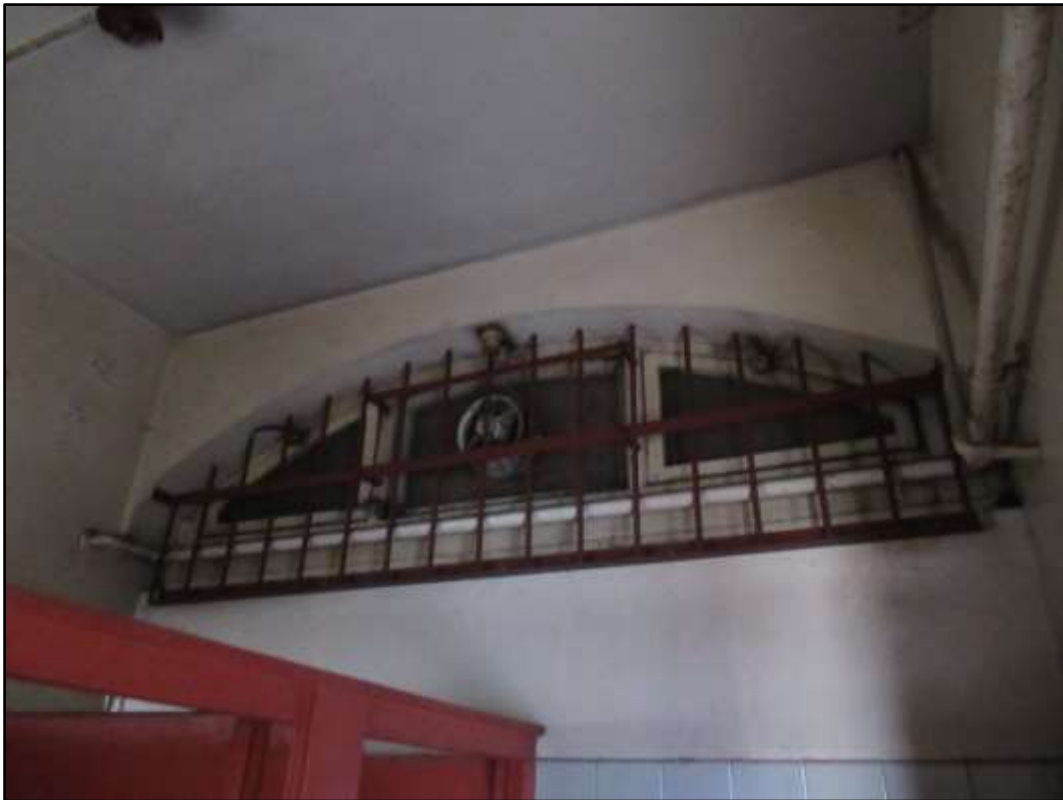
4.3.12 The outline of the segmental arched opening positioned to the south of the east frontage is visible and retains three top-light timber casement windows (feature 110) which provide some evidence of the possible, original designs of the opening.

Plate L - Timber top light casement windows to the segmental arched openings to the ground floor of the east elevation viewed from the interior of the central bay

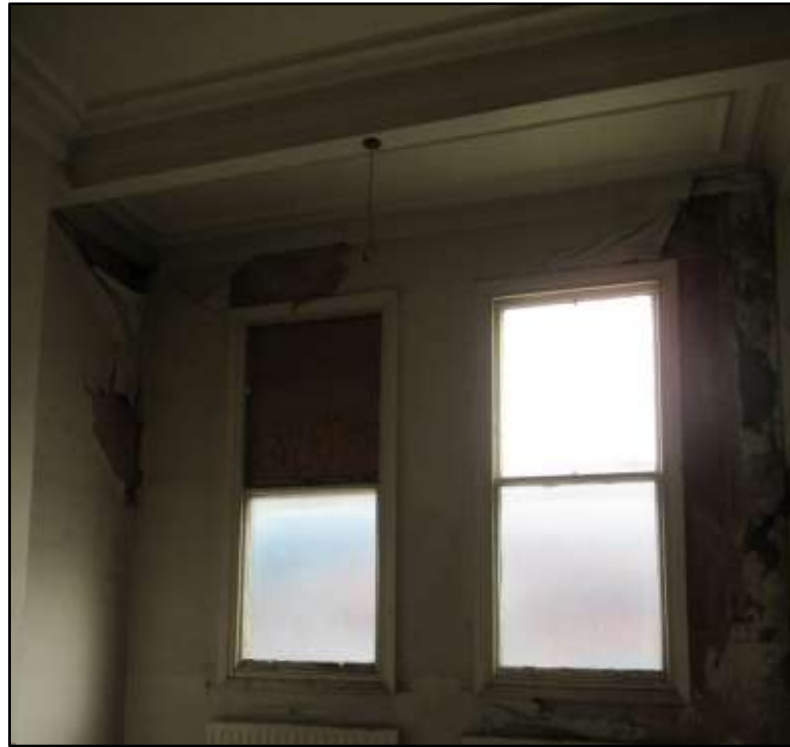
Plate O - Plaster cornice work to the north east corner of the main room to the first floor

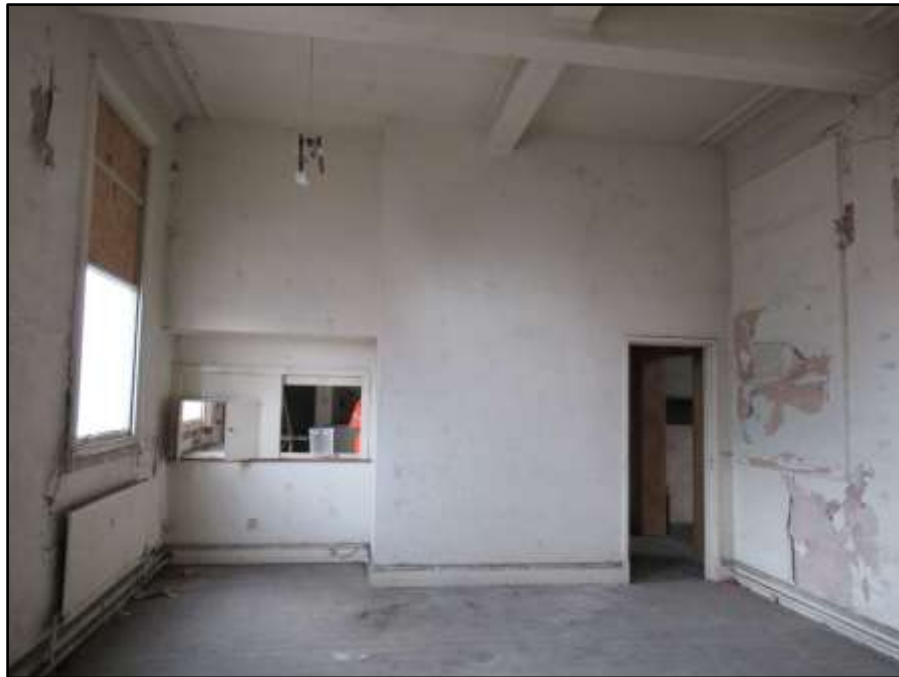
Plate P - View south towards later partition walls inserted to create kitchen area (left) and small WC (centre) and second landing area (right) at first floor level. Boxed in structural elements are positioned below the ceiling level.

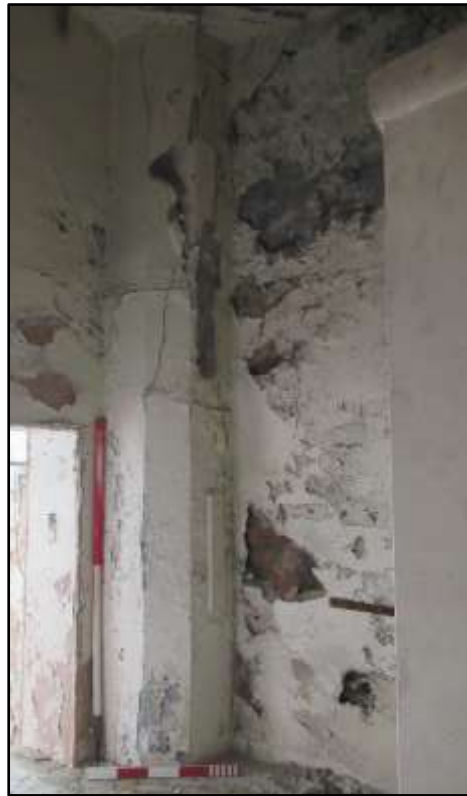
- 4.3.27 A canted stone pillar is present within the north east corner of the pantry/store area extending the full height of the first-floor space. This pillar was not observed at ground floor or second floor level and its function is unknown.

Plate Q – Canted stone pillar to small storeroom adjacent to first floor kitchen

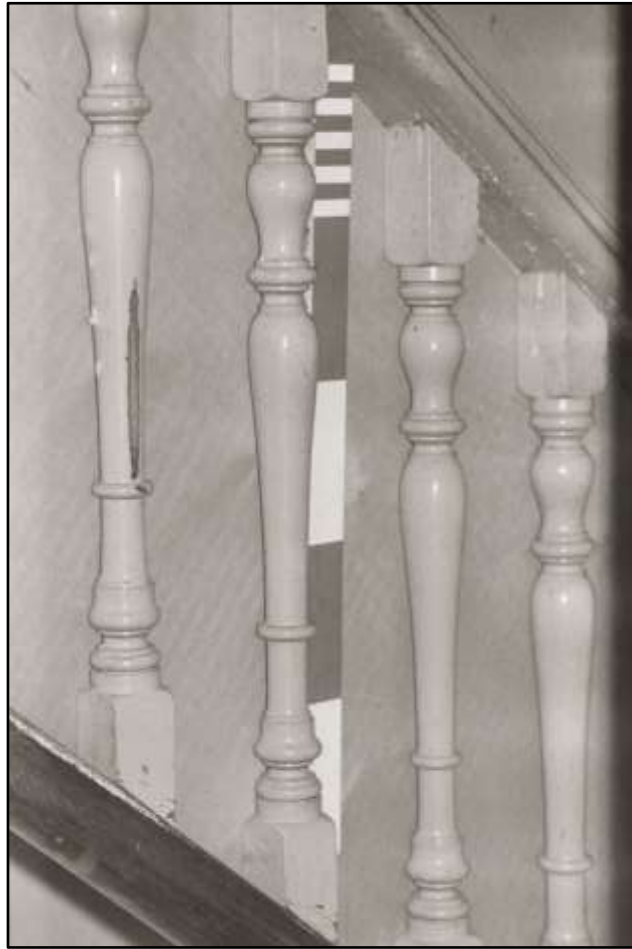
Plate R - Timber vase balusters to second floor staircase (feature 116)

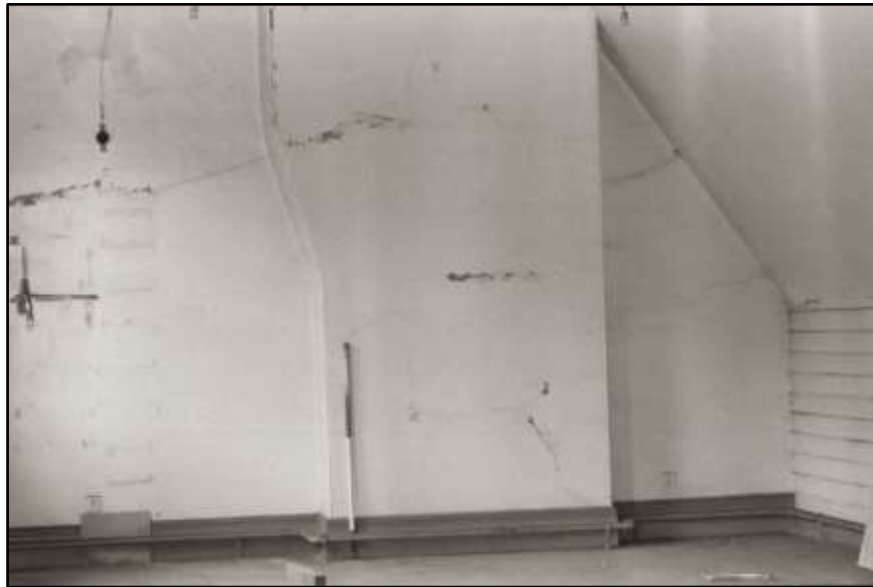
Plate S - North elevation of the second-floor room with chimney breast serving the first floor and timber boarding applied to the external east elevation

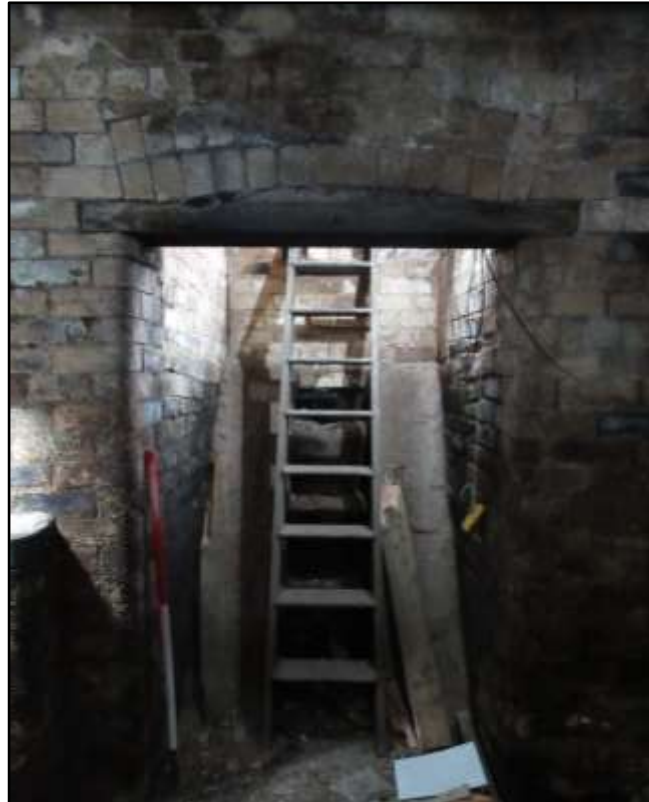
- 4.3.40 Entry into the main space of the cellar is through a wide segmental arch opening with double course brick heads sitting on a timber lintel. The opening has rounded brick jambs which is indicative of ease of movement into in the space.

Plate V - Segmental arch opening into main cellar and altered stepped access (feature 120)

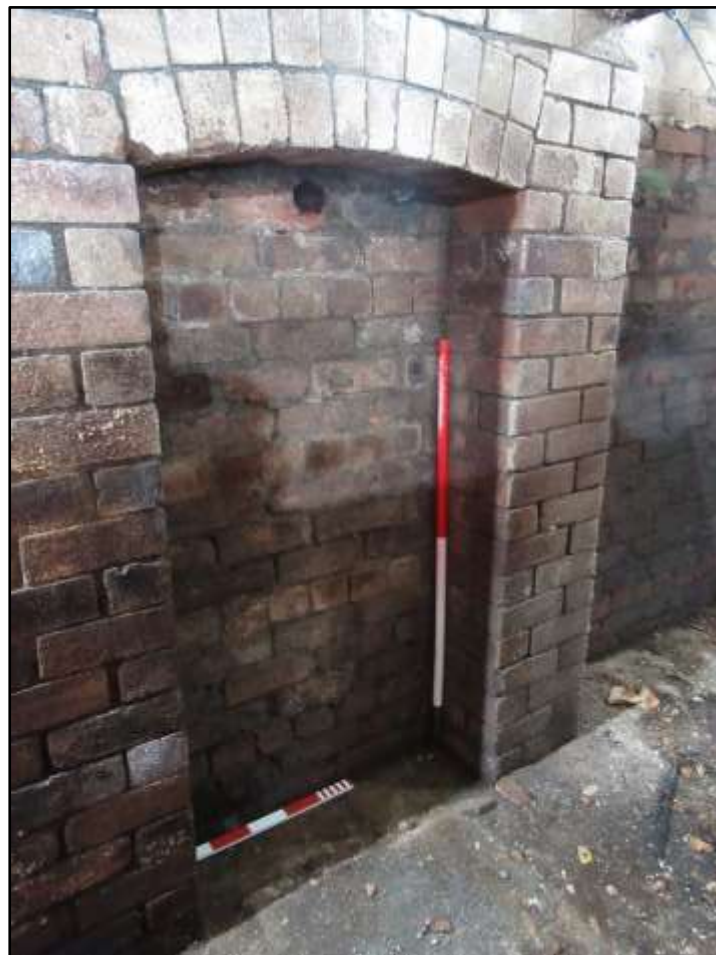
Plate W - Segmental arch aperture to north wall of cellar under the north bay (feature 121)

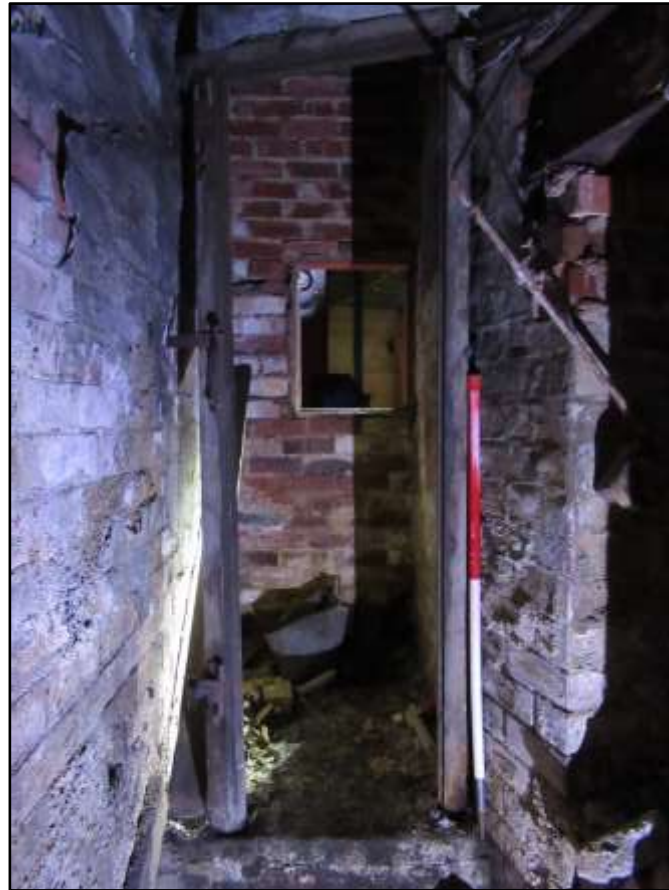
or altered. Two Stone steps also remain aligned with the hatch opening and the timber architrave of a door frame (feature 122) evidence alteration to the original means of access to this secondary, cellar space has occurred.

Plate X - Altered access into the cellar area below the main stair well with remains of timber door frame (feature 122)

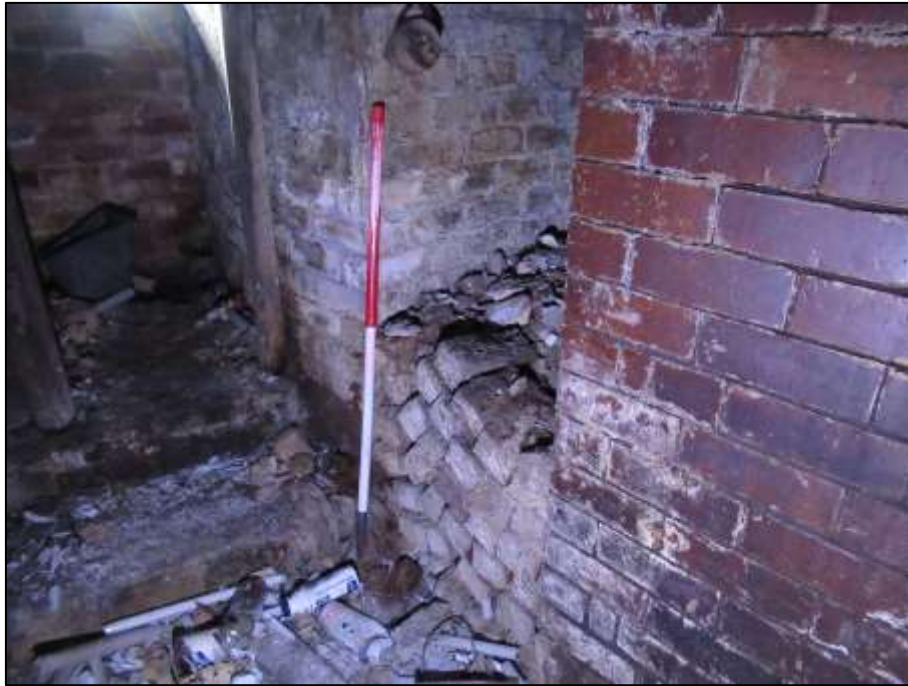
- 4.3.44 The area comprises a loosely T shape plan form, the vertical element of the 'T' aligned north to south. The space is enclosed by red brick walls with changes in brick size, texture and coursing indicative of several phases of alteration and it is possible the extent of the space has been reduced in size and the configuration altered. This is further supported by the presence of metal beams inserted within the east wall.
- 4.3.45 The area has a lower head height than the larger cellar space to the north which is likely related to the sloping topography of the Site generally. The area also extends partly under the footway to Bailey Lane which may relate to an earlier arrangement however it is unclear from historic mapping that this area of the building footprint was developed with buildings prior to the erection of the extant building.

Plate Y - Remains of stone steps (left) and changes in brickwork (feature 122)

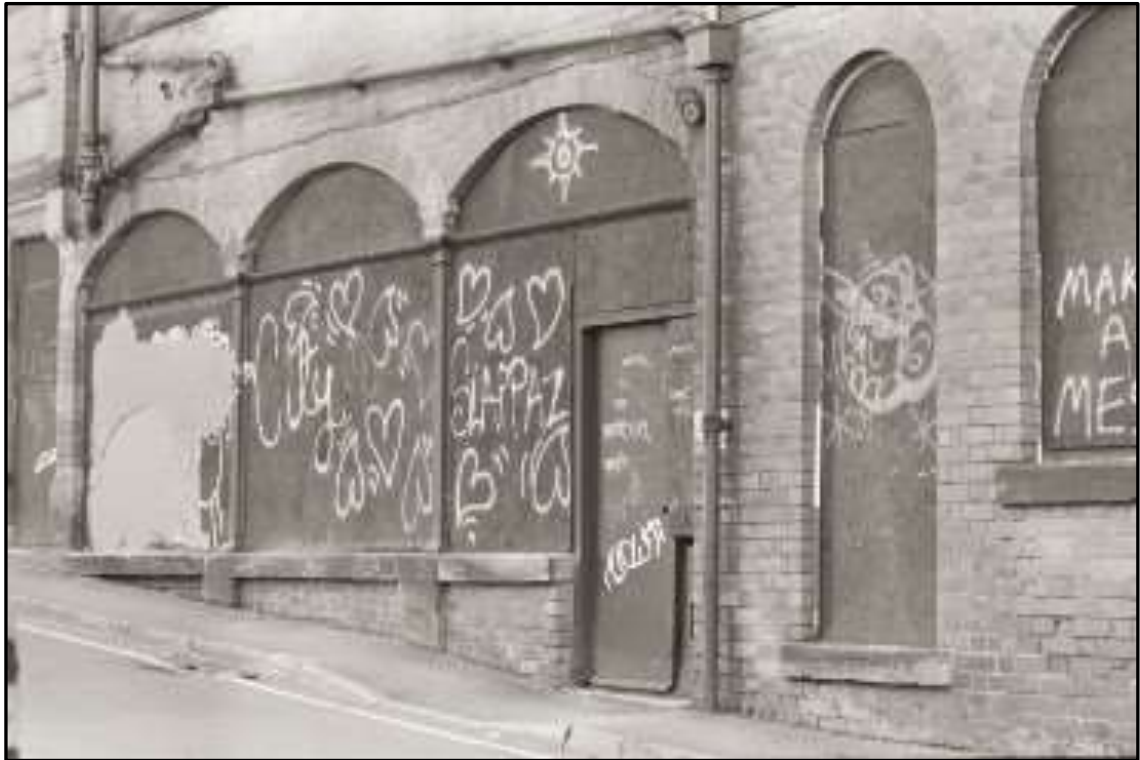
Plate B7 - East Elevation: Iron pier between segmental arch openings

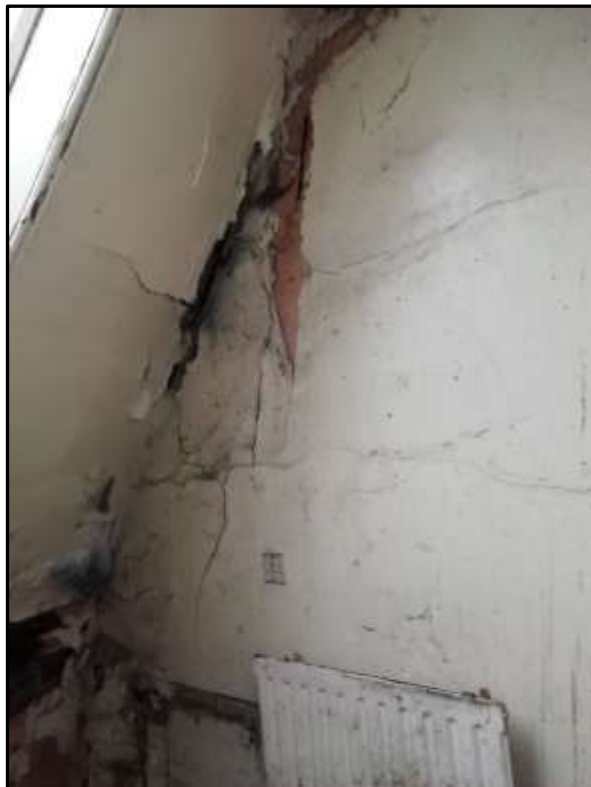
Plate C43 - Cracked plaster work to the interior of the south end elevation
