**LAND AT
EMERSONS GREEN,
BRISTOL,
SOUTH GLOUCESTERSHIRE.**

**ARCHAEOLOGICAL
EVALUATION REPORT**

CP. No: 10049/12

DOCUMENT TITLE: Emersons Green, Bristol, South Gloucestershire
DOCUMENT TYPE: Archaeological Evaluation Brief Report
CLIENT: Gallagher Estates, Heron Land Developments Ltd. & Quintain Estates and Developments Ltd.
CP NUMBER: 10049/12
SITE CODE: EGB-A
PLANNING APP. NO: PK04/1965/O
OASIS REFERENCE: -
PRINT DATE: 06/09/2013
GRID REFERENCE: ST 677 777

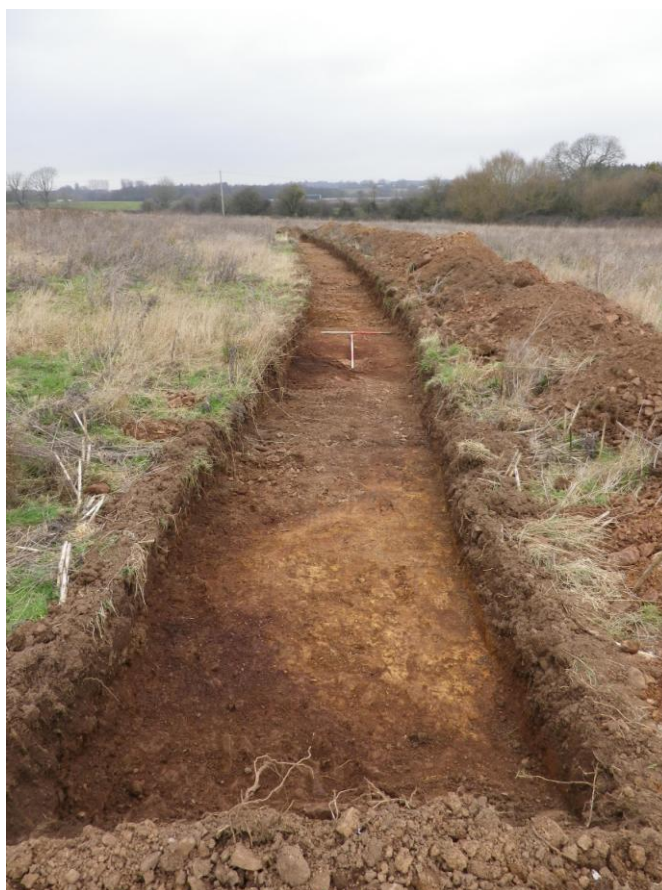
Plate 1: Shot of possible quarry pits [103] and [105], looking north

4.2.3 The first possible quarry pit [103], was located at the south end of the trench and was only partially visible. What was visible, measured 2m in length by 1.45m in width and it appeared to be sub-circular in shape. The fill (104) was mostly stony with loose dark brown silty clay mixed in. It appears to be a continuation of a very large quarry pit [3205], observed in Trench 32, which was located to the south.

4.2.4 The second possible quarry pit or bell pit [105] was located 0.2m to the north of [103]. It was only partially visible on the west side, extending beyond the side of the trench. What was visible, measured 5.1m in length by 1m and was possibly sub-circular in shape. The fill deposit (106) was a mostly stone fill with loose dark brown silty clay. This feature is possibly a bell pit given its size and compares to the feature Avon Archaeology observed in geotechnical trenches they monitored in 2010.

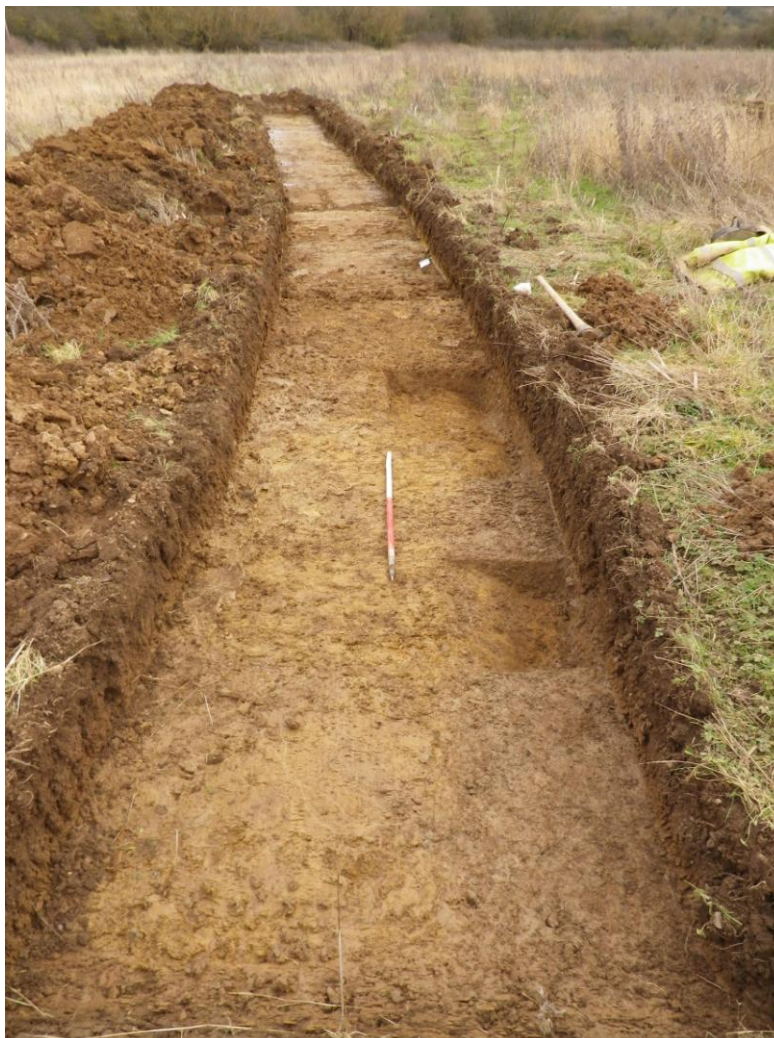
Plate 2: Shot of linear features [203] & [205], looking southeast

- 4.2.6 Linear [203] was located in the NW end of the trench and was aligned NW-SE with only its northeast side visible. It measured 3.2m in length by 0.65m in width and was excavated to a depth of 0.11m. It had a gradual sloping side on to what probably was a flat base which gave it a U-shaped profile. The fill (204) was a moderately compact light grey silty clay. It appears to be continuation of linear [3004] which was observed in the northwest end of Trench 30. It appeared to truncate the northwest side of linear [205] which was to the southeast of [203].

- 4.2.7 Linear [205] was located in the NW end of the trench and was aligned NE-SW. It measured 1.9m in width and was excavated to a depth of 0.40m. It had a gradually sloping northwest side, very steep southeast side with flat base which gave it a U-shaped profile. The fill (206) was a moderately

compact mid grey brown silty clay. The linear appeared to be a continuation of linear [3012] which was observed in the southeast end of Trench 30. It was one of two linear features, [3010] was the second, running parallel to each other, but the dimensions of [3012] were very similar to [205].

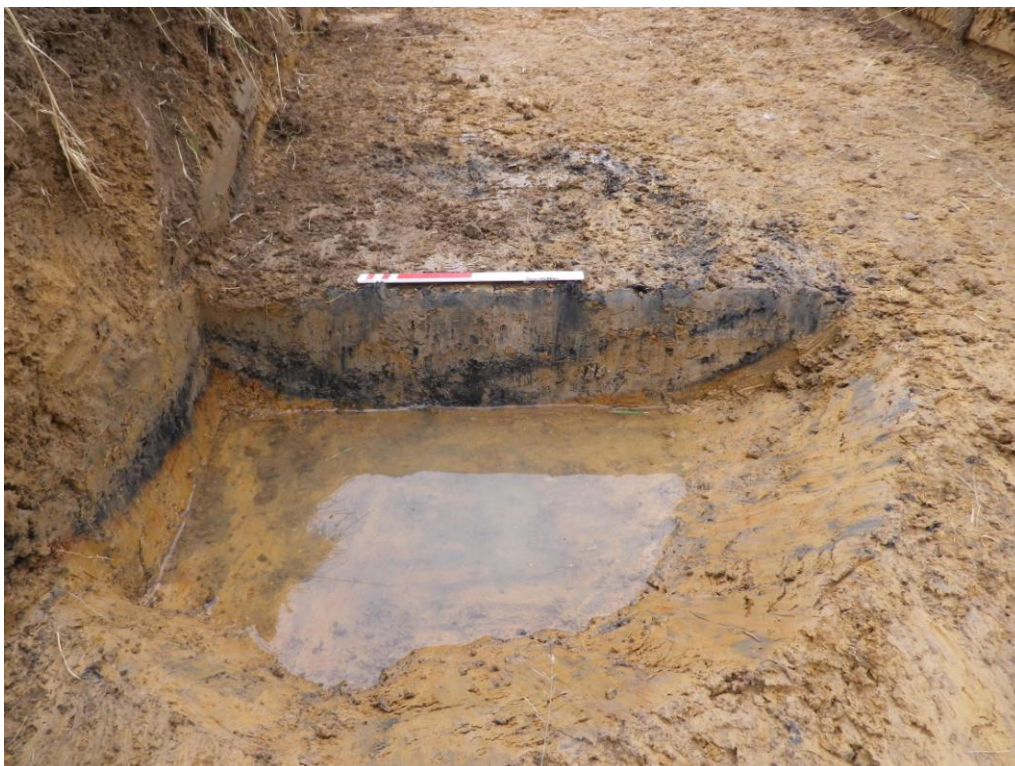
Plate 3: Shot of pit [304], looking west

4.2.10 Pit [304] was located near the centre of the trench on its south side. It measured 1.08m in length by 0.9m in width and was excavated to a depth of 0.18m. It was oval shaped and shallow with gradual sloping sides and a

concave base. The fill (305) was a firm dark grey / orange brown clay that contained moderate amounts of burnt coal mixed in the sediment.

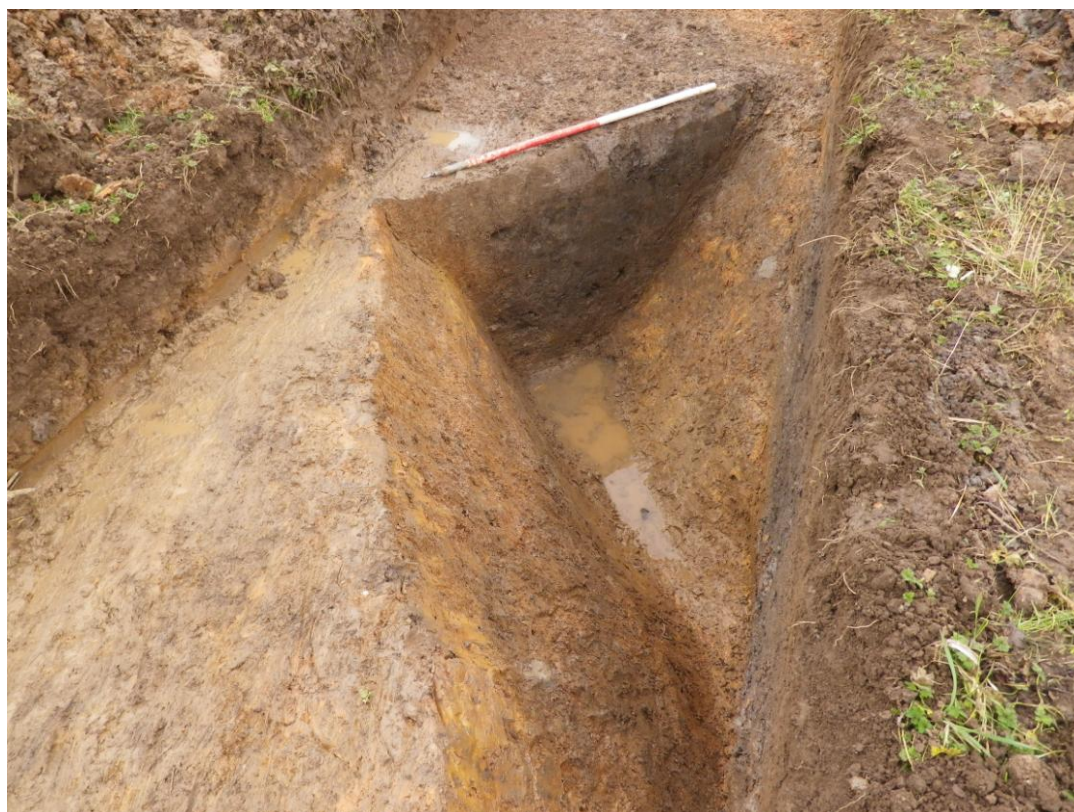
Plate 4: Shot of linear [402], looking southeast

- 4.2.12 Linear [402] was located near the centre of the trench and was aligned E-W. It measured 1.9m in length (visible in trench) by 1.7m in width and was excavated to a depth of 1m. It had sharp, near vertical sloping sides and had a V-shaped profile. The fill (403) was a firm dark grey silty clay that appeared to be well sorted with large stones on the base with occasional amounts of Roman pottery found under these stones. A single piece of worked flint was found also. This linear appears to be a continuation of a linear feature [3203] which was observed in Trench 32, which was to the south. However, from a previous geophysical survey done by ArchaeoPhysica Ltd in 2006, it appears to be a separate ditch running parallel to a possible square enclosure.

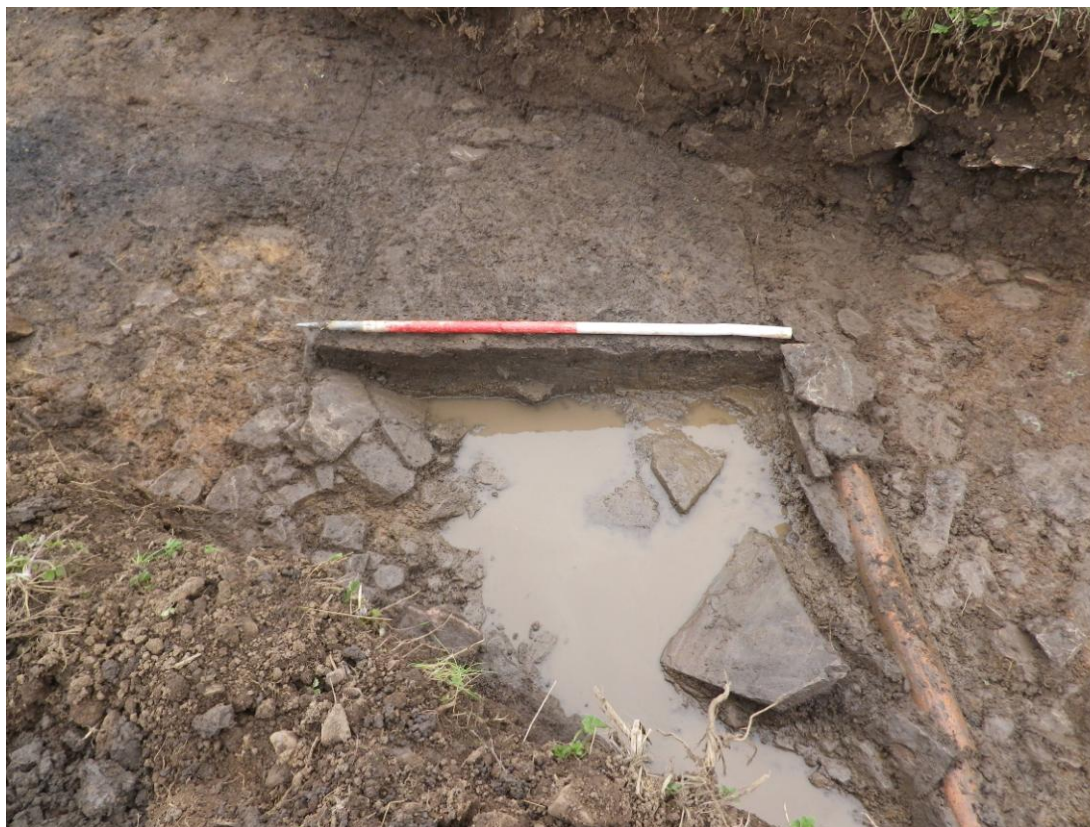
Plate 5: Shot of linear [419], looking southwest

- 4.2.15 Linear [419] was located at the northwest end of the trench and it was aligned NE-SW. It measured 2.2m in length (visible) by 2m in width and was excavated to a depth of 0.2m. The northwest side of the feature was truncated by a ceramic land drain that followed the line of the feature. The southeast side had a gradual sloping side with a flat, slightly rounded base. The fill (421) was a firm dark grey / brown silty clay that contained occasional amounts of stone and charcoal flecks. The fill also contained 3

pieces of tile, 2 sherds of Roman pottery, 1 piece of worked flint and an animal tooth. The fill mostly covered a layer of flat stones (420) which covered most of the base and on the sides. The ceramic drain which truncated it appeared to re-use the stones to cover the pipe. It was possibly the remains of a culvert which was observed in a trench (Area K) (Figure 17) opened by Avon Archaeology in 2011. It also truncated a gully, [407] and a possible second gully, [405], on its southeast side.

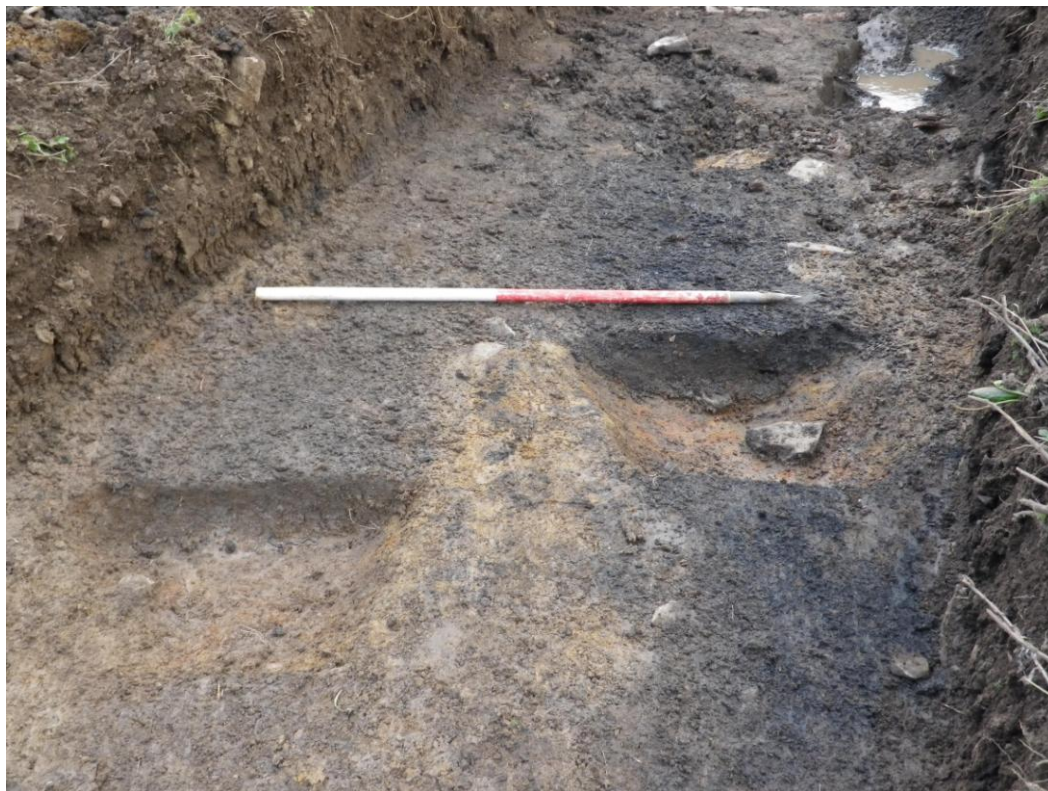
Plate 6: Shot of gullies [405] & [407], looking northwest

- 4.2.16 Gully [407] was located in the northwest end of the trench, 0.1m northeast of parallel gully [405] and was aligned WNW-ESE with its western side truncated by linear [419]. It measured 2.4m in length (visible in trench) by 0.64m in width and was excavated to a depth of 0.17m. It had gradual sloping sides with a rounded base which gave it a U-shaped profile. The fill (408) was a moderately compact dark grey brown / black silty clay that contained occasional amounts of stone, charcoal flecks and pottery which was possibly Roman.
- 4.2.17 Gully [405] was located in the northwest end of the trench and was aligned WNW-ESE. It ran parallel with another gully, [407], 0.1m to the northeast and similarly, was truncated by linear [419] which it intersected with at the side of the trench. It measured 2.1m in length (visible in trench), terminating

at its east-southeast end, by 0.59m in width and was excavated to a depth of 0.11m. It had sharp, steeply sloping sides with a flat base which gave it a U-shaped profile and had a rounded terminus. The fill (406) was a loose light grey / brown silty clay that contained occasional amounts of small stone and also one piece of Roman pottery.

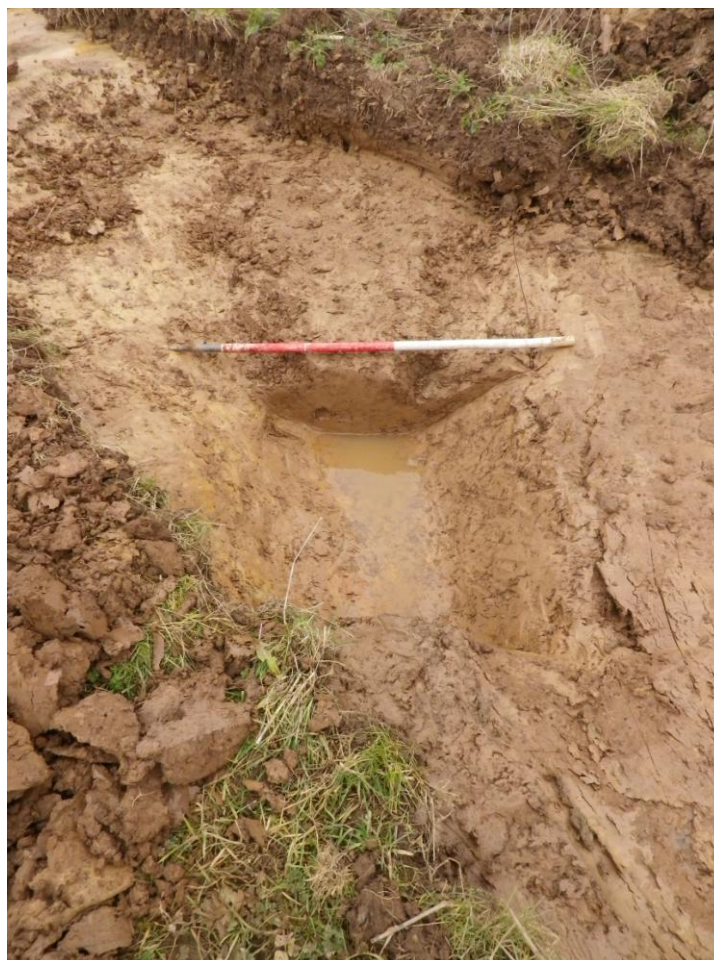
Plate 7: Shot of linear [2402], looking west

U-shaped profile. The fill (2403) was a firm mid grey brown clay that contained very occasional amounts of stone. This section of the trench sloped to the west, towards a brook which makes up the western boundary of the field and the linear, which heads towards it, may just be a drainage ditch.

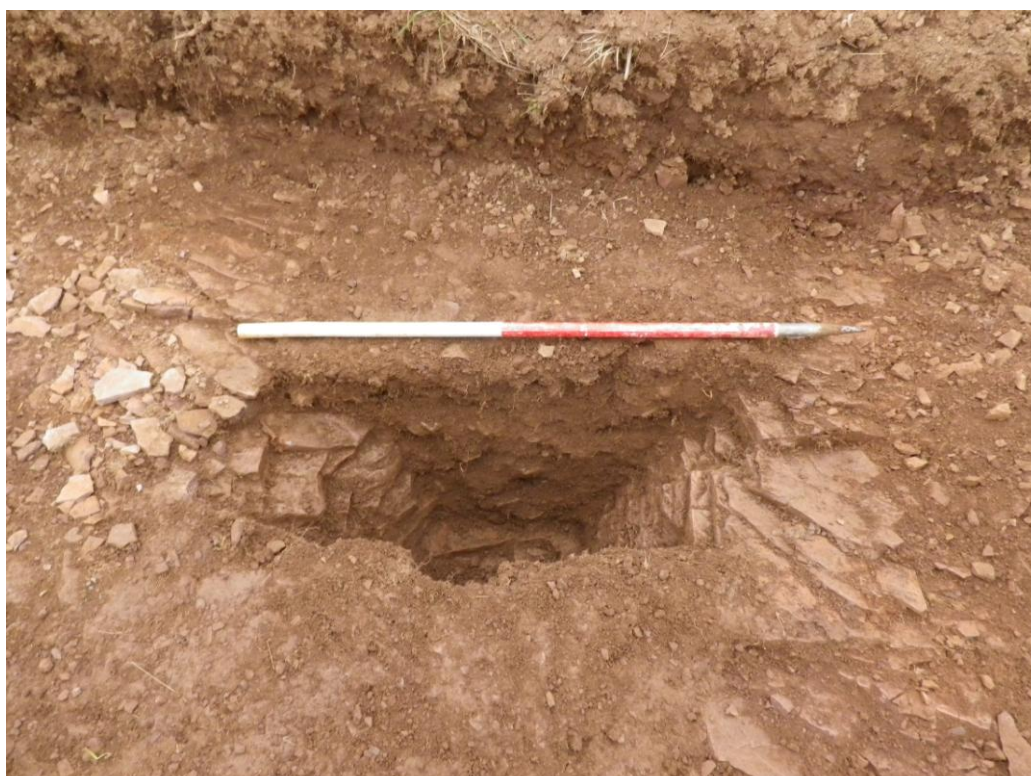
Plate 8: Shot of linear [2804], looking north

- 4.2.21 **Trench 28:** Trench 28 was located in a field, to the north of Hallen Farm and was aligned E-W (Figures 9 & 19). The trench was excavated to a maximum depth of 0.58m revealing a firm light yellow / orange natural clay and mid reddish brown bedrock (2801) below c.0.23m of a loose dark brown clayey silt topsoil (2800). A linear feature [2804] and possible drainage gully [2802] were observed within the trench. There was a modern rubbish dump was observed at the east end of the trench also.
- 4.2.22 Linear [2804] was located near the centre of the trench and was aligned N-S. It measured 0.95m in width and was excavated to a depth of 0.49m. It was cut into the natural bedrock and had very steep sloping sides, slightly stepped due to the layer formation of the bedrock and had a flat base, which

gave it a U-shaped profile. The fill (2805) was moderately loose mid brown silty clay that contained small amounts of stone and root activity.

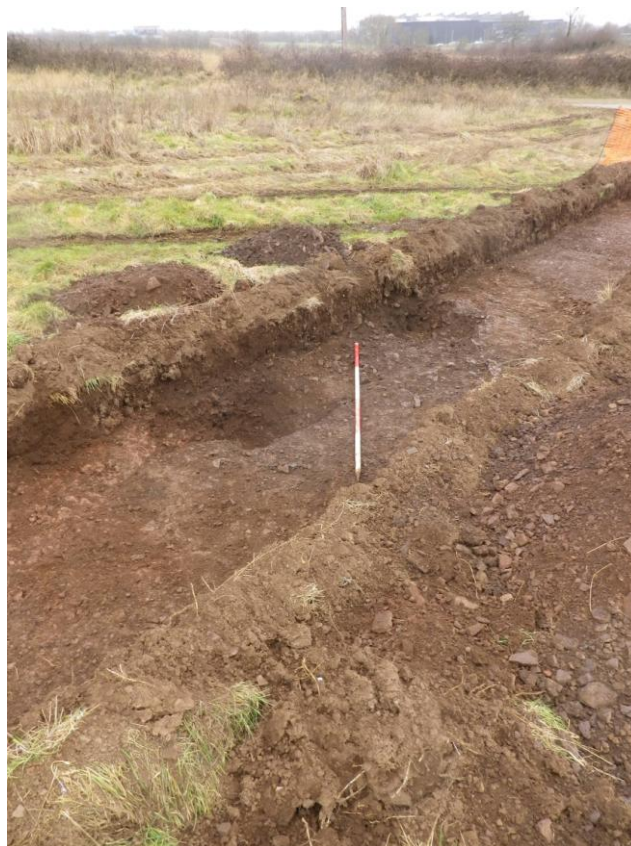
Plate 9: Shot of possible backfilled mineshaft [2902], looking west

4.2.25 The feature [2902] was located near the centre of the trench and was aligned E-W. It was rectilinear in plan, and extended beyond either side of the trench. It was cut into the natural bedrock and had very steep to vertical sloping sides. It measured 2m in width, but length and depth were not established. The fill (2903) was a loose dark brown / black silty clay that contained frequent amounts of metal slag and charcoal flecks. It was only partially visible in the trench so its function was not certain though it may have been a backfilled mineshaft given the large quantity of slag in the fill.

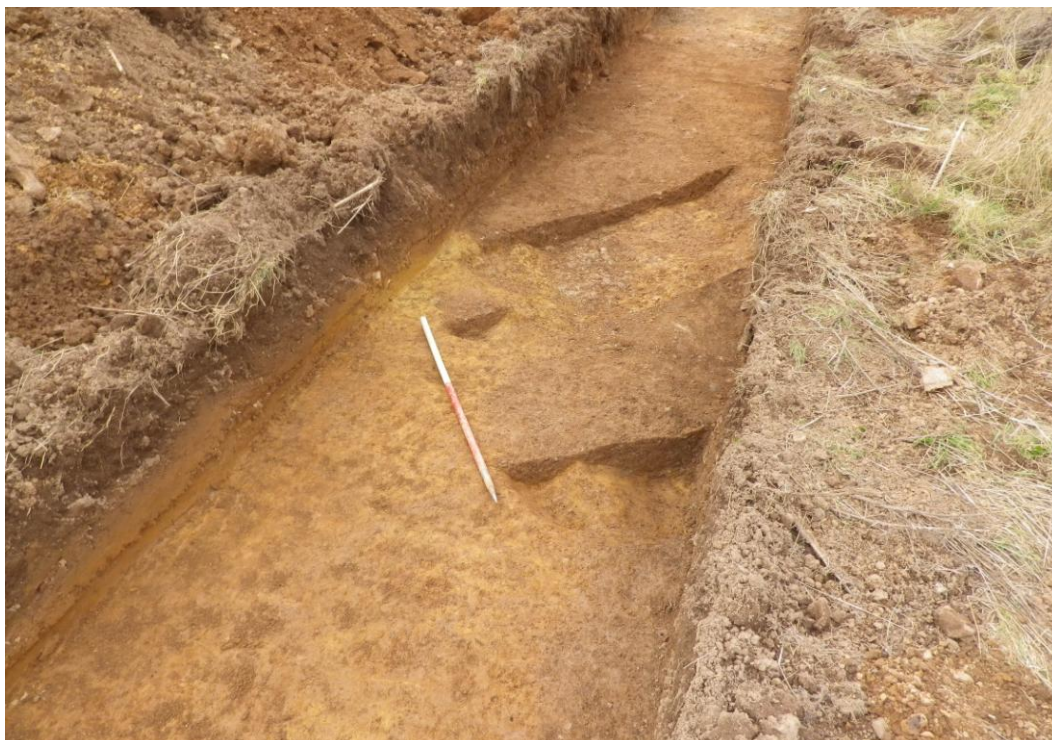
Plate 10: Shot of linear [3004] and pits [3006] & [3008], looking west

4.2.31 Pit [3006] was located 0.1m to the south of the south edge of curvilinear [3004] and 0.06m west of pit [3008]. It was sub-oval in plan with steep sloping sides and a rounded base in profile. It measured 0.6m in length by 0.35m in width and was excavated to a depth of 0.1m. The fill (3007) was a

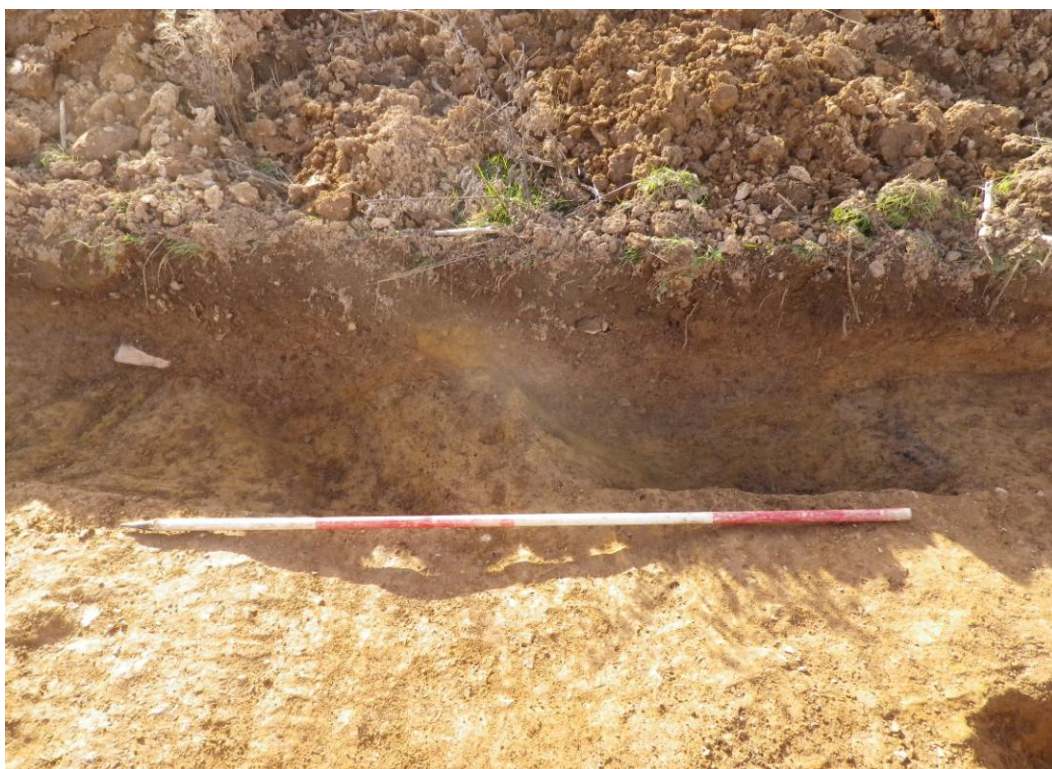
Plate 11: Shot of linear features [3010] & [3012], looking southwest

- 4.2.29 Linear [3012] was located in the SE end of the trench, 0.3m NW of linear [3010] and was the larger of the two linear features. It was aligned N-S and measured 1.4m in width and was excavated to a depth of 0.48m. It had steep sloping sides with a concave base which gave it a U-shaped profile. The fill (3013) was a loose mid brown grey silty clay that contained small amounts of irregular shaped stone and daub. It or [3010] may be the return of a possible enclosure, which included [3004], in the NW end of the trench, and linear [203] which were observed in Trench 2, which was to the north of Trench 30.

- 4.2.30 Linear [3010] was located in SE end of the trench, 0.3 SE of linear [3012], which runs parallel to it, aligned N-S. It measured 0.9m in width and was excavated to a depth of 0.5m. It had moderately steep sloping sides with a concave base. The fill (3011) was loose mid brown / grey silty clay that contained small amounts of Roman pottery and irregular shaped stone. The linear was not visible in Trench 2 which was located to the north which may indicate that it terminated between these two trenches.

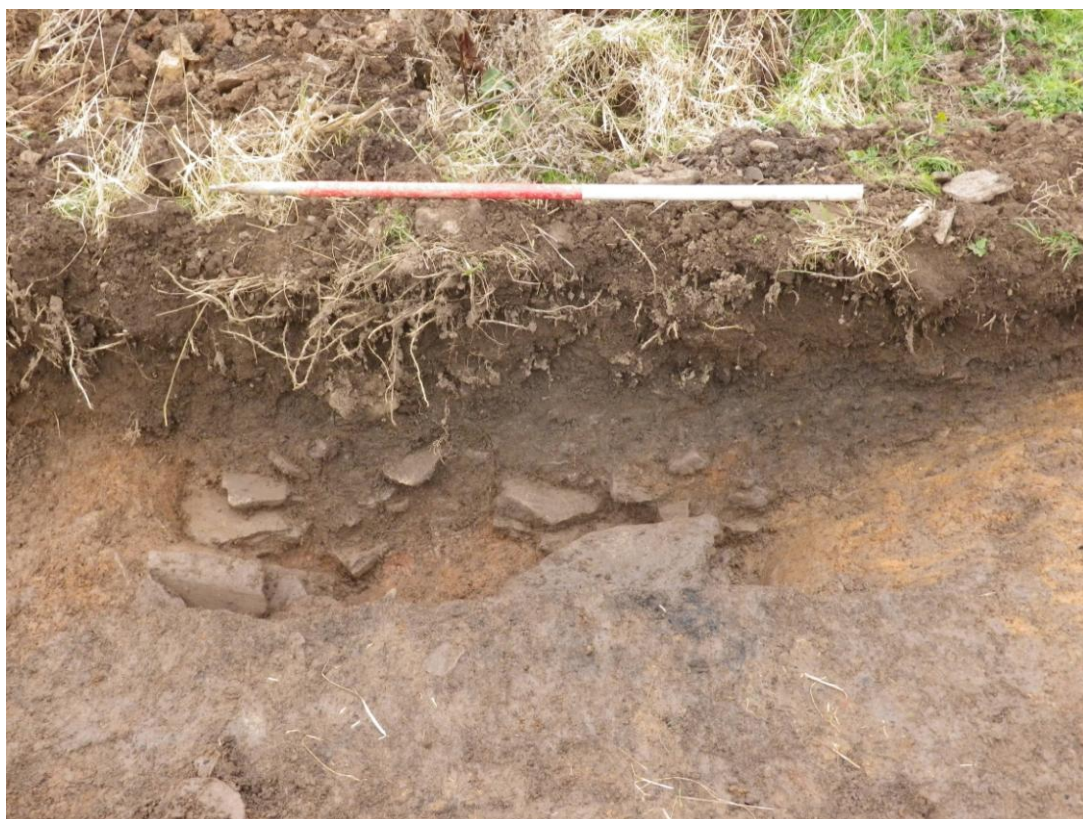
Plate 13: Shot of linear feature [3304], looking west

- 4.2.39 Linear [3304] was located in the northern end of the trench and was aligned E-W. It measured 1.67m in width and was excavated to a depth of 0.6m. It had steep, concave sloping sides with an undulating base which gave it a U-shaped profile. The fill (3305) was a moderately loose grey / brown clayey silt that contained frequent amounts of large stone, Roman pottery along with large pieces of slag and charcoal flecking.

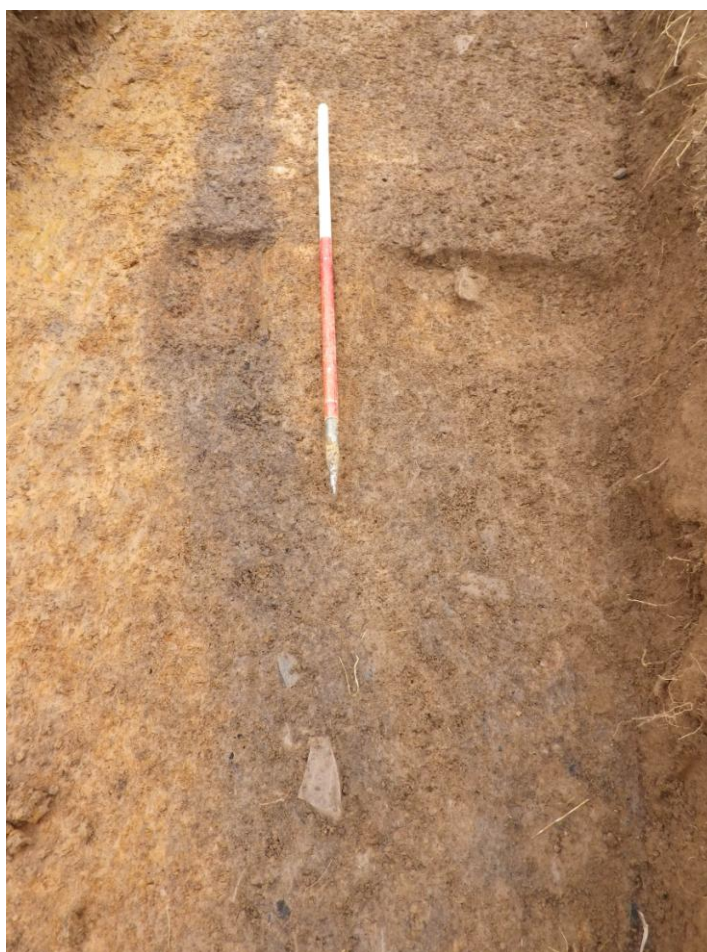
Plate 14: Shot of gully [3314] & feature [3316], looking southeast

The fill (3317) was a moderately compacted mid brown silty clay that contained occasional fragments of coal.

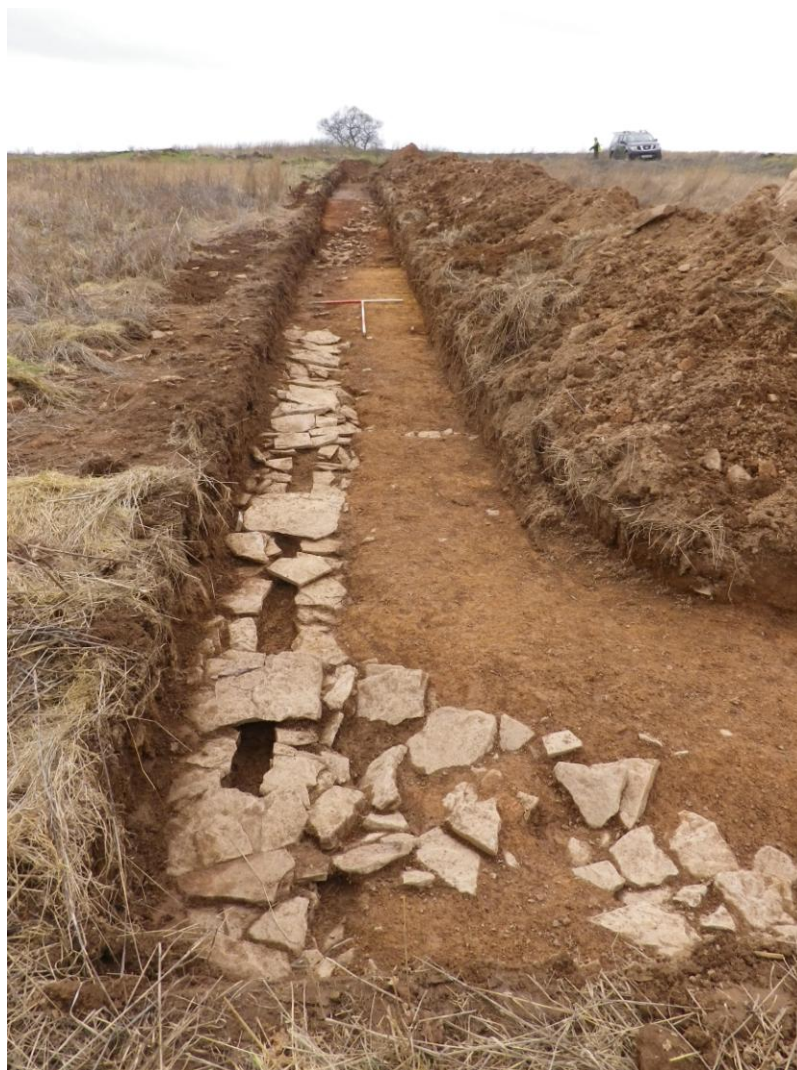
Plate 15: Shot of culvert {3404}, looking west

- 4.2.49 The cut [3403] mostly linear shaped in plan, curved slightly at its east end and centre. It consisted of sharp steep sloping sides with a flat base, which gave it a U-shaped profile. The culvert was covered by deposit (3405) which was a loose light brown silty clay that contained moderate amounts of Roman pottery. The fill was mostly concentrated over the disturbed part of the culvert and was mixed with large stone. It was in this section that most of the pottery was found along a blue glass bead (SF#1), and a jet spacer bead (SF#2). A second fill (3406), was a loose light/mid brown silty clay that

was located in the channel of the culvert that was covered by the flagstones and was very similar to (3405) which covered the culvert. There were 3 narrow stone filled drains, [3407], [3409] (north side) and [3411] (south side) that may be associated with the culvert, though initially all 3 were thought to be modern stone filled land drains.

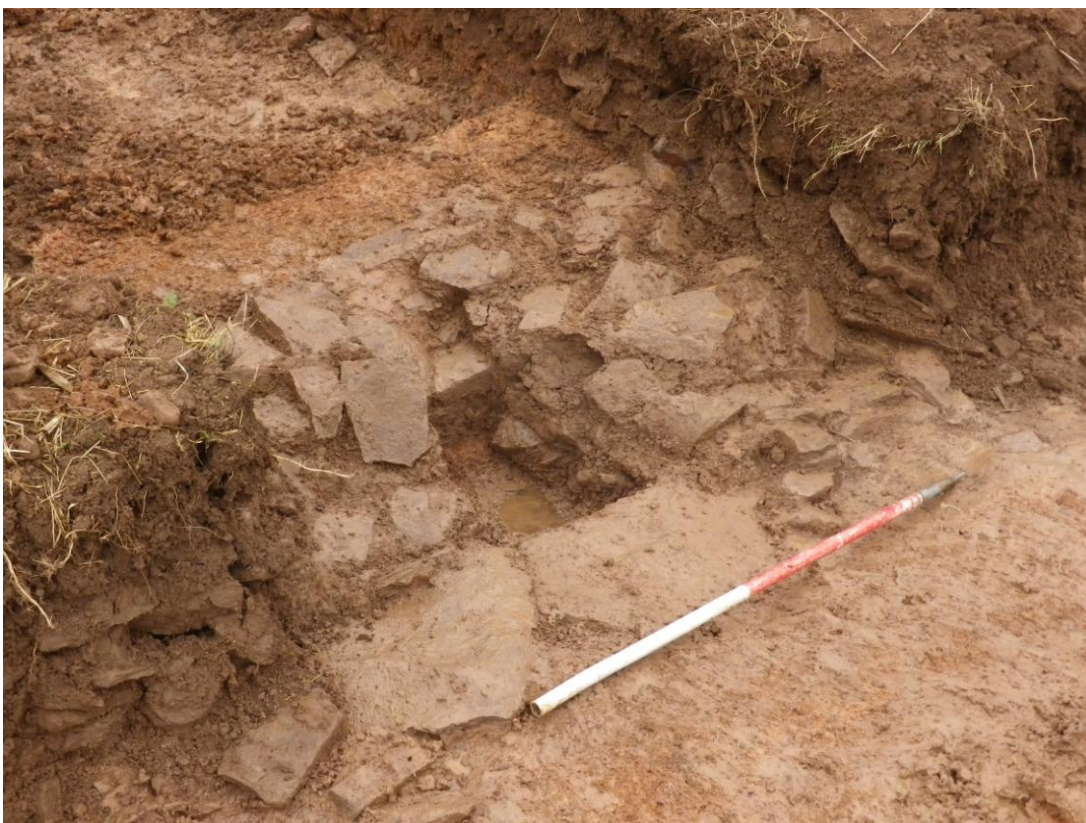
Plate 16: Shot of culvert {3404}, looking northeast

4.2.50 Drains [3407] and [3409] were located in the eastern side of the trench, on the north side of the culvert [3404] and drain [3411] was located near the centre of the trench on the south side the culvert. Drain [3407] was roughly aligned NE-SW and N-S and measured 0.92m in length by 0.16m in width and was 0.11m in depth. Drain [3409] was roughly aligned N-S and measured 0.82m in length by 0.22m in width and was 0.13m in depth. Drain [3411] was roughly aligned NE-SW and measured 0.76m in length by 0.16m in width and was 0.10m in depth. The three drains all had steep sloping sides and flat bases. And the three drains had very similar fills, (3408), (3410) and (3412)

respectively, which consisted mostly of stones mixed with a mid brown silty clay. The features abut up against the culvert's north and south sides but did not appear part of the structure though they could be an additional run-off for water making it contemporary with the culvert or it may have been truncated by it.

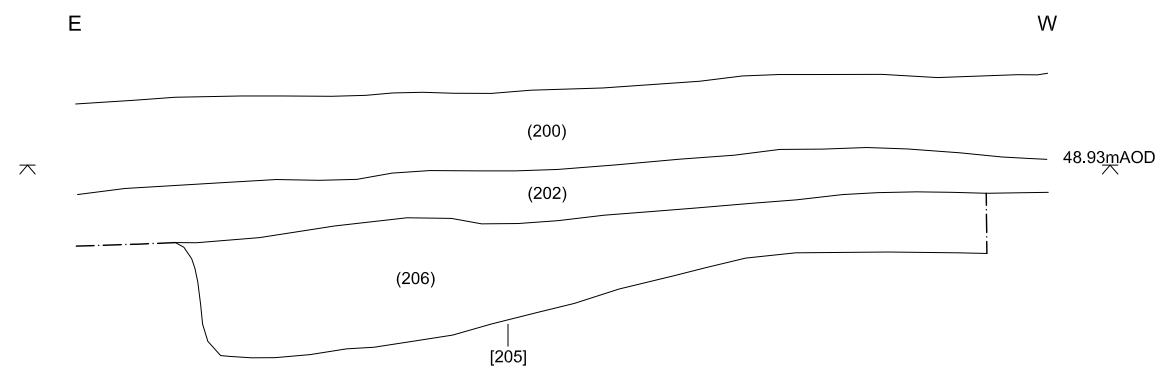
Section 1. North facing section across linear [205].

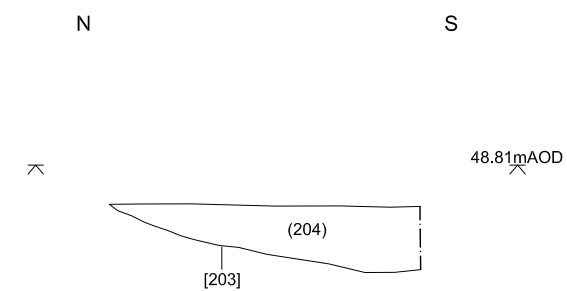
Section 2. West facing section across linear [203].

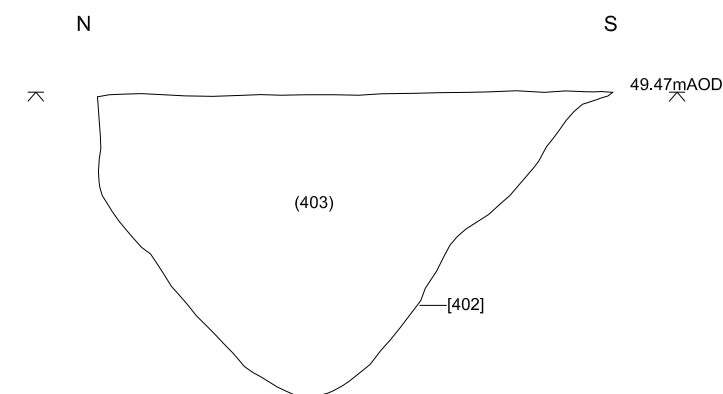
Section 10. West facing section across [402].

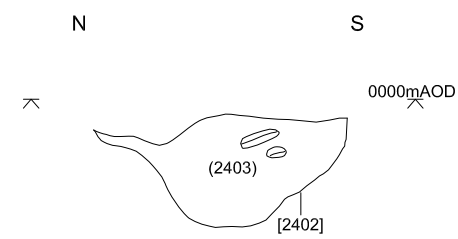
Section 11. West facing section across [2402].

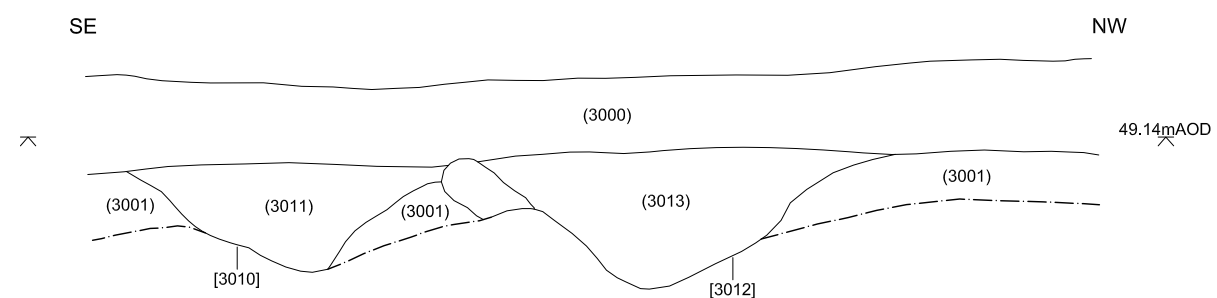
Section 20. North-east facing section across [3010] and [3012].

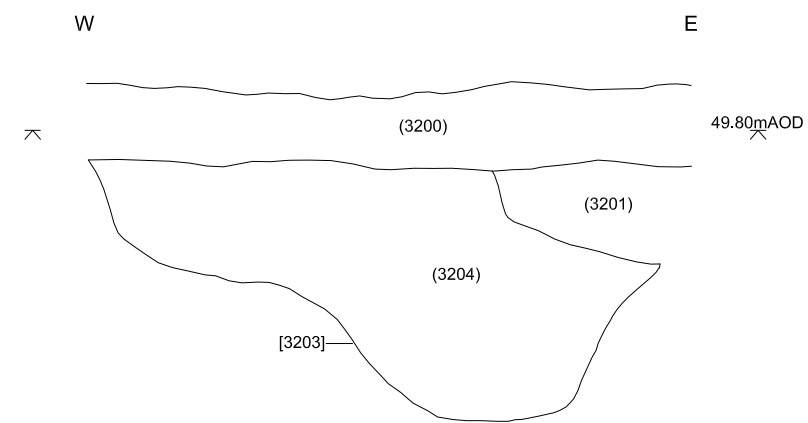
Section 21. South facing section across [3203].

- 4.2.36 Linear [3203] was located in the western side of the trench and was aligned N-S. It measured 2m in width and was excavated to a depth of 1.17m. It had very steep sloping sides with a concave base which gave it a V-shaped profile. The fill (3204) was a loose dark grey / brown silty clay that contained frequent amounts of stone, moderate amounts of charcoal flecking and a small amount of Roman pottery and a worked piece of flint. Linear feature [402] in Trench 4 is possibly a continuation of [3203] and may represent part of an enclosure.

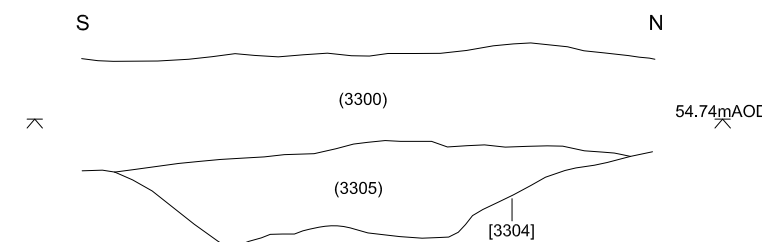
Section 28. East facing section across [3304].
