**HARD LEVEL ADIT, BARNEY BECK, OLD GANG, REETH HIGH MOOR,
RICHMONDSHIRE, NORTH YORKSHIRE**

WATCHING BRIEF REPORT

DECEMBER 2020

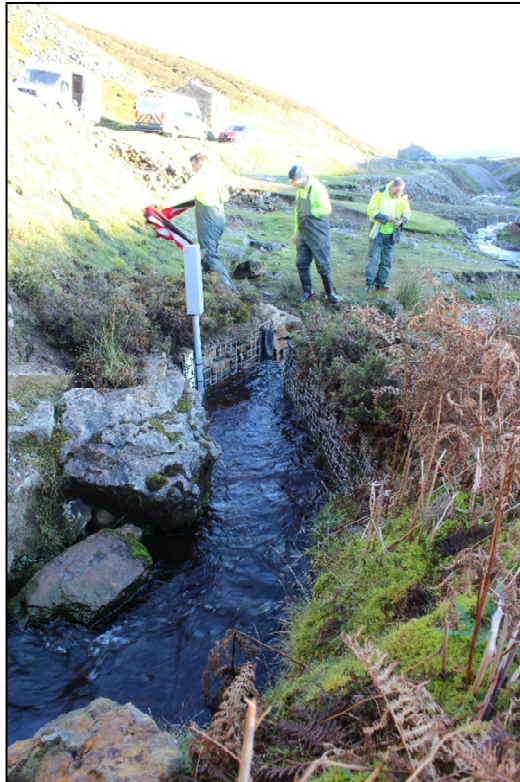
Plate 1: Completed structures, channel and monitoring structure facing south

- 4.2.3 Two new retaining wall structures were created, comprising custom-built gabion baskets, the western measuring 2.1m by 0.35m and inserted on an approximate east to west orientation, and the eastern measuring 1.4m by 0.35m and placed on an approximate north-west to south-east orientation. This created a channel 0.37m wide through which water would pass. These gabion baskets were filled with the large stones and boulders earlier relocated, with additional stones utilised from the bed of Barney Beck, in a neat, compact arrangement. A water resistant membrane was then secured over these gabion baskets, to prevent water from seeping through these new retaining wall structures, and narrow wire baskets, 0.15m in width, were affixed to the visible sides of this (the north side of the western structure and the west face of the eastern structure) to reduce the visual impact of the new structures on the scheduled monument. These narrow gabion baskets were neatly filled with stone from the immediate vicinity, and stones were placed on top and around, and covered in earth (removed from a raised heap on the north side of Barney Beck) and mosses, to blend the new structures into the landscape. An area of dry-stone wall revetment, 1m in length, was also built adjacent to the north-western extent of the newly inserted eastern wall structure to secure it into place.

- 4.2.4 Once the water outfall had been controlled by the establishing of these two new wall structures, a metal monitoring post with rectangular structure attached was affixed to the eastern wall structure. The monitoring structure extends above the height of the new wall structures, and as a silver metal unit, is the most visually different element in the area (Plates 1-2). Weathering and moss growth is anticipated, which will further help these new features to blend into the landscape.

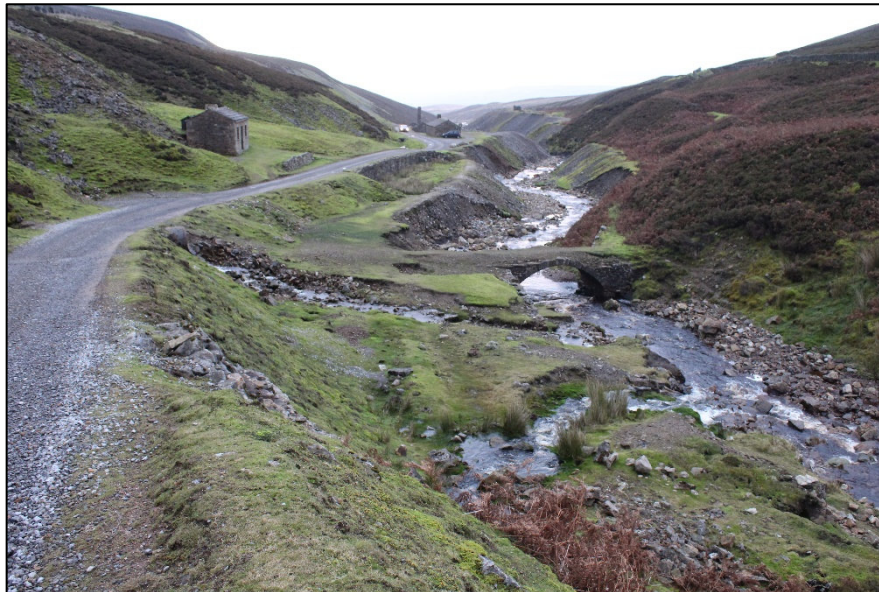
Plate 3: View of Hard Level Adit and beyond from north-west

- 5.1.2 The pre-works photographic survey showed that periodically, high volumes of water passed through the Hard Level Adit, resulting in the pooling of water, and the cutting of an additional channel to the south-east, as well as the direct route straight from the Hard Level Adit into Barney Beck. This was posing a present and future risk of damage from erosion within the scheduled area. The new retaining wall structures have created a narrower channel for the water to be directed through, with no opportunity for it to seep into the wider areas. This will reduce the risk of future erosion. In addition, this water will now pass the new monitoring structure and thus will provide data on concentrations of pollutants, allowing assessments to be made on how to reduce these and minimise future leaching into the wider area.

Pre-works

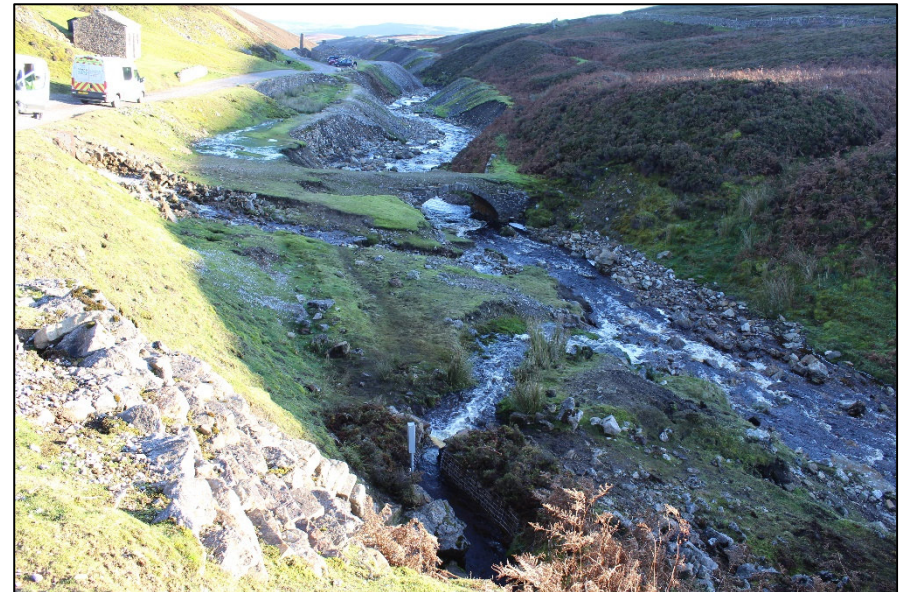
Plate 4: View of Hard Level Adit and beyond from north-west

- 5.1.3 No adverse direct impacts on sub-surface archaeological remains occurred as a result of the installation of the new monitoring structure.
- 5.1.4 Although the pre and post-work photographic surveys show the impact of the new monitoring structure and its associated retaining wall structures visually on the wider area, these have been minimised by the use of materials from the immediate vicinity, with only metal from the gabion baskets visible at certain angles, and the metal monitoring structure itself (Appendix 1, Plates 3-8). It is anticipated that weathering and future moss growth will further help these new features blend into the landscape, diminishing their impact on the scheduled area.

Post-works

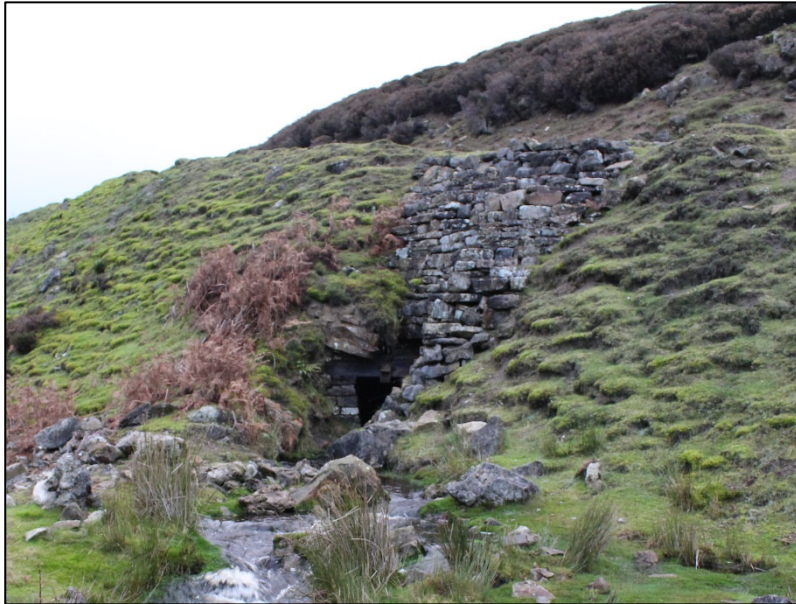
Plate 5: View of Hard Level Adit from south-south-east

Pre-works

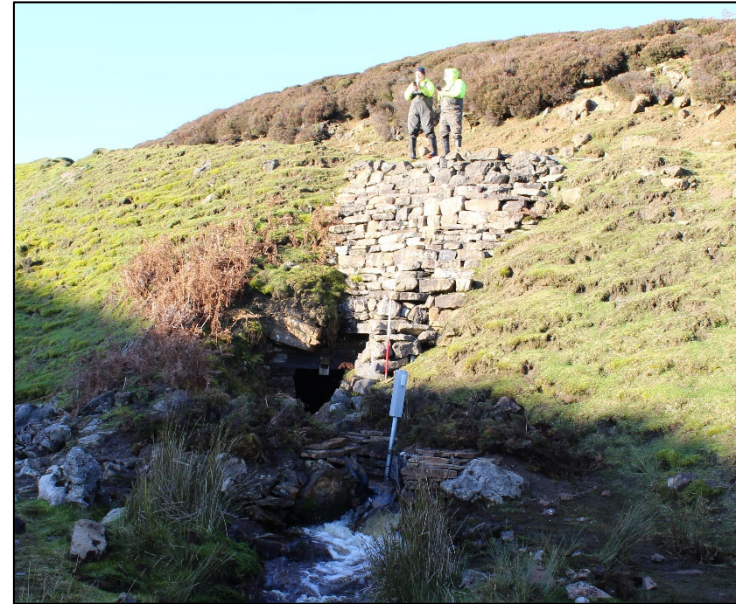
Plate 6: View of Hard Level Adit from south-south-east

Post-works

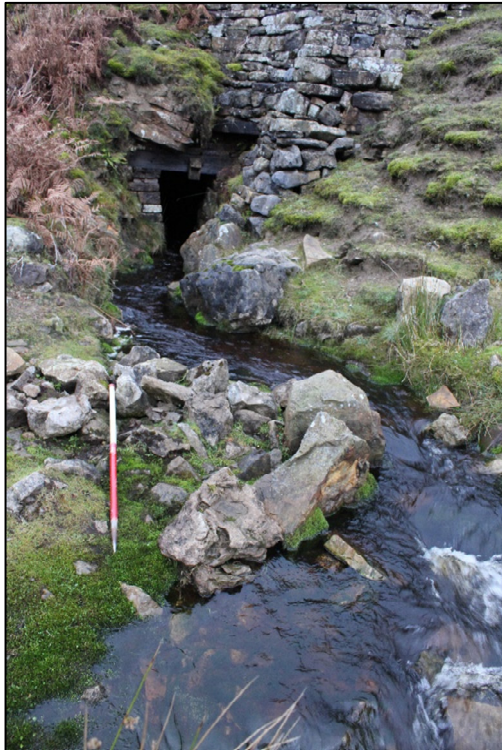
Plate 7: View of Hard Level Adit from south

Pre-works

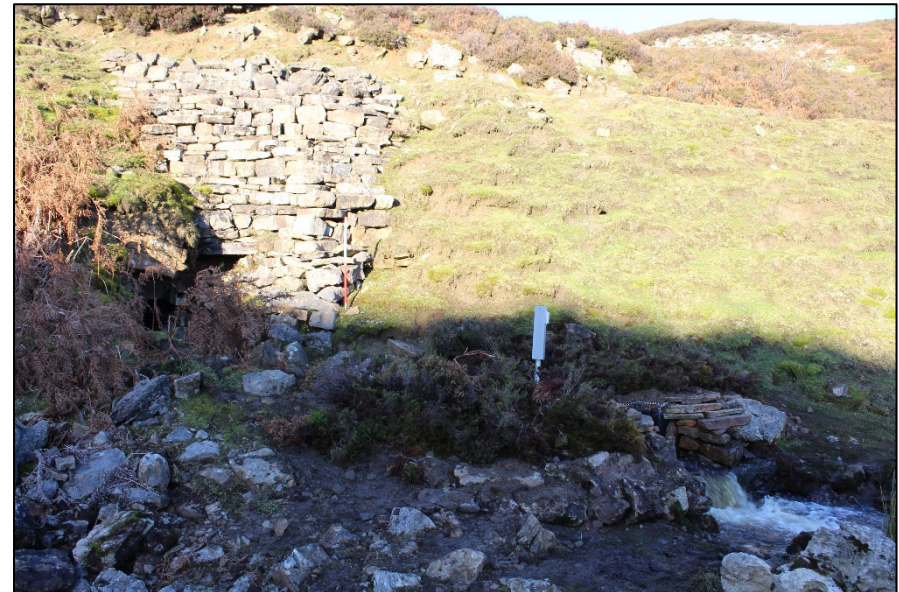
Plate 8: View of Hard Level Adit from south

Post-works

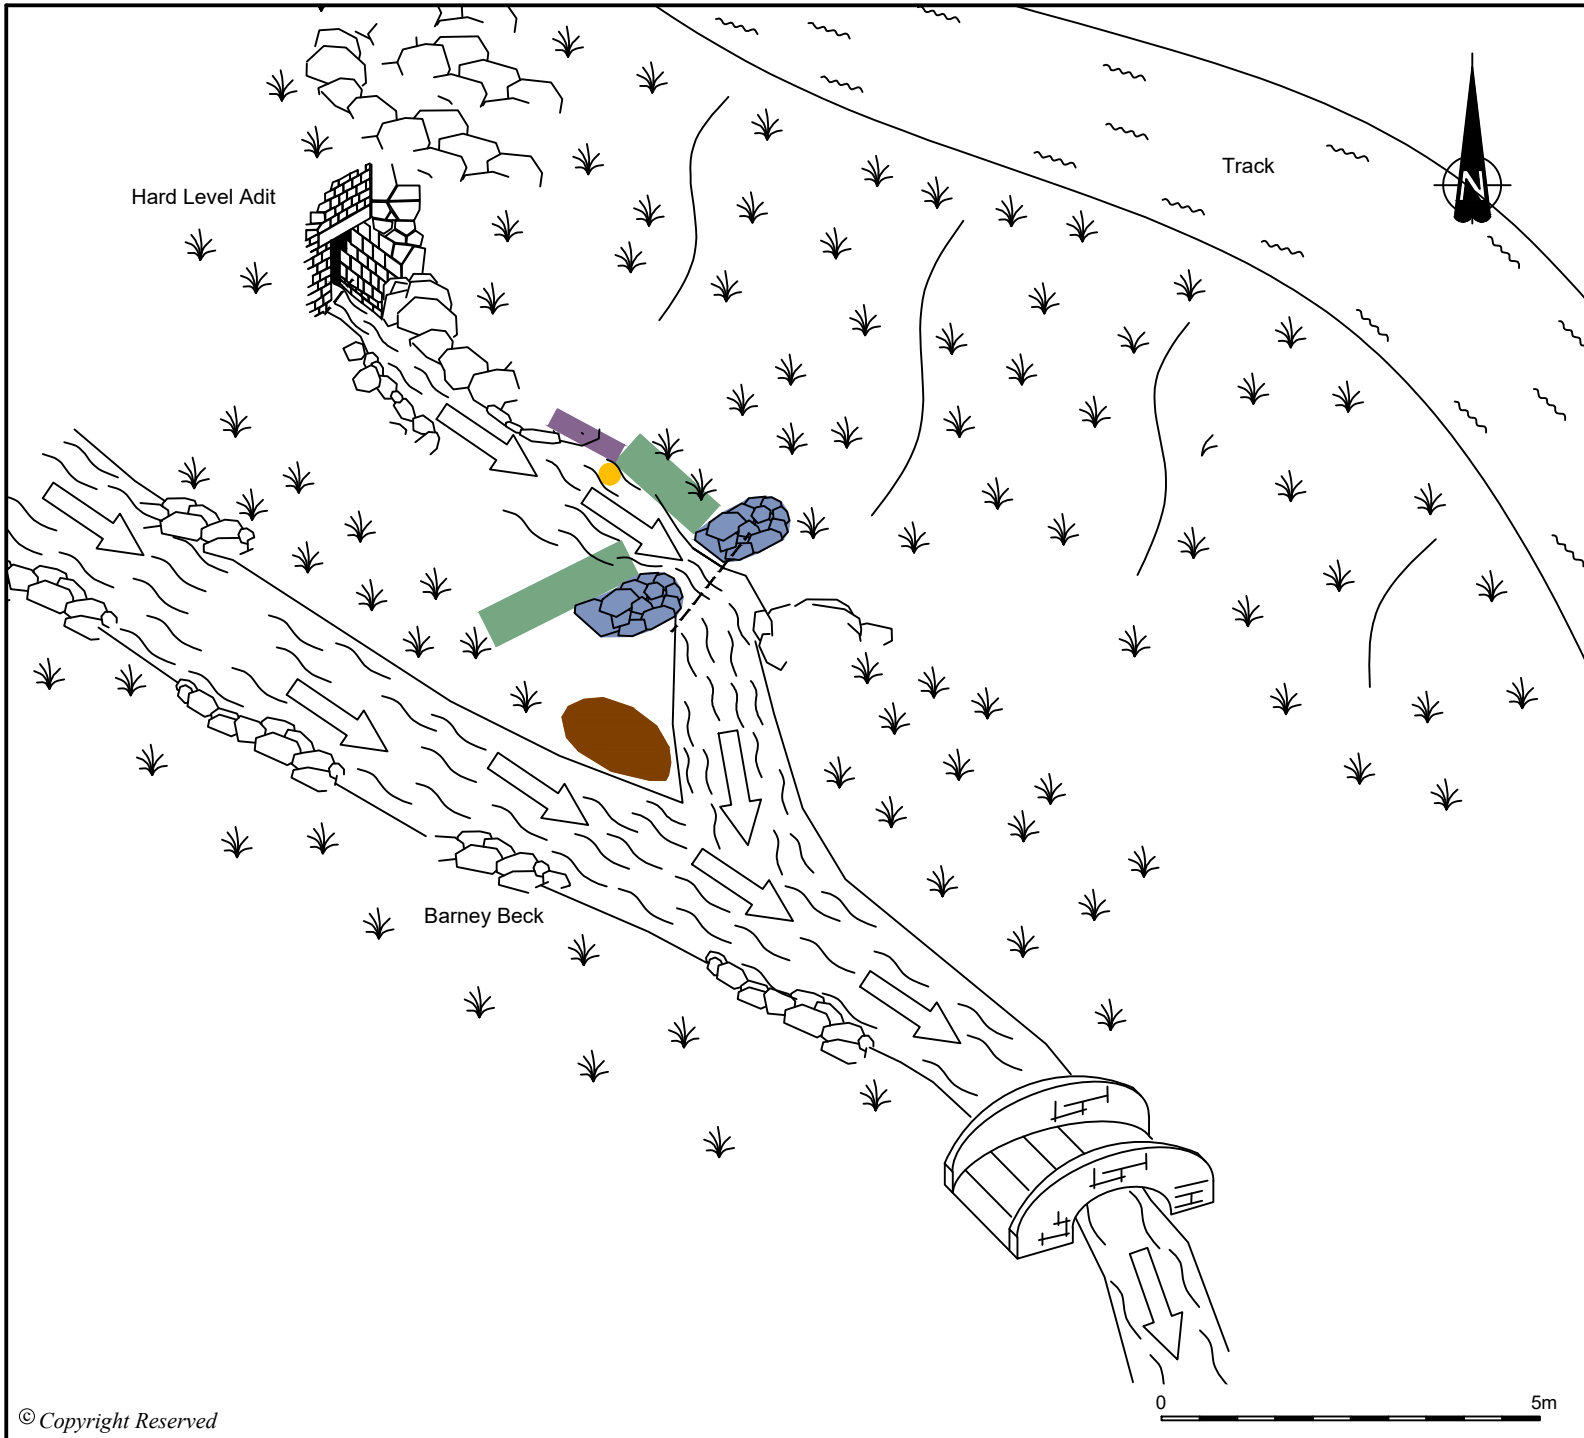
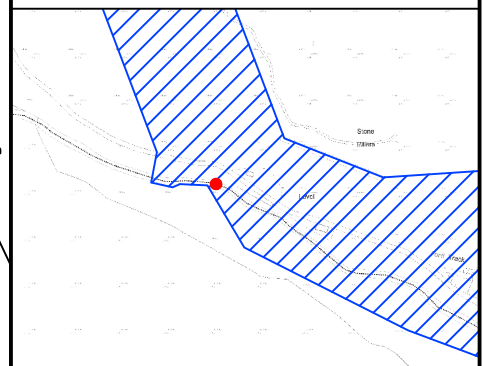
DRAWING TITLE
Figure 3:
Results of watching brief
(after R.H. Harrison Construction Limited)

3.1.2 The location of the new monitoring structure and associated groundworks was a little to the south of Hard Level Adit, and north of Barney Beck (Figure 3).

4.2.2 The groundworks undertaken to facilitate the installation of the new monitoring structure initially required the relocation of large stones and boulders from the outflow from the Hard Level Adit, and from the east and west banks. Several large boulders were retained either side of an existing drop in level, to support the new retaining wall structures, and to create a narrower channel for the water to be directed through, whilst also passing the location of the new monitoring structure.
