**KILNCLEUCH HOUSE
LANGHOLM
DUMFRIES AND GALLOWAY**

ARCHAEOLOGICAL WATCHING BRIEF REPORT

DECEMBER 2020

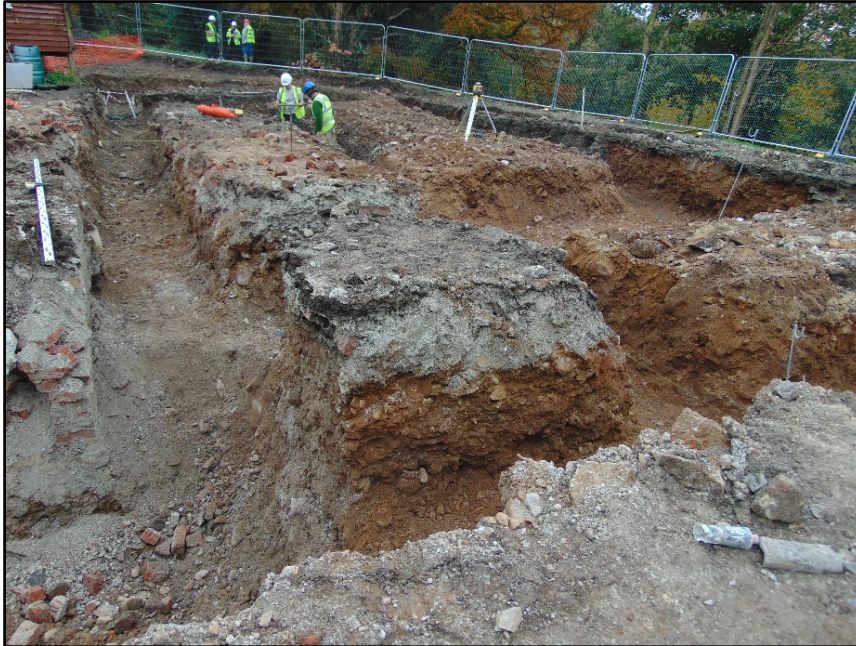
- 4.1.3 Foundation trenches for the new dwelling were excavated over an area measuring roughly 24m x 19m. The linked trenches measured an average of 0.80m wide and were excavated to an average 1m depth. A series of pits were also excavated to the south of the trenches (Plate 1; Figure 2).

Plate 1; Foundation trenches for new dwelling. Looking south east

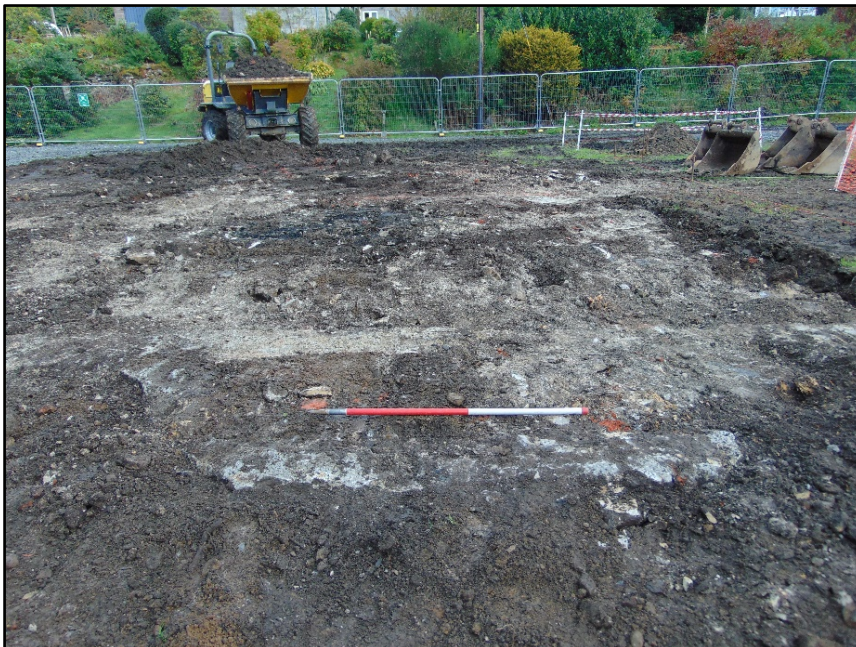
- 4.1.4 An area measuring 15m x 17m was stripped of an average of 0.10m topsoil immediately to the west of the new foundation trenches, to allow for a hardcore surface for parking and turning (Plate 2).

Plate 2; Wall foundations of earlier building seen in topsoil strip. Looking north East.
1m scale

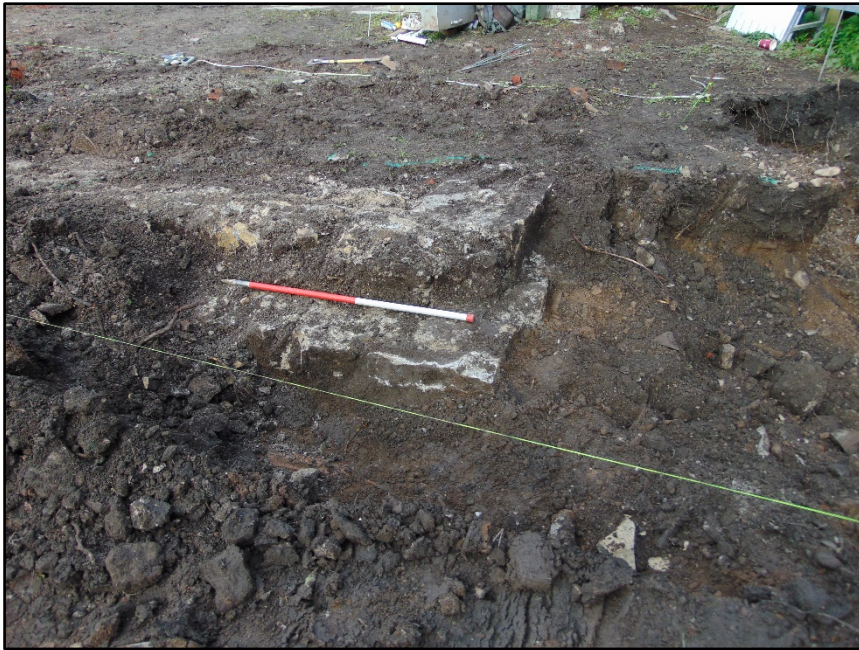
- 4.2.1 The foundation trenches exposed the footprint of the earlier substantial building measuring 30m x 17m+, comprising sandstone sandstone walls, e.g. **(103)**, **(106)**, **(113)**, **(120)**. The walls were constructed using a pale-yellow sandstone blocks and were an average of 0.60m wide. The blocks were built onto a wide platform of sandstone slabs measuring 0.90m in width e.g. **(106)** (Plate 3; Figure 3). It was noted that the foundation slabs were often bonded with concrete.

Plate 3; Wall 106 seen in foundation trench. Looking north west. 1m scale

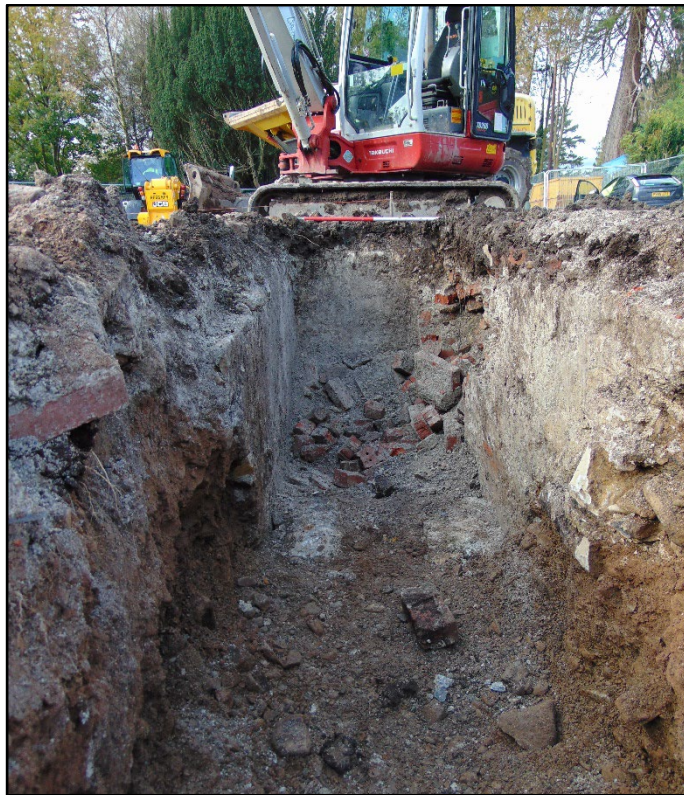
- 4.2.5 A subterranean cellar was encountered to the north west of the new foundations (Plate 4). The cellar had whitewashed walls **(131)** and remnants of a red sandstone flagged floor was noted. The cellar had been backfilled with red unfrogged bricks and household rubbish including glass bottles and metal objects, presumably during the demolition of the house.

Plate 4; Entrance to subterranean cellar and rubble backfill. Looking north west. 1m scale

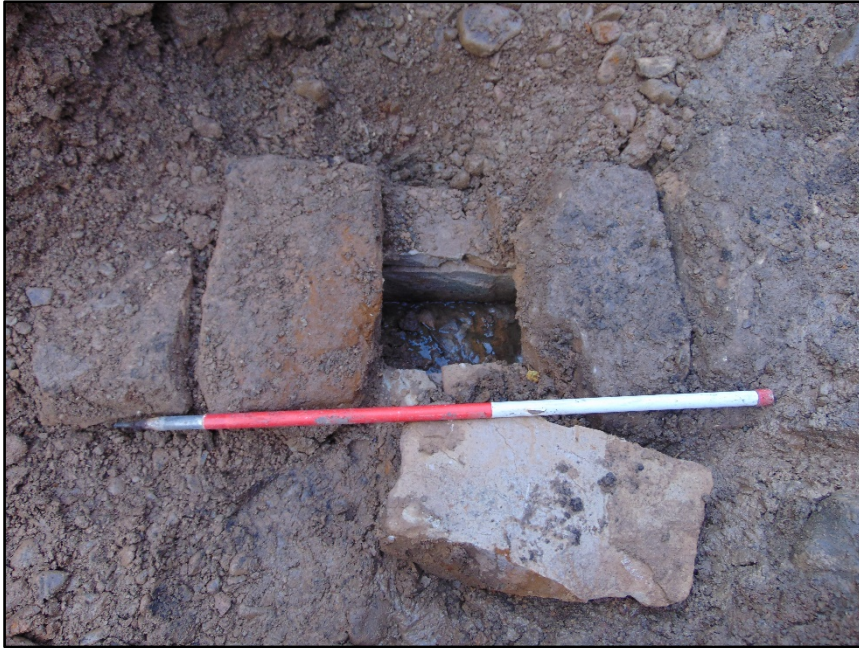
- 4.2.7 The stone culvert **(102)** seen at the eastern end of the new foundation trenches runs west north-west to east south-east and appears unconnected to the wall foundations (Plate 5; Figure 3). The culvert measured 0.60m in width and was seen at a depth of 0.80m below the current ground surface. Dye was added to the known sewage system uphill which proved that this culvert was still in use by the surrounding properties.

Plate 5; Culvert 102 Looking east. 1m scale

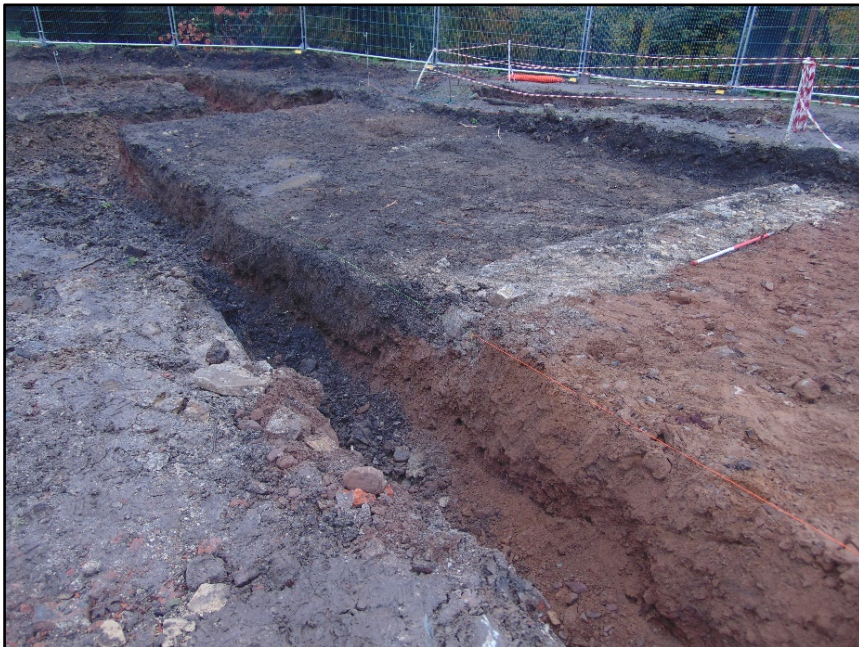
- 4.2.8 A thick deposit of sandy silt was noted to the south east corner of the foundation trenches **(124)**. The deposit measured an average 0.50m and was likely a garden soil associated with Oak Cottage (Plate 6).

Plate 6; Garden soil to east of wall (120). Looking south east. 1m scale

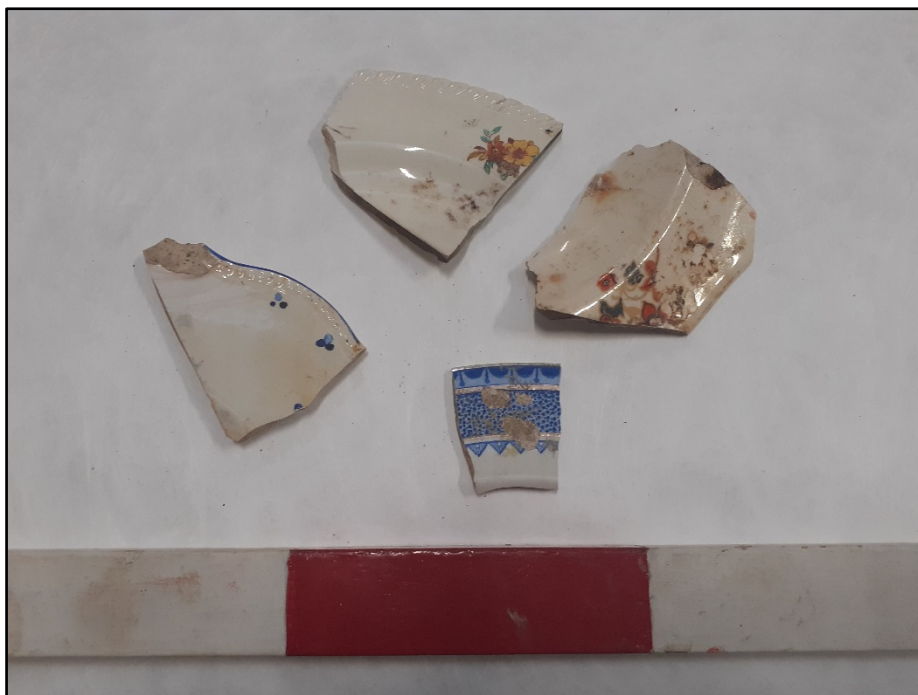
- 5.3.1 A total of 26 sherds of late post-medieval to early modern pottery and other ceramics, weighing 1,185g, were recovered from two contexts and as unstratified material (Table 1; Plate 8). The sherds are in fairly good condition.

Plate 8; Pottery recovered from watching brief (10cm scale)

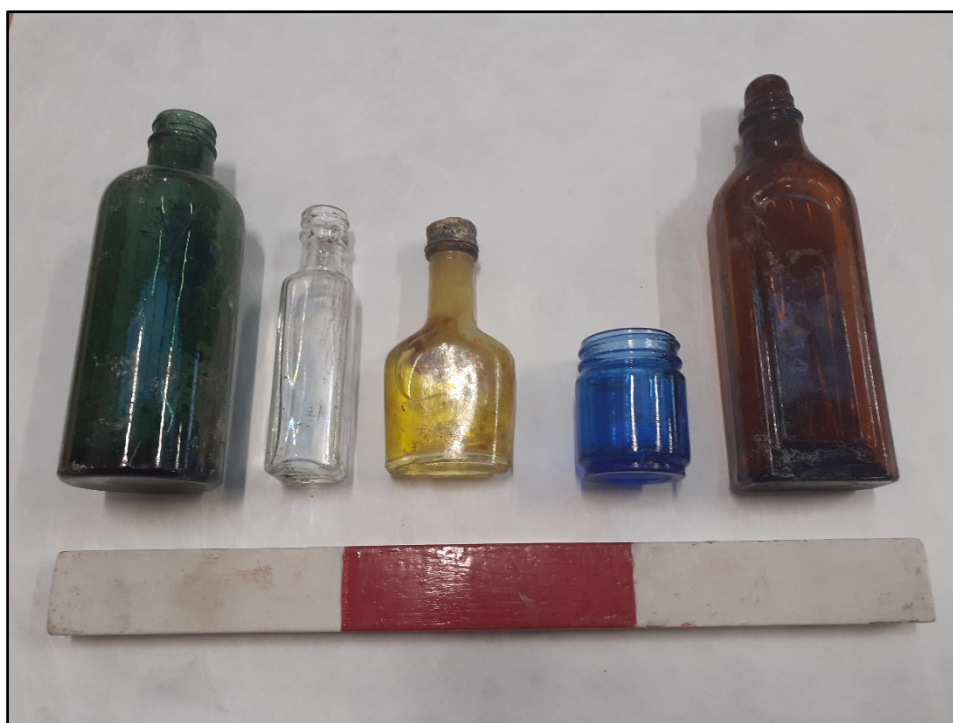
- 5.5.1 A total of 75 glass artefacts, weighing 17,815g, was recovered from two contexts (Table 1; Plate 10). The artefacts are in good condition.
- 5.5.2 The vast bulk of the glass artefacts comprise green, brown, blue and clear bottles which would have originally contained food and drink consumables such as Oxo, meat paste, whisky and condiment sauces. A Brylcreem jar was recovered from context **(132)** as well as a Calific (California) fig syrup bottle dating to c.1880 and a

Plate 10: Glass bottles (30cm scale)

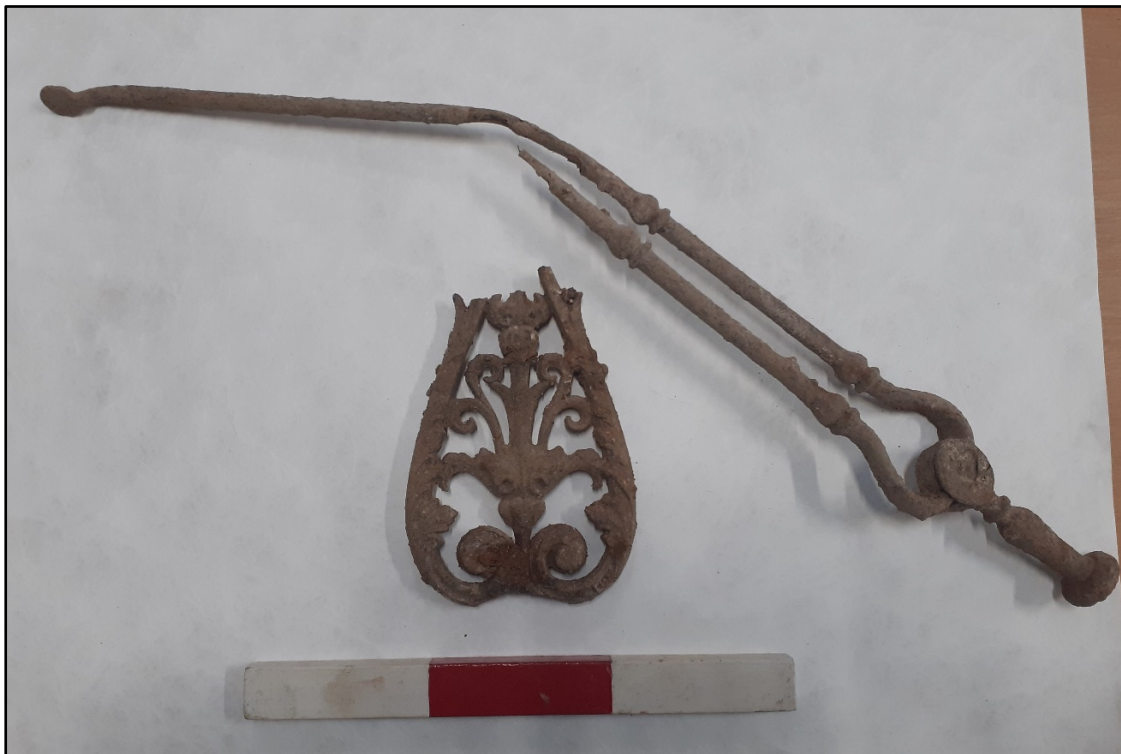
5.6.1 A total of twelve iron artefacts, weighing 8,530g, were recovered from two contexts and as unstratified material (Table 1; Plate 11). The iron is in poor condition with heavy rust corrosion present on all edges and surfaces.

Plate 11; Iron fire tongs and decorative fitting (30cm scale)

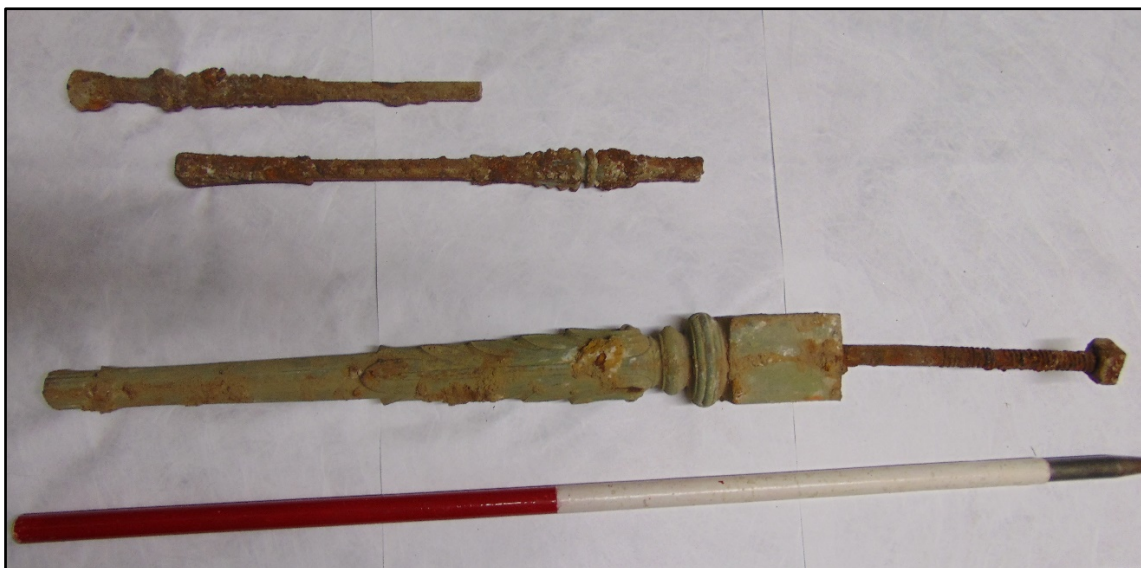
5.7.2 The artefacts comprise a partial ornate curtain rail and a large ornate leg, possibly from a bed (Plate 12).

Plate 12; Possible bed leg and associated iron fittings (1m scale)

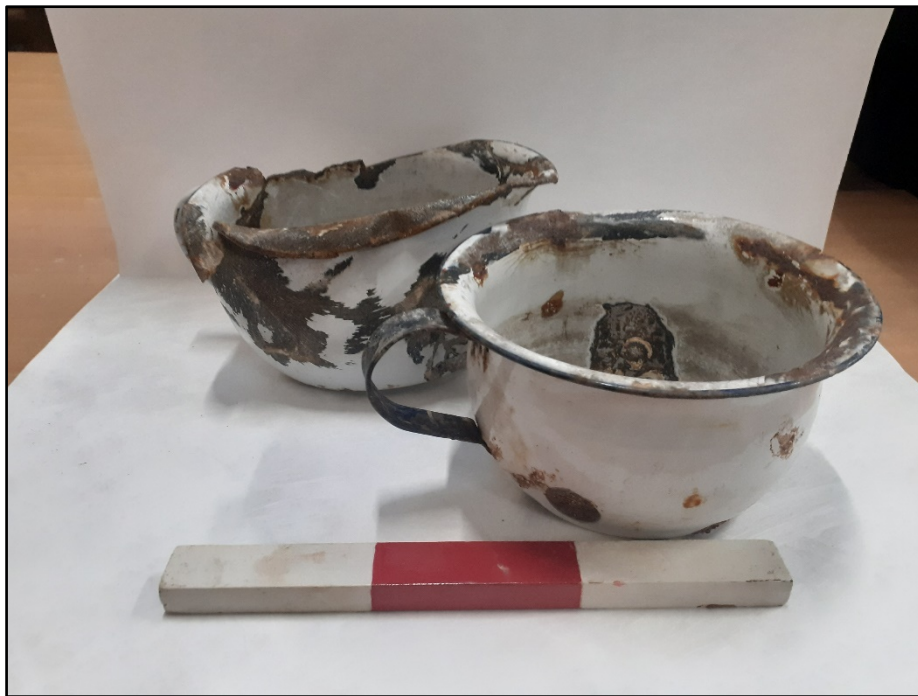
5.8.2 The artefacts include a stove kettle, two enamelled chamber-pots (Plate 13), an enamelled plain dish and a saucepan as well as a circular lid or cap.

Plate 13; Chamber Pots (30cm scale)
