PELL WALL HALL, PELL WALL, MARKET DRAYTON, SHROPSHIRE

ARCHAEOLOGICAL BUILDING RECORDING REPORT

**NOVEMBER 2021**

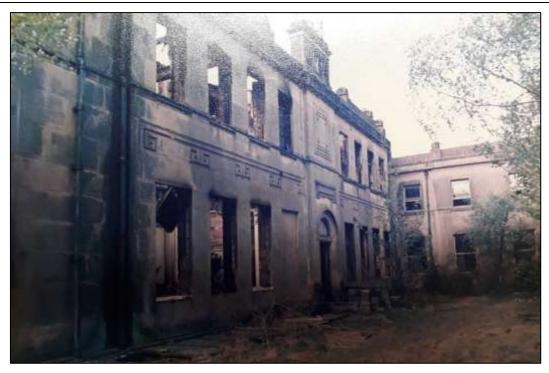
Fig.G: A 1992 photograph of the derilict Victorian extension (Shropshire SMR Slide Storage) - showng the south east elevation and later Edwardian wing adjoing perpendicular. Evidence of the covered passageway (*Confer para 3.5.2*)

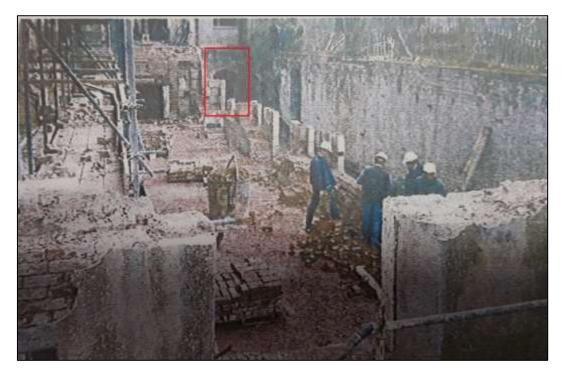
Fig.H: A 1997 photograph of the demolition programme (PWPT 1993), with the probable access to the passageway highlighted by the author.

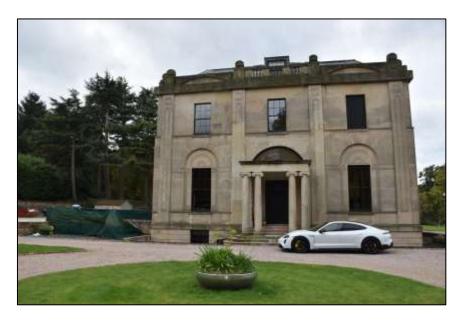
- 4.2.2 The principal elevation is of 3 bays. The north-western elevation is similar to that to the east, except for a central and full-height bow, and is of 1:3:1 bays. The southwestern elevation looks over the garden and is of 5 bays.

Plate 1: The north-eastern elevation of Pell Wall Hall (DP 1).

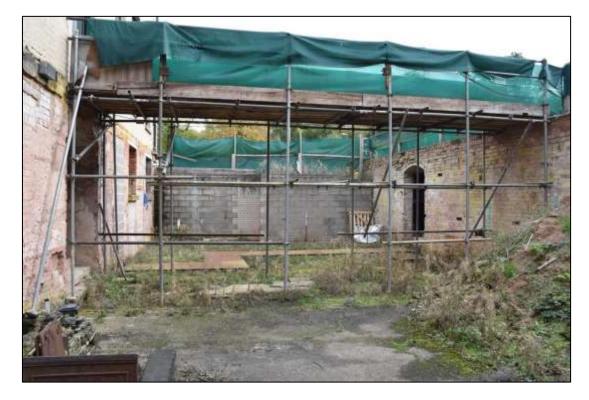
- 4.3.1 The area subject to the archaeological building recording comprises the former southeastern basement; an area that has witnessed extensive redevelopment since the construction of Soane's original range of domestic offices (Plate 2).
- 4.3.2 The south-eastern external wall of the principal structure attests to the extent of these redevelopments, with a relatively limited amount of original material surviving.
- 4.3.3 The basement area is bound to the north-east and south-west by a modern retaining wall of blockwork construction, which imitate Soane's original curved retaining wall design (Appx.1.2) and may be situated in the same location. The south-eastern side of the former basement is bounded by a wall of mid to late 19<sup>th</sup> century brickwork. The wall is pierced by an arched doorway positioned towards the eastern corner that gives access to a vaulted cellar structure.

Plate 2: The former southern basement (DP 8).

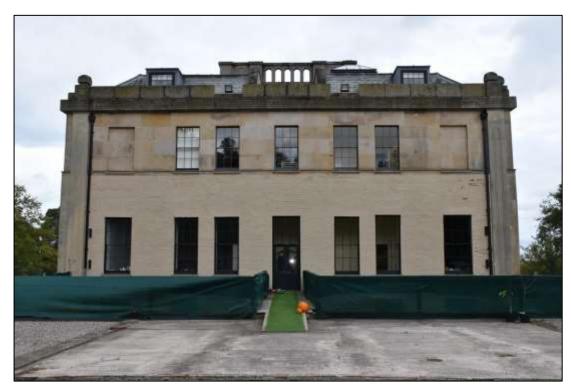
- 4.4.3 The elevation is pierced by a central doorway, which is currently accessed via a raised walkway supported by scaffolding over the basement void. Either side of the door is a pair of modern six-over-six sliding sash windows, which appear to have been installed to reinstate the symmetrical aesthetic of the elevation. A photograph taken following the demolition of the southern Victorian range shows the former arrangement of the fenestrations (Fig.J). This demonstrates that the central door was previously a window, and that the second window from the east replaced a doorway that provided access at ground floor level. The two windows immediately to the west of the central door have been enlarged, while the easternmost and westernmost windows do not appear to have been altered since the 1990s.

Plate 3: The south-eastern elevation (DP 4).

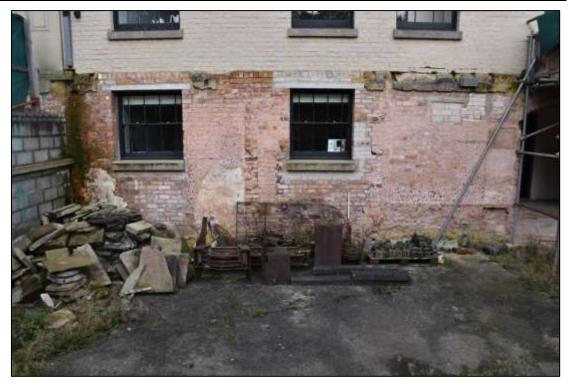
- 4.4.8 Immediately to the west of the central arched doorway, straight joints in the brickwork are evident which correlate with a slight recess in the wall noted within Soane's plans of the basement (Plate 6). The bricks utilised to block-up the recess are not like those used to infill the former doors to the west and were likely laid during the Victorian phase of development. The bricks were set in a lime mortar in a common or American bond, and exhibited evidence for skintling which is typical of bricks produced in the early to mid-19<sup>th</sup> century. The recessed area was partially disturbed by a further fenestration that was likely blocked with modern materials during the works to Pell Wall Hall in the 1990s. It may have had an extractive function related to the kitchen that once lay beyond.

Plate 4: The western section of the south-eastern elevation (DP 11).

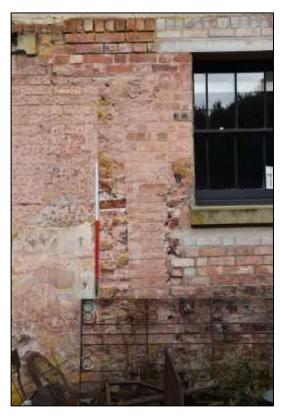
Plate 5: Remnants of an original demolished wall – left (DP 16).

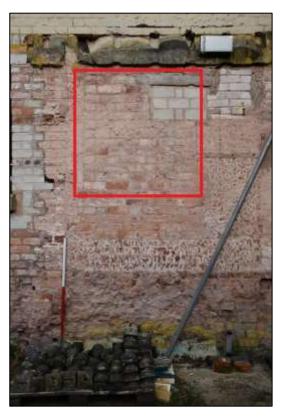
Plate 6: The infilled brick recess of the south-eastern elevation – right (DP 14).

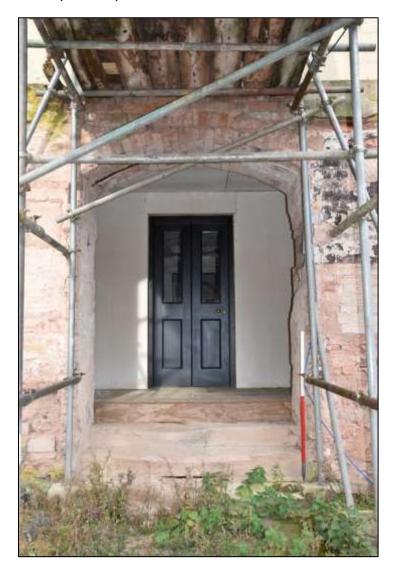
- 4.4.9 The elevation is pierced centrally by a brick segmental arch that leads to a recessed entrance via four heavily worn stone steps (Plate 7). Sections of plaster adhering to the brickwork of the arch survive, and at lower level, a formed skirting that was once painted is preserved in parts extending up the steps.
- 4.4.10 The recessed area has been largely modernised, though Flemish bond brickwork is exposed on its north-eastern side. The stud wall dividing the recessed area and the principal building is a modern addition; Soane's original 1828 basement plans, and later plans, do not depict this partition.

Plate 7: The central segmentally arched entrance (DP 19).

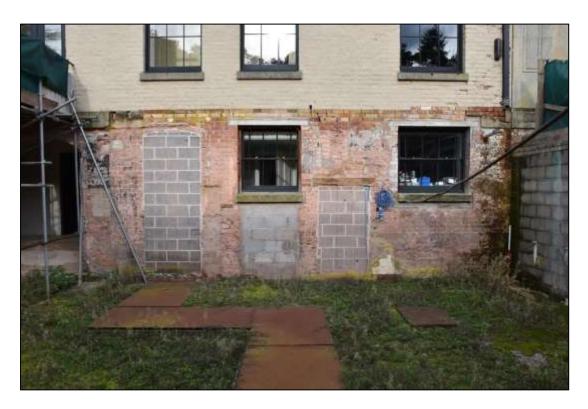
4.4.12 To the east of the central entrance further infilled fenestrations are evident (Plate 8). Notably, a small section of likely original Flemish brickwork survives, though now heavily scarred to receive render, immediately to the east of the central entrance. Further to the east is a blocked-up doorway with a segmental brick head, which has been infilled with modern cement blocks. Soane's original plans of the basement record this fenestration as a window. The pre-demolition plans appear to suggest that the doorway provided direct access to the staircase constructed during the Victorian period, which led to the ground floor corridor.

Plate 8: The eastern section of the south-eastern elevation (DP 25).

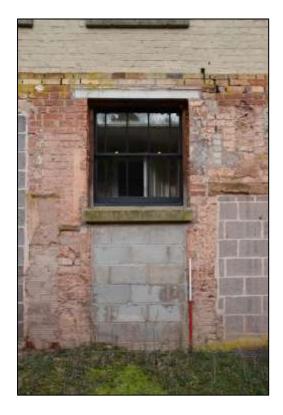
4.4.13 To the east of the aforementioned blocked-up door is a modern window, beneath which is a further cement block infilled area (Plate 9). This infilled doorway, significantly, appears to correlate with the linkage between the main villa and the original service wing at basement level. This doorway was positioned to provide access to Soane's original laundry room and to the domestic staircase up to the ground floor. According to records produced prior to the demolition of the southern Victorian wing, this doorway continued to be used into the Edwardian period to provide access to the servery. This doorway appears to once have had a segmental arch, like that to the west, and was clearly still in use following the demolition of the southern Victorian wing (Fig.J).

Plate 9: The infilled door of the demolished linkage at basement level – left (DP 27).

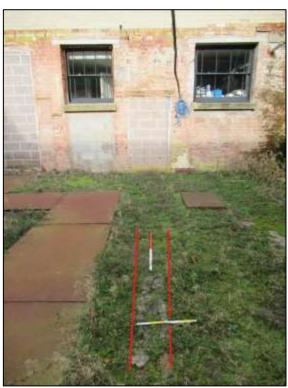
Plate 10: Remnants of an original wall at ground level – right (DP 31).

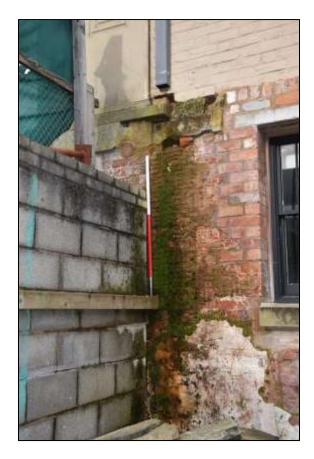
4.4.17 The remnants of the original western retaining wall may underly a section of scored rendering in the north-western corner of the basement area, which was likely applied to provide a relatively flat surface for subsequent layers of render. The proposed location of the original retaining wall also aligns with the end of the plinth. Overlying the square-scored render at lower level was a further layer of render that appears to have been whitewashed. A significant portion of the potentially original brickwork has been keyed so that render could be directly applied to the surface. This indicates that the entire western section of the southern elevation was rendered during the Victorian and Edwardian periods, when this area was utilised as a laundry or utility room.

Plate 11: Potential remnants of the original retaining wall and later render (DP 15)

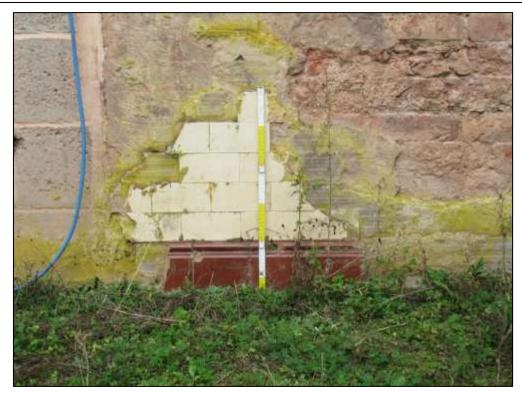
4.4.18 The brickwork in the east has also been keyed and was likewise rendered at upper level. At lower level, however, the eastern section of this elevation was tiled. A small section of glazed cream wall tile, with reddish brown tiled skirting below, survives (Plate 12). Although most of the tiles are lost, the extant tiles adhere to a horizontally scratched cement adhesive that survives at lower level elsewhere. The tiles, which would have adorned the former kitchen, are typical of those produced in the late 19th to early 20th century.

Plate 12: The surviving tiles of the former kitchen (DP 34)

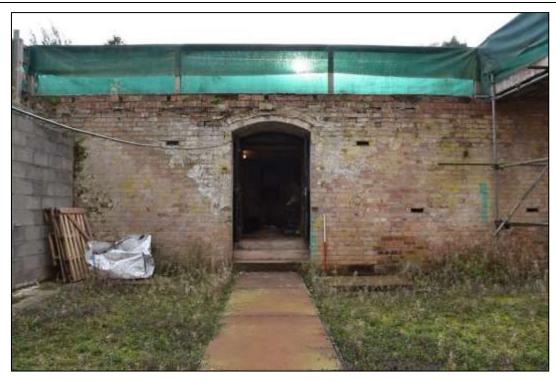
- 4.5.1 As noted above, the south-eastern side of the former basement is bounded by a wall of mid to late 19<sup>th</sup> century brickwork. The brickwork is set in lime using an 'American' or English garden wall bond, with six courses of stretchers for every course of headers (Plate 13). This wall was built during the construction of the southern Victorian range and formed the southern side of a passageway leading from the eastern wing (Fig.L). Interestingly, this wall was built as a brick 'skin' appended to the northern wall of the passageway linking the two ranges of Soane's original domestic offices. This formation is evident from ground floor level (Plate 14) and can be seen through a missing air vent grille. The construction of the wall has created a significant cavity area, measuring approximately 3.50m in width. The passageway linking Soane's two domestic ranges, in addition to a relatively slim area of unknown function, is now completely enclosed. A series of ornamental, metal vents along the Victorian wall facilitate air circulation of the cavity.

- 4.5.2 The wall is pierced by a segmentally arched, and recessed, entrance with three stone steps that lead to a pair of double doors. It appears to have been constructed to emulate the original arched entrance of the south-eastern elevation.

Plate 13: The Victorian wall of the vaulted cellar (DP 36)

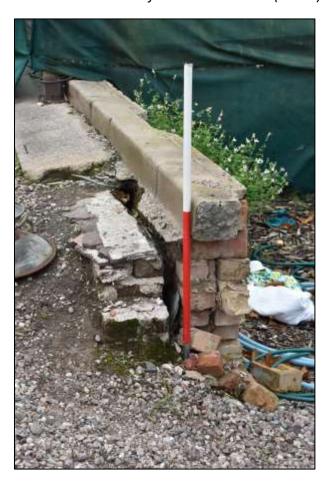
Plate 14: The Victorian wall and Soane's original (DP 41)

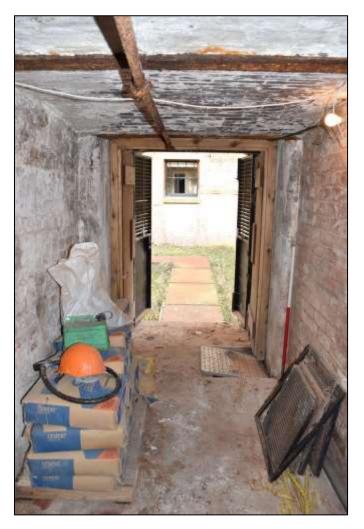
- 4.5.4 Two brick barrel vaults, orientated on a north-east to south-west alignment, form the cellar corridor at ceiling level. The edges of the vaults have been reinforced with I-Beam metal girders throughout the cellar. A heavily corroded metal bar of unclear function hangs from the ceiling and extends along the entire length of the corridor. At the southern end of the cellar corridor is a small chute-like structure, which may have actually functioned as a light well; the feature is lined on all sides with cream glazed bricks which would have enhanced light reflection into the area.

Plate 15: The corridor of the vaulted cellar (DP 45)

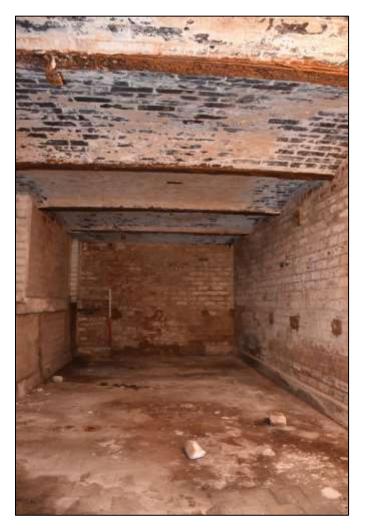
- 4.5.6 Beyond the short linkage is the primary vaulted cellar unit. Five brick barrel vaults, orientated on a contrasting north-west to south-east alignment to that of the access passage, form the ceiling. I-Beam metal girders have likewise been used in this unit, though they appear to have been adorned with hooks of unclear function in places. The bricks used in the construction of the vault appear vitrified and are somewhat covered in efflorescence. Differing from the brickwork of the corridor and perhaps to better counteract the considerable lateral forces, the walls of the main cellar unit are laid in stretcher bond.

Plate 16: The barrel-vaulted cellar (DP 50)

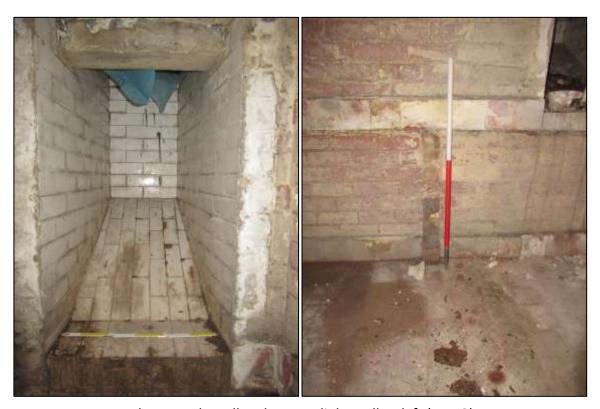
- 4.5.8 Two protruding brickwork features are present at either end of the southern window that may have been supported shelving. This interpretation is also evidenced by marks alluding to the former presence of horizontal timbers, which may have supported the shelving along the span of the southern wall (Plate 18).

- 4.5.9 The main cellar unit is floored with square quarry tiles. Similar tiles appear to have adorned the southern wall above the hypothesised shelf, perhaps functioning as a 'splashback'. The evidence suggests the tiles were used solely as skirting along the northern wall.

Plate 17: The cellar chutes or light wells – left (DP 52)

Plate 18: Remnants of the former cellar shelf – right (DP 53)

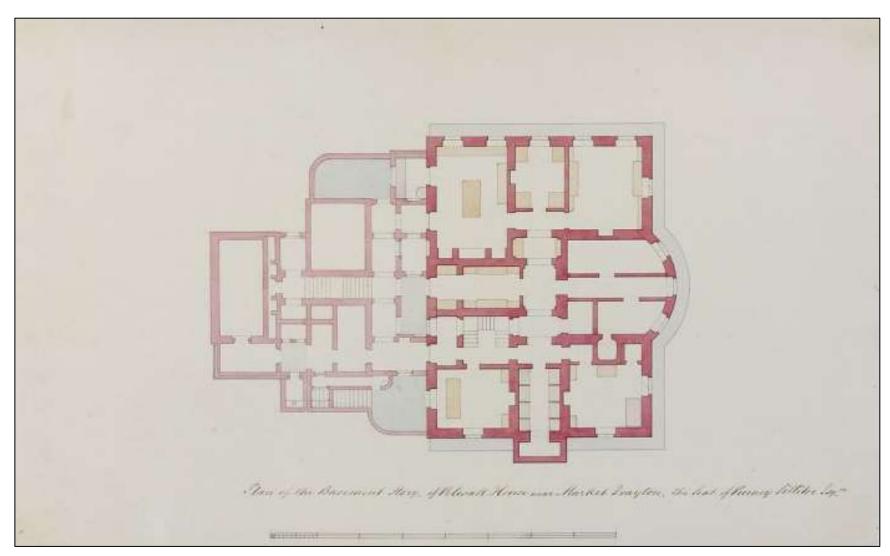
large wing of domestic offices, which likely meant the arrangement and function of the basement rooms of the principal structure changed in response to the additional service accommodation (Appx.1.2).

2. Presentation drawing of the basement dated to September 1828 (© Sir John Soane's Museum)

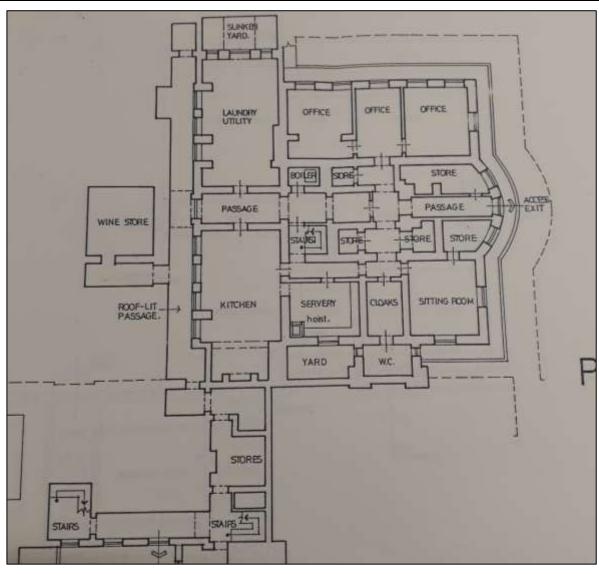
- 3.6.2 A historic building survey plan of the structure in the 1990's, prior to demolition, produced a schematic plan of the basement level during the Edwardian period (Appx.1.6). The area of the southern extension comprised a laundry and a partly tiled kitchen divided by a passageway, mirroring the drawing and dining room on the ground floor. Appended to the laundry was an external sunken yard which, according to the later demolition plans, was accessed via Victorian or Edwardian external steps (Appx.1.7). It also notes that Soane's original vaulted cellar functioned as a wine cellar, accessed via a roof-lit passage linked to the eastern wing.

6. A schematic plan of the basement at basement level during the Edwardian period (PWPT 1993: Vol.1)
