**20 WELLINGTON STREET, LITTLEPORT, ELY,
CAMBRIDGESHIRE**

HISTORIC BUILDING RECORDING

FEBRUARY 2022

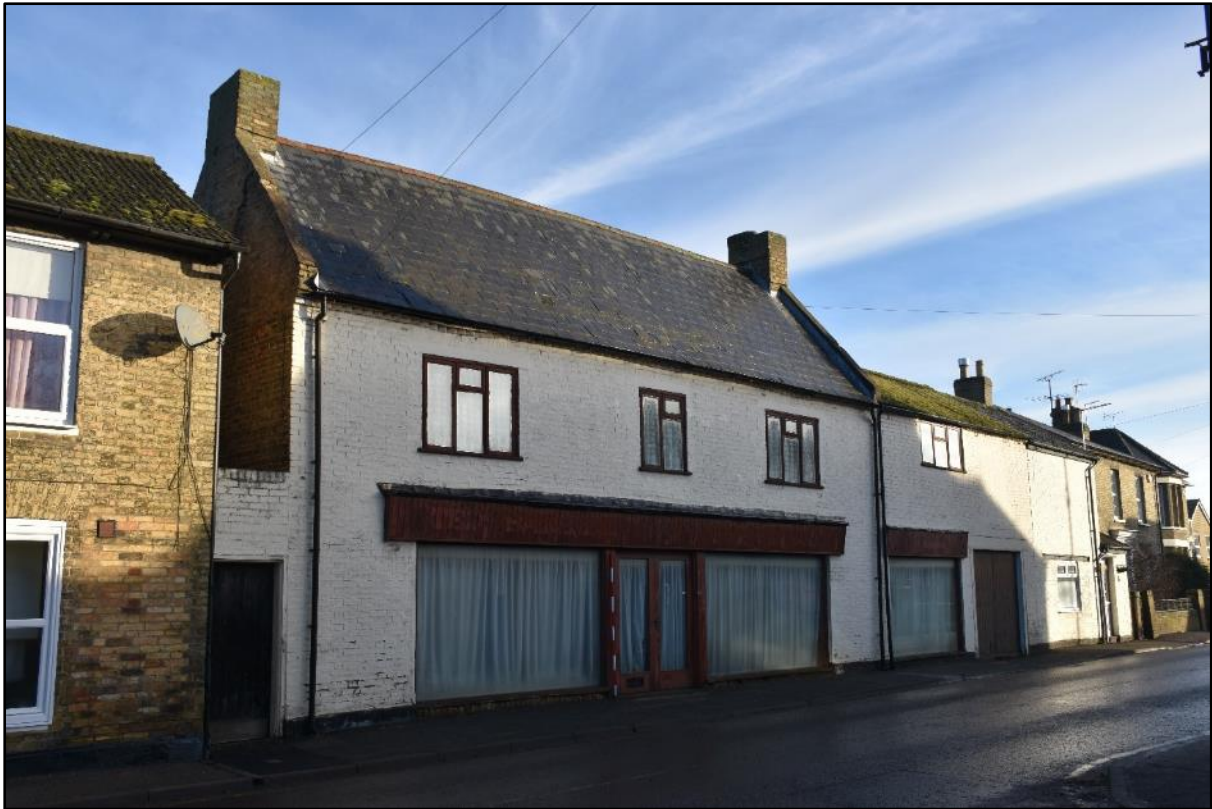
Plate 1 South elevation, taken from the south-west of Ranges 1 and 2 (DP 5)

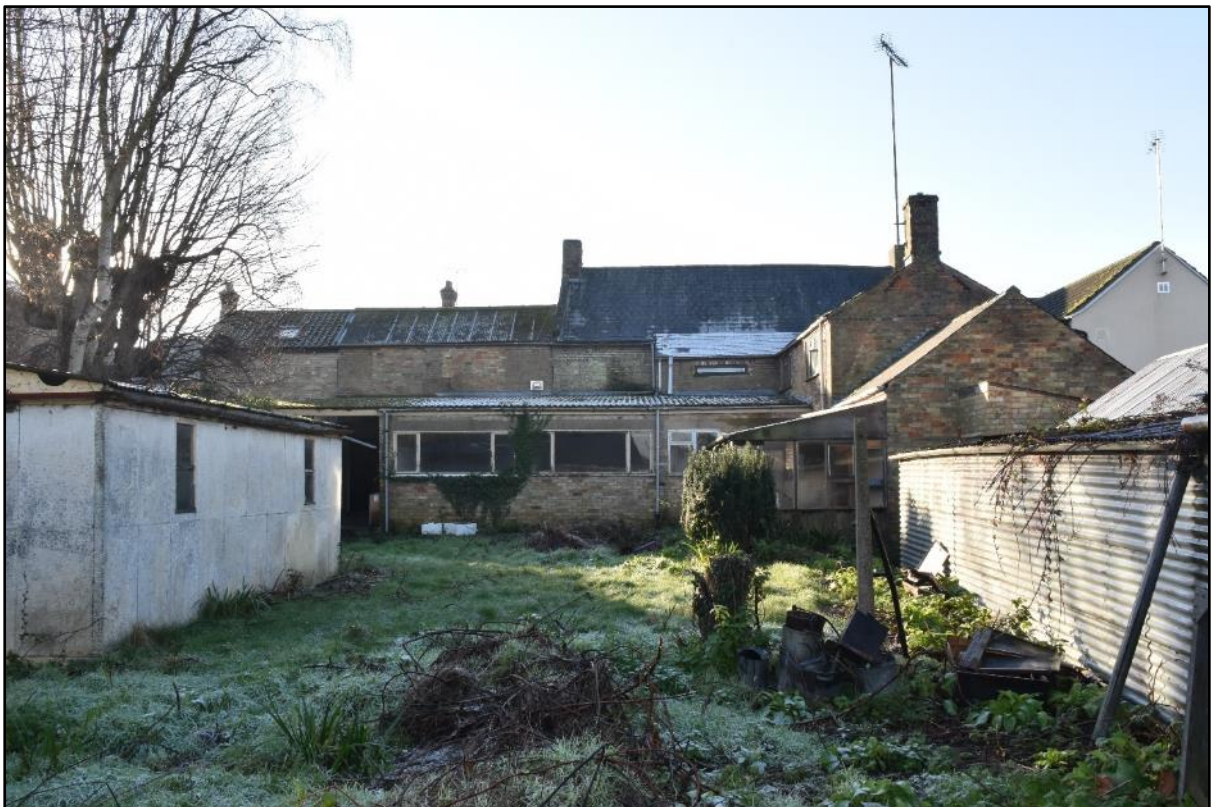
Plate 2 North side of the building with outbuildings to both sides, taken from the north (DP 38)

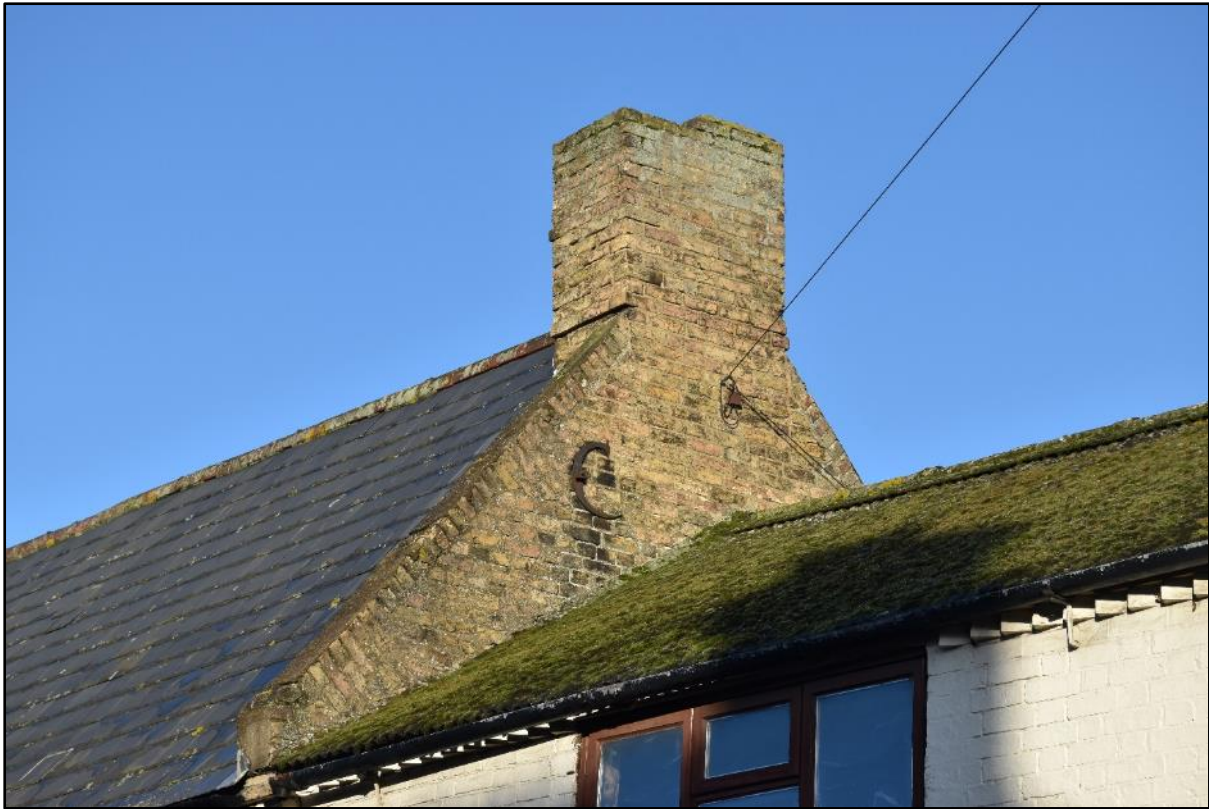
Plate 4 East gable-end of Range 1 showing tumbled-in brickwork and iron tie-plate, taken from the south-east (DP 8)

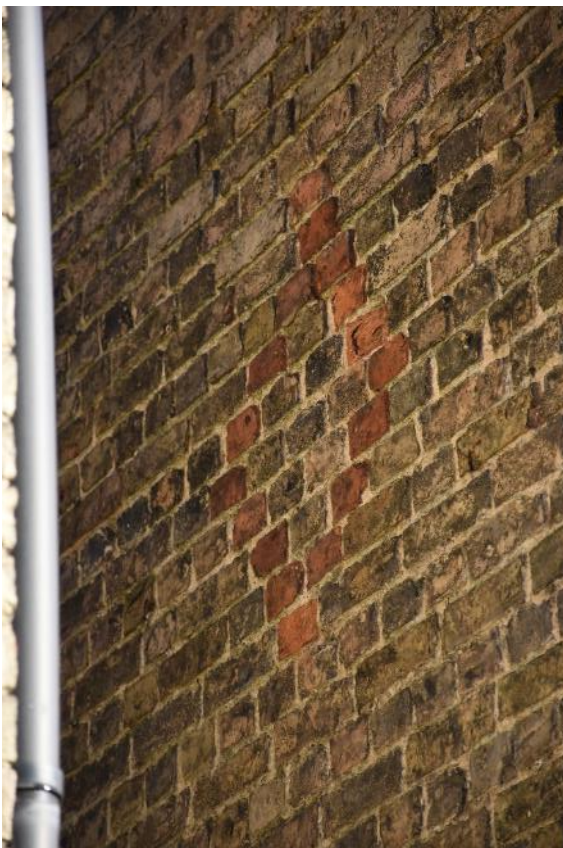
Plate 5 West elevation (Range 1) showing decorative diamond picked out in red brick, taken from the south-west (DP 29)

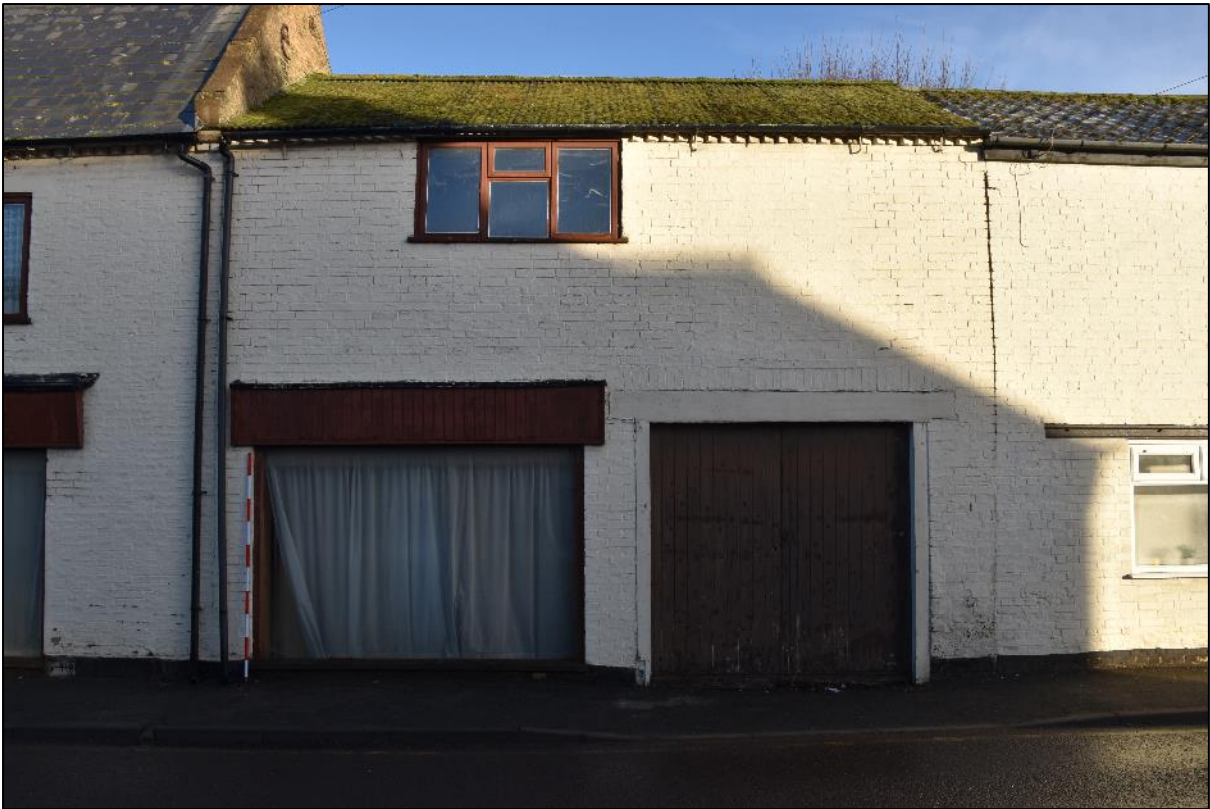
6.1.12 Range 2 extends inline with Range 1 having eaves at the same height but is clearly secondary to the primary range in having a straight joint in the brickwork and a lower roofline (**Plate 6**). This range rises over two storeys in brick laid in Flemish bond, all painted on this side. The bricks have both straight and diagonal skintles. No original apertures or joinery appears to survive. Instead, the ground floor here has been altered with a modern shop front to the west and a pair of double doors to the east enclosing a throughway.

Plate 6 South elevation (Range 2), taken from the south (DP 15)

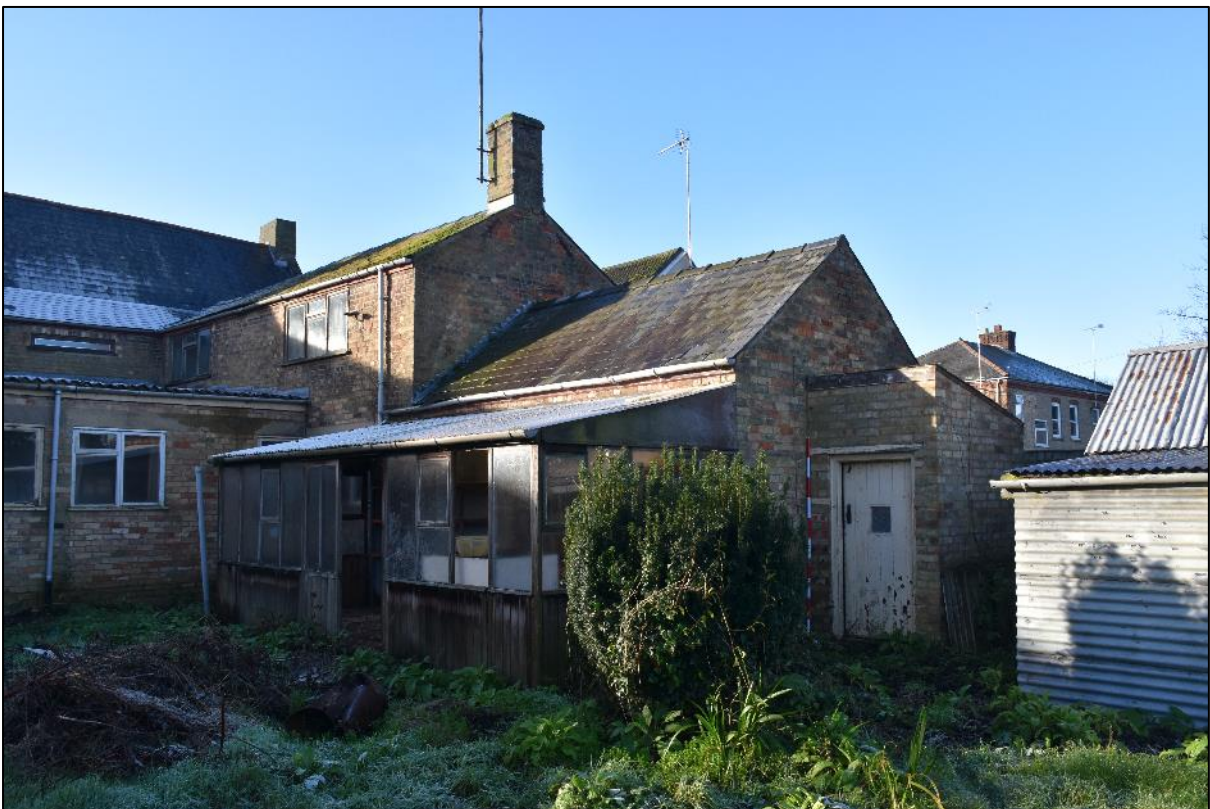
Plate 7 View of Ranges 3 and 4 with attached units at low level, taken from the north-east (DP 39)

6.1.17 Range 3 extends from the north side of range 1 along the boundary of the site and in form and character is consistent with use as workshops or storage (**Plate 7**). This range is built of 19th century variable yellow / orange brickwork with many bricks displaying straight skintles and creasing. The brickwork is laid in English bond and the west elevation is largely plain at ground and first floor level apart from

6.1.21 Range 4 comprises a small single-story range extending in line from the north end of Range 3 (Plate 7). It has been reconfigured on several occasions, and although some 19th century stock brick is visible much has been replaced with Fletton bricks. The west elevation contains a timber casement of 20th century date.

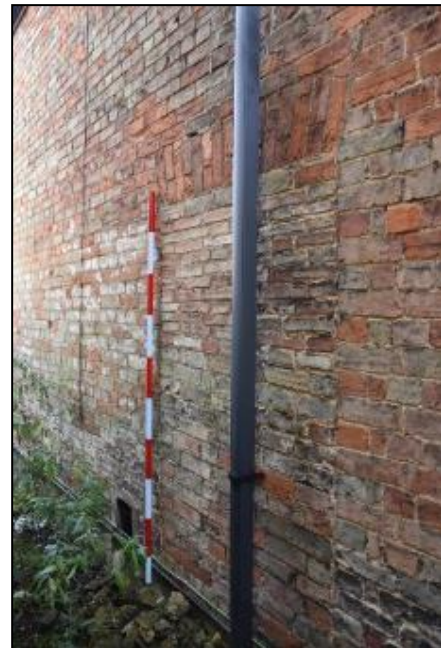
Plate 8 West elevation (Range 3) showing blocked doorway in the centre, taken from the south-west (DP 9)

a blocked doorway in the centre which lies below a flat brick arch (**Plate 8**). This aperture has queen closers on the southside only. Adjacent to the doorway is a small recess for a former boot scraper. To the north, a section of brickwork at low level appears to be a slightly different fabric; the bricks are slender and this may represent reuse of earlier bricks for the lower courses or reflect on earlier section of wall.

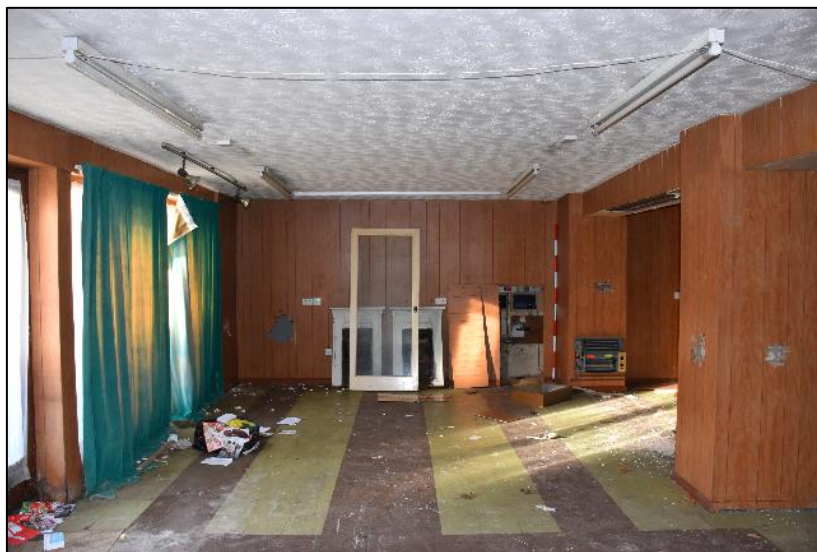
6.1.30 The ground floor of Range 1 is now open with Range 2 and the original rear wall removed, leaving only brick piers with RSJs inserted to support the upper structure, and the space is now open with the southern half of Range 3 and Range 5. The shop floor (GF01, GF02, GF03) is entirely floored and lined throughout in modern materials. This includes floor tiles, thin plywood cladding to the walls and artex plaster work to the ceiling (**Plate 9**). Where aperture's have been pierced through the boarding the brickwork of isolated piers is visible and at the West End two recesses lie to either side of the chimney stack and were once enclosed with cupboards. the walls all painted within and have impressions of shelving. Two small decorative iron fire grates lie *ex-situ* here.

Plate 9 *GF01 (Range 1) showing modern wall surfaces and openings created in the rear wall of the building (right), taken from the east (DP 61)*

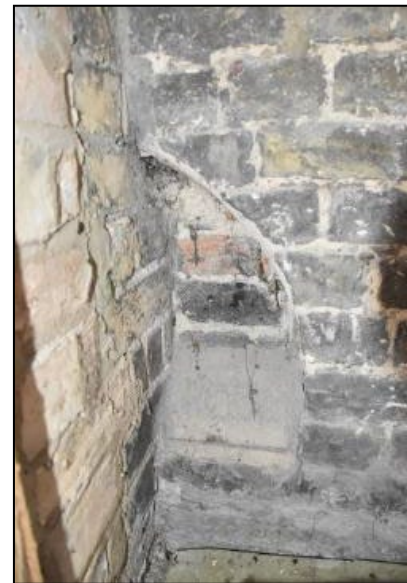
6.1.32 GF02 originally comprised a discrete space probably accommodating a staircase (Range 5) but is now open on all sides. Despite this, small sections of brickwork survive, and demonstrates this range was built against Range 1 prior to the construction of Range 3. The level of disturbance in this area, however, makes the sequence difficult to elucidate. Evidence of the formerly external wall of Range 3 is also visible where it

Plate 10 West wall of GF02a (Range 6) showing junction between Ranges 3 and 5 and position of boot scraper, taken from the east (DP 75)

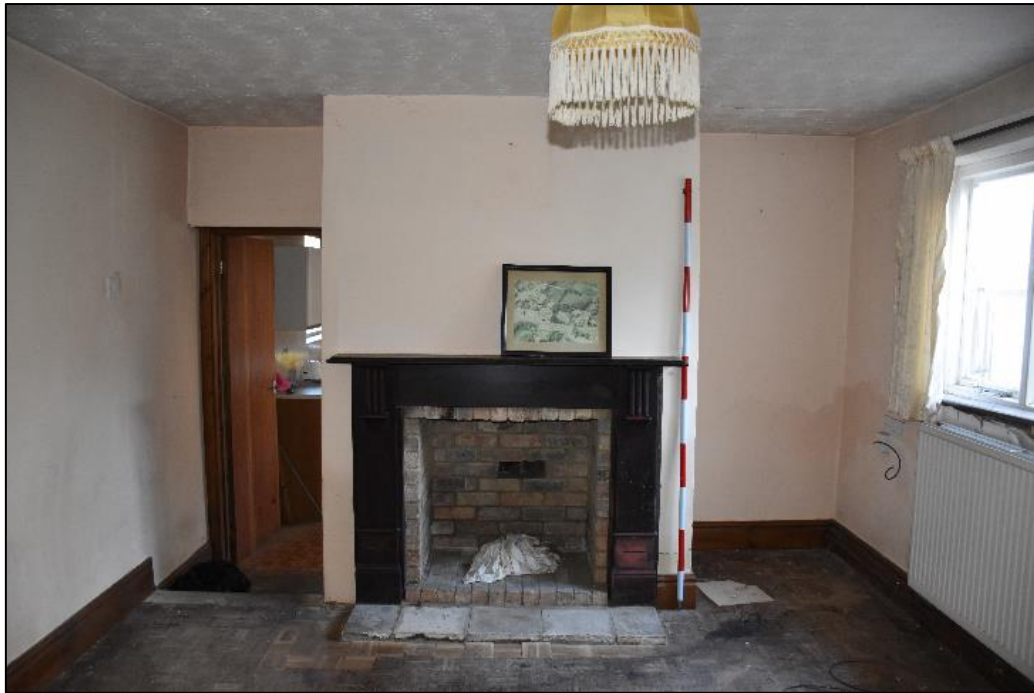
Plate 11 GF04 (Range 3), taken from the south (DP 77)

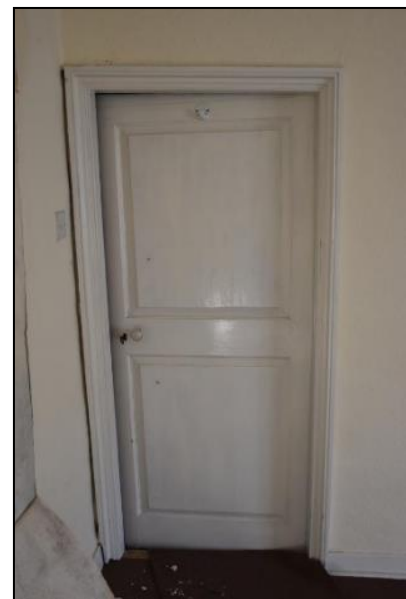
Plate 12 Two-panel door in the north-east corner of FF01 (Range 1), taken from the west (DP 138)

6.1.37 Room FF01 occupies the west end of the main range. It comprises a former bedroom with a modern floor, plain skirting board and no cornice. The window overlooking the street is modern and, as noted, the only feature is the two-panel door which is set in a moulded surround. It has been augmented and utilises butt hinges but retains a good rim lock.

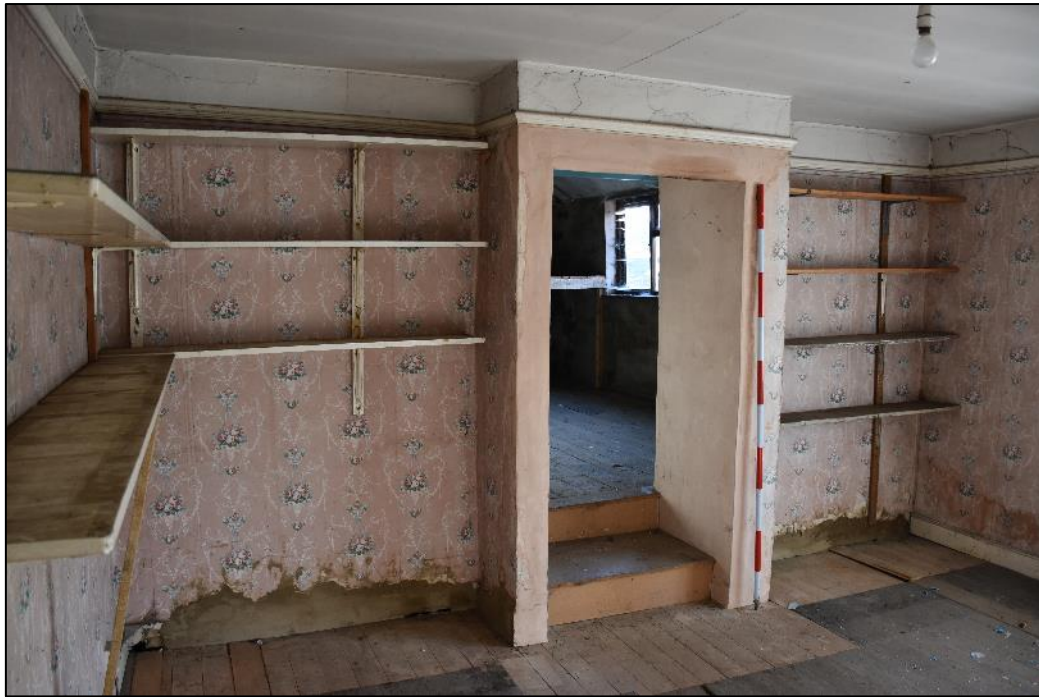
Plate 14 East side of FF04 (Range 1) showing doorway punched through the chimney stack into the adjoining range, taken from the west (DP 111)

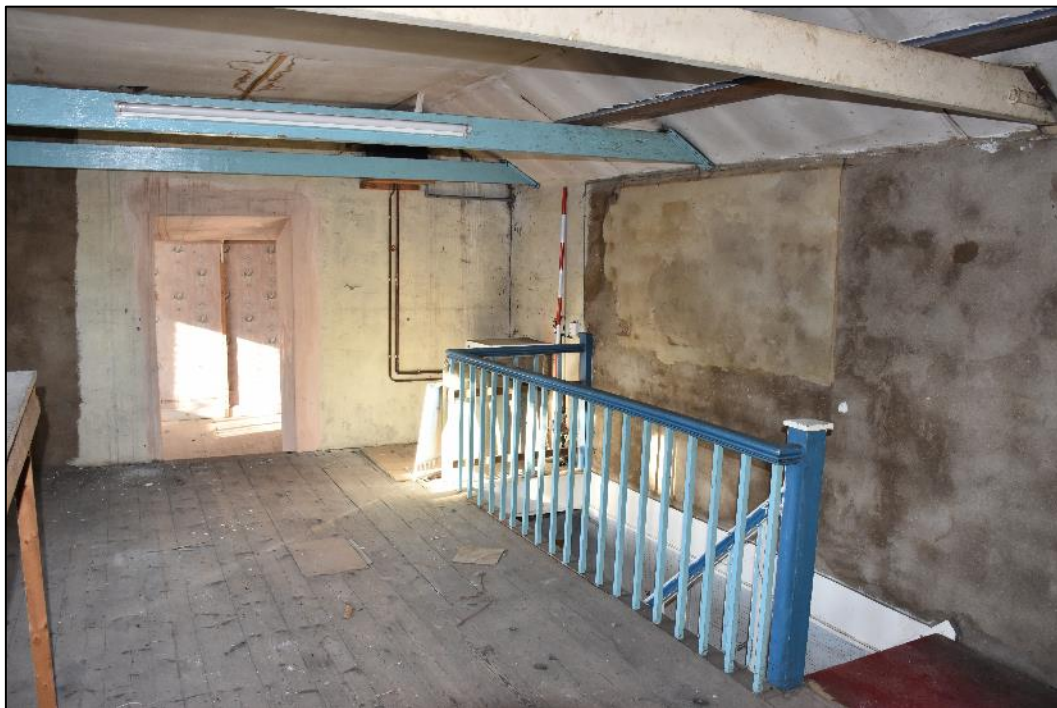
Plate 15 FF06 (Range 2), taken from the east (DP 104)

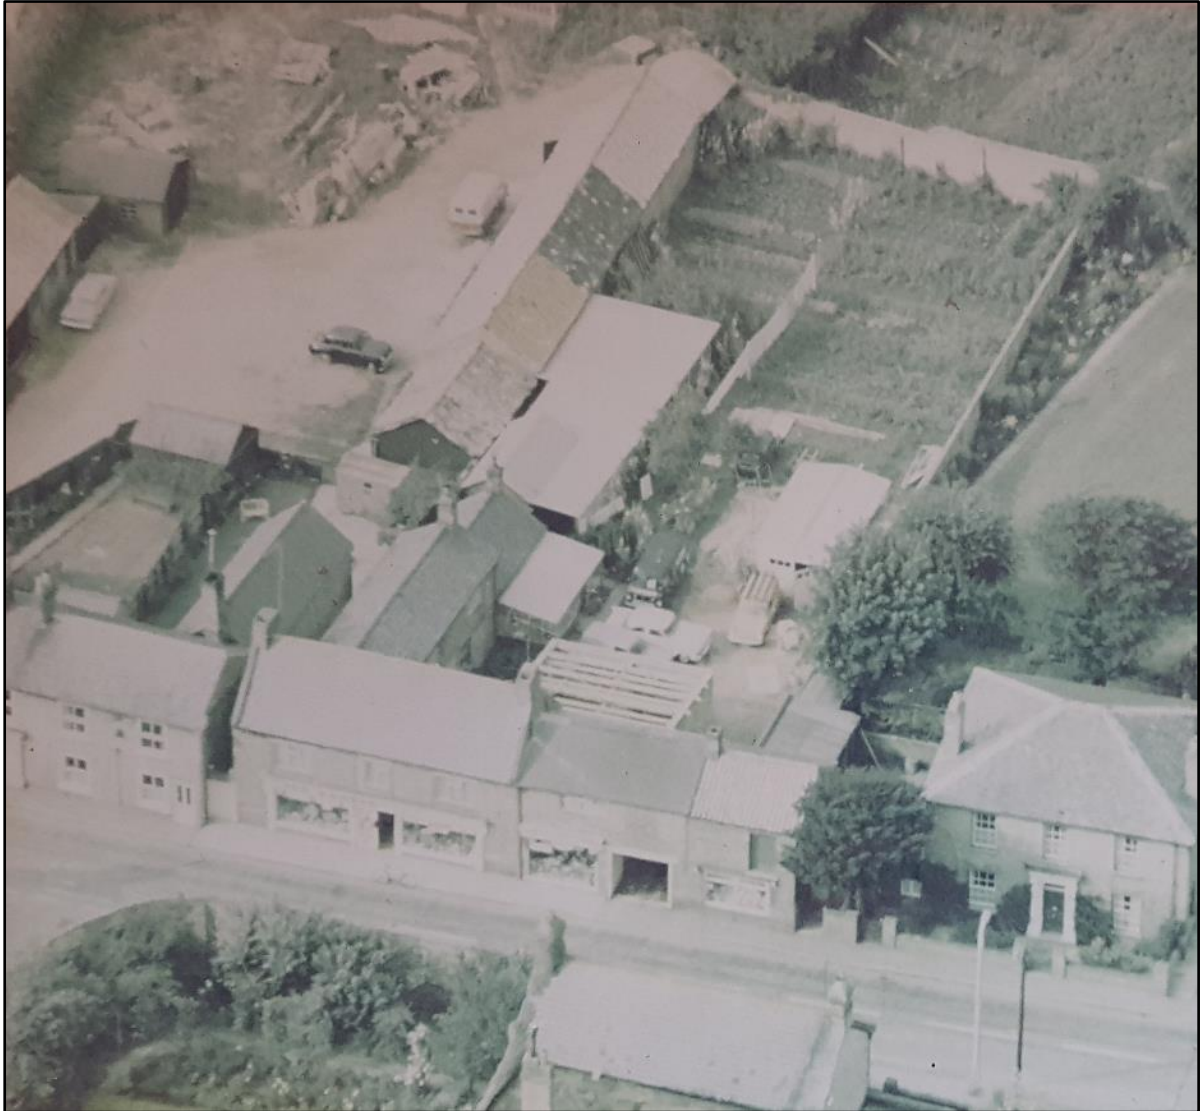
- 5.6 Not long after this date the small outbuildings are removed, and an aerial photograph taken in 1965 shows the building and rear plot in detail (App. 1.1). By this time, the frontage had already been extensively altered and the bow window outlined on earlier maps is not visible and instead a wide shop front which appears to comprise the existing shop front with central doors is present. This photograph was taken during the construction of Range 6. The existing ephemeral outbuildings are also visible to the rear. More recently the building has been used as a television sales or repair shop.

1.1 Aerial photograph of No. 20 Wellington Street, 1965 (Source: surviving within No. 20)

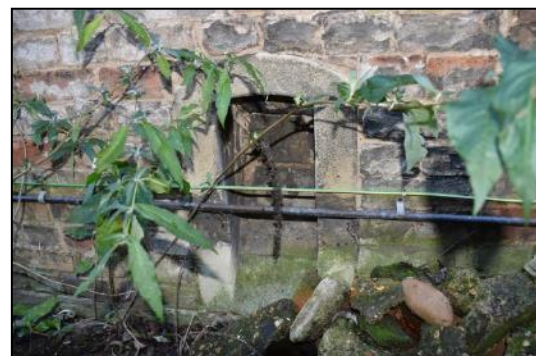
DP 36
West elevation (Range 3) showing position of former boot scraper adjoining the blocked doorway, taken from the west

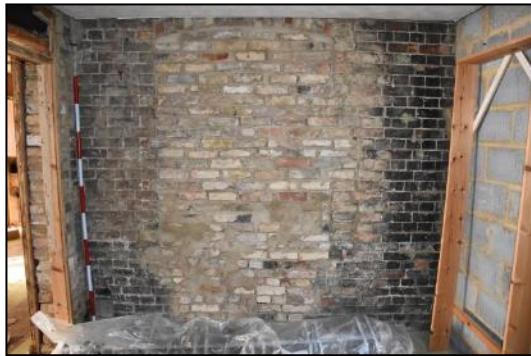
DP 73
West wall of GF02a (Range 6) showing formerly external wall of Range 3 containing blocked doorway, taken from the east

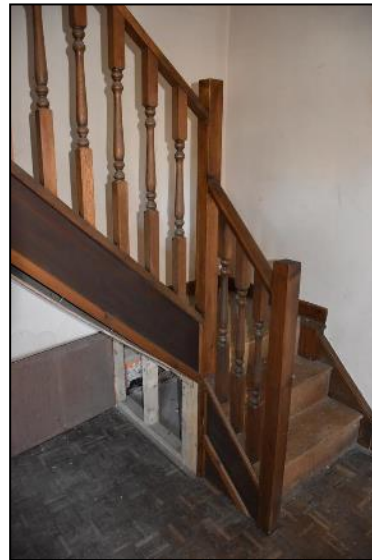
DP 80
Modern staircase in GF04 (Range 3), taken from the north-east

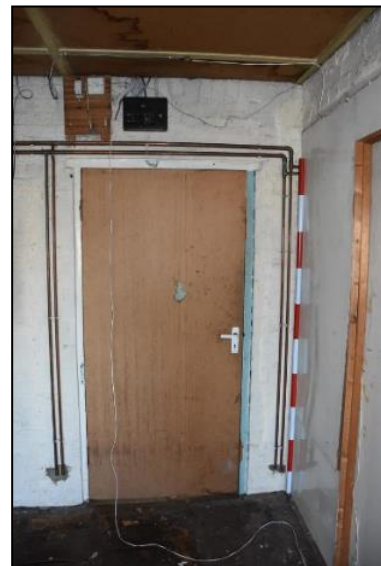
DP 96
South end of GF06 (Range 6) showing modern doorway inserted into the rear wall of Range 1, taken from the north

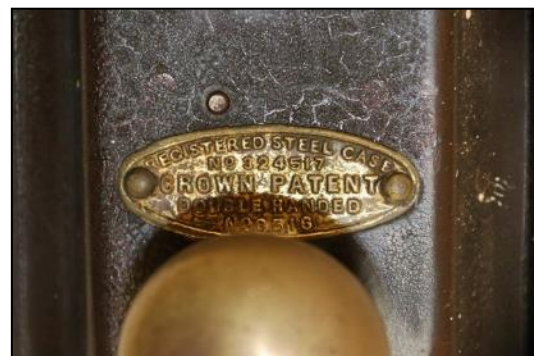
DP 132
Detail of the patent rim-lock on the door in FF02 (Range 1), taken from the south

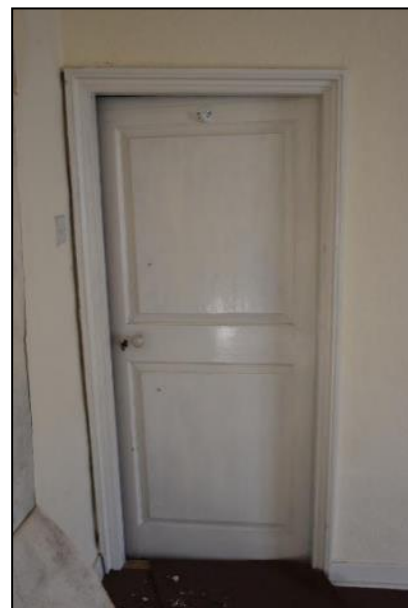
DP 138
Two-panel door in the north-east corner of FF01 (Range 1), taken from the west

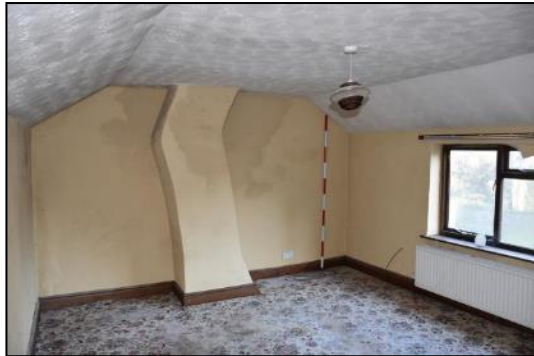
DP 157
FF10 (Range 3) showing integral chimney stack,
taken from the south
