LAND NORTHWEST OF WELL HOUSE FARM

Colwell

Archaeological Evaluation

Project 234-18-HS | November 2018

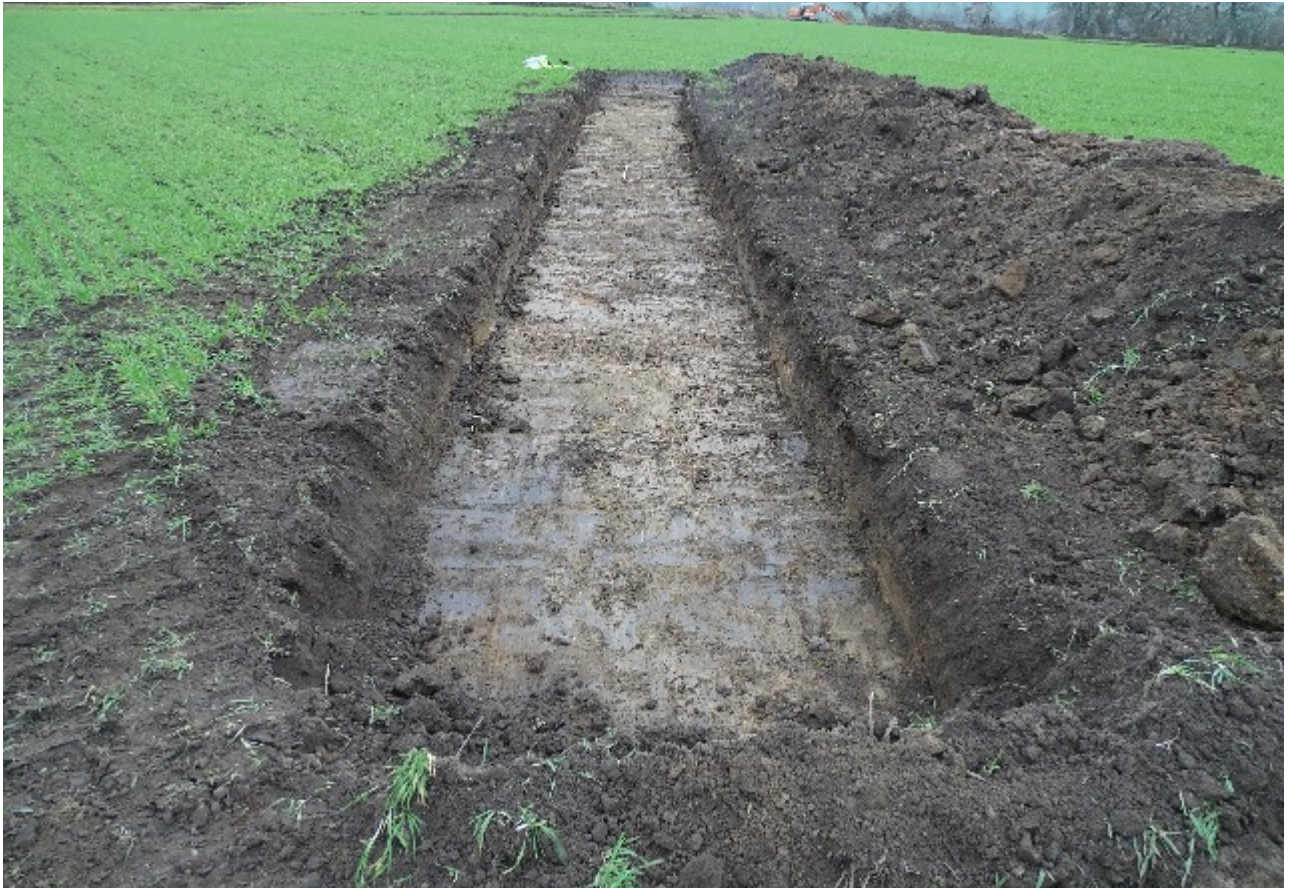
Plate 4. Trench A, looking southeast.

- 3.2.1 Trenches A-C were located to evaluate the proposed access track.
- 3.2.2 No differential ploughsoils could be ascertained within the topsoil overburden in these three trenches. Each trench measured 20m long by 1.8m wide.
- 3.2.3 **Trench A:** (Plate 4) Aligned northwest-southeast, the topsoil measured between 0.4 and 0.45m deep with mid yellow-brown compact clay geology beneath.
- 3.2.4 **Trench B:** (Plate 5) Aligned northwest-southeast, the topsoil measured an average of 0.40m deep with dark brown compact clay with patches of gravel and small sandstone fragments (natural) beneath.

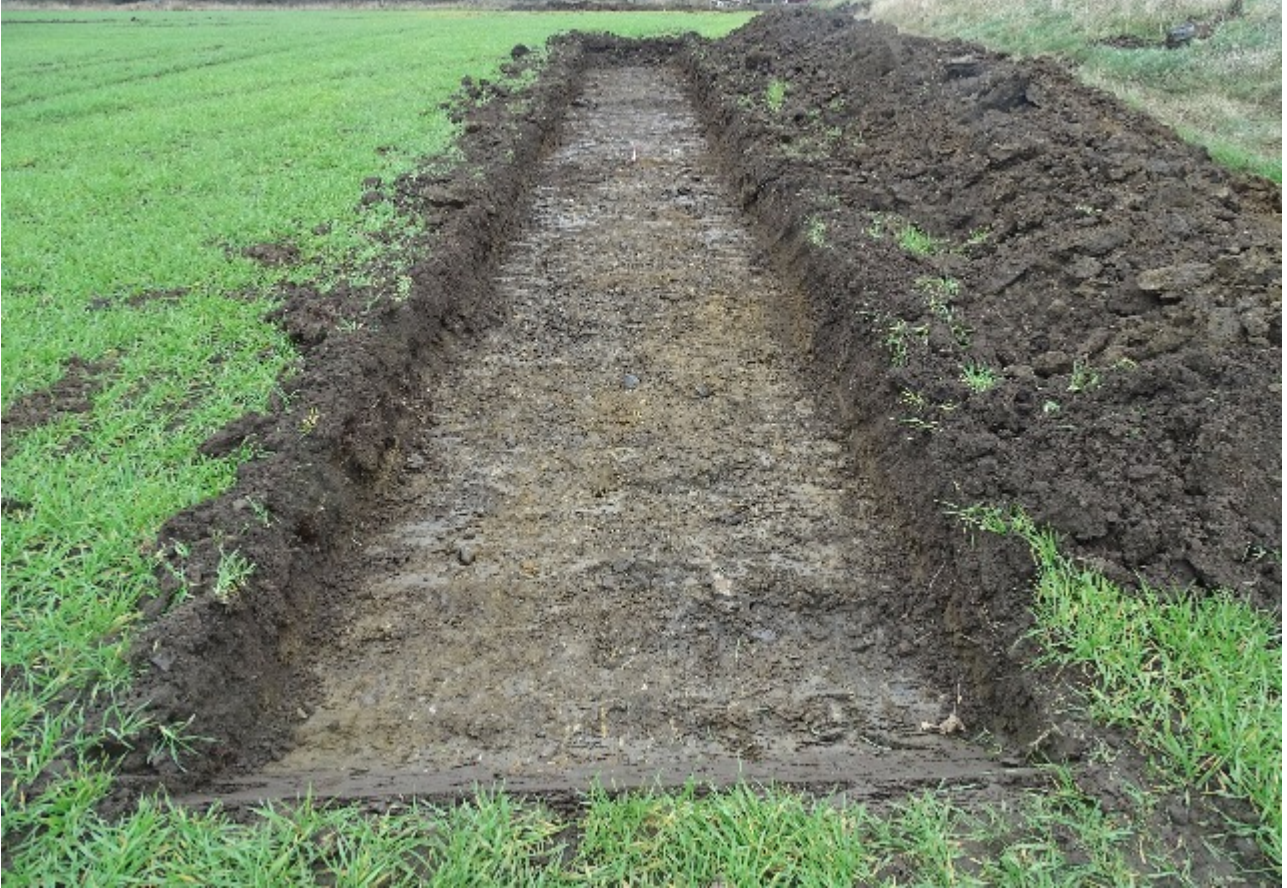
Plate 6. Trench C, looking north.

- 3.2.5 **Trench C:** (Plate 6) Aligned approximately north-south, the topsoil measured an average of 0.50m deep with dark brown compact clay with patches of gravel and small sandstone fragments (natural) beneath. A modern plastic service pipe (water) was observed crossing the trench on an east-west alignment 7.5m from the northeastern corner of Trench C.
- 3.2.6 **No archaeological material was observed within the evaluation of the proposed access track.**

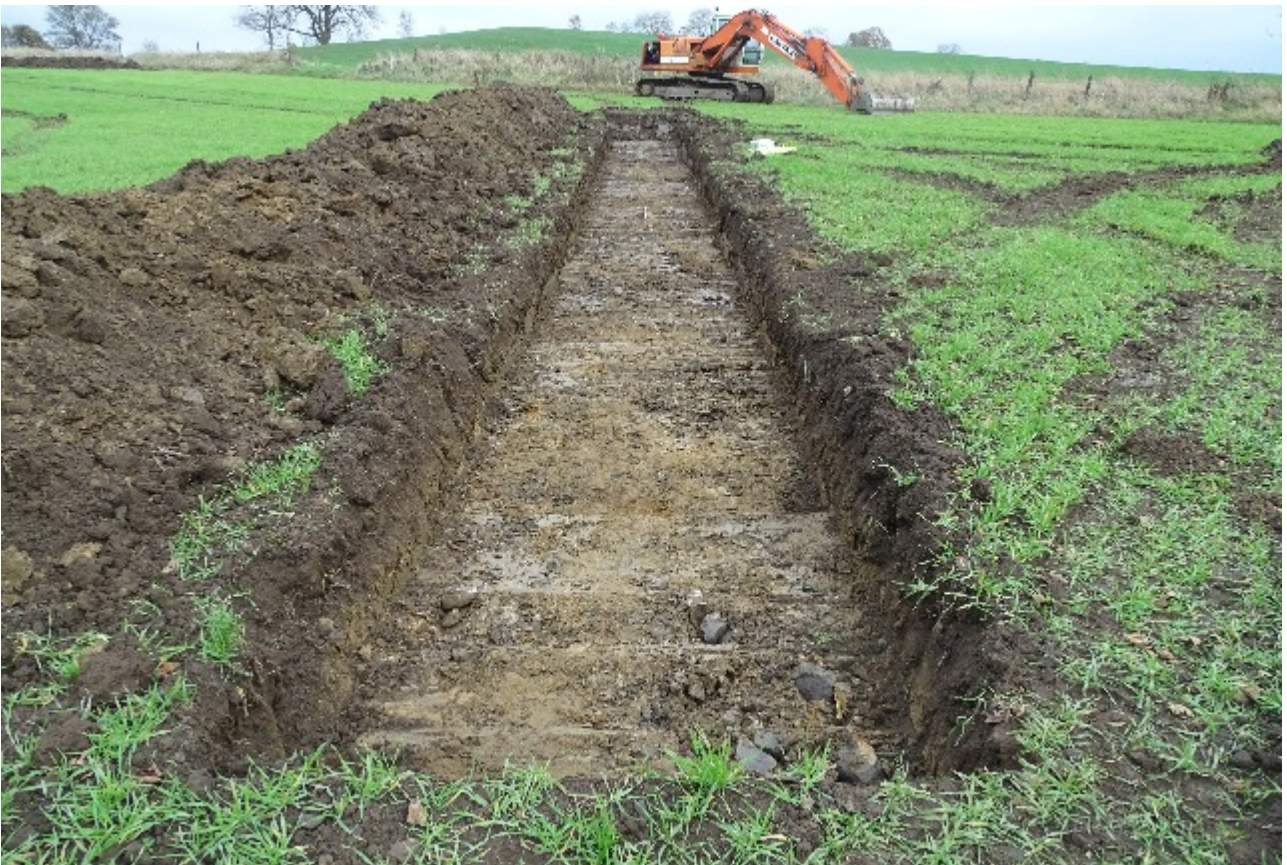
Plate 7. Trench D, looking northeast.

3.3.3 **Trench D:** (Plate 7) Aligned northeast-southwest, the topsoil measured between 0.55 and 0.6m deep with dark brown compact clay with patches of gravel, brown-orange clay and small sandstone fragments (natural) beneath.

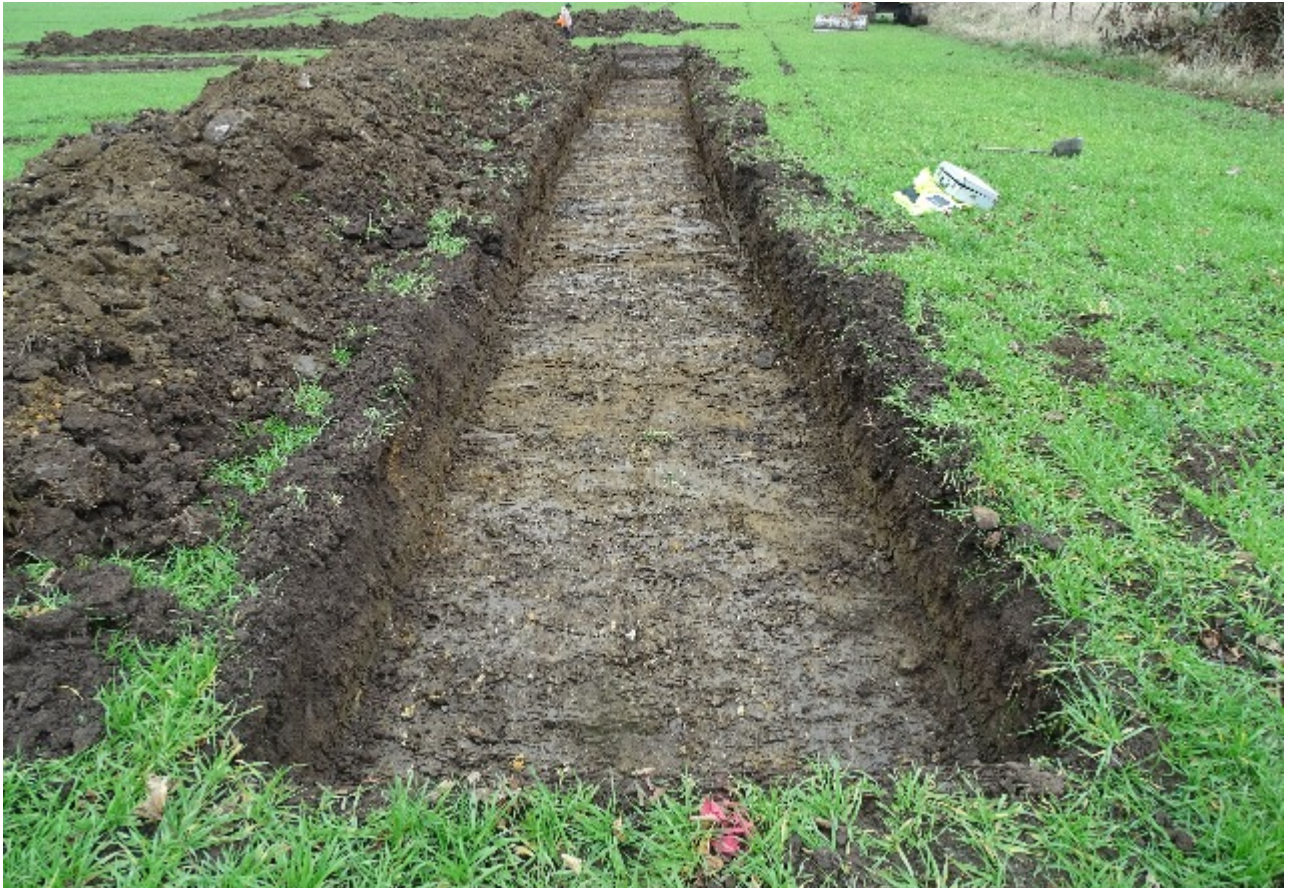
Plate 8. Trench E, looking north.

3.3.4 **Trench E:** (Plate 8) Aligned approximately north-south, the topsoil measured an average of 0.5m deep with dark brown compact clay with patches of gravel, brown-orange clay and small sandstone fragments (natural) beneath.

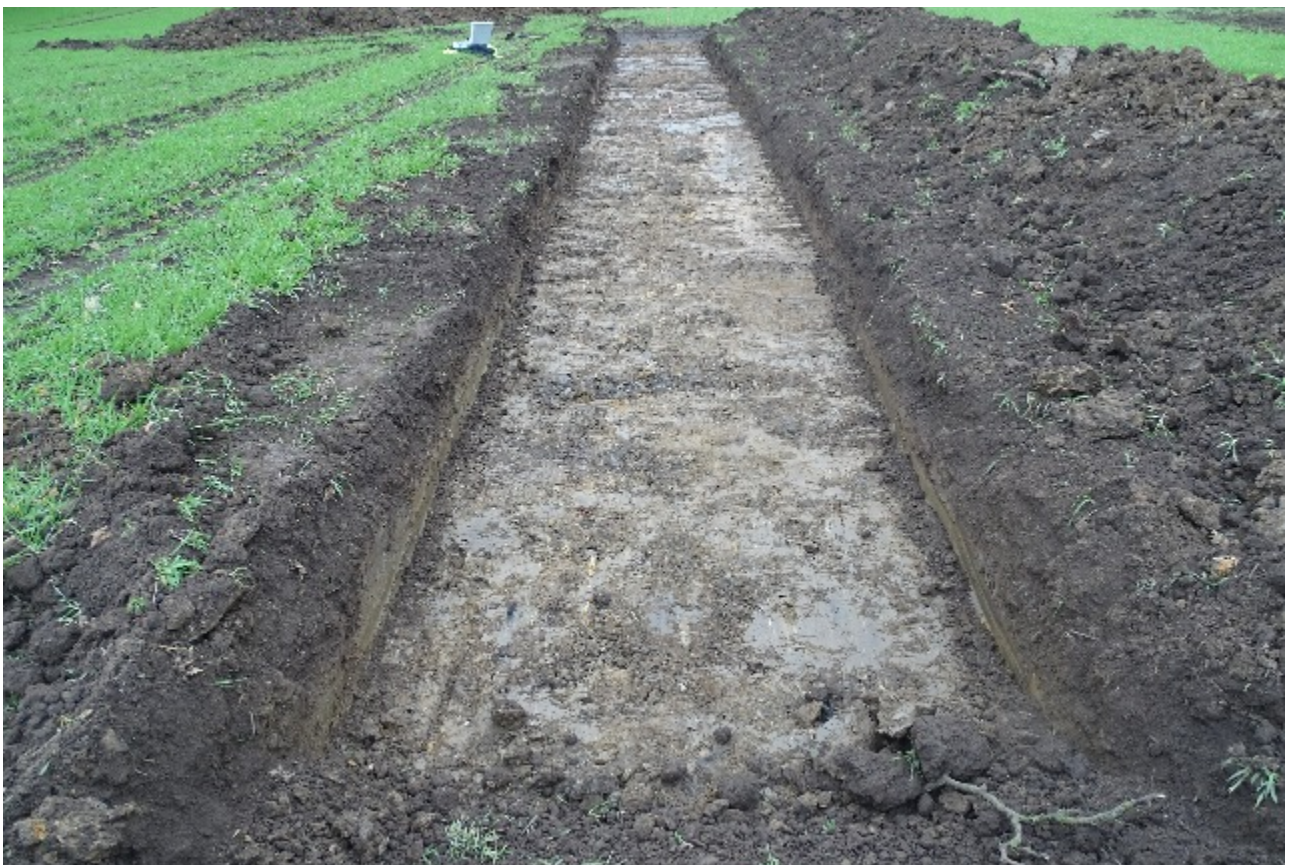
Plate 9. Trench F, looking southwest.

3.4.3 **Trench F:** (Plate 9) Aligned northeast-southwest, the topsoil measured between 0.35 and 0.4m deep with mid yellow-brown compact clay (natural) beneath.

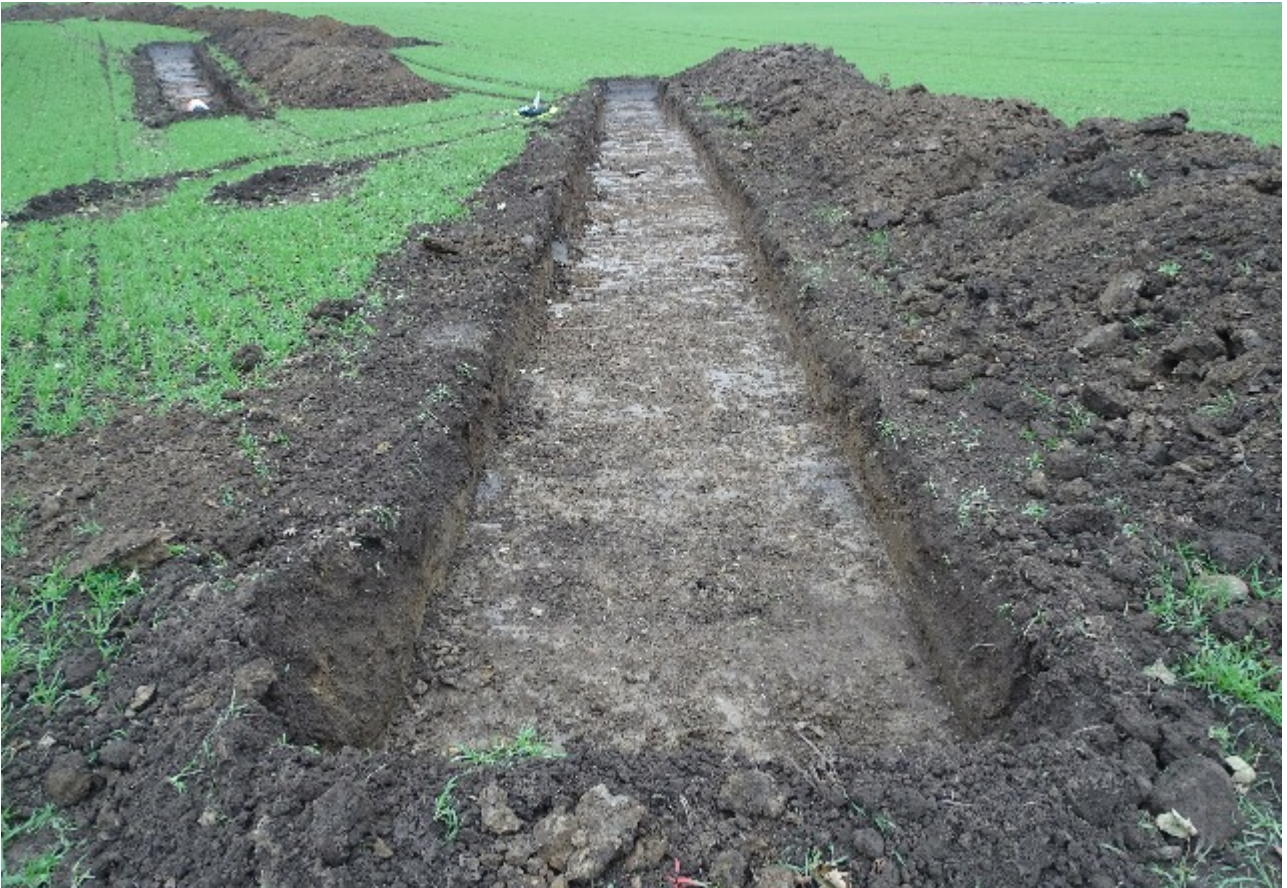
Plate 10. Trench G, looking west.

3.4.4 **Trench G:** (Plate 10) Aligned east-west, the topsoil measured an average of 1m deep in its western extent and only 0.35m deep on its eastern extent. Beneath the topsoil was mixed geology consisting of mid yellow-brown compact clay on its eastern side with dark brown compact clay with patches of gravel, brown-orange clay and small sandstone fragments to the west.

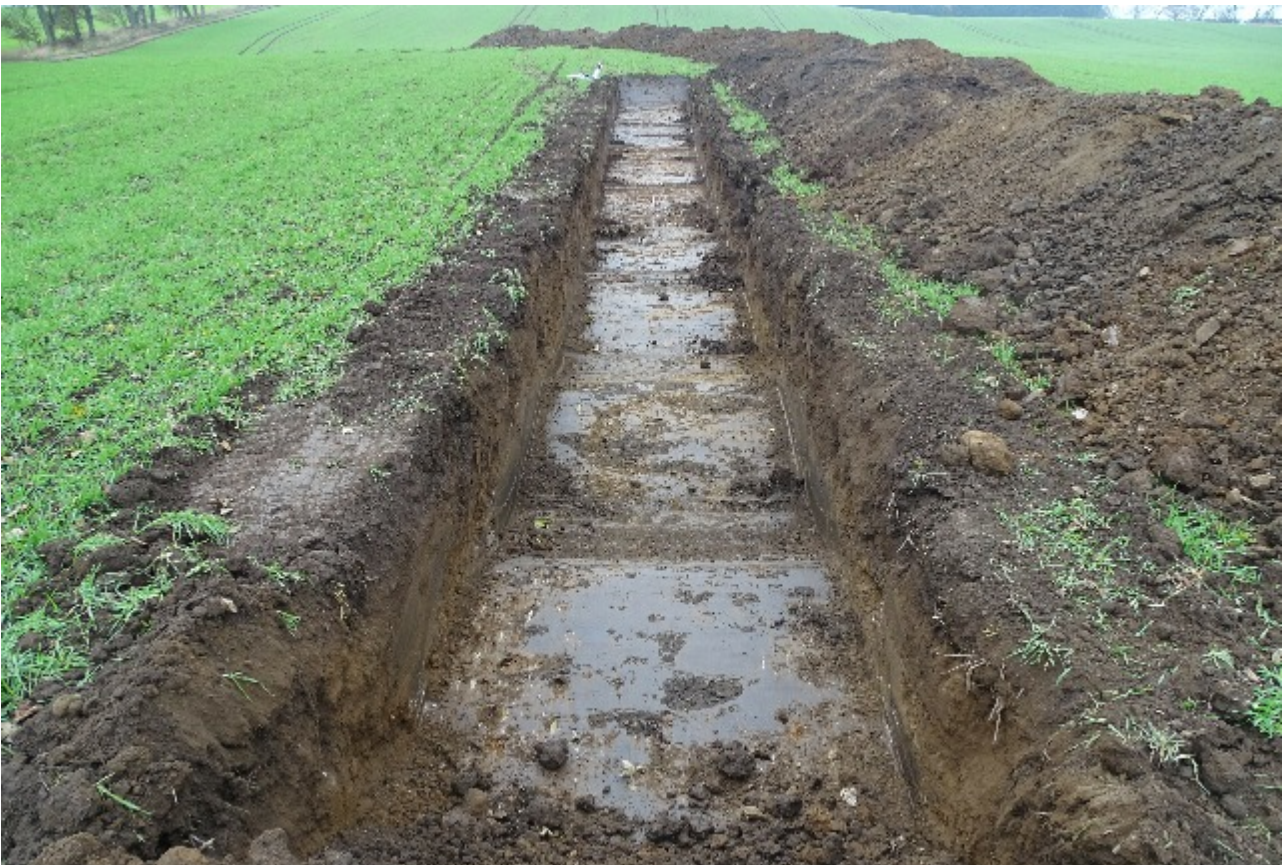
Plate 11. Trench H, looking east.

3.4.5 **Trench H:** (Plate 11) Aligned east-west, the topsoil measured between 0.7 and 1.2m deep with banded natural consisting of grey-brown silty clay, orange-brown clay and gravels beneath.

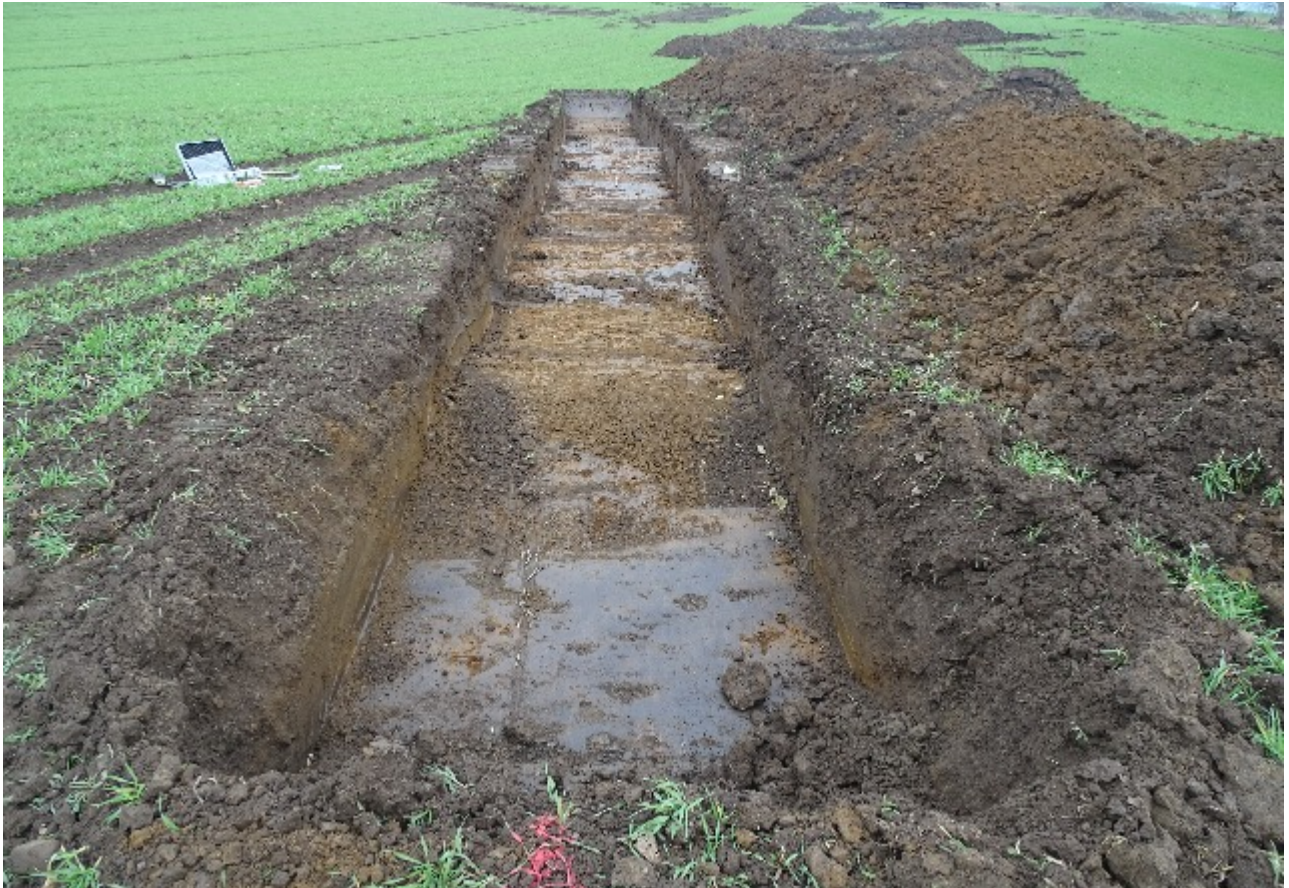
Plate 12. Trench I, looking northeast.

3.4.6 **Trench I:** (Plate 12) Aligned northeast-southwest, the topsoil measured between 0.45 and 1.2m deep with banded natural consisting of grey-brown silty clay, orange-brown clay and gravels beneath.

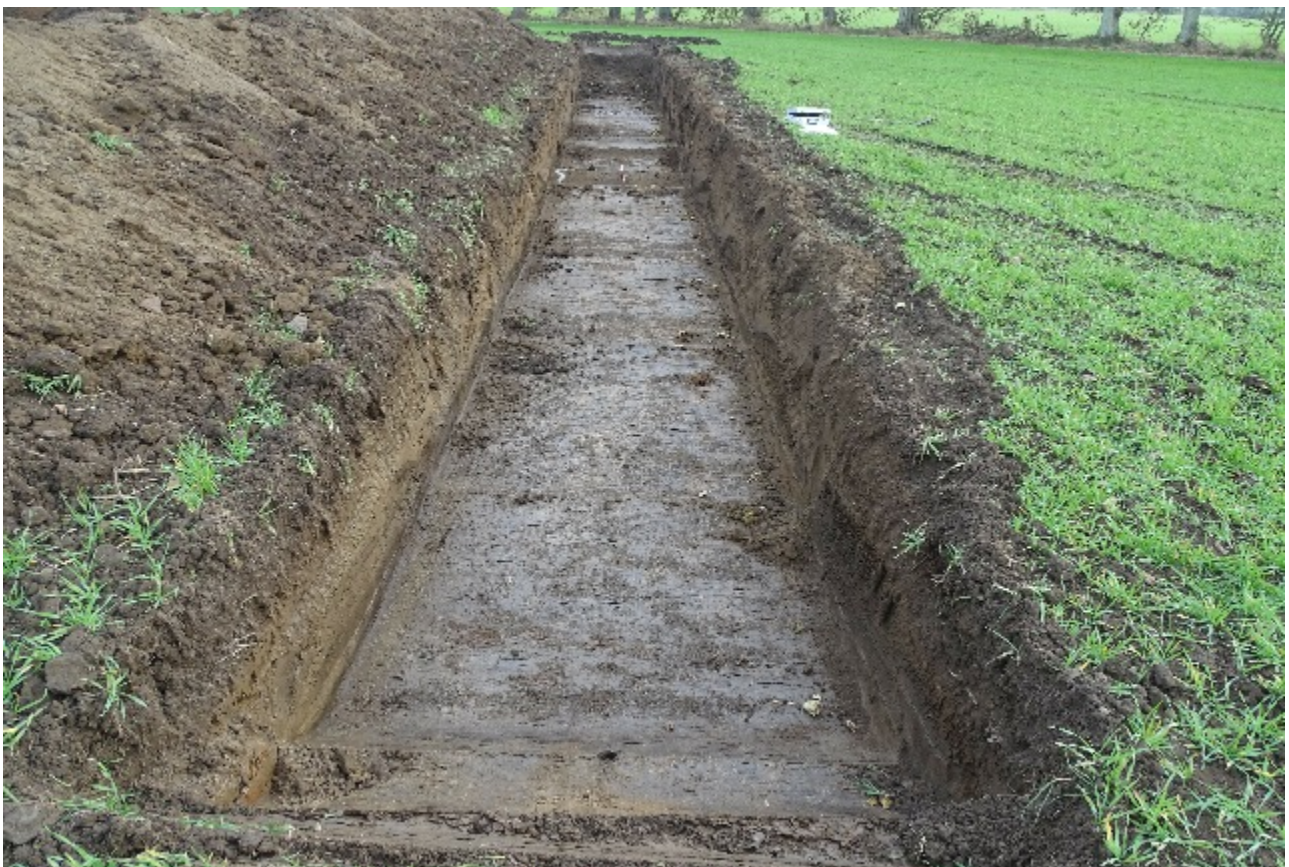
Plate 13. Trench J, looking southeast.

3.4.7 **Trench J:** (Plate 13) Aligned northwest-southeast, the topsoil measured between 1m and 1.1m deep with banded natural consisting of grey-brown silty clay, dark brown compact clay and gravels beneath.

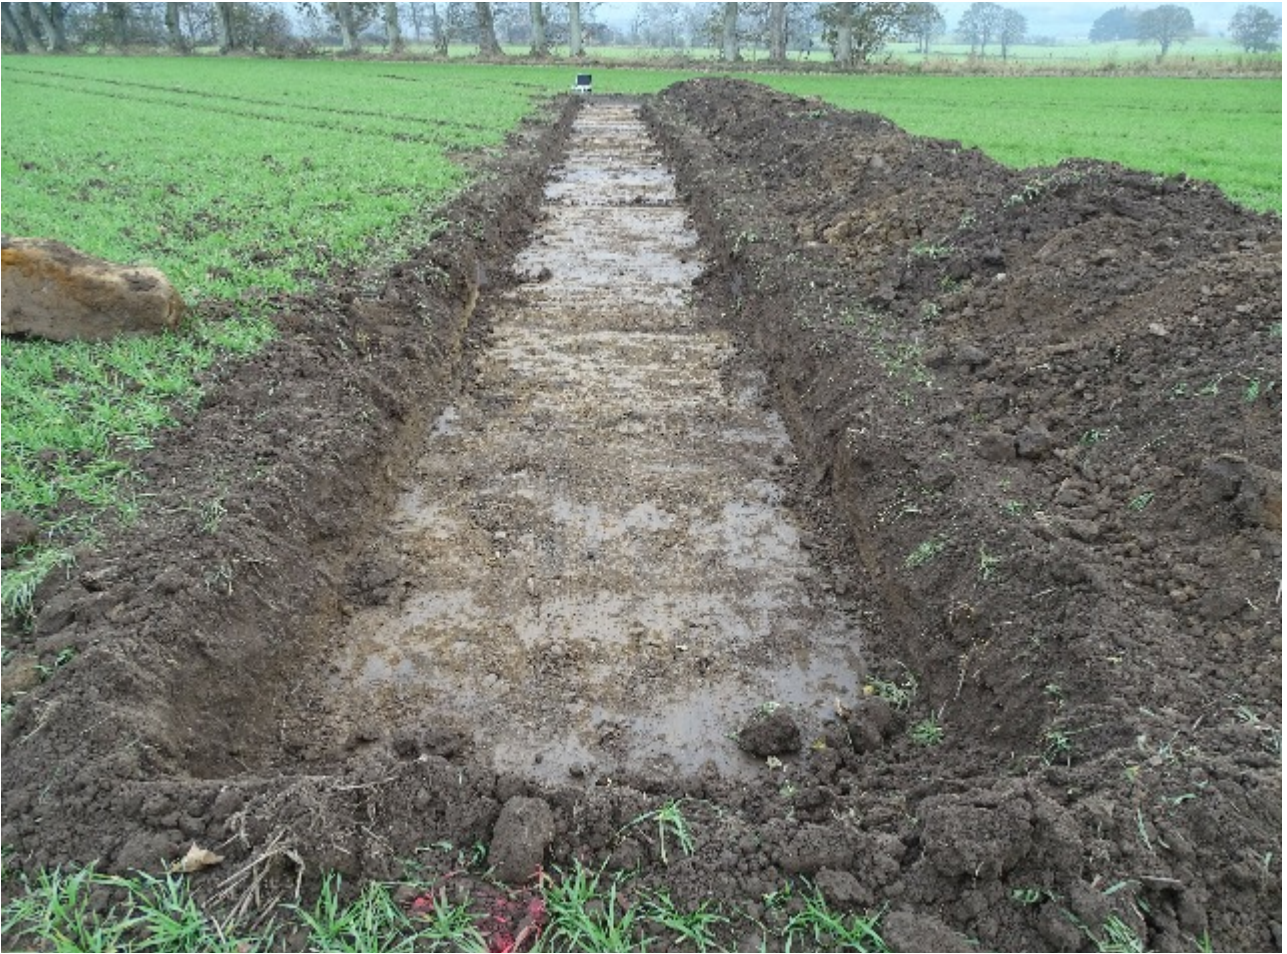
Plate 14. Trench K, looking south.

3.4.8 **Trench K:** (Plate 14) Aligned northwest-southeast, the topsoil measured an average of 0.4m deep with mid yellow-brown compact clay (natural) beneath.
